**Historic building recording
at Old Lodge Farm,
White Hart Lane,
Springfield, Essex
May 2013**

CAT project ref: 13/04i
NGR: TL 7289 0990 (c)
ECC HEM code: SFOLF13
Chelmsford Museum
accession code: CHMER 2013.077

CAT Report 705
May 2013

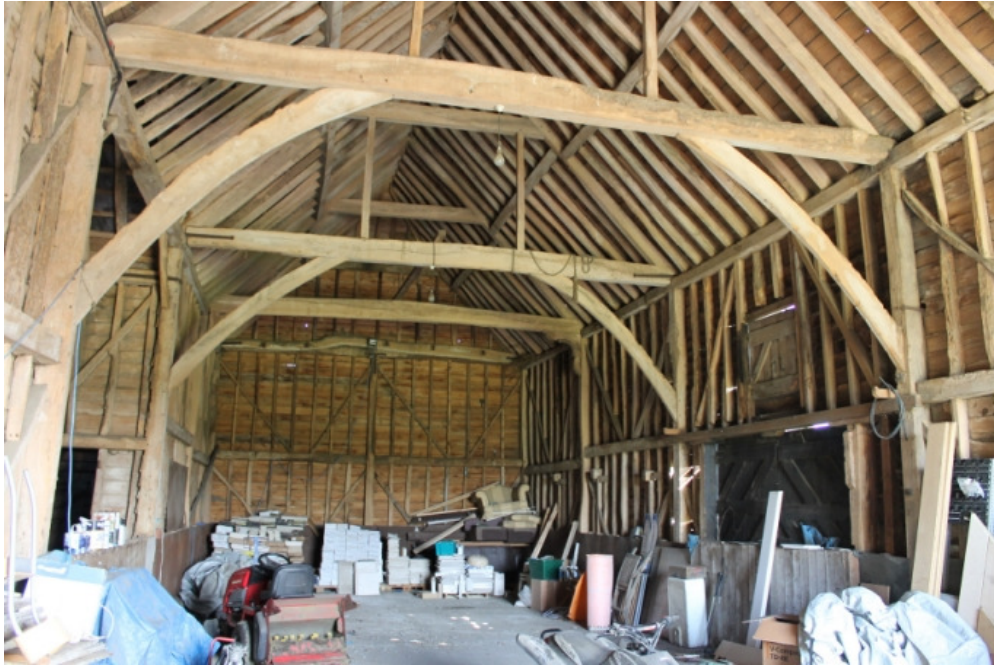
The interior of the barn was heavily cluttered at the time of the survey with the plinth and a portion of the lower register obscured by iron sheeting (Plate 3). The barn is divided into five bays, four of equal size with the central bay slightly wider, reflecting its function as the threshing floor. The floor throughout the barn is of modern concrete, although the central bay is higher than those to the sides which may indicate the presence of a brick threshing floor beneath.

Plate 3 Interior of barn 1a – view north-west

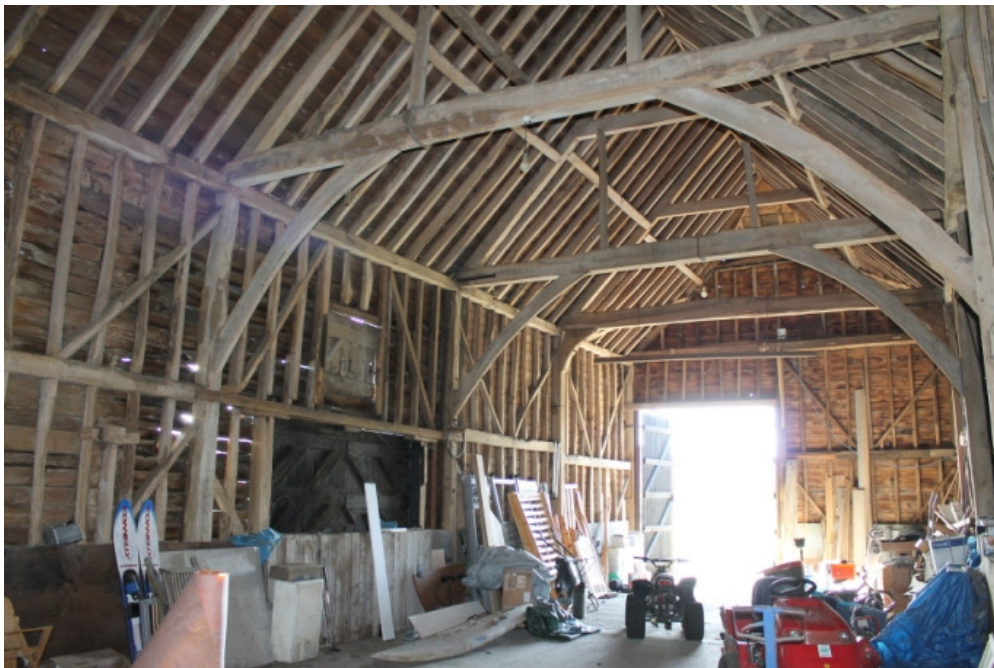
The roof trusses of the outer bays are carried on bolted knees and have a collar beam double-pegged to the principal rafters. The trusses flanking the threshing floor have lightly curved braces, double-pegged to post and tie beam (Plate 4). These trusses also have queen posts single-pegged to tie beam and collar. The roof has staggered butt purlins strengthening the rafters which support sarking boards. Wind braces are present in the roof above bay 5 but not at the other end of the barn, which suggests these are a later addition.

Plate 4 Interior of barn 1a showing trusses B and C with curved bracing and queen posts and truss D with knee braces – view south-east

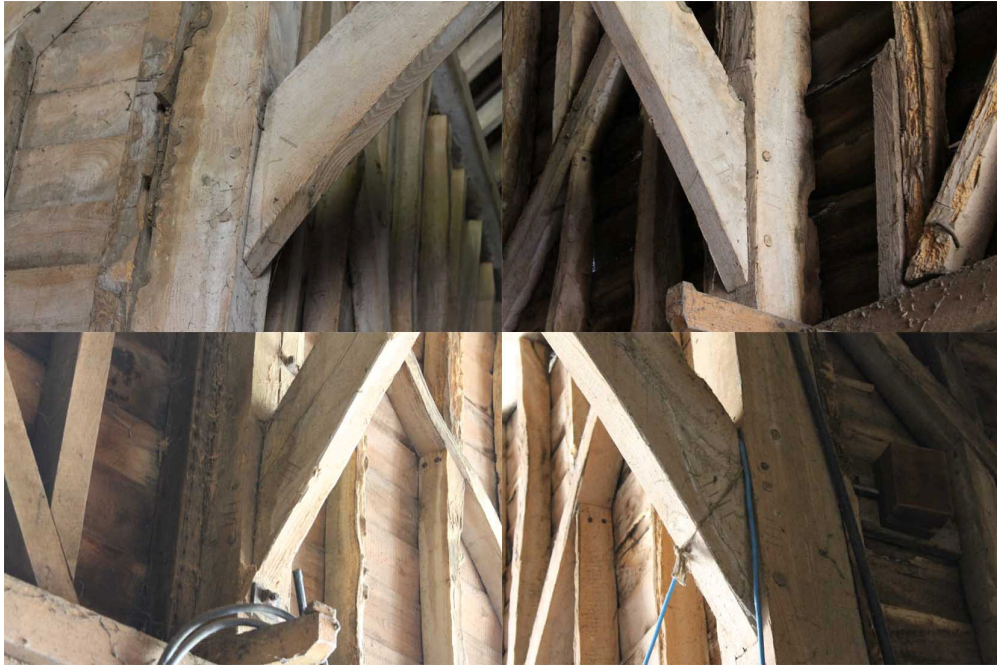
Chiselled carpenters' marks appear on trusses B and C. Truss B has an 'I' at the joint with the post and brace on the midstrey side and an 'II' at the joint with the post and brace on the other side. Truss C has an 'IIII' at the joint with the post and brace on the midstrey side and an 'III' at the joint with the post and brace on the other side (Plate 5).

Plate 5 Carpenters' marks on posts and braces of trusses B (top) and C (bottom)

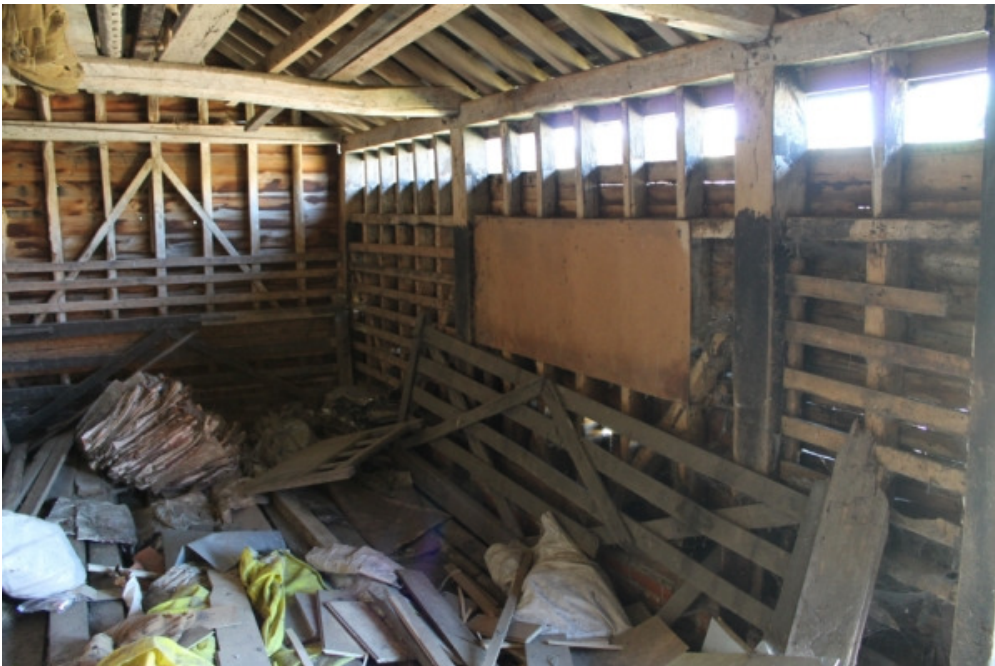
The interior shows that the lean-to is timber-framed, with the frame of the short end constructed differently to that of the long side (Plate 8). The frame of the short end has eight hand-sawn and equally-spaced studs between the barn and the corner post, with straight braces falling from the central post. The wall plate of the short end has the same dimensions as the wall plate and intermediate posts of the long side. However, the studs between the intermediate posts along the long side are machine-cut, supporting the theory that the long side was originally open-fronted. Horizontal battens are attached to the interior of the lean-to, presumably to protect the frame from damage. The lean-to conceals the original weatherboarding of the barn.

Plate 8 Interior of lean-to 1d, showing the differences between the framing of the short end and long side – view south

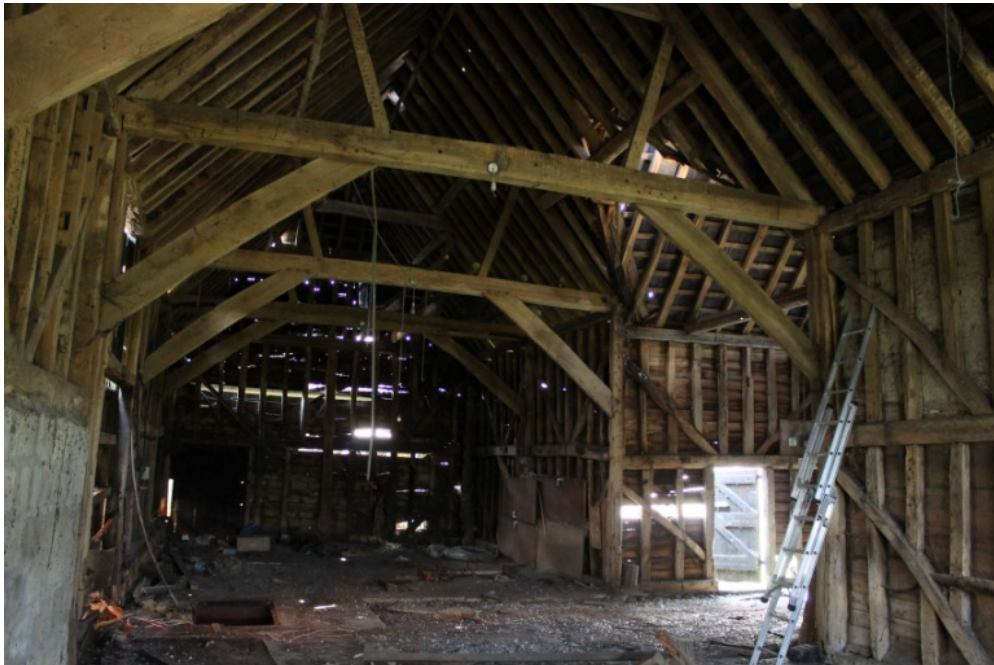
The interior of barn 2a was empty at the time of the survey and appears to have been unused for some time (Plate 12). The barn is divided into five bays, four of equal size with the central bay slightly wider, reflecting its function as the threshing floor. The 1990 list entry for the barn recorded that the threshing floor was of York stone, but this has since been replaced by concrete.

Plate 12 Interior of barn 2a - view west

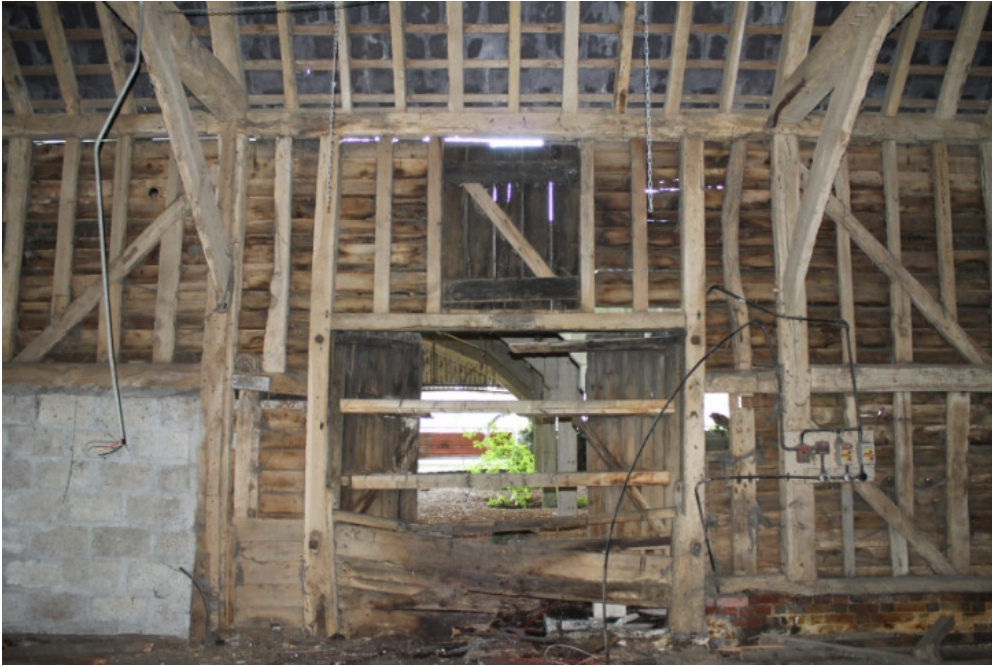
with edge-halved scarf joints in each bay. The upper registers of bays 1 and 2 have the original render. The barn doors in bay 3, opposite the midstrey doors, have flared bases to the door posts with slots holding a threshold leap. The original girding beam has been replaced and a pitching door has been inserted above it (Plate 13).

Plate 13 Barn 2a, showing jowled bases to rear barn doors, threshold leap and inserted pitching door – view south

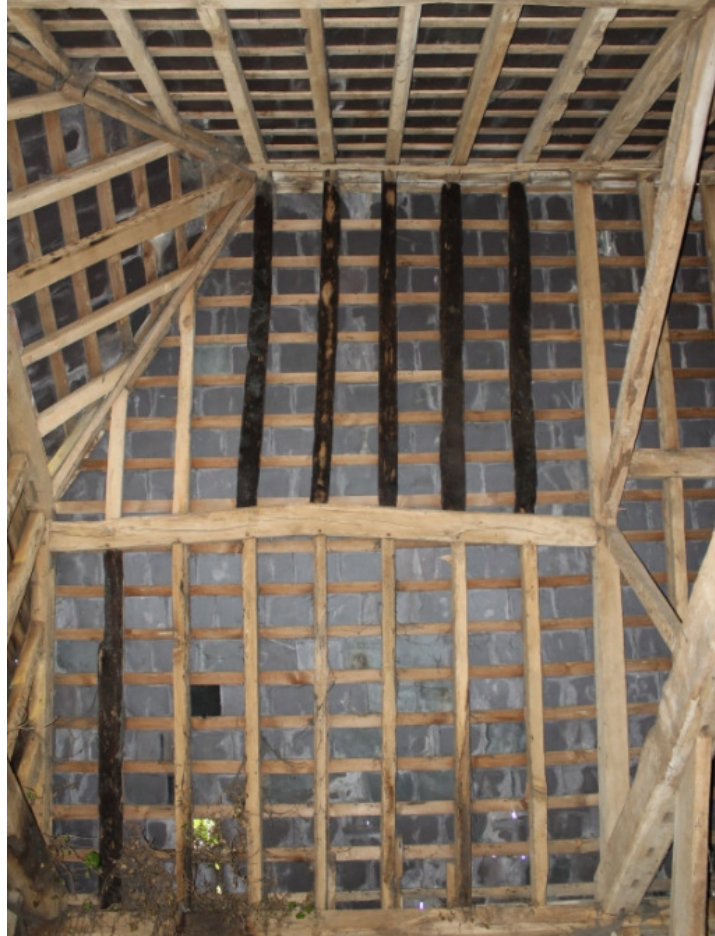
Plate 15 Barn 2a, detail of fire-blackened and reused timbers in roof of bay 1

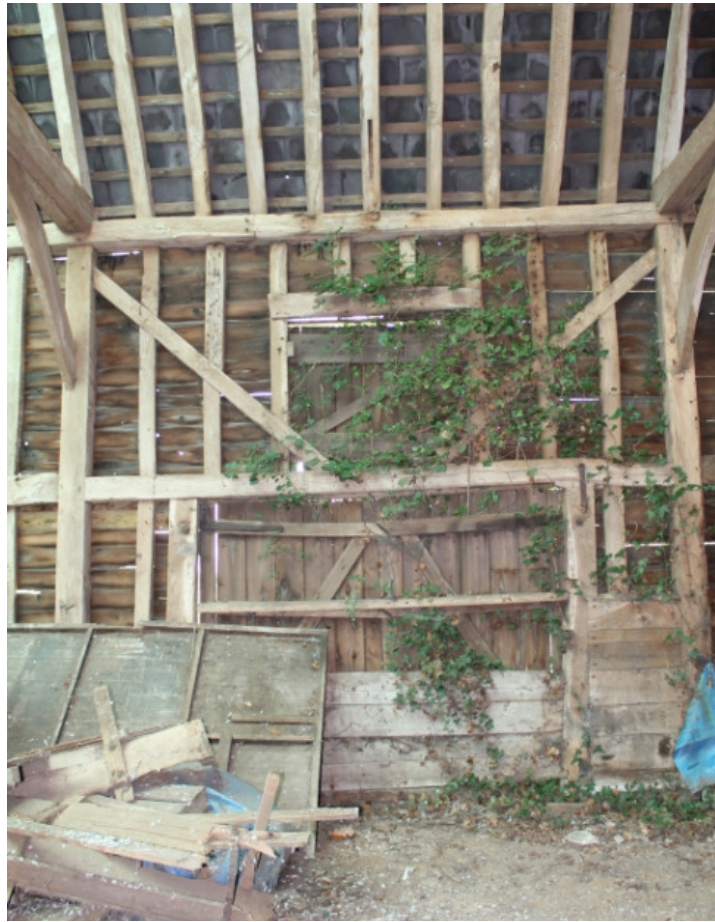
Plate 25 Barn 3a, showing rear barn doors with replacement girding beam and threshold leap – view west

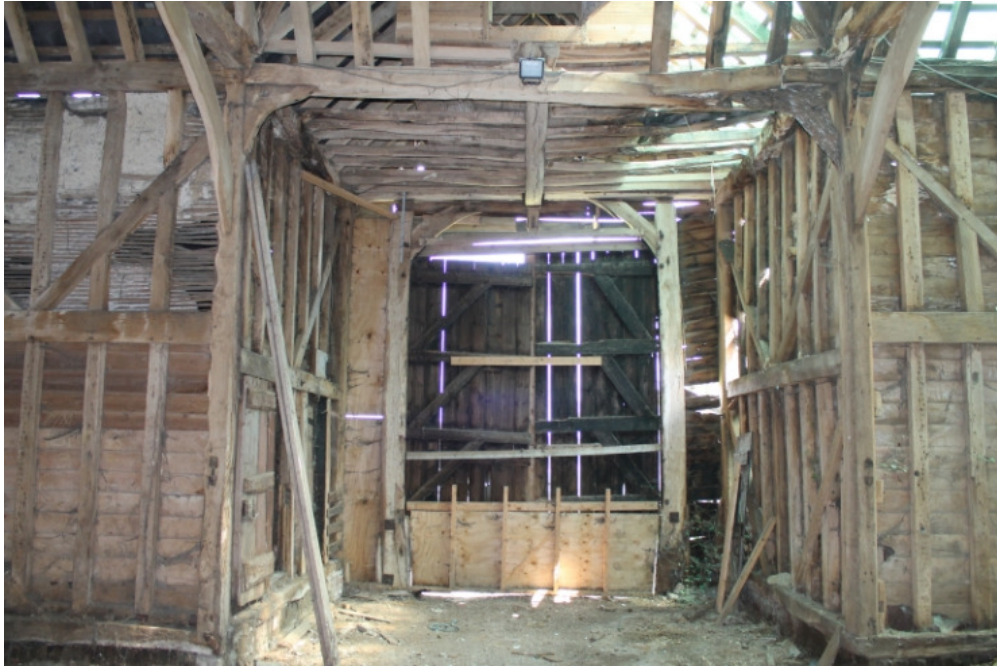
The midstrey has short curved braces supporting the wall plate above the doors which are single-pegged to the wall plate (Plate 27). The braces were originally single-pegged to the posts as well but these pegs have been replaced by iron bolts. The barn doors are later replacements but the posts, which are flared at the bases, have the original slots for the threshold leap. Two doorways have been inserted into the north midstrey wall, one providing access to granary 3c, the other opening onto the farmyard (Plate 23). A pigeon loft has been inserted into the gable, complete with nesting boxes (Plates 28, 29)

Plate 27 Barn 3a, showing midstrey – view east

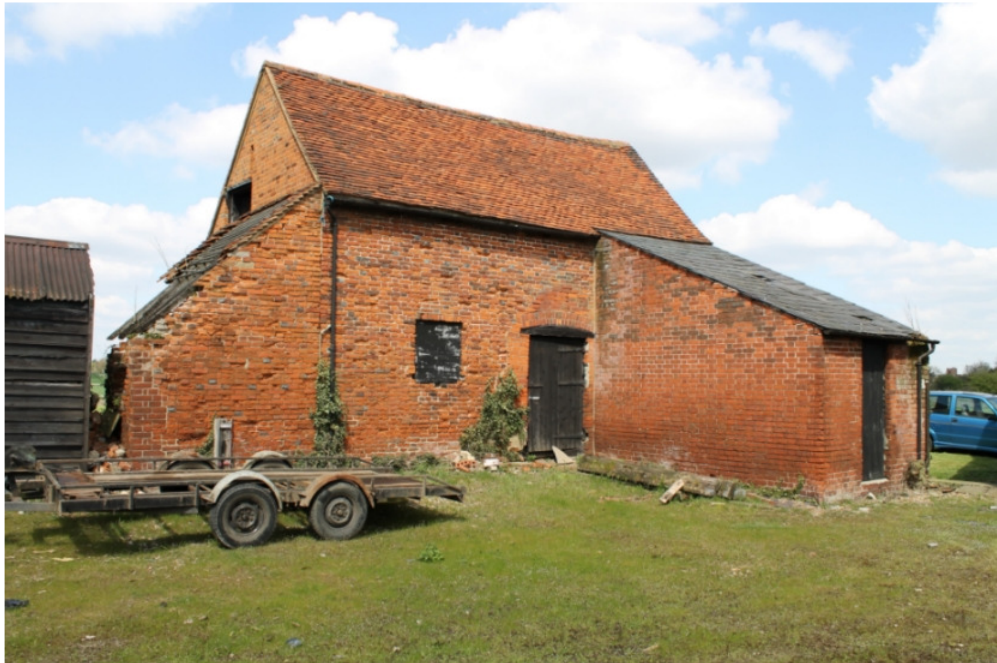
Stable/granary 4a is a two storey rectangular brick building aligned north-east to south-west, measuring 8.6m long x 4.8m wide (Plate 34). At the time of the survey the building was structurally unsafe with substantial cracking clearly evident. The fabric has been repaired and patched multiple times (including the complete rebuilding of both gables) and buttresses have been added to the north-east corner. Despite these repairs it was possible to ascertain that the original fabric was of red brick with dimensions of 238 x 114 x 55mm, laid in Flemish bond. The gabled roof is of plain tiles. The south-east elevation has a centrally located doorway surmounted by a brick arch, which is a later insertion. This is flanked by lean-to 4c and a square wooden-framed window. The north-west elevation is plain brickwork apart from the presence of two small modern vents and the brick buttresses. The north-east elevation has a large window that has been converted from an earlier doorway and a smaller window in the gable (Plate 35). The south-west elevation has lean-to 4b attached to the stable and an elevated plank door providing access to the granary loft (Plate 36). The doorpost closest to the centre of the gable rises eight courses of brick higher than the lintel and has a pattern of rust-stained holes. This would have been the anchor point for a hoist used for raising sacks of grain to the loft.

Plate 34 Structure 4 – view north-east

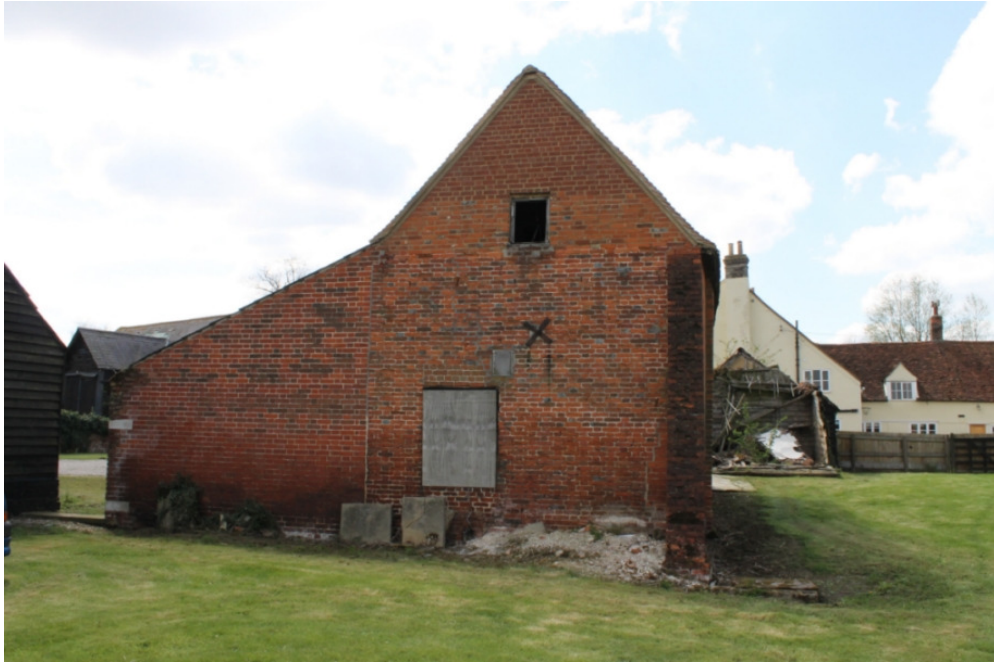
Plate 35 Stable/granary 4a, showing converted doorway, rebuilt gable and later buttress – view south-west

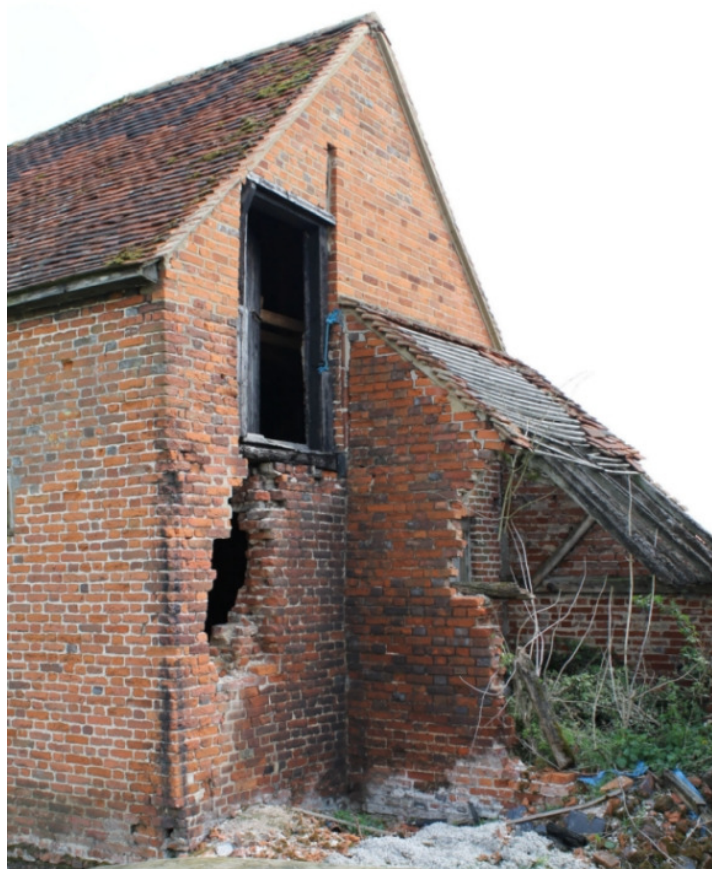
Lean-to 4b is a single storey structure on the south-west end of stable/granary 4a (Plate 34). It projects 2.5m out and is 3m wide. The lean-to is in a ruinous state, with many patches of repair to the brick work, but it is possible to see that the original construction was of red brick with dimensions of 230 x 109 x 60mm laid in Flemish bond. There are no indications of windows or doorways in any of the exterior walls, although most of the north-west corner has collapsed, which may be the result of structural weakening caused by such an opening (Plate 36). The roof is a steep mono-pitch of plain tiles carried on timber battens.

Plate 36 Stable/granary 4a with lean-to 4b and elevated doorway to granary loft – view east
