**Historic building recording at B Mess,  
formerly the Officers' Quarters,  
Le Cateau Barracks, Colchester,  
Essex,  
November 2013 and December 2019**

**report prepared by  
Chris Lister and Mark Baister**

NGR: TL 9935 2455 (c)  
Planning reference: 173017  
CAT project ref: 2019/11h  
CHER ref: ECC4408  
OASIS reference: colchest3-375264

**CAT Report 1512**  
February 2020

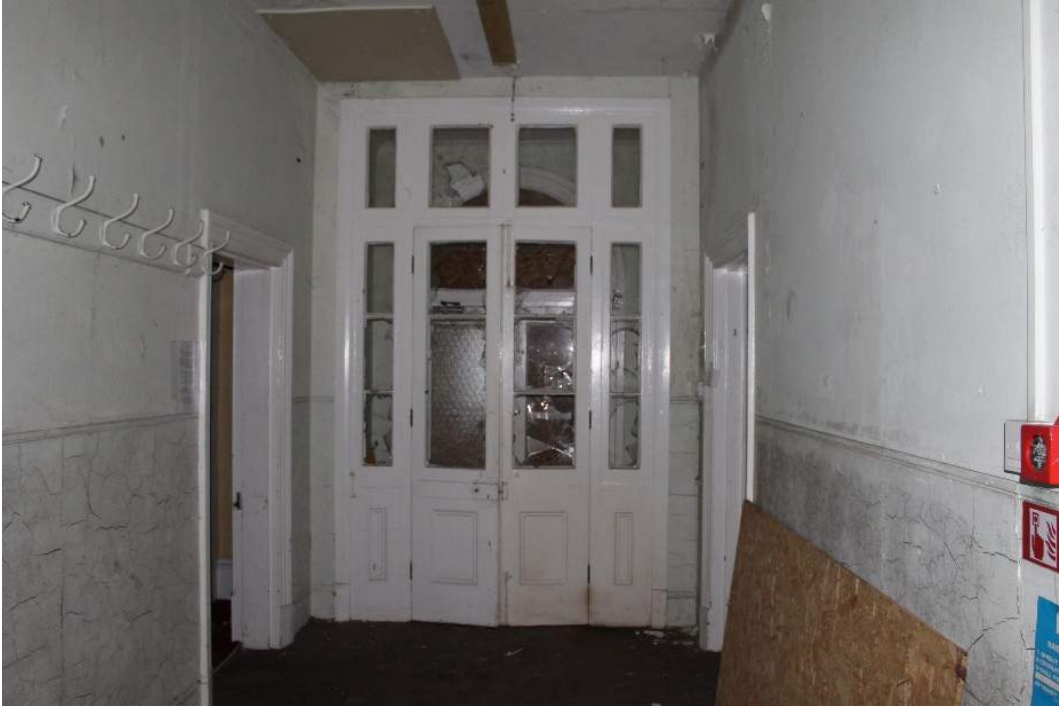
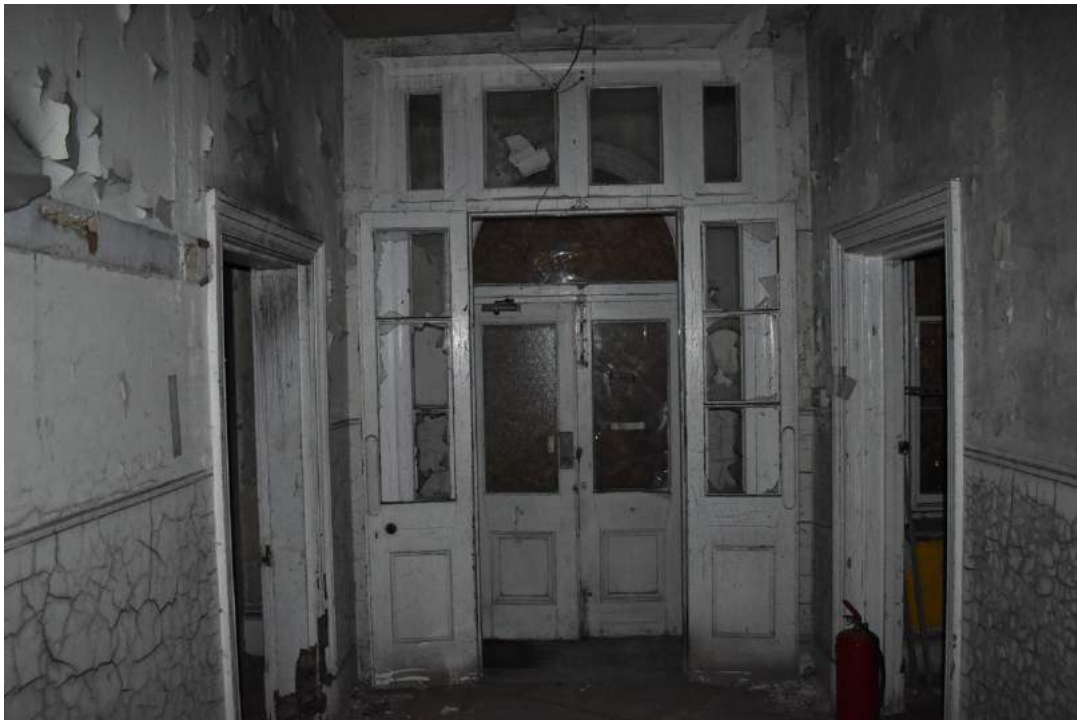
**Plate 1** Entrance way ii, showing the original inner and outer doors of the porch and original coat hooks on the left wall - view south-east. Photo from November 2013 above, photo from December 2019 below.

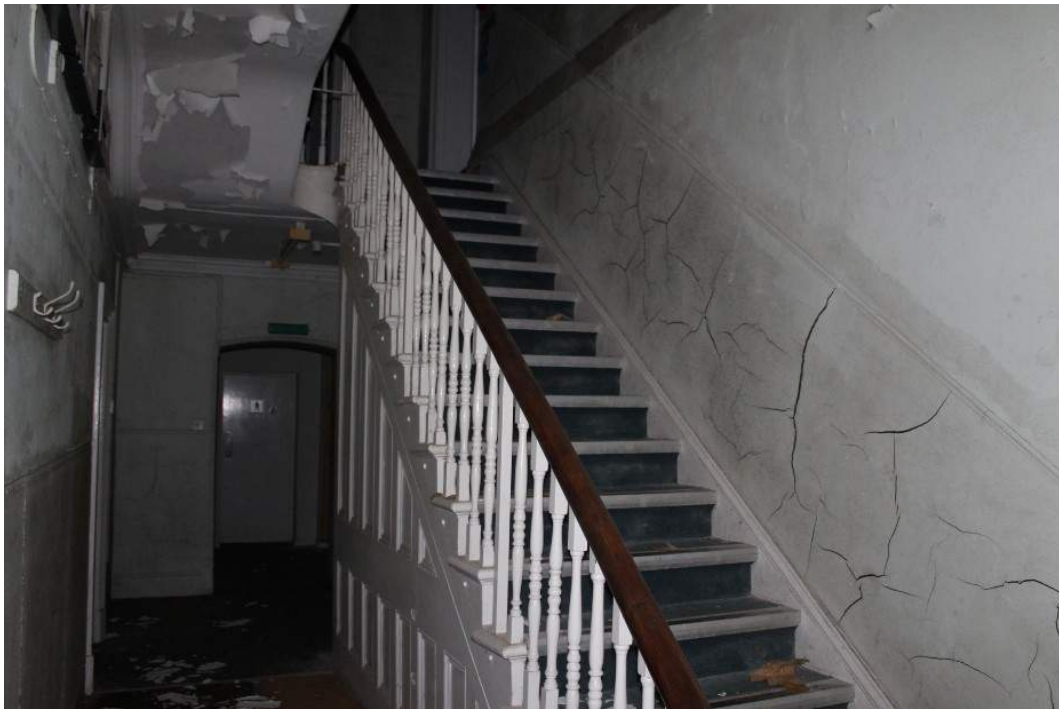
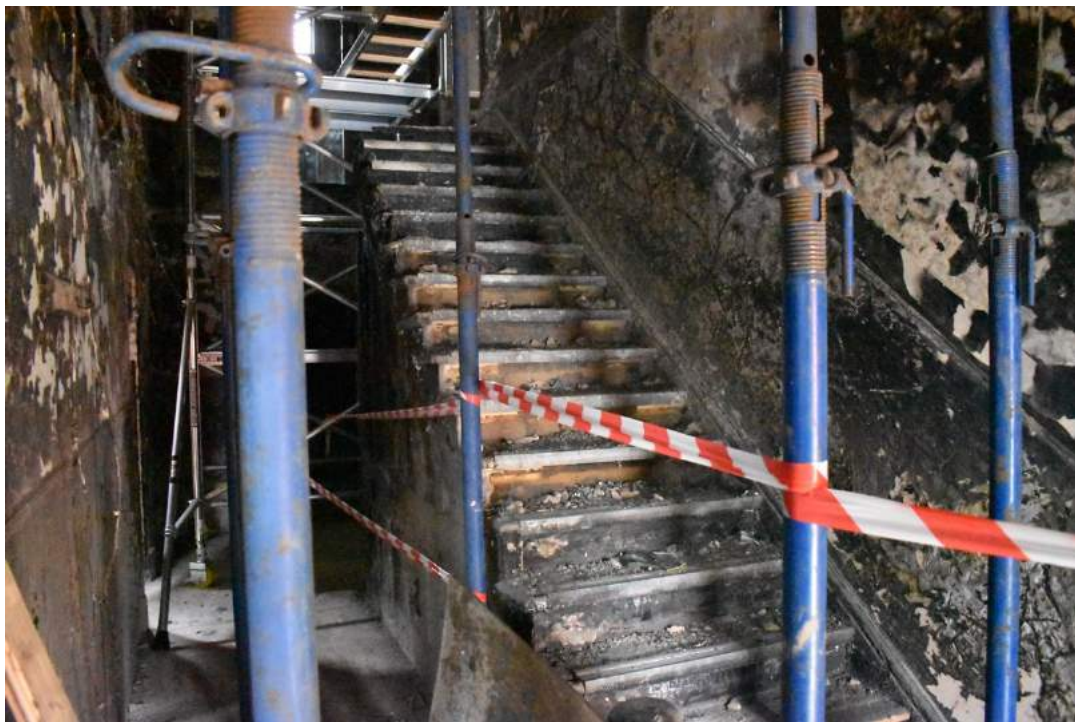
**Plate 2** Stairwell *iv*, showing the original staircase, coat hooks and the entrance to the 1904 lavatory – view north-west. Photo from November 2013 above, photo from December 2019 below.

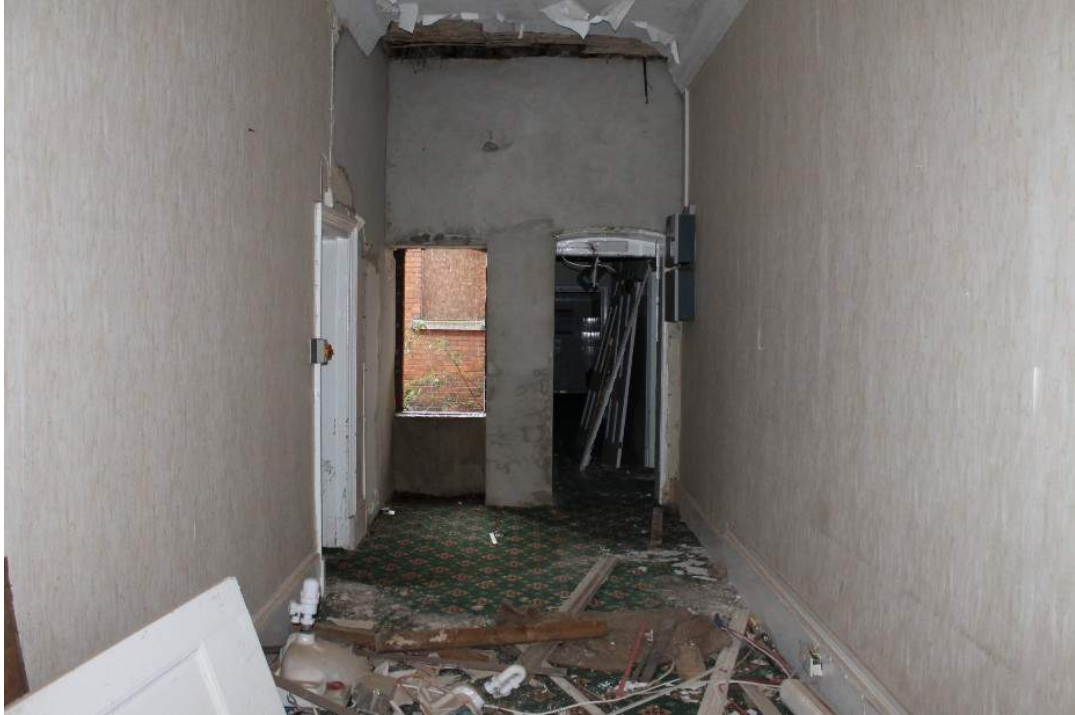
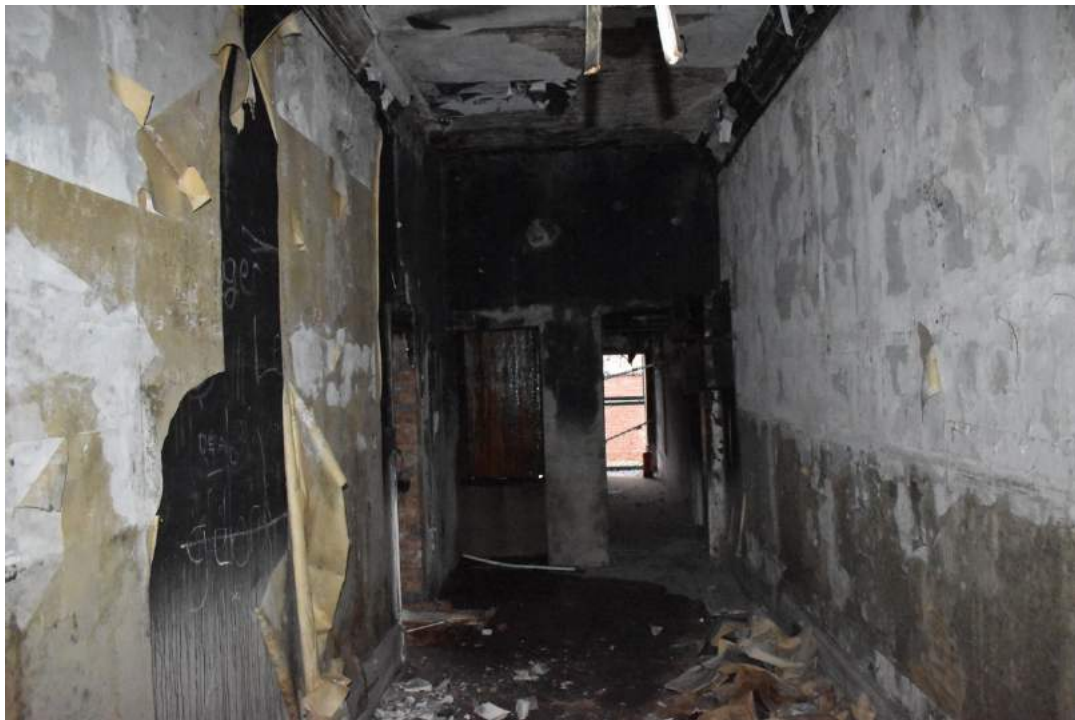
**Plate 4** Entrance way *iii* with the removed staircase and the 1904 toilet block to the rear - view north-west. Photo from November 2013 above, photo from December 2019 below.

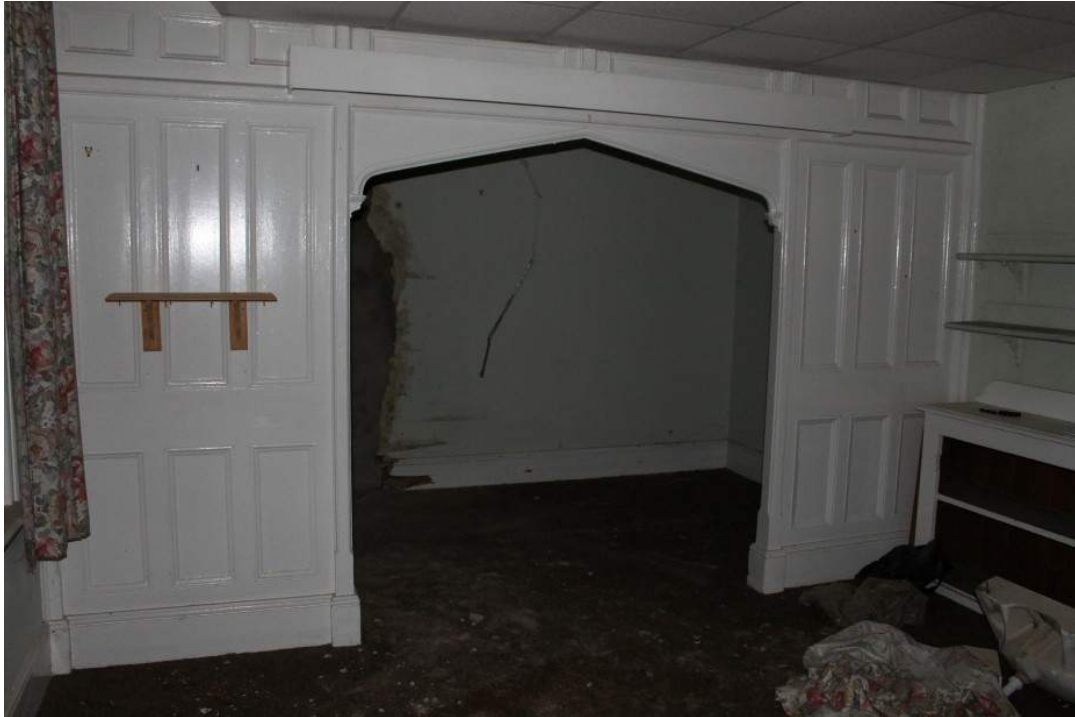
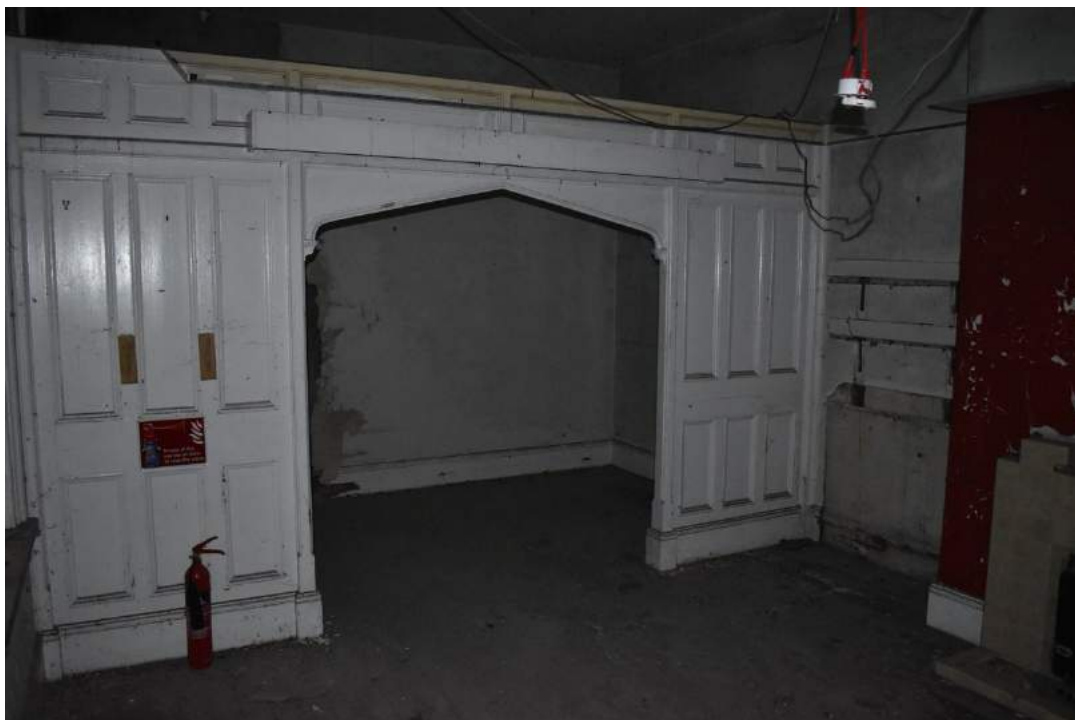
**Plate 5** Original wooden partition in room 2 separating the sleeping area from the sitting room – view south-west. Photo from November 2013 above, photo from December 2019 below.

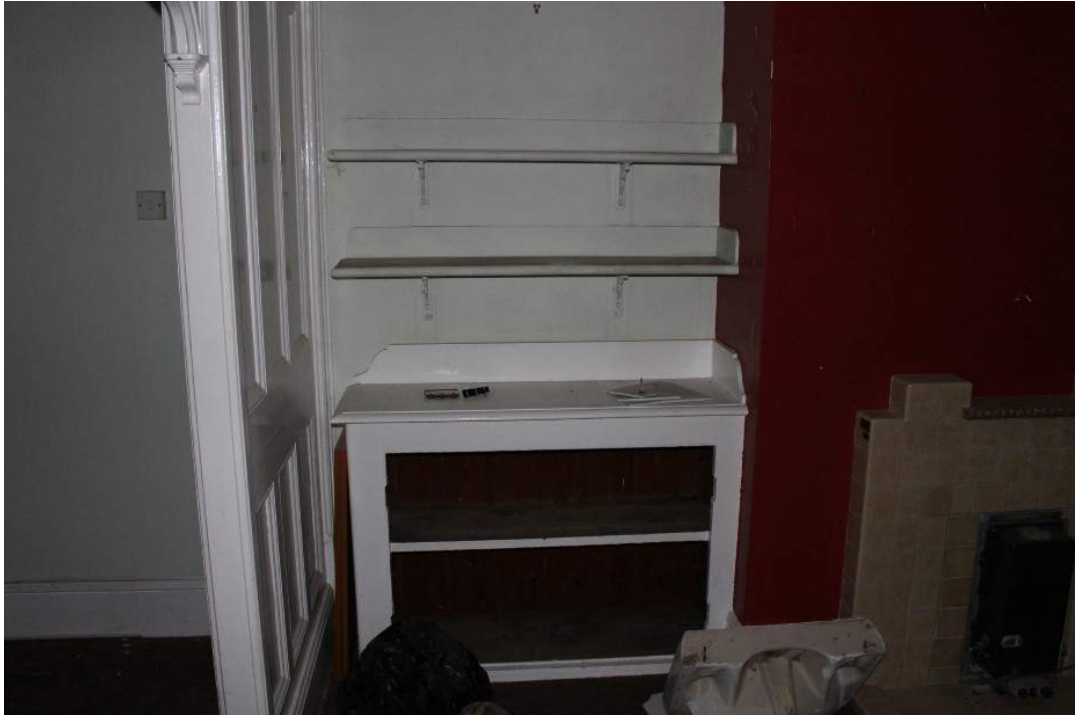
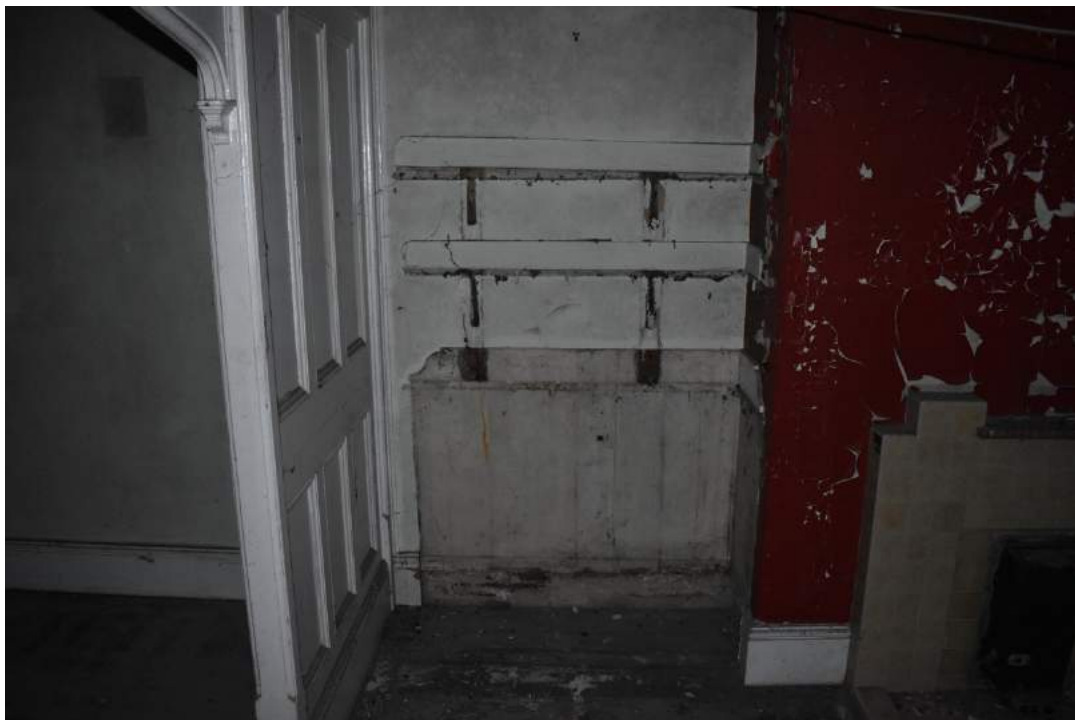
**Plate 6** Dresser and shelving in room 2, either relocated from the 1876 rooms or faithfully reproduced – view north-west. Photo from November 2013 above, photo from December 2019 below.

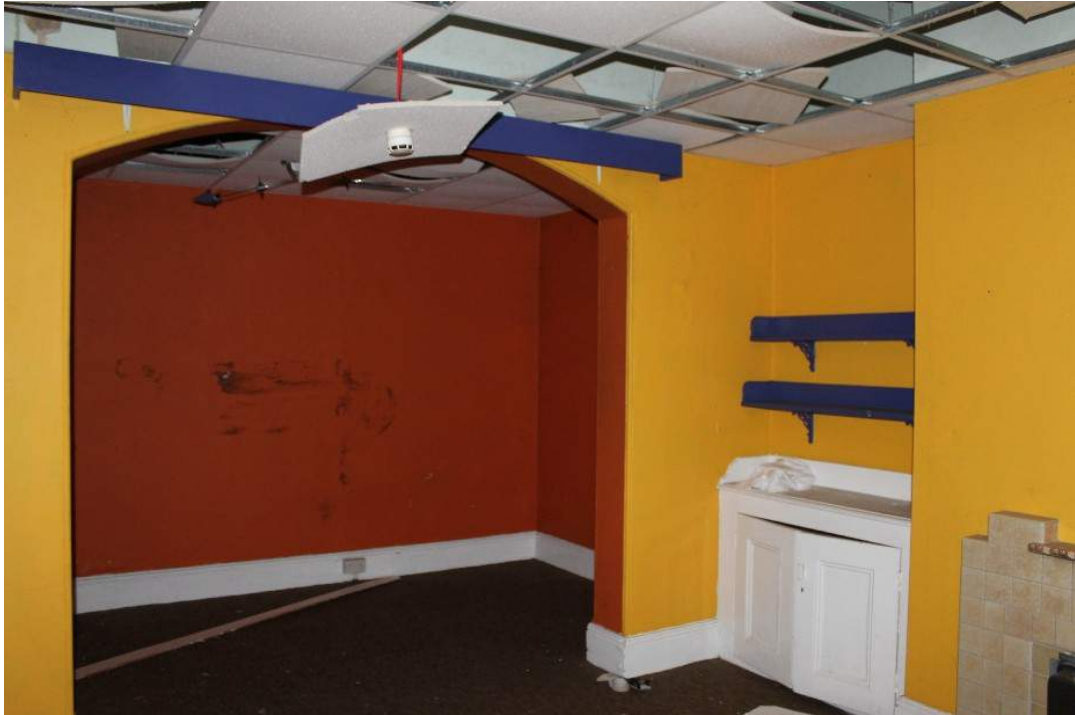
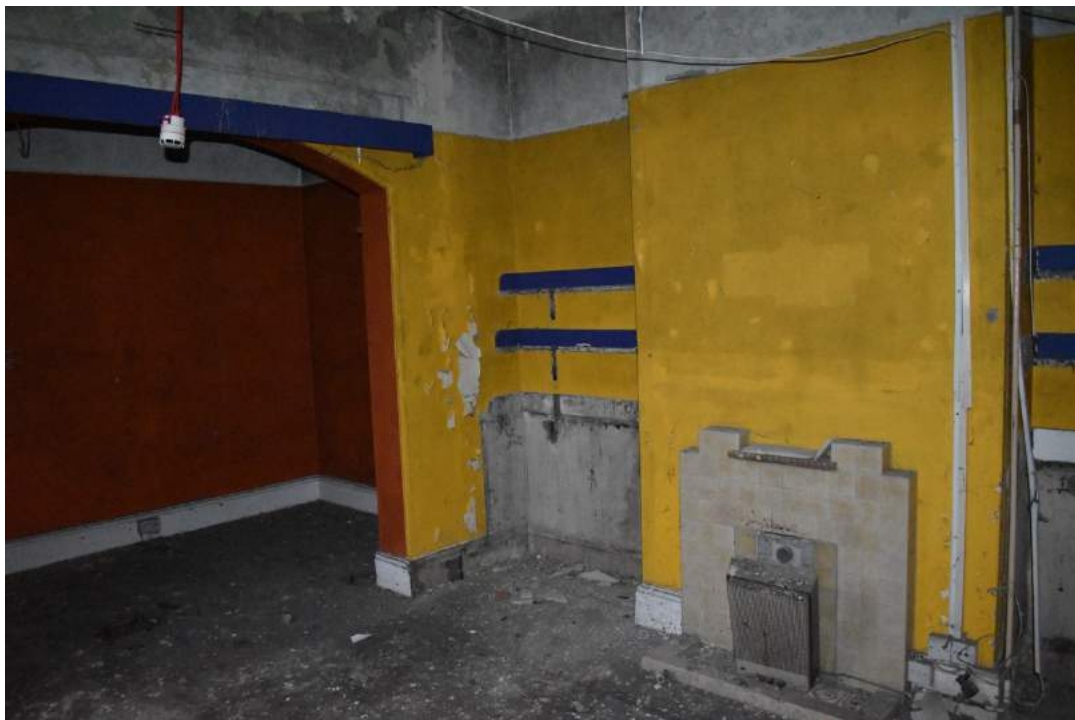
**Plate 9** Room 7, formerly the quarters for Officer No.1, showing the brick arch separating the sleeping area from the sitting room, with the original dresser and shelving to the left of the chimney breast – view south. Photo from November 2013 above, photo from December 2019 below.

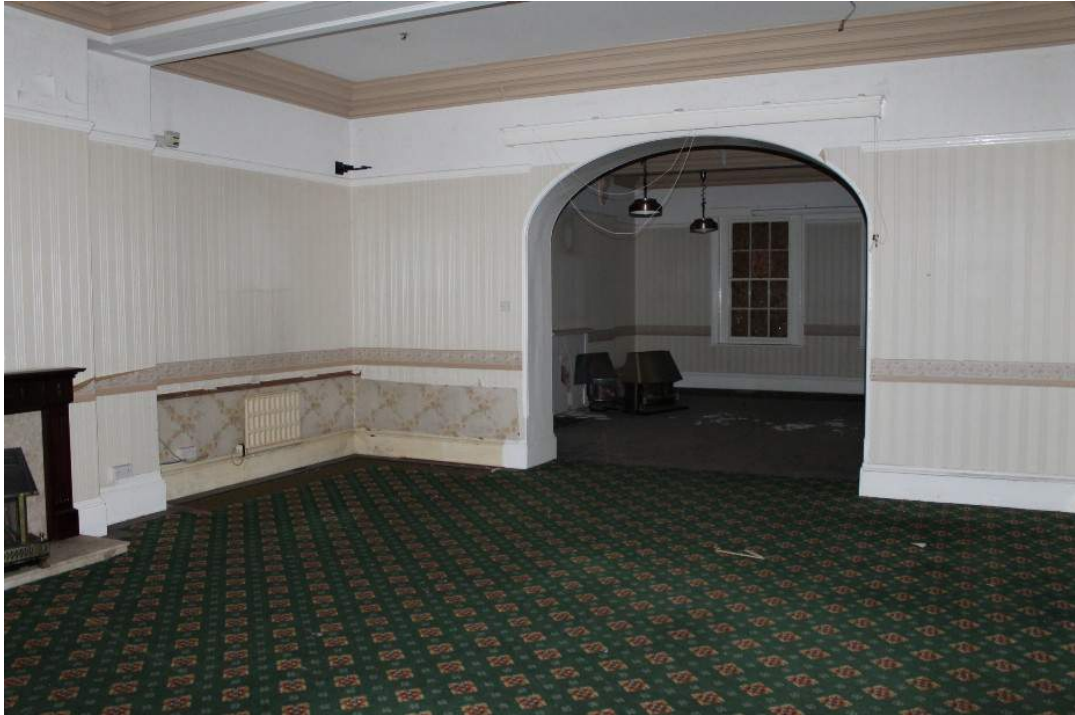
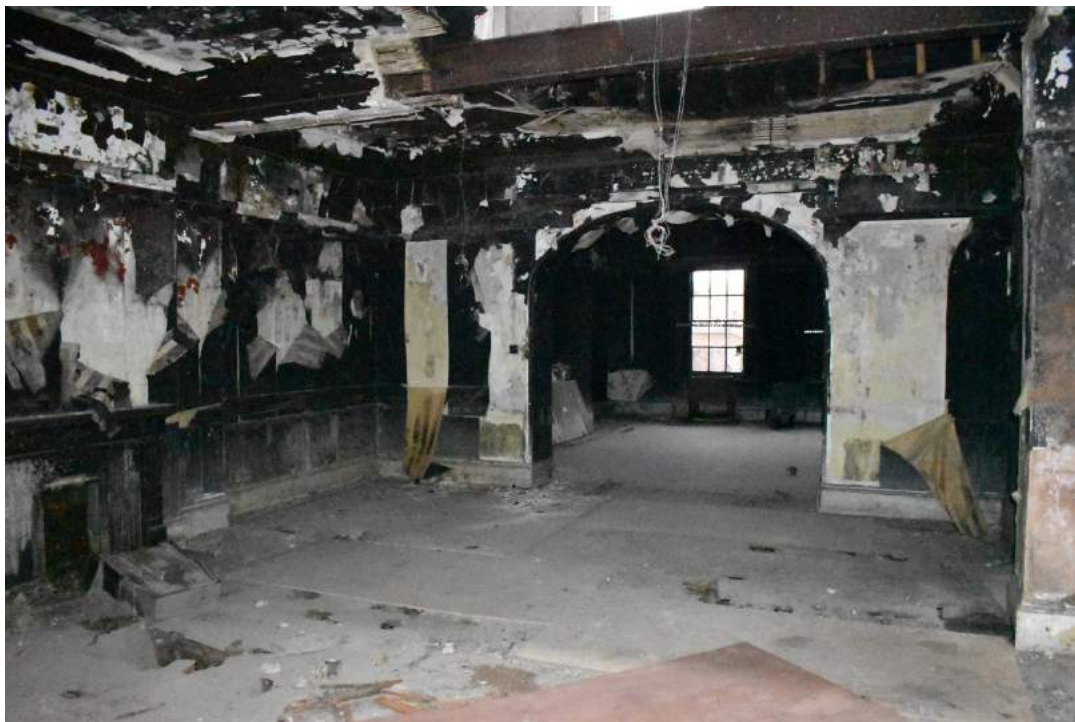
**Plate 12** The 1904 bar converted from the quarters for Officers Nos.2 and 3, with the extension through the archway and the inserted fireplaces on the left-hand walls – view west. Photo from November 2013 above, photo from December 2019 below.

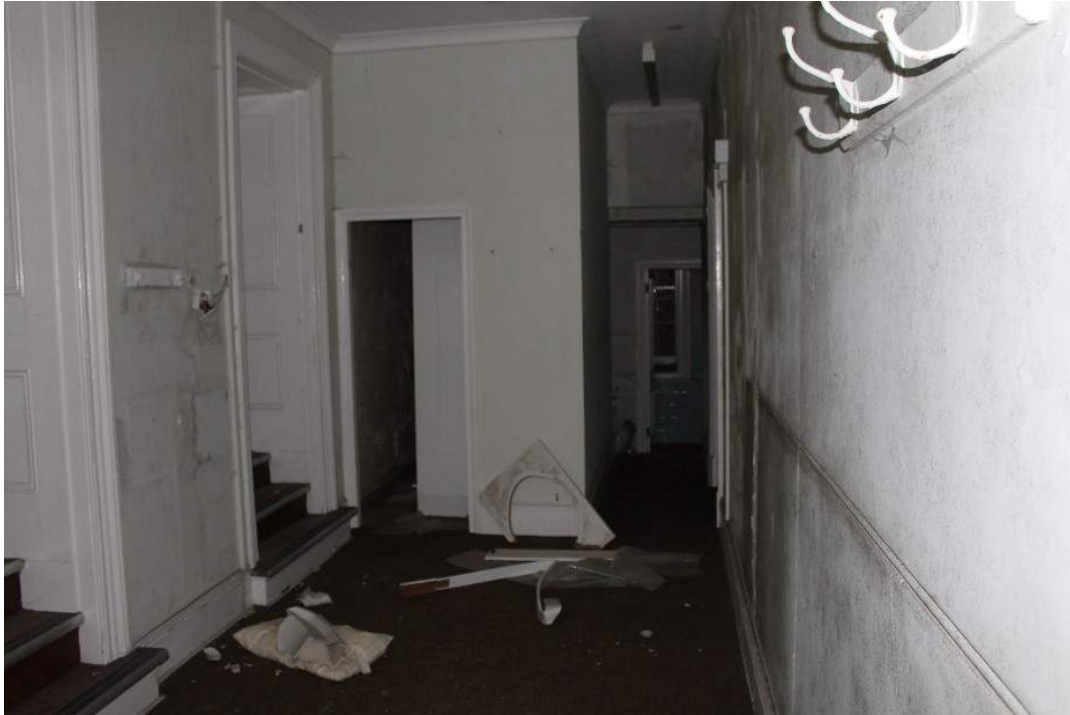
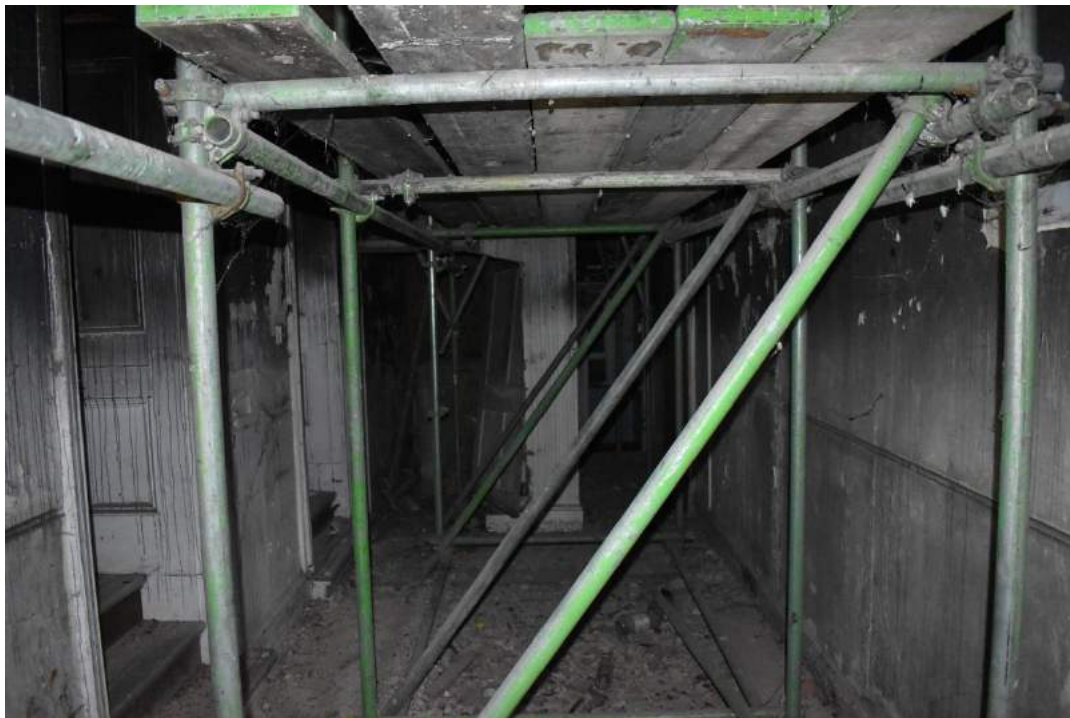
**Plate 19** The converted landing of the former stairwell *iii*, with the inserted shower room, the 1904 ablution block to the rear and the original doorways to the servants' quarters in the left-hand wall – view north-west. Photo from November 2013 above, photo from December 2019 below.

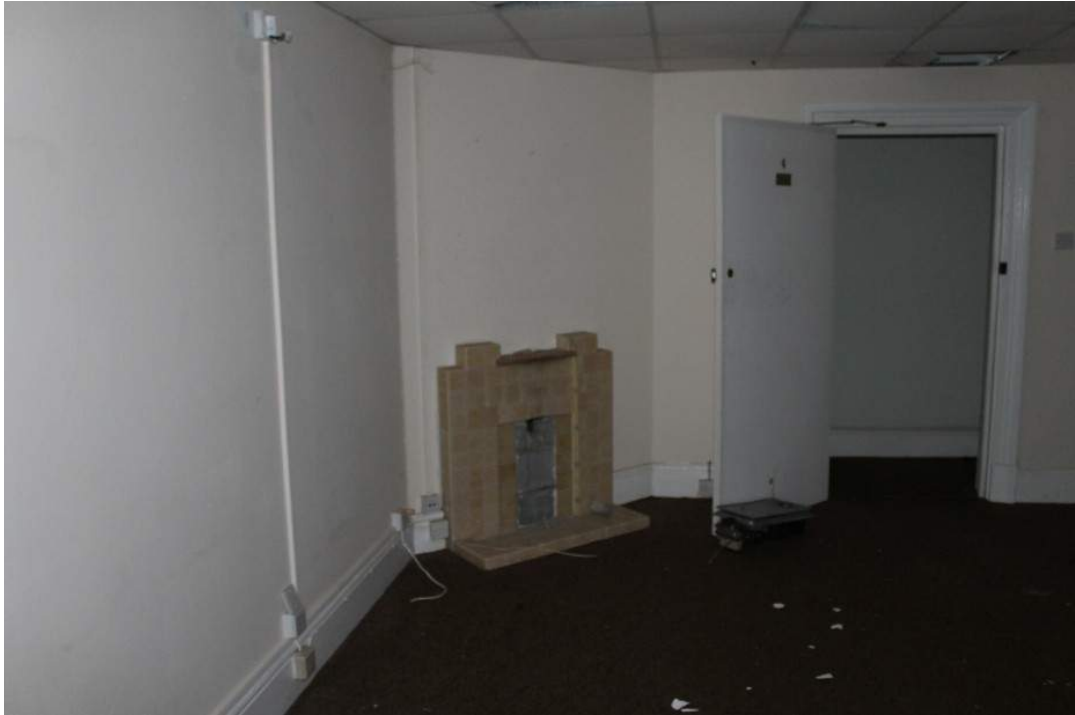
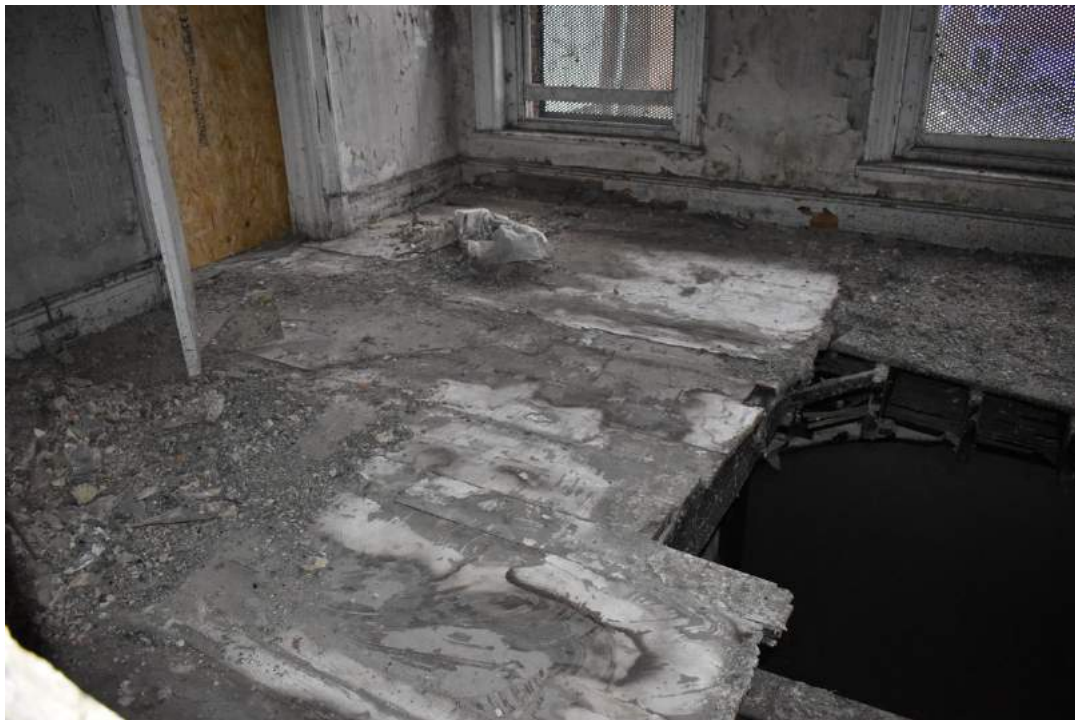
**Plate 20** Room 22, formerly the quarters for Officer No.9, showing the relocated doorway and fireplace – view south-west. Photo from November 2013 above, photo from December 2019 below.

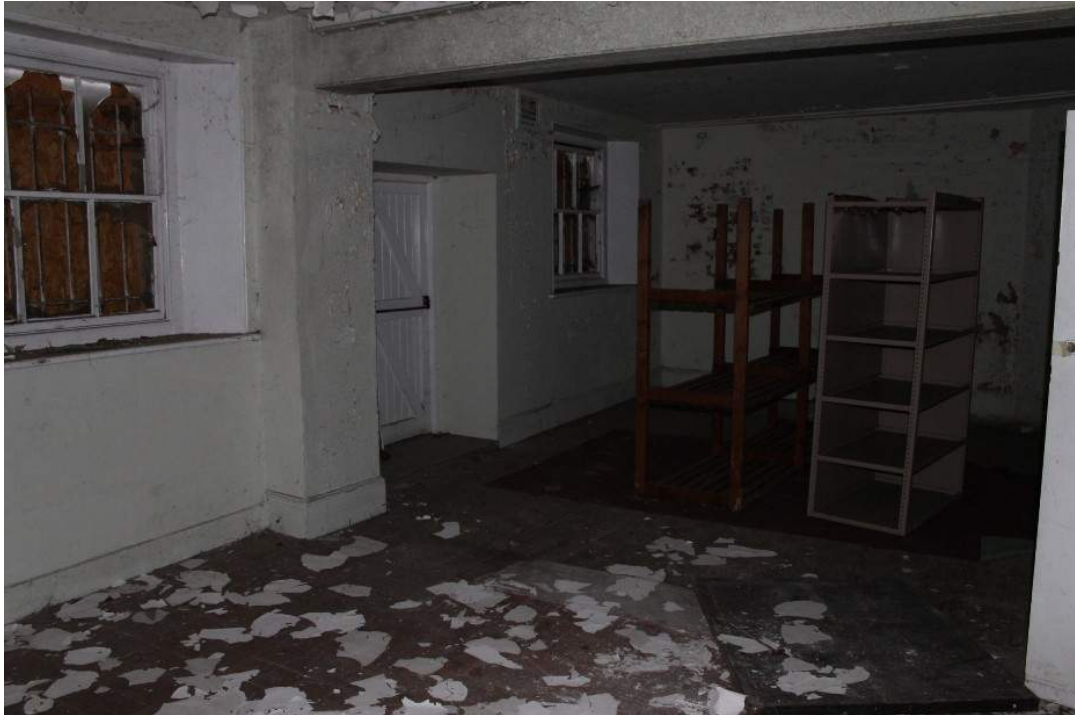
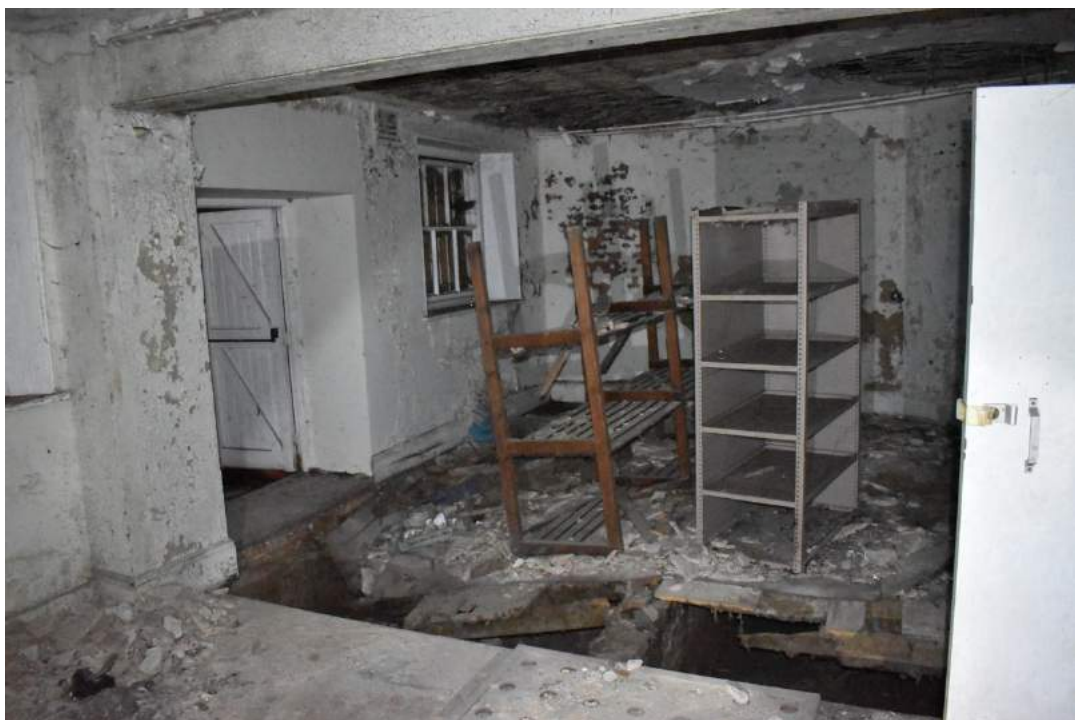
*The basement was largely insulated from the effects of the fire, and so the only damage suffered is the floor of rooms 38 and 39.*

**Plate 22** Rooms 39 and 38, the former kitchen and mess manager's room, with the dividing wall removed and a doorway inserted through one of the windows of the mess manager's room – view south. Photo from November 2013 above, photo from December 2019 below.

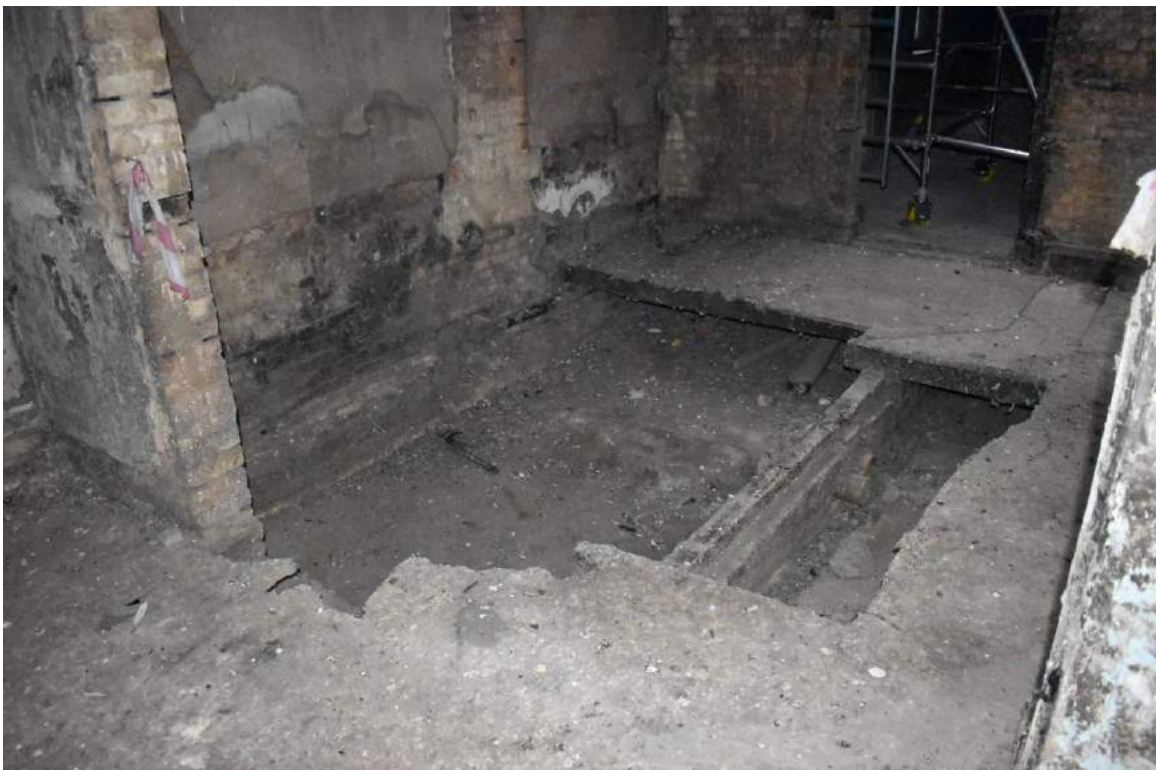
*The fire the Officers' Quarters suffered in 2014 caused considerable damage to the building. It has completely destroyed rooms 24 and 25 on the first-floor, and the rooms below them on the ground-floor, leaving only the brick-built shell. Rooms immediately adjacent to the epicentre of the blaze, including the bar and entranceway iv, have also been heavily damaged. The fire is, however, not responsible for all of the damage the building has suffered in the last six years. A large number of the original features and fittings, including dressers, shelves and some doors, have been removed from the structure, most of them from the south-west end of the building in areas impacted very little by the fire. Ironically, the rooms left most inaccessible due to the blaze (rooms 26 and 27 on the first-floor) have all their features surviving (albeit in a damaged state).*

**Plate 24** Missing floor in ground-floor on building below room 24, with exposed brick plinths - view north.

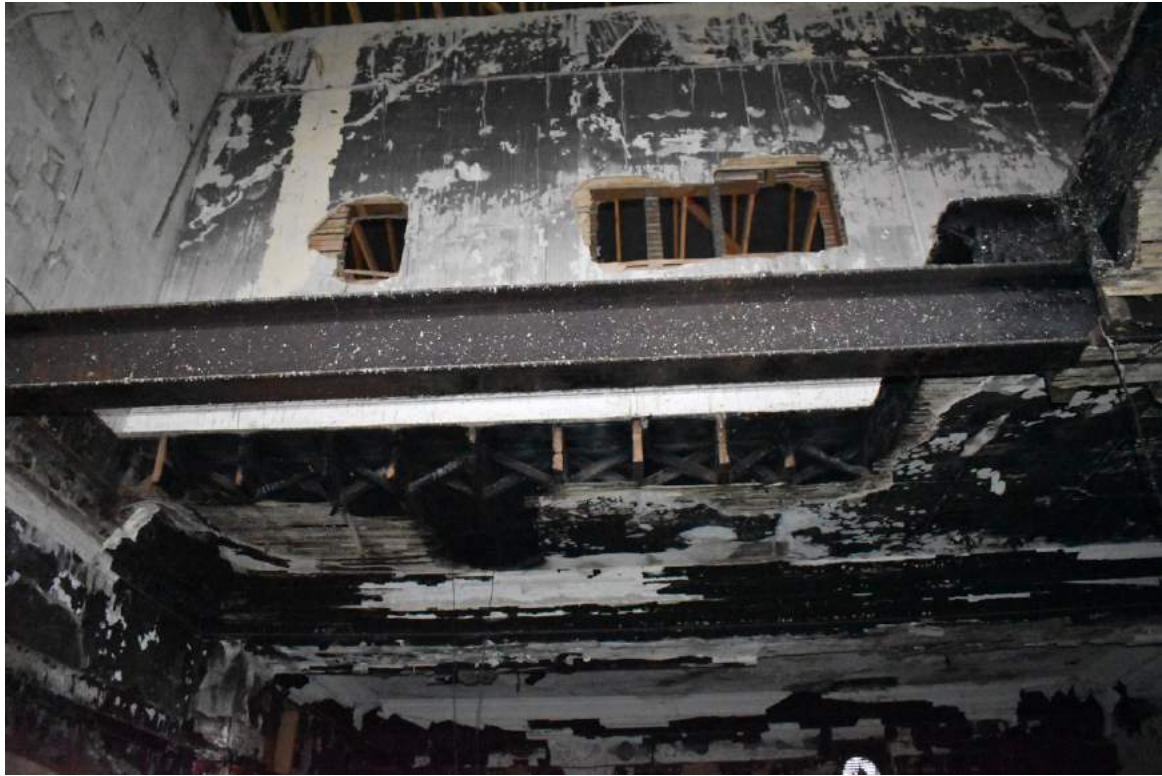
*From the bar eastwards is the section of the Officers' Quarters most severely damaged by the 2014 fire, and many of the features described above no longer survive, or, if they do, are in a significantly dilapidated state. Most of the wallpaper has burnt away and the flooring is heavily damaged, with several holes exposing the brick plinths below (Plate 24). In addition, the first-floor above the eastern rooms only partially survives, with a large section of ceiling above the bar completely absent. This has exposed the bridging beams and shown them to be constructed of metal, rather than timber. Similarly, the beams supporting the inserted archways are also shown to be of metal construction (Plates 25 and 26).*

**Plate 25** Metal beam that would have supported the floor of room 22 prior to the fire. Herringbone strutting visible behind - view south-east.

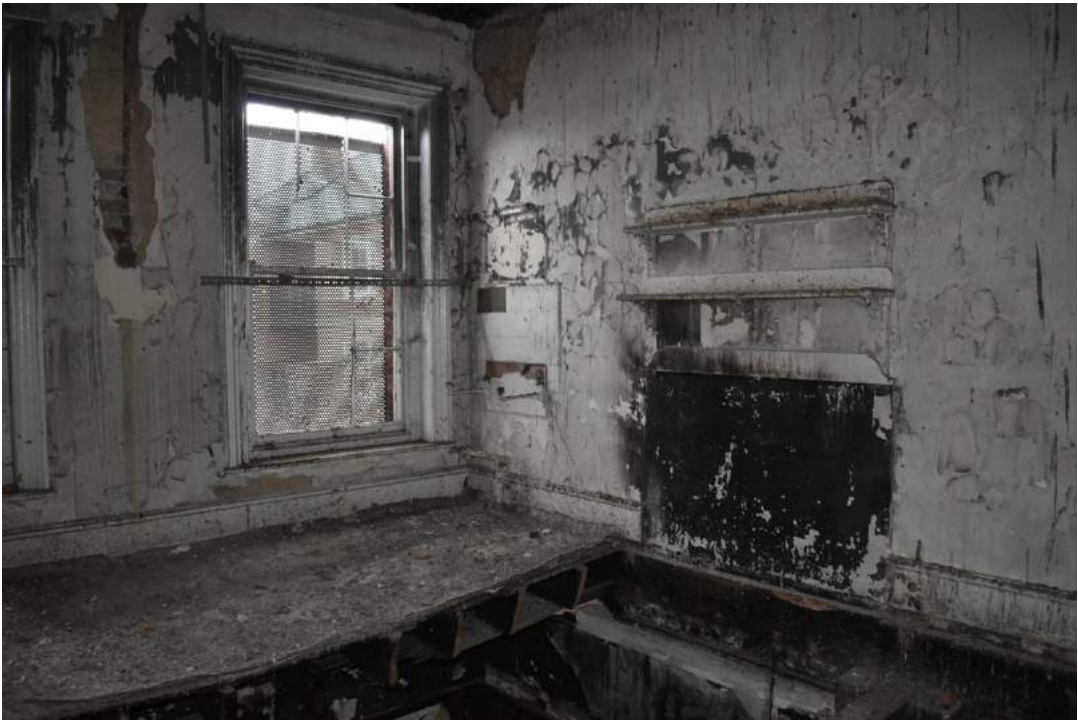
**Plate 30** Room 22, showing the missing floor and dresser, but surviving shelves - view north.

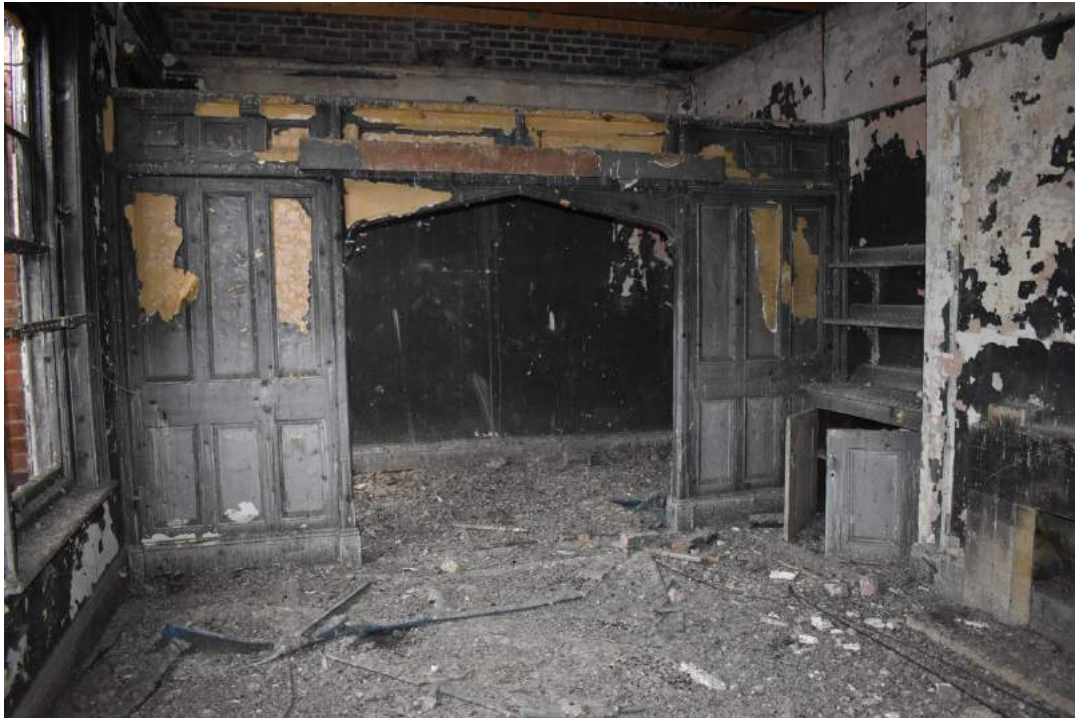
*The landing above stairwell iv was destroyed by fire, but remarkably the dressers, shelving and wooden partitions in rooms 26 and 27 have all survived, albeit in a damaged state (Plates 31 and 32).*

**Plate 31** Interior of room 26 showing surviving, but damaged, features - view north-east.

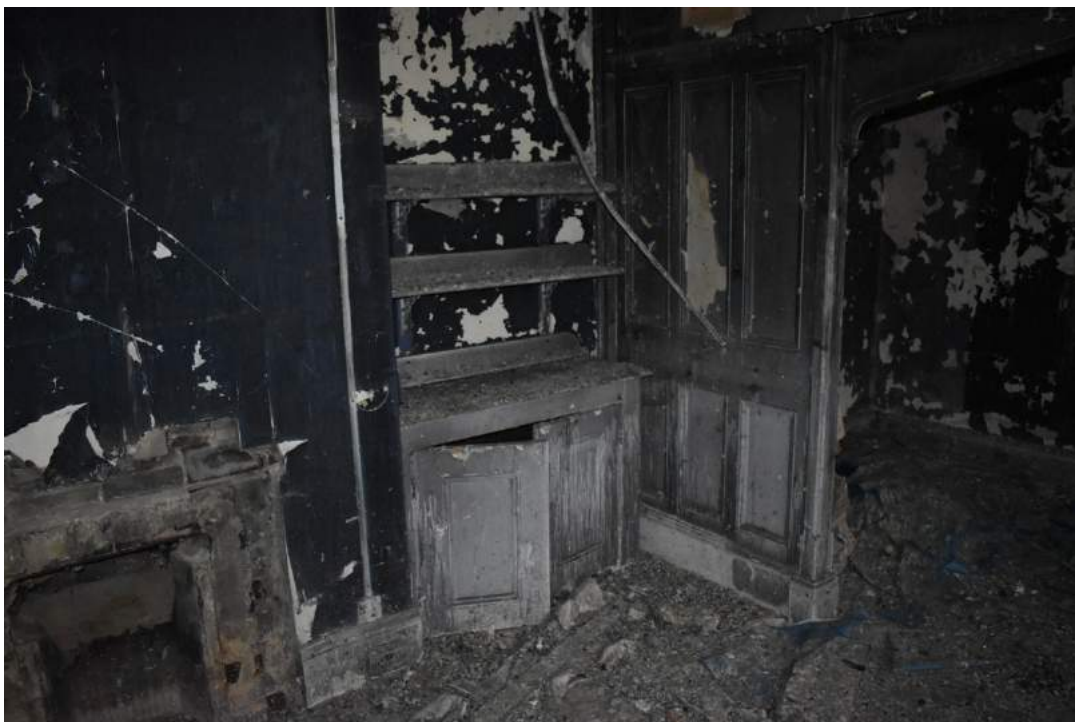
**Plate 32** Surviving, but damaged, dresser and shelves in room 27 - view north.

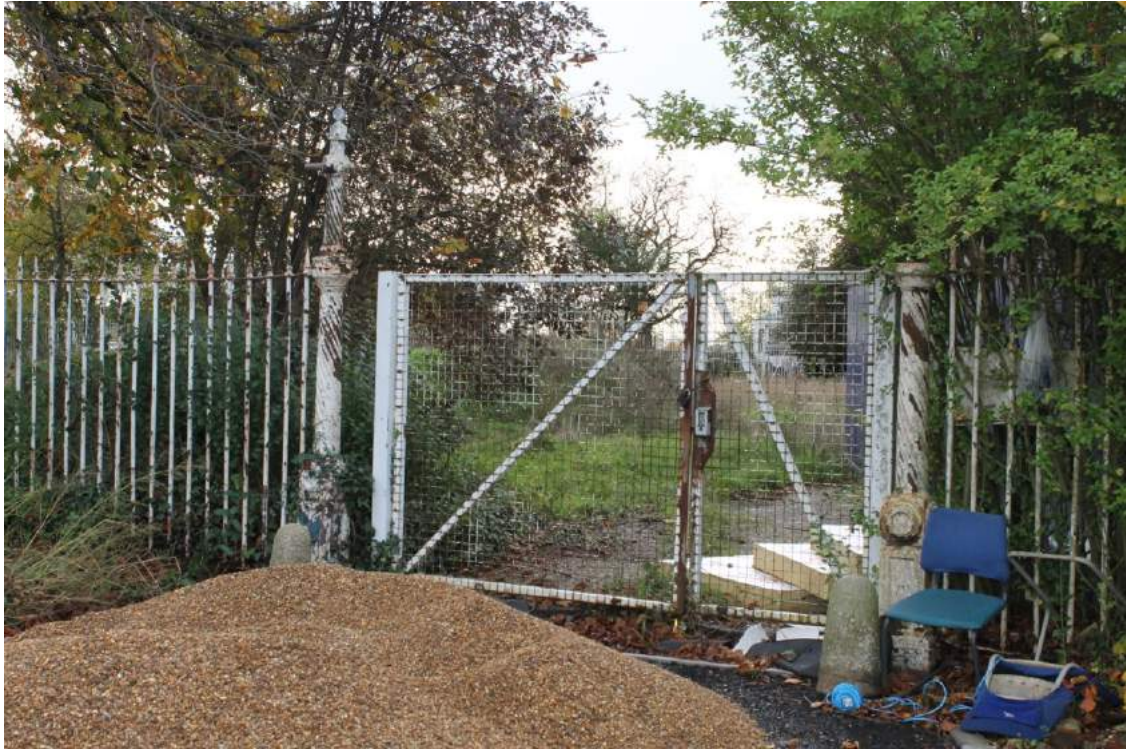
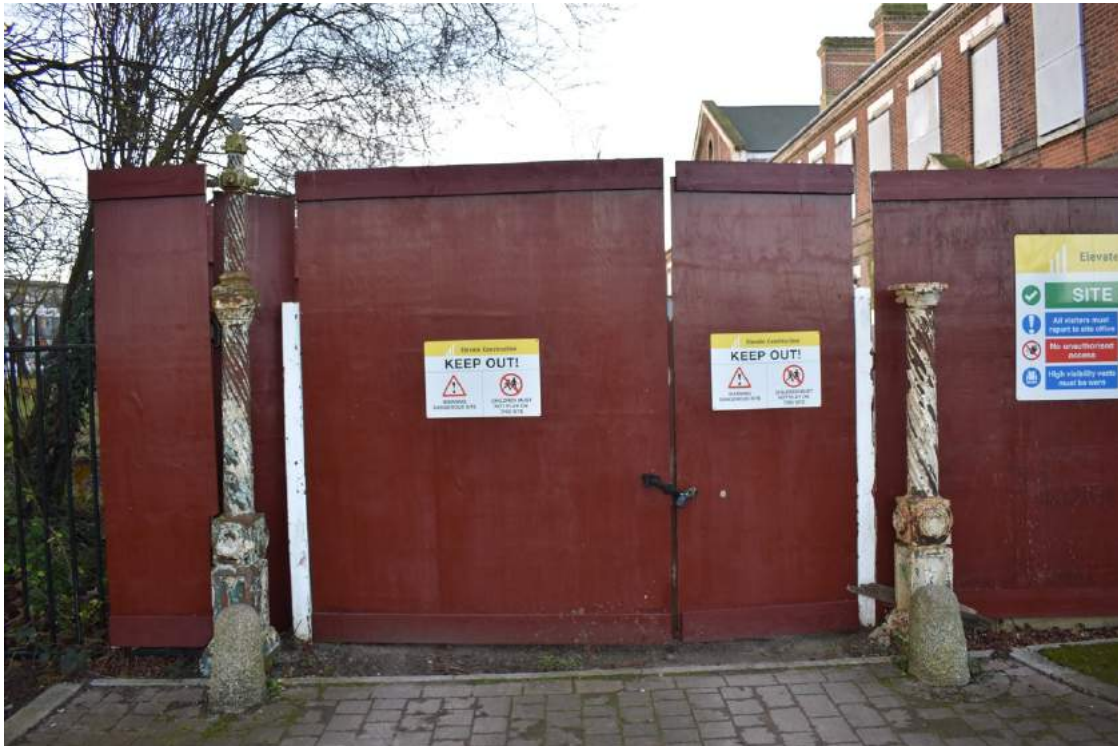
The perimeter fence of the Royal Artillery Barracks has long since been removed, with only the section surrounding the garden in front of the Officers' Quarters surviving. Probably at the same time as the 1904 alterations were carried out (or shortly after) the Officers' Quarters was enclosed in its own iron fence, joined to the earlier palisade and provided with gates formed by iron barley-twist posts incorporating gas lamps. Although the gates themselves have since been replaced, all four of the gate posts and short sections of the fence have survived. *Only three of the gate posts are now extant; the northern one on the western entrance is missing. The surviving posts, however, are in the same condition they were six years ago (Plates 33 and 34). The fence has since been entirely replaced.*

**Plate 33** Surviving gate posts with gas lamps at eastern entrance to site. Note missing top of right post. Photo from November 2013 above, photo from December 2019 below.
