**Historic building recording
at King's Farm Barn, Bishops Lane,
Alphamstone, Essex
March 2014**

**report prepared by
Chris Lister**

CAT Report 767
May 2014

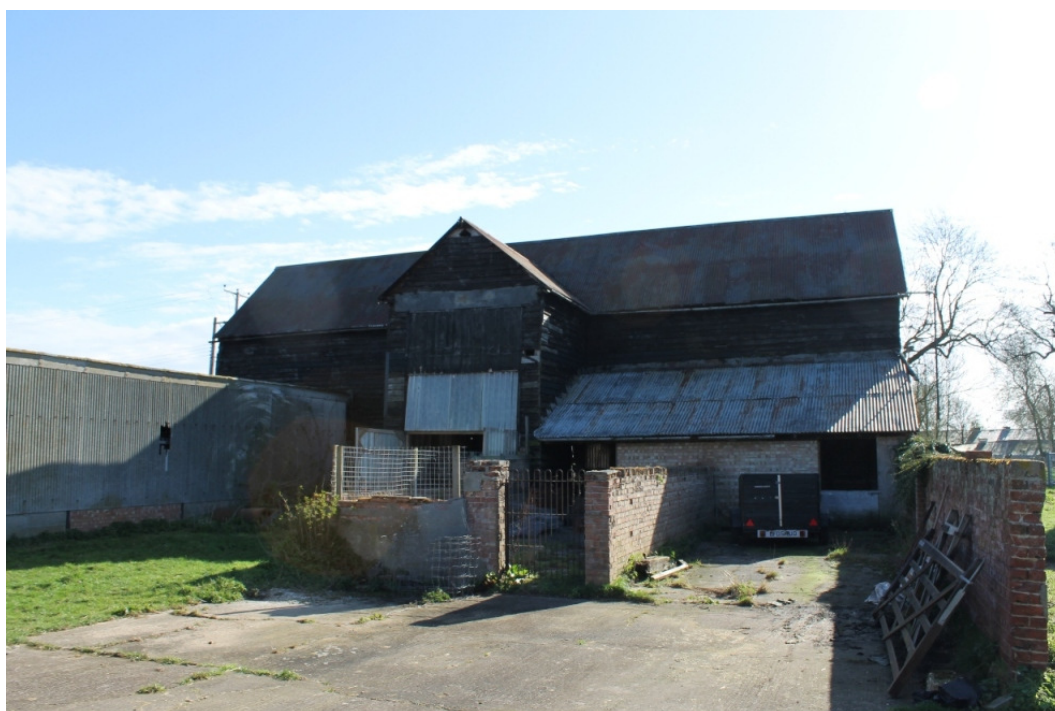
The barn is a rectangular timber-framed building, 21.7m long x 6.75m wide, with a centrally-located midstrey projecting from the north-west elevation (Plate 1). It is constructed from softwood timbers and the entire structure sits upon a plinth of red brick with dimensions of 226 x 115 x 65mm, laid in Flemish bond above a chamfered course and in English bond below it (Plate 2). The barn is clad in black-painted horizontal weatherboard and the gabled roof is covered with corrugated iron sheeting. To the south of the gabled midstrey, the north-west elevation has a single-storey lean-to, originally open-fronted but subsequently enclosed by a wall constructed from later Fletton brick. An animal pen, also constructed from Fletton brick, extends into the yard from the front of this lean-to. Although map evidence suggests there was a second lean-to on the other side of the midstrey this, and the shelter shed perpendicular to the barn, have been replaced by a single-storey range with a mono-pitch roof, which is built on top of the farmyard wall. The door opening in the midstrey is exceptionally high; reaching to the eaves. Although the lower barn doors have been replaced, the upper section retains the original barn doors, which are held on simple strap hinges (Plate 3).

Plate 1 North-west elevation of the barn - view north-east

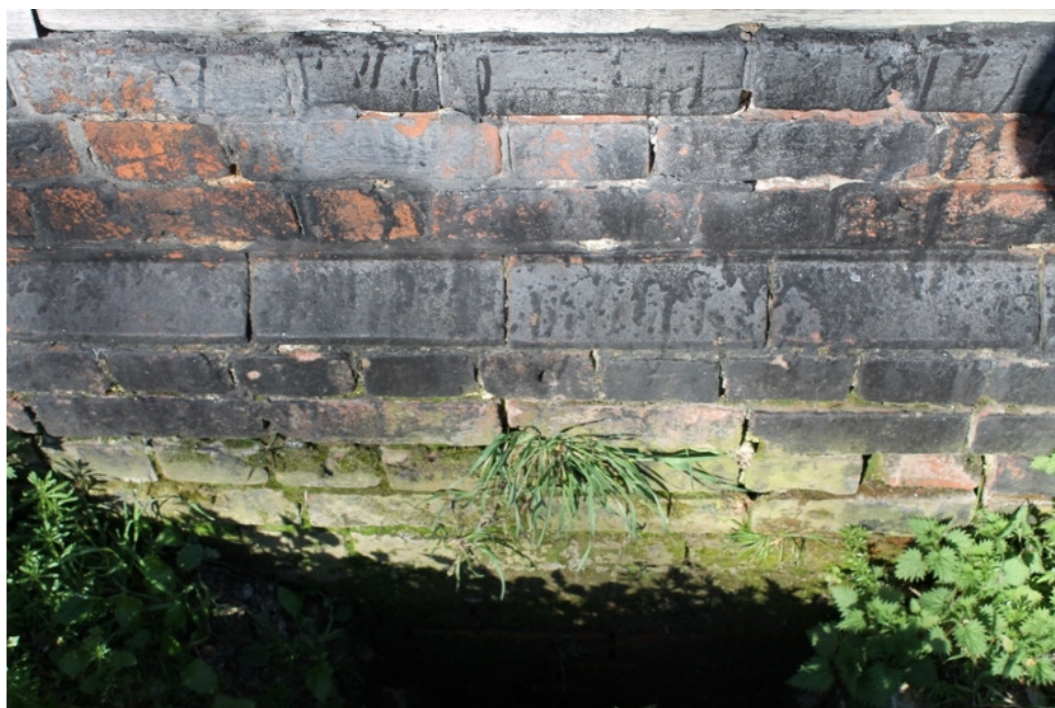
Plate 2 Detail of the brick plinth, with Flemish bond above the chamfered course and English bond below

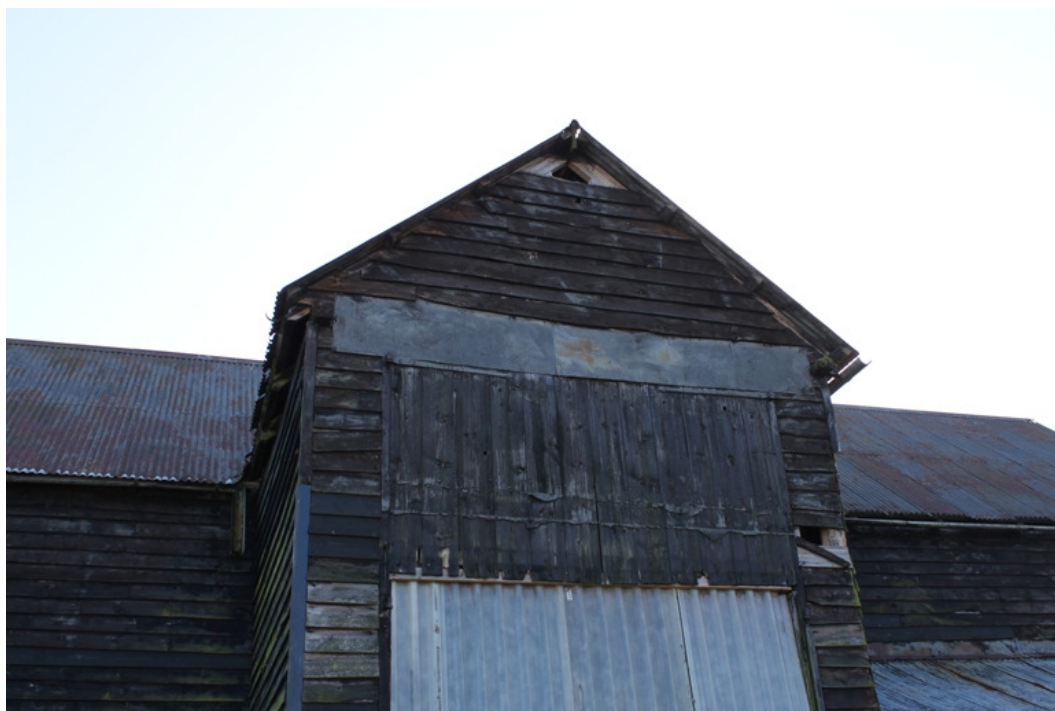
Plate 3 Surviving portion of the full-height barn doors in the midstrey - view south-east

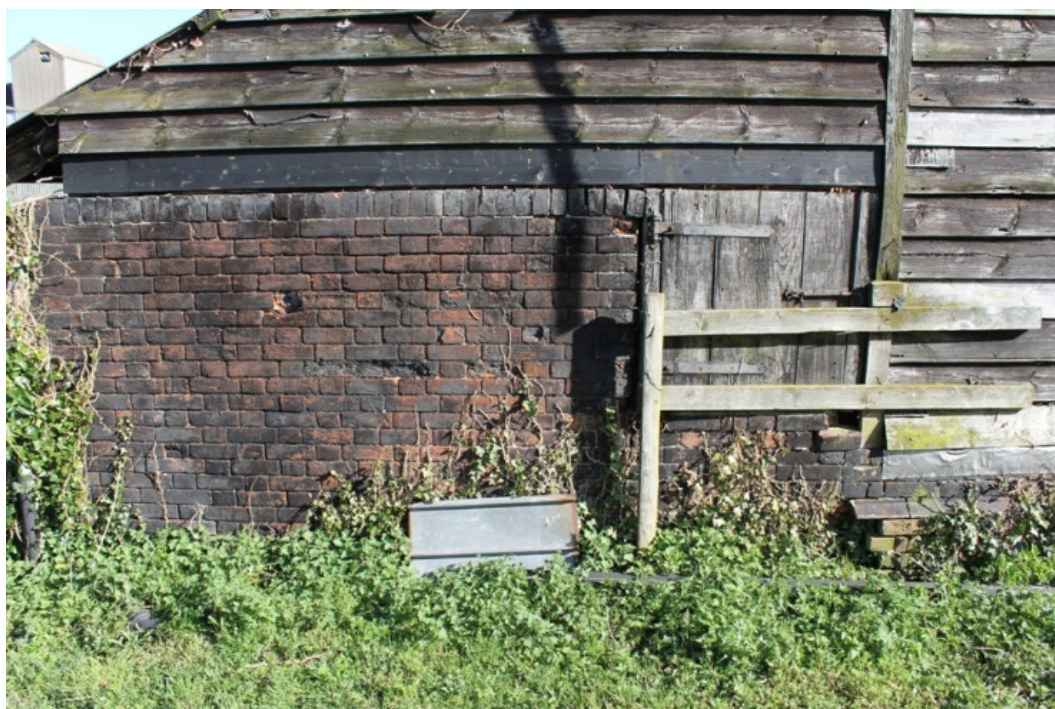
of the lean-to is predominantly of brick, laid several courses higher than the farmyard wall and with a small feed door within it (Plate 4). As with the north wall, the brickwork is Flemish bond and supports the roof timbers of the lean-to. The feed door has hinges identical to those on the stable block, suggesting the lean-to was constructed at the same time as the barn and the farmyard walls.

Plate 4 South-west elevation of the lean-to, with Flemish bonded brickwork and the feed door with hinges identical to those of the stable block - view north-east

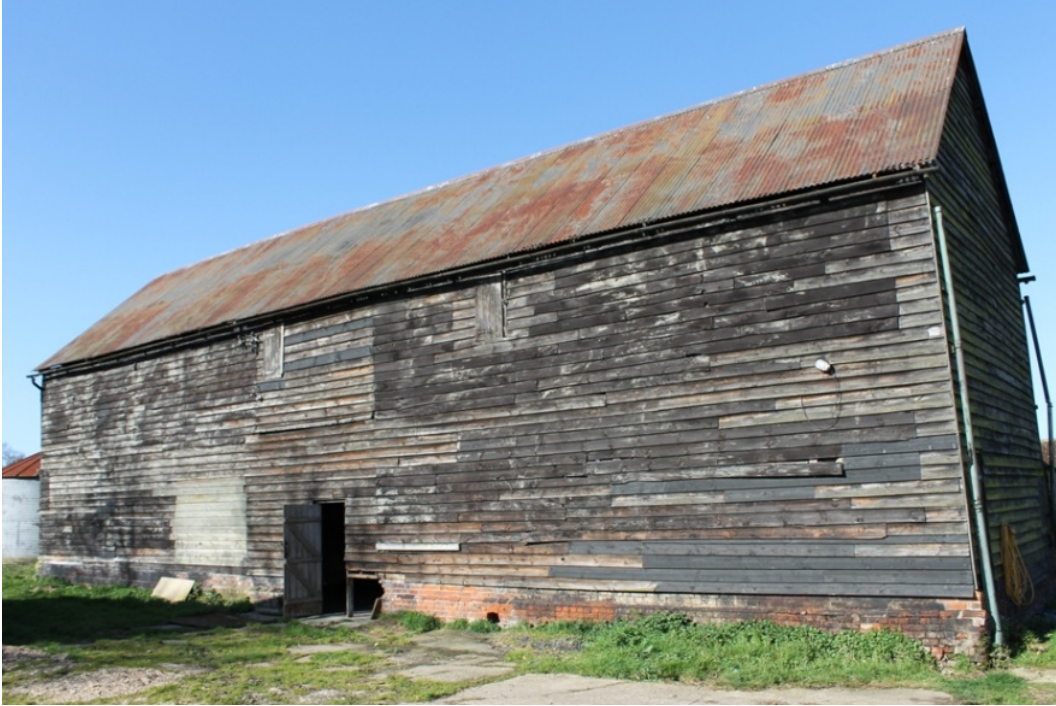
The south-east elevation has an off-centre doorway and two pitching doors below the eaves (Plate 5). The weatherboarding indicates that there were originally full height doors in the centre of the elevation, the opening for which has since been blocked. The plinth to either side of the doorway has been rebuilt in Fletton brick, although a section of this is missing next to the door (Fig 2).

Plate 5 South-east elevation, showing the blocked cart door opening and the inserted pitching doors below the eaves - view south-west

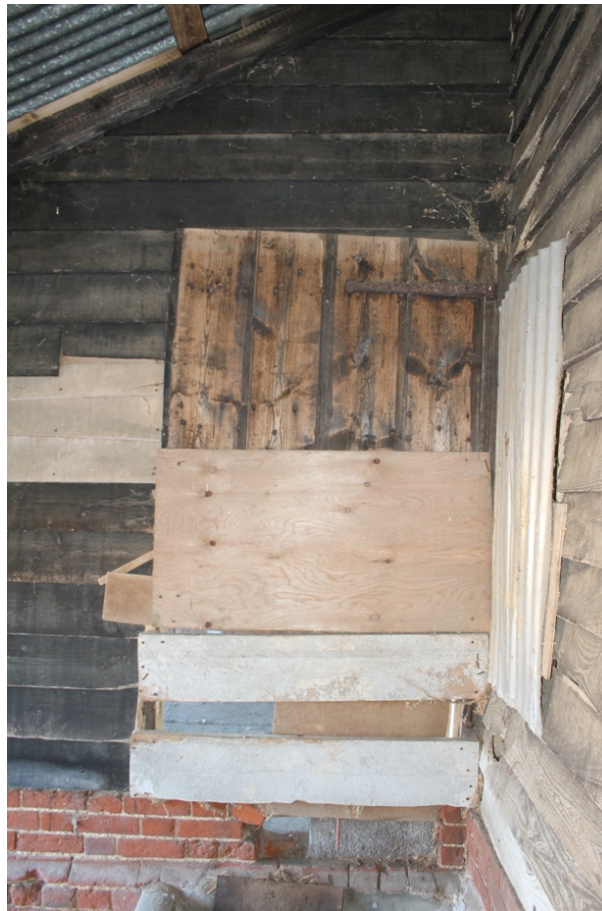
Plate 6 Remains of original door in side wall of midstrey - view north-east

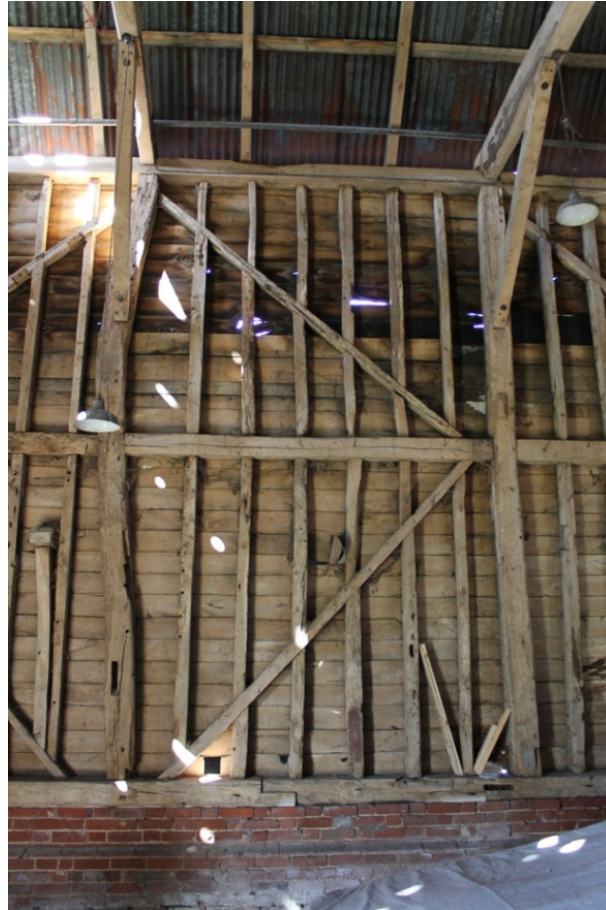
Plate 7 Framing of bay 6, showing the primary bracing forming a diamond pattern - view north-west

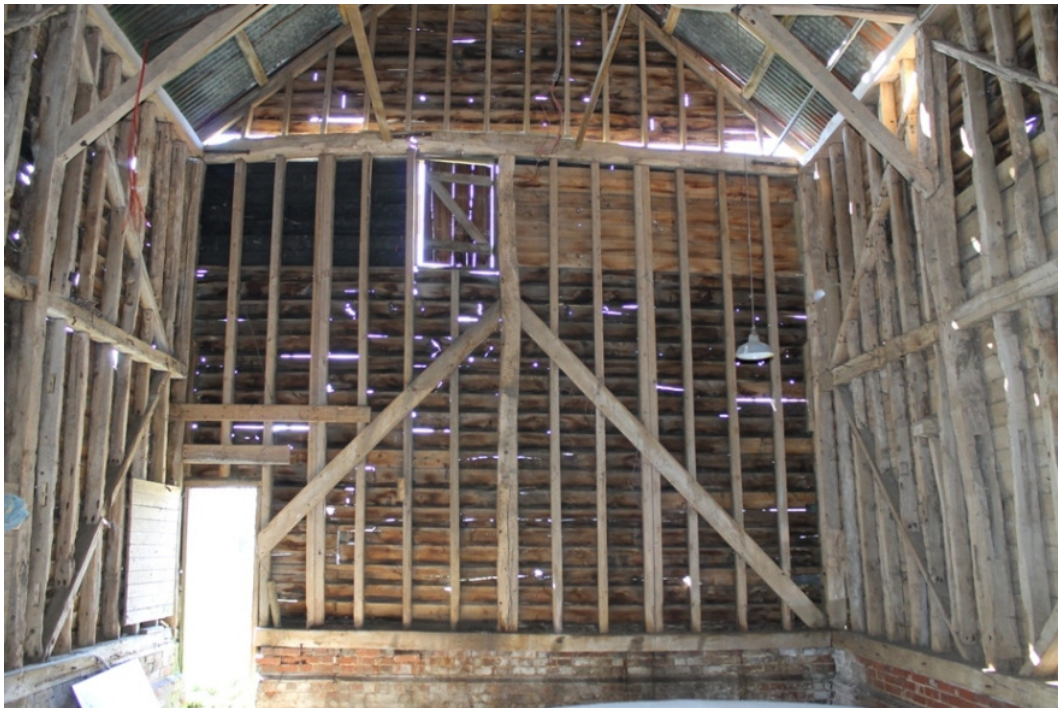
4). The frame of the south-west gable end has been completely rebuilt due to collapse. Although the wall plate, sill beam and the corner posts have been salvaged, the latter needing new bases scarfing to the main body of the post, the studding has been replaced with modern machine-cut timbers, reinforced with nailed plank bracing (Fig 6, Plate 8). This collapse was probably caused by pressure placed upon the frame when the sill beam and plinth was cut by the insertion of the doorway at the south-east corner.

Plate 8 The south-west frame, rebuilt after collapse, with modern machine-cut studs and nailed plank bracing – view south-west

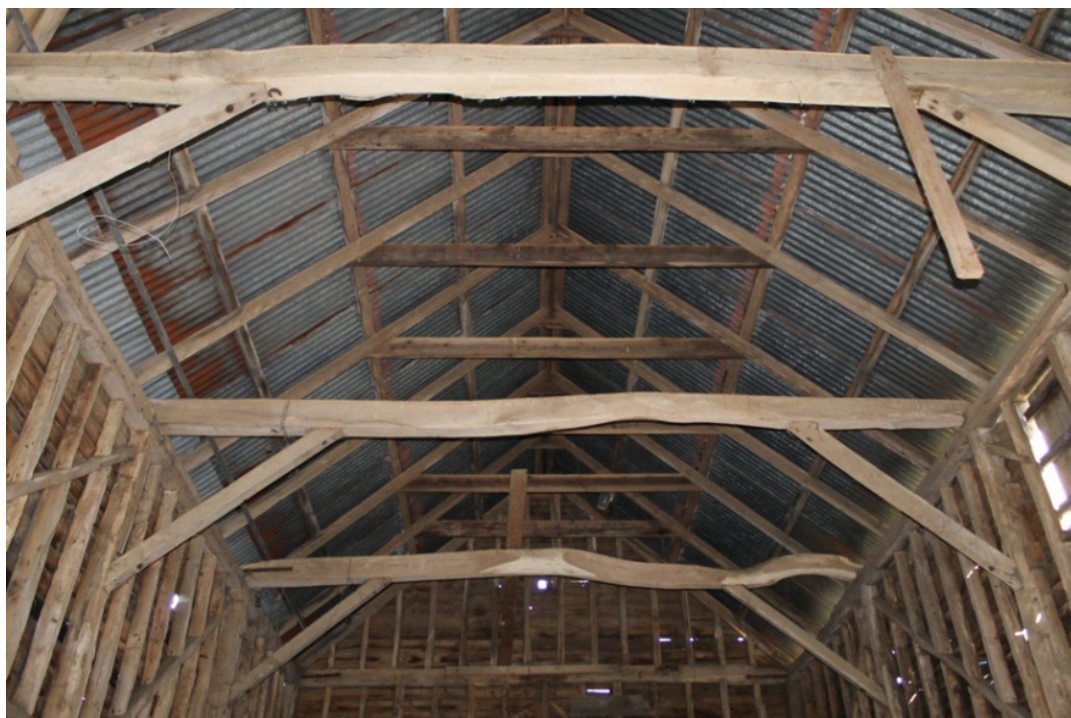
The tie beams are original to the building and, although machine-cut, illustrate the difficulty in obtaining straight timbers long enough to span a structure of this width (Plate 9). Several of the tie beams have a sinuous profile, indicating that smaller trees were chosen to provide the timbers, rather than those with a continuous square section which were sourced from larger trees. Straight braces, attached to the intermediate posts and the tie beams by a bolt and two nails, support the tie beams (Fig 7). The heads of each tie are strengthened by iron strapping.

The tie beams are the only surviving members of the roof trusses. The original principle rafters, purlins and collars have been replaced by a modern roof with a covering of corrugated iron sheeting (Plate 9). The original roof covering can only be guessed, but comparison with the farmhouse and other surviving buildings on the farm suggest it was probably peg tile or slate, rather than thatch.

Plate 9 The original tie-beams with the replacement roof above - view north-east.

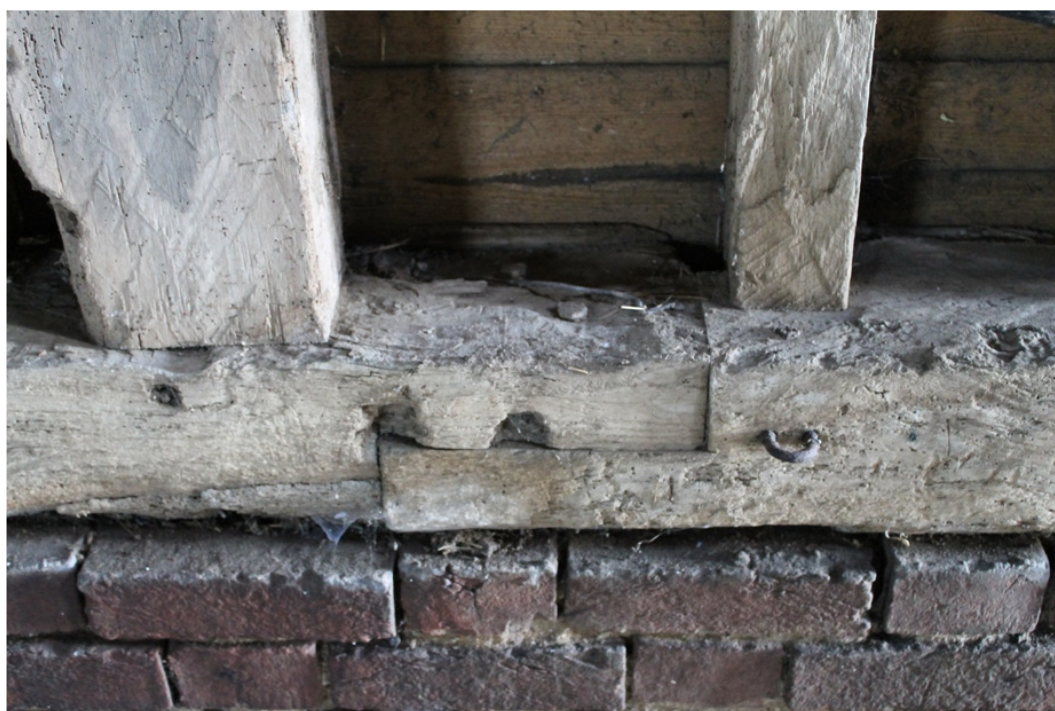
There are a number of scarf joints on the sill beam (Fig 2). These are all simple edge-halved joints secured with two wooden pegs (Plate 10). The wall plate has more varied scarf joints. The south-east wall plate has a face-halved scarf, secured by four pegs, in bay 2 and face-halved scarfs, with bladed abutments secured by four pegs, in bays 4 and 5 (Fig 4, Plate 11). The north-west wall has face-halved scarfs, with bladed abutments secured by four pegs, in bays 2 and 6 (Fig 3). There are edge-halved and bolted scarf joints in bays 3 and 5, close to the heads of the midstrey corner posts.

Plate 10 Detail of edge-halved scarf joint, secured by two pegs in the sill beam of bay 6 – view south-east

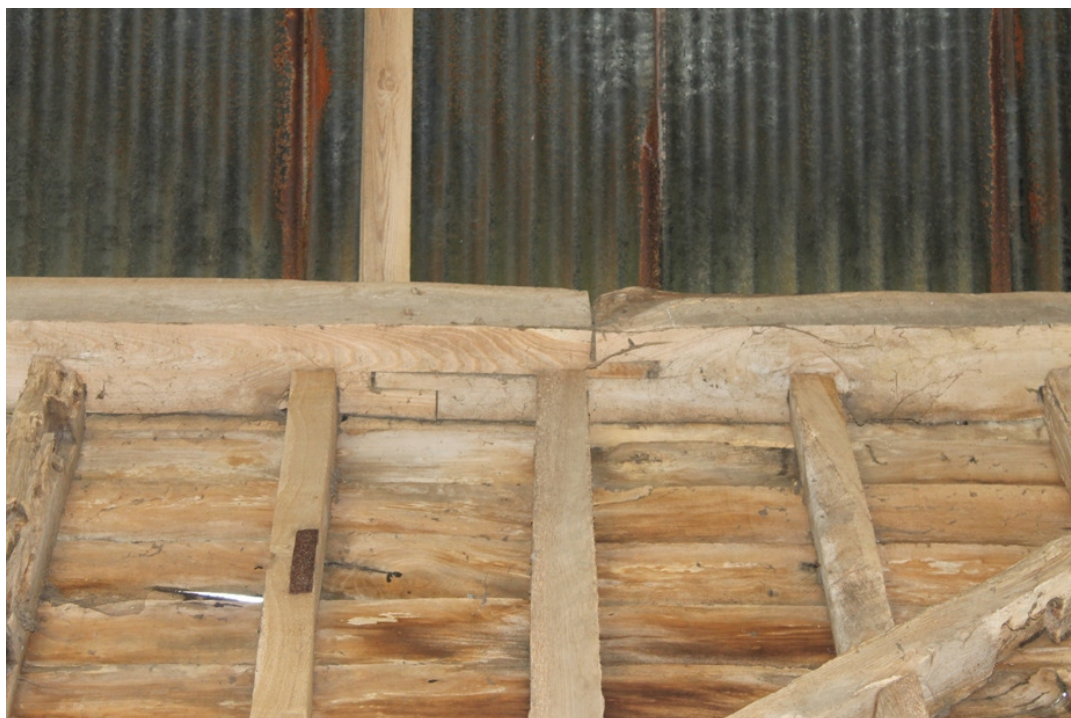
Plate 11 Face-halved scarf joint with bladed abutments, secured by four pegs in the wall plate of bay 5 – view south-east

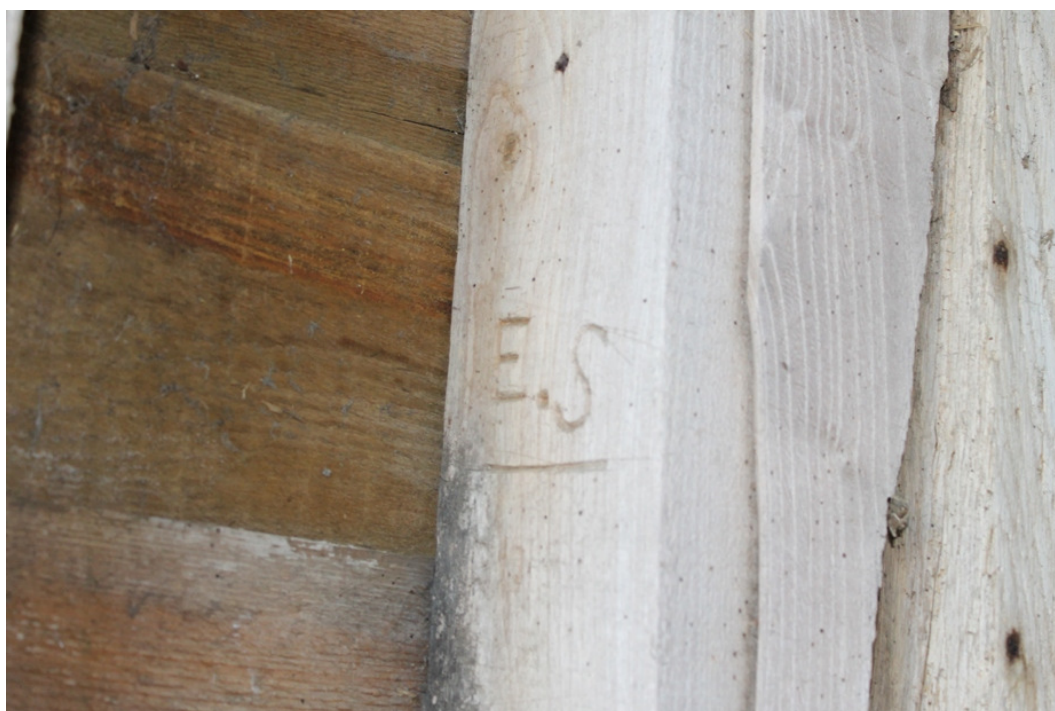
Despite the high proportion of re-used timbers in the structure, no evidence for carpentry or Baltic marks was observed. One instance of graffiti was discovered on the north-east midstrey wall: the initials 'E.S' were carved on a stud next to the internal corner post (Plate 12). These initials do not match the name of anyone encountered during the historical research of the farm and it is not possible to place a firm date to them. It is probable that they were carved there by a farm worker or possibly a carpenter during the alterations to the barn.

Plate 12 The initials 'E.S.' carved into a stud in the north-east wall of the midstrey - view east

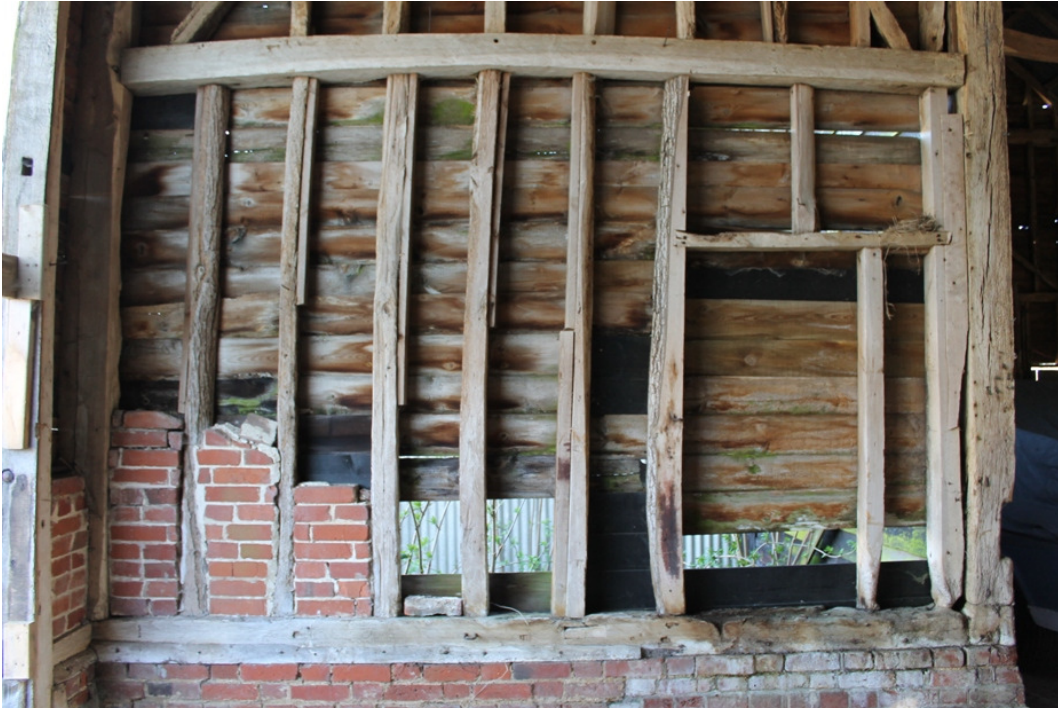
The midstrey offers one final point of interest. Brick nogging is present between the first few studs of the lower registers on both sides of the midstrey (Plate 13). There is no apparent trace of nogging between the other studs of the midstrey or in any other part of the barn's frame. It is possible that the nogging was inserted to strengthen the outer corners of the midstrey, perhaps in order to provide greater structural integrity where farm carts could potentially crash into the building.

Plate 13 Remains of brick nogging between studs of midstrey wall - view north-west

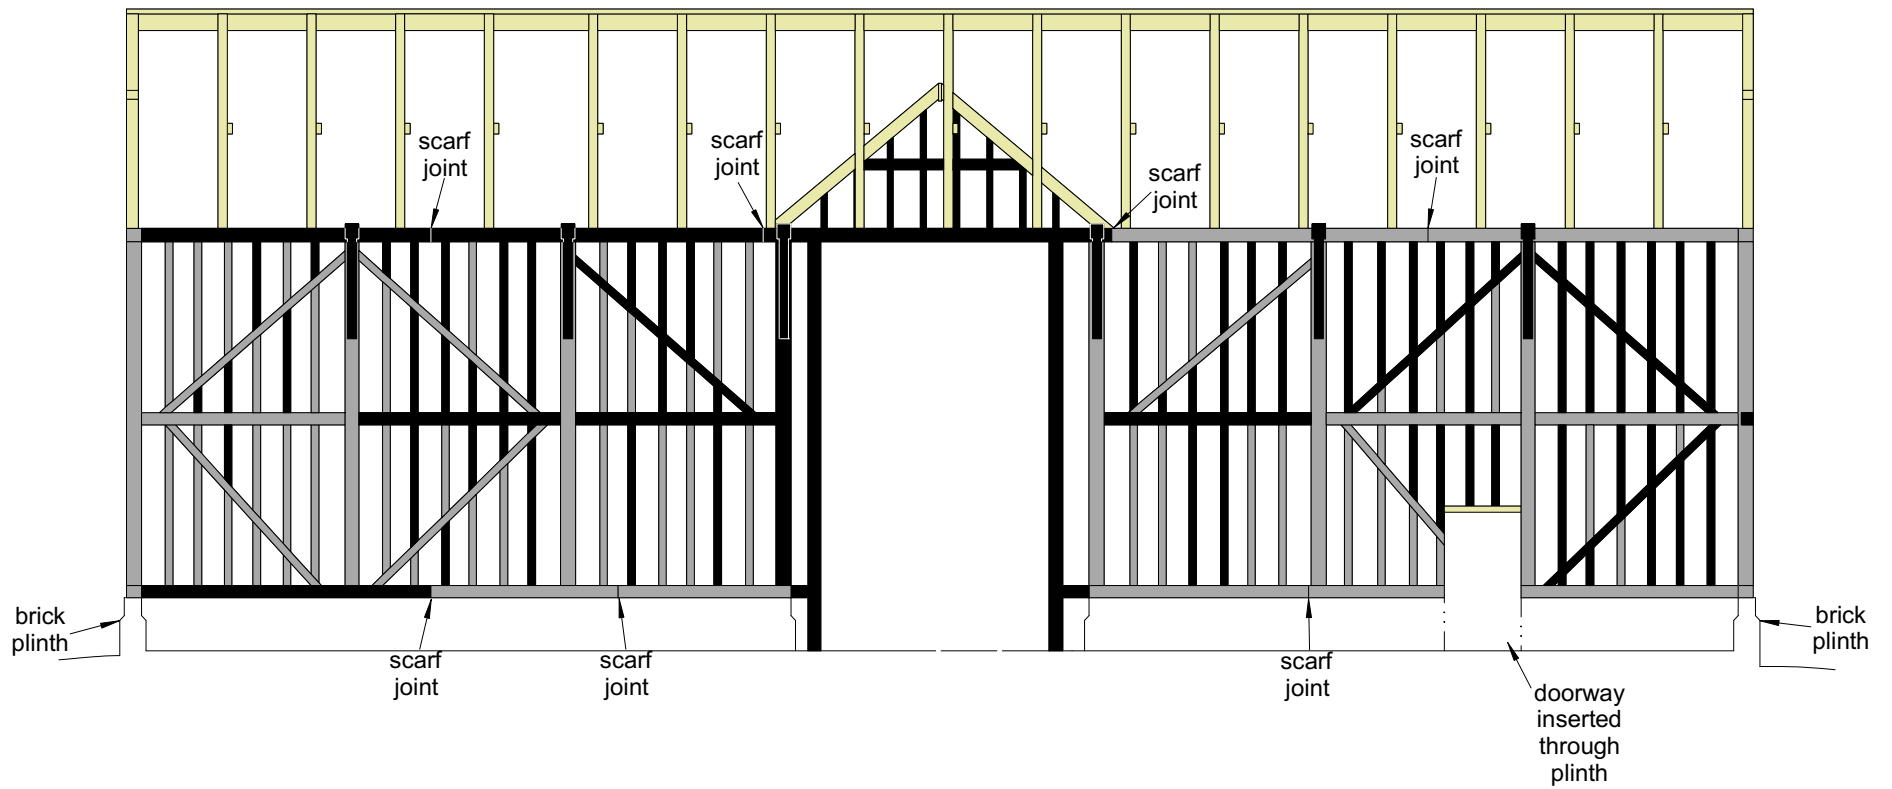
Fig 3 Frame drawing of north-west elevation, indicating the locations of original, re-used and replacement timbers.

The components of the frame are an almost equal mix of machine-cut timbers, original to the structure and re-used, hand-sawn timbers sourced from an earlier building. The re-used timbers all display empty mortices and recesses for bracing. The principle posts of the frame are formed of straight, hand-sawn timbers with variable dimensions of 140-200 x 140-200mm. The intermediate posts are predominantly straight, hand-sawn timbers, approximately 180 x 180mm, joined by girding beams with dimensions of 160 x 160mm. The different sections of the sill beam have variable dimensions of 150 -220 x 160-190mm and the wall plate is approximately 200 x 180mm. The girts, sill beams and wall plates are mainly re-used timbers, with some sections original to the structure. The studs have dimensions of 70-120 x 120-140mm with divisions of 300-350mm, with approximately half being re-used timbers. Bays 1-2 and 6-7 have primary bracing in both registers, forming a diamond pattern, as does the frame of the north-east gable end (Figs 3-5, Plate 7). Bays 3 and 5, flanking the threshing floor, have primary bracing only in the upper registers (Figs 3-
