**Historic building recording
at Shalford Hall Farm barns,
The Street, Shalford, Essex
February 2015**

**report prepared by
Chris Lister**

**commissioned by
Alun Design Consultancy Ltd
on behalf of
Mr Allan Stevenson**

CAT Report 841
July 2015

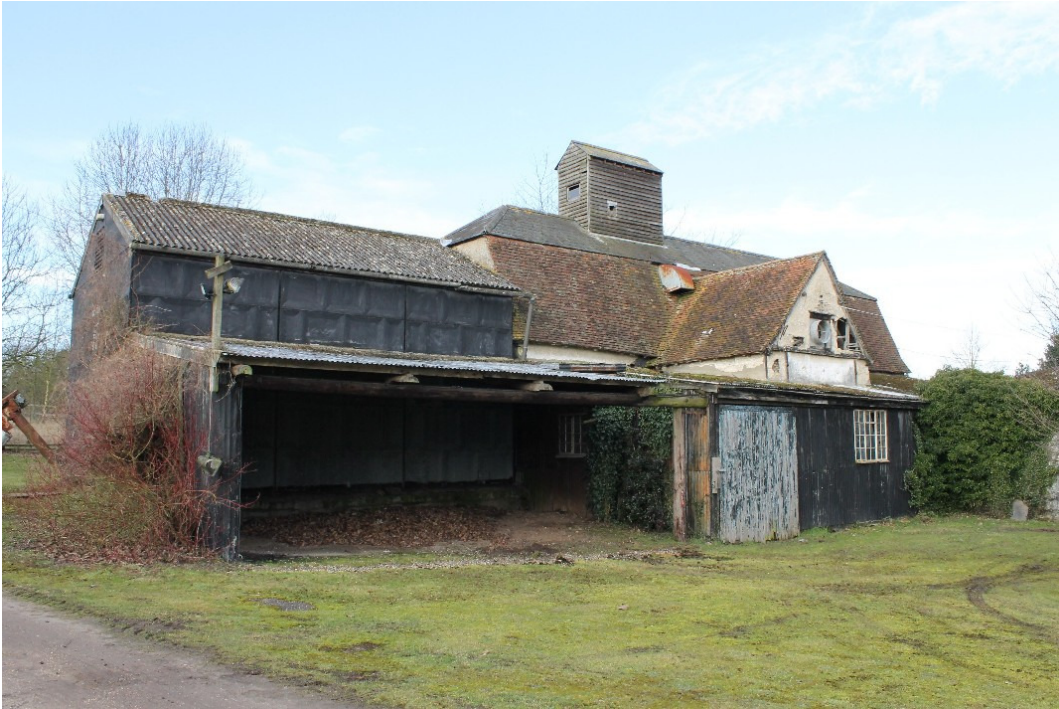
The main range of the barn has a half-hipped mansard roof (Plate 1), the lower slopes of which are clad in plain clay tiles. The upper slopes are clad in slate, clearly an alteration to the roof, probably carried out when the timber-clad housing for the grain hoist was installed on top of the ridge. The roof of the midstrey is clad in plain clay tiles.

Plate 1 North-east elevation of the Grain Barn, partially obscured by 20th-century outbuildings - view north-west

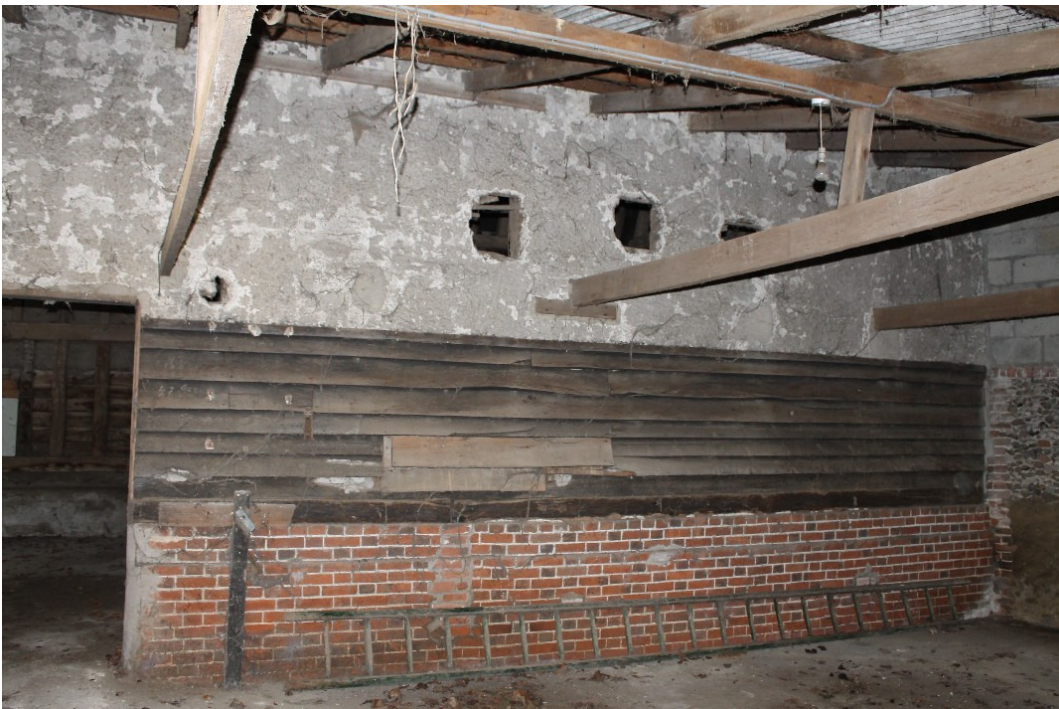
The Grain Barn is a rectangular timber-framed building, 19m long x 7m wide, aligned north-west to south-east, with an off-centre midstrey projecting from the north-east elevation (Plate 1). The barn sits upon a plinth of red brick with dimensions of 220 x 110 x 70mm, laid in Flemish bond. The exterior appears to have been weatherboarded to the lower portion of the framing with wattle and daub render above, although this survives in only a few locations and has subsequently been covered by a modern render (Plate 2, Figs 3-6).

Plate 2 Detail of the brick plinth to the Grain Barn with weatherboard above this and then render covering the upper portion of the frame – view west.

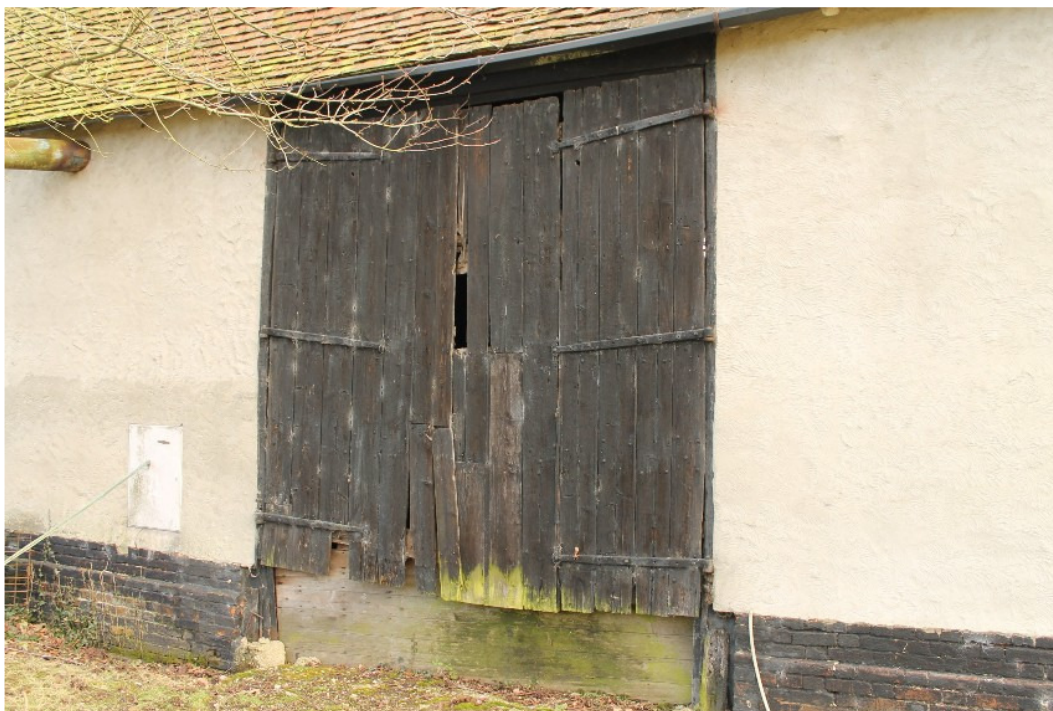
The north-east elevation (Fig 3) has an off-centre midstrey projecting from it, in line with a pair of full height barn doors in the south-west elevation (Fig 4). The midstrey doorposts have recesses for a threshold leap and there is a modern equivalent of a threshold leap in the south-west doorway, although the recesses have been replaced by iron stanchions. Although the barn doors have been replaced they appear to retain the original strap and pintel hinges (Plate 3).

Plate 3 Full-height barn doors in the south-west elevation of the Grain Barn with original strap and pintel hinges - view north

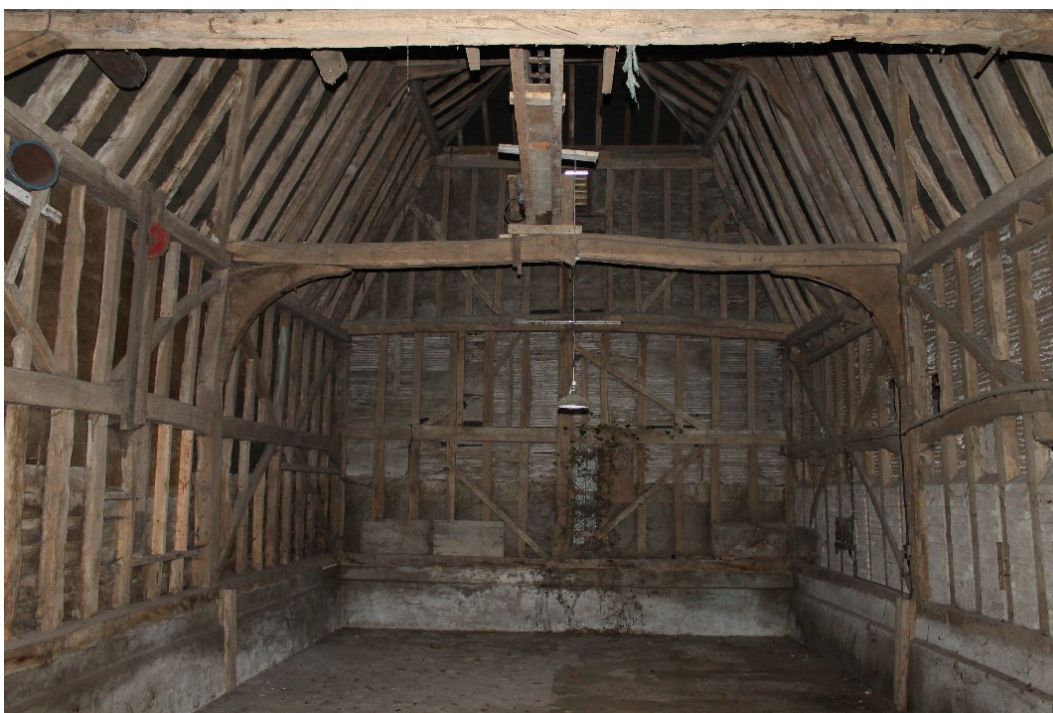
The barn is constructed from large-section hand-sawn hardwood timbers and is divided into 4 roughly equal bays (Plate 4, Fig 2). The sill beams, girding beams and wall plates all seem to be original to the building with a mixture of original and re-used timbers forming the studs. Several of the storey posts and girding beams display natural curves, particularly the girding beam to the south wall of bay 1, which has a 35- 40 degree bend at one end that has been incorporated into the studding of the corner post (Fig 8). The internal face of the brick plinth has been rendered with concrete making it impossible to visualise the brick work.

Plate 4 Interior of the Grain Barn - view north-west

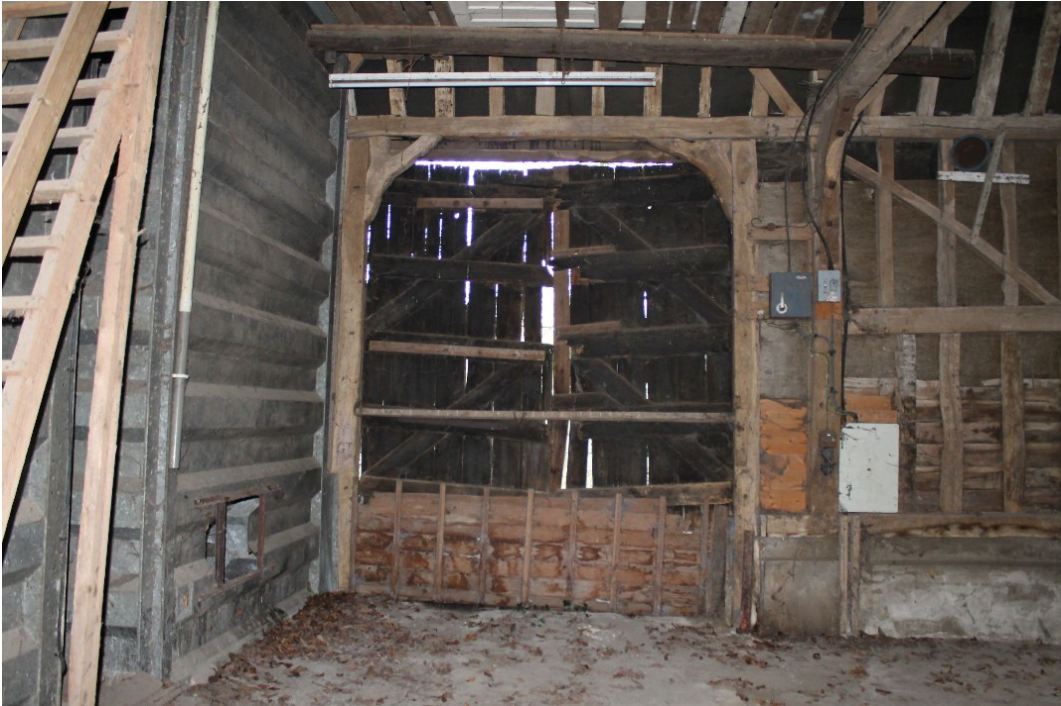
Bay 1 has primary bracing to upper and lower registers on both sides, which are single-pegged to the girding beams and storey posts. Bay 2 has primary bracing to the upper registers but not the lower registers. A doorway has been inserted through the north-east wall of bay 2 and the north-east side of bays 1 and 2 have brick nogging to two thirds of the height below the girding beam (Fig 7). Bay 3 is the midstrey but all trace of the threshing floor has been removed by the modern concrete floor. The barn door opening in the south-west frame of bay 3 appears to be original. It has a modern threshold leap but the recesses for this have been replaced by iron stanchions. The doorposts have knee braces, formed from roughly squared Y-shaped branches of a tree (Plate 5, Fig 8).

Plate 5 Barn doors in south-west wall of Grain Barn with roughly squared knee braces - view south-west

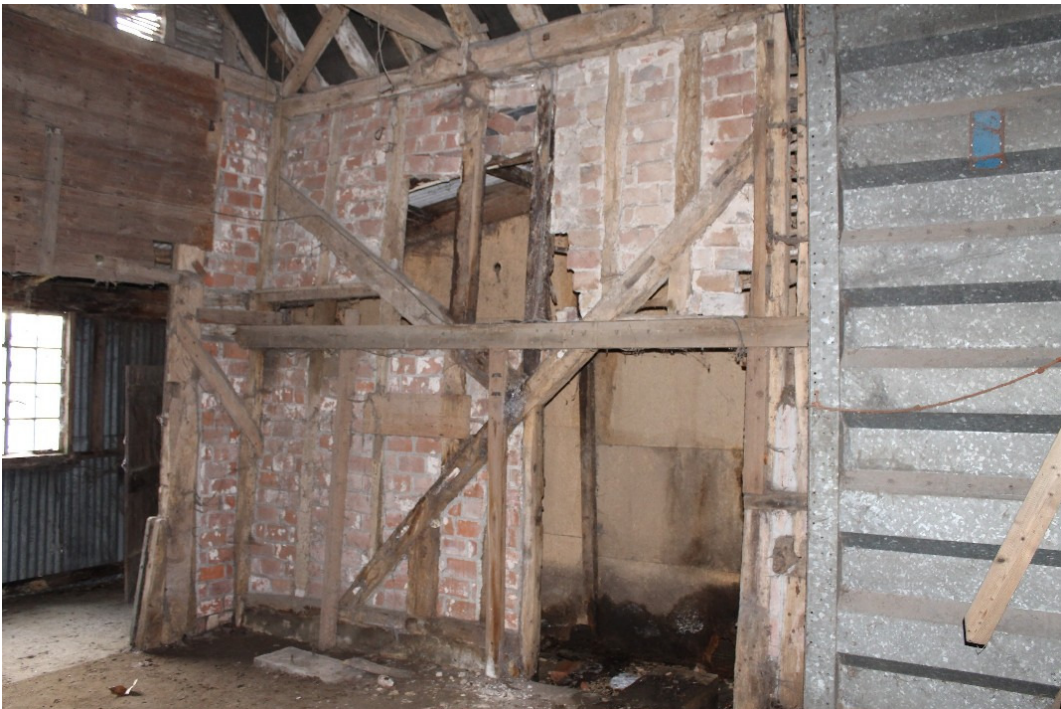
Plate 6 South-east wall of the Grain Barn midstre showing the Y-shaped bracing and brick noggin - view east

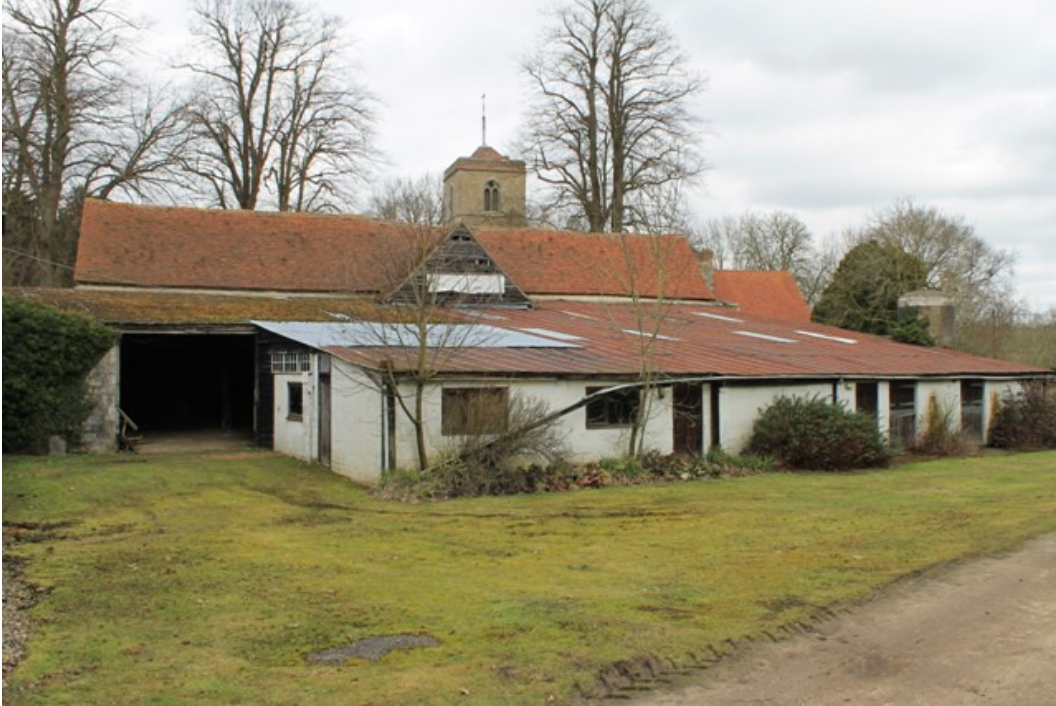
Plate 7 South-east elevation of the Church Barn with 20th-century outbuildings in the foreground and St Andrew's Church behind - view north

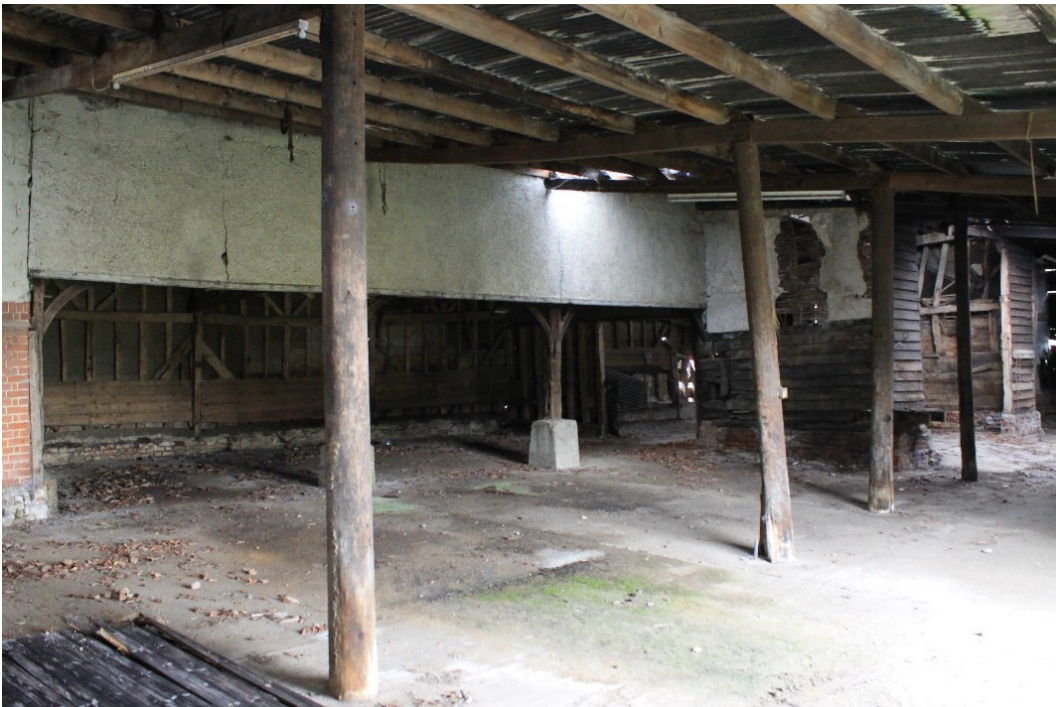
The south-east elevation is almost entirely hidden behind 20th-century outbuildings (Plate 8) which has had the effect of turning the area in front of the barn into a covered yard. Part of the frame to this elevation, south-west of the midstrey, has been removed converting this part of the barn into a cart lodge (Fig 13).

Plate 8 The south-east elevation of the Church Barn, concealed beneath/behind the 20th-century outbuildings – view north-east

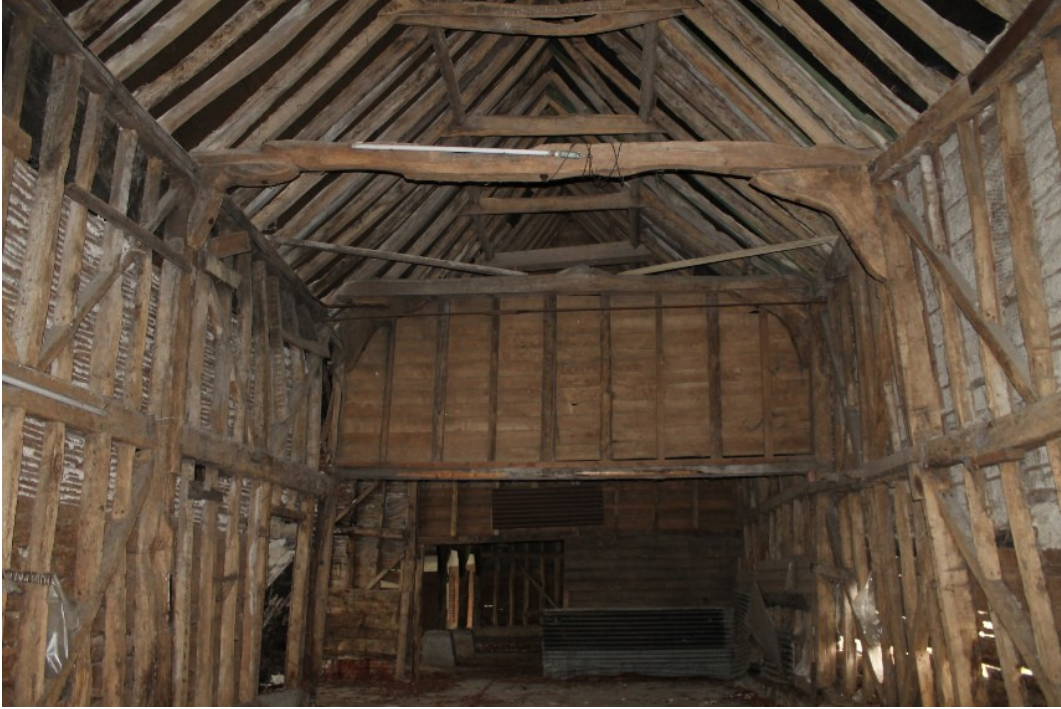
The interior of the Church Barn is divided into seven bays, three roughly equal-sized bays to either side of the midstrey bay which is much wider (Plate 9, Fig 12). The frame consists of hand-sawn hardwood timbers with posts of varying dimensions, girding beams and wall plates, all of which include many re-used timbers (Figs 17-21). The studs are not of uniform scantling and consist of both re-used timbers and timbers original to the building, although the deteriorated state of the posts and studs makes differentiating this very difficult.

Plate 9 The interior of the Church Barn with the dividing walls to the sides of the midstrey - view south-west.

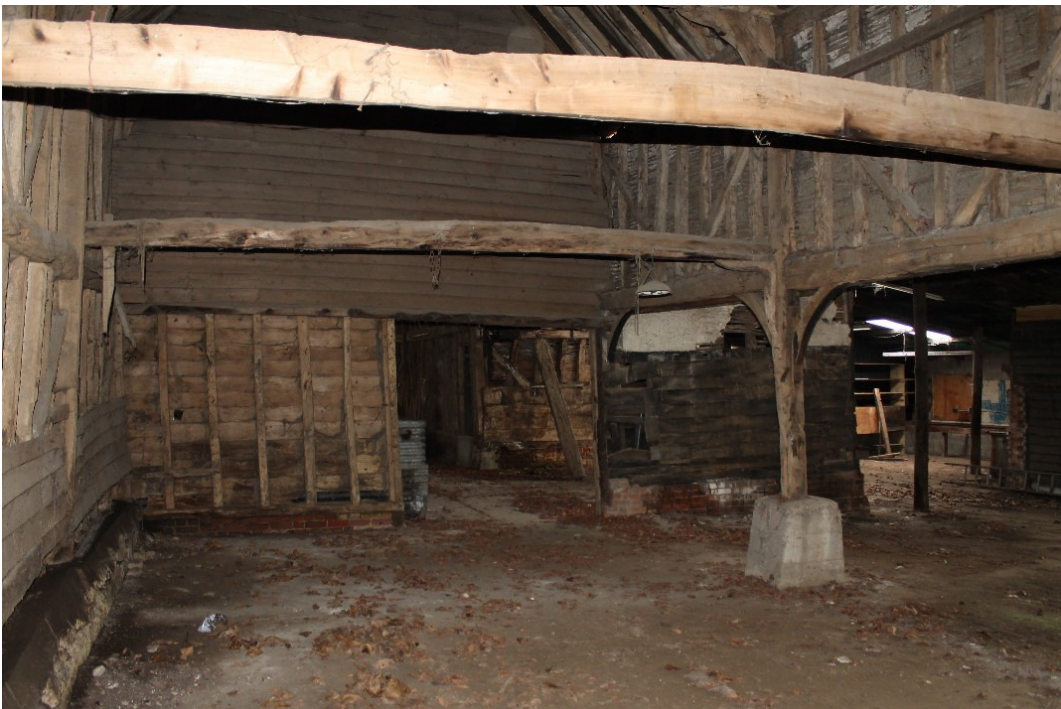
Bays 1-3 have been converted to a cart lodge by the removal of the lower registers of the south-east wall (Plate 10). The storey posts were retained when this was carried out and machine-cut arched braces have been nailed to the underside of the girding beams and the sides of the posts to provide additional support (Fig 17). The exposed mortices for the removed studs are clearly visible in the underside of the girding beams.

Plate 10 The interior of bays 2-3 in the Church Barn, converted to a cart lodge by the removal of the lower framing – view east

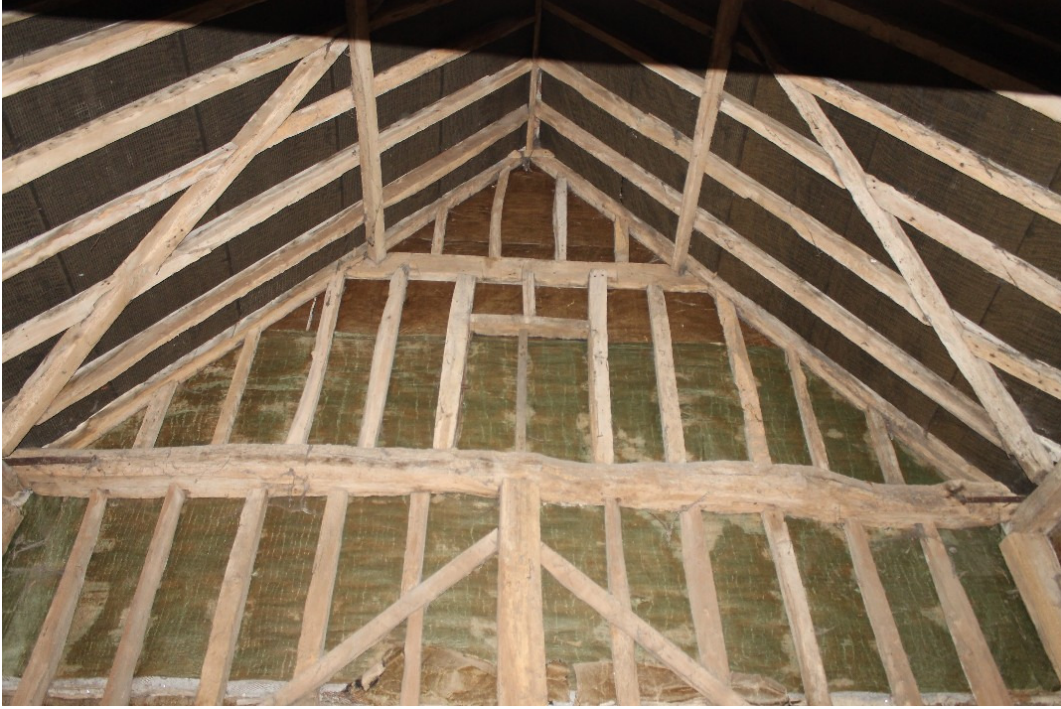
The south-west gable has square-section corner posts and a central storey post, with girding beams either side of the storey post. Primary braces form a rough diamond pattern (Fig 20). Above the gable wall plate there is a centrally-positioned opening for a pitching door, which has been blocked and was probably an alteration rather than an original feature (Plate 11).

Plate 11 South-west gable frame of the Church Barn with inserted window above the wall plate – view south-west

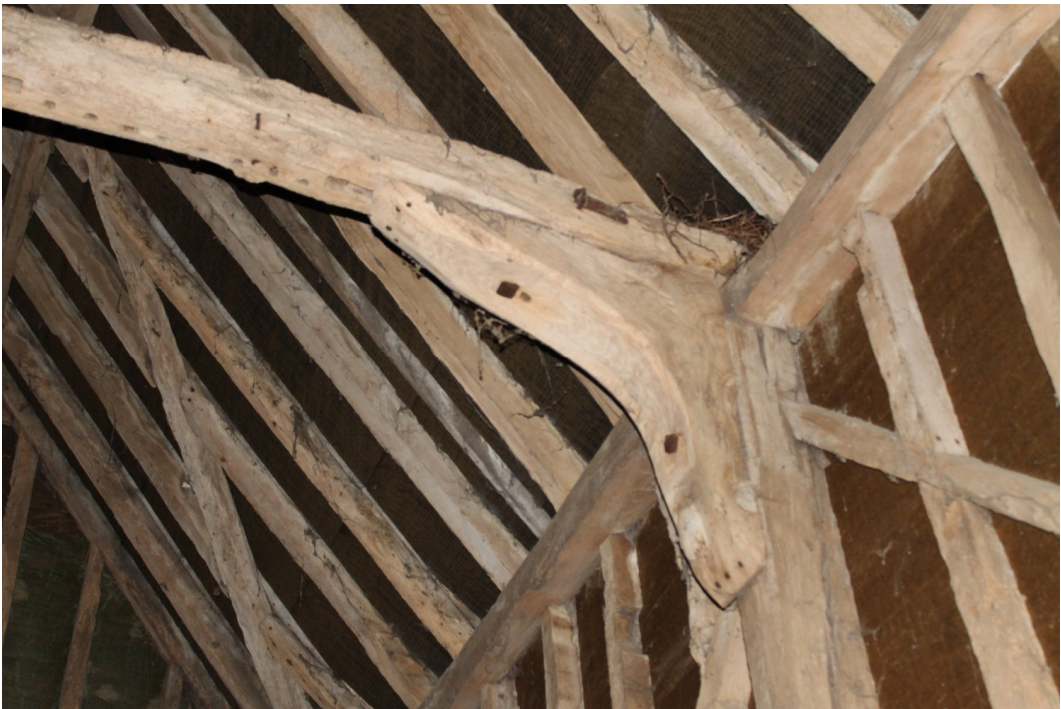
The large-section tie beams (several of which are re-used beams with exposed mortises and peg holes for a much larger brace) are supported on large hewn knee braces, bolted and nailed to the post and tie beam (Plate 12, Fig 21).

Plate 12 Large hewn knee brace supporting re-used tie beam of truss A in the Church Barn - view west

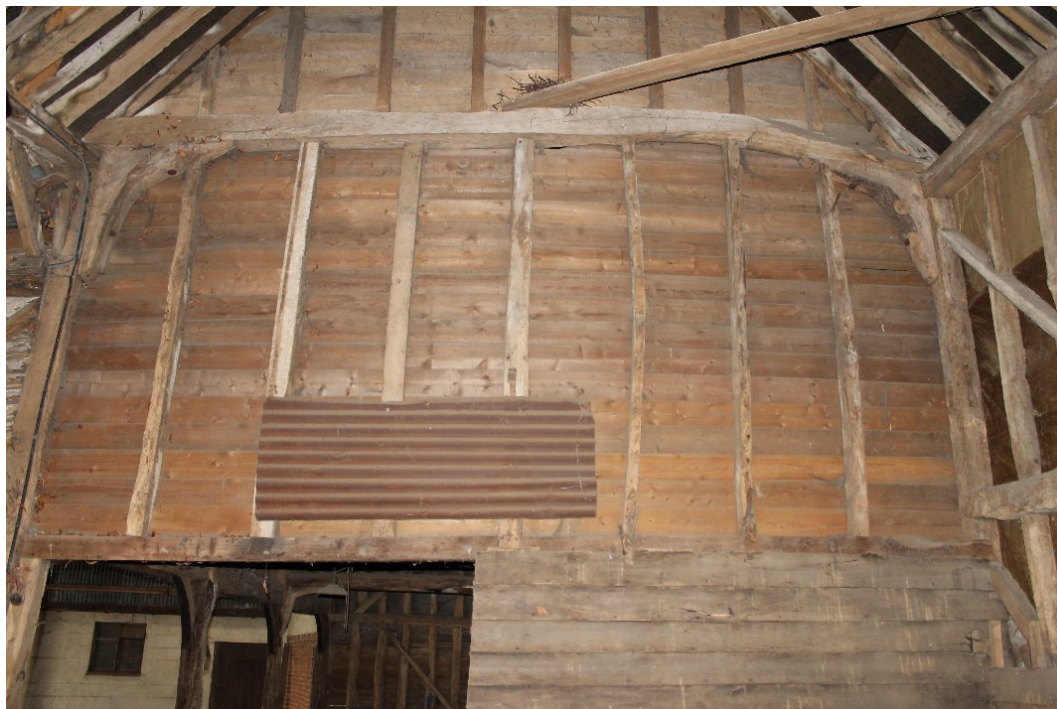
Dividing walls have been inserted between bays 3-4 and bays 4-5. The dividing wall between bays 3-4 has been inserted underneath the tie beam of truss C, which has two hewn knee joints double-bolted to the tie beam and posts. This wall sits on a low brick plinth with a sill beam supporting studs clad in planking (Plate 13, Fig 12). The visible studs appear to be machine-cut timbers, which suggest that the wall is a later feature. An original opening in this wall has been widened by the removal of two of the studs. The dividing wall between bays 4-5 starts at the height of the girding beams with the heads of the studs inserted into the underside of the tie beam to truss

Plate 13 Inserted dividing wall between bays 3-4 of the Church Barn - view south-west

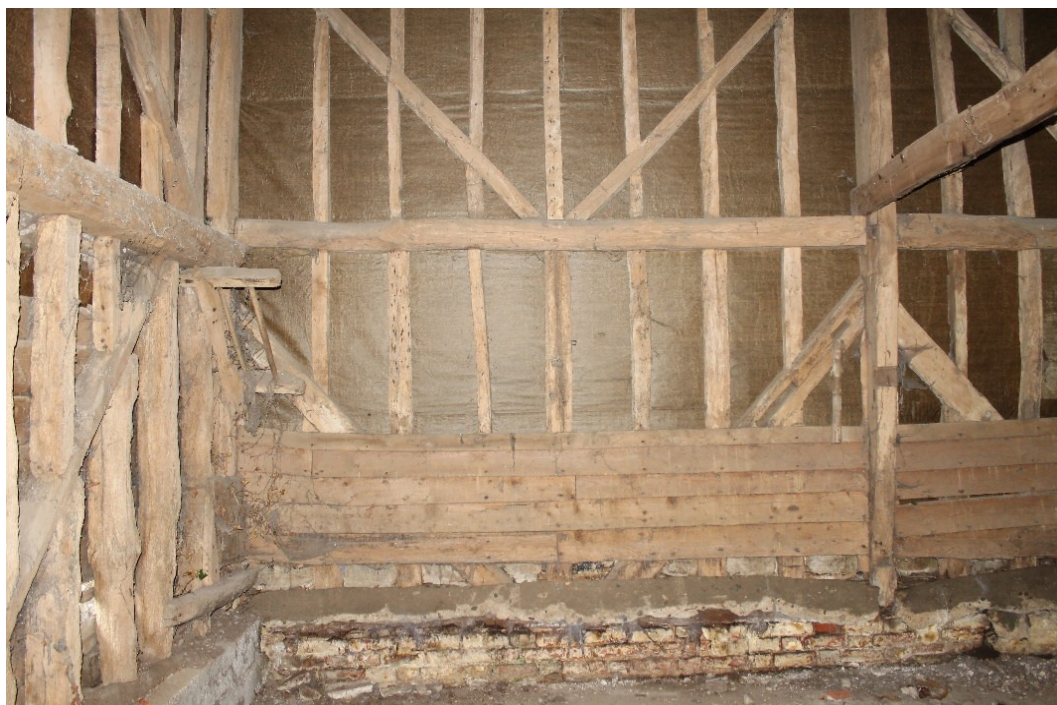
In addition to the alterations carried out to bays 1-3, trusses A and B have small, hewn knees supporting a cross beam that sits on top of the girding beams on both sides, single bolted to the posts and tie beam and with three nails at the tips of the knee braces. The north-west wall of bays 1-3 has plank cladding to a height of about 1.3m and in the corner of bay 1 there are the remains of a hay rack (Plate 14, Fig 12). This has circular-section mortices for the spindles rather than diamond-section ones, which are more usual. The hay rack and the plank cladding indicate that these bays were, at some point, used to house livestock.

Plate 14 Plank cladding to wall of bay 1 and remains of hay rack, indicating bays 1-3 of the Church Barn were once used to house animals - view north-west

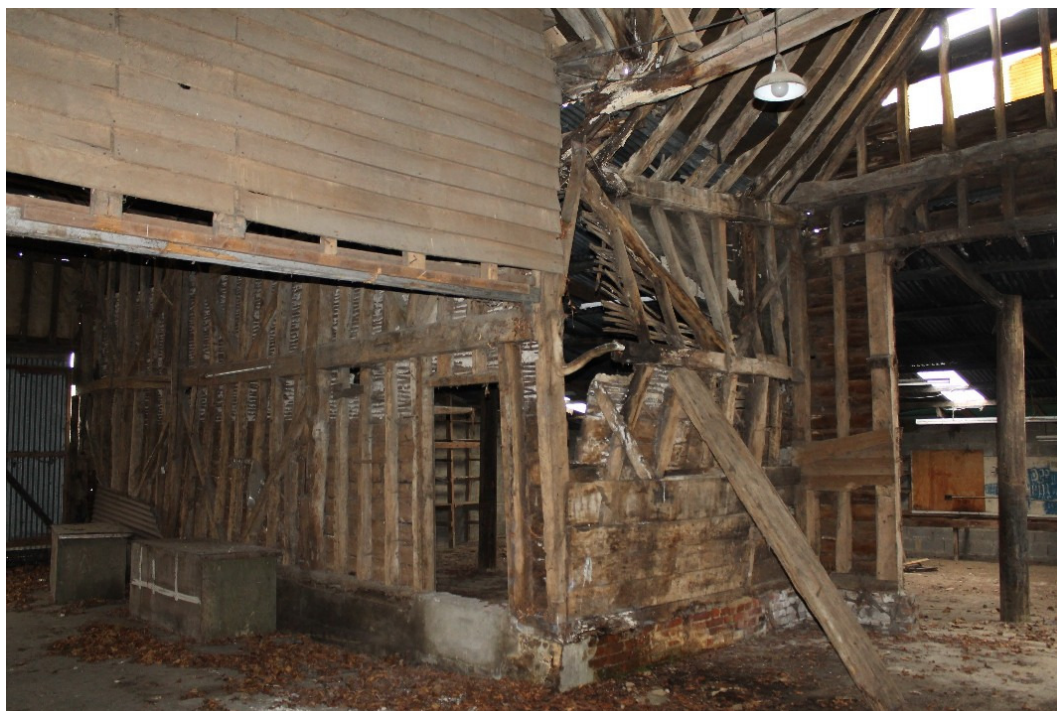
The midstrey projecting from bay 4 is carried on a plinth of red brick with dimensions of 226 x 110 x 65mm, laid in irregular bond. The north-east wall of the midstrey is in a very bad state of repair and is propped by a baulk of timber (Plate 15, Fig 19). The frame is divided by a girding beam with the lower portion of the bottom register obscured by wide-section planking. The lower register has a single brace falling from the post of truss D to the sill beam and the upper register has diagonal bracing falling from both corner posts. The wall plate, although in a very poor state of repair, appears to be original. The south-west frame of the midstrey has diagonal bracing falling from both corner posts in each register. Wide-section planking covers the lower half of the bottom register (Plate 16, Fig 20).

Plate 15 The north-east frame of the midstrey to the Church Barn - view south-east

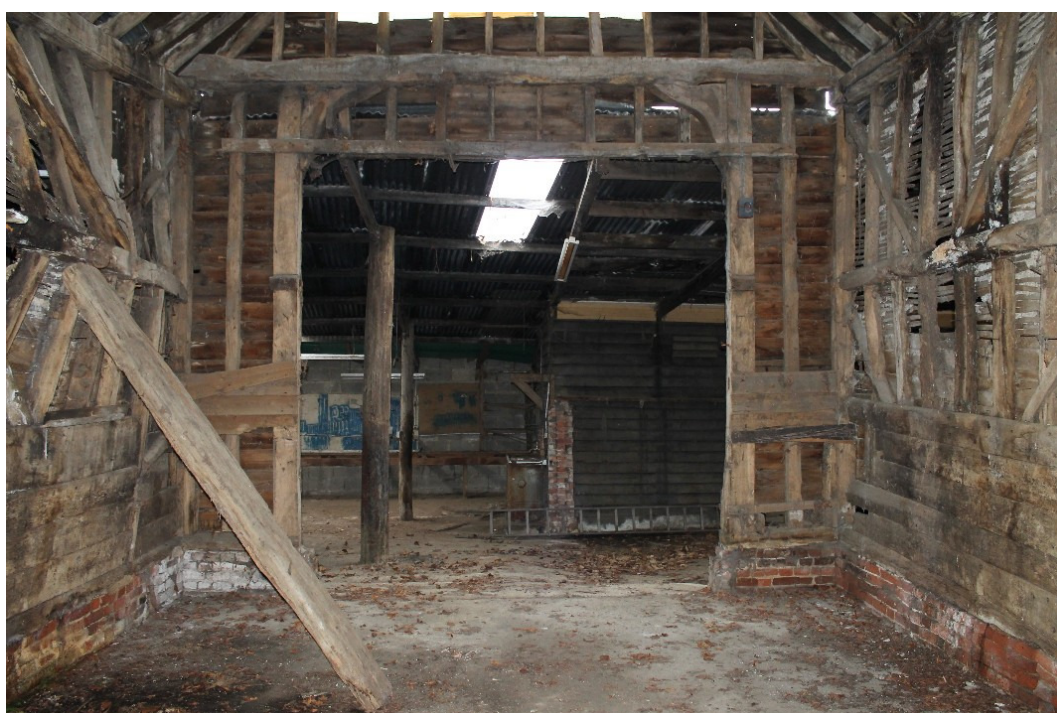
Plate 16 The midstrey to the Church Barn - view south-east

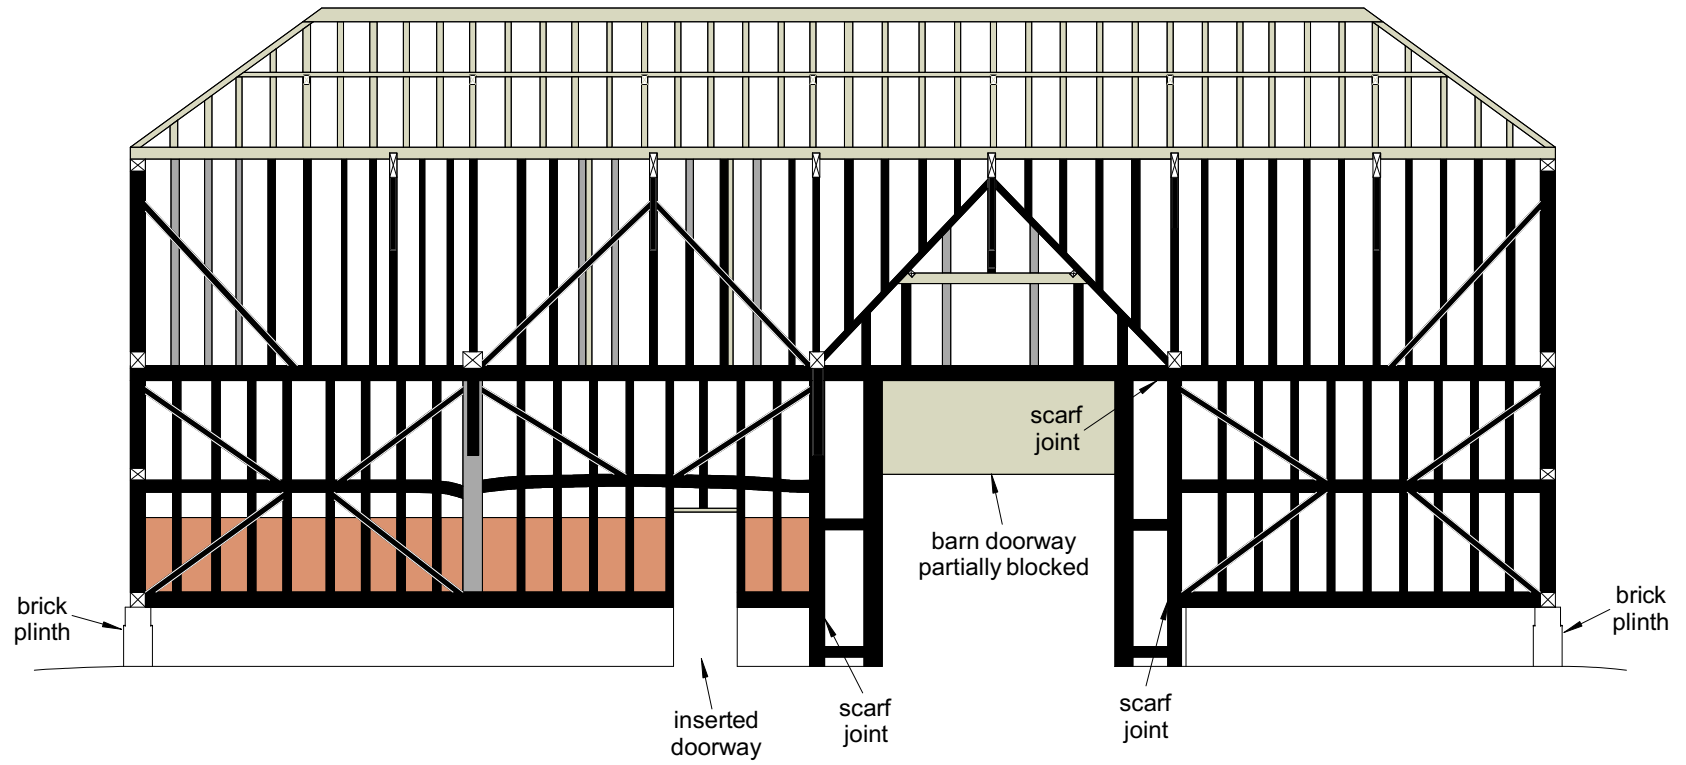
Fig 7 Frame drawing of the north-east wall to the Grain Barn, indicating the locations of original, re-used and replacement timbers.

A single face-halved scarf joint with bladed abutments was noted in the sill beam of bay 1 (Fig 2) and others were present in the wall plate above the barn door opening in bay 3 (Fig 8) and near the head of the post in the wall plate on the north-east side of truss C (Fig 7). Additionally the bases of the north-east posts to trusses B and C have crude scarf joints, which may have something to do with the rebuilding of the midstreys (Fig 7).

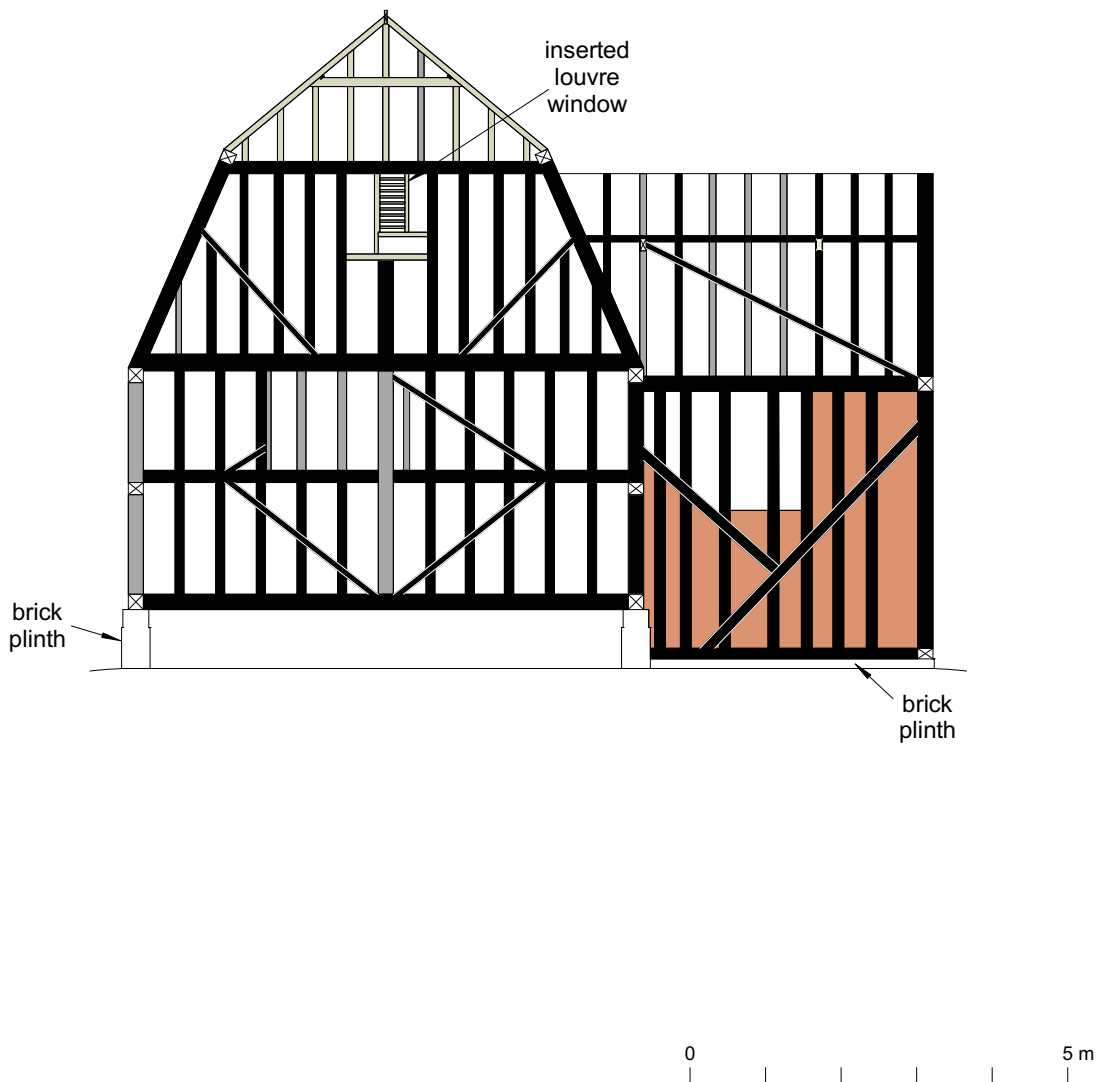
Fig 9 Frame drawing of the north-west wall to the Grain Barn, indicating the locations of original, re-used and replacement timbers.

The mansard roof has large-section timbers as common rafters, many of which appear to be re-used timbers. There are no principle rafters rising from the heads of the tie beams; instead there are staggered principle rafters with collars formed from a large-section beam, supported on bolted knee braces (Fig 11). These collars carry the kerb beams for the upper pitch of the roof, from which rise rafters supported by purlins with intermediate high collars. All the timbers above the kerb beams are machine-cut timbers and have probably replaced original high collars. This was probably carried out when the upper slopes of the roof were clad in slate. The lower pitch of the roof in bay 1 has primary bracing falling from the gable on both sides, whilst the roof of bay 2 has primary bracing falling from the principle rafter in two directions on both sides. There is no bracing in the upper pitch of the mansard roof. The north-west frame above the wall plate has primary bracing falling from the sides of the frame to the wall plate. The central post of the gable has been cut by the insertion of an opening, subsequently reduced in size and incorporating a louvre window (Fig 9).

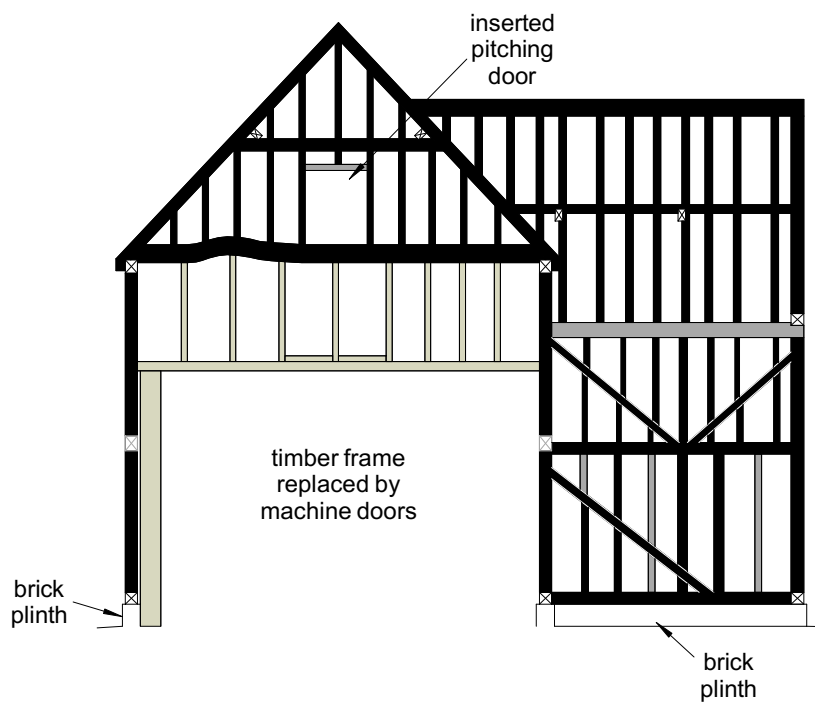
Fig 19 Frame drawing of the north-east wall to the Church Barn, indicating the locations of original, re-used and replacement timbers.

The north-east gable frame has been completely removed below the wall plate and replaced with a large set of doors for farm machinery (Fig 19). Above these doors there is an area of vertical studding, obviously not original, with a large window formed from corrugated plastic sheeting. Above this, in the middle of the gable, a pitching door has been inserted.
