**Historic building recording
at Mudwall Farm,
High Easter Road,
Barnston, Essex
April 2013**

**report prepared by
Chris Lister**

**commissioned by
Alun Design Consultancy Ltd**

CAT Report 702
May 2013

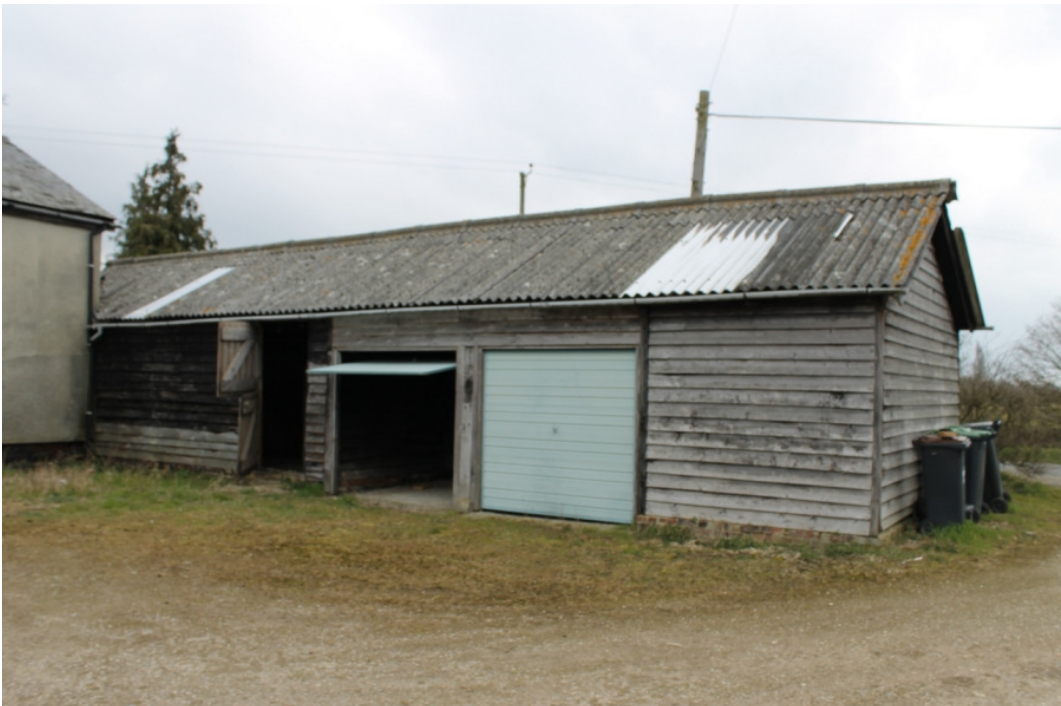
Plate 9 Stable block with converted two-bayed horse shed to the right and carhorse stable to the left of the Henderson garage doors

The stable block is a single storey structure 4.8m wide x 16.9m long, orientated north-west to south-east and located perpendicular to the barn (Plate 9). The short elevations and the north-east elevation (parallel to High Easter Road) are clad in horizontal weatherboarding. There are no adornments to these elevations apart from a single tethering ring on the north-east wall. The south-west elevation presents two distinctly different parts. The first extends from the barn and is characterised by black-painted horizontal weatherboarding (identical to that on the north-west and north-east elevations) that terminates in a traditional stable door. The remainder of the structure is clad in unpainted horizontal weatherboarding and has two inserted metal garage doors, the handles of which are stamped 'Henderson'. Apart from where it has been removed by the inserted garage doors, the entire structure sits on a red brick plinth laid in irregular bond. An exception to this is the south-east end where the plinth has been rebuilt in modern brick which has dimensions of 220 x 105 x 61mm.

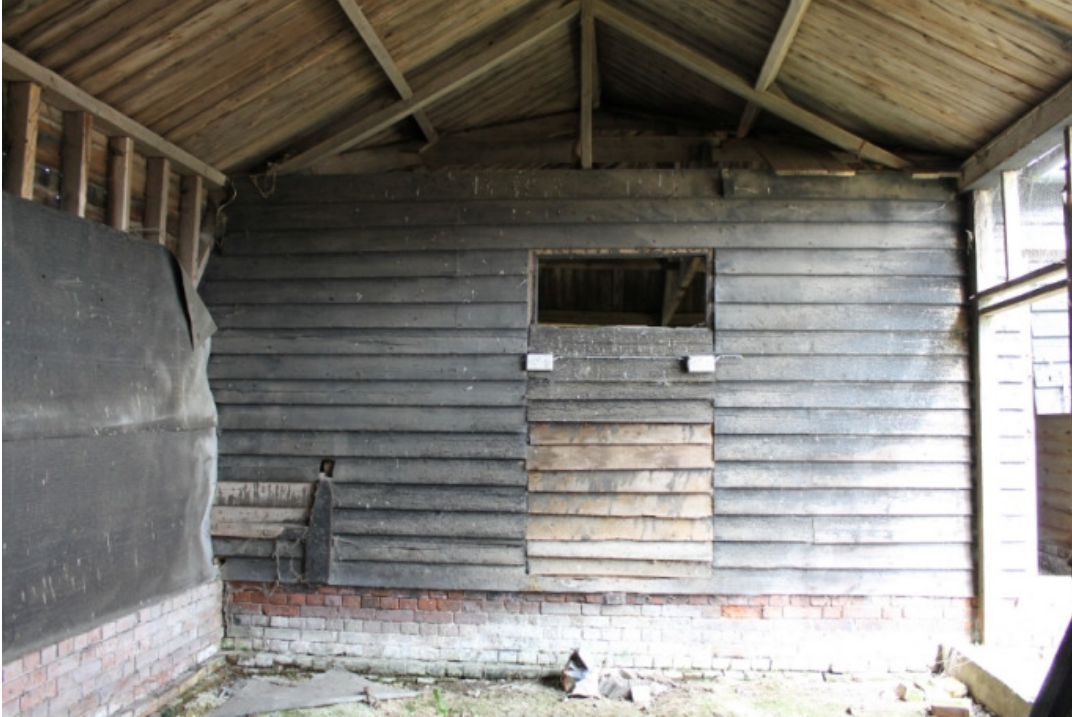
Plate 22 Interior of the 'four-bayed' cattle shed showing the original short king post truss and remains of the manger – view north-west

dividing wall to the chaise house. This has the original principal rafters rising to meet the head of a short king post. The later ridge board and purlins rest on this truss (Plate 22).
