Historic building recording at 11 Trinity Street, Colchester, Essex, CO1 1JN

May-June 2016

CAT Report 990
August 2016

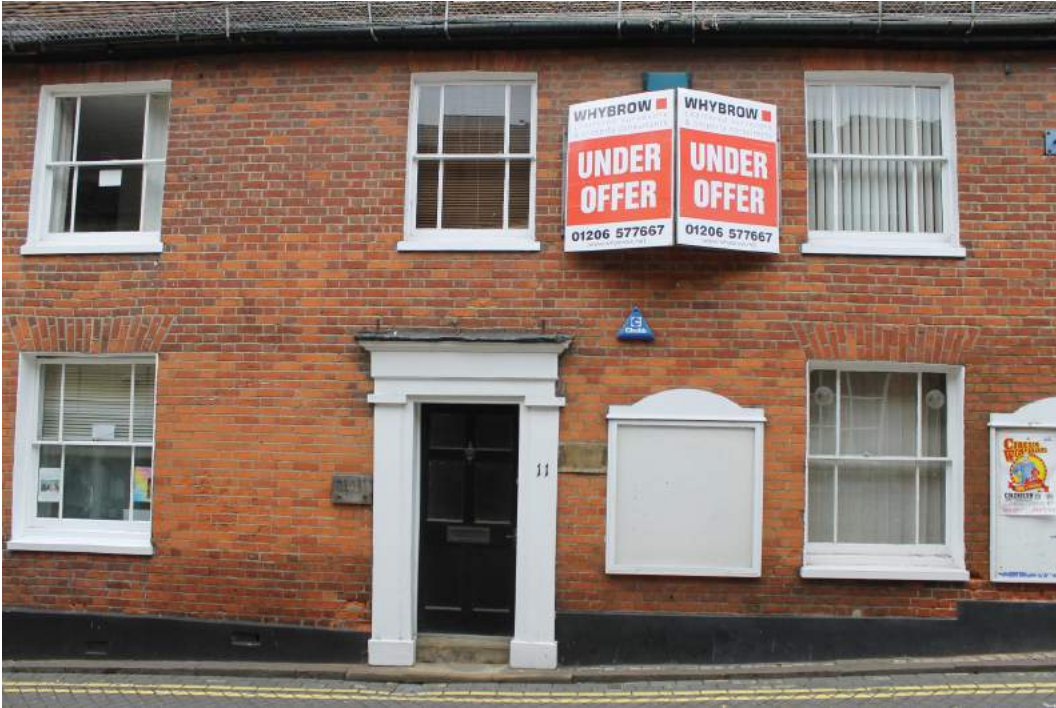
Photograph 1 Street frontage of No. 11 showing the symmetry of the probable 19th-century brick facing – view west

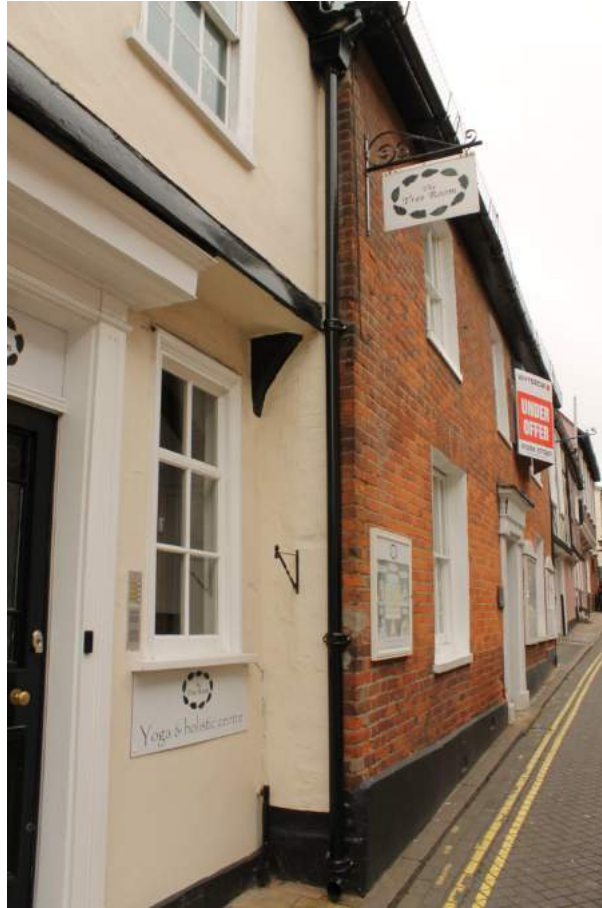
The brick facing conceals the jettied first floor to No. 11. However, this is still present behind the brickwork as shown by Photograph 2, which also shows the exposed jetty of No. 12.

Photograph 2 Brick facing to No. 11 with the jettied first floor of No. 12 showing what is concealed by the brick facing – view north-west

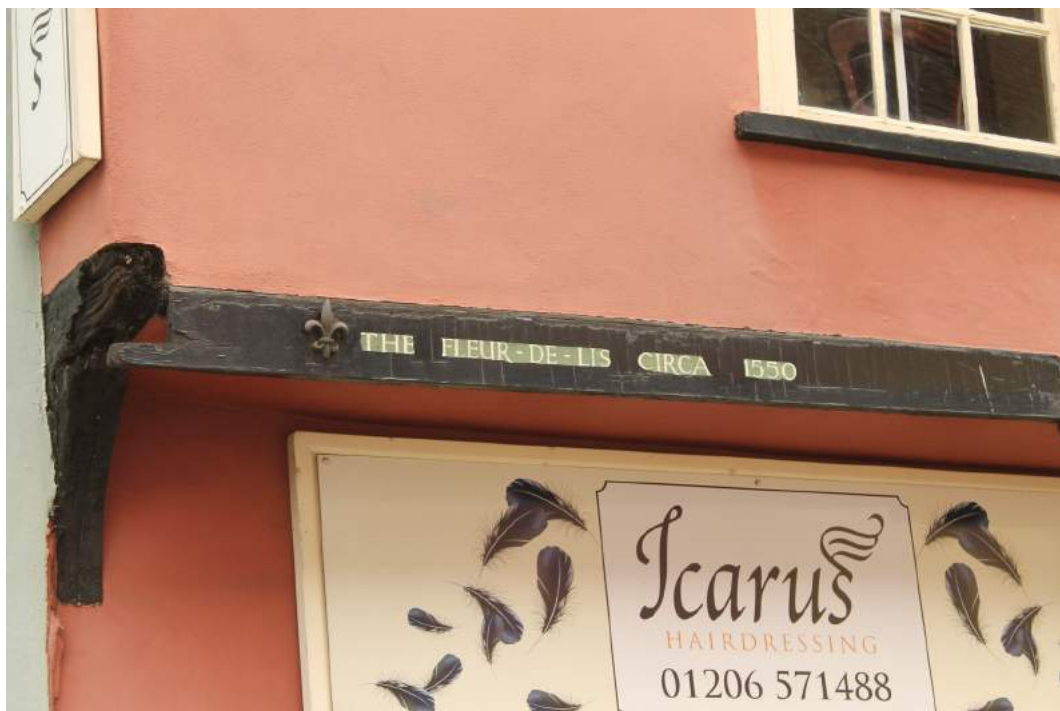
No. 13 has an inscription on the jetty recording “THE FLEUR DE LIS CIRCA 1550” (Photograph 3). Although this inscription probably dates to the 20th century it is presumed to be an accurate date for the building group.

Photograph 3 Inscription on jetty of No. 13 – view west

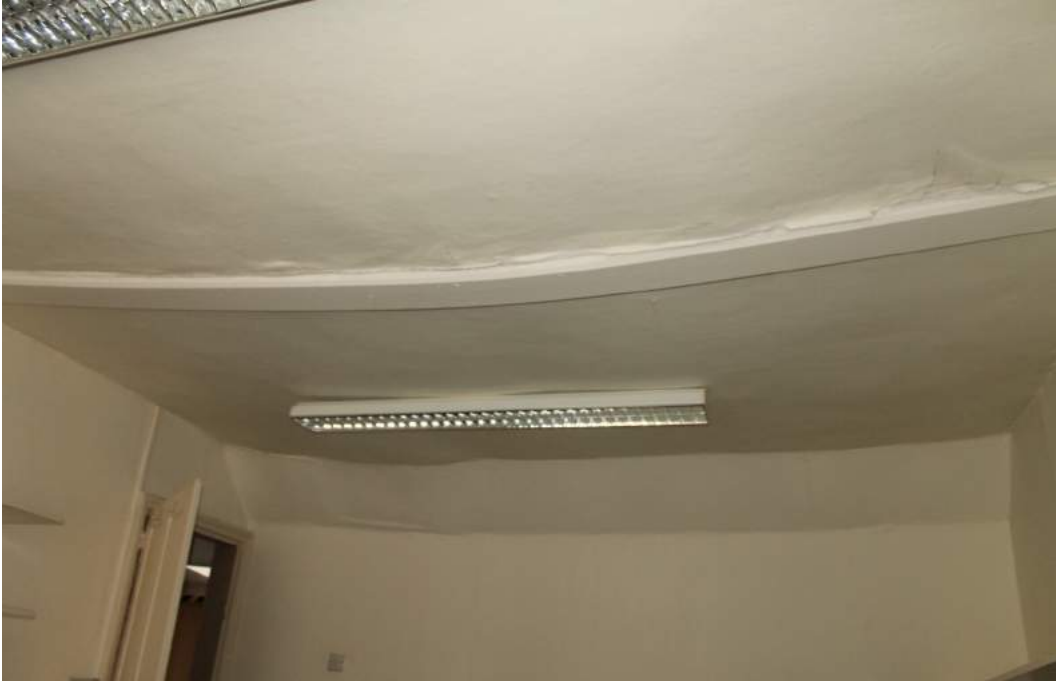
Photograph 4 shows the sagging ceiling in the first floor room prior to any repair works being undertaken. The bridging beam is clearly bowed and the ceiling has a pronounced central bulge. Access into the roof space showed this to be caused by the weight of debris lying on the surface of the ceiling, deriving from an earlier ceiling's gradual collapse, as shown in Photograph 5.

Photograph 4 Sagging ceiling, with bowed bridging beam in first floor room – view west

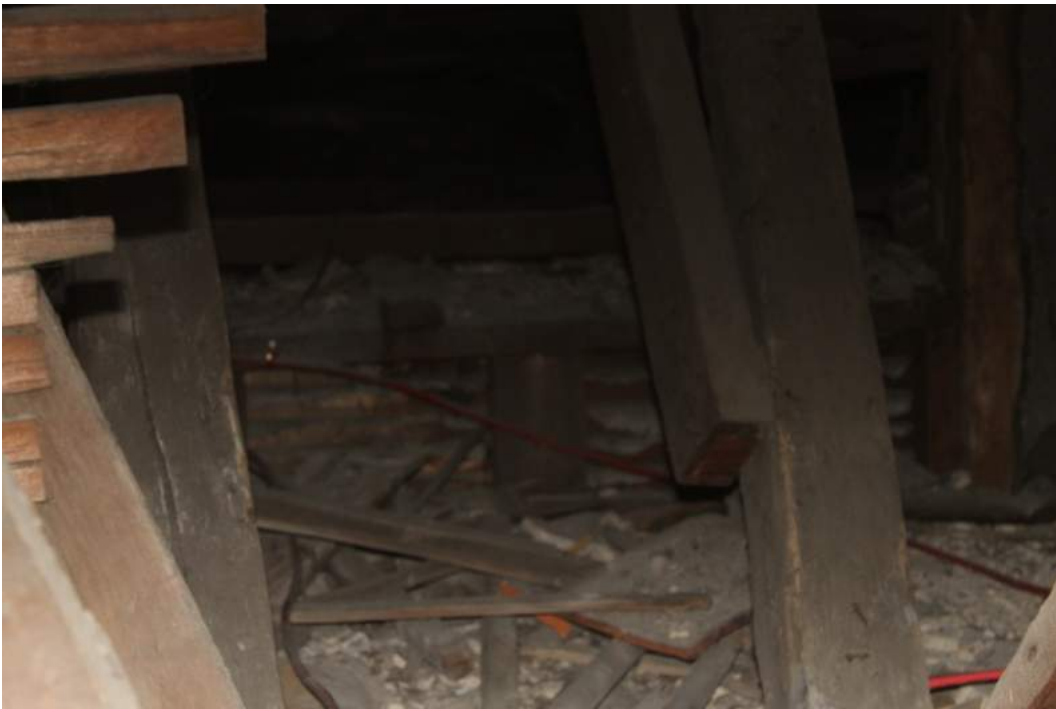
Photograph 5 Interior of roof space showing debris from earlier ceiling on top of existing ceiling – view east

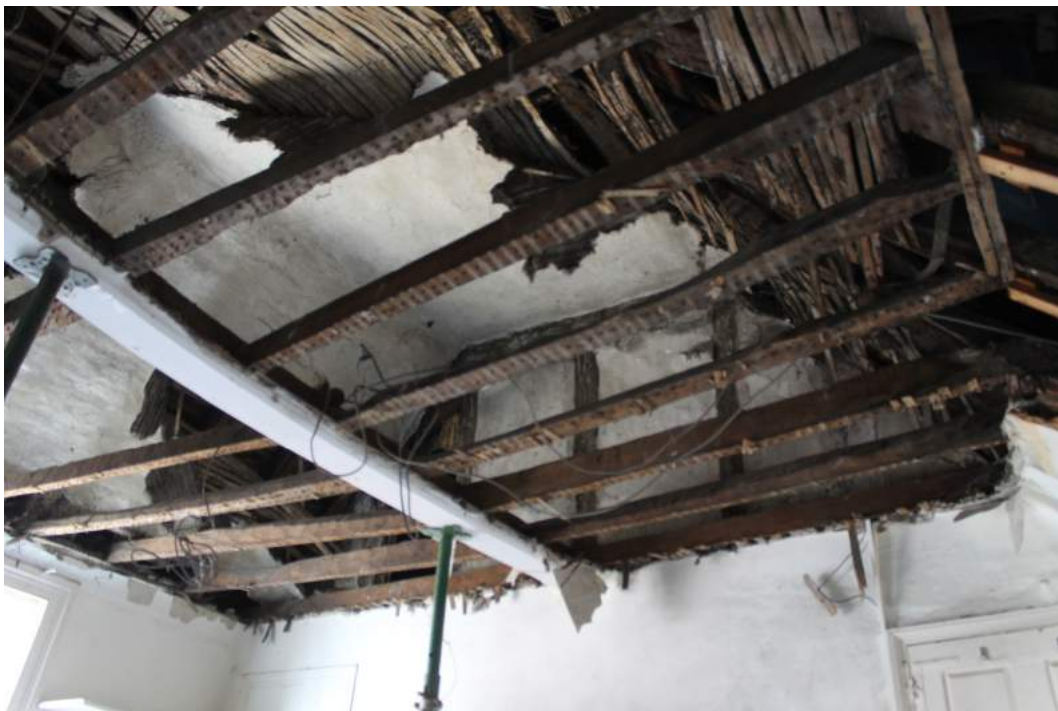
Visible above the inserted ceiling were the remains of an earlier lath and plaster ceiling, the deterioration of which had caused the later ceiling to sag and bulge. This was constructed from horsehair plaster applied to laths nailed to the rafters and the undersides of collars. These collars were scarfed to the purlins with birdsmouth joints but were formed from machine cut-timbers (Photograph 8), which suggests that this earlier lath and plaster ceiling dates to the late 18th or early 19th century (machine cut-timbers appear with the advent of the circular saw blade during the Industrial Revolution towards the end of the 18th century).

Photograph 6 Exposed ceiling joists with earlier lath and plaster ceiling above – view south-east

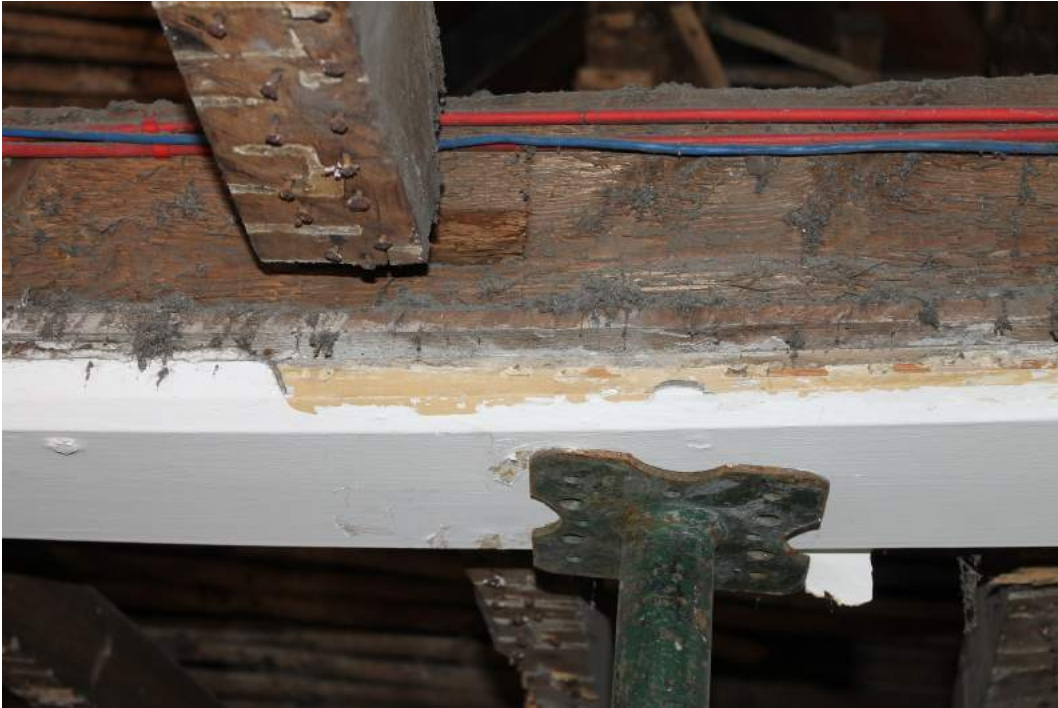
Photograph 7 Staggered mortises for the 19th-century ceiling joists in the bridging beam – view west

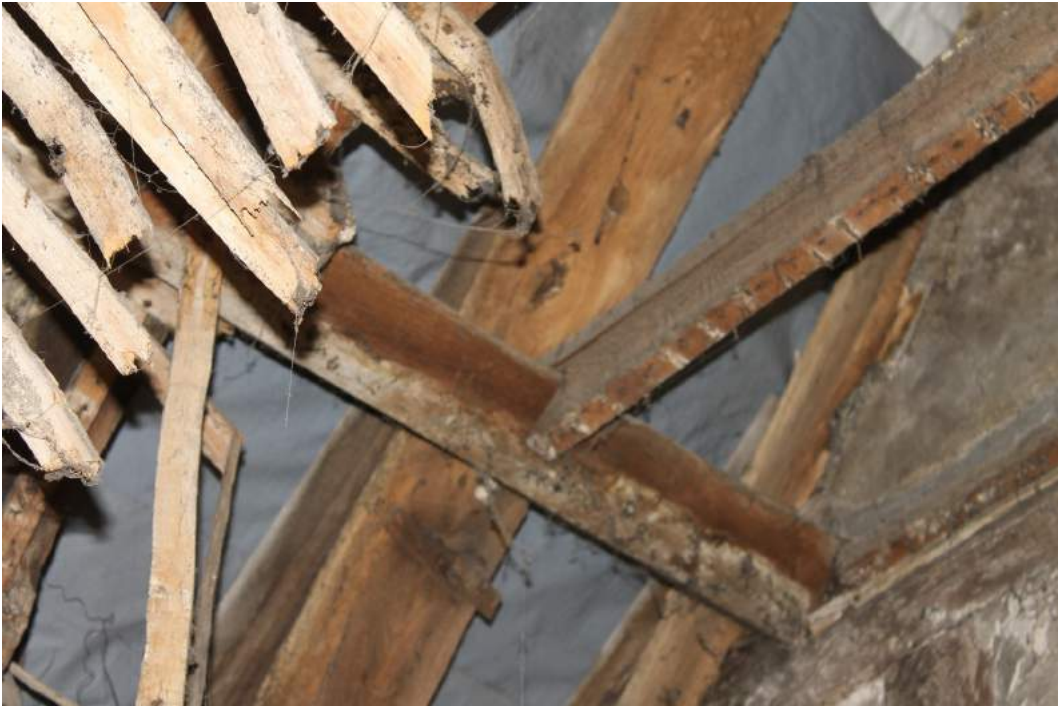
Photograph 8 Machine-cut collar with birdsmouth scarf joint to the purlin, to which the earlier lath and horsehair plaster ceiling was nailed – view south-east

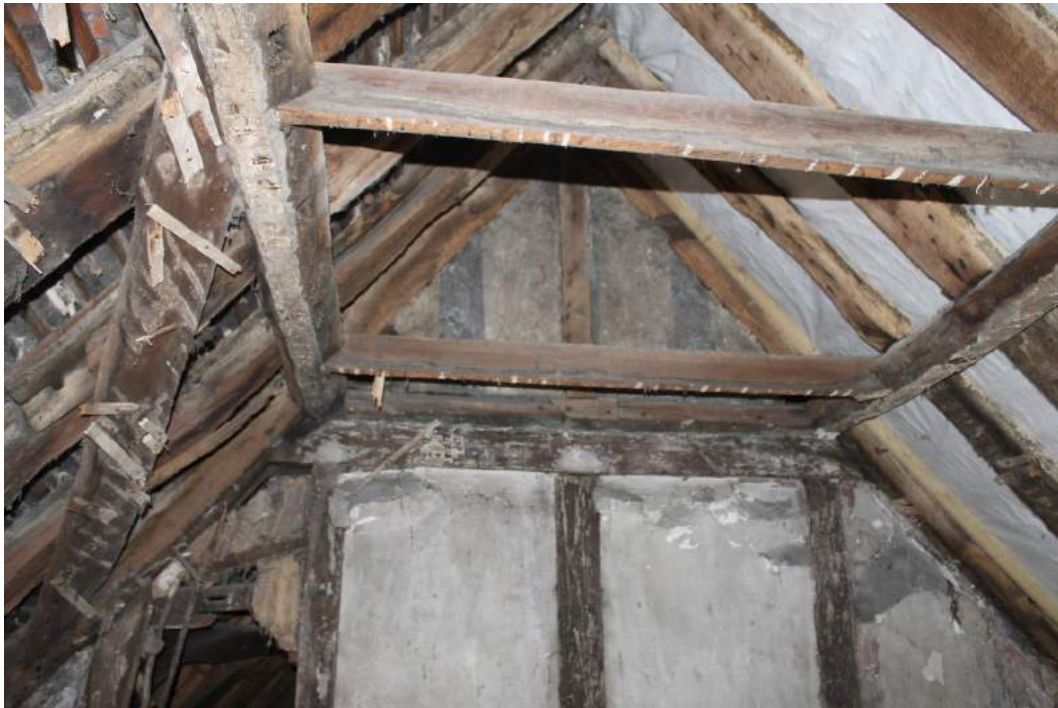
Photograph 9 Interior of the roof space looking towards the central cross frame with the original wattle and daub infill panels. The wind brace can be seen on the left, below the street side purlin which displays toolmarks on its underside and empty mortises, indicating it is a re-used timber – view south

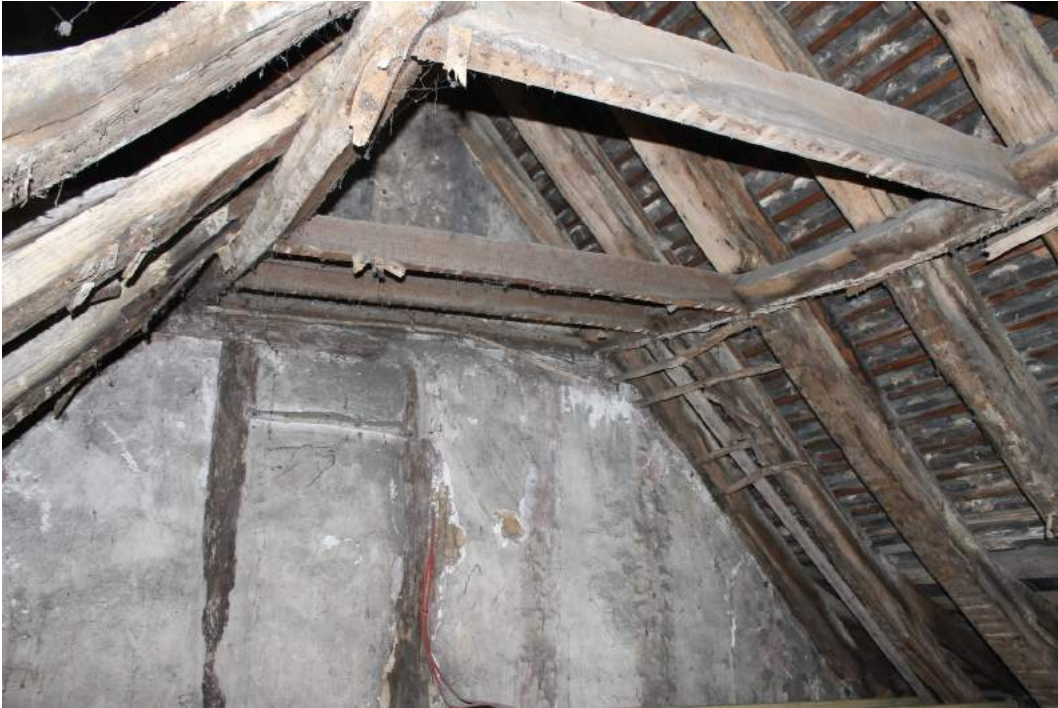
Photograph 10 Interior of the roof space looking towards the gable frame with the original wattle and daub infill panels – view north

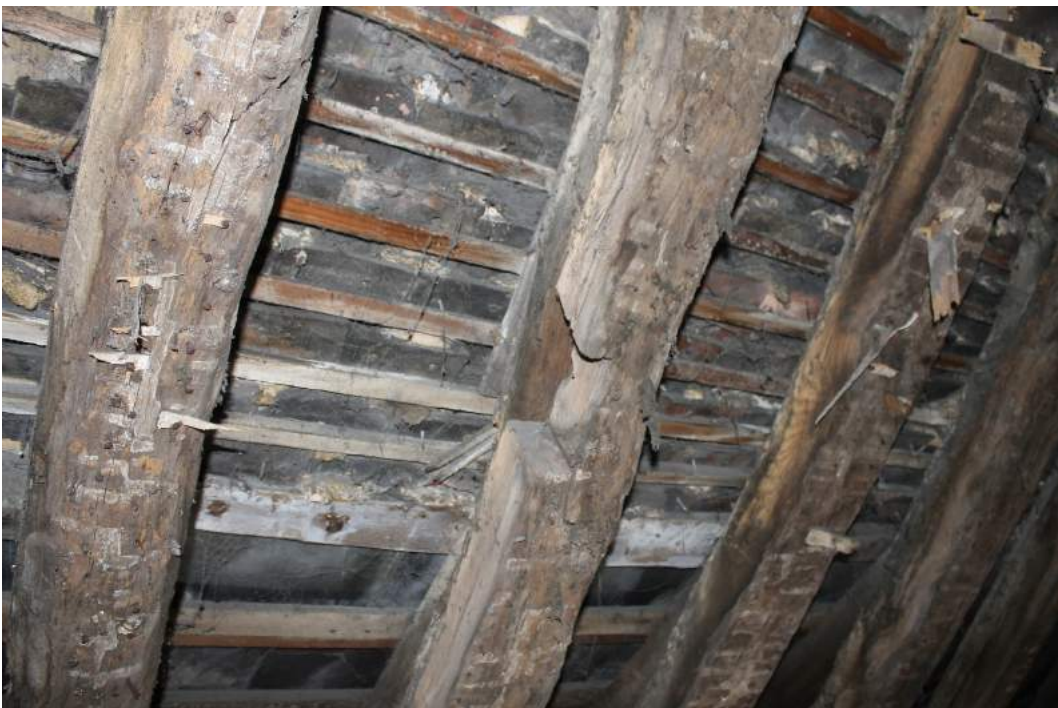
Photograph 11 Common rafter formed from re-used timber – view south-east

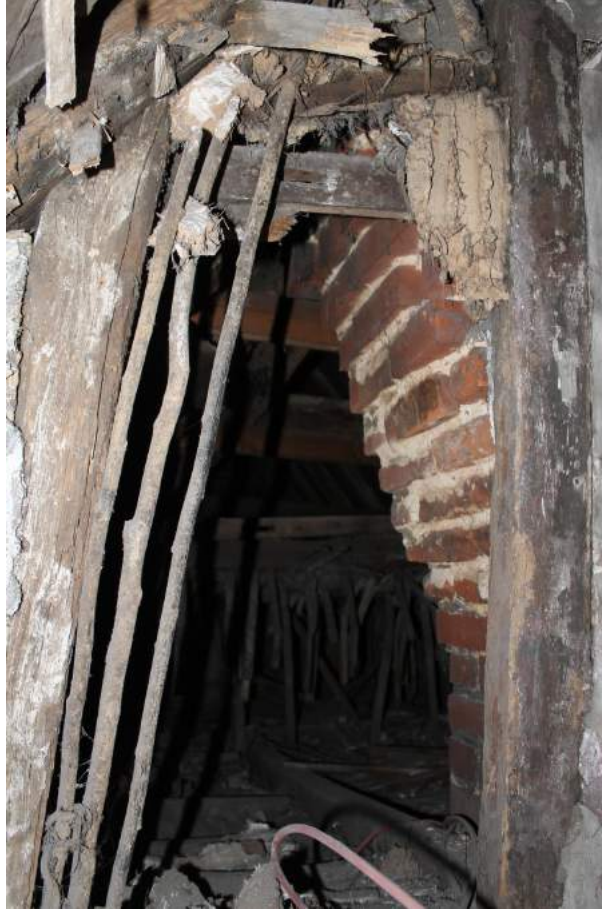
The gable frame and the cross frame have widely-spaced studs with wattle and daub infill panels. This can particularly be seen in Photograph 12.

Photograph 12 Cross frame with the remains of one of the original wattle and daub infill panels – view south

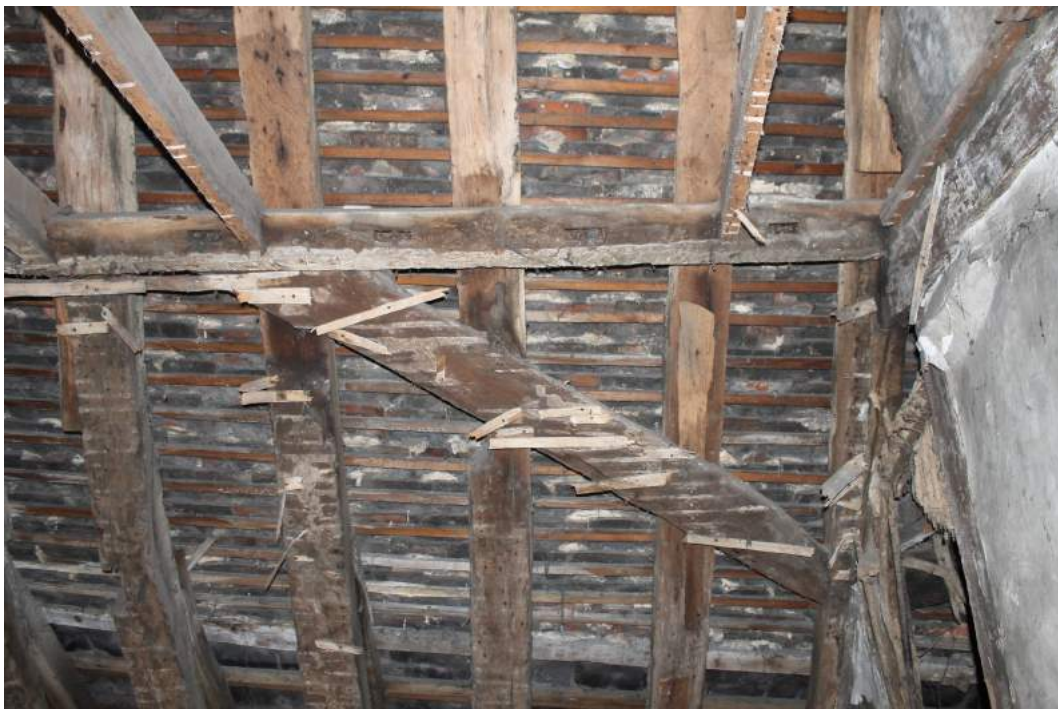
There is a wind brace to the street side pitch (Photograph 13) and the purlin on that side displays both toolmarks and empty mortises, indicating it is a re-used timber.

Photograph 13 Wind brace in street side roof pitch – view east

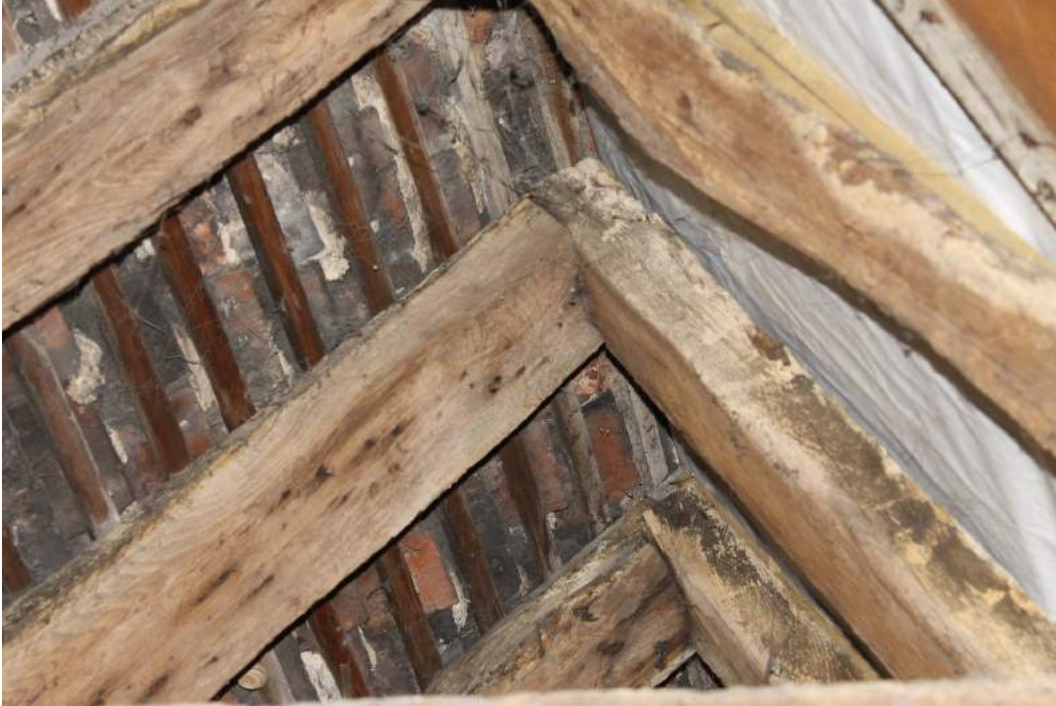
There is no ridge board; instead the heads of the rafters rise to meet each other and are single-pegged (Photograph 14).

Photograph 14 Heads of the common rafters, single-pegged to each other

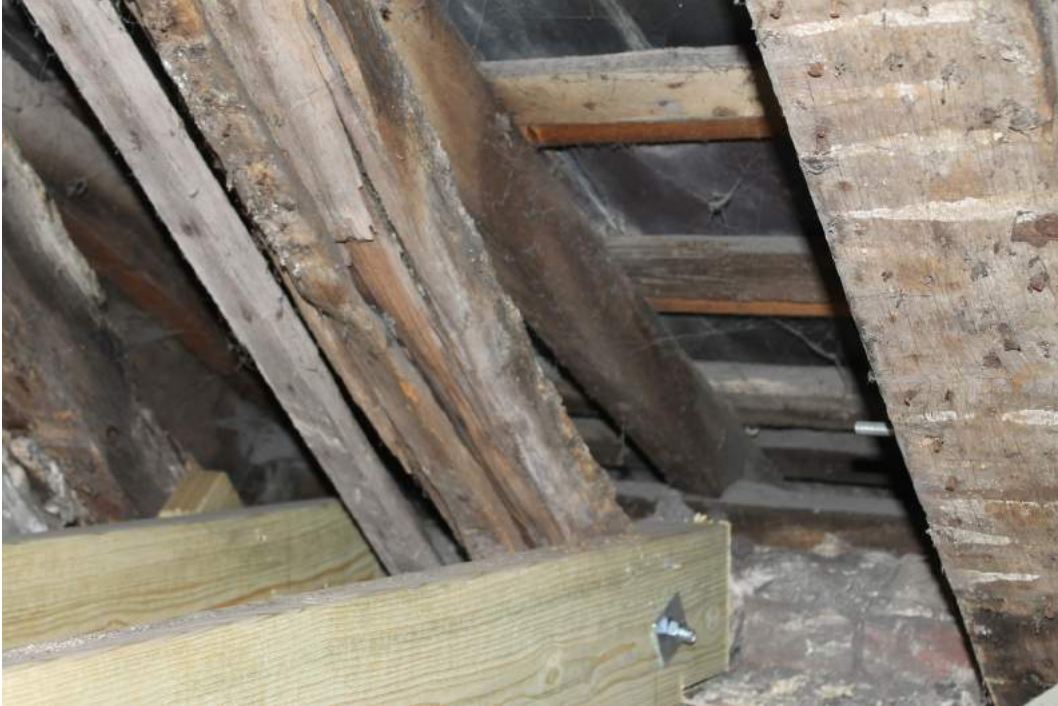
Photograph 15 Sprockets at the feet of the street side rafters, allowing the roof to flare out over the brick facing – note the slate roof covering above the battens – view north-east

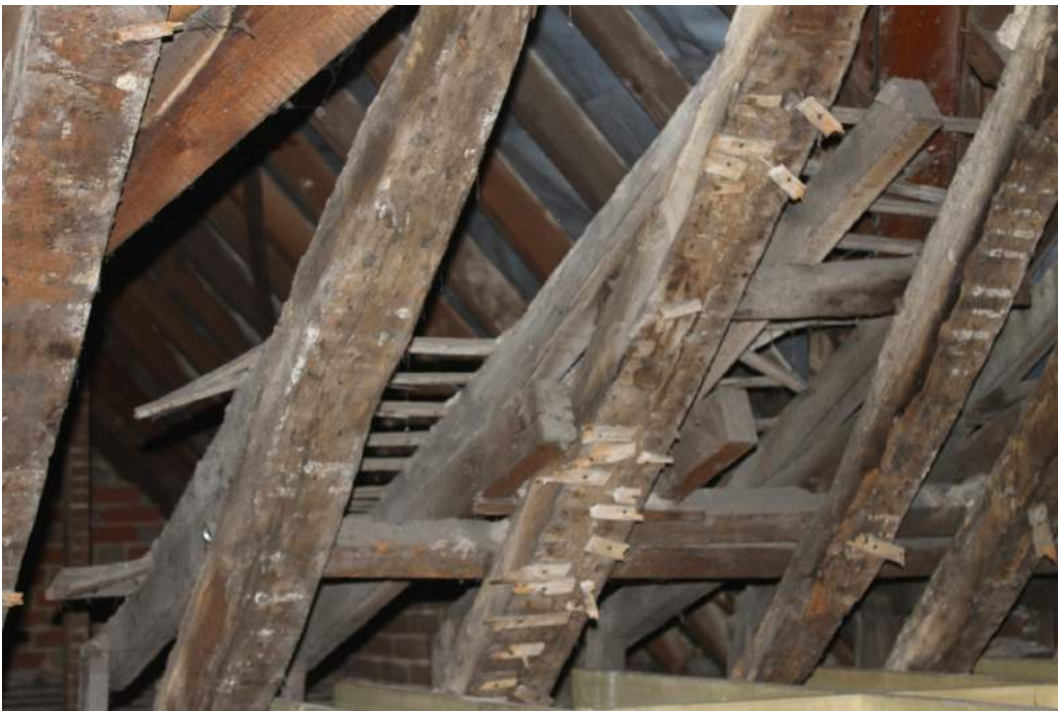
Photograph 16 Longer sprockets at the feet of the rear side rafters, allowing the roof to flare out over the possible earlier 19th-century extension, with the machine-cut timbers of the 19th-century extension behind – view north-west

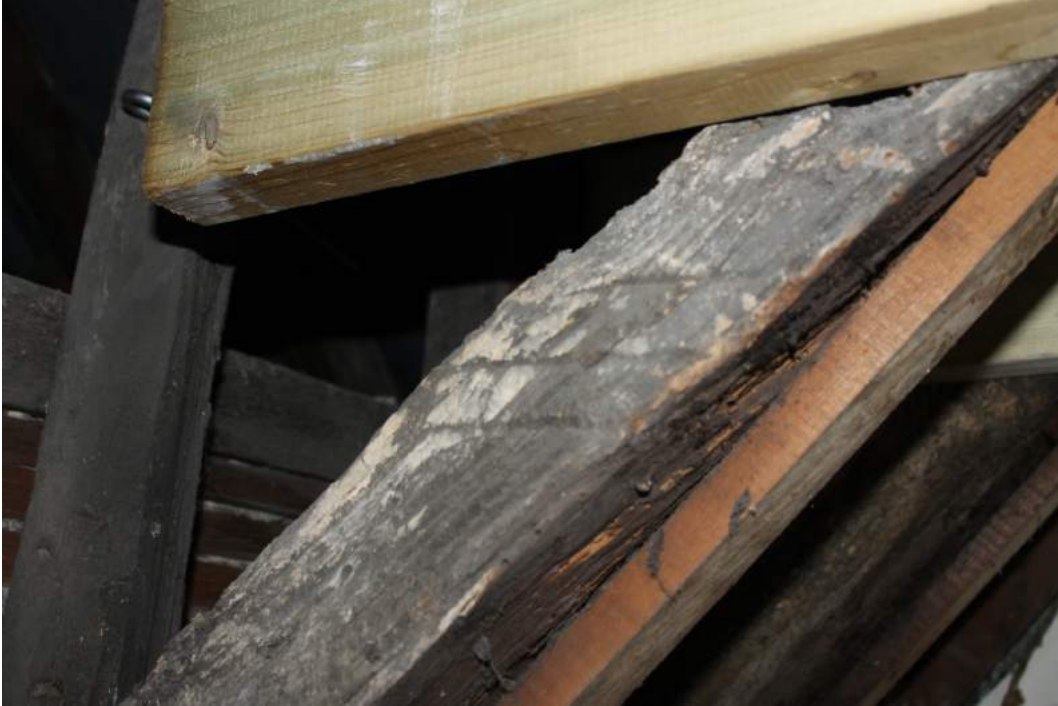
Despite the large number of re-used timbers in the framing of the roof only one set of potential carpenter's marks were observed. Three horizontal lines were scratched into the foot of one of the rafters of the rear pitch (Photograph 17), although these may not be original to either the building or the beam.

Photograph 17 Possible carpenter's mark on the foot of one of the rear side rafters - view north-west

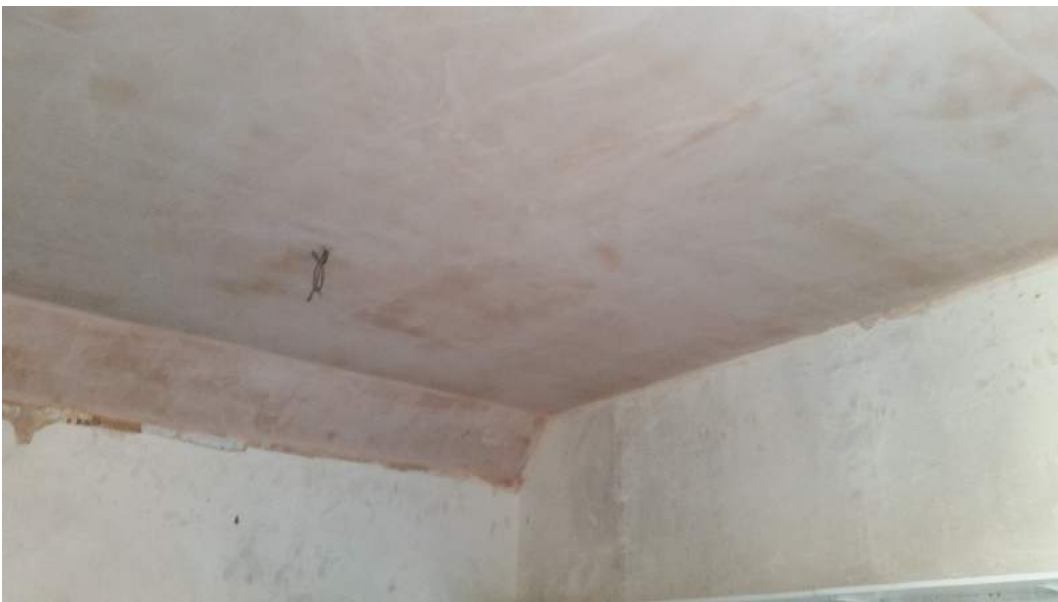
Photograph 18 The new ceiling prior to painting - view north-west

After the final inspection of the roof space new joists were inserted, plasterboard attached to these and the new ceiling skimmed (Photograph 18).
