**Historic building recording at
50 Silver Street, Buckden, St Neots,
Huntingdonshire, Cambridgeshire, PE19 5TS**

June 2016

**commissioned by
S. Pell Builders Ltd**

CAT Report 976
August 2016

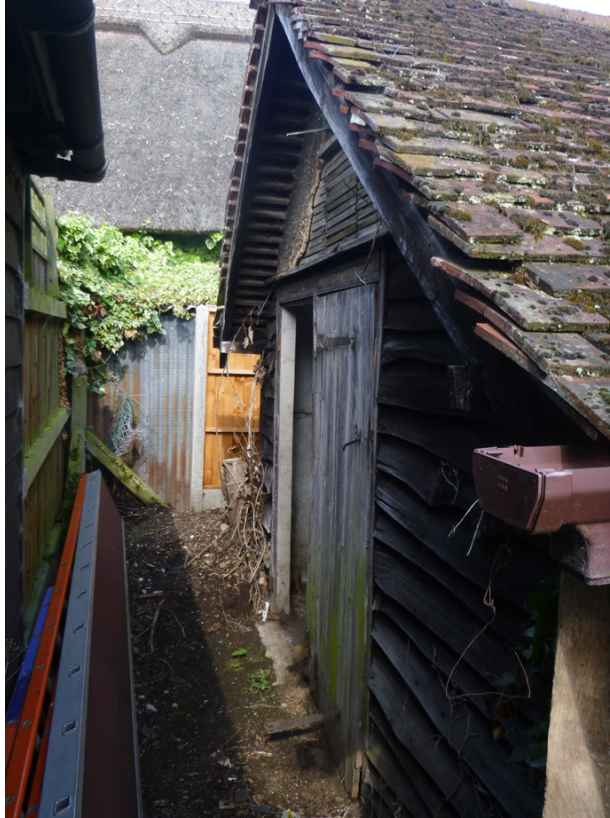
The southern elevation (Fig 4) has two entrances, both on the south wing (Photograph 3). One is into the building proper and has a vertical planked door, and the other has no door and leads into a separate room not accessible from the main structure. This separate room is totally devoid of features and, like the rest of the building, the interior is clad in asbestos panels (Photograph 6). The owner suggested that at some point it was in use as an outside privy (*pers comm*) – although, given the use of the building, it seems more likely to have been a petrol store. Also on the south elevation on the main building is a six-light fixed window, identical to the one on the north elevation (see above). As in the north wing, the south wing gable is covered by pebble-dash render and contains a wooden louvre.

Photograph 3 South elevation – shot taken facing west.

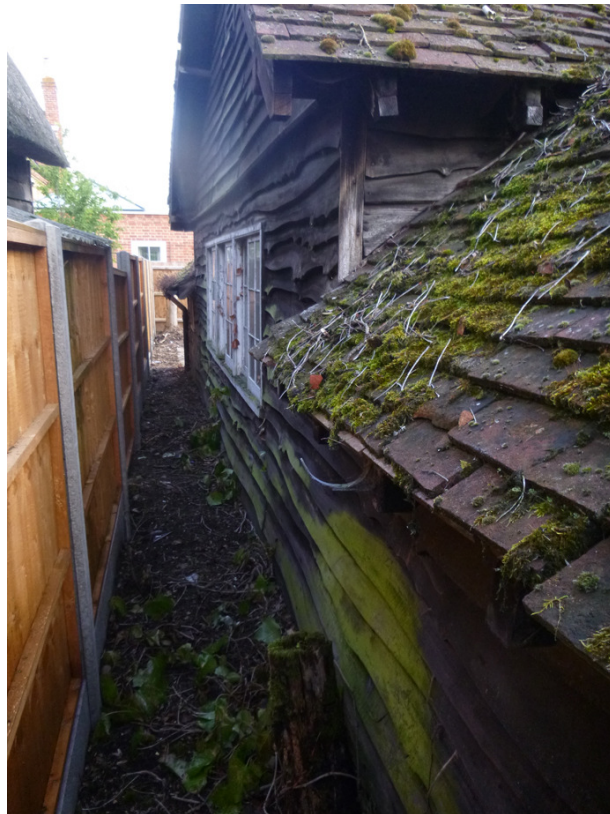
The western elevation (Fig 5) has three twelve-light sliding casement windows centrally positioned on main building (Photograph 4). Like every other elevation, there is a wooden

louvre placed centrally on the gable. The north wing has a four-light fixed window with hammered glass on this elevation.

Photograph 4 West elevation – shot taken facing north.

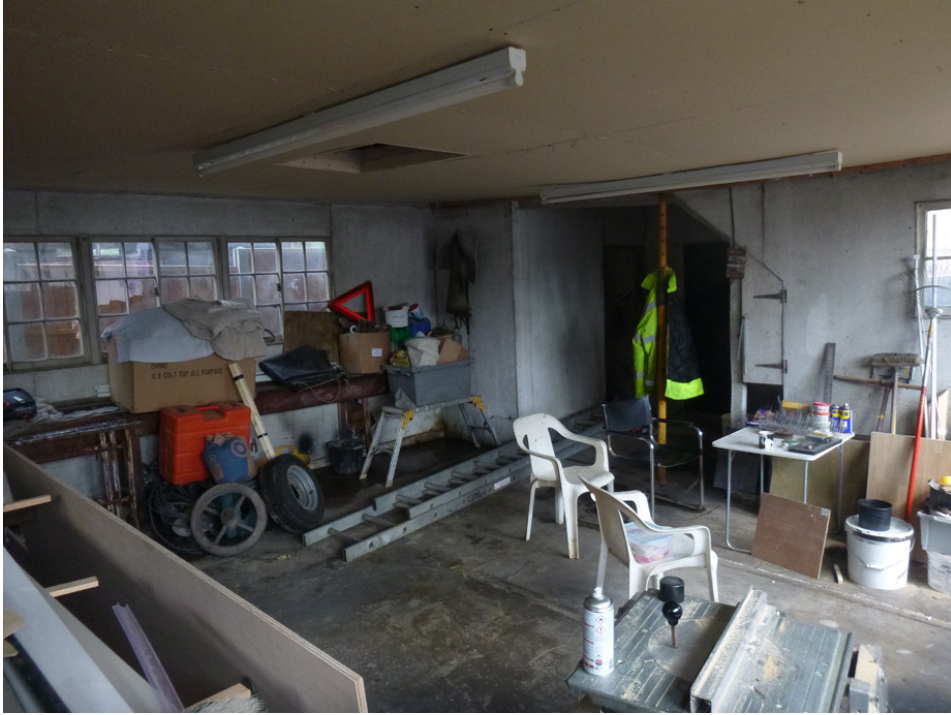
The timber-frame of the building is almost entirely masked on the interior by a series of asbestos panels (Photograph 5). Likewise, the ceiling of the building is made of these same panels. All of these are nailed in place and seem to be original to the building.

Photograph 5 Interior shot of main building, showing current use as a tool store – shot taken facing north-west.

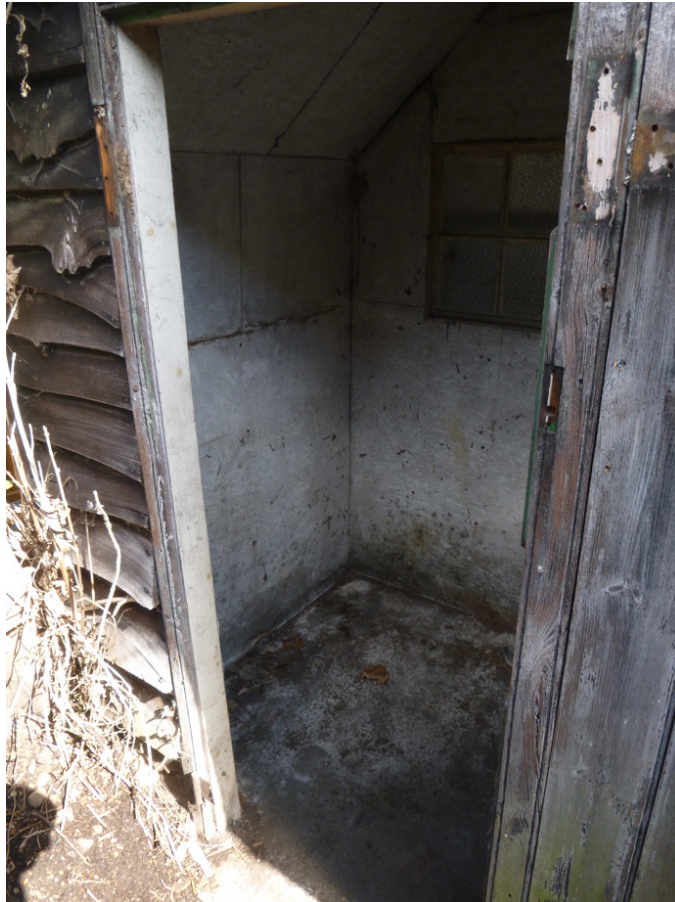
There is an interior four-light fixed window with hammered glass between the main building and the separate room in the south wing (Photograph 6).

Photograph 6 Interior of separate room in south wing – shot taken facing north-west.

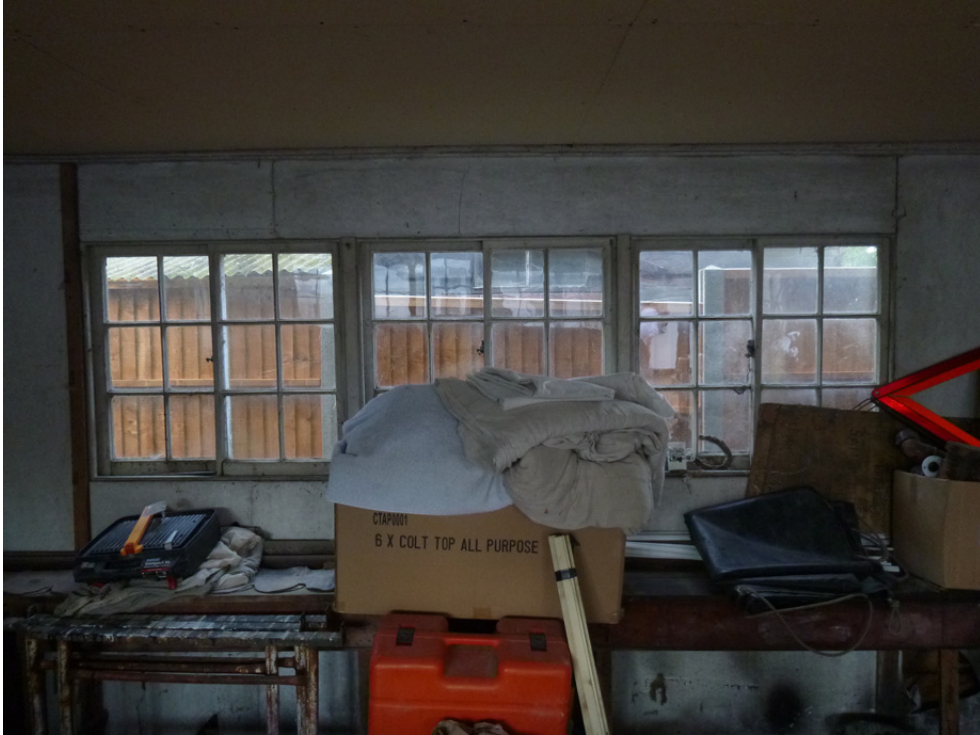
Photograph 7 Interior shot of three sliding casement windows on west elevation – shot taken facing west.

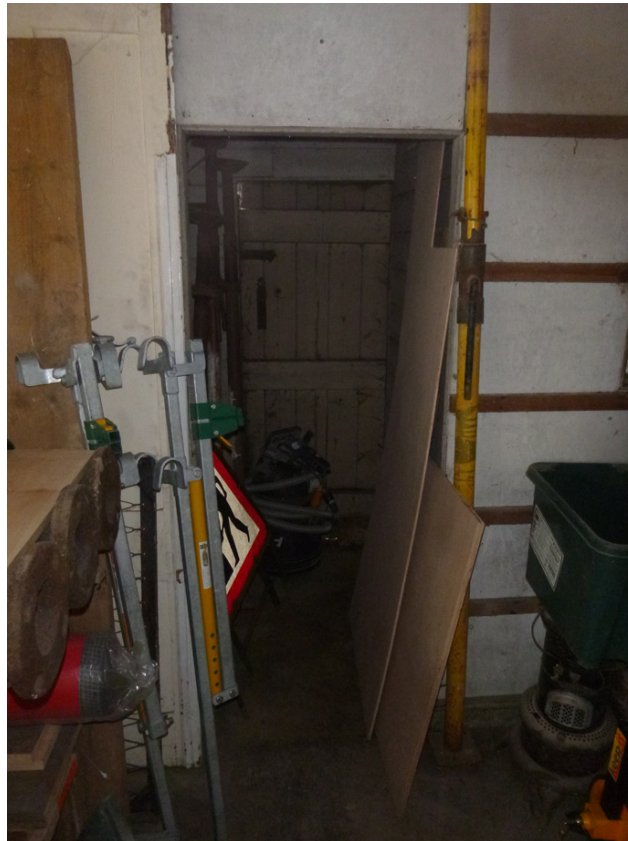
Photograph 8 Interior shot of south wing – shot taken facing south.

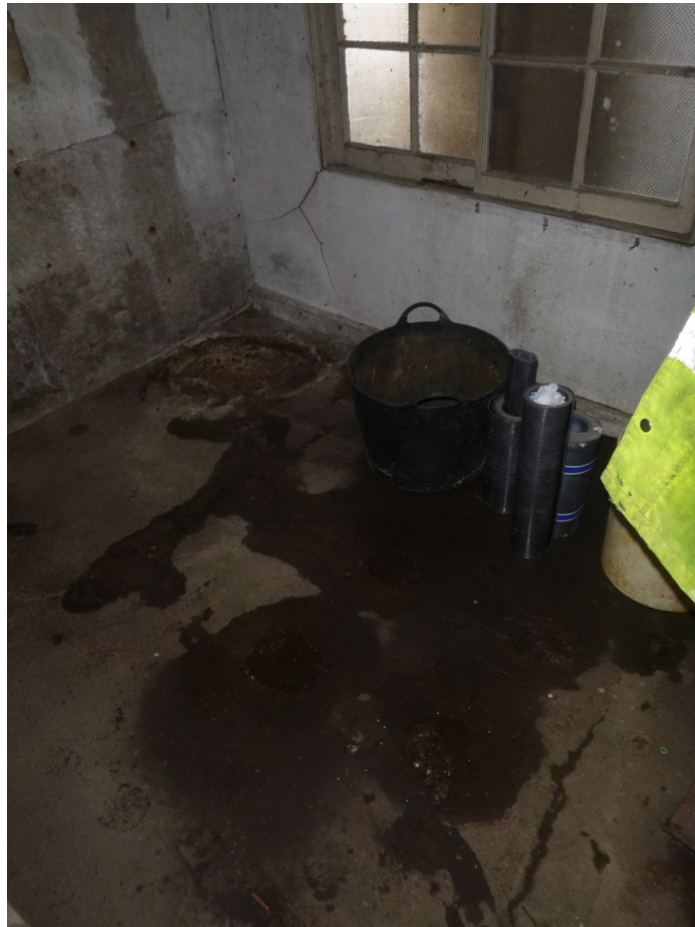
In the north wing (Photograph 9) the concrete floor has several scars, possibly suggesting that there was at one time machinery in this location (Photograph 10). There is also a small hatch between the wall and a supporting post in the north wing (Photograph 11). Presumably at some point, this would have provided access to a cabinet or set of drawers – possibly associated with the machinery.

Photograph 10 Scars on floor of concrete in north wing, showing location of possible machinery – shot taken facing north-east.

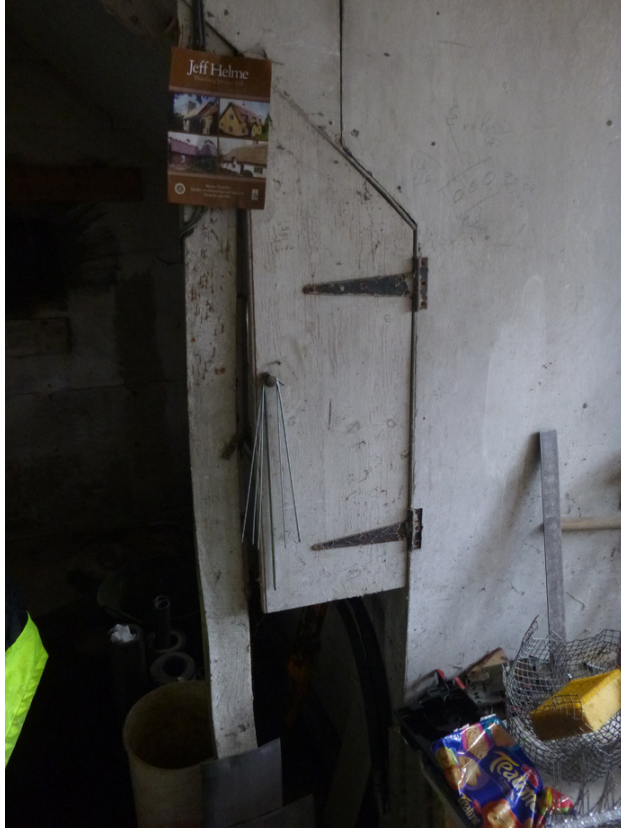
Photograph 11 Hatch in-between wall and supporting post in north wing – shot taken facing north.

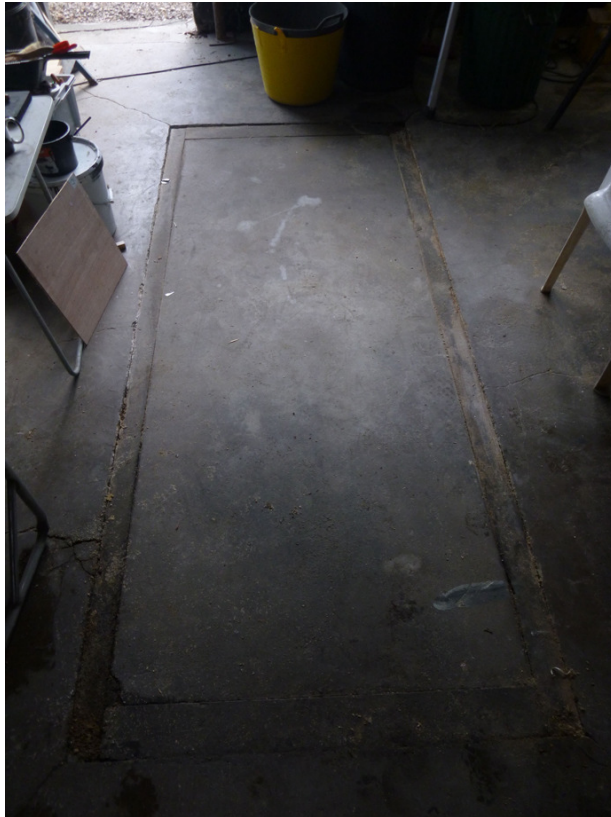
Photograph 12 Backfilled and concreted over inspection pit in main building – shot taken facing east.

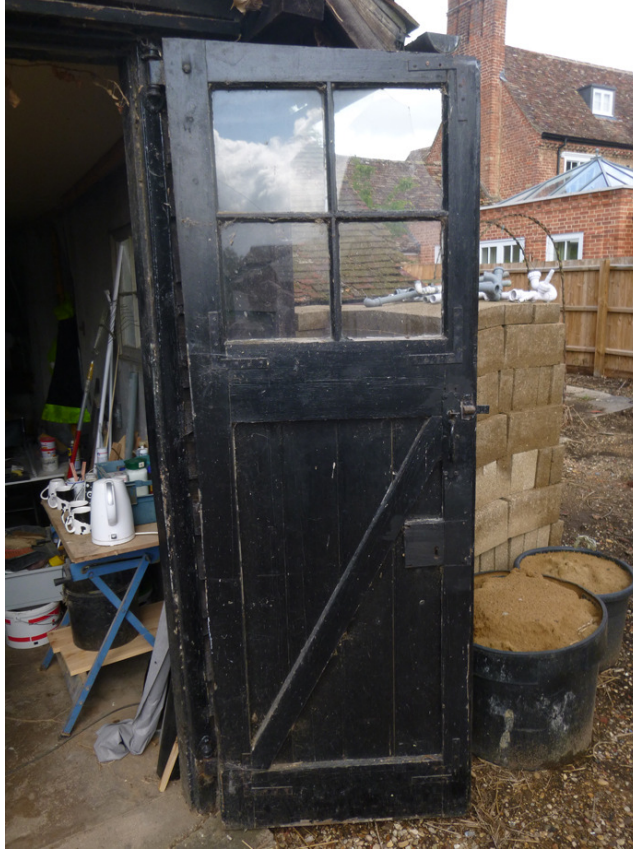
Photograph 13 Detail of single width door on east elevation – shot taken facing north-west.

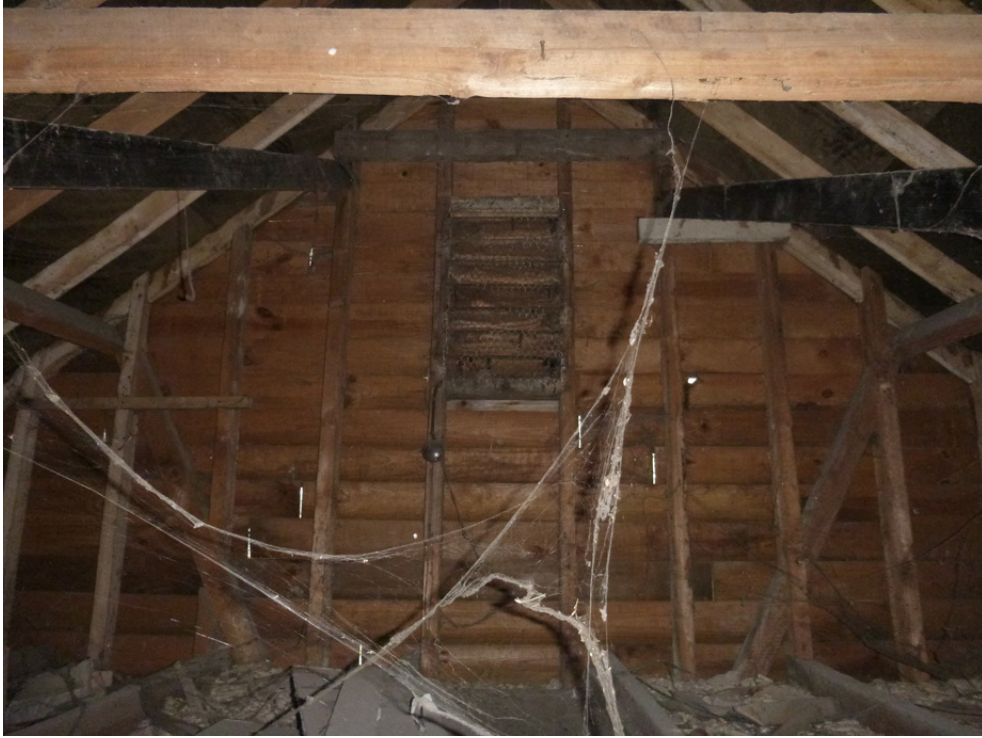
When the roof was observed through an inserted hatch, it was found to be made of nailed machine-cut timbers (Photograph 15). Several timbers had been nailed in place at various angles in order to further support the roof, running from one truss to another and varying in length and size. The truss cross-section (Fig 6) shows only what appears to be the original elements of the roof's structure.

Photograph 15 Interior shot of west gable of main building. Additional timbers used to support tiled roof visible – shot taken facing west.

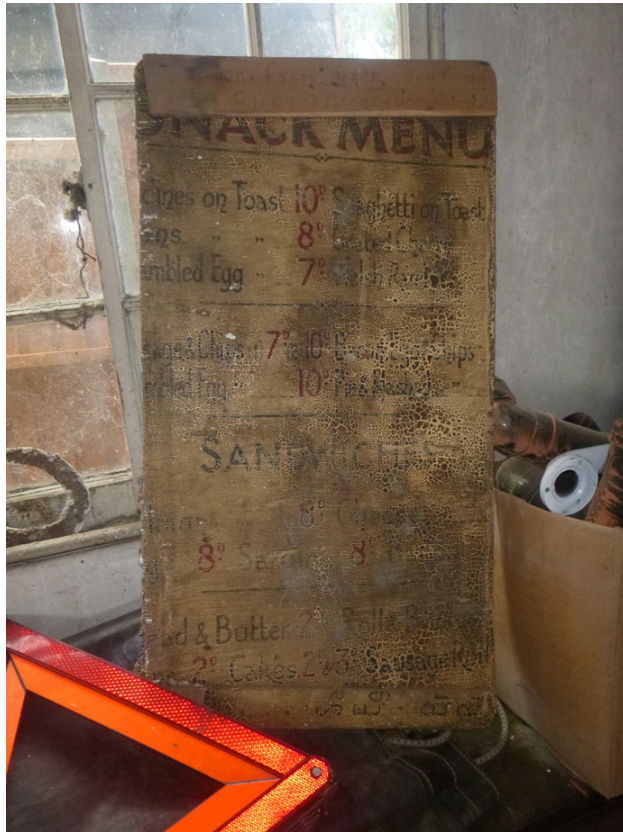
At the time of this investigation, the building was in use as a store, containing large amounts of building equipment and tools. The only thing amongst the tools relating to the buildings past use as a garage was an intriguing sign for a “Snack Menu” that was labelled as having been “taken from the back seat of 1933 Riley 9 Ascot (Doctors Coupé)” (Photograph 17).

Photograph 17 Snack Menu found in the garage labelled as "taken from the back seat of 1933 Riley 9 Ascot (Doctors Coupé)".
