Historic building recording at Sturgeon's Farm, Middle Green, Wakes Colne, Colchester CO6 2BN

May 2017

CAT Report 1131
July 2017

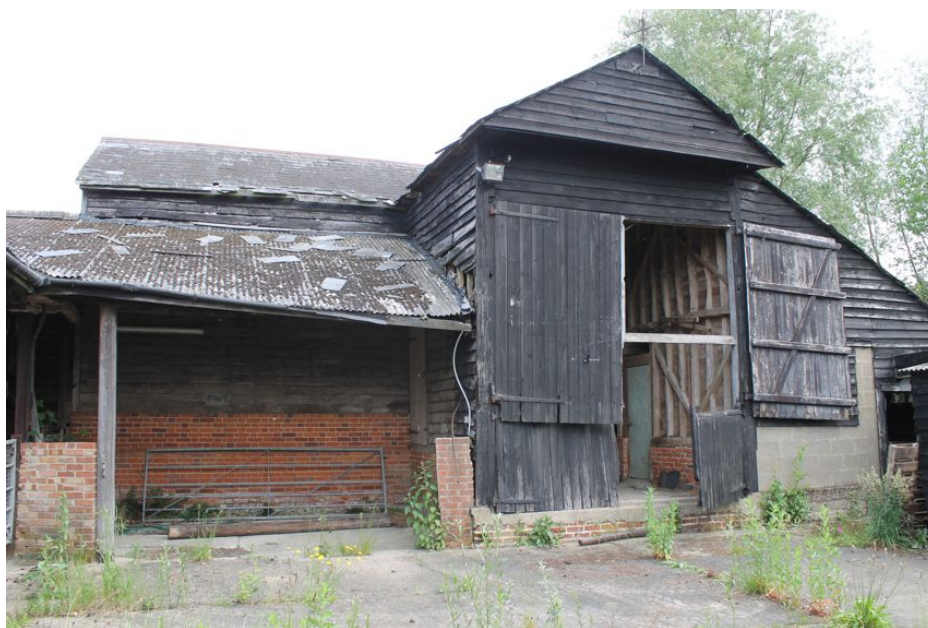
The barn is a rectangular timber-framed building, 14.7m long x 5.3m wide, with a centrally-located midstrey projecting from the south-west elevation (Photograph 1). It is constructed from softwood timber, and the whole structure sits upon a two-tier plinth of red brick, with seventeen courses and brick dimensions of 230mm x 110mm x 65mm. The building is clad in traditional black-painted horizontal weatherboarding, with a modern, slate-covered, gabled-ended roof. The timber-frame of the building is partially pegged and partially nailed together.

Photograph 1 South-west elevation of barn, showing midstrey. Photograph taken facing north-east.

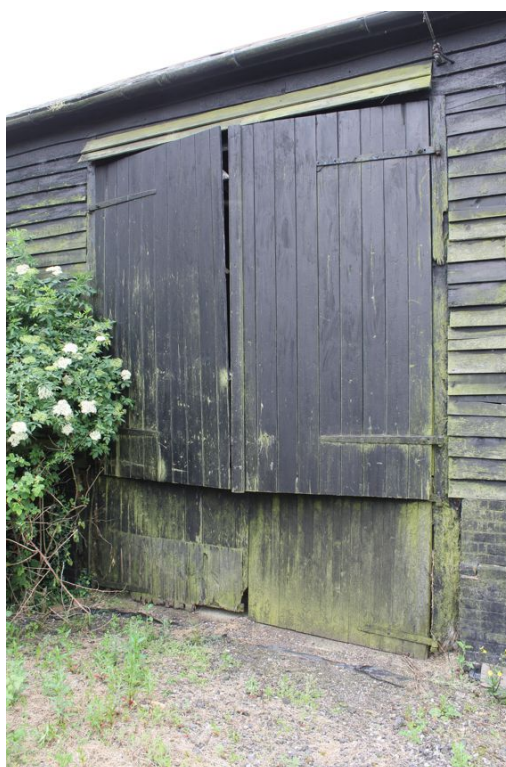
The northern elevation of the building has a central vertically-planked threshold door, with a tall 'upper' door, and a shorter 'lower' door attached with metal hinges (Photograph 2). The midstrey has a slightly larger, but otherwise identical, corresponding door. The western elevation of the midstrey has an original vertically-planked door with a hole at its base to allow farm cats access (Photograph 3). The eastern elevation of the midstrey has an inserted modern door leading into Building F. The midstrey has an overhang projecting above the threshold door.

Photograph 2 North-east elevation of barn, showing barn door. Photograph taken facing south.

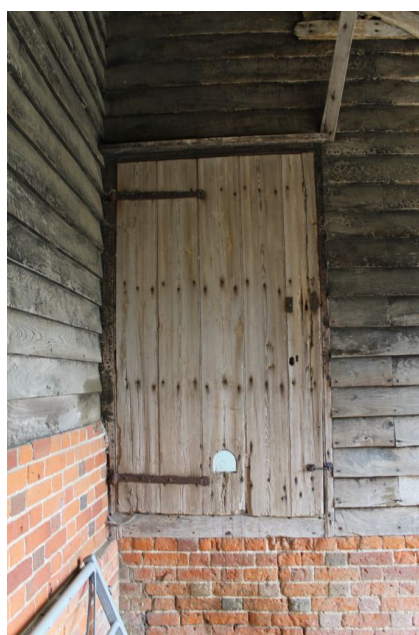
Photograph 3 West elevation of midstrey, showing door with hole for farm cats. Photograph taken facing south-east.

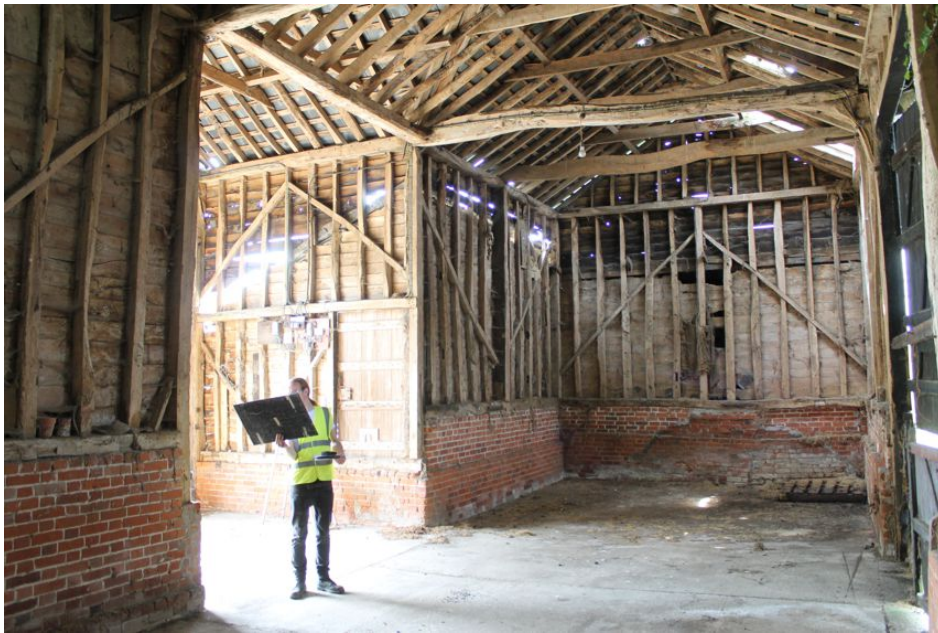
The timber-frame of the barn contains a mixture of machine-cut and hand-sawn timbers, and is supported by primary diagonal-bracing (Photograph 4). Some of the hand-sawn timbers are carved in a very rudimentary fashion, similar to some of the timbers in Buildings C and D (see below).

Photograph 4 Interior shot of barn, showing timber-frame. Photograph taken facing west.

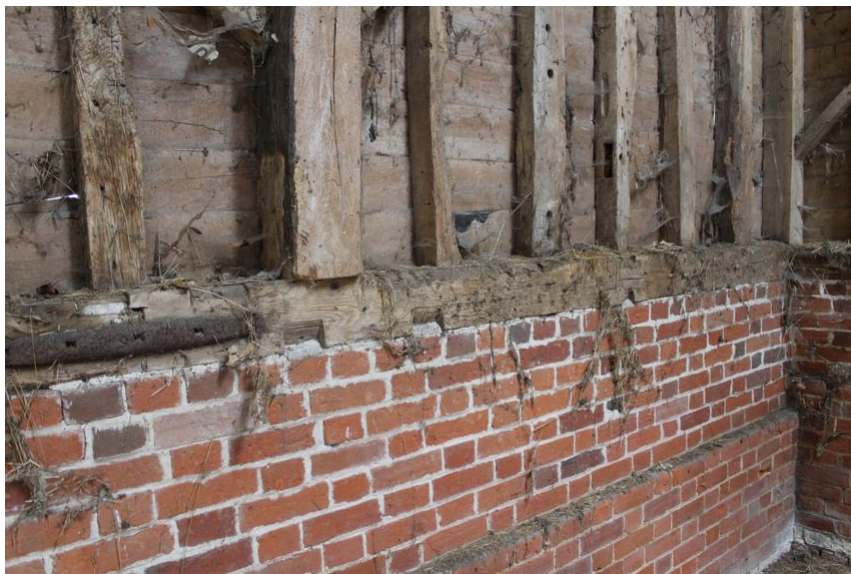
Photograph 5 Detailed shot of sill-beam on the south-east end of bay 1. Photograph taken facing west.

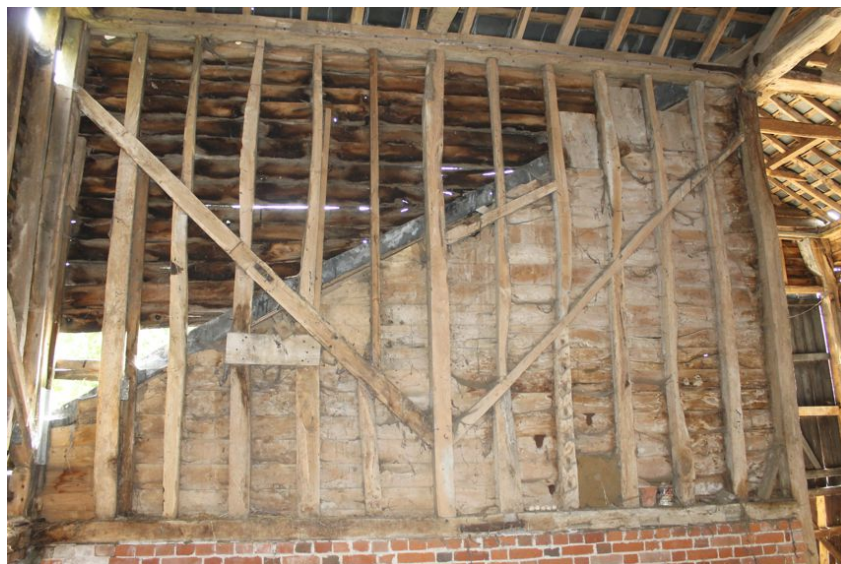
A substantial number of the hand-sawn timbers in the building have evidence of re-use, in the form of unused mortices and recesses for bracing. Most notably, all of the sill-beams around the frame are re-used from an earlier building (Photograph 5). Several of the primary braces also have evidence of re-use (Photograph 6), as well as some studs. For there to be such a preponderance of re-used timbers heavily suggests the barn was raised from the remains of an earlier structure.

Photograph 6 South-west elevation of bays 4 and 5. Re-used primary bracing visible, as well as old weatherboarding. Photograph taken facing south-west.

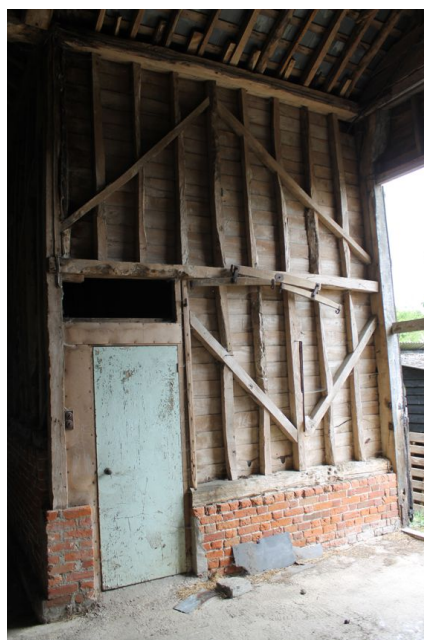
The machine-cut timbers in the barn include the principal post to the north of Bay 1, some of the primary bracing in the midstrey (Photograph 7) and some rafters and the purlins in the roof. All the machine-cut timbers are original to the building.

Photograph 7 South-east elevation of the midstrey. Machine-cut timber visible as primary bracing. Photograph taken facing south-east.

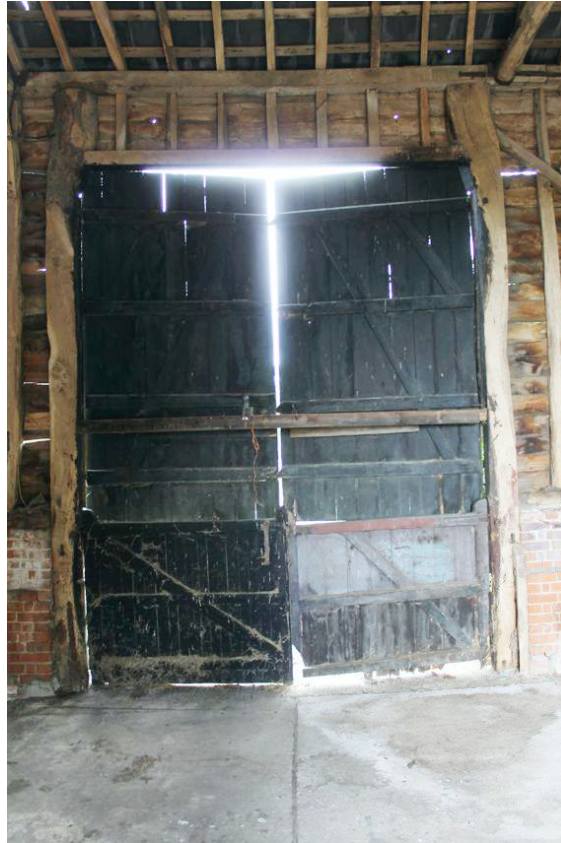
Either side of, and supporting the hinges of, the threshold doors in the midstrey and the northern elevation of the barn are substantial hand-sawn intermediate posts with large jowled heads (Photograph 8). Notably, the infill between the top of the doors and the start of the wall-plate in both doorways is constructed entirely from machine-cut timber. This could suggest that the current doors are a later addition, and that the original doors would have been taller, reaching the wall-plate.

Photograph 8 Interior shot of the door on the north-west elevation of the barn. Large posts with jowled heads visible on either side of doorway. Photograph taken facing north-west.

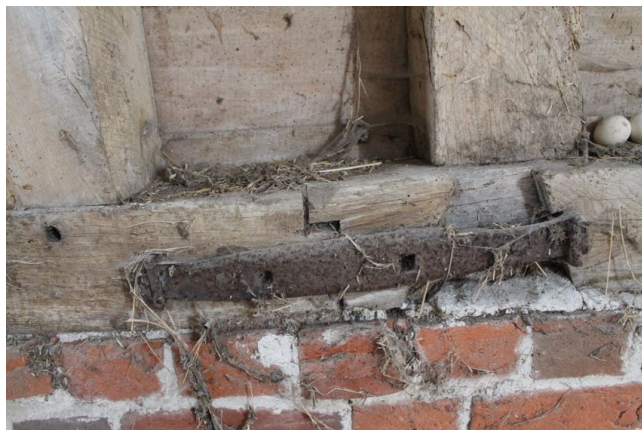
The sill-beams of the barn are jointed together with a rudimentary scarf joint, a straight bridling with vertical abutments and an over-lipped face. All of these scarf joints are reinforced by an iron strap joining the two timbers (Photograph 9).

Photograph 9 Detailed shot of scarf joint in sill-beam on south-west side of bay 4. Photograph taken facing south-west.

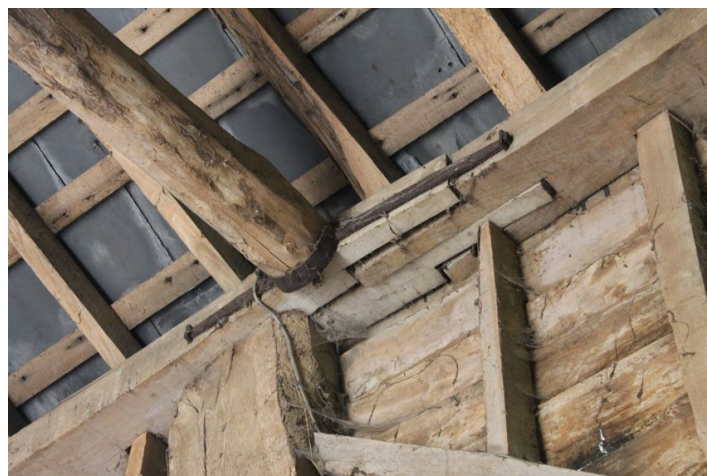
There are another two scarf joints on the wall-plate of the northern elevation, either side of the threshold door (Photograph 10). These scarf joints are face-halved and bladed, and held together, like the scarf joints on the sill-beam, by an iron strap joining the two timbers.

Photograph 10 Detailed shot of scarf joint in wall-plate on north-east side of bay 4. Photograph taken facing north.

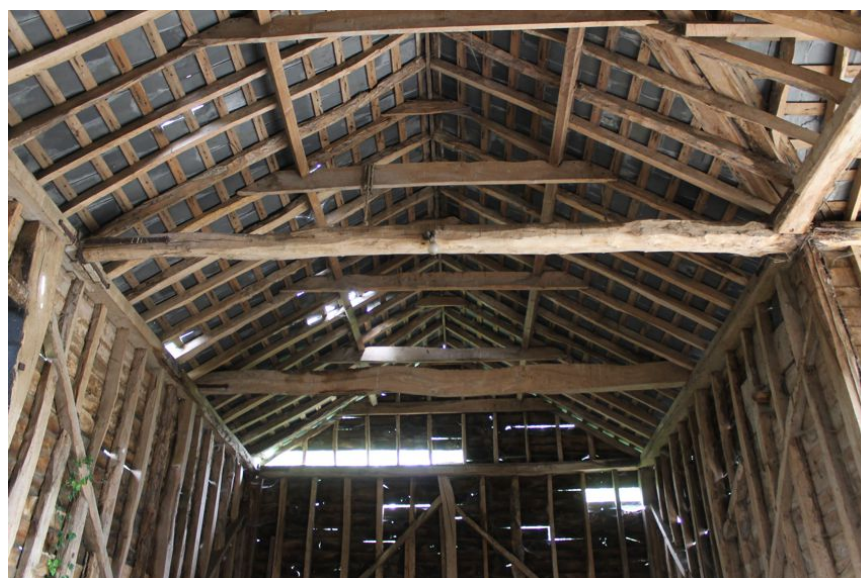
The truss in this building consists of tie-beams supported on the wall-plates, with a collar above them supporting a single, clasped, purlin on each roof pitch (Photograph 11). The tie-beams are all hand-sawn timbers, and they are very rudimentary in design, resembling the tie-beams in Buildings C and D (see below). All the tie-beams, bar one, are attached to the wall-plates using iron straps, rather than joints (Photograph 10). None have braces or mortices on their underside, with the exception of one tie-beam that forms the division between bays 2 and 3. This beam is unlike the others, in that its northern end is supported by a knee-brace, and it has no iron straps attaching it to the northern wall-plate (Photograph 12).

Photograph 11 Truss between bays 3 and 4 in barn. Photograph taken facing south-east.

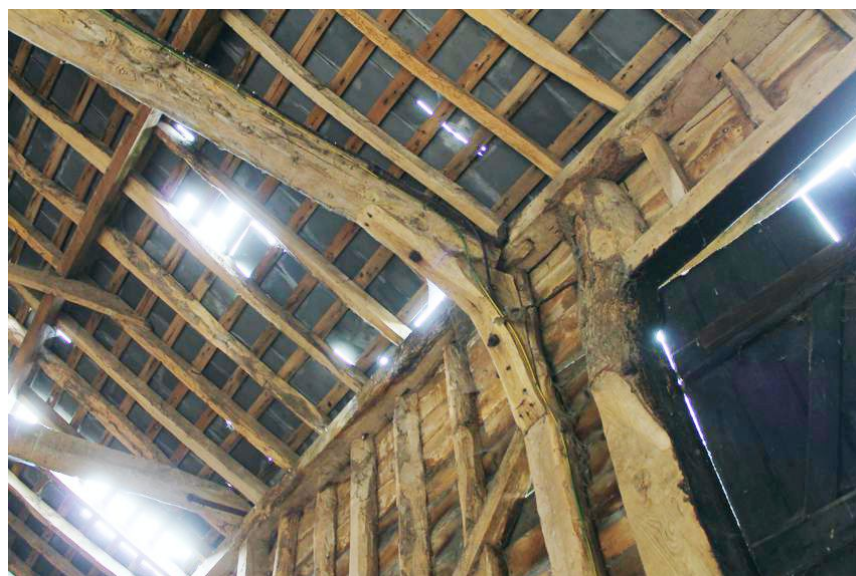
Photograph 12 Detailed shot of knee brace supporting tie-beam between bays 2 and 3. Photograph taken facing north.

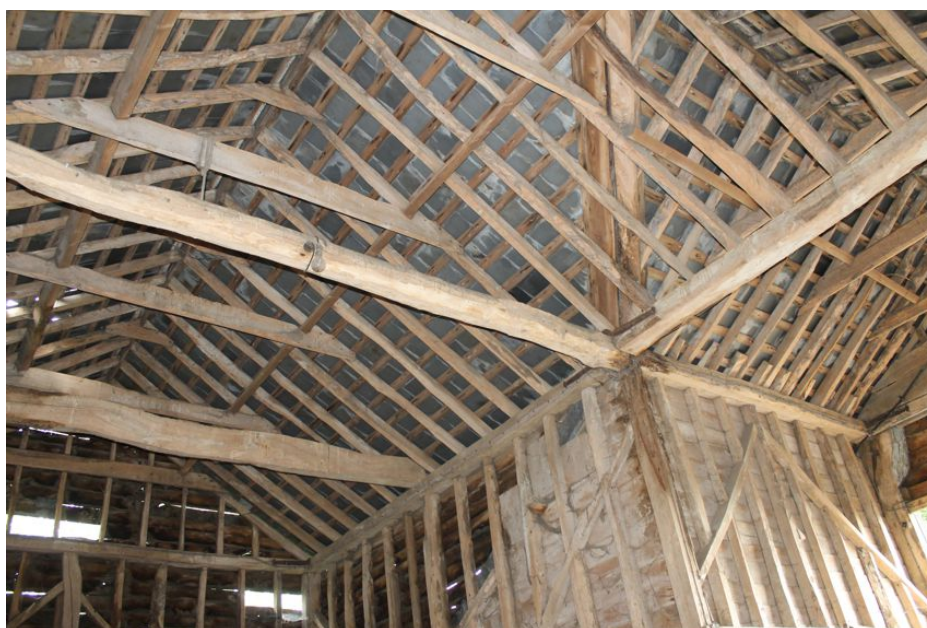
The two central tie-beams (the ones either side of bay 3), have another interesting feature: those same timbers are also the wall-plates of the midstrey (Photograph 13). This is an unusual feature in a timber-frame and indicates the vernacular methods used during the raising of the barn (which is examined further in the discussion).

Photograph 13 Shot showing the tie-beam between bays 3 and 4 is the same timber as the wall-plate of the midstrey. Photograph taken facing south.

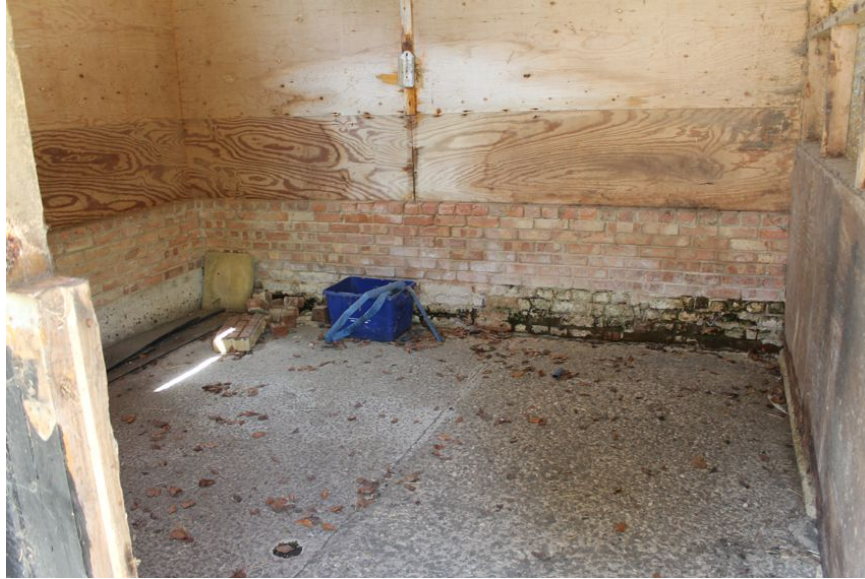
The only point of interest, in what is otherwise a very modern building, is the plinth. On the interior of the building, it is clearly visible that the plinth supporting the western wall is constructed from two different types of brick (Photograph 18). The top seven courses are modern red bricks (measuring 215mm x 65mm x 100mm), but the bottom four courses are older, shorter, red bricks in a much worse state of repair (measuring 205mm x 67mm x 110mm).

Photograph 18 Interior shot of Building B, showing different bricks visible in plinth. Photograph taken facing west.

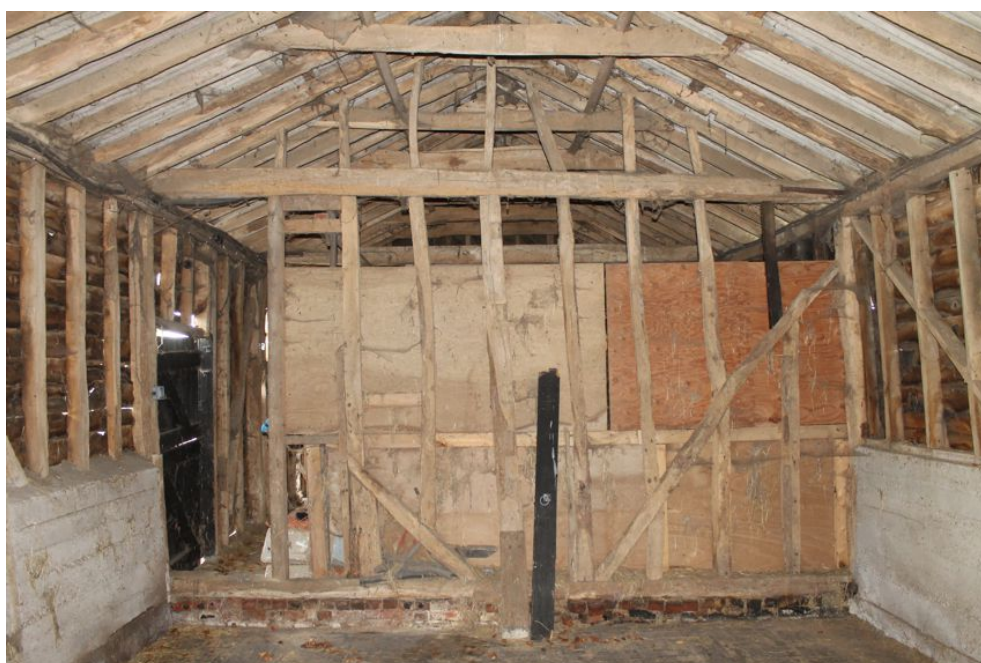
Building C has a concrete floor, and a dividing wall in the centre of the structure (Photograph 20). Large sections of the timber-frame have been rebuilt or replaced. The entire western elevation is constructed of modern machine-cut timber, and the roof, although largely constructed of hand-sawn rafters, must have been rebuilt as a result. The wall-plate on the eastern elevation is also machine-cut, and was probably inserted when the other alterations were made to the building.

Photograph 20 Dividing wall in the centre of Building C. Photograph taken facing south-west.

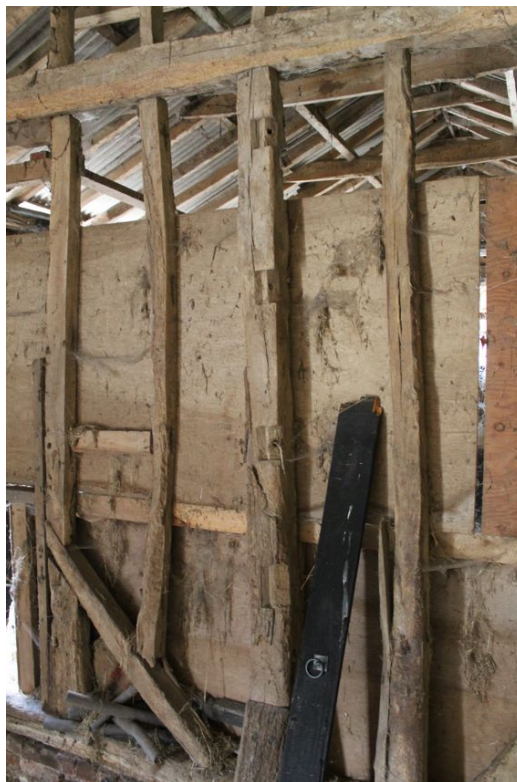
The dividing wall in the centre of the building is supported by a plinth, and its sill-beam, primary-post, studs and wall-plate are all hand-sawn, original and pegged together (Photograph 20). The vertical braces from the wall-plate to the roof are later insertions, and nailed into place. The primary-post in this dividing wall is a re-used timber from an earlier structure, with several unused mortices and peg-holes (Photograph 21).

Photograph 21 Detailed shot of re-used intermediate post in dividing wall in the centre of Building C. Photograph taken facing south.

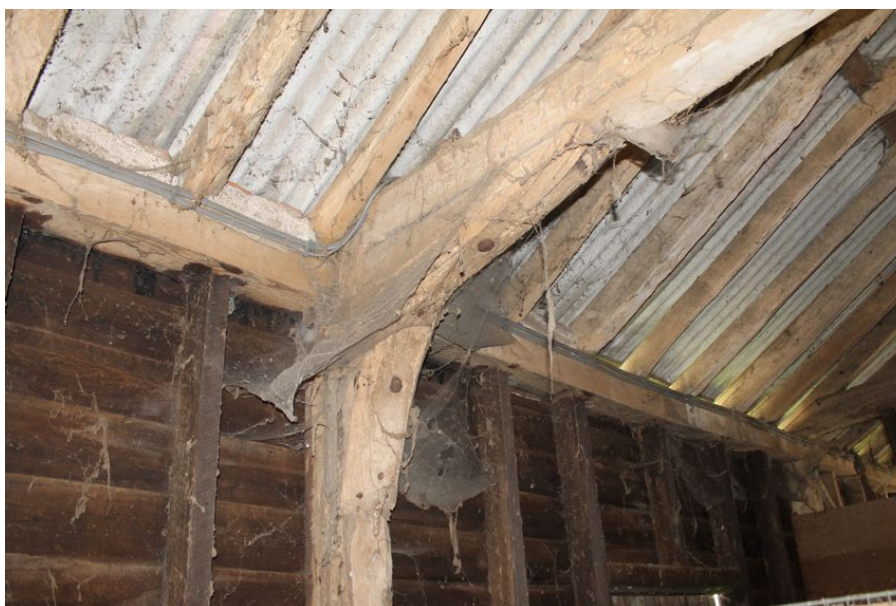
Photograph 23 Knee brace supporting tie-beam in Building C. Photograph taken facing north.

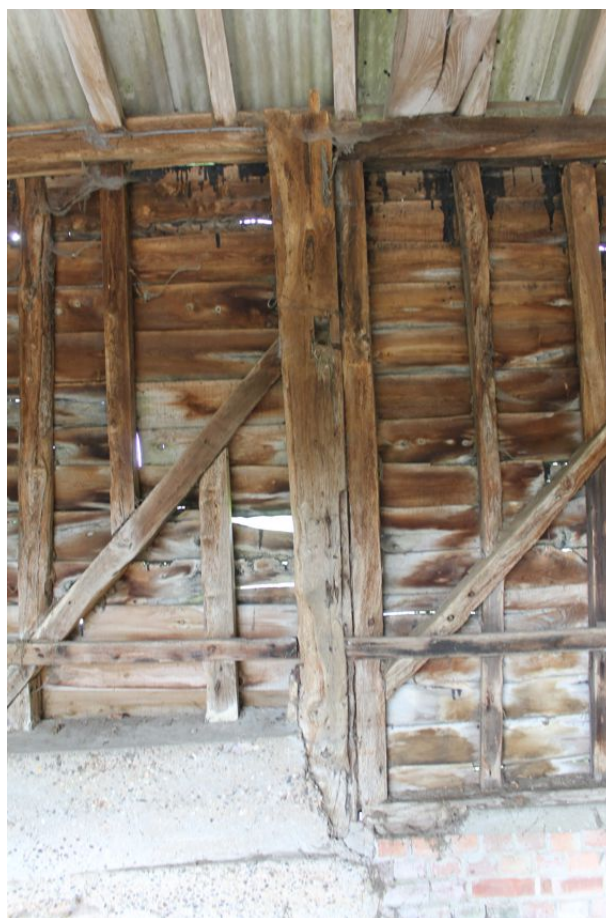
27). Although difficult to examine closely, the joint appears to be a full-lap dovetail with a tenon set to one side.

Photograph 27 Principal post in north-west elevation of Building D, with tenon set to one side visible at apex. Photograph taken facing north-west.

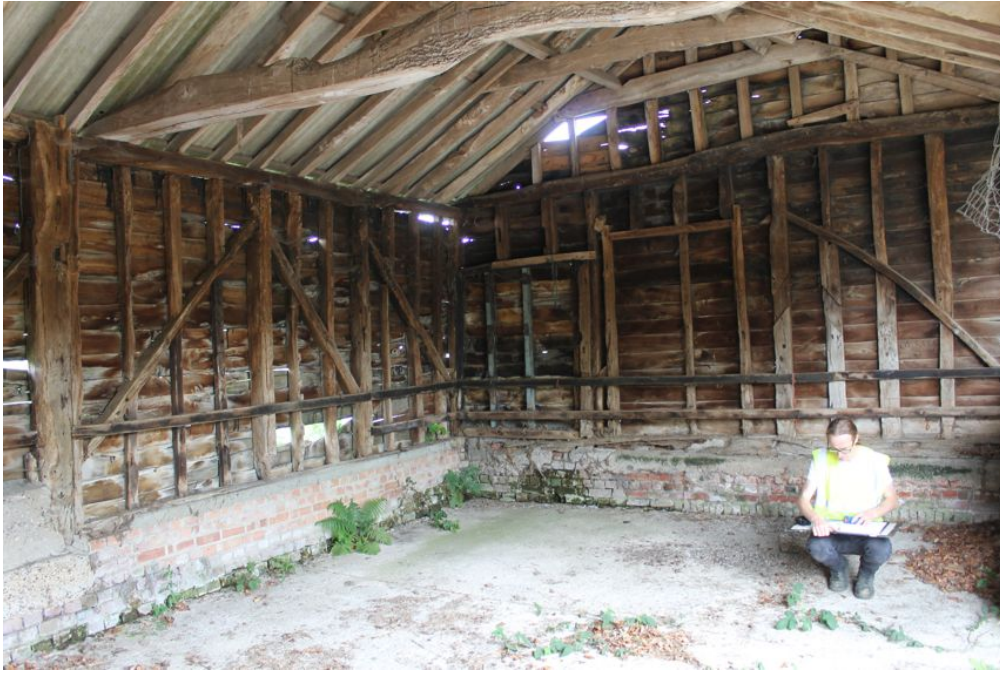
Photograph 29 Interior shot of Building D, with two modern timbers and possible blocked entrance visible in centre of photo. Photograph taken facing north.

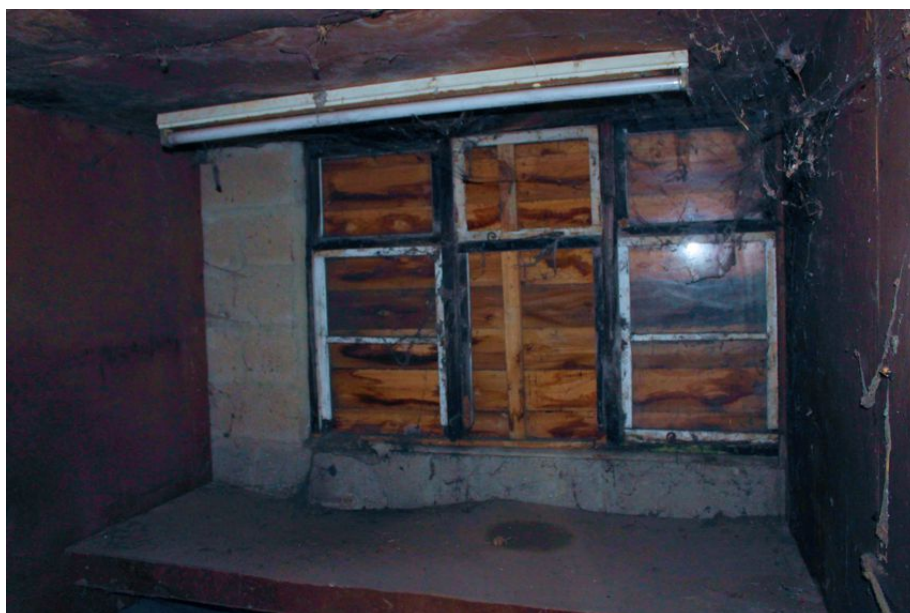
Photograph 30 Interior shot of Building F, showing blocked modern window. Photograph taken facing south.

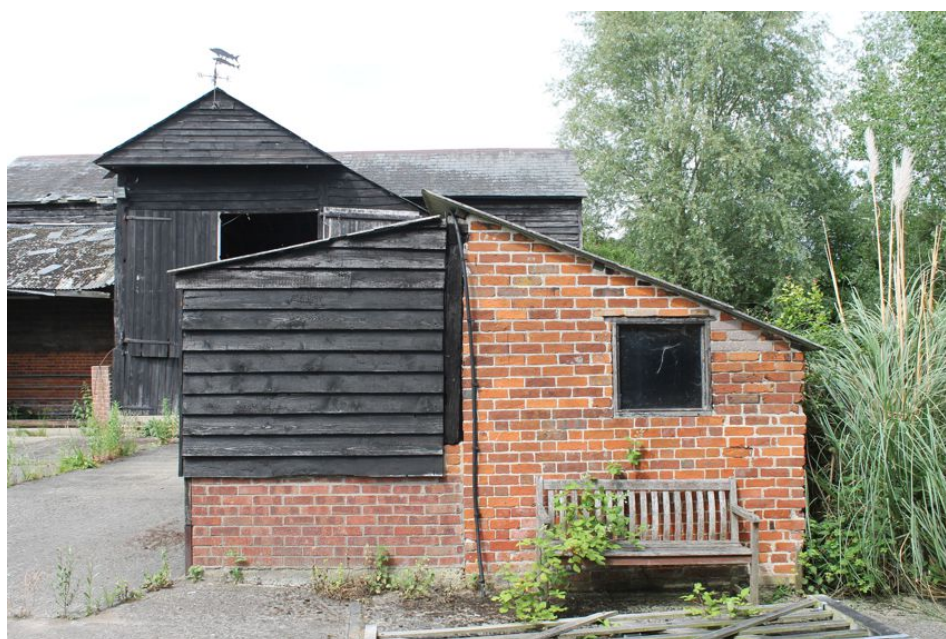
Photograph 34 South-west elevation of Building H, showing two phases of construction. Photograph taken facing north-east.
