**Historic building recording at
5 and 6 St Nicholas Street (formerly 'Jacks'),
Colchester
CO1 1LB**

September 2017

**report prepared by
Mark Baister**

CAT Report 1222
March 2018

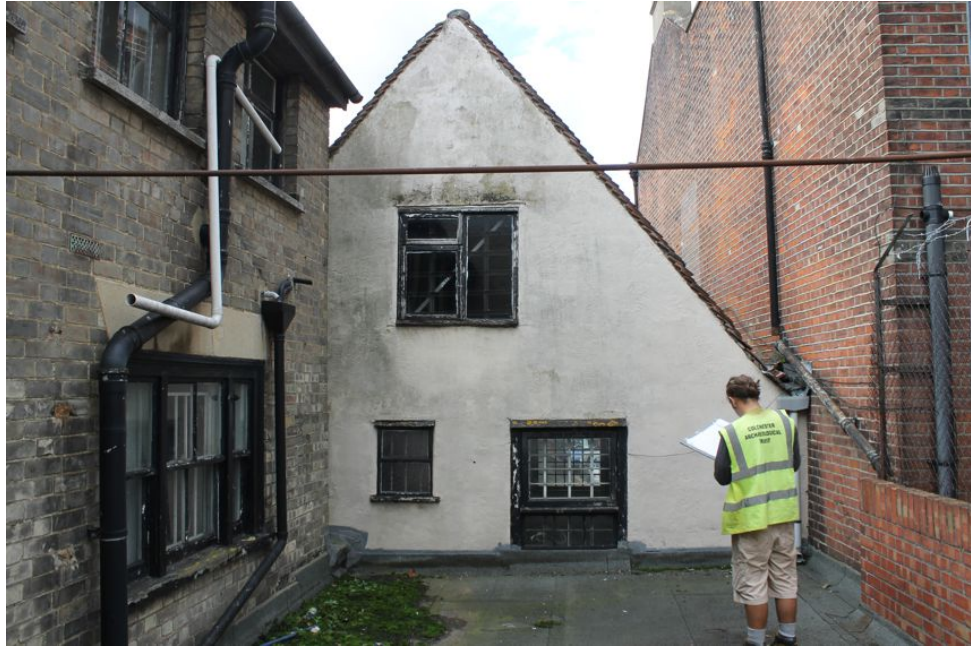
The eastern gable-end of the building is rendered over and contains four inserted wooden-framed windows of varying sizes (Photograph 3). The lowest of these three is partially obscured by the roof of Building E. Within Building E the surviving first-floor eastern elevation of Building A has been stripped, exposing the original timber-frame as well as modern timbers nailed onto it. Nothing remains of the ground-floor elevation.

Photograph 3 Eastern elevation of Building A. Photograph taken facing west.

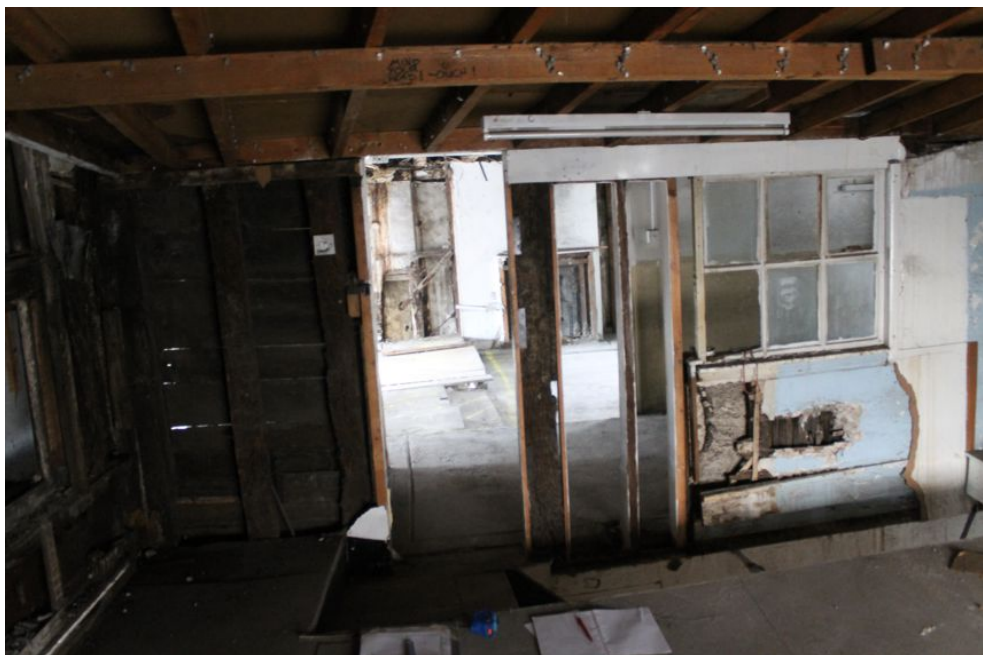
The southern elevation of Building A does not survive at the ground-floor level, but at the first-floor there is an inserted wooden-framed six-light fixed window (Photograph 4). An entrance has also been formed adjacent to this window by removing a stud. Some of the plaster has been removed below the inserted window on this elevation, exposing a section of lath and plaster. Adjacent to Building B on the first-floor, most of the exterior is covered with modern plasterboard, with the exception of a bricked up and plastered over doorway between the two structures (A and B).

Photograph 4 Southern exterior elevation of the first-floor of Building A, with exposed lath and plaster below inserted window. Photograph taken inside Building C, facing north.

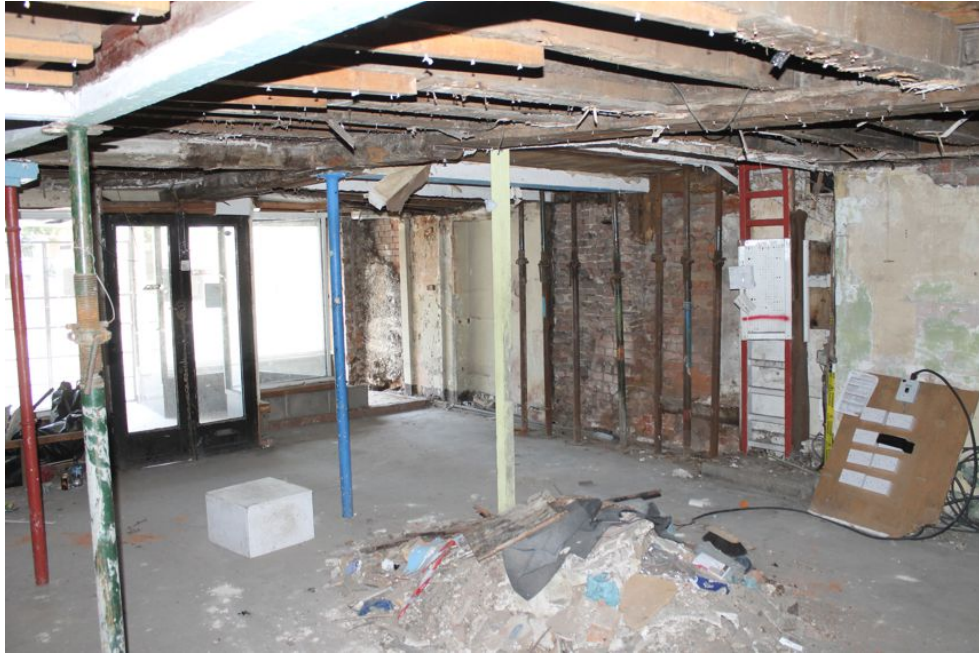
The ground-floor of Building A is open plan, with no surviving divisions (Photograph 6). It has a modern concrete floor. As mentioned previously, very little of the building's original fabric survives at this level, with brick-built walls and pillars, as well as some replacement timbers, now supporting the upper floors. It seems likely that most of the structure's stability is the result of it being directly adjacent to the large brick-built structure to the north (4 St Nicholas Street).

Photograph 6 Ground-floor of Building A. Photograph taken facing north-west.

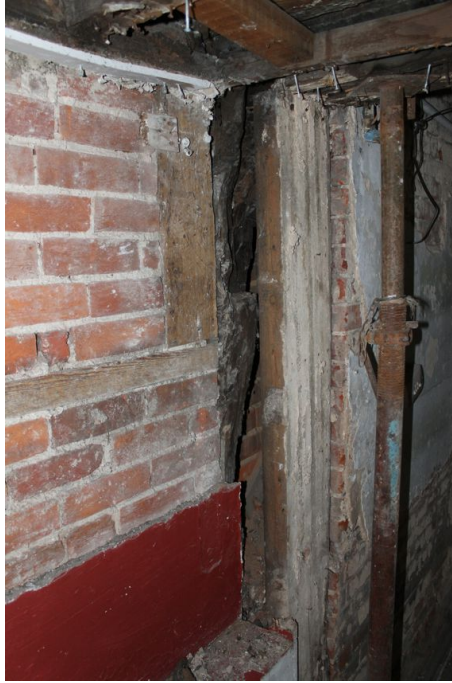
Three of the four corner-posts are still present, but none survive to ground level, either being supported by brickwork, or, in some cases, not being supported at all (Photograph 7 and 8). The corner-post in the south-west corner is not visible, and has probably been replaced by a metal girder (see Building B below). No studs survive. Only one small section of the northern sill-beam survives. Beneath this is a section of brick plinth that may be original to the building: it is in very poor condition, with three courses of indeterminate bonding and bricks measuring 170 x 100 x 60mm (Photograph 9).

Photograph 7 Remains of north-east corner-post of Building A at the ground floor. Photograph taken facing north-east.

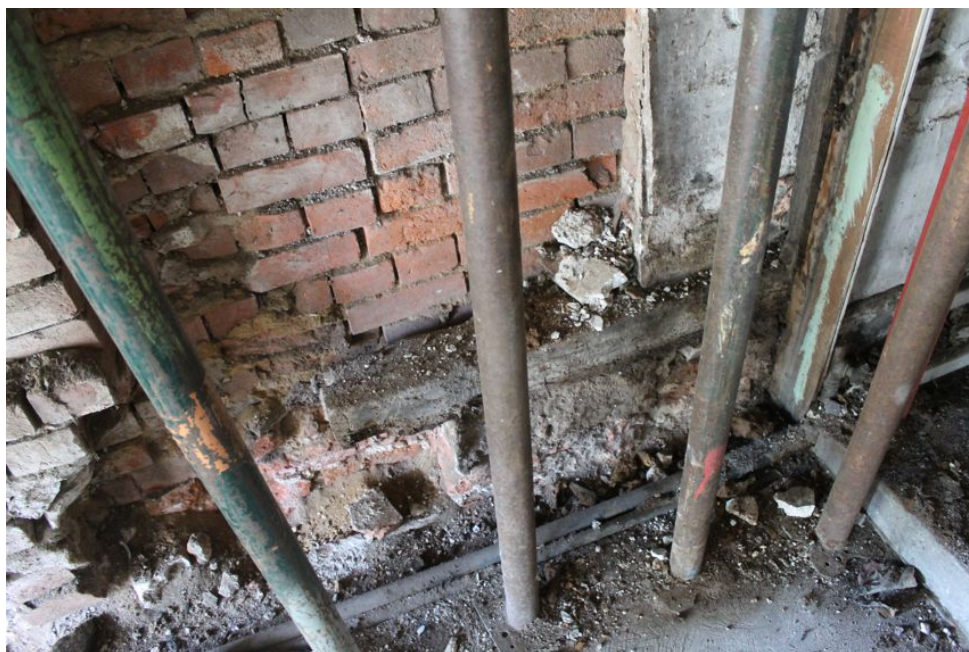
Photograph 9 Remains of sill-beam and brick plinth on northern elevation of Building A. Photograph taken facing north.

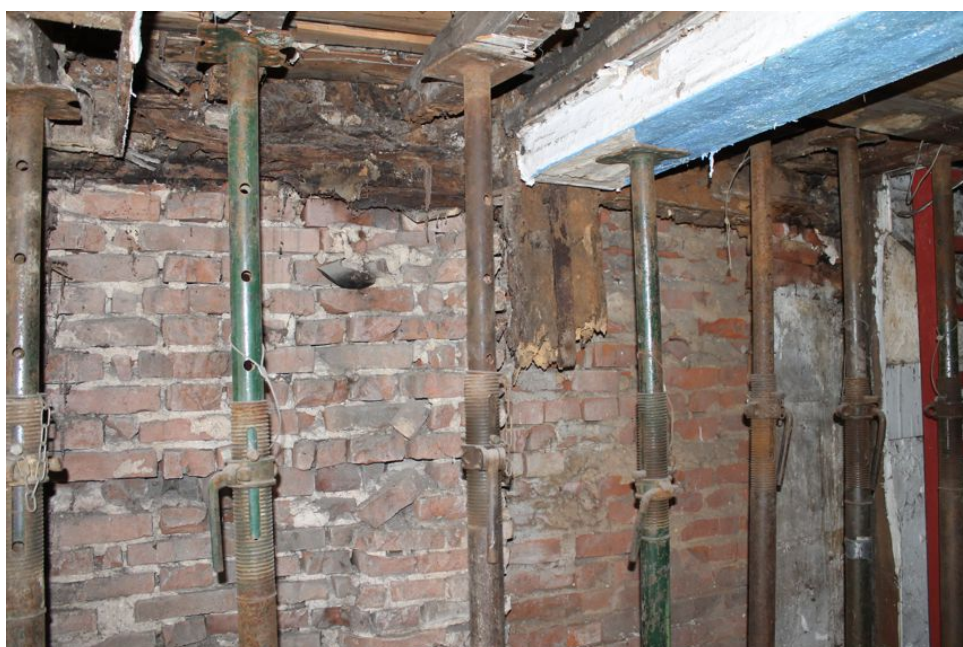
Photograph 10 Remains of principal-post on ground-floor on the northern elevation of Building A. Underpinning of girder-beam by brickwork also visible. Photograph taken facing north.

Also on the northern elevation is an inserted red brick chimney stack and blocked fireplace. Evidence of this chimney stack is seen again on the first- and second-floors, but its associated chimney is not longer extant. The principal-post on the northern elevation is broken and does not reach ground level (Photograph 10).

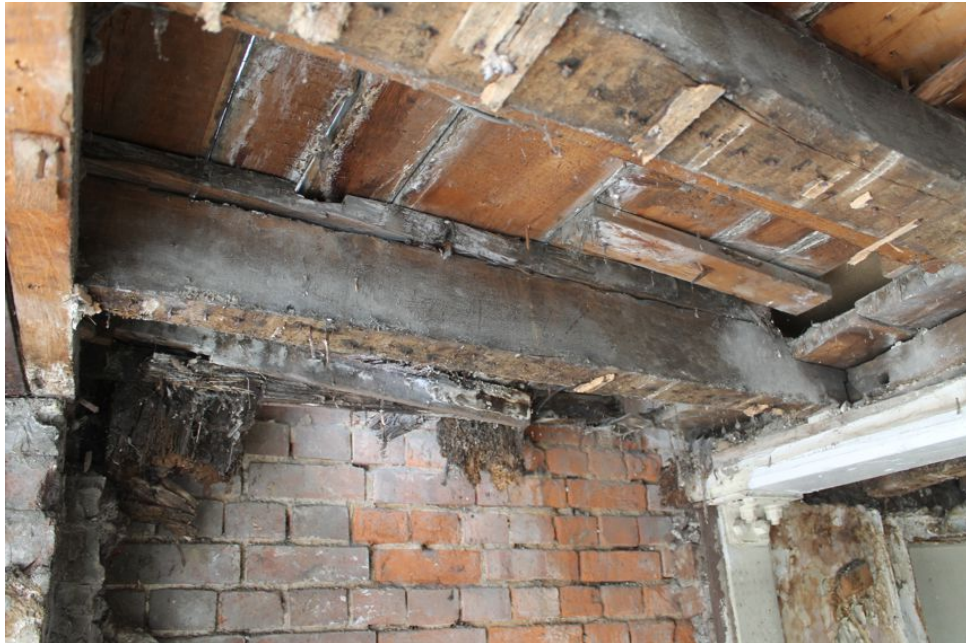
Towards the west of the north elevation, adjacent to the damaged north-west corner-post and in the location of the section of missing girding-beam, a timber is visible projecting from the floor above (Photograph 11).

Photograph 11 Remains of current corner-post (left) and possible original corner-post projecting from first-floor (centre) on ground-floor on the northern elevation of Building A. Photograph taken facing north.

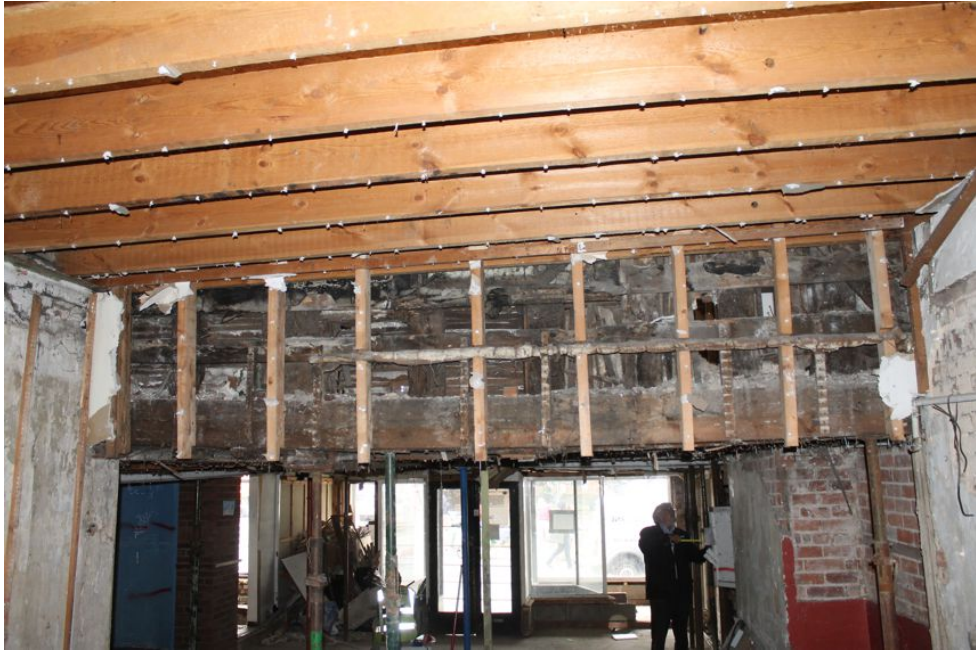
The eastern elevation of the ground-floor is devoid of any features, and largely opens up into Building E (Photograph 12). The south-east corner of the structure is supported by a later rendered-over brick wall. The principal-post in this elevation is entirely absent. Of note on this elevation, however, is the intact girding-beam, and on the underside of it a series of diamond window mullions and a shutter groove, as well as mortices for studs (Photograph 13). These features are remnants of an unglazed opening on this elevation, a feature found in buildings up to the early 16th century, but typically dating to the 15th century or earlier (Historic England 2017, 8). The implications of the date of this feature is examined in the discussion.

Photograph 12 Eastern elevation of Building A at ground level. Photograph taken within Building E and facing west.

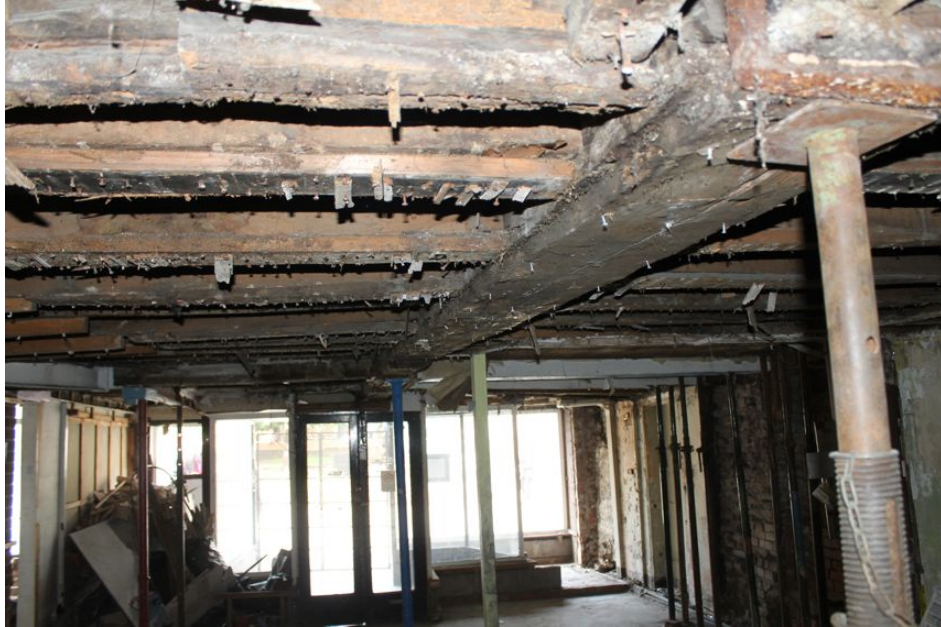
elevations when they were extant (Photograph 14). It is now supported by an iron strap at its eastern, and, presumably, western end, although the modern shop frontage masks any evidence of it on the western elevation. Jointed to the centre of this binding-beam are two more smaller chamfered binding-beams that are jointed to the principal-posts in the north and south elevations. There is a replacement modern post supporting these beams where they meet in the centre of the building.

Photograph 14 Underside of first-floor in Building A. Chamfered binding-beam and supporting iron strap visible. Photograph taken facing west.

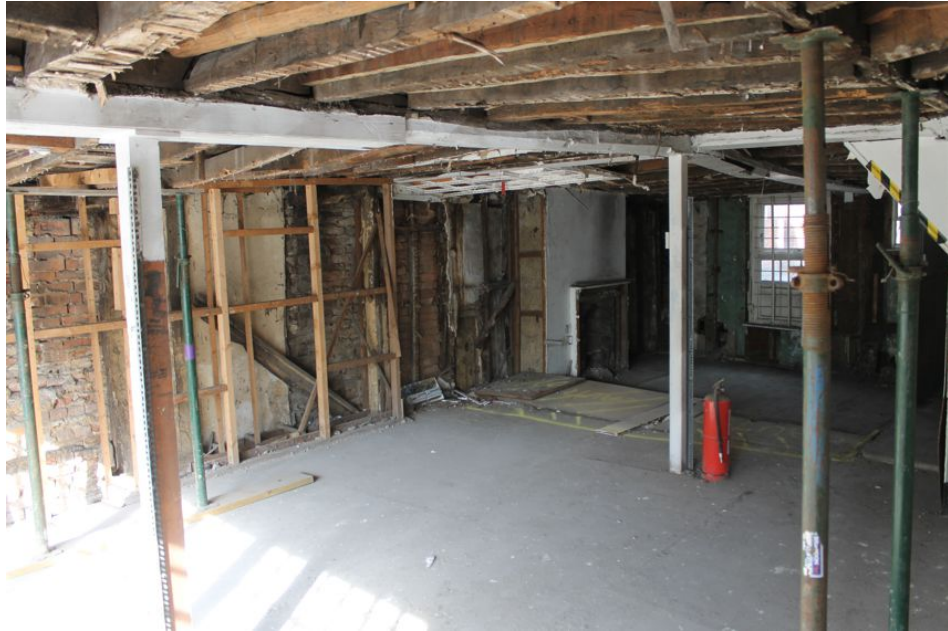
More of the original fabric of the building survives on this floor than the ground-floor, but it is still heavily damaged, with several areas of modern insertion and repair. The wall-plate survives around most of the building, although it is completely obscured by modern plasterboard on the western elevation, above the row of large inserted windows. Like the binding-beams, the wall-plate is chamfered. Several studs on the northern elevation are missing or have been replaced by modern machine-cut timbers. All four corner-posts, rising from the ground-floor, are intact at this level.

Photograph 15 First-floor in Building A. Photograph taken facing north-east.

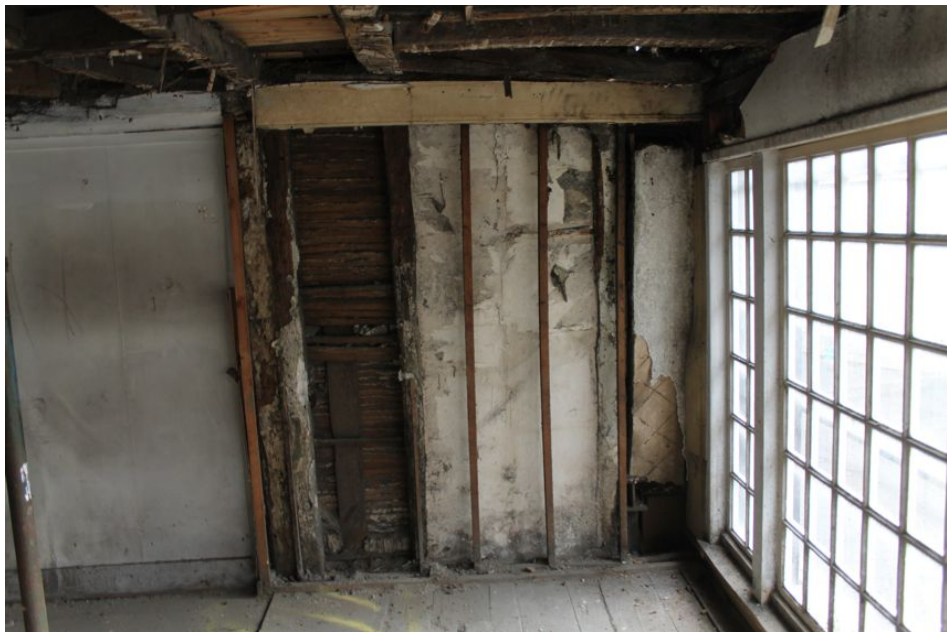
(and later machine-cut replacements) are visible. Also visible towards the west of the this elevation, nearby the inserted door between Buildings A and B, is some lath and plaster on the exterior of the building (Photograph 20).

Photograph 20 Photograph of internal southern elevation of first-floor in Building A. Exposed lath and plaster render visible on exterior of building, as well as bricked over inserted door between Buildings A and B. Photograph taken facing south.

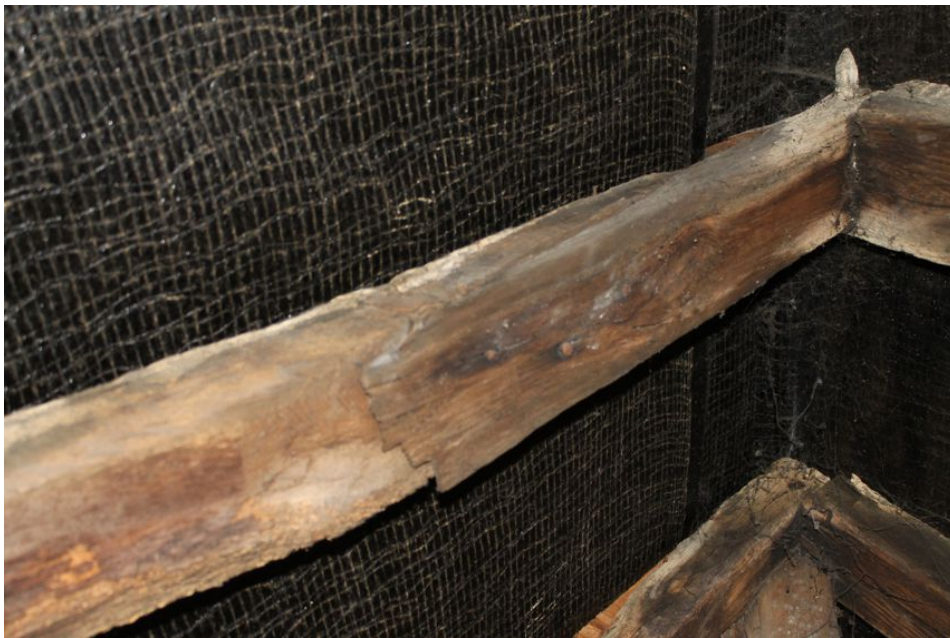
Photograph 24 Detail of rafters in Building A. Peg at apex visible, along with scarf joint/repair to rafter.

Notably, on rafter pairs that have both sets of carpenter's marks, they don't match (Fig 6). Some rafters have very rudimentary splayed scarf joints, or possibly repairs (Photograph 24).

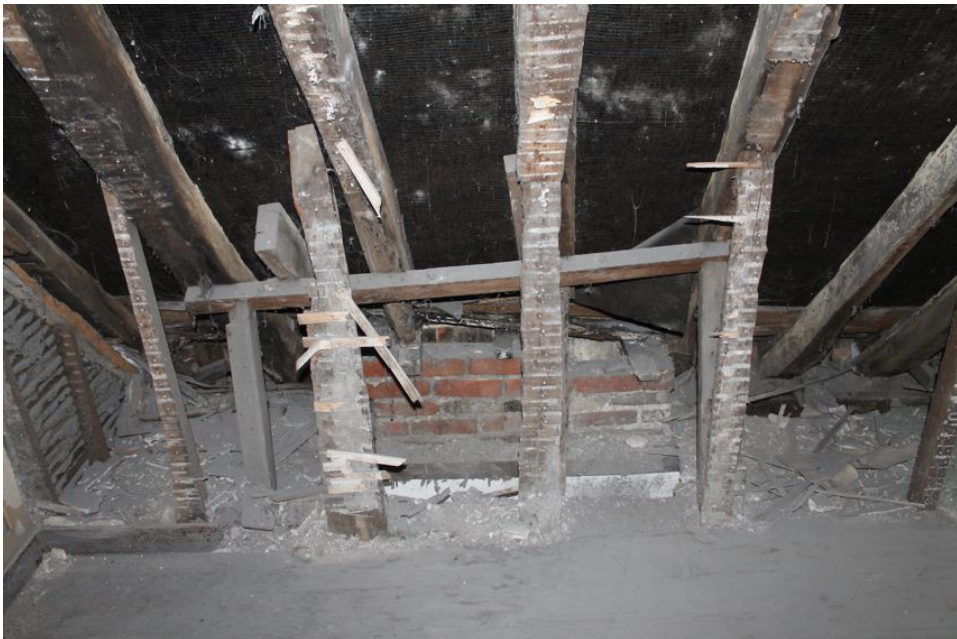
In the northern elevation of the eastern room is the chimney stack (as observed in the lower floors) surviving to a height of four brick courses above the floorboards (Photograph 35).

Photograph 35 Remaining top of chimney-stack in Building A. Possible original lath and plaster on east side of modern skylight visible to left. Photograph taken facing north.

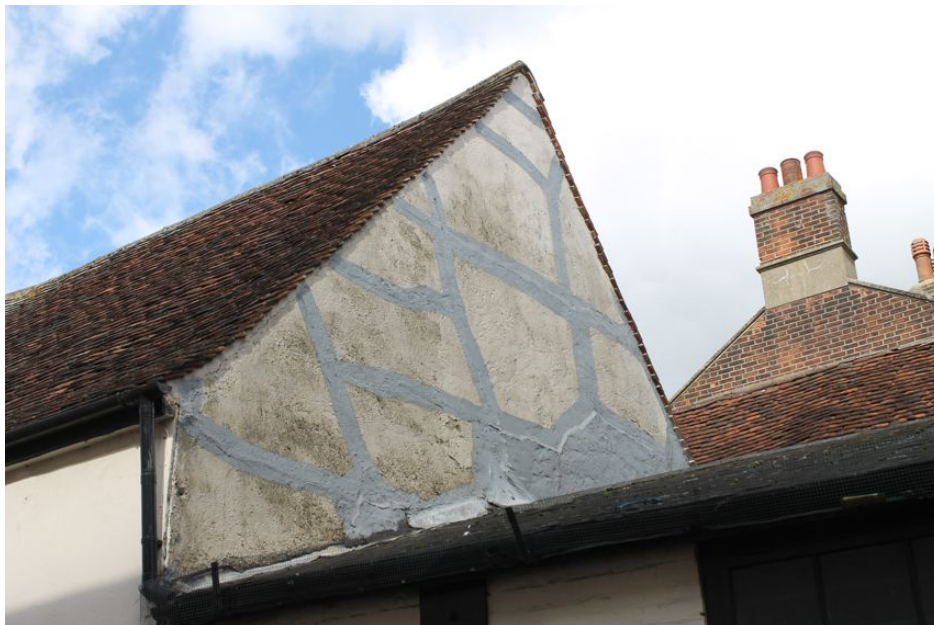
The eastern gable-end of the building is partially obscured by Building C, but what is visible is rendered over and featureless. Cracks in the lath and plaster rendering on this elevation have been repaired by later rendering with grey plaster (Photograph 38). Within Building C the surviving first-floor eastern elevation of Building B has been stripped, exposing the original timber-frame as well as an inserted doorway and wooden-framed window (Photograph 39). The entire first-floor has been raised, and is now supported on a reinforced steel girder, also visible on this elevation.

Photograph 38 Eastern gable-end of Building B, showing repairs to plaster. Photograph taken facing north-west.

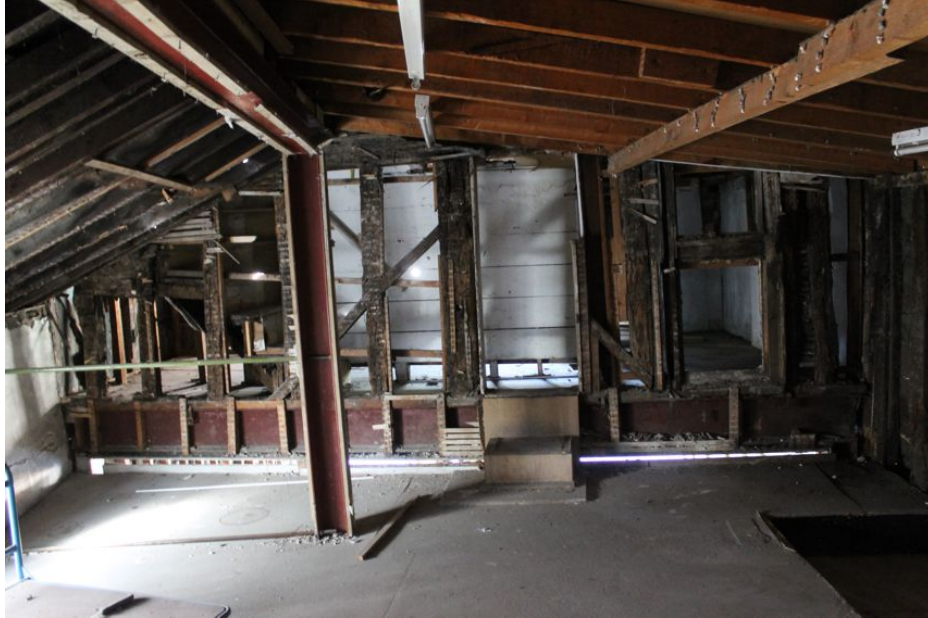
Photograph 39 Eastern elevation of exterior of first-floor of Building B, showing inserted doorway and window-frame. Also visible is metal beam supporting raised first-floor. Photograph taken facing west.

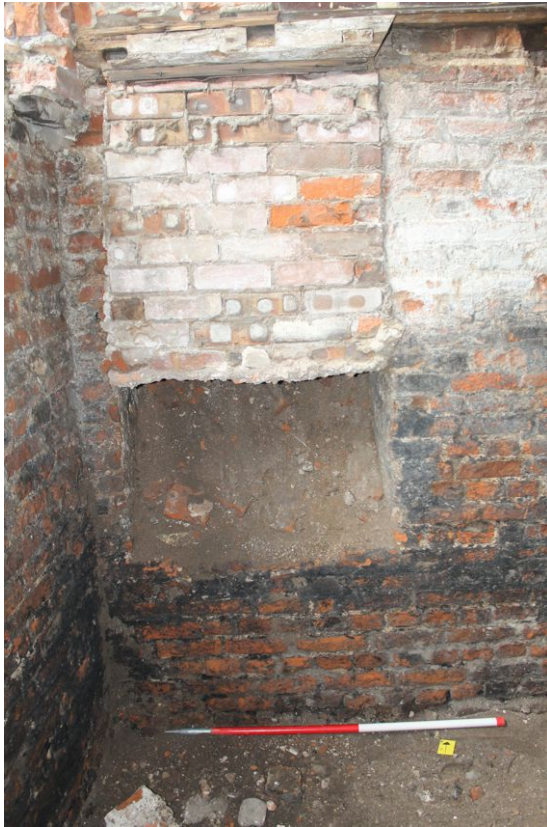
Photograph 42 Bricked-up opening in northern elevation of cellar. Photograph taken facing north.

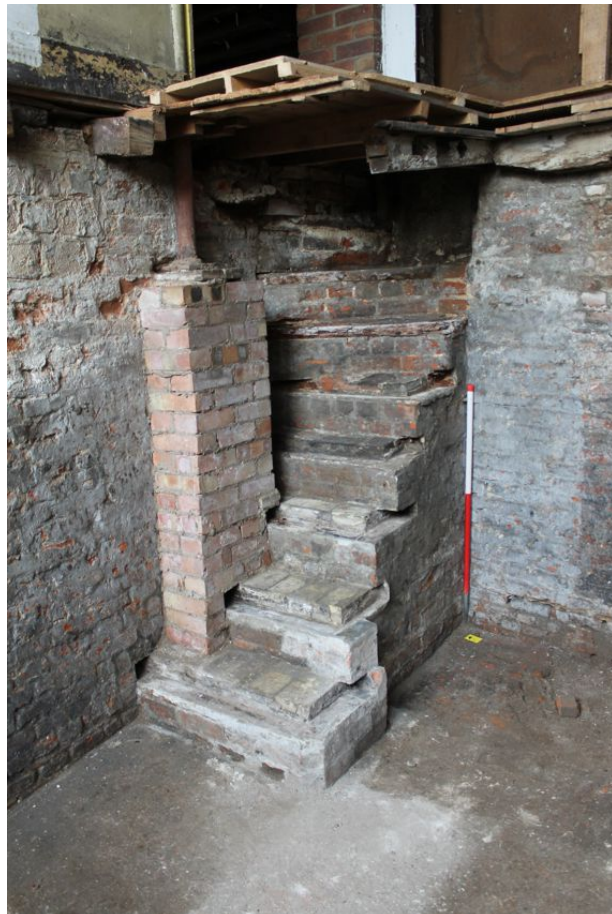
Photograph 43 Brick stairway into cellar. Also visible is brick pillar added to support metal post. Photograph taken facing north-east.

that they were laid when the cellar was divided. The western half of the northern room has no paving bricks at all; the floor is just soil. A small strip to the west of the southern room is also unpaved (Fig 3). At the foot of the stairs on the northern elevation there is a concrete surface, presumably inserted because of the increased wear in this location (Photograph 43).

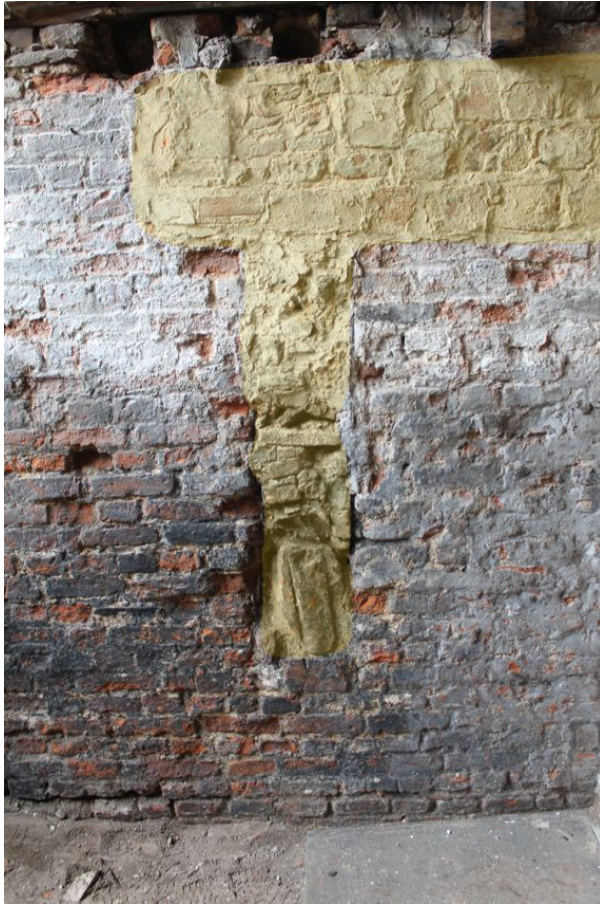
There is also a significant area of infilling within the brick wall on the northern elevation (Photograph 47). As well as more substantial brickwork (230 x 140 x 110mm) and irregular bonding, there is a large piece of worked stone that has been inserted into the wall (Photograph 48). This infilling appears to be where a post was embedded into the brickwork and has since been removed, with associated damage to the top of the wall.

Photograph 47 Northern elevation of cellar, with repaired section of wall highlighted. Photograph taken facing north.

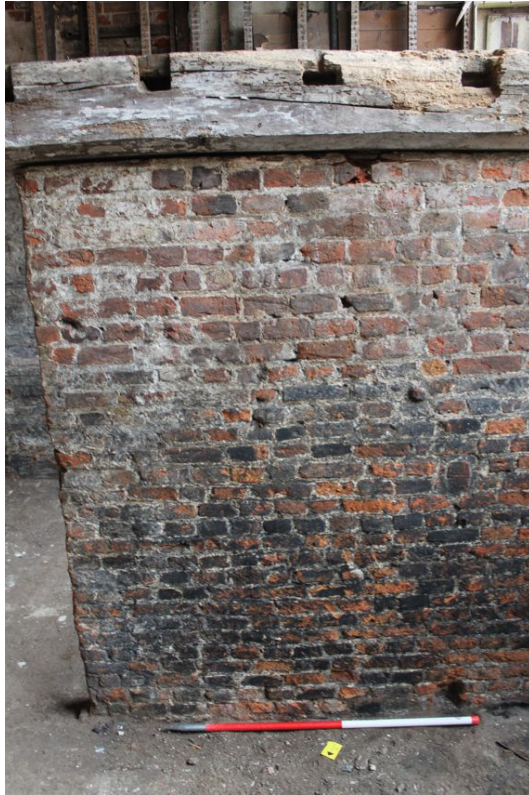
The central wall has two distinct phases of brickwork, with smaller, earlier, bricks (120 x 90 x 50mm in size) making up the bottom 1.3m of the wall, and larger bricks (180 x 90 x 60mm in size) making up the top 0.7m (Photograph 49). Both types of bricks are laid in an irregular bond. Whether this change in brickwork indicates a repair of the wall, or that originally the wall was lower and then increased in height, is unclear.

Photograph 49 Detail of dividing wall in cellar, showing two phases of brickwork. Photograph taken facing south.

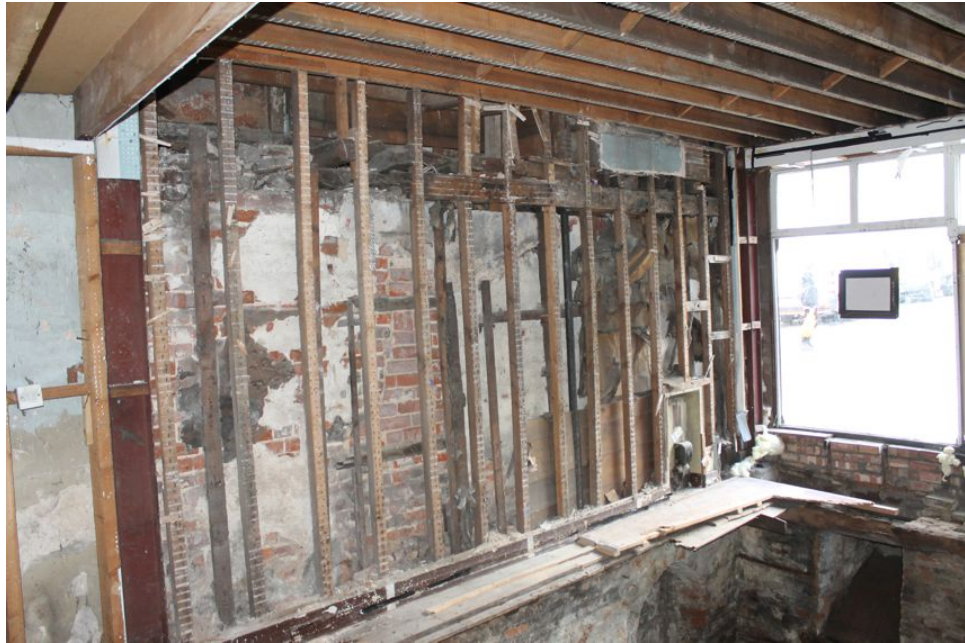
Photograph 52 Southern elevation of ground-floor of Building B, showing timber-frame partially surviving but obscured by later brickwork. Partially surviving girding-beam visible. Photograph taken facing south-west.

The two southern corner-posts of Building B have been replaced with metal posts, supporting the raised floor (Photograph 52). The north-east corner-post of the building (one of the principal-posts of Building A) is intact within a brick pillar. No stud work survives on any elevation.

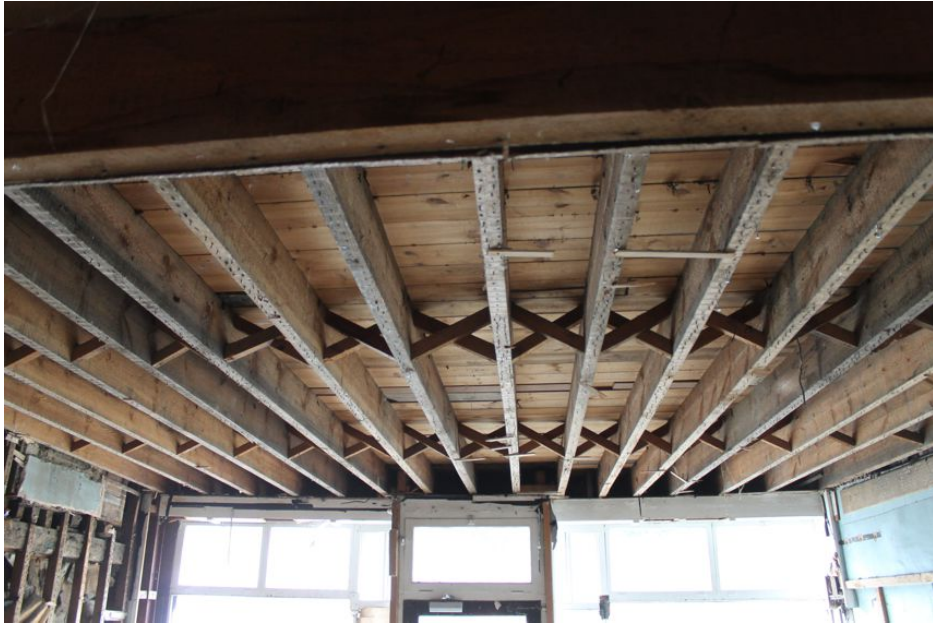
A major reason for this lack of surviving original timber is that the level of first-floor has been raised, with a new floor inserted, the joists of which are reinforced with herringbone strutting (Photograph 53). The raising of the first-floor accounts for the almost complete absence of the girding beam around the structure, and also the replacement of part of the girding-beam in Building A with a metal beam (Building B shares all of its major timbers with Building A on the northern elevation – see Fig 11).

Photograph 53 Underside of raised first-floor in Building B, showing herringbone strutting supporting joists. Photograph taken facing west.

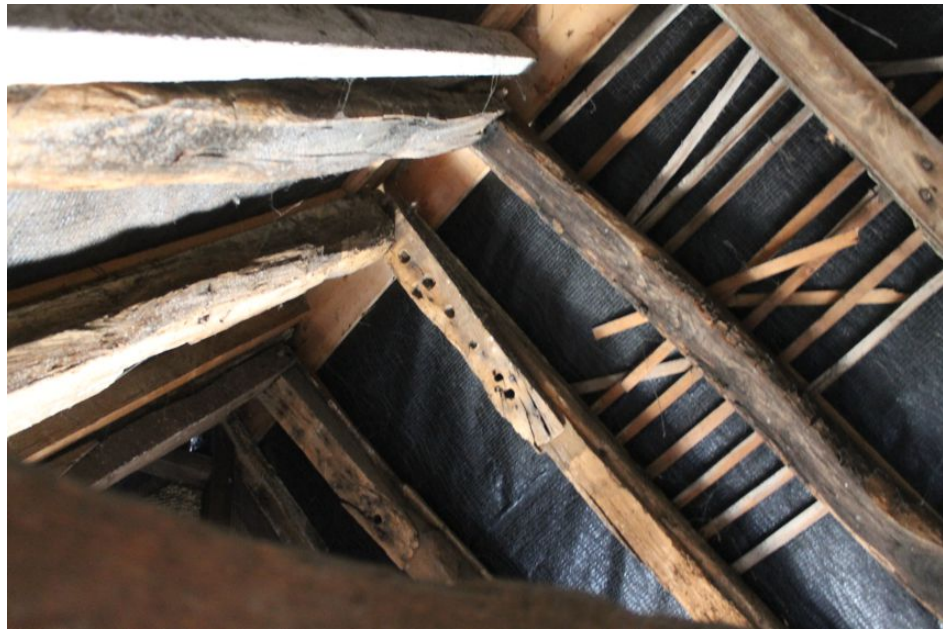
Photograph 61 Roof of Building B with scarf joints on rafters. Photograph taken facing south-east.
