Historic building recording at The Lordships Stud, Back Road, Writtle, Essex, CM1 3PD

August 2017

CAT project ref.: 17/07h
NGR: TL 6712 0637 (centre)
Planning reference: CHL 15/01855/FUL
ECC project code: WRLS17
Chelmsford Museum accession number: CHMRE: 2017.095
OASIS reference: colchest3-290699

CAT Report 1237
March 2018

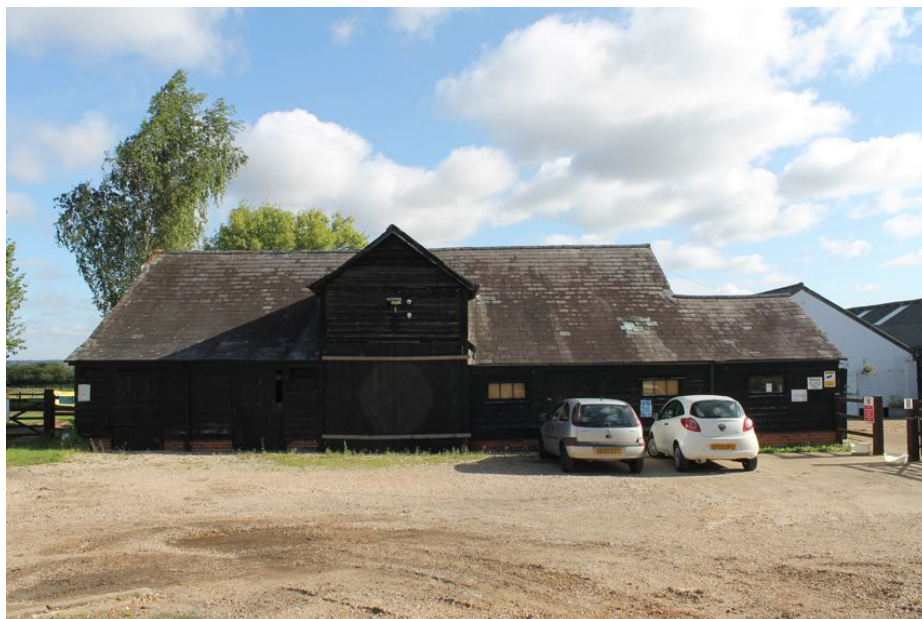
Photograph 1 Southern elevation of barn and outshots A and B. Photograph taken facing north.

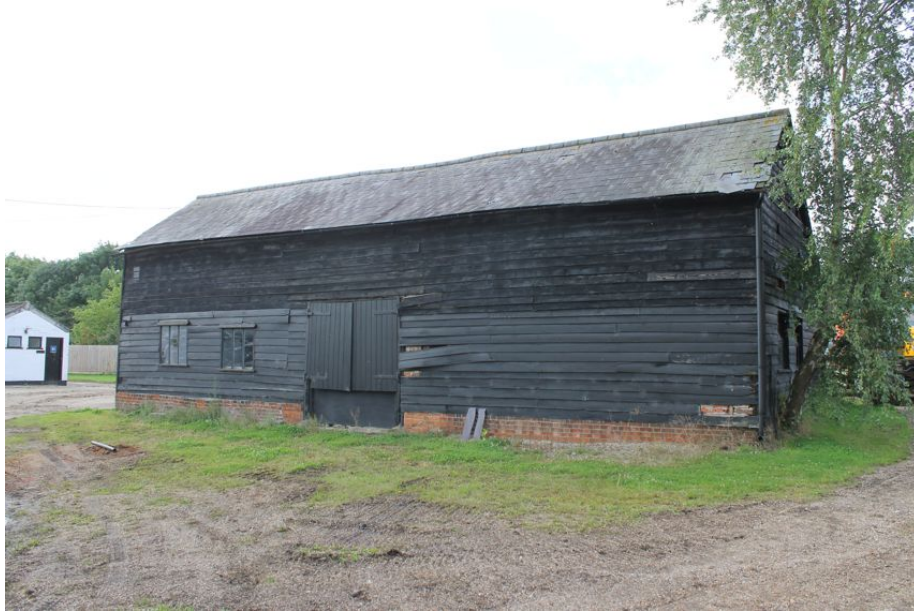
The northern elevation of the barn (Fig 4) has a central vertically-planked double door, with a threshold leap beneath (Photograph 2). Around this door is a clear section of more recent weatherboarding and brick plinth, suggesting that originally the entrance (and corresponding doorway) would have been larger (Photograph 3).

Photograph 2 Northern elevation of barn. Photograph taken facing south-east.

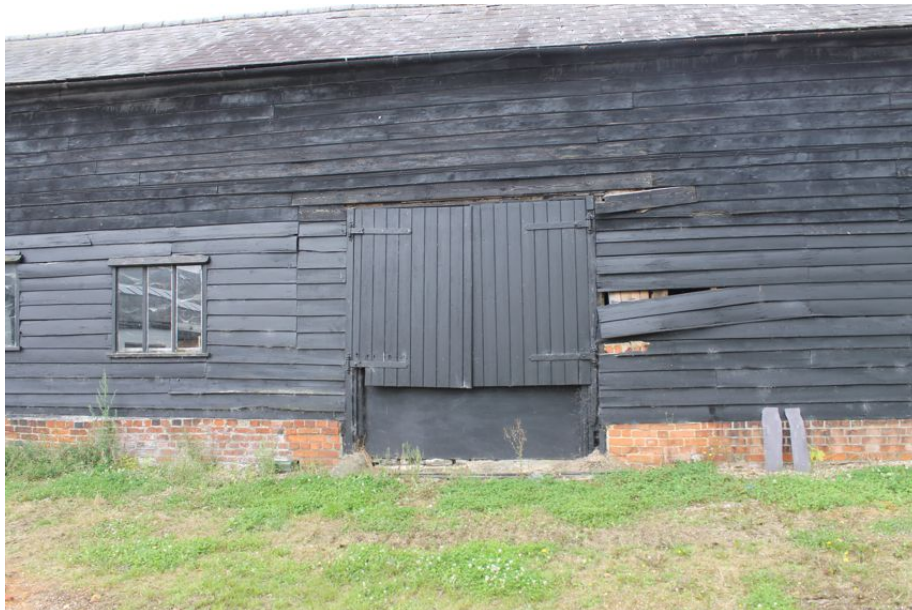
Photograph 3 Detail of double-door on northern elevation of barn, with evidence of rebuilt plinth visible. Photograph taken facing south.

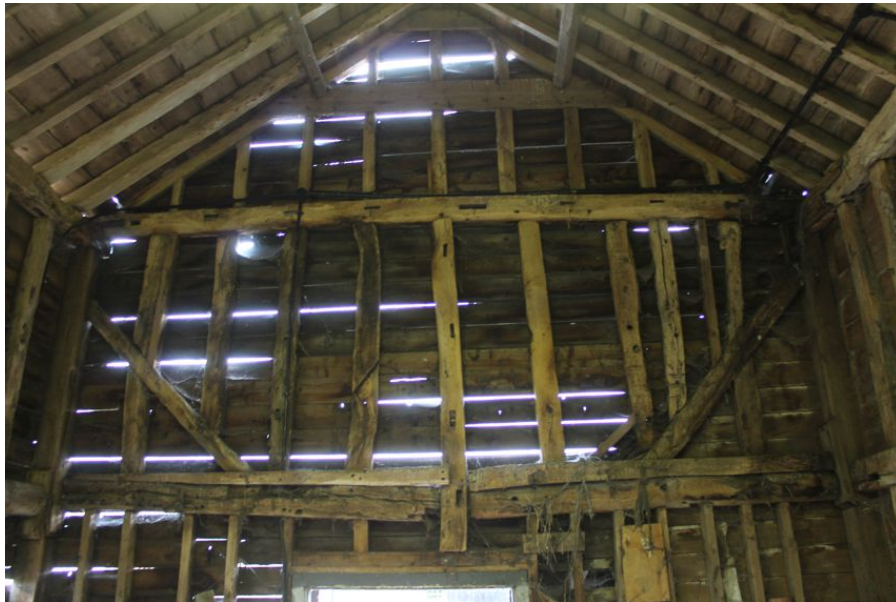
Almost every principal hand-sawn timber in the barn has evidence of re-use in the form of unused mortices and recesses for bracing or, in the case of the underside of the northern wall-plate in bay 4, diamond mullions (Photographs 9 and 10). Several of the through braces also have evidence of re-use as well as some studs. For there to be such a preponderance of re-used timbers strongly suggests the barn was raised from the remains of an earlier structure.

Photograph 9 Detail of eastern gable-end of barn, showing multiple re-used timbers. Photograph taken facing east.

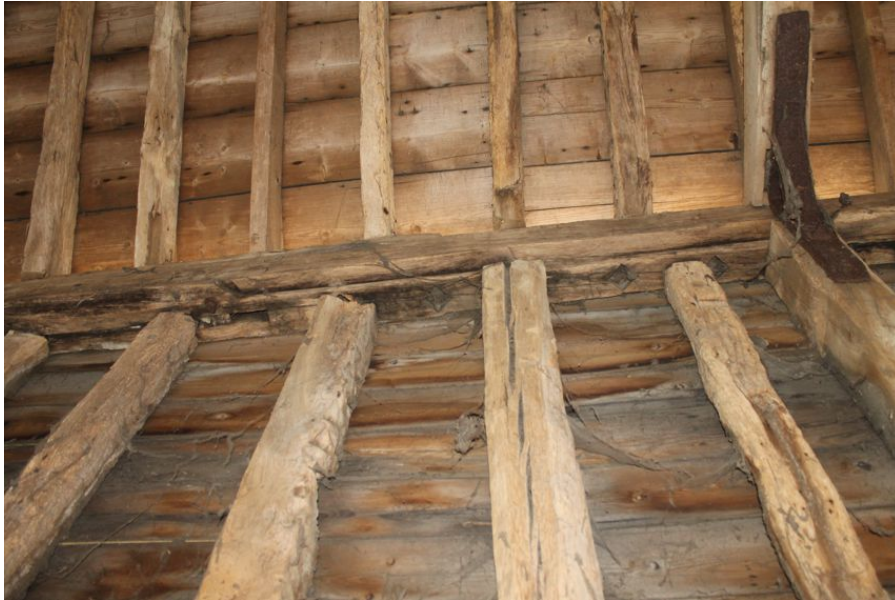
Photograph 10 Detail of underside of northern wall-plate in bay 4, showing diamond mullions. Photograph taken facing north.

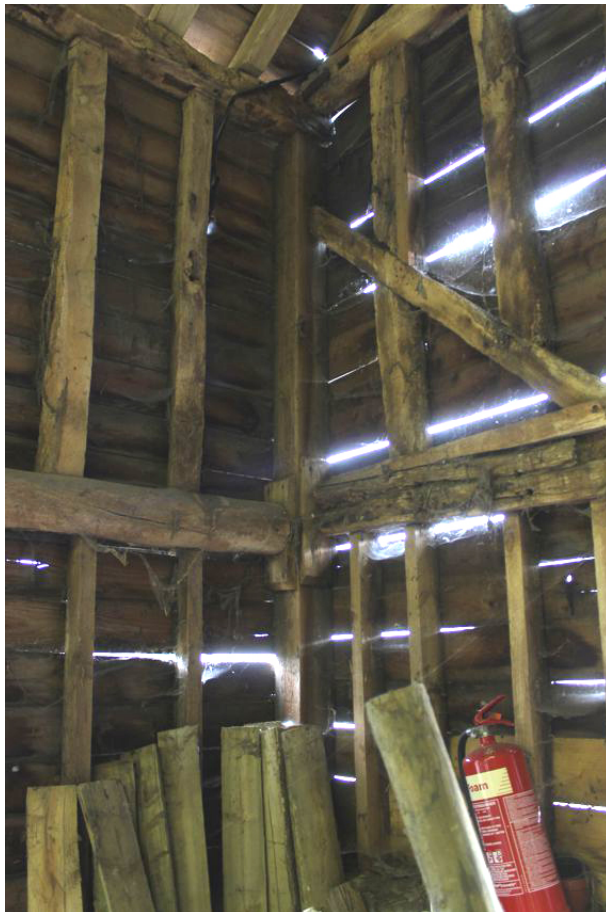
Photograph 11 Detail of north-east corner-post, showing extra timber supporting girding-beams. Photograph taken facing north-east.

The most prominent machine-cut timbers in the barn are three of four the corner-posts. The only hand-sawn original corner-post is in the north-west corner. These machine-cut corner-posts are the result of repairs to the building. The girding-beams and braces that would joint onto them are instead supported on additional segments of timbers nailed onto the corner-posts (Photograph 11). Judging from the clear damage on the wall-plates in the corners of the building (particularly on the eastern elevation) it seems likely that water damage was the reason for these new corner-posts insertion.

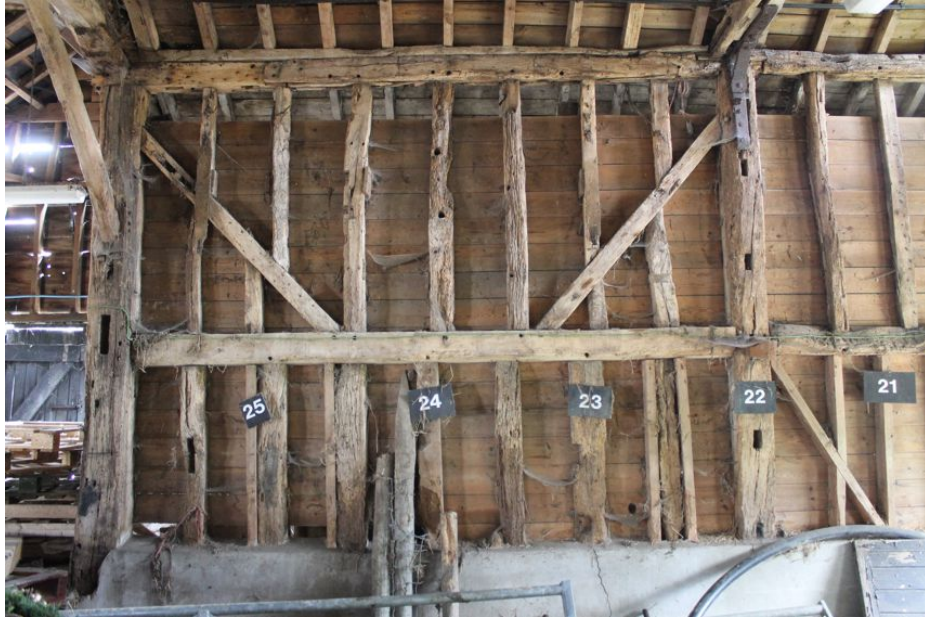
Photograph 12 Southern elevation of bay 2, showing multiple re-used timbers and rafters supported on intermediate timber, rather than wall-plate. Photograph taken facing south.

A large number of the rafters are also machine-cut, most commonly on the southern pitch. The roof of the main range of the barn does not rest directly on the wall-plates, instead resting on several intermediate timbers which are themselves supported on the wall-plate (Photograph 12). The machine-cut rafters and these intermediate timbers both suggest that the roof has been rebuilt and raised, probably coinciding with the replacement of the three corner-posts. That the wall-plates were not replaced at this point, despite their evident water damage in some areas, is testament to the difficulty in finding timber of suitable size.

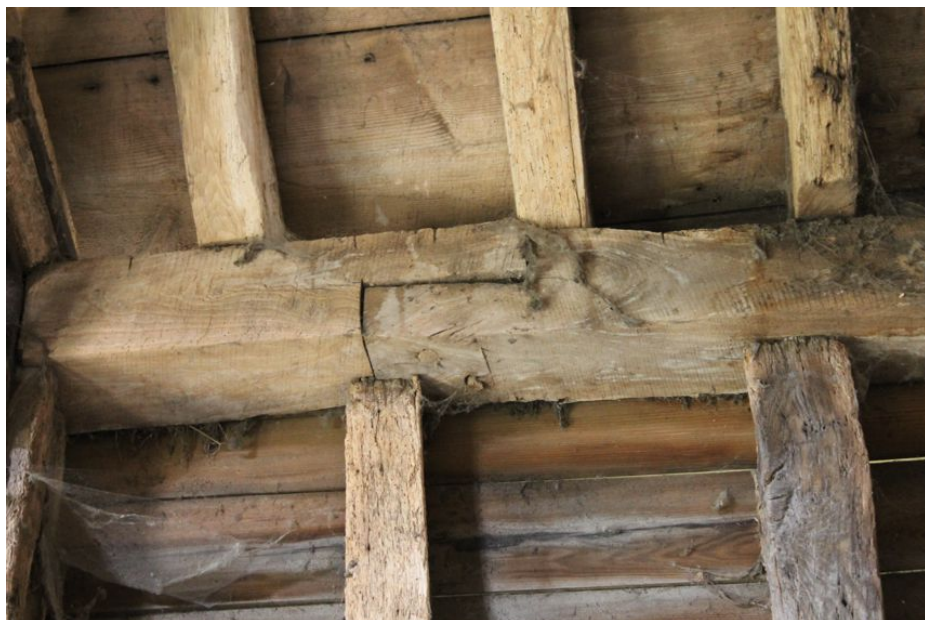
Photograph 13 Rudimentary scarf joint in northern wall-plate of bay 2. Photograph taken facing north.

The wall-plates of the barn have four scarf joints (Fig 3). Three of them are rudimentary: an edge-halved scarf with square abutments and one or two face pegs (Photograph 13) and sometimes supported with a metal strap. One scarf joint differed: adjacent to the south-east corner-post was an edge-halved scarf with bridled abutments and a single metal bolt (Photograph 14). This scarf joint is probably the result of re-use of the timber, as having a joint so close to the corner of the barn makes little sense structurally.

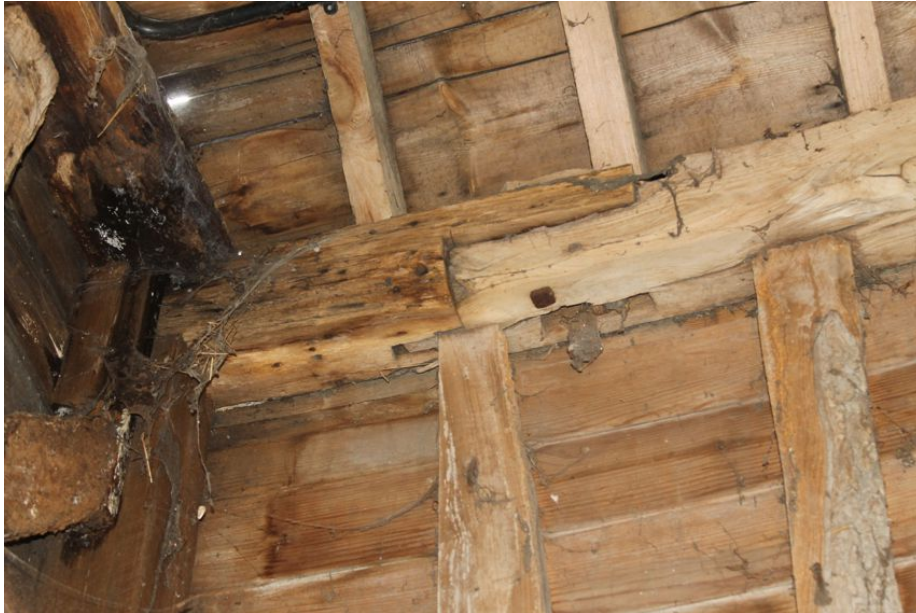
Photograph 14 Edge-halved scarf joint with bridled abutments in southern wall-plate of bay 5, adjacent to south-east corner-post. Photograph taken facing south.

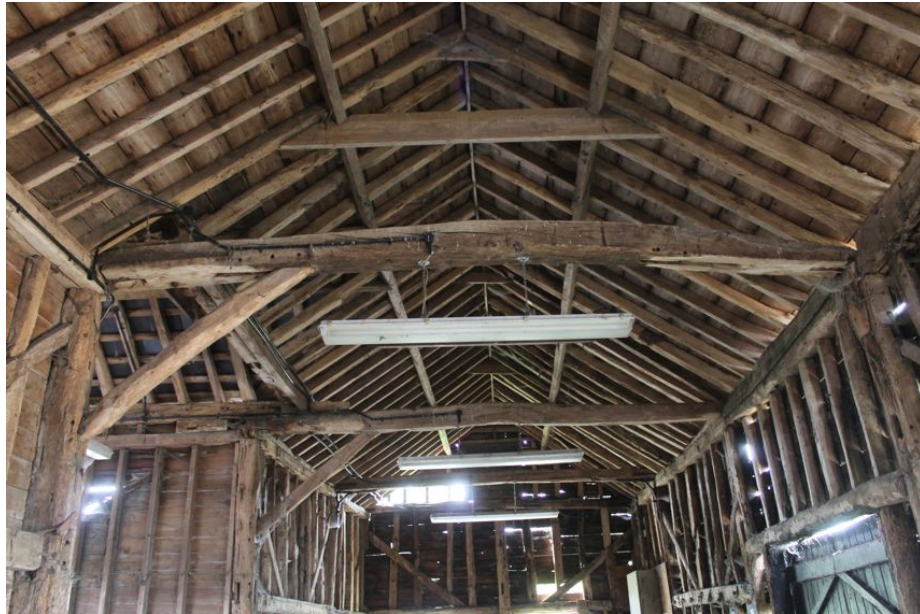
2 and 3 and bays 3 and 4) are supported by a straight brace at their southern end, and by metal straps at their northern (Photograph 15).

Photograph 15 Interior of barn, showing roof trusses. Tie-beam between bays 3 and 4 in foreground. Photograph taken facing west.

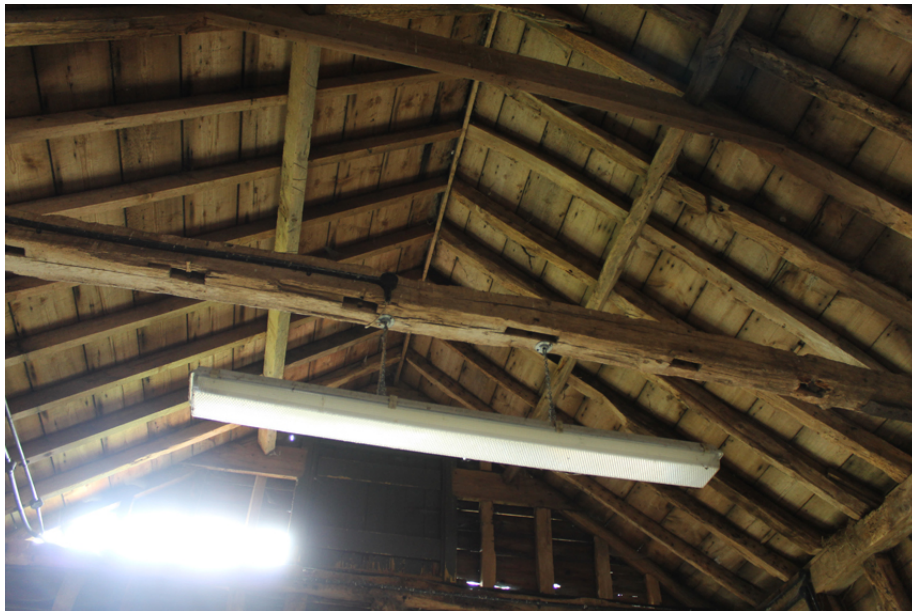
Photograph 16 Underside of roof truss between bays 1 and 2, showing unused mortices. Photograph taken facing west.

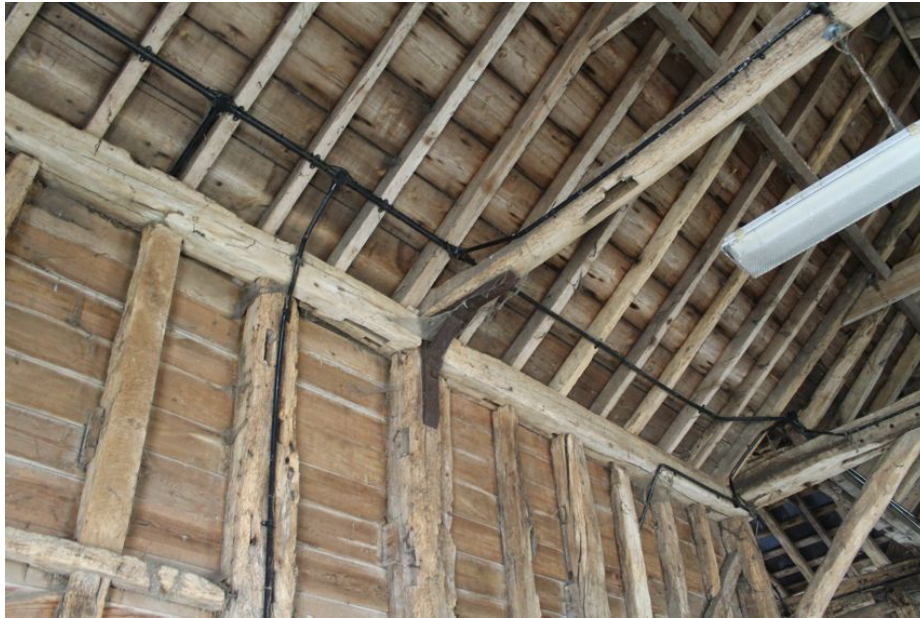
Photograph 17 Metal knee-brace supporting southern end of tie-beam between bays 4 and 5. Photograph taken facing south-west.

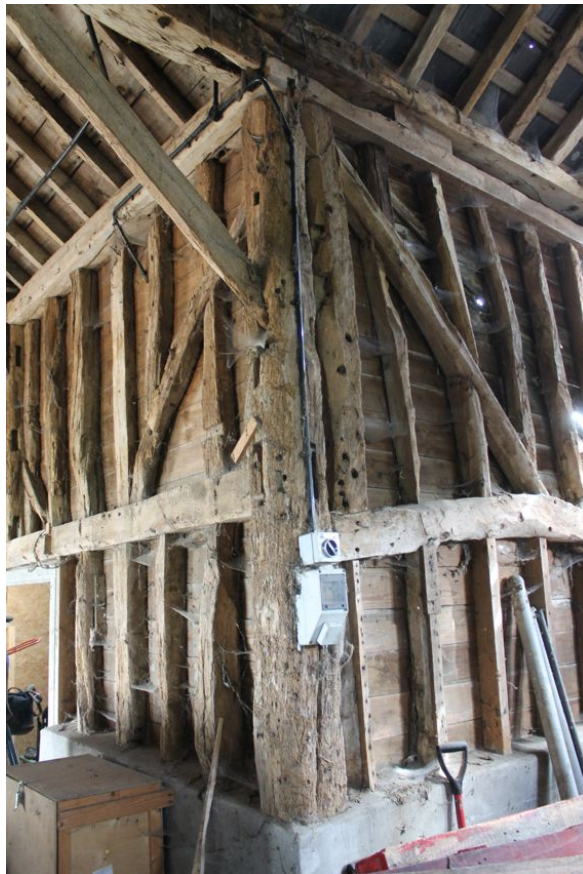
The two southern principal-posts on either side of bay 3 both have an unused mortice on their inner face, matching with each other (Photograph 18). If these mortices are original to the building and not the result of re-use, then they must have housed a girding-beam, meaning the midstrey is a later addition to the barn. Further evidence of this is seen at the apex of these principal-posts, where the wall-plate of the main range of the barn has clearly been cut (Photograph 18).

Photograph 18 Principal-post on southern elevation between bays 3 and 4. Open mortice for possible gird-beam visible on west (right) face. Cut wall-plate visible at top of post. Photograph taken facing south-east.

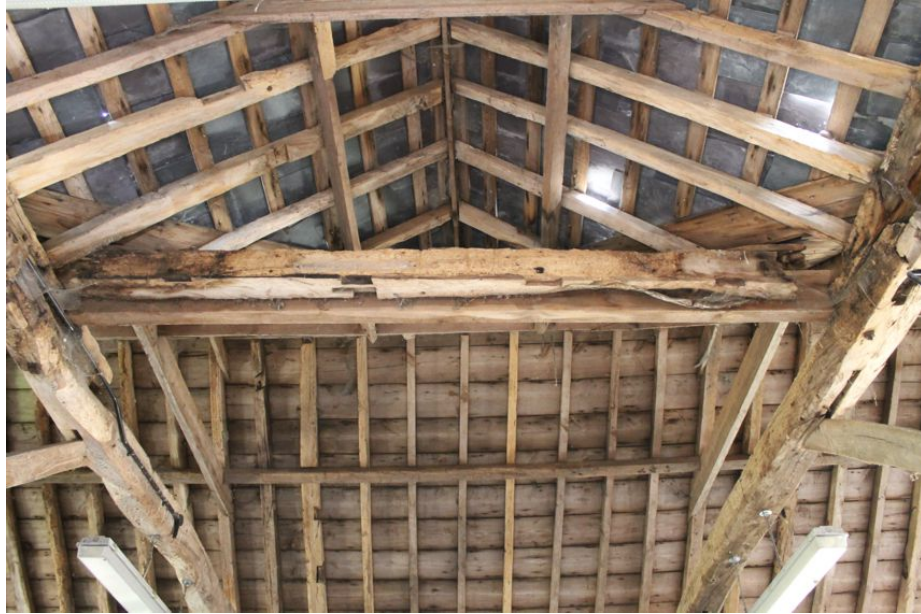
Supported further north on the two tie-beams, and reinforced with modern additions, is a timber with empty mortices on its underside and cut ends. This timber supports some (shortened) rafters and may have been the original southern wall-plate of bay 3 (Photograph 19).

Photograph 19 Timber supported between two central tie-beams in the barn. Might possibly have been the original wall-plate on the southern elevation of bay 3. Photograph taken facing north.

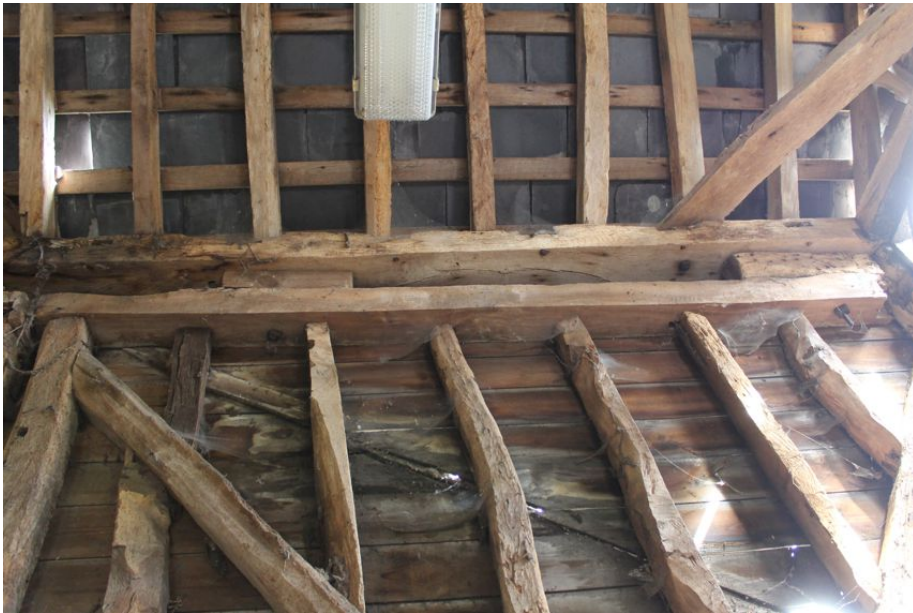
The wall-plates of the midstrey are constructed of multiple pieces of timber, some of which is re-used and hand-sawn and some of which is machine-cut (Photograph 21). They are partially supported on the southern end of the central tie-beams, with multiple other pieces of timber and metal straps providing further support. The studs

Photograph 21 Eastern wall-plate of midstrey, with multiple timbers.
Photograph taken facing east.

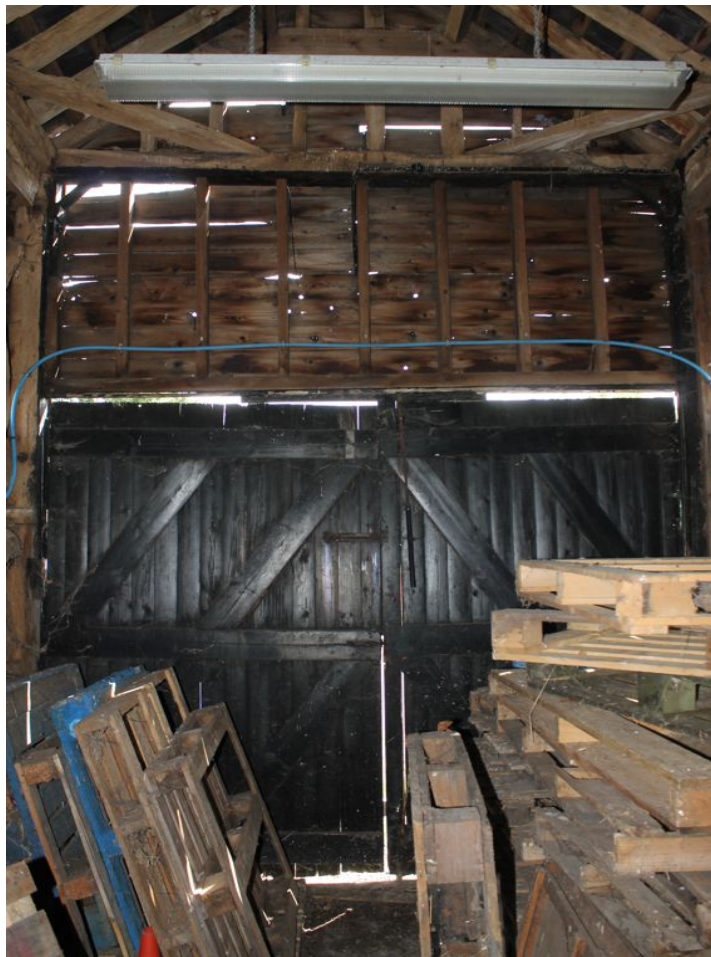
inserted door and the wall-plate is filled by modern machine-cut timbers –
Photograph 22).

Photograph 22 Southern elevation of midstrey, with
inserted modern timbers above double-doors. Original door
would have been full height. Photograph taken facing south.

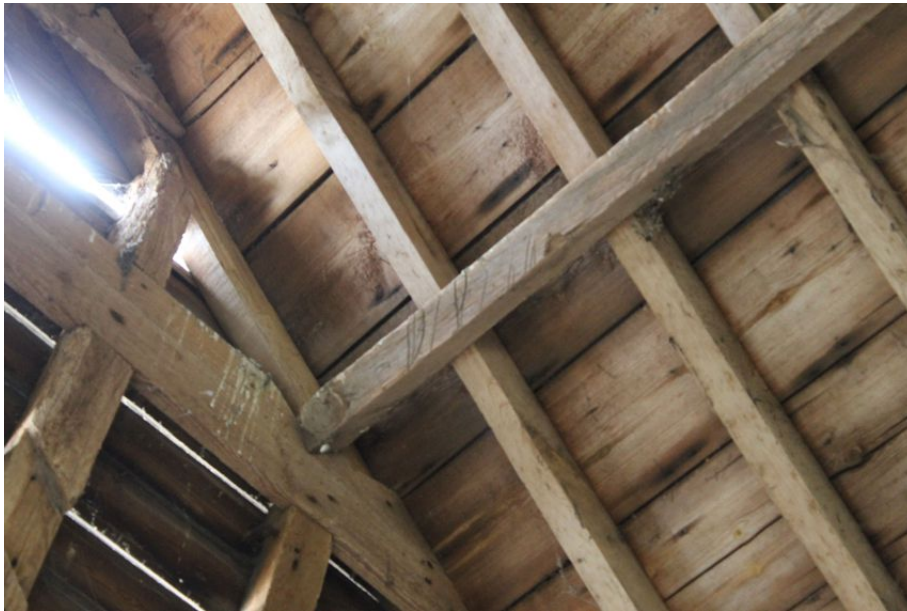
The purlins on the main range of the barn have Baltic shipping marks (Photograph 23), but no carpenter's marks were observed in the barn. There may be some carpenter's marks surviving on the exterior of the building, hidden by the weatherboarding.

Photograph 23 Purlin on southern pitch of roof, adjacent to eastern gable-end. Baltic shipping marks visible. Photograph taken facing south-east.

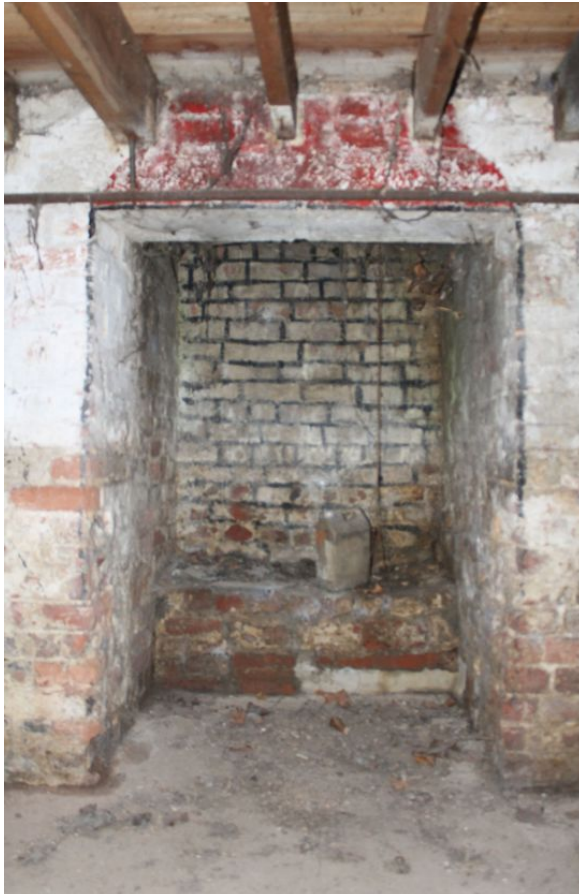
Photograph 29 Bricked up entrance? to cellar below skylight. Photograph taken facing east.

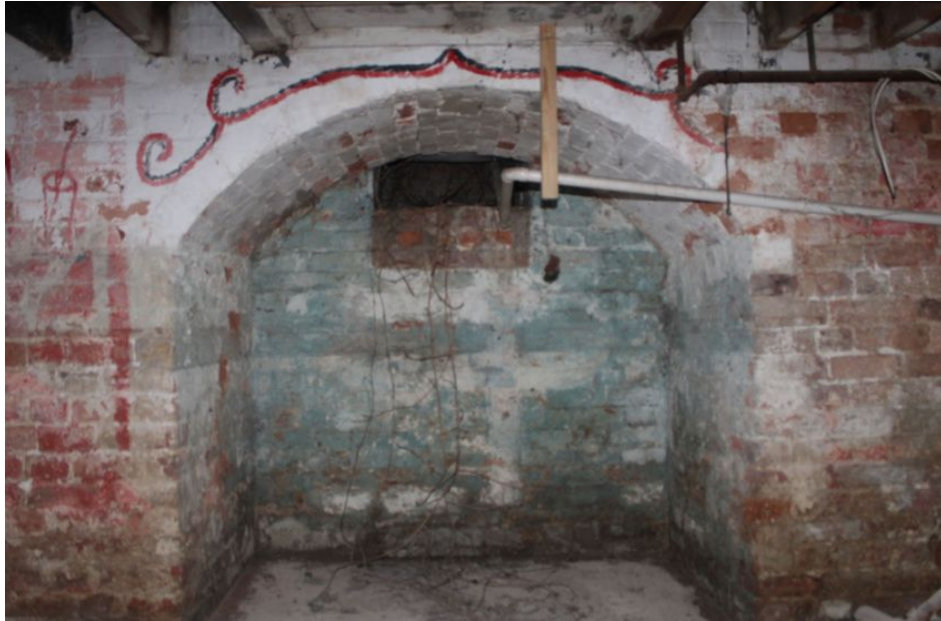
Photograph 30 Alcove in western wall of cellar. Bricked up skylight? visible. Photograph taken facing west.

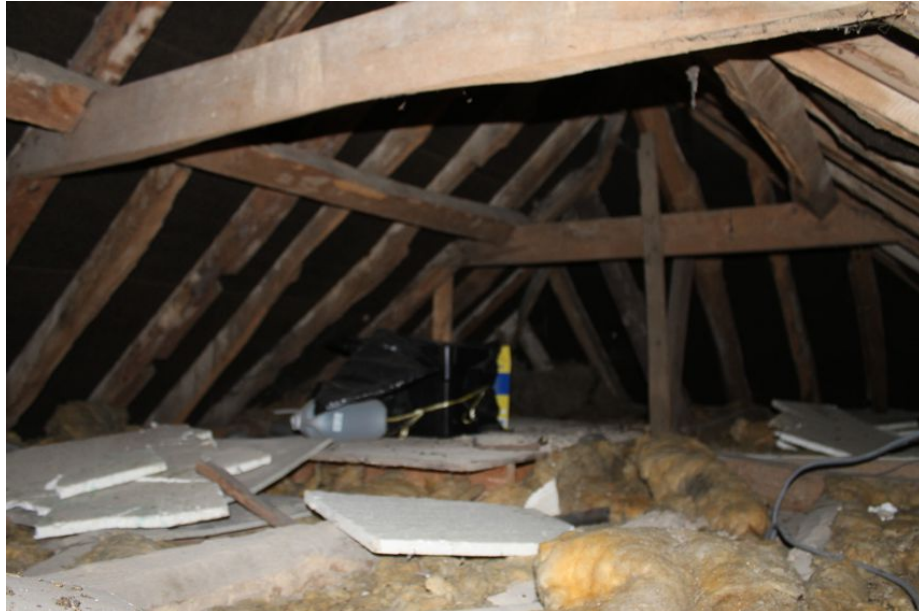
loft hatch and was found to be constructed largely of re-used hand-sawn timber. It is supported by two tie-beams and four collars offset to them (Photograph 38). Some of these collars are supported by additional modern machine-cut struts. The ridgeboard of the roof is a machine-cut modern timber.

Photograph 38 Roof of farmhouse, with multiple re-used timbers and modern supports. Photograph taken facing north-west.

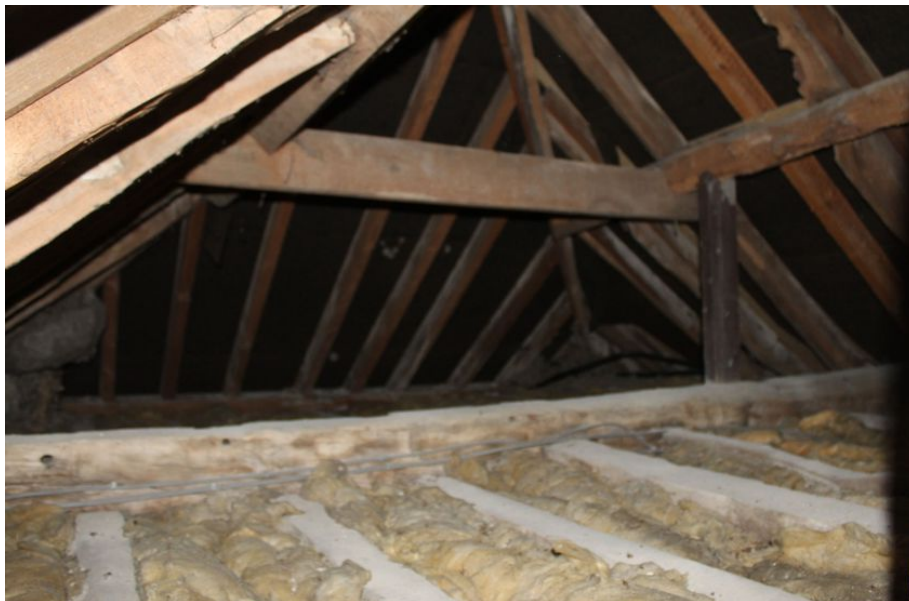
Photograph 39 Roof of farmhouse, showing rebuilt south hip. Photograph taken facing south-west.
