**Historic building recording at
the White Hart Hotel, 1 High Street,
West Mersea, Essex CO5 8QD**

August 2018, April and November 2019

**report prepared by
Mark Baister
with contributions from
Chris Lister**

CAT Report 1324
May 2020

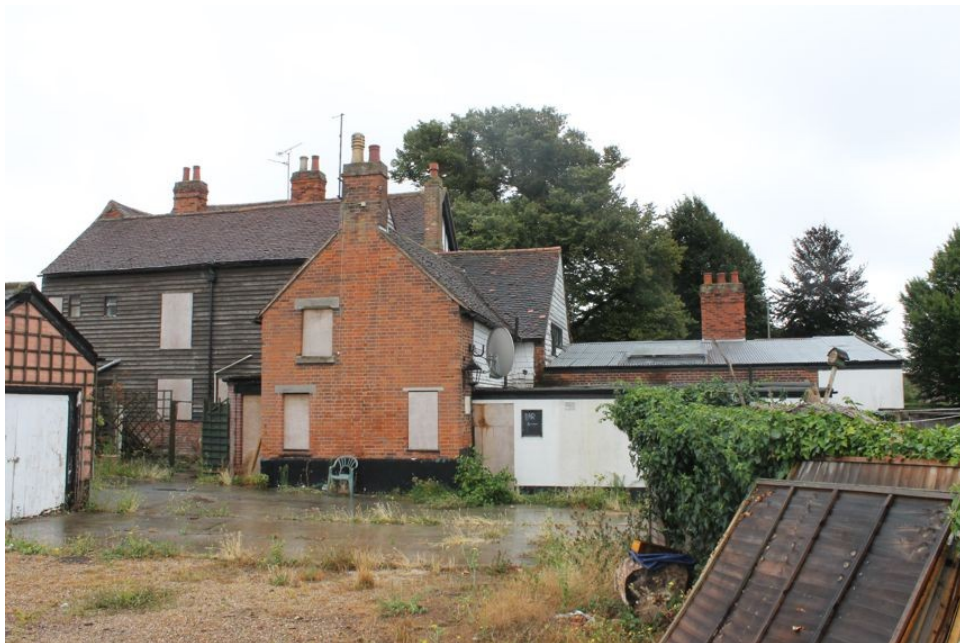
Photograph 8 North-west elevation of the White Hart. Photograph taken facing east.

The two windows on the ground-floor are six-light sashes with horns. The two smaller windows on the first-floor are modern awnings with two lights each. The two larger windows are twelve-light sash windows with no horns. This disparity of horned sashes on the ground-floor and hornless sashes on the first-floor suggests that the ground-floor windows are later insertions or replacements of the original windows (horns on sash windows being a later development; Historic England 2017).

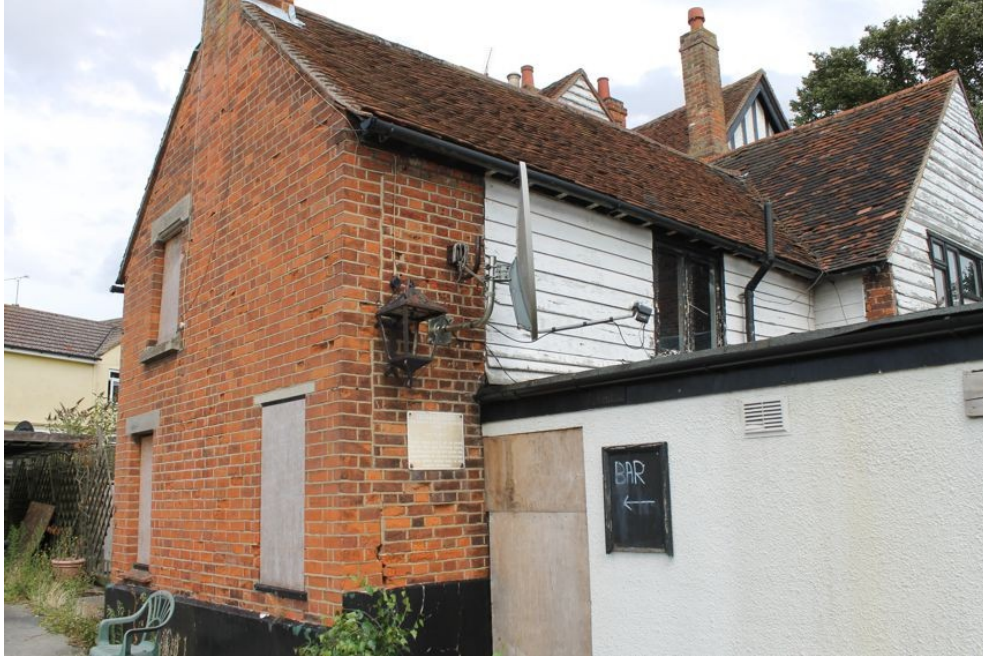
Structure B is constructed of red brick on this elevation (although on others it appears to be timber-framed, see below). The bricks are laid in a variant on Flemish-bond and bonded in lime mortar. They have dimensions of 230mm x 105mm x 65mm. The brickwork becomes irregular and mismatched when it joins with the timber-framing on the other elevations (Photograph 9).

Photograph 9 North-west and south-west elevations of Structure B, showing mismatched brickwork adjacent to timber-frame. Photograph taken facing east.

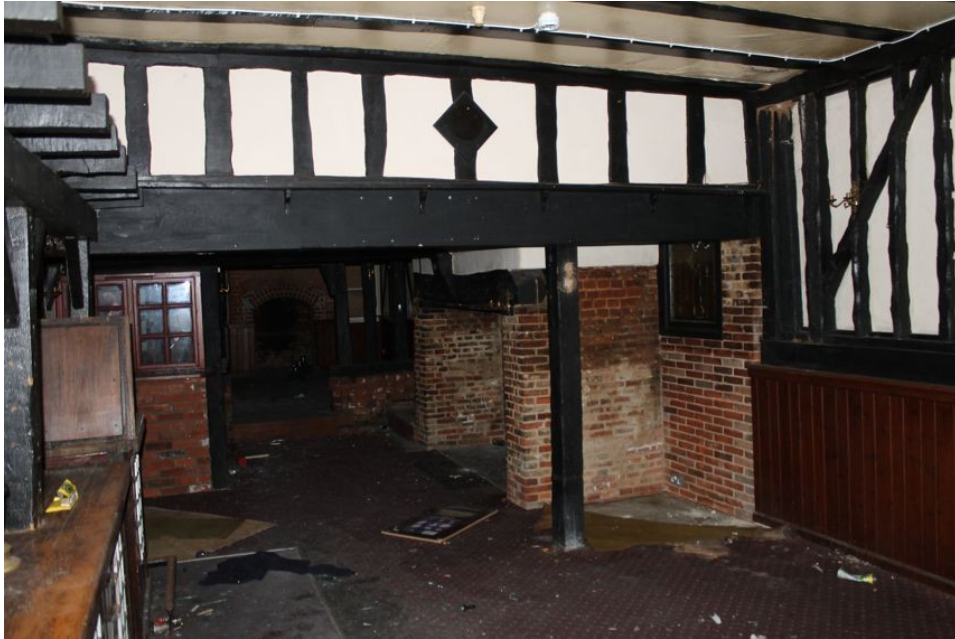
Very little remains on the ground-floor of Structure A. The original south-east and south-west ground-floor walls of the building are almost entirely absent, and in these locations the first-floor is supported by inserted modern brickwork associated with Structure E and an inserted beam and post associated with Structure F (Photograph 13).

Photograph 13 South-east elevation of Structure A from interior of Structure F. Inserted beam and post visible. Photograph taken facing north-west.

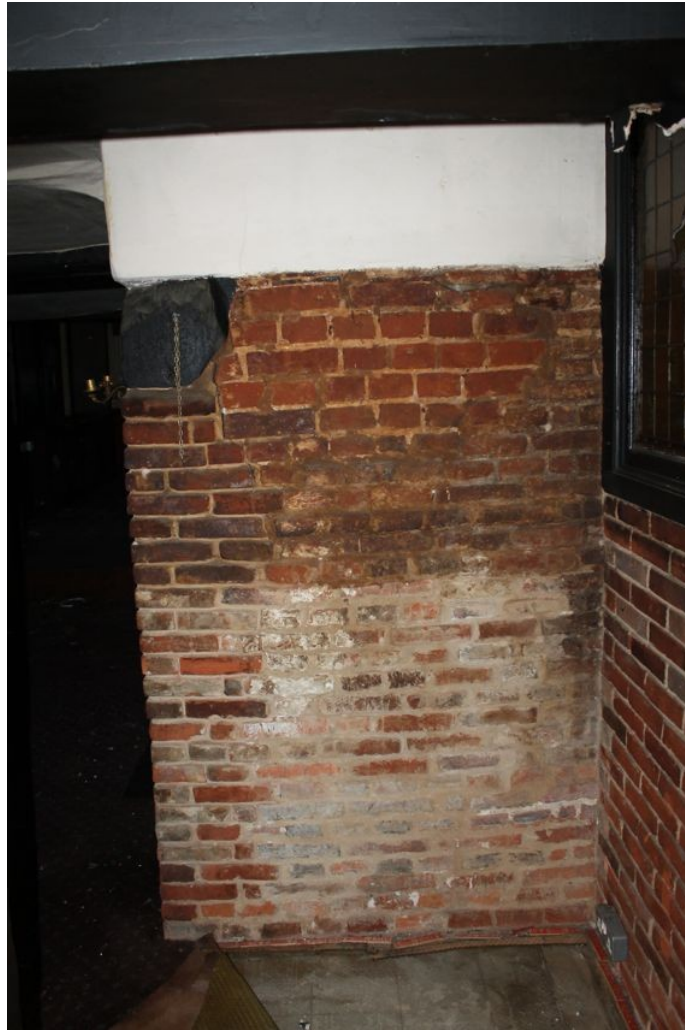
Photograph 15 South-east side of fireplace, showing rebuilt areas compared to original brickwork. Photograph taken facing north-west.

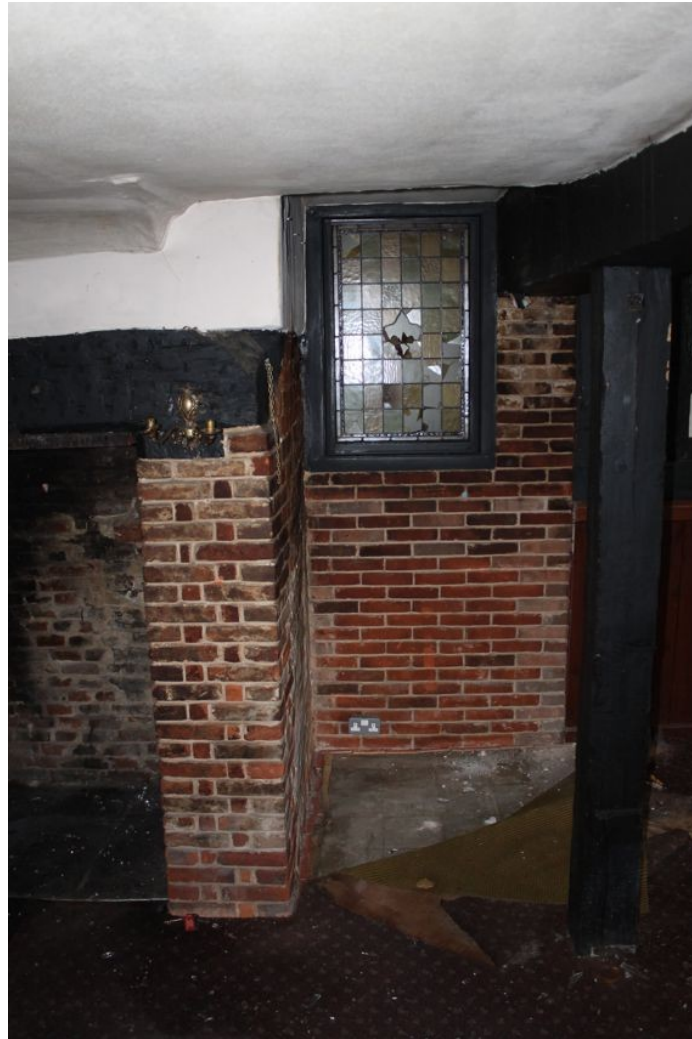
Also in the north-east wall on the ground-floor is a section of brickwork surrounding a stained-glass window. This brickwork is laid in stretcher-bond and bonded in lime mortar, and has dimensions of 220mm x 50mm. The window is leaded with a wooden-frame and a *fleur-de-lys* motif in the centre (Photograph 16).

Photograph 16 North-east ground-floor wall to Structure A, showing inserted brickwork and stained-glass window. Photograph taken facing north-east.

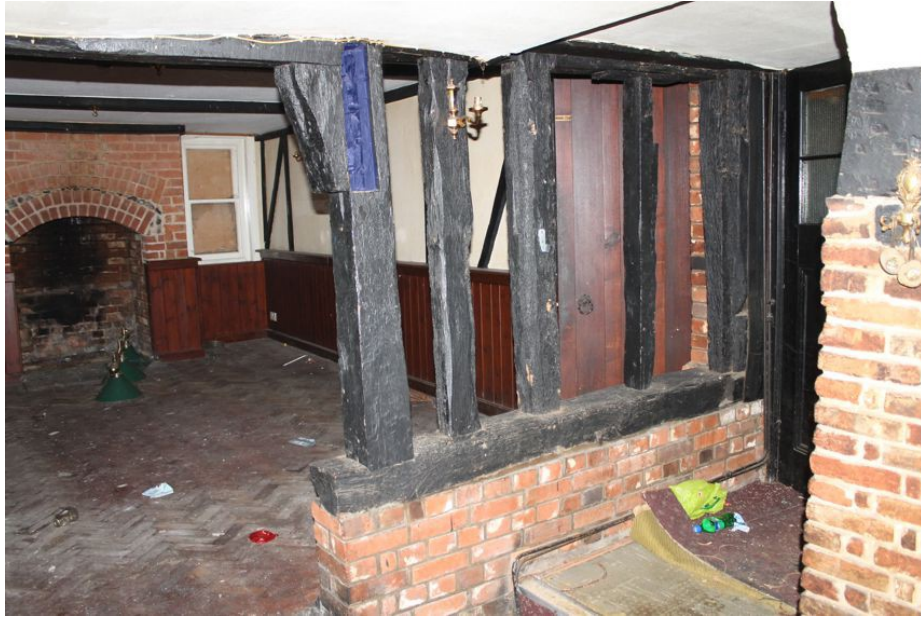
The north-west wall of the ground-floor has a small section of stud-work comprising hand-sawn timbers (Photograph 17). Although heavily altered (the brick plinth has been raised and rebuilt, and the sill-beam is clearly a later addition) these studs appear to be part of the original timber-frame of Structure A. Within this small section is a clear gap in the stud-work filled with an un-morticed modern timber and with an original hand-sawn wooden header (Photograph 18). This is the location of an original doorway into the building and is in line with a doorway observed on the south-east elevation (see below).

Photograph 17 Section of surviving original stud-work in north-west wall of Structure A. Modern inserted timber blocking doorway second from right. Mortice for brace supporting original first-floor highlighted in blue. Photograph taken facing north.

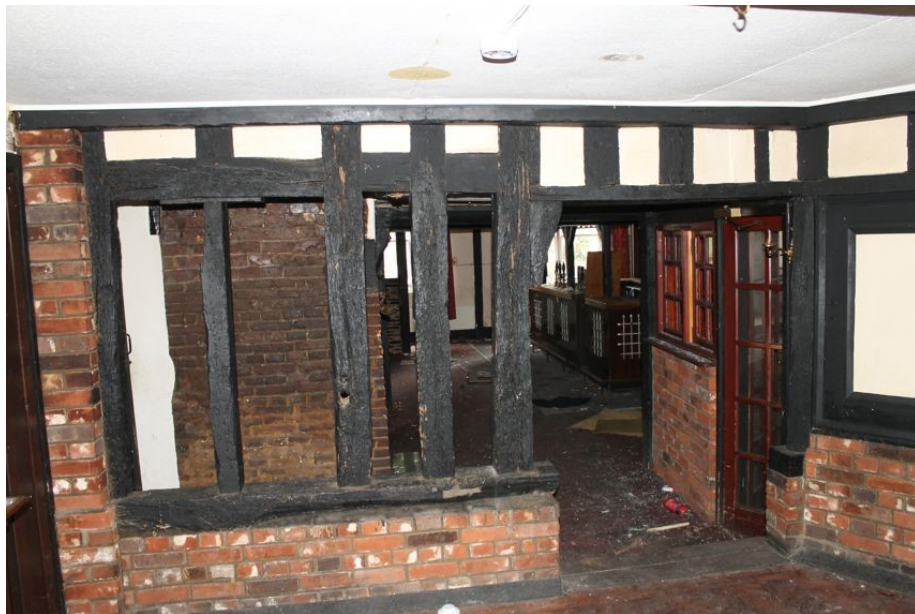
Photograph 18 Original stud-work viewed from Structure B. Inserted modern timber clear, as is original header for doorway. Photograph taken facing south-east.

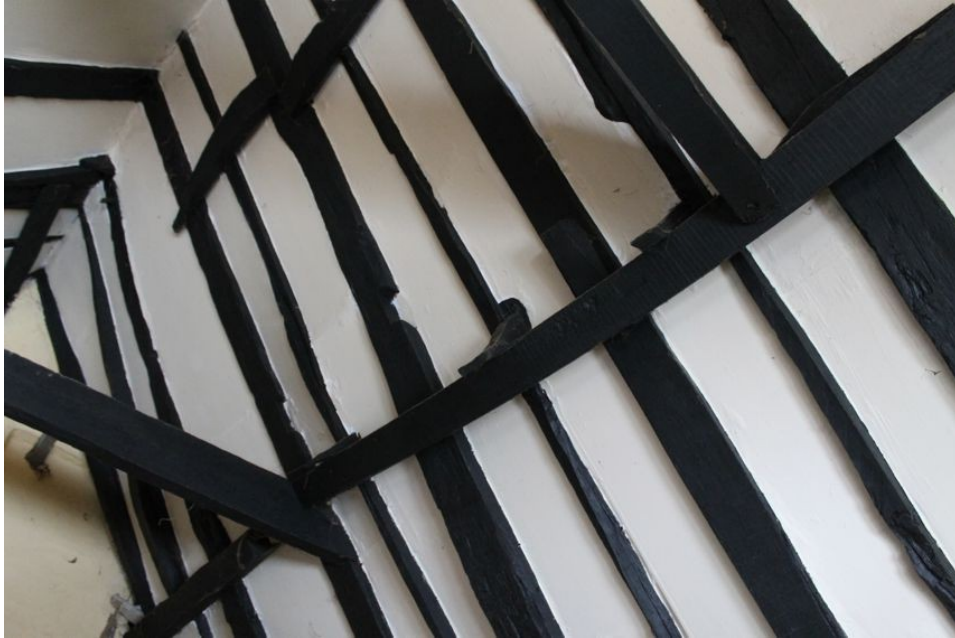
Each roof pitch has a purlin, which are supported by two upper collars. Close inspection of these was unfortunately not possible, but they appear to be machine-cut and later additions to the roof structure. There are several other additions to the roof, predominantly in the form of *ad hoc* bracing between rafters (Photograph 24). Additionally, in some locations rafters appear to have been replaced entirely.

Photograph 24 North-west pitch of Structure A's roof. Showing later bracing, collars and purlin. Photograph taken facing west.

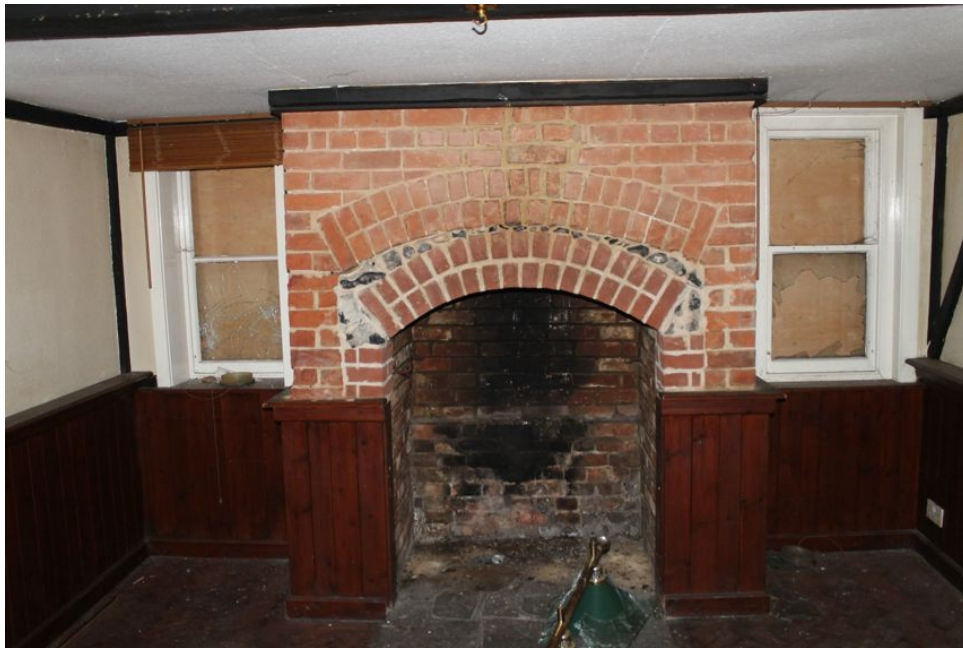
Photograph 27 Repaired fireplace on north-west ground-floor elevation of Structure B. Photograph taken facing north-west.

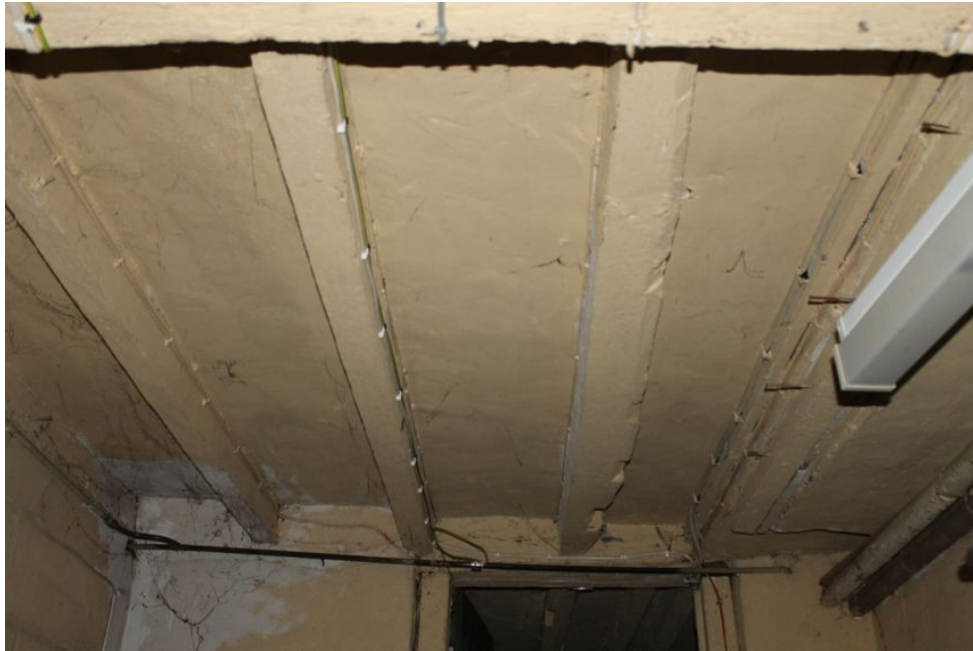
Photograph 31 Underside of ground-floor of Structure C, observed from cellar. Re-used timbers visible. Photograph taken facing north-west.

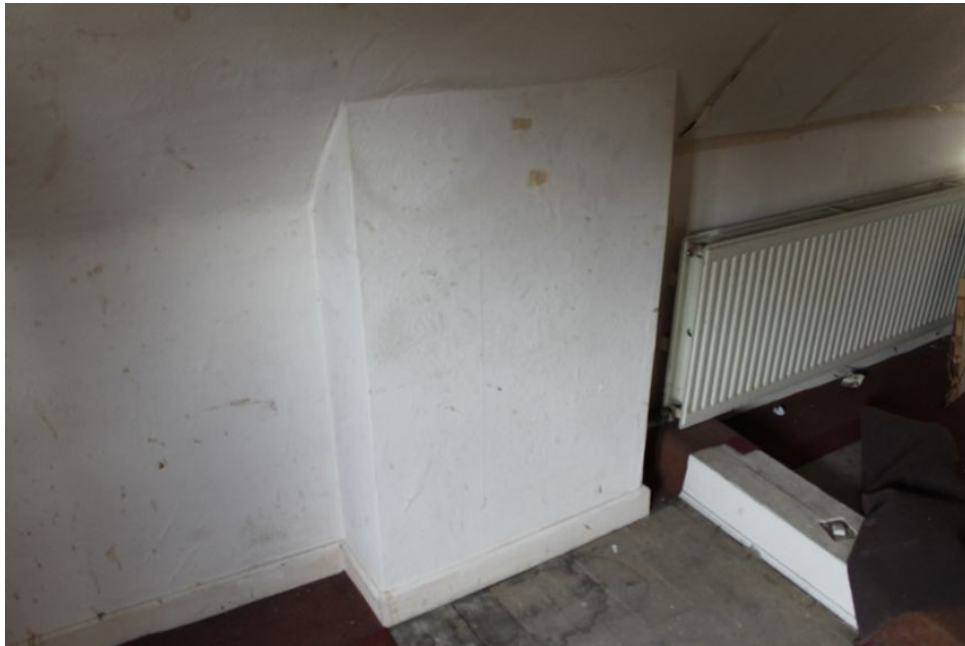
Photograph 33 Blocked fireplace and exposed tie-beam on second-floor of Structure C. Photograph taken facing north.

The second-floor of Structure C is a converted attic space, accessed from the first-floor of Structure D (Fig 6). It contains two modern divisions and a modern kitchenette, as well as a fireplace (Photograph 33). The fireplace and associated chimney were probably added to Structure C when this second-floor was inserted into the attic space. The roof timbers of Structure C were observed through a loft hatch and found to be machine-cut, with the rafters pegged at the apex and no ridgeboard (Photograph 34).

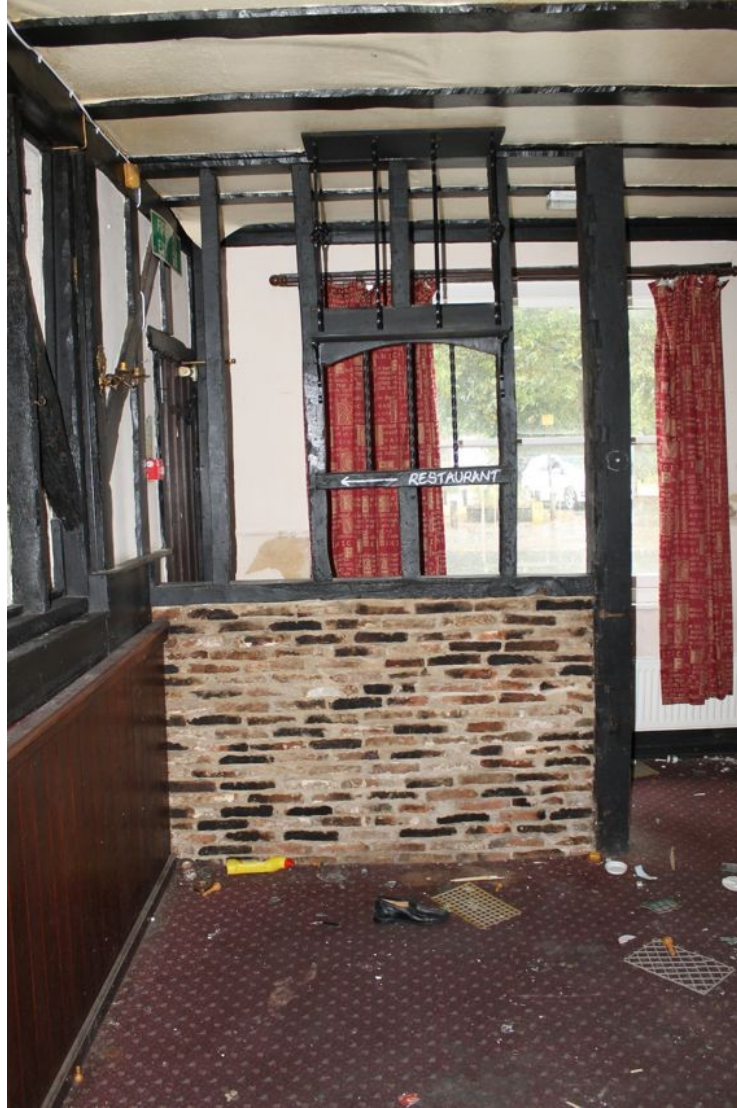
Photograph 39 Modern wall in Structure F consisting of re-used bricks and a re-used tie-beam (to right). Photograph taken facing south-east.

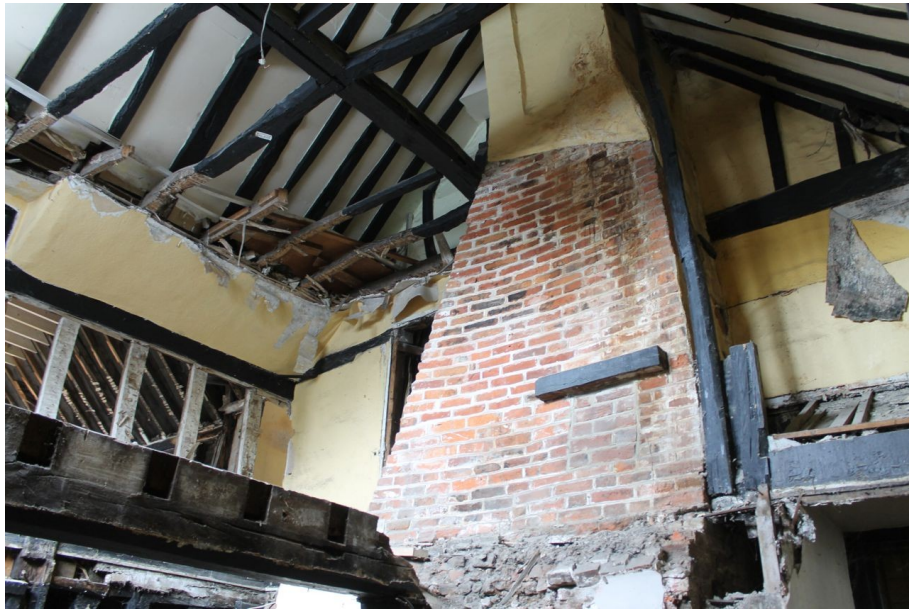
The removal of the first-floor of Structure A, prior to the second visit, allowed the chimney and fireplace to be examined in more detail (Photograph 41). It was clear, once observed in its entirety, that the fireplace had been extended and rebuilt, possibly coinciding with the lowering of the floor of Structure A (see below).

Photograph 41 Chimney-stack in Structure A after soft strip. Photograph taken facing north.

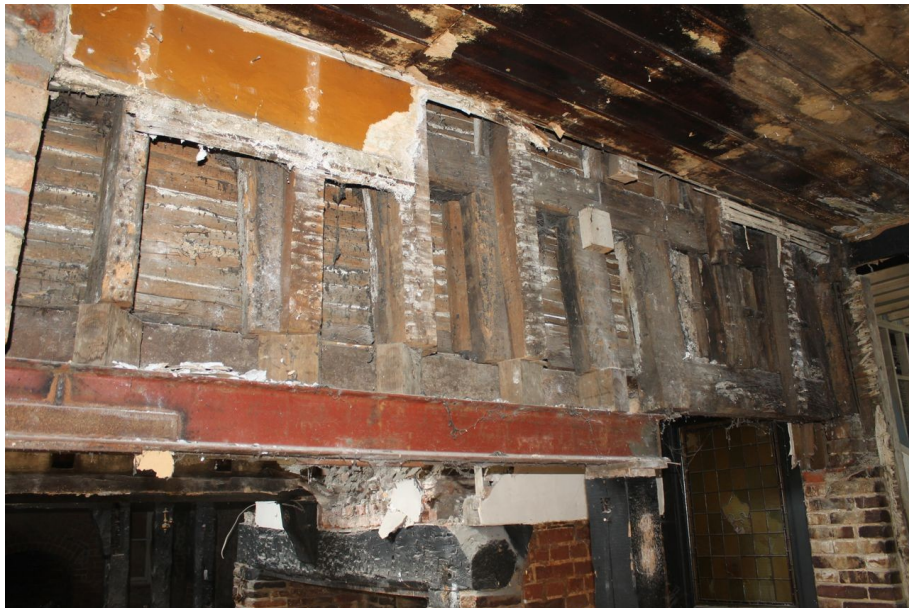
Photograph 42 Exposed partially surviving studs and girding-beam on south-east elevation of Structure A after soft strip. Photograph taken facing north.

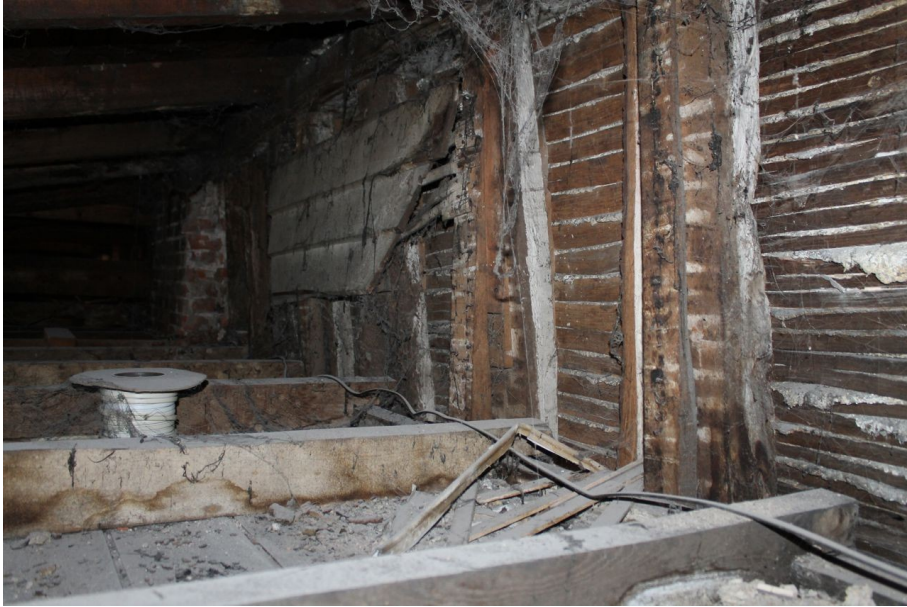
The upper register of Structure A was observed in the roof space of Structure F during the second visit to the building and showed no evidence of grooves in either the studs or the upper face of the girding-beam (Photograph 45). This suggests that originally the upper register of Structure A was weatherboarded on the exterior, and indeed, a section of weatherboarding survives (although is probably not original).

Photograph 45 Upper register of Structure A's south-east elevation, showing surviving weatherboarding. Photograph taken facing west.

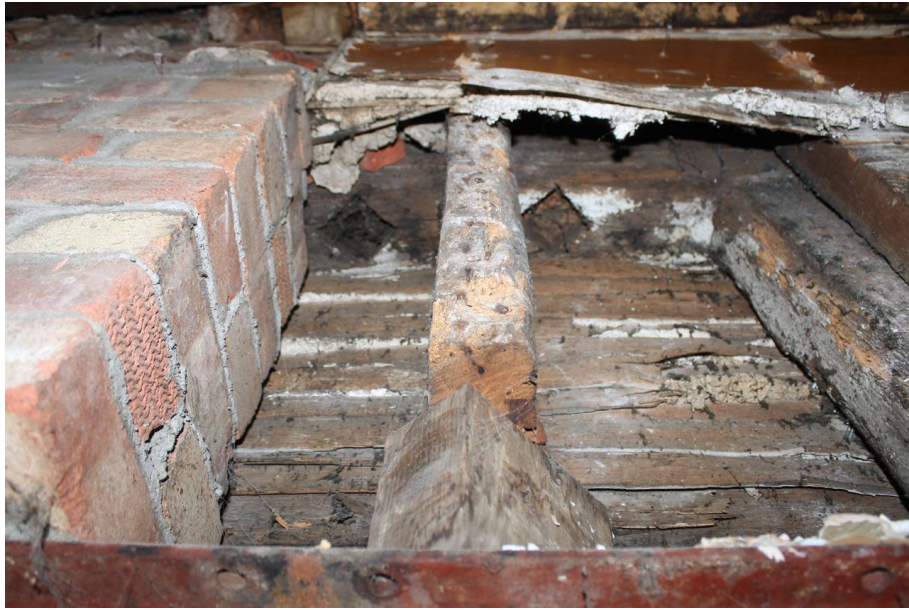
The mortices for diamond mullions observed on the underside of Structure A's south-eastern girding-beam (pg 19) provide further dating evidence, representing as they do the location of an unglazed opening (Brunskill 2000, 132). Unglazed openings were common until the 16th century, when window glass began becoming cheap and common enough to be used in lower-status houses, rather than exclusively ornate public buildings or high-status homes (Historic England 2017, 8).

Photograph 47 Detail of diamond mullion mortices on underside of Structure A's south-east girding-beam. Photograph taken facing north-west.

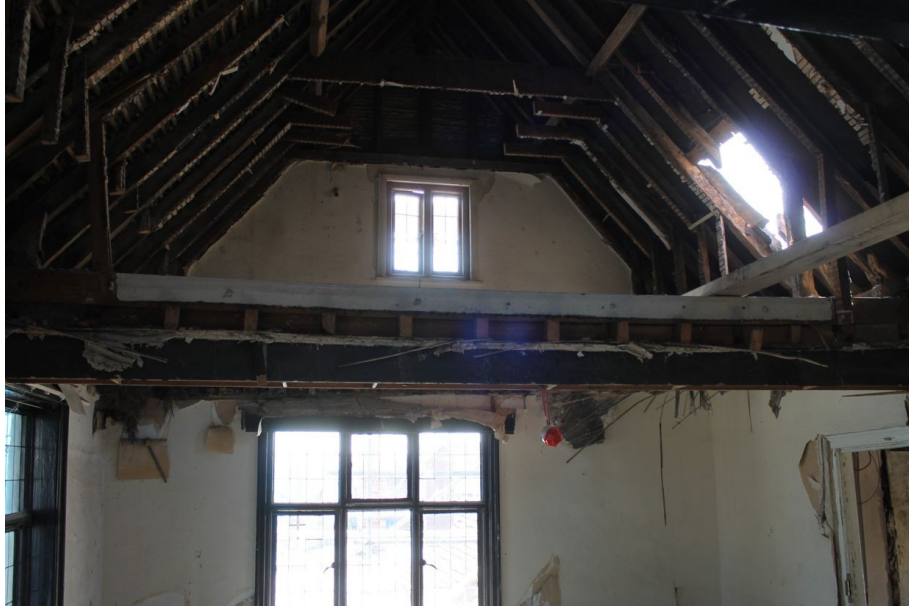
Photograph 56 Southern-most tie-beam in Structure C, showing secondary modern timber attached to its upper face for reinforcement. Photograph taken facing south-west.

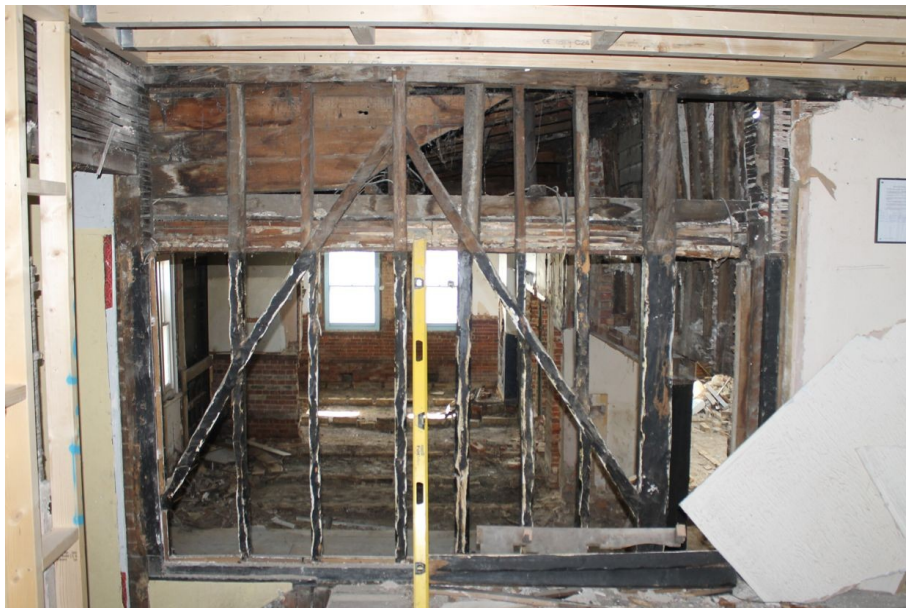
Photograph 59 Timber-framing in north-east end of Structure F, showing machine-cut timbers that have been altered to appear hand-sawn. Photograph taken facing south-west.

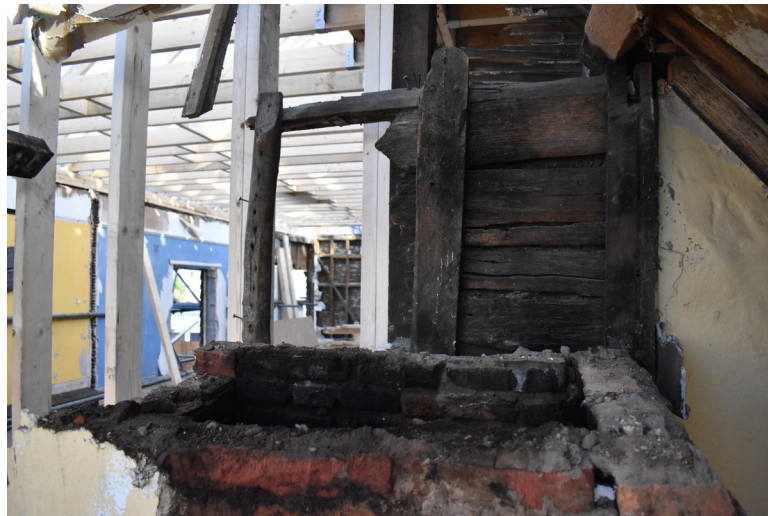
The removal of the chimney allowed a closer investigation of the timber-frame behind it, previously postulated to be the product of re-use of Structure A's original fabric (see discussion pg 34). Although no further evidence of re-use of timbers was observed, an area of, possibly original, weatherboarding was observed behind the chimney, similar to the type previously observed on the eastern elevation of Structure A (Photograph 64).

Photograph 64 Detail of possibly original weatherboarding behind chimney-stack on northern elevation of Structure A. Photograph taken facing north-east.
