**Historic building recording at  
the Rising Sun and Maçonite buildings,  
3 Hythe Station Road,  
Colchester, Essex CO2 8JZ**

**November 2018**

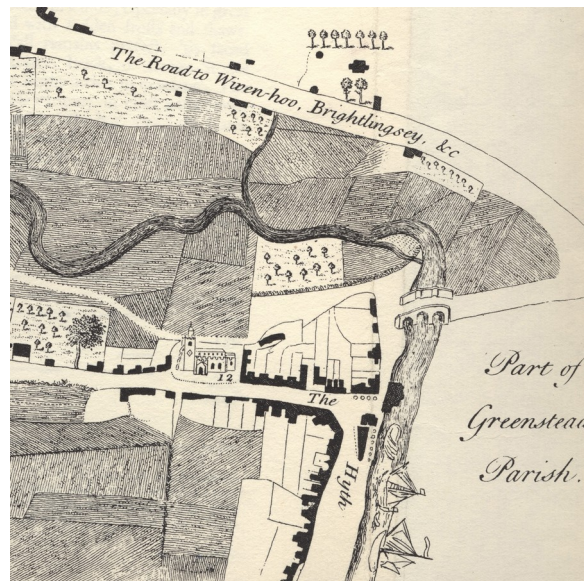
**Map 1** Detail of the Hythe from Morant's map of Colchester (1748). Hythe Bridge visible but no development on eastern bank of the river.

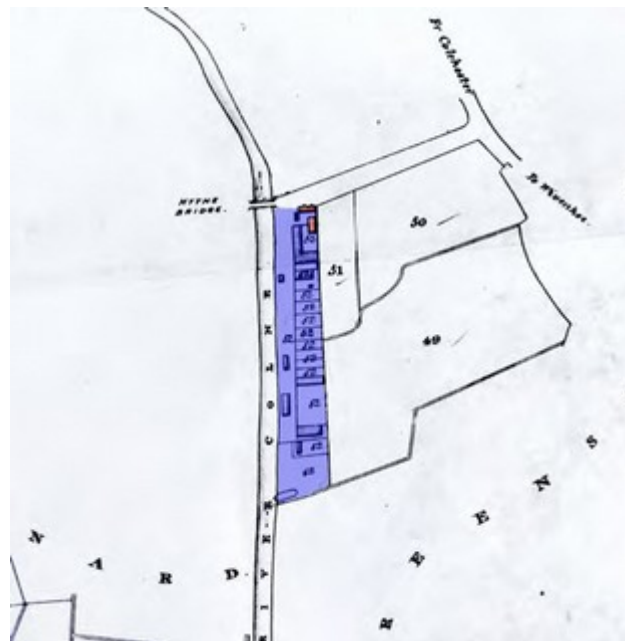
**Map 3** 1837 tithe map, with Rising Sun, its extension and outbuilding highlighted in red (Structures 1 – 3). Development on eastern side of River Colne (under same ownership) highlighted in blue (ERO D/CT 90B).

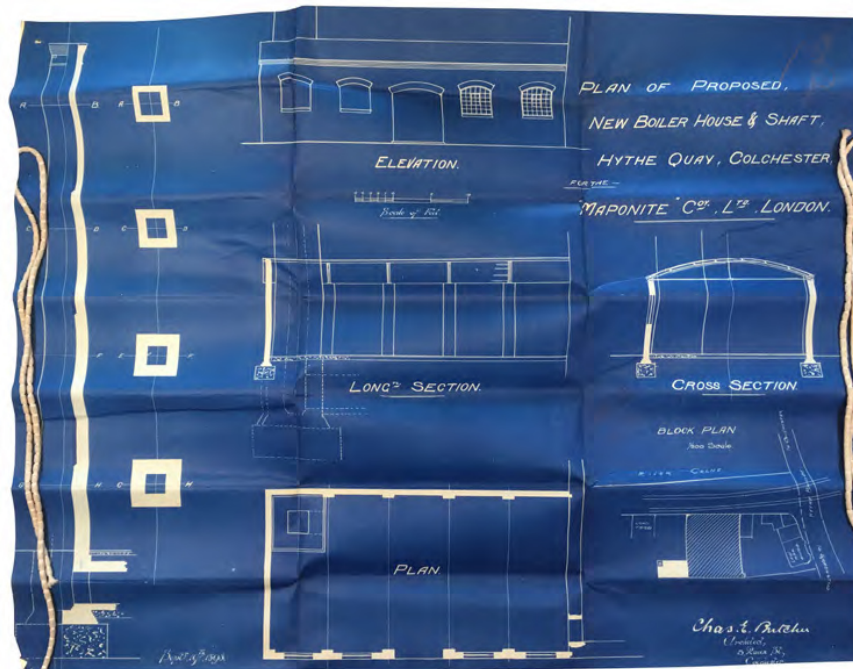
**Plan 2** 1898 plan of extension to warehouses for a boiler-room (Structure 9). ERO D/B 6 Pb3/1256. The eastern elevation of the boiler-room in this plan is slightly different than its current appearance (see Fig 12). This is likely due to a change in the plan or later alteration. Also visible is the original barrel-roof (now replaced with a single pitch).

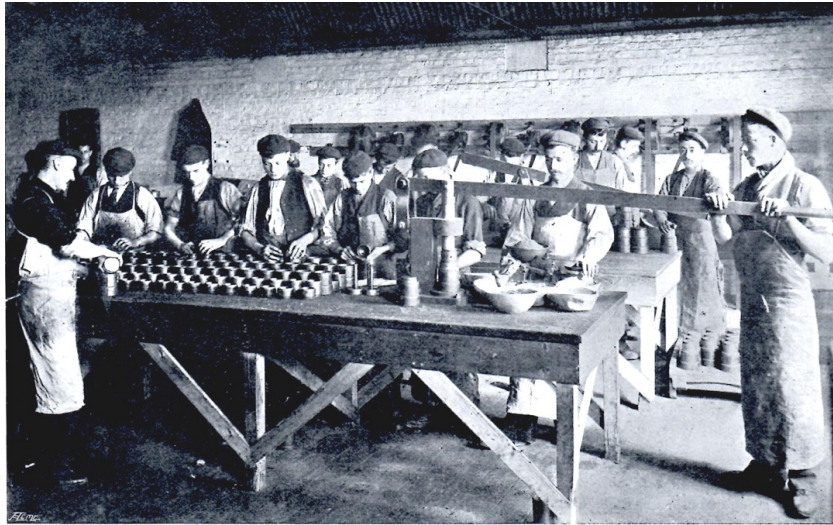
PACKING MAPONITE GOLF BALLS.

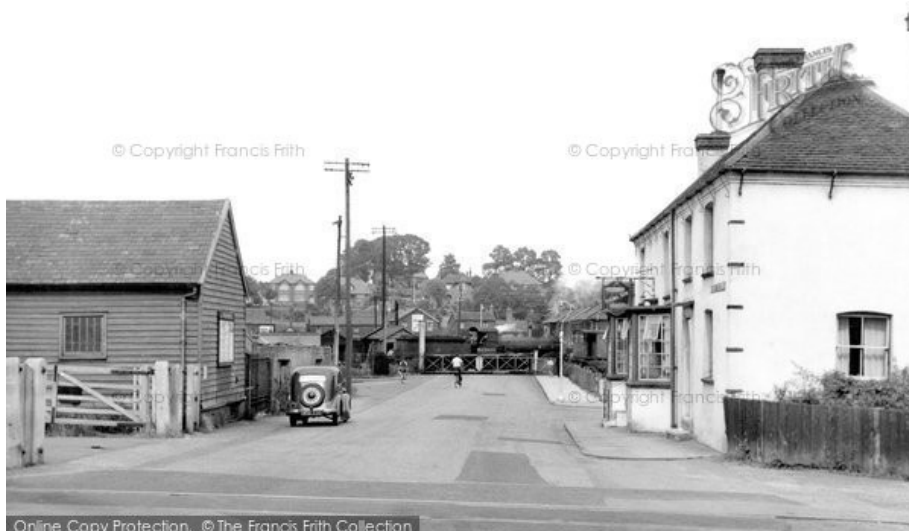
**Photograph 3** Taken from the old Hythe Bridge, this shows Hythe Station Road and the north and western elevations of the Rising Sun (now rendered) in 1945. From [www.francisfrith.com](http://www.francisfrith.com).

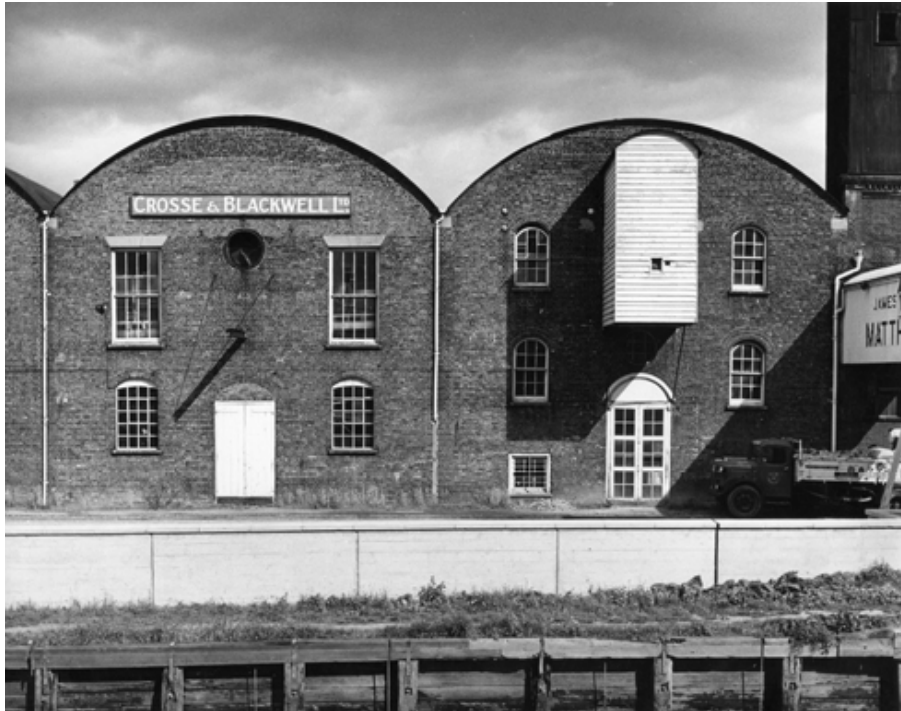
**Photograph 4** West elevation of warehouses in 1956 (Structures 7 and 8), showing original barrel roofs. Shows warehouses were occupied by Crosse and Blackwell Ltd. Also visible is the lift on the frontage of Structure 8. The large chimney in the top right, rising from the adjacent warehouse, is much taller than it is today.

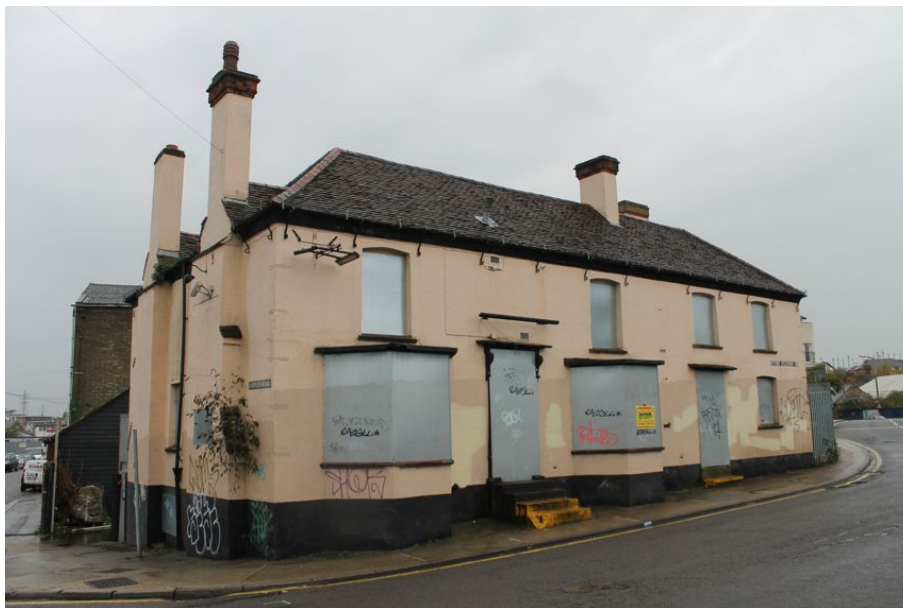
**Photograph 5** North-west and north-east elevations of the Rising Sun (left of frame; Structure 1) and the house extension (right of frame; Structure 2). Photograph taken facing south.

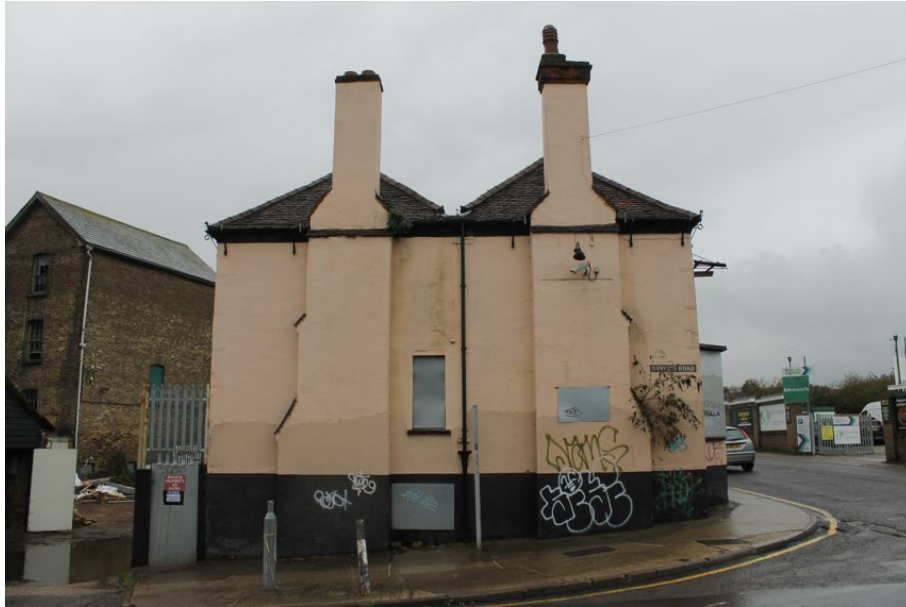
**Photograph 6** North-east elevation of the Rising Sun (Structure 1).  
Photograph taken facing south-west.

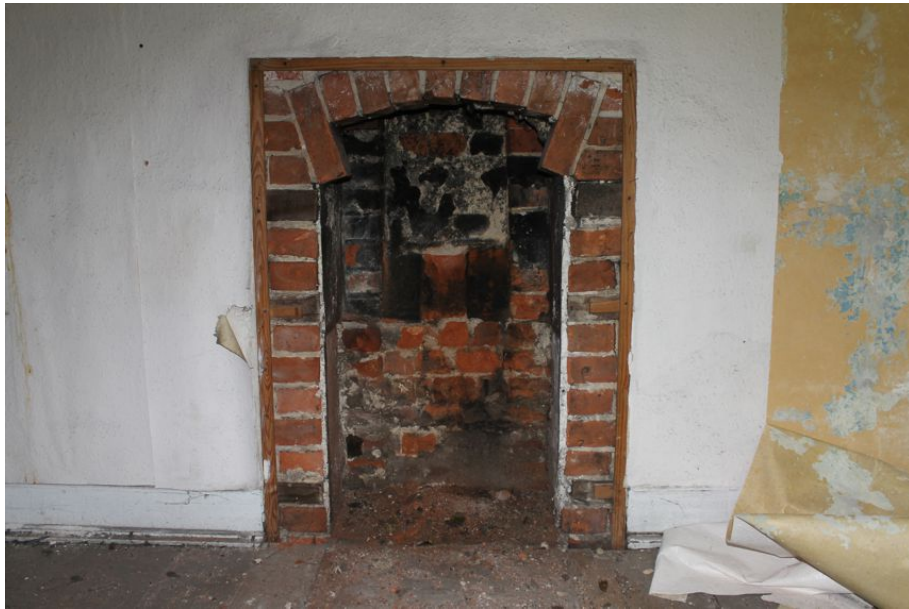
**Photograph 18** Original brick fireplace in north-east room on the first-floor of the Rising Sun. Photograph taken facing north-east.

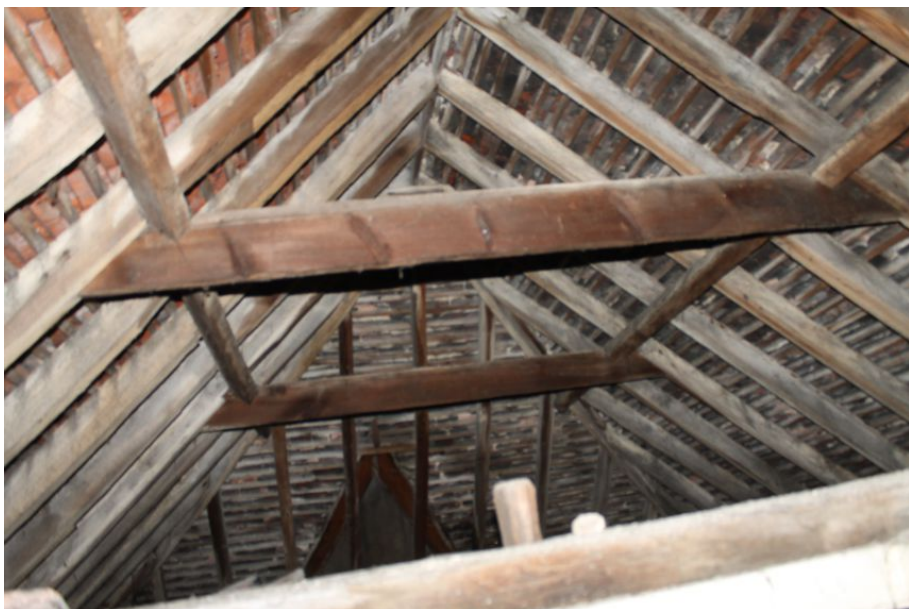
**Photograph 19** Roof structure above southern range of Rising Sun, observed from first-floor. Photograph taken facing east.

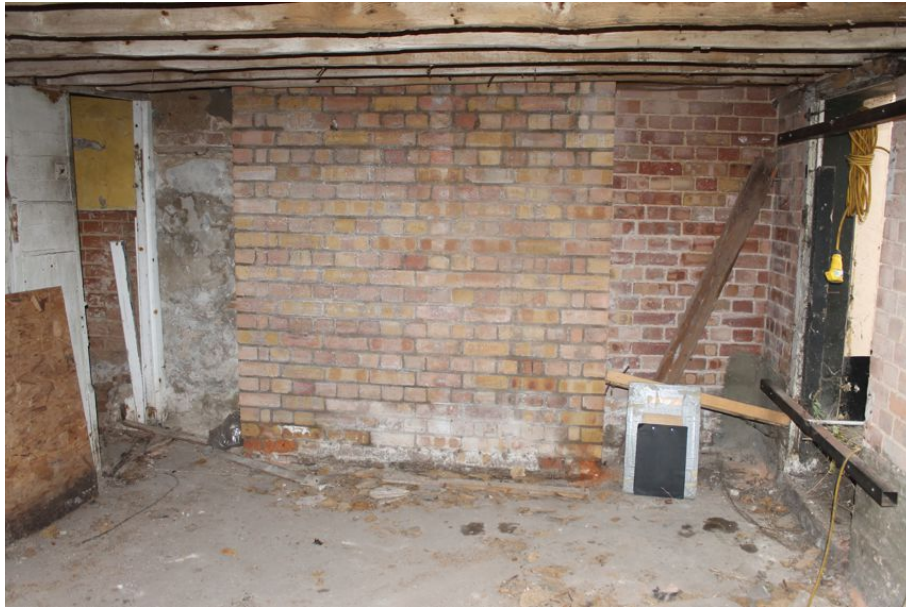
**Photograph 21** Rebuilt chimney-stack of Rising Sun, visible in basement of Structure 2. Photograph taken facing east.

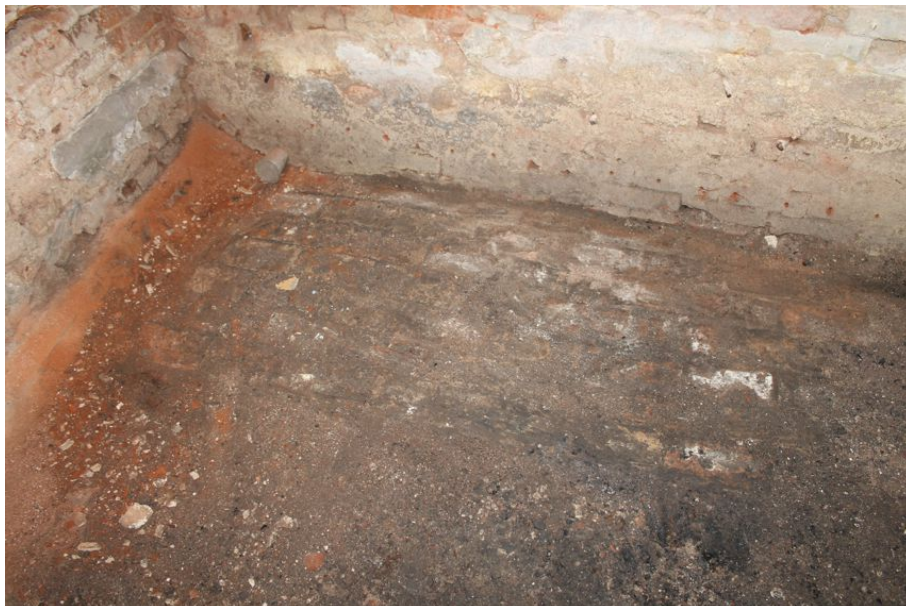
**Photograph 22** Surviving section of pavior-brick floor in northern room of house extension's (Structure 2's) basement. Photograph taken facing south-east.

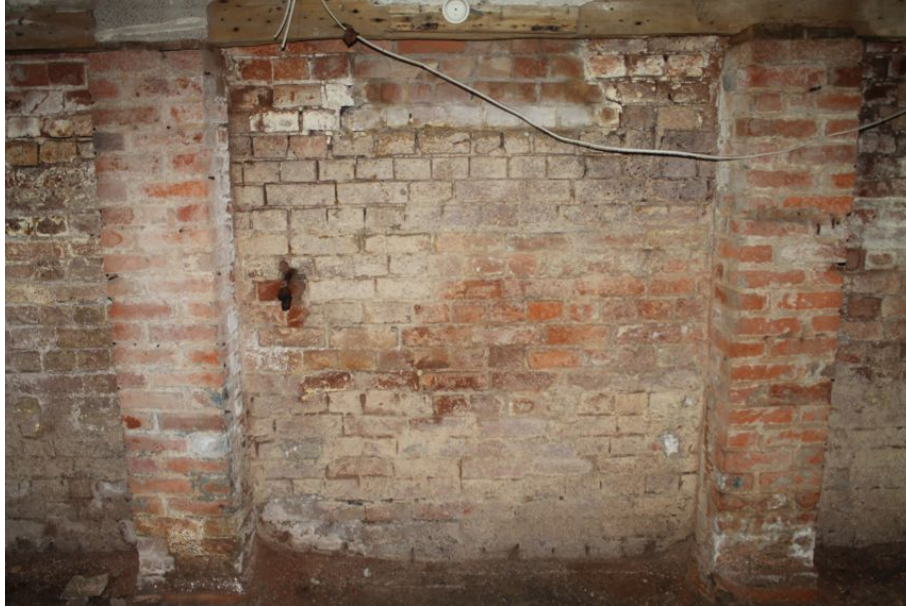
**Photograph 23** Detail of wall in northern room of Structure 2's basement, showing inserted brick pillars. Photograph taken facing north-west.

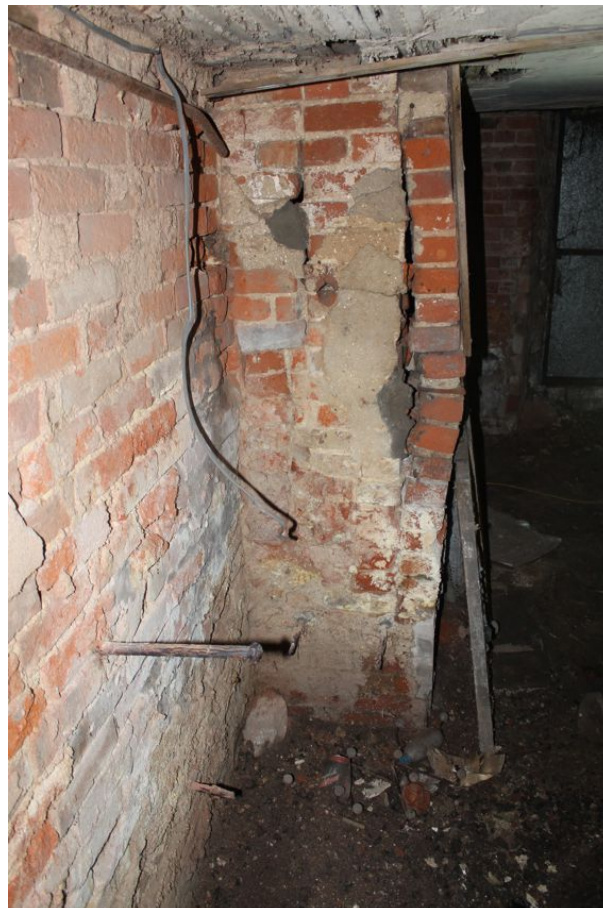
**Photograph 24** Eastern side of fireplace in northern room of house extension, showing damage. Photograph taken facing south-west.

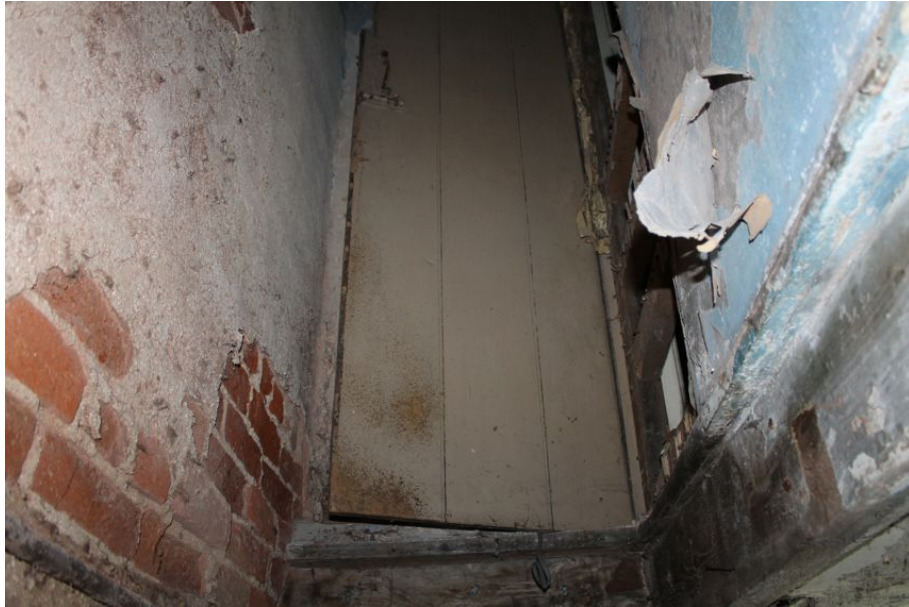
**Photograph 25** View of original door on ground-floor from location of removed stairway in basement of Structure 2. Photograph taken facing south-west.

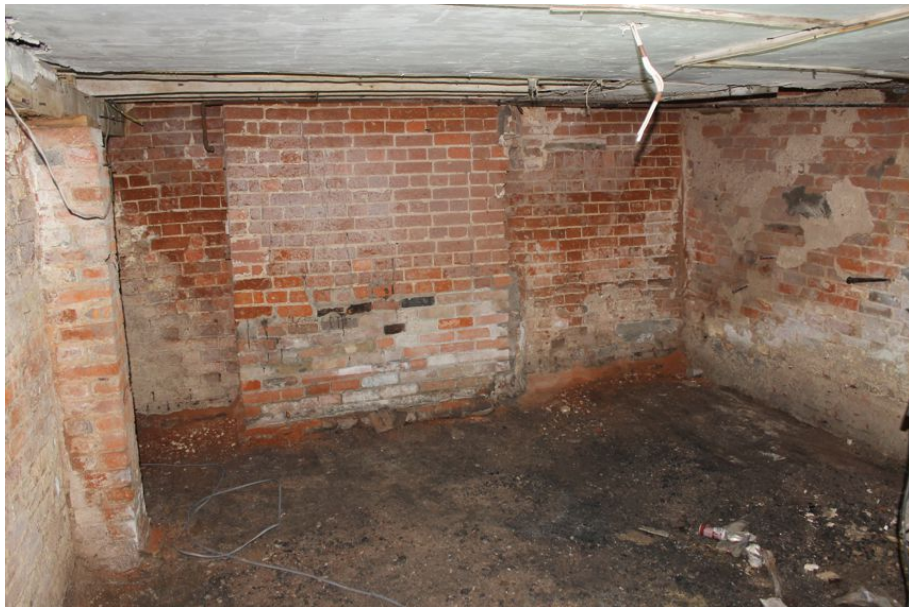
**Photograph 26** Northern room of Structure 2's basement, showing west wall of Rising Sun. Note the central structural wall of the house extension (to right) is not bonded to the pub's walls. Photograph taken facing east.

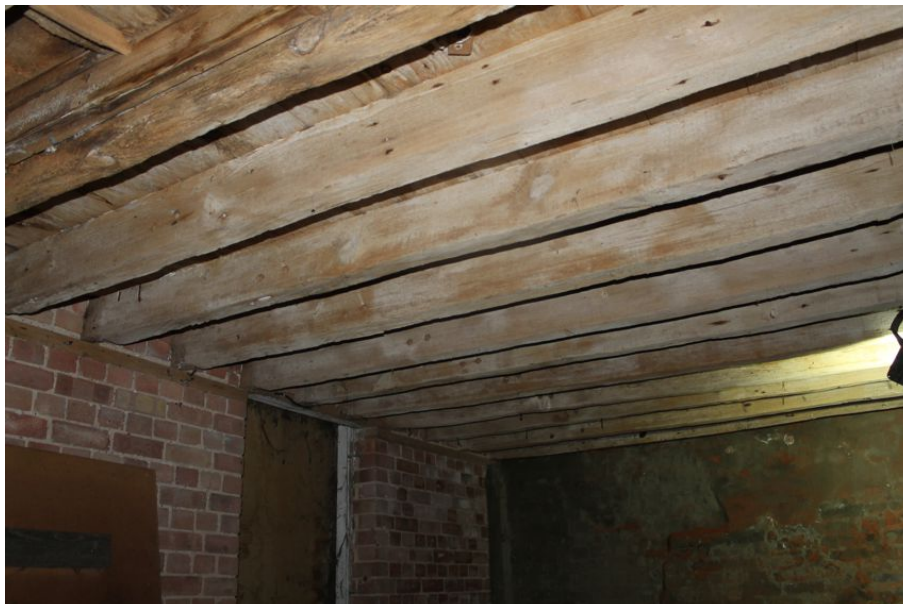
**Photograph 27** Joists supporting ground-floor, view from southern room of basement in Structure 2. Photograph taken facing south.

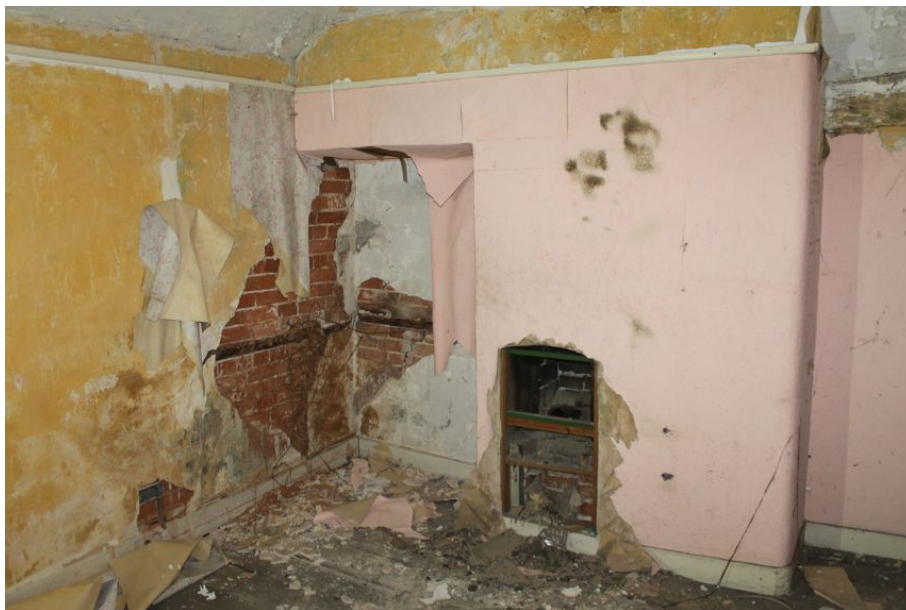
**Photograph 31** South-west room on first-floor of Structure 2, showing exposed brickwork and fireplace. Photograph taken facing north-west.

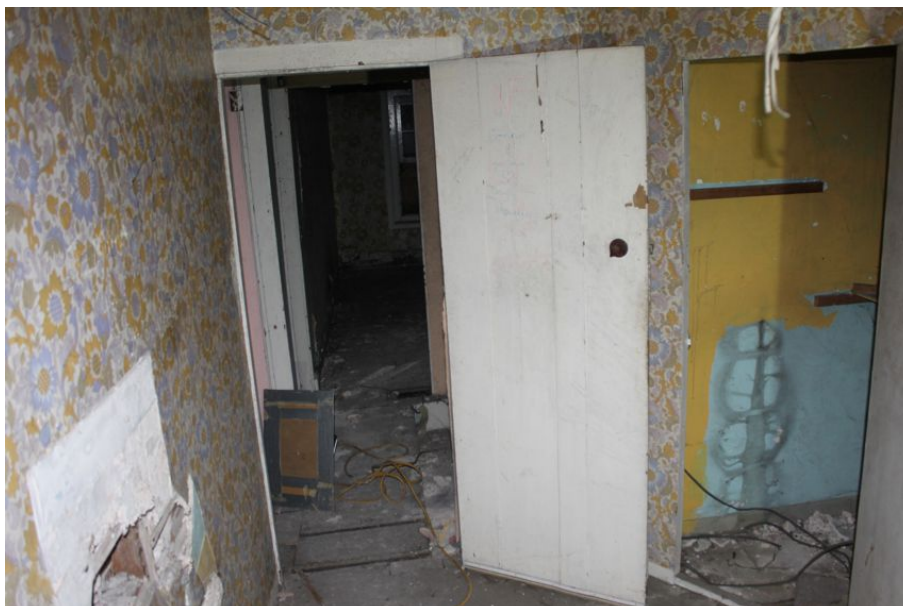
**Photograph 32** Vertical-planked door on first-floor of the house extension. Photograph taken facing north-west.

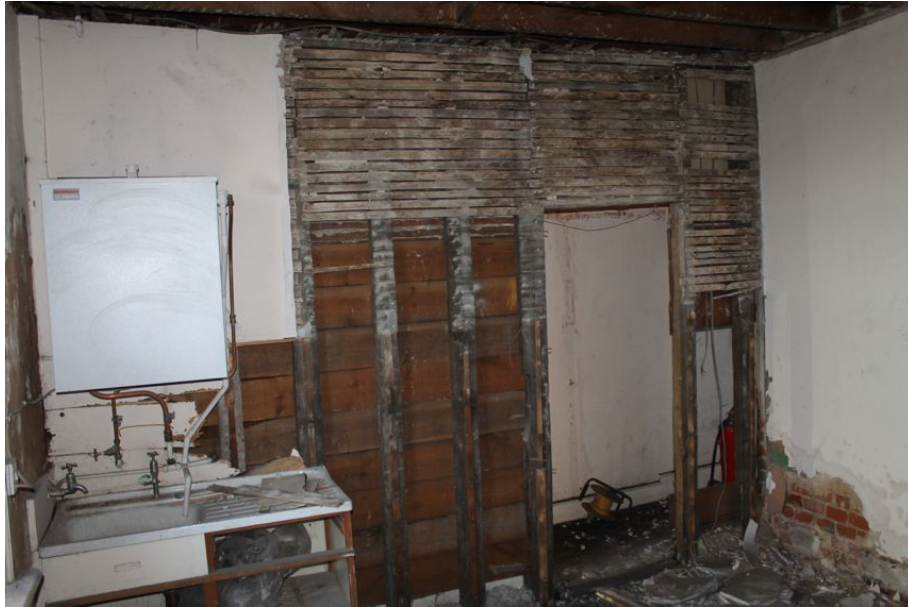
**Photograph 46** Exposed lath and plaster wall forming division in ground-floor of Structure 5. Photograph taken facing south-west.

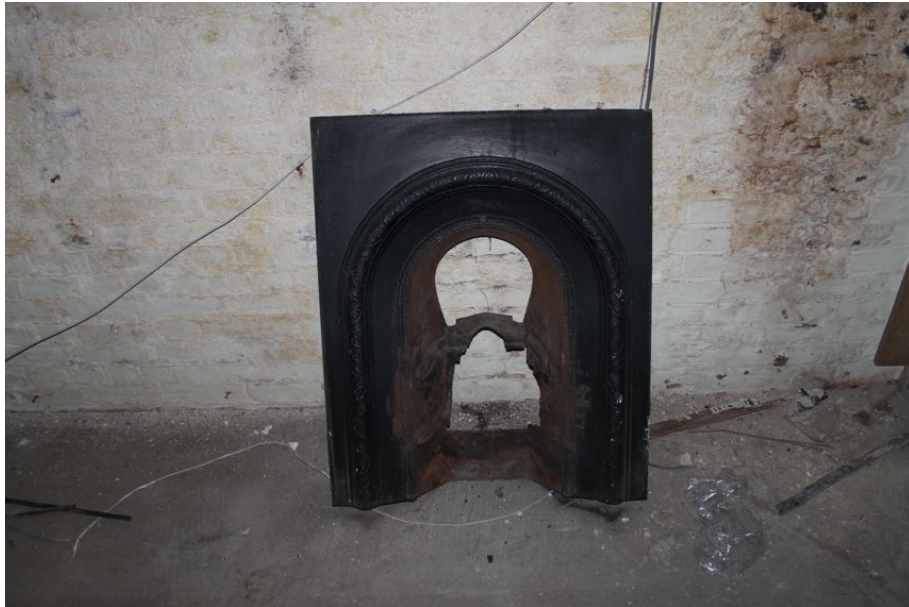
**Photograph 50** Metal register grate taken from fireplace on first-floor of Structure 5.

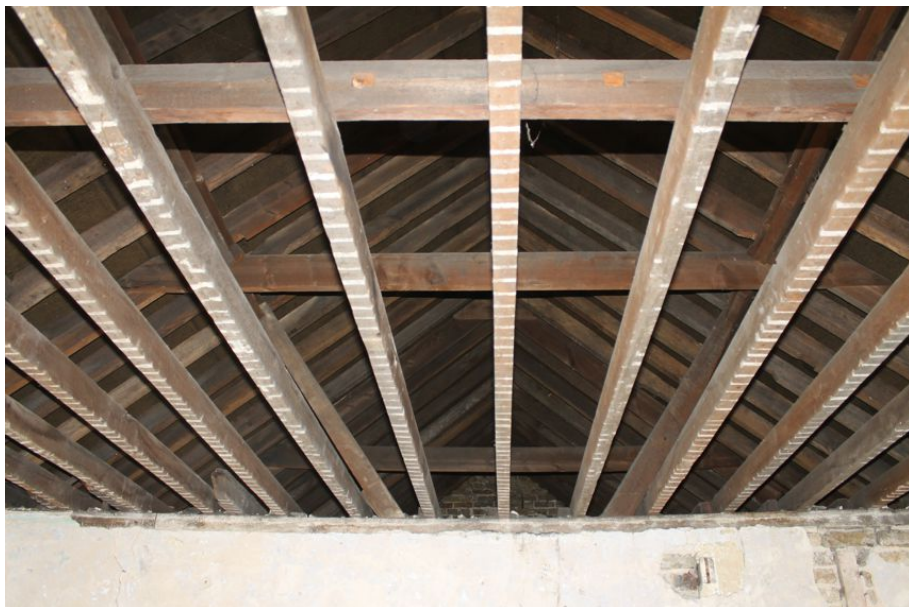
**Photograph 51** Timber roof of Structure 5. Photograph taken facing west.

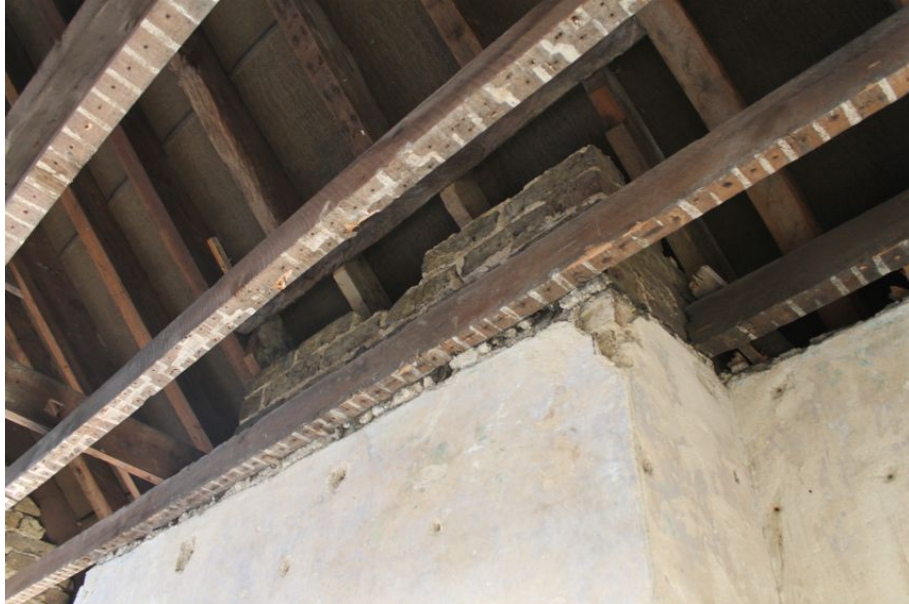
**Photograph 52** Top of chimney-stack in Structure 5, having been removed to below the rafters. Note the modern rafters above it. Photograph taken facing north-west.

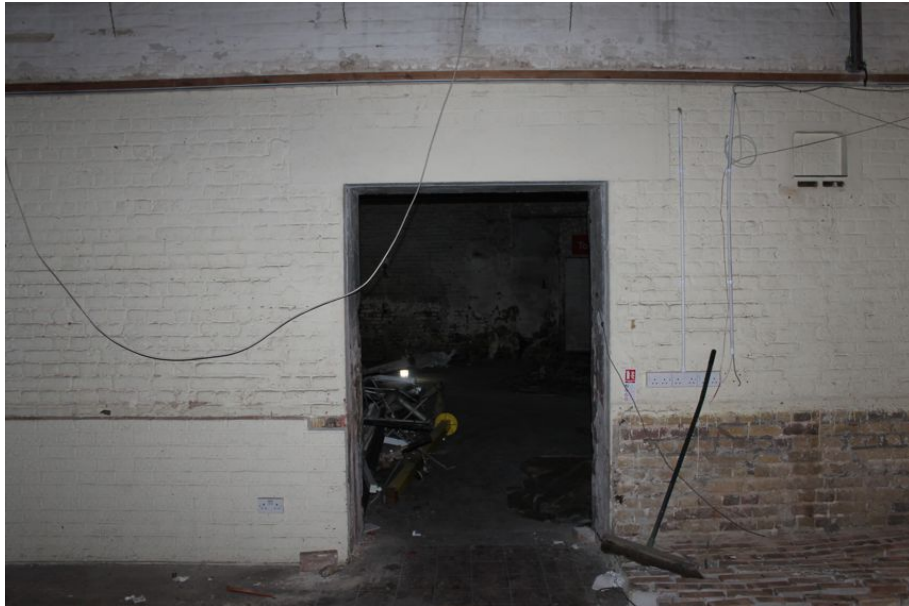
**Photograph 61** Inserted entrance with a concrete lintel between Structures 6 and 7 on the ground-floor. Photograph taken facing north.

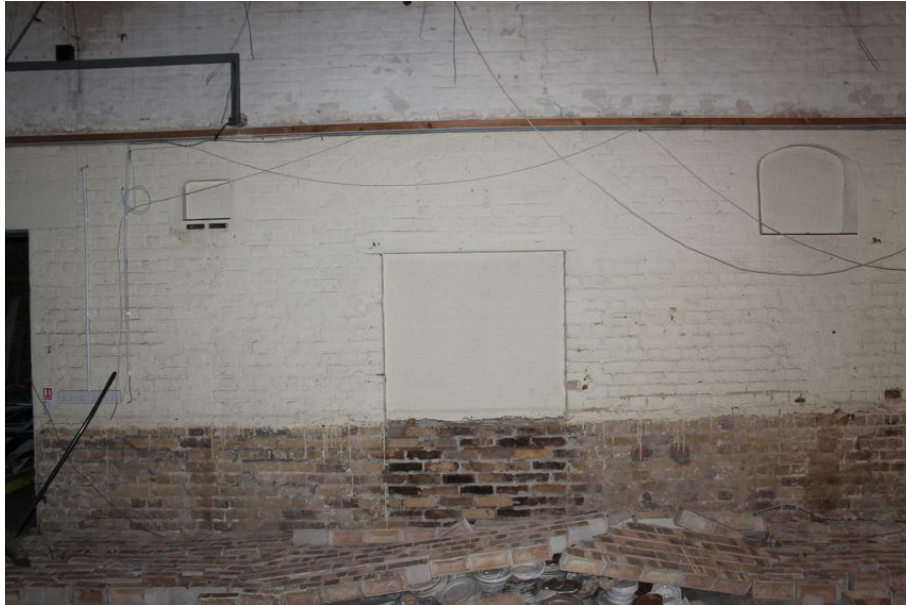
**Photograph 62** Original entrance with arch between Structures 6 and 7 at ground-floor level, now bricked over. Photograph taken facing north.

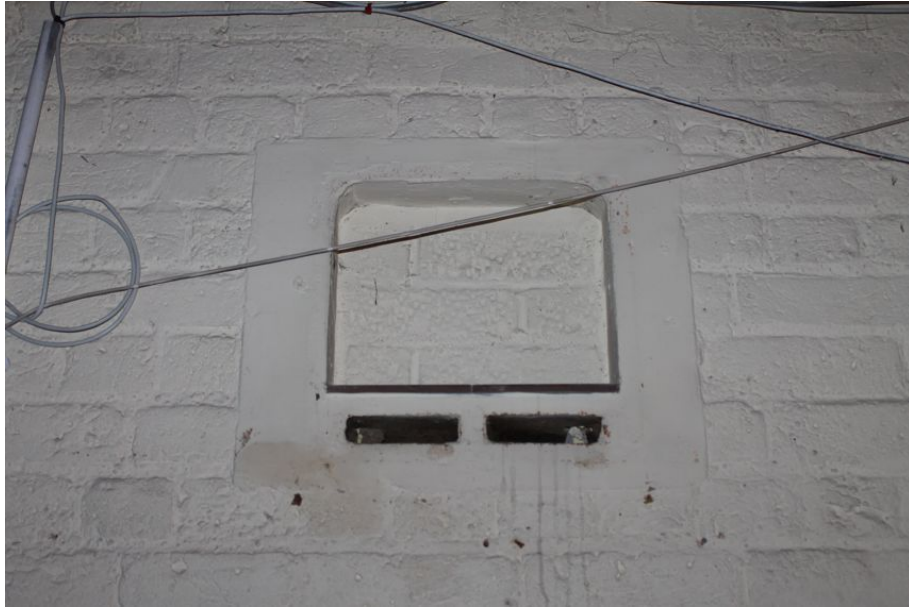
**Photograph 74** Possible ?gas-light holder in northern brickwork on ground-floor of Structure 7. Photograph taken facing north.

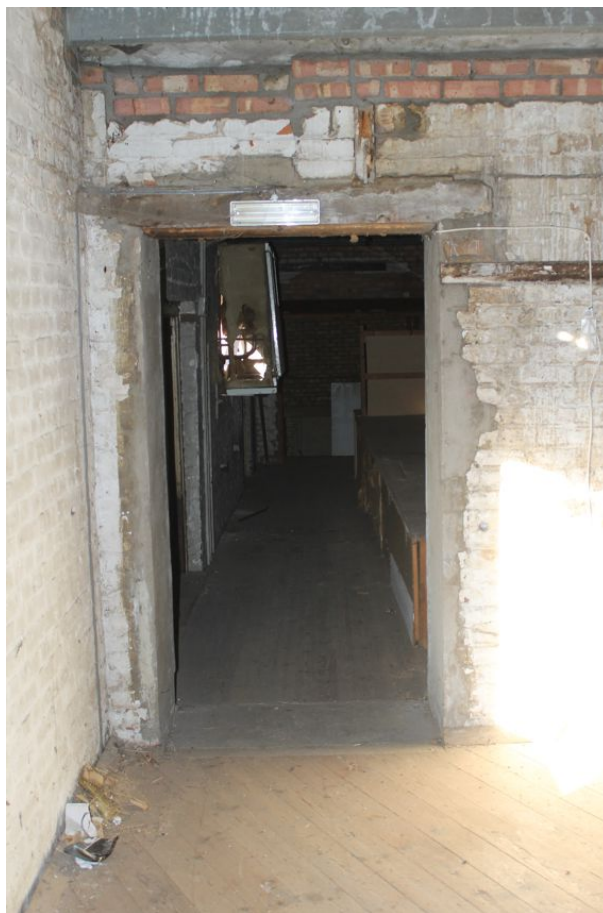
**Photograph 80** Entrance into second-floor of Structure 7, showing differing floor-levels. Photograph taken facing north.

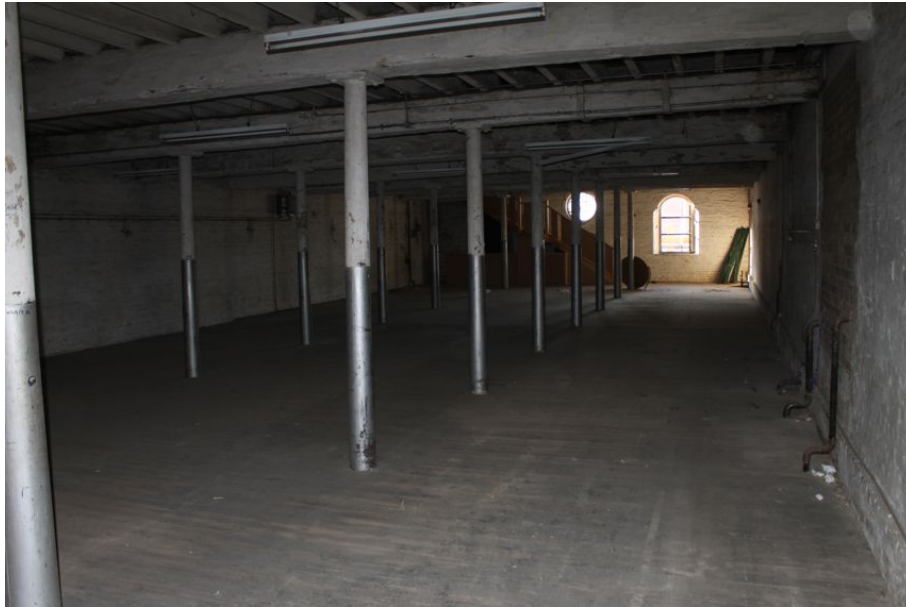
**Photograph 89** First-floor of Structure 8. Photograph taken facing south-west.

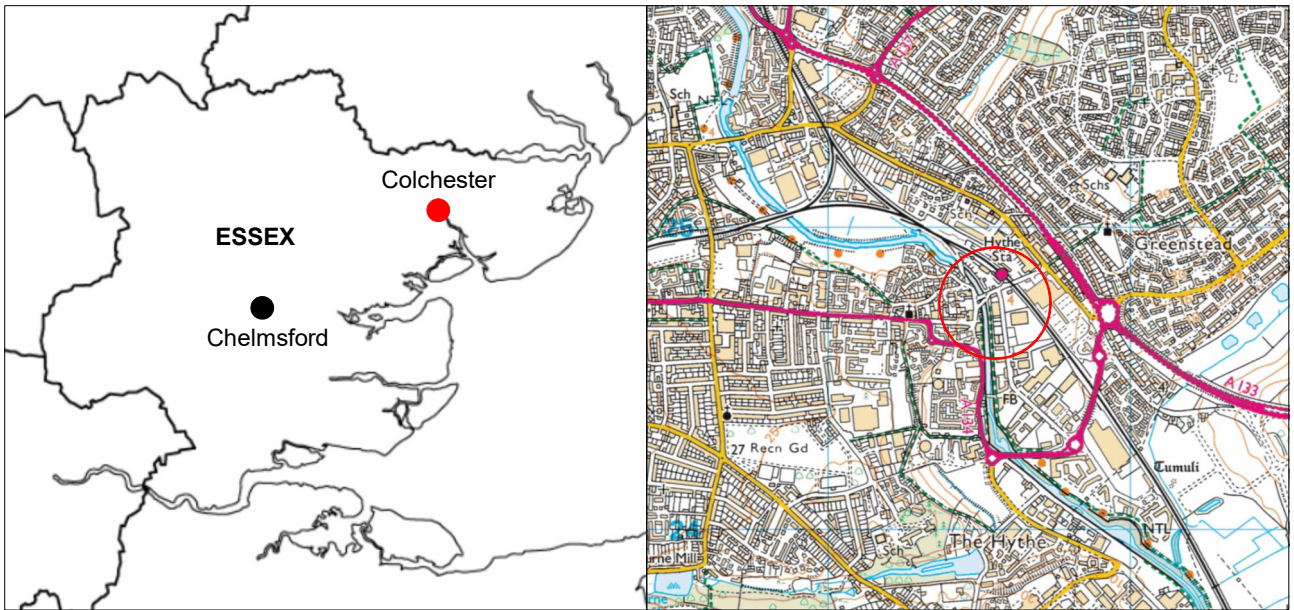
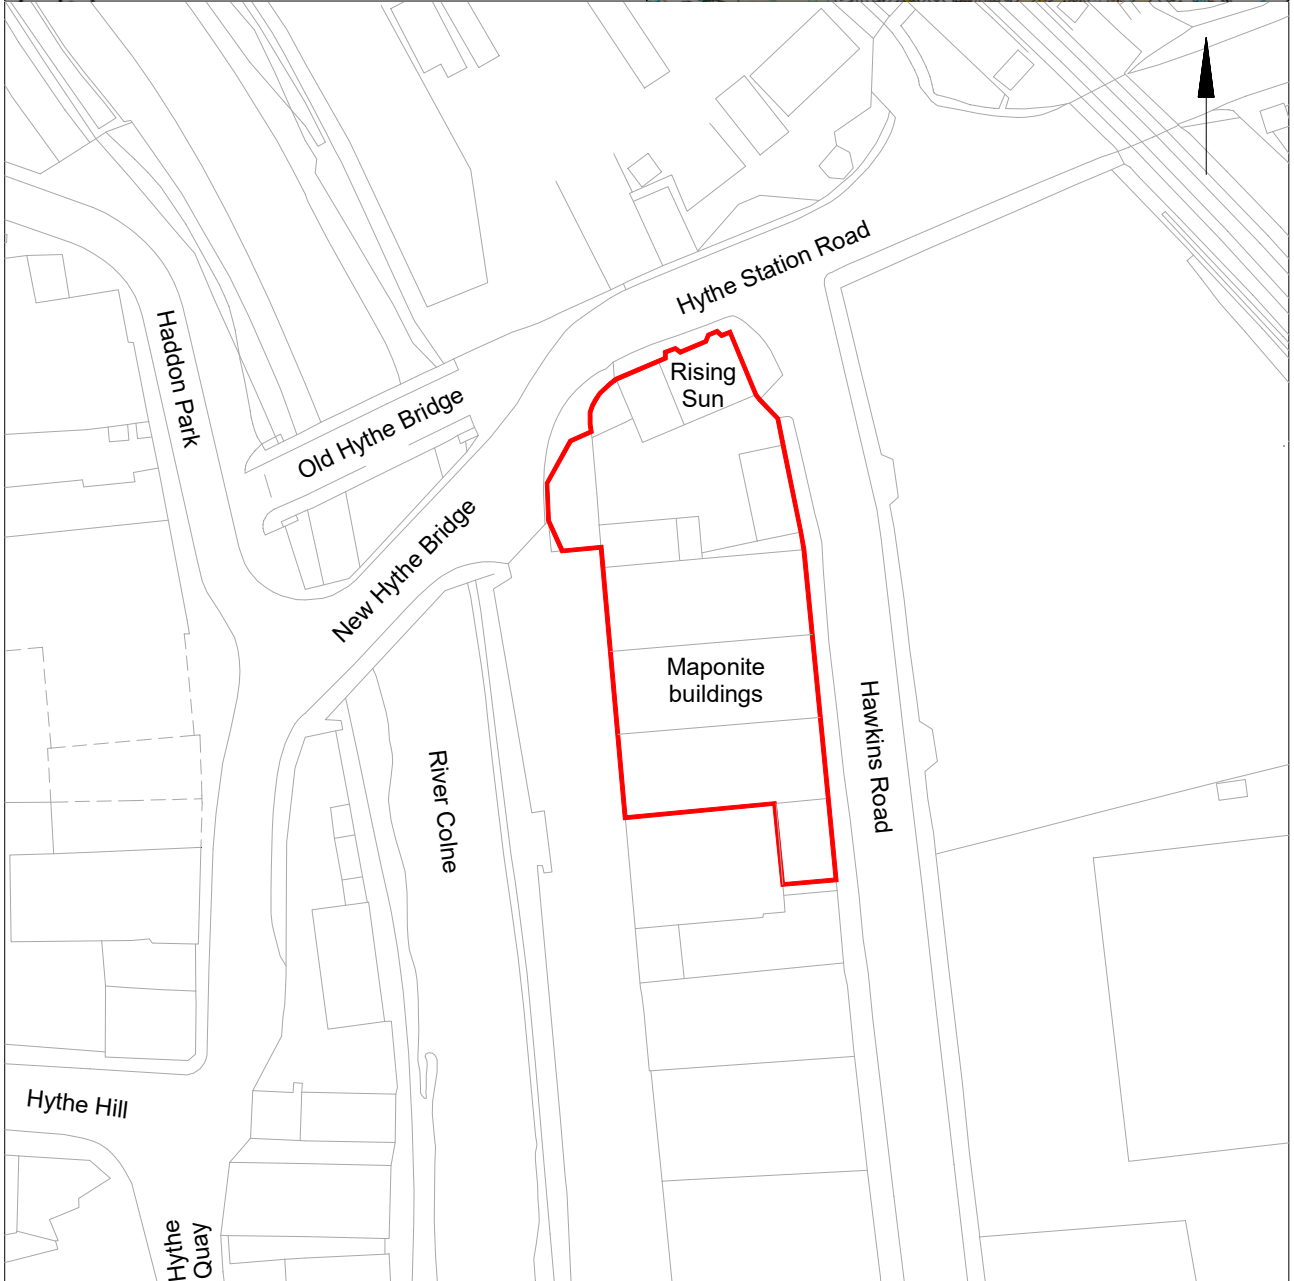
© Crown copyright. All rights reserved. Licence number 100039294.
