**Historic building recording at  
79 Magdalen Street,  
Colchester, Essex CO1 2LA**

**February 2019**

**CAT Report 1391**  
March 2019

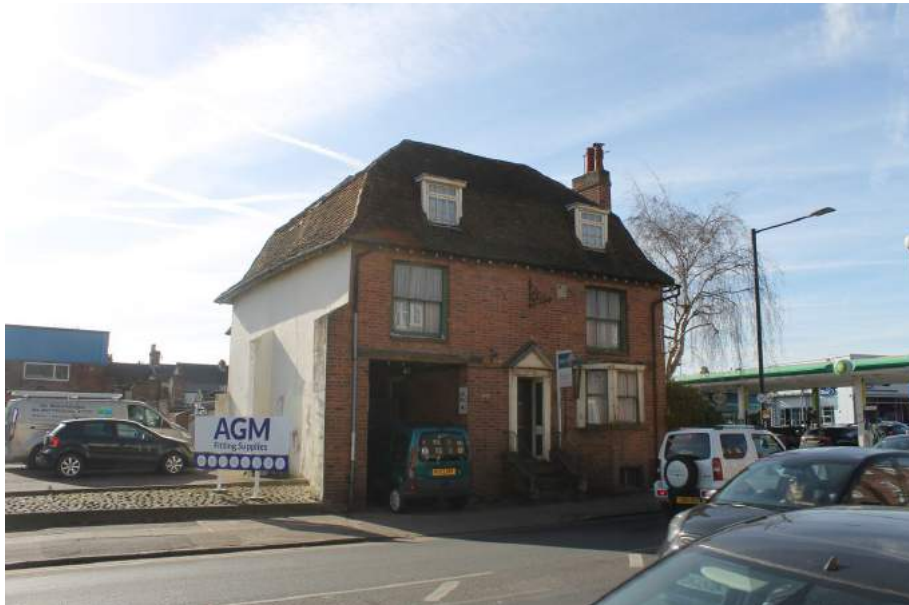
The main range of the building has a double-hipped mansard roof (Photograph 1) and the extension has a hipped mansard roof. Both these roofs are covered in peg-tiles and appear contemporary – it seems likely that the entire roof was redone when the extension was built. There is a cornice around the whole building, beneath the eaves of the mansard roof; the ends of the rafters have been uniformly chamfered and abut against a cement render depicted with angular decoration (Photograph 2).

**Photograph 1** North and east elevations of 79 Magdalen Street.  
Photograph taken facing south-west.

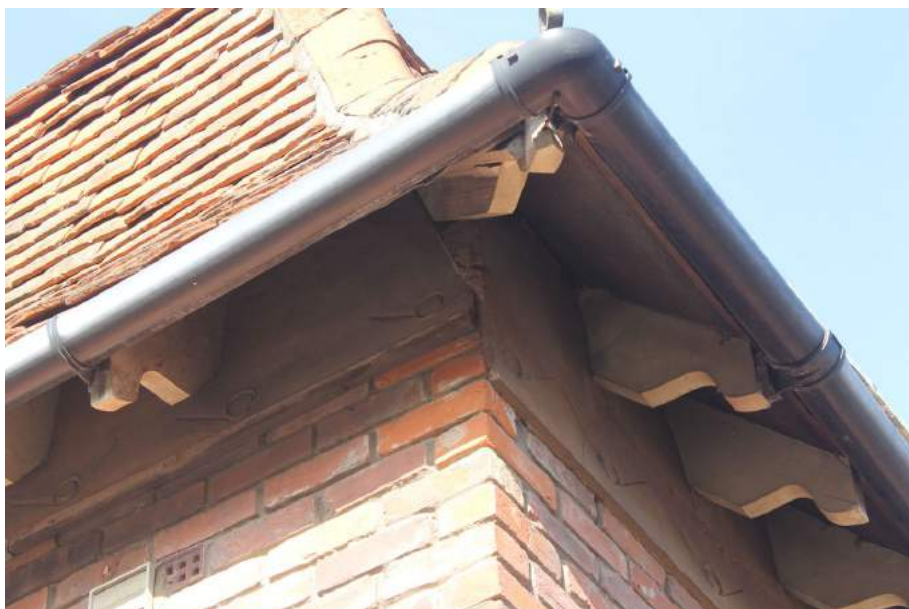
**Photograph 2** Detail of cornice around entire building. Chamfered rafter-ends and incised cement shown.

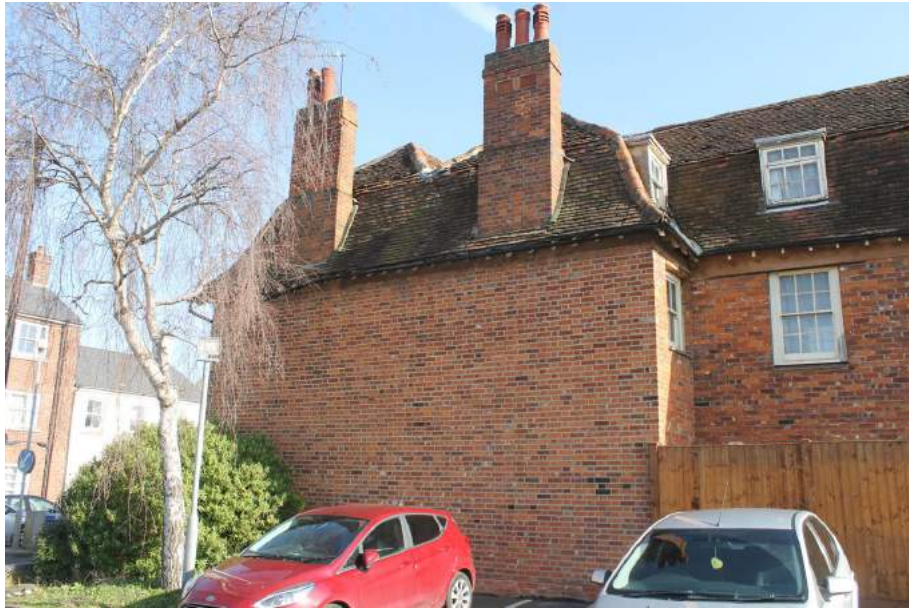
The building has two brick chimney stacks on its western end (Photograph 3). The extension has no chimney.

**Photograph 3** Western elevation of 79 Magdalen Street. Two chimney-stacks visible on main range. Photograph taken facing north-east.

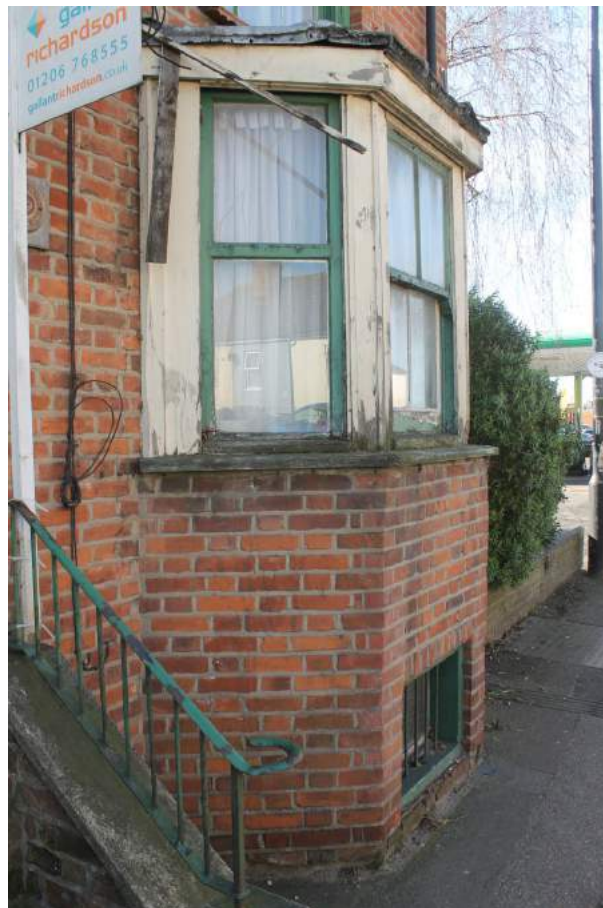
**Photograph 4** Bay window on northern elevation of 79 Magdalen Street. Photograph taken facing south-west.

There is a bay window at ground-floor level on this elevation (Photograph 4) containing 2 two-light fixed and one three-light horned sash window. Below this bay window is a small fixed window providing light to the cellar. The main entrance into the building is on this elevation, consisting of a doorway about 1m above ground-level, accessed by a flight of brick-built steps with concrete treads and metal balusters and handrails (Photograph 5). The doorway is heavily recessed into the building and surrounded by a porch-like slight forward projection with a hood above (Fig 7). Within the doorway is a six-panel door that appears to be a modern replacement.

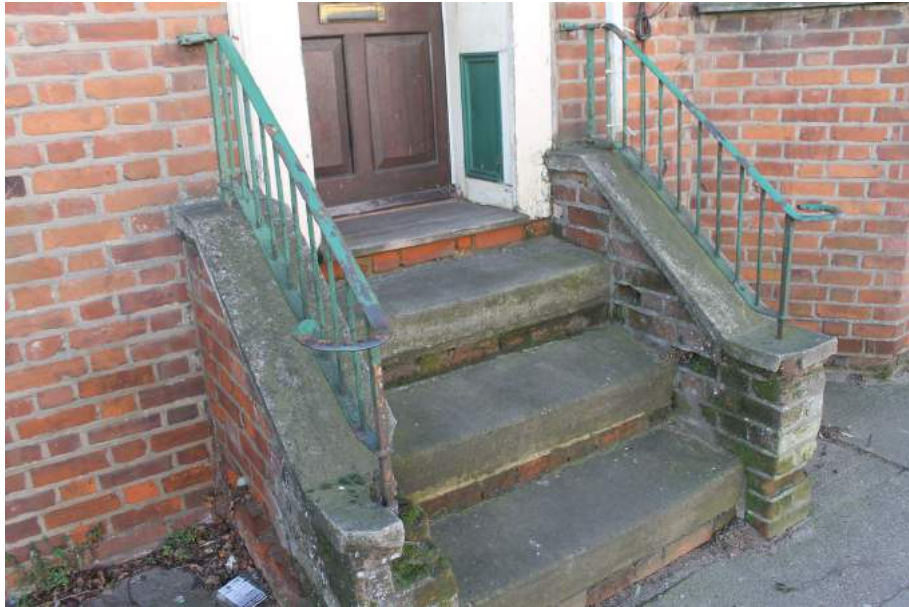
**Photograph 5** Detail of steps up to front door on northern elevation of 79 Magdalen Street. Photograph taken facing south-west.

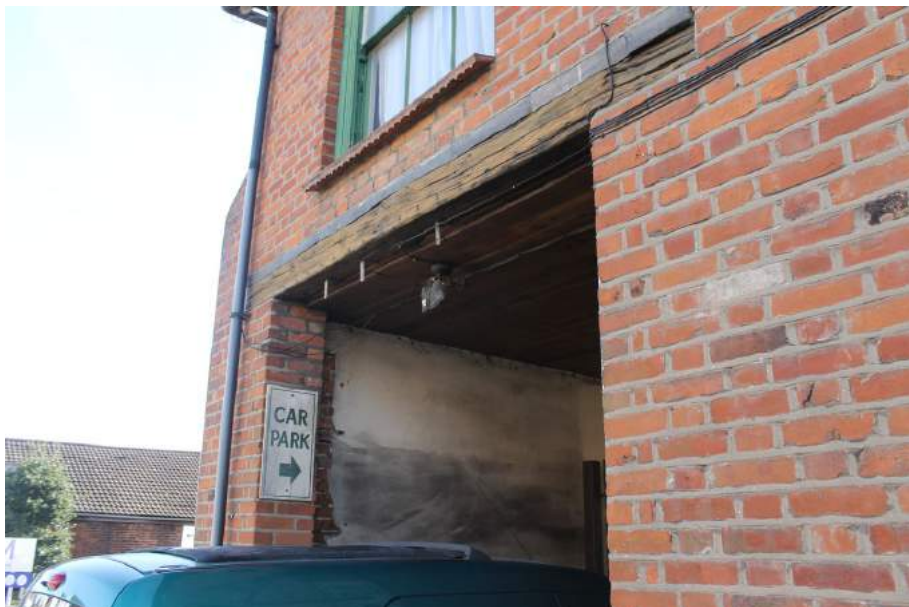
The passageway to the rear of the building has a large timber lintel supporting the opening and the floor of the room above (Photograph 6).

**Photograph 6** Entrance into passage leading to rear of building on northern elevation. Substantial timber lintel visible. Photograph taken facing south-east.

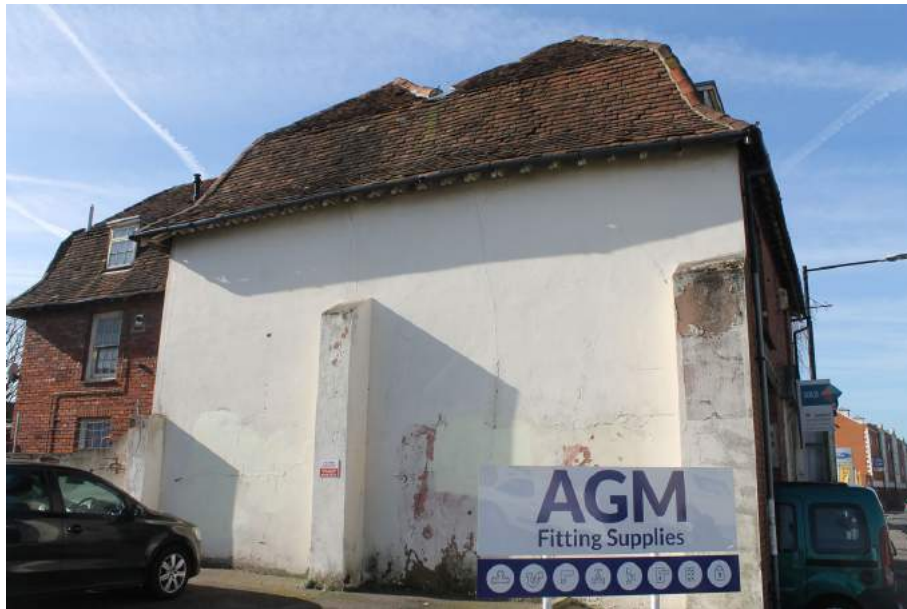
The main range of the building is rendered on this elevation (Photograph 7). It has no windows, but it has three brick buttresses. The extension on this elevation has two twelve-light horned sash windows on the ground-floor, mirrored by two more above on the first-floor (Photograph 8). In the mansard roof above, like on the main range, are two dormers each containing six-light fixed and three-light awning windows.

**Photograph 7** East elevation of 79 Magdalen Street. Photograph taken facing south-west.

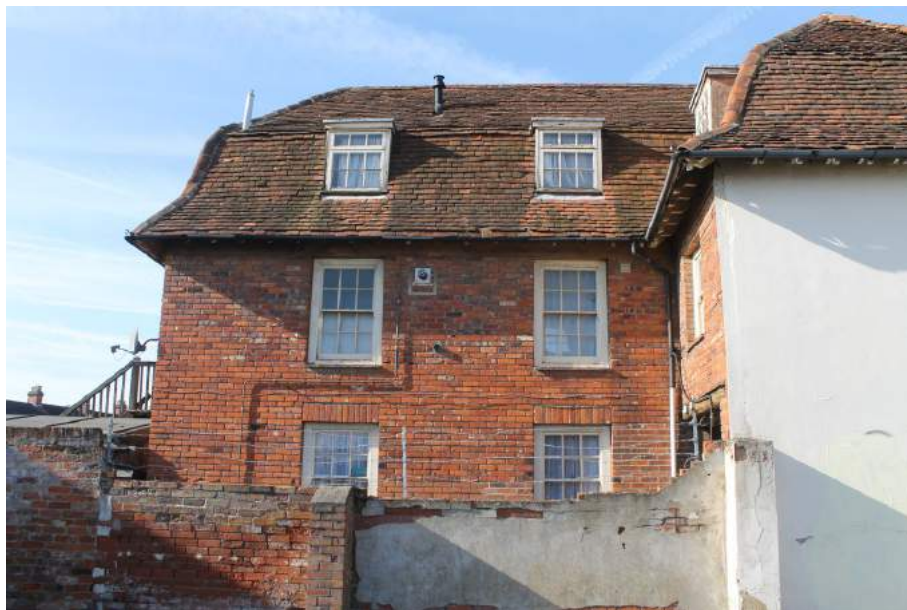
**Photograph 8** East elevation of extension. Photograph taken facing west.

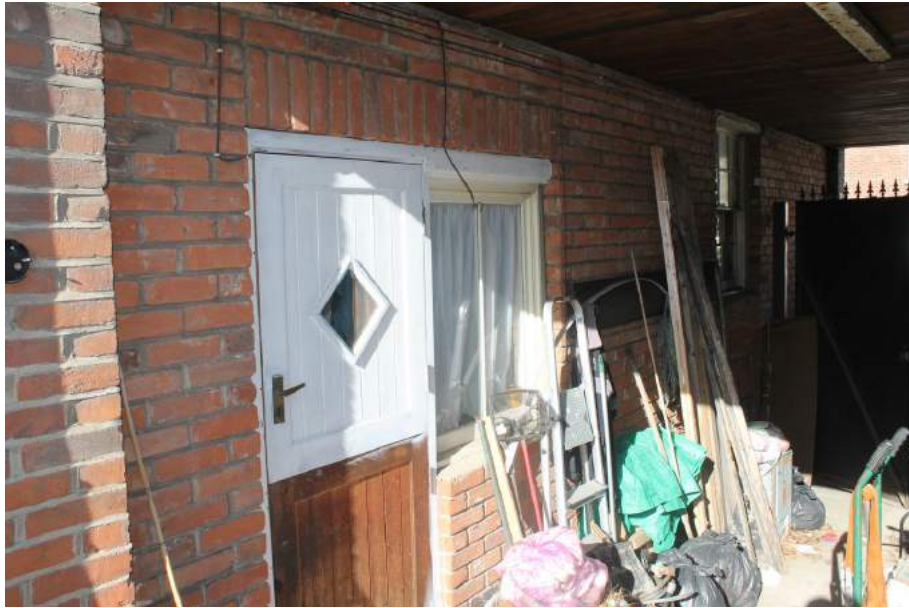
The western side of the ground-floor passageway (Photograph 9) is constructed of spacer-bond brickwork with the dimensions of 225mm x 110mm x 70mm. This is significantly different to the brickwork in the rest of the main range, which suggests it has been rebuilt. Also present within the brickwork are several modern hammer-glass

**Photograph 9** Western wall of passageway on ground-floor of 79 Magdalen Street, showing rebuilt wall. Photograph taken facing north-west.

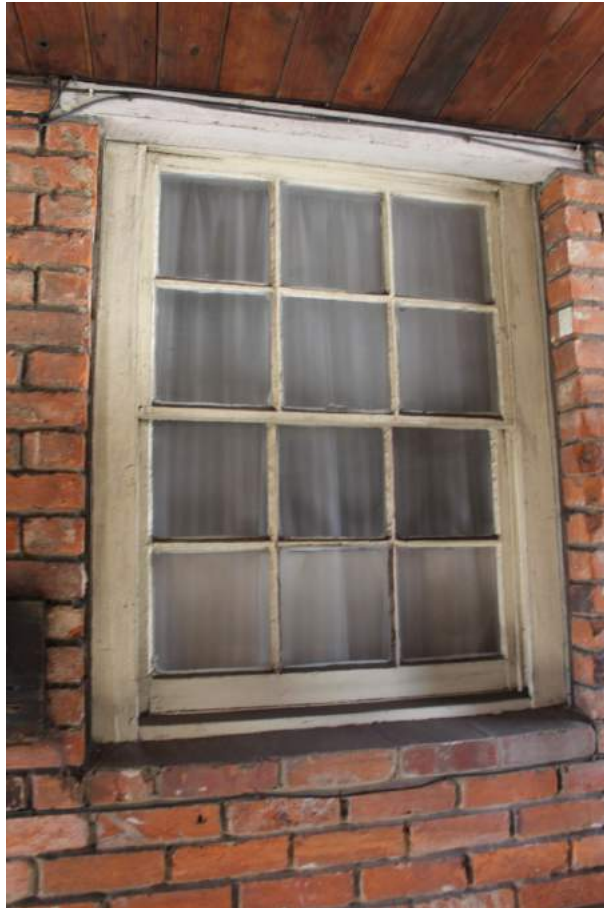
**Photograph 10** Sash window on west side of passageway on ground-floor. Photograph taken facing west.

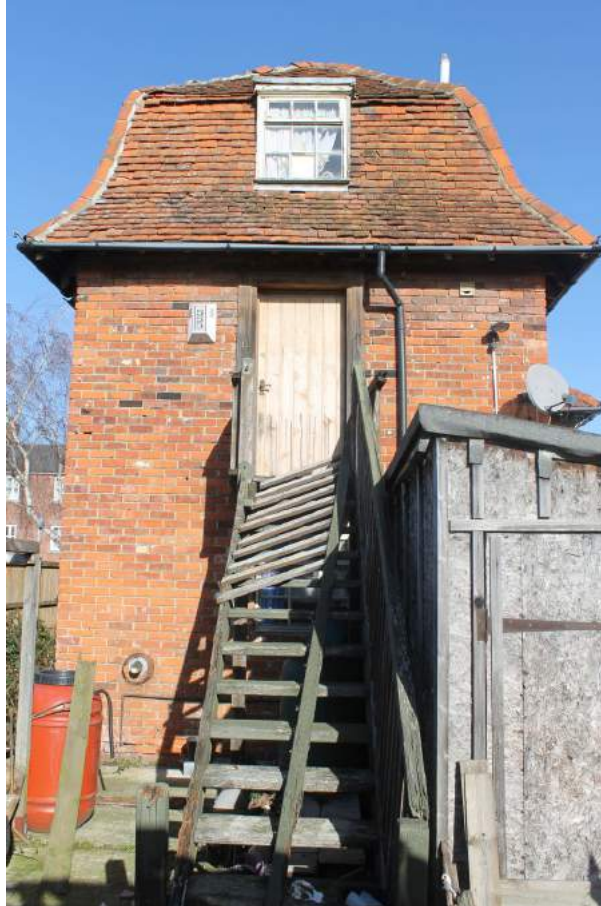
**Photograph 11** Southern elevation of extension, showing staircase up to first-floor door. Photograph taken facing north.

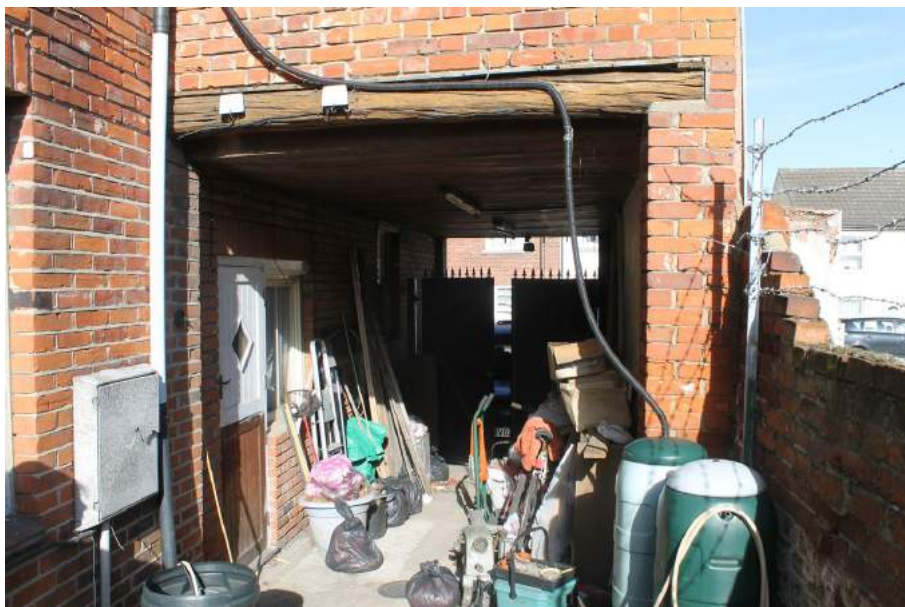
**Photograph 12** Passageway on ground-floor on southern elevation. Photograph taken facing north.

Like on the north elevation, the passageway in the main range has a large timber lintel (Photograph 12).

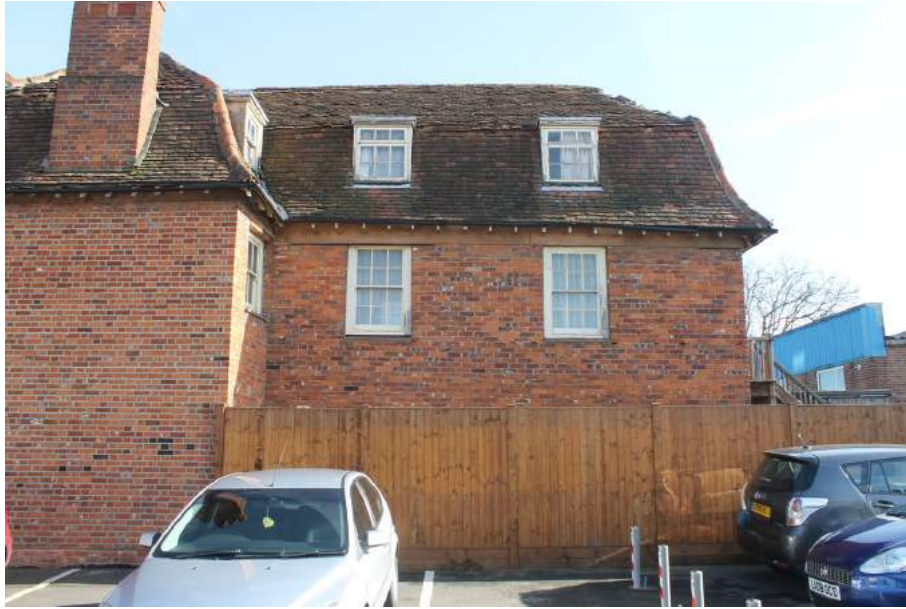
The main range has two chimneys on this elevation, but no other features (Photograph 3). The extension has two six-light horned sash windows on the first-floor, with the usual dormers above, but no windows on the ground-floor (Photograph 13).

**Photograph 13** West elevation of extension. Photograph taken facing east.

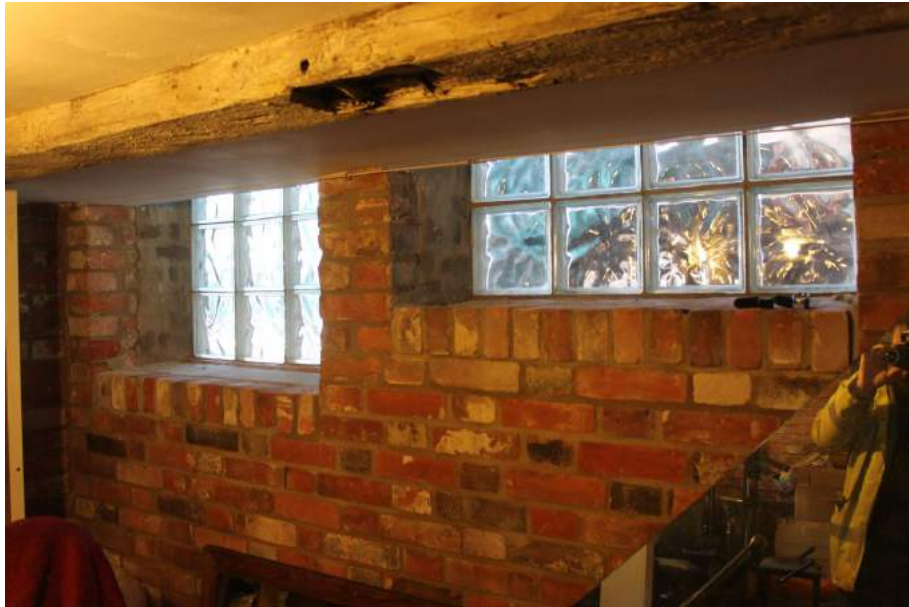
**Photograph 14** Hammered-glass windows on east side of cellar, looking out onto passageway. Photograph taken facing north-east.

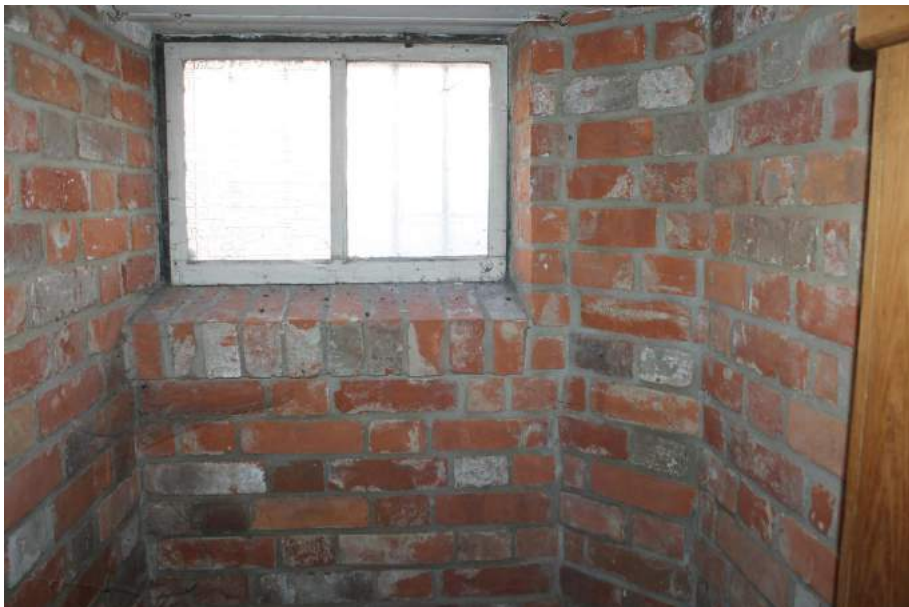
**Photograph 15** Fixed window in cellar below bay window on ground-floor. Rebuilt brickwork around. Photograph taken facing north.

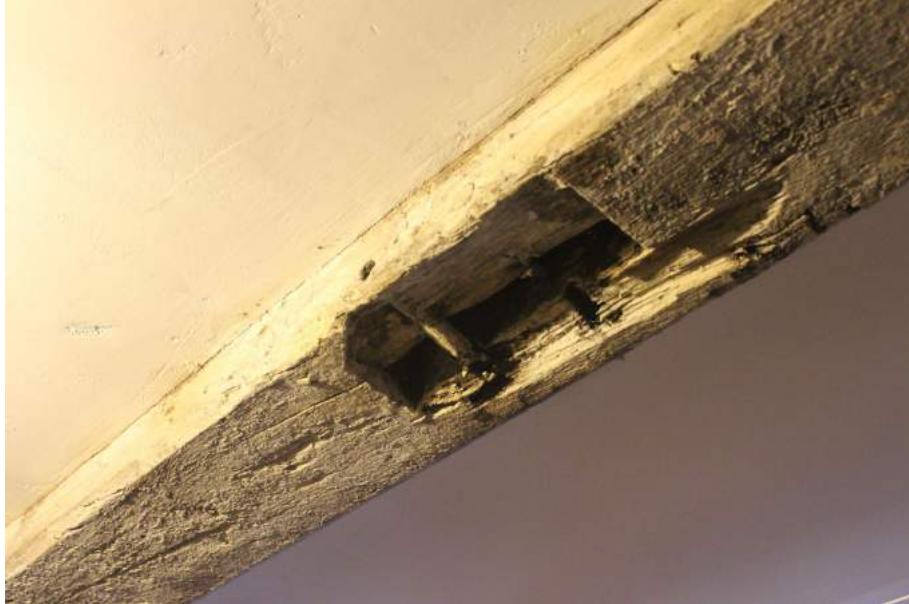
Visible in the cellar, and of some interest, are the joists of the ground-floor above. Seven of the joists, to the west of the cellar, are modern machine-cut timbers measuring 75mm x 70mm. The three joists to the east, however, are much larger hand-sawn timbers, two of which have evidence of re-use in the form of empty mortices (Photograph 16). One of these mortices has an associated carpenter's mark of "IIII" (Photograph 17).

**Photograph 16** Detail of empty mortise on joist in cellar. Photograph taken facing north-east.

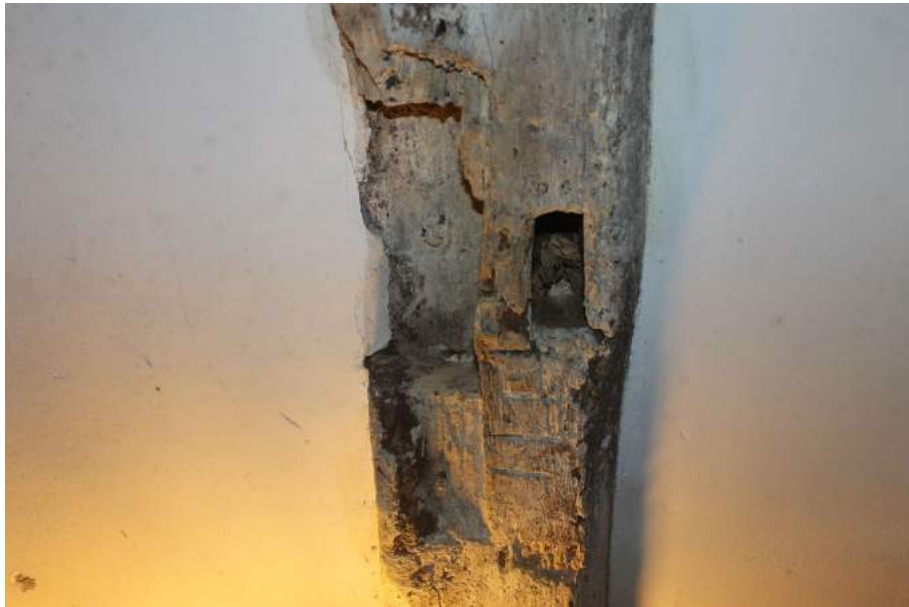
**Photograph 17** Detail of empty mortise and carpenter's mark "IIII" on underside of joist in cellar.

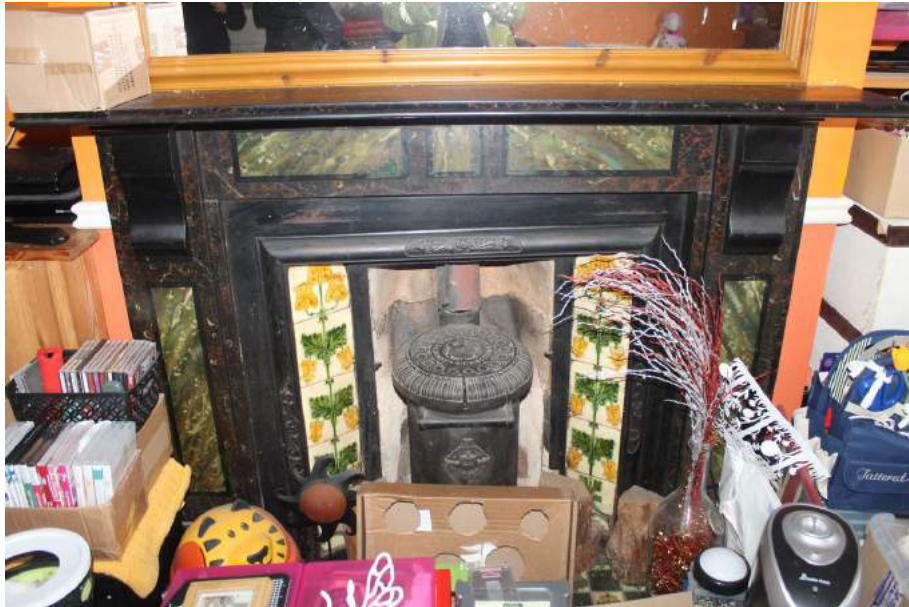
Although there are no original features, some are still of note. Within the northern room on the ground-floor is an example of a late 19th-century fireplace (Yorke 2005, 75). While the cast-iron fireplace has been removed and replaced with a wood burner, the decorative surround, with its tiles and carved brackets, survives (Photograph 18). The fireplace in the southern room has been blocked (Fig 3).

**Photograph 18** Tiled fireplace surround in northern room of ground-floor. Wood burner in centre a modern insertion. Photograph taken facing west.

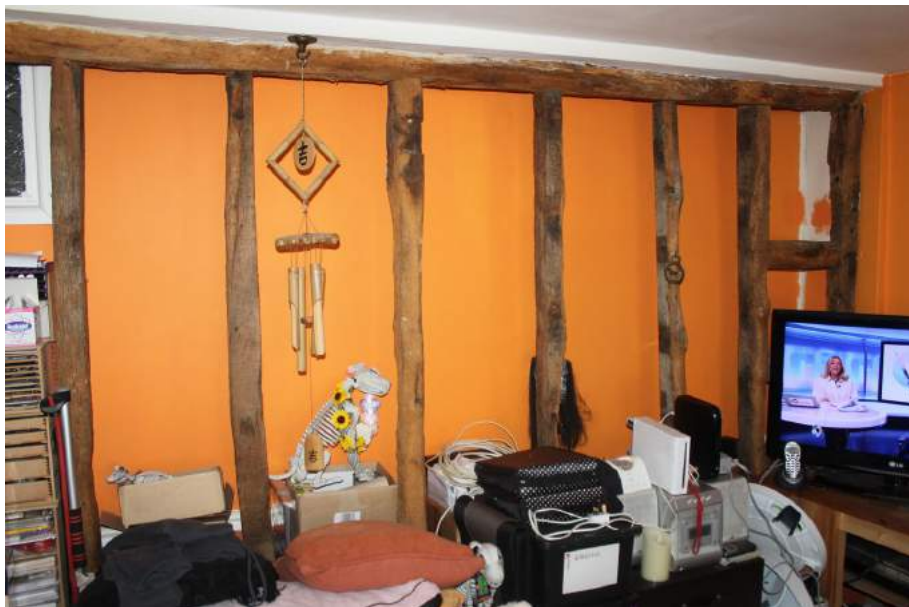
Within the northern room is what appears to be a timber-framed wall, constructed of hand-sawn timber with studs rising to a beam in the ceiling (Photograph 19). Closer inspection, however, reveals that this is an imitation wall and not a legitimate part of the fabric of the building; the studs are not set in mortices and are simply nailed to the upper beam. Behind this timber-framed imitation is the actual interior wall of the building, but as it is rendered it is impossible to tell if it is brick or timber.

**Photograph 19** Imitation timber wall in northern-room of ground-floor. Photograph taken facing south-west.

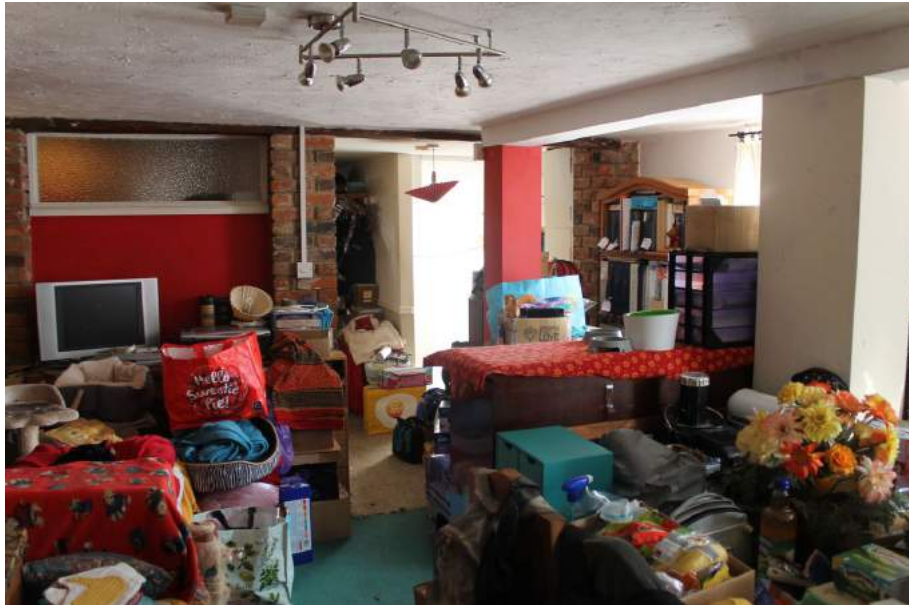
Visible on the ground-floor, and supporting the upper-floors, are several brick-pillars. These all appear to be later additions, presumably added to the building when part of the southern wall of the main range was removed to allow access into the extension. Three of these pillars are supporting an inserted timber beam of the floor above (Photograph 20).

**Photograph 20** Ground-floor of extension, showing brick pillars supporting upper floors of main range. Photograph taken facing north.

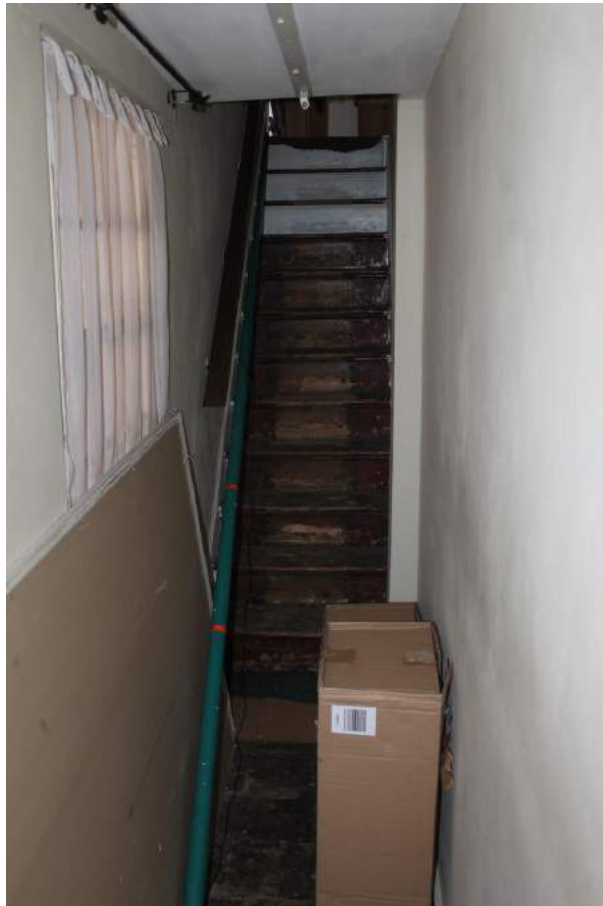
The staircase up to the first-floor is constructed of wooden riser and treads with a modern handrail. Although relatively undiagnostic, there is no reason that this staircase could not be original to the building (Photograph 21).

**Photograph 21** Staircase leading up to first-floor. Photograph taken facing south.

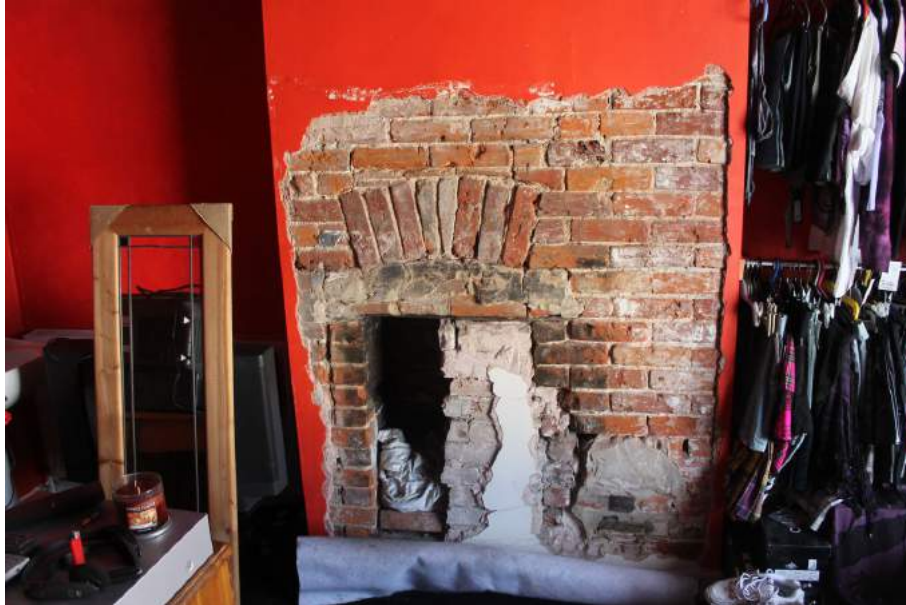
The southern fireplace is blocked on this floor but the northern one has been partially reopened, revealing a segmental brick arch above (Photograph 22). In the same room as this exposed fireplace, a beam is partially visible above the central wall (Photograph 23).

**Photograph 22** Blocked then partially reopened northern fireplace on first-floor. Photograph taken facing west.

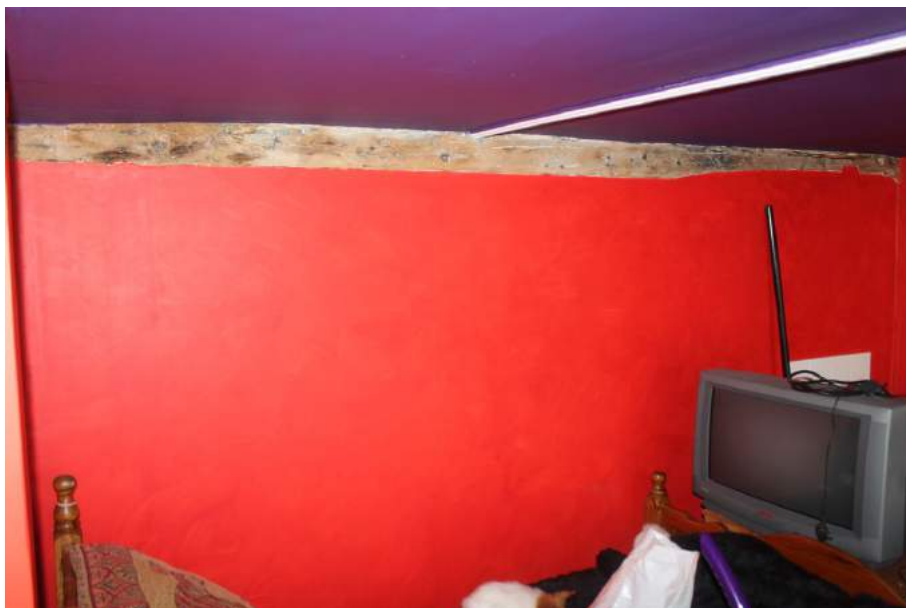
**Photograph 23** Visible beam in north-west room on first-floor. Photograph taken facing south.

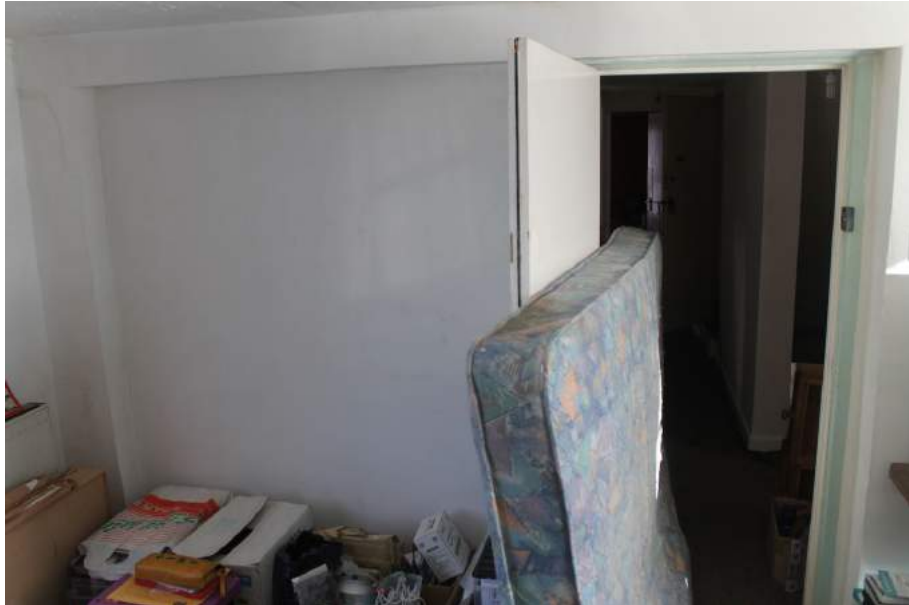
location of a previously removed window originating from before the extensions construction.

**Photograph 24** View from extension showing entrance into main range on first-floor, alongside possible blocked entrance or window. Photograph taken facing north.

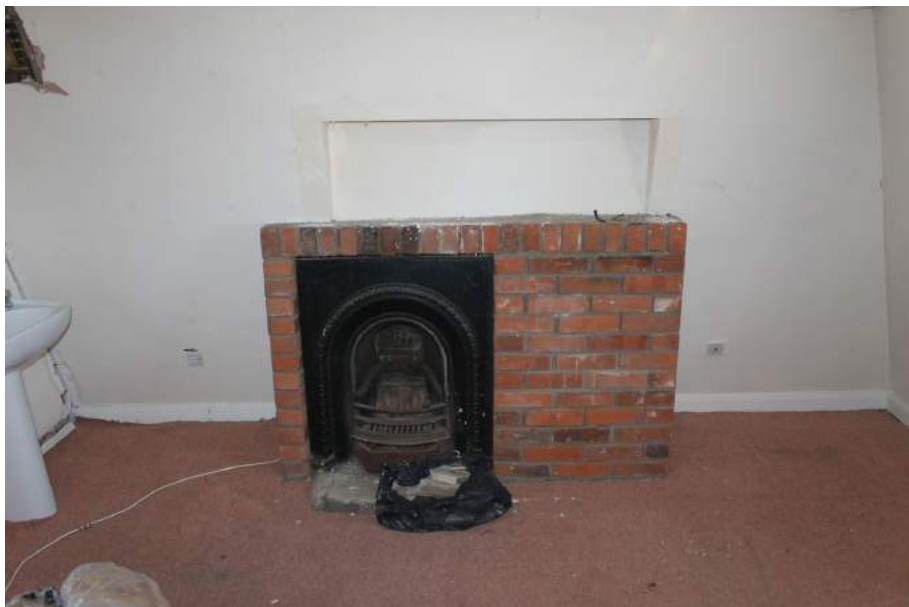
The southern fireplace has been blocked, but the northern has had a new brick surround built and a late 19th-century cast-iron fireplace within it (Photograph 25). The origin of this cast-iron fireplace is unclear, but it may originate from the ground-floor of this building (in the location now occupied by a wood burner; see pg 18).

**Photograph 25** Rebuilt northern fireplace surround on second-floor. Photograph taken facing west.

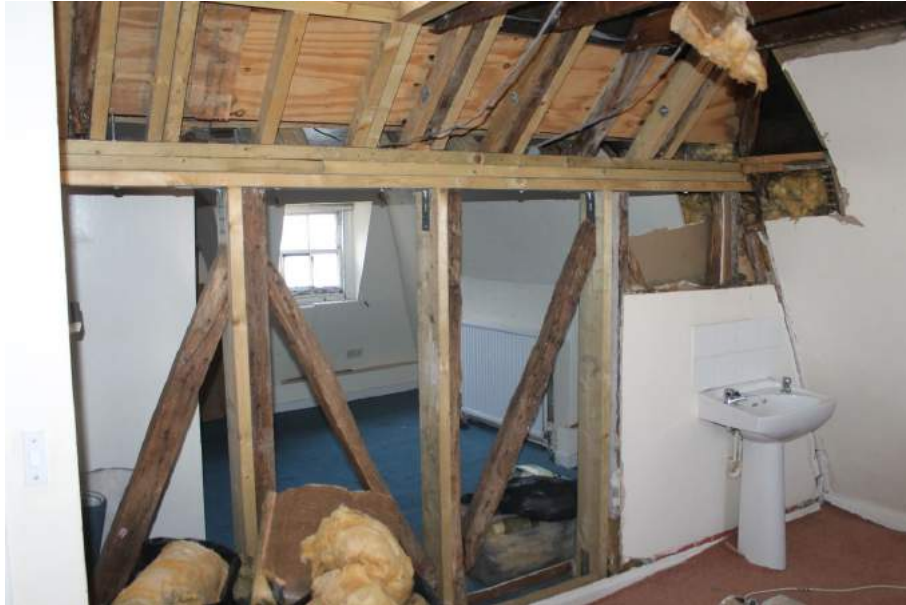
Of note on this floor is that the plasterboard has been removed from one of the interior walls, exposing its fabric which consists of a mix of older hand-sawn and very modern machine-cut timber (Photograph 26). The hand-sawn sections of the wall are studs and diagonal bracing supporting them, all resting on a beam below (as observed on the first-floor; see pg 21). The hand-sawn studs are supported by modern metal braces and machine-cut timbers, and all rise to a very modern wall-plate (Photograph 26). Although these hand-sawn timbers are clearly of some significant age, there can be no doubt that the wall they are currently part of is not. The question becomes where these hand-sawn timbers originate from: were they part of the original fabric of 79 Magdalen Street or are they from an earlier structure? This question is examined in the discussion (pg 25).

**Photograph 26** Timber wall between north-west and south-west room in main range on second-floor. Mixture of modern machine-cut and historic hand-sawn timber visible. Photograph taken facing south-west.

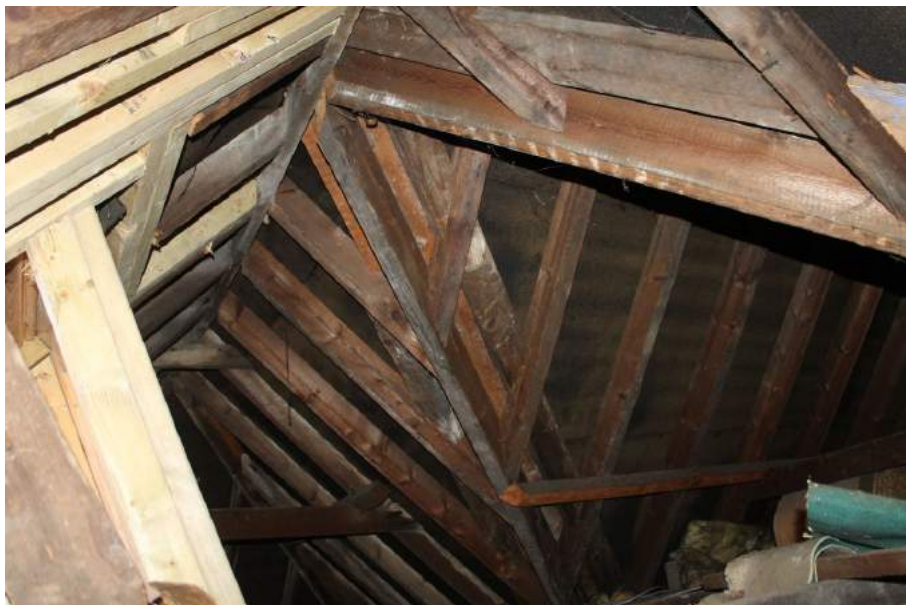
**Photograph 27** Roof structure, showing extension's roof to right attaching to main ranges roof. Photograph taken facing east.

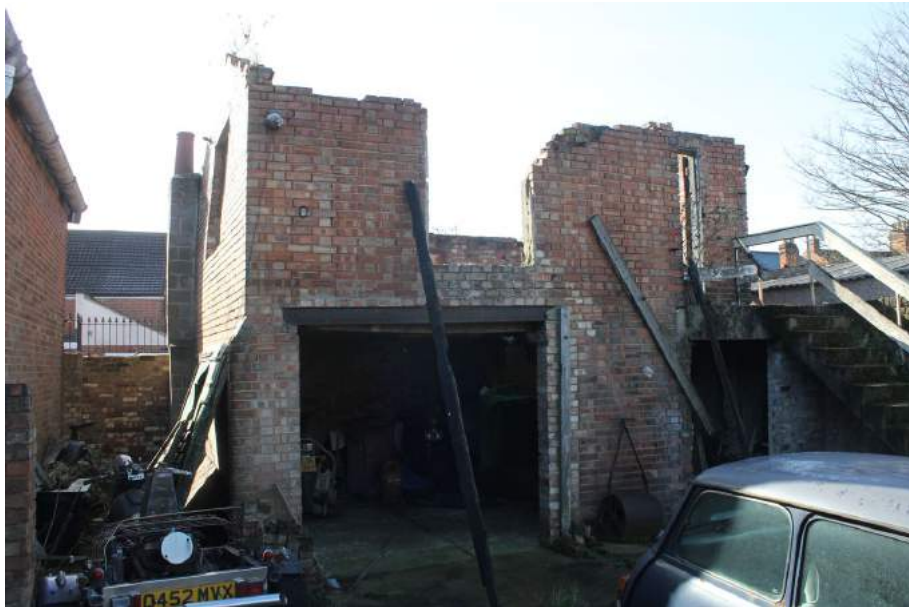
**Photograph 28** North elevation of outbuilding. Photograph taken facing south-west.
