**Historic building recording at
No 10-12 Botany Cottages,
London Road, Purfleet,
Essex, RM19 1PS**

**report prepared by
Mark Baister**

**commissioned by
Thurrock Council**

CAT Report 1427
May 2019

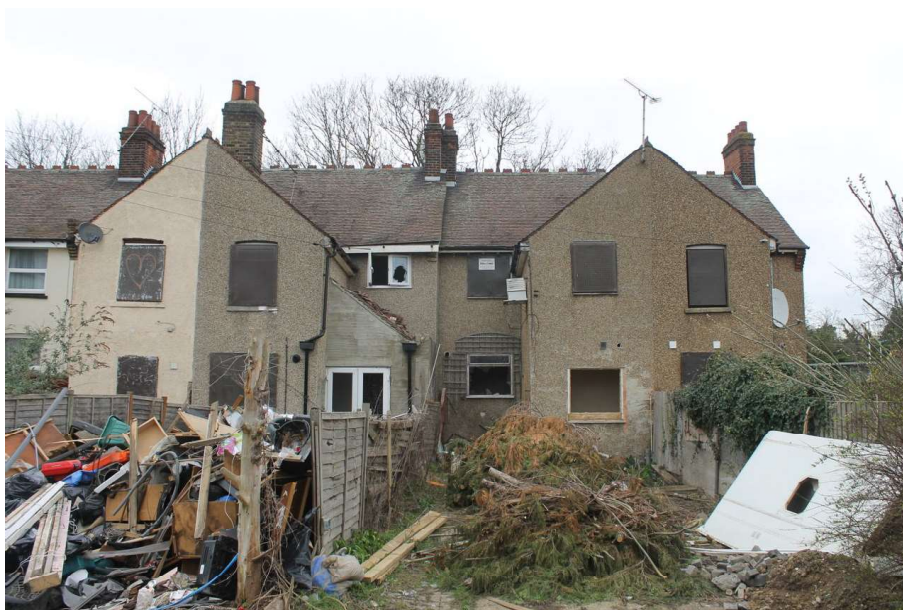
Photograph 4 South-west elevation of No 10-12. Photograph taken facing north-east.

The south-west elevation of the buildings is covered in pebbledash render, with no visible brickwork (Photograph 4). Each building has four windows on this elevation, two on the main range and two on the south-west wing, split between the ground and first-floors (Photograph 4). The vast majority of these are modern plastic-framed awning and casement windows, although the two on the main range of No 11 are both modern wooden-framed awnings (Fig 5). The windows vary in size significantly, and on the ground-floor of No 11 no window remains at all on the ground-floor of the south-west range (Photograph 4).

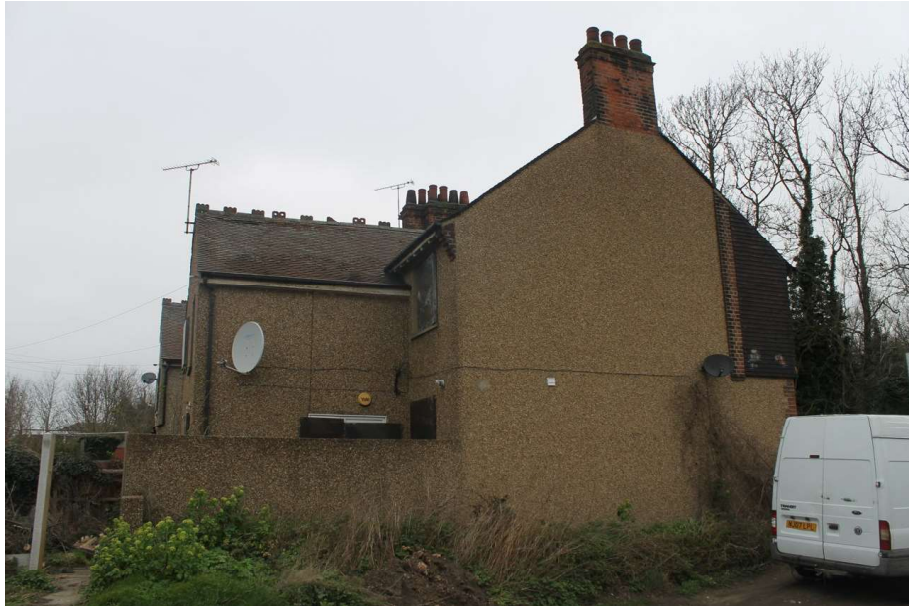
Only No 12 has a south-east elevation. It is featureless and covered with pebbledash render, with a small section of hanging tiles and brickwork to the north (Photograph 5).

Photograph 5 South-east elevation of No 12. Photograph taken facing north-west.

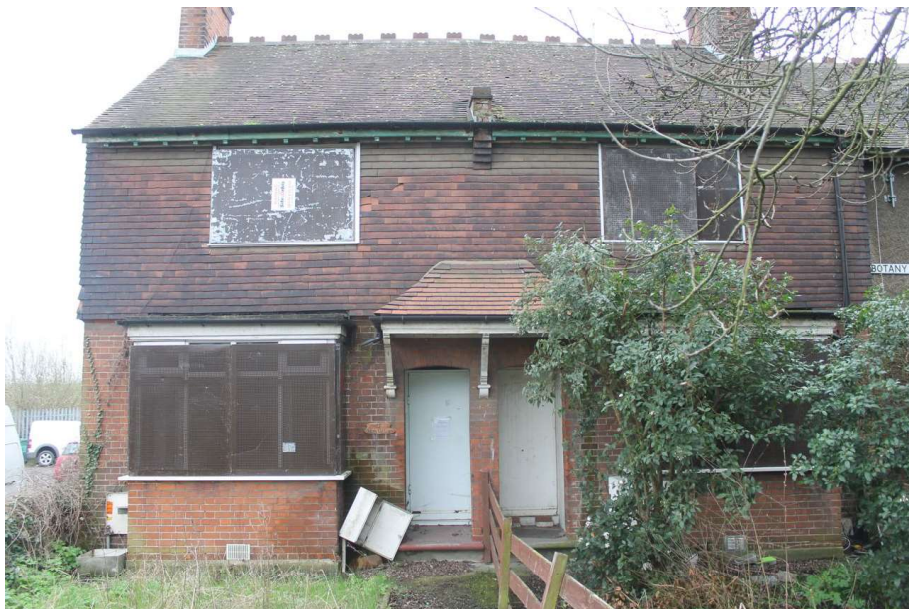
Photograph 6 North-east elevation of Nos 11 and 12. Photograph taken facing south-west.

The main entrances into the buildings are on this elevation, with each pair of houses having doorways side by side (Photograph 6). Above the doorways is a timber-framed hood, covered in plain tiles (Photograph 7). The doors into the buildings are modern replacements.

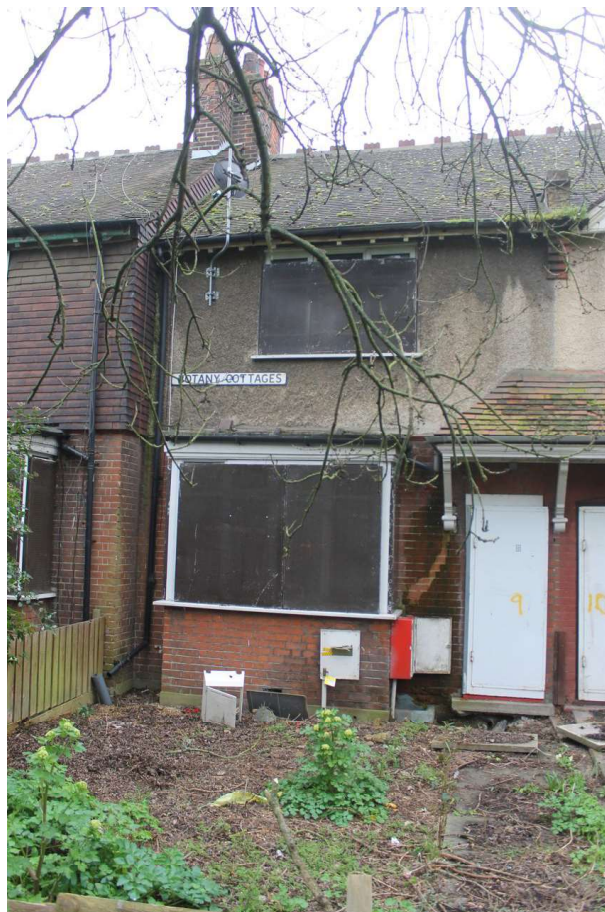
Photograph 7 North-east elevation of No 10.
Photograph taken facing south-west.

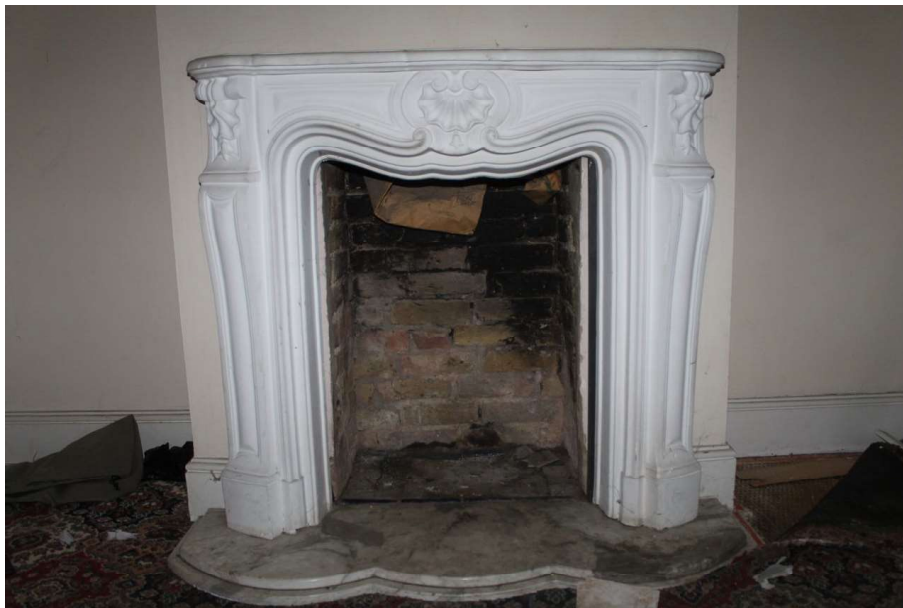
The fireplaces in the living-rooms are all still open on the ground-floor, although none of them have their original surrounds: No 11 has a moulded plaster surround, No 12 a tiled surround and in No 10 no surround survives at all (Photographs 8-9).

Photograph 8 Modern plaster fireplace surround in living-room on ground-floor of No 11. Photograph taken facing north-west.

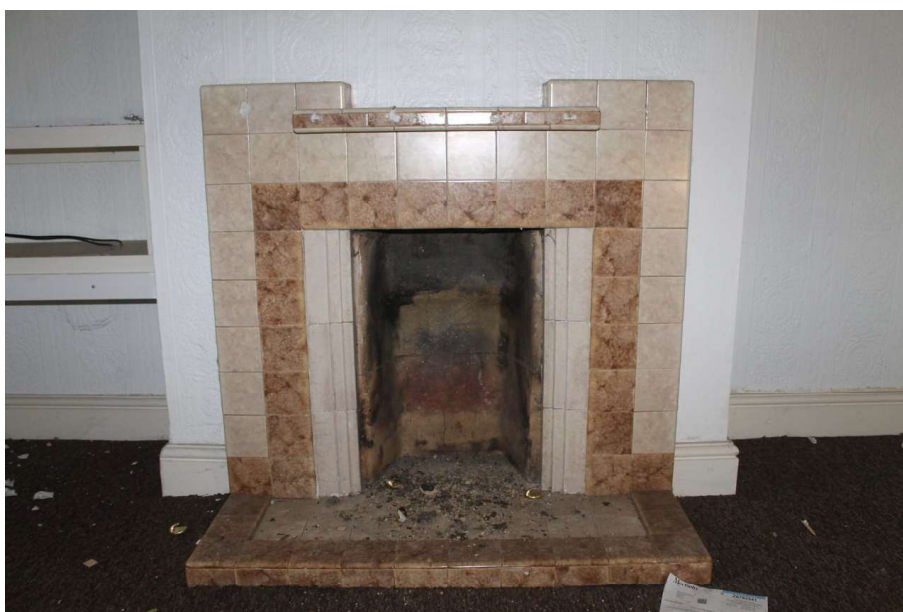
Photograph 9 1930s tiled fireplace surround in living-room on ground-floor of No 12. Photograph taken facing south-east.

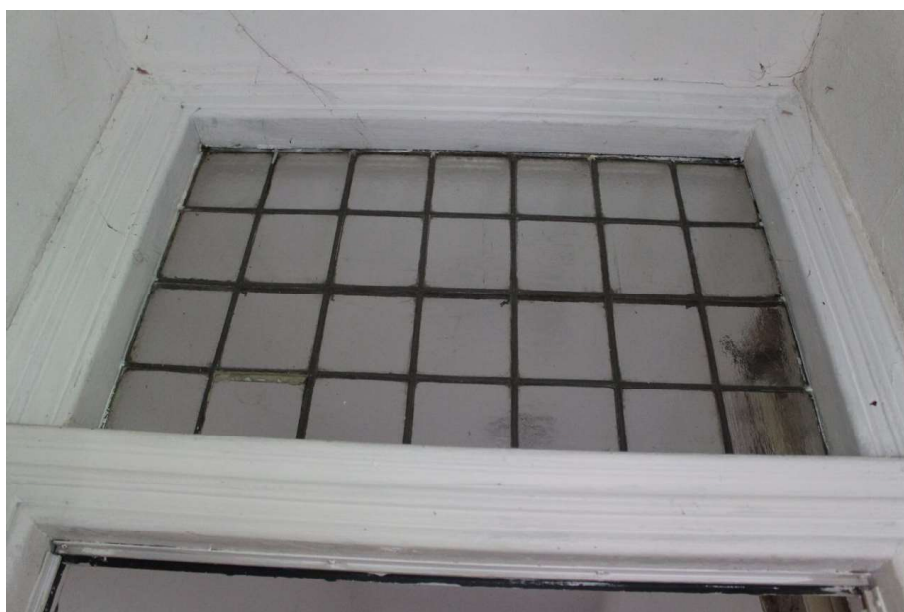
In the entrance hall of each property is a doorway with a window opening above (Fig 2). A fixed 28-light leaded window survives in this location in No 10, and is probably original (Photograph 10). The other two cottages have a modern plastic-framed window in this location (Photograph 11).

Photograph 10 Detail of original leaded light in entranceway of No 10 on ground-floor. Photograph taken facing north-east.

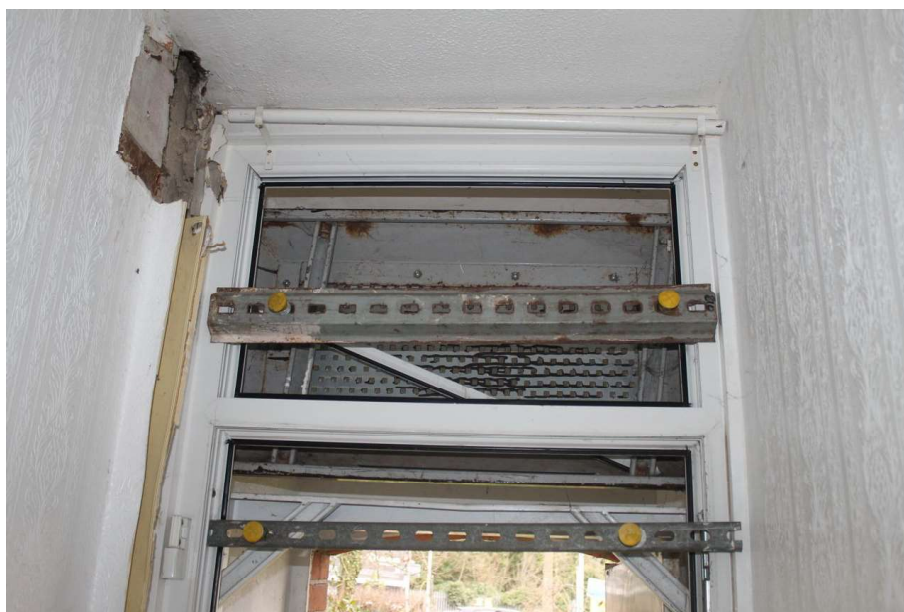
Photograph 11 Plastic-framed window above entranceway on ground-floor of No 12. Photograph taken facing north-east.

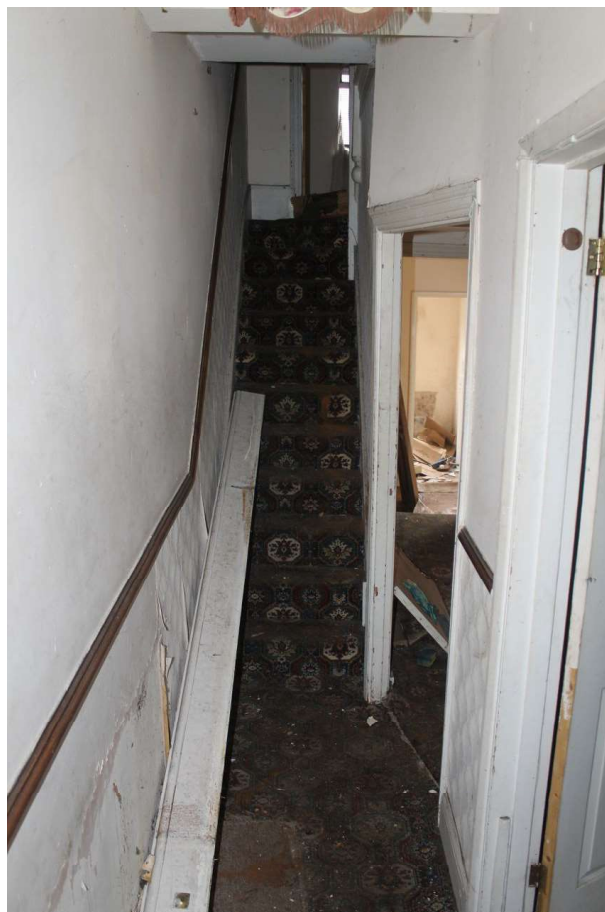
No 11 has a surviving dado rail on the both the ground, stairs and first-floor (Photograph 12).

Photograph 12 Ground-floor of No 11, showing dado rail to left of frame. Photograph taken facing south-west.

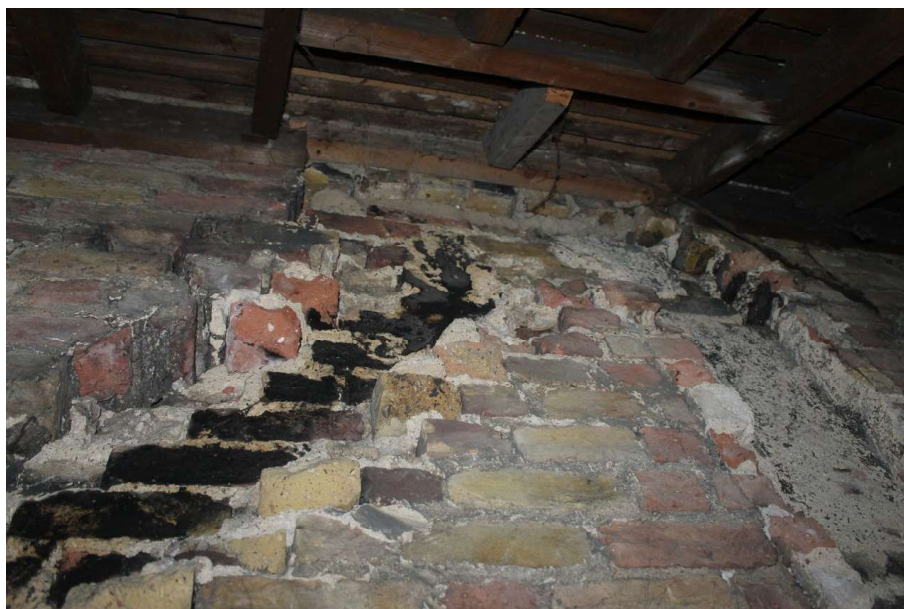
The first-floor of each of the buildings has a large bedroom to the north of the main range, taking up half the floor (Fig 3). The southern half of the main ranges at the first-floor level is divided between a smaller bedroom and a landing (Fig 3). The first-floor of the south-west wing contains a single bedroom with a fireplace (Fig 3). In Nos 11 and 12 the first-floor fireplace in the south-west wing has been removed (see above), but evidence for the chimney remains in the attic space (Photograph 13).

Photograph 13 Remains of chimney in the attic space of No 11's south-west wing. Photograph taken facing south-east.

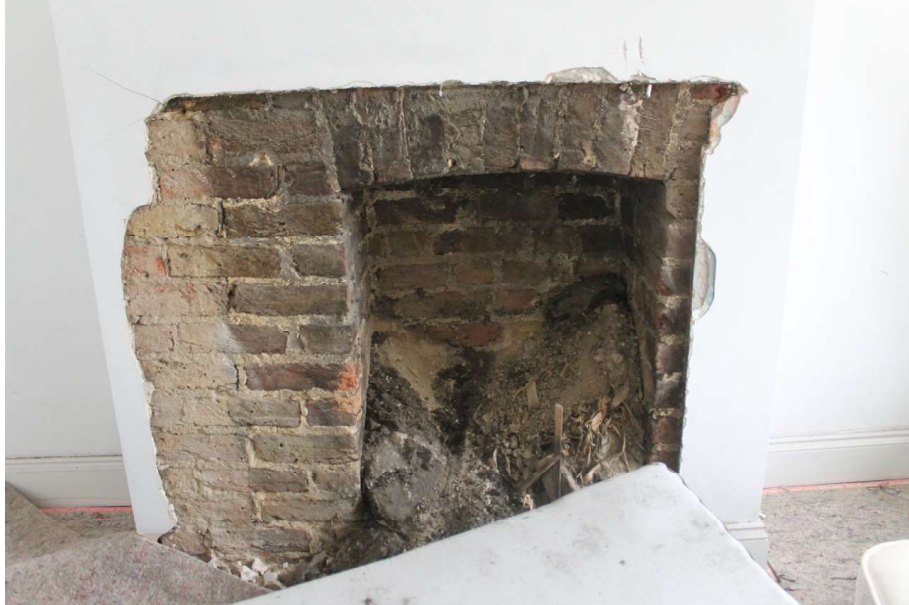
As with the ground-floor, No 10 has had the most alteration at the first-floor level, with a W.C. being inserted into the landing, removing an original wall (Fig 3). More space has been created in the landing to compensate for this insertion by moving the wall of the smaller bedroom (Fig 3). The northern fireplaces on the first-floor have been blocked in Nos 11 and 12, but the southern ones remain open and have brick arches above (Photograph 14). All the fireplaces on the first-floor of No 10 are still open.

Photograph 14 Exposed fireplace in southern room of main range on first-floor of No 10. Photograph taken facing south-east.
An original cupboard survives on the first-floor landing of No 12 (Photograph 15). Although the interior shelves appear to be more recent replacements, the cupboard's four-panelled door is probably original.

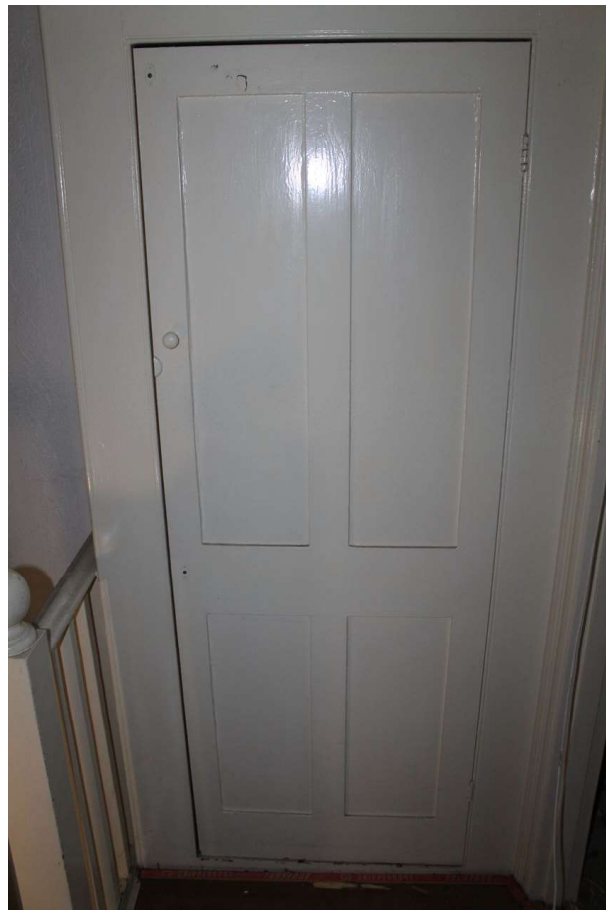
Photograph 15 Original cupboard on first-floor landing of No 12. Photograph taken facing north-west.

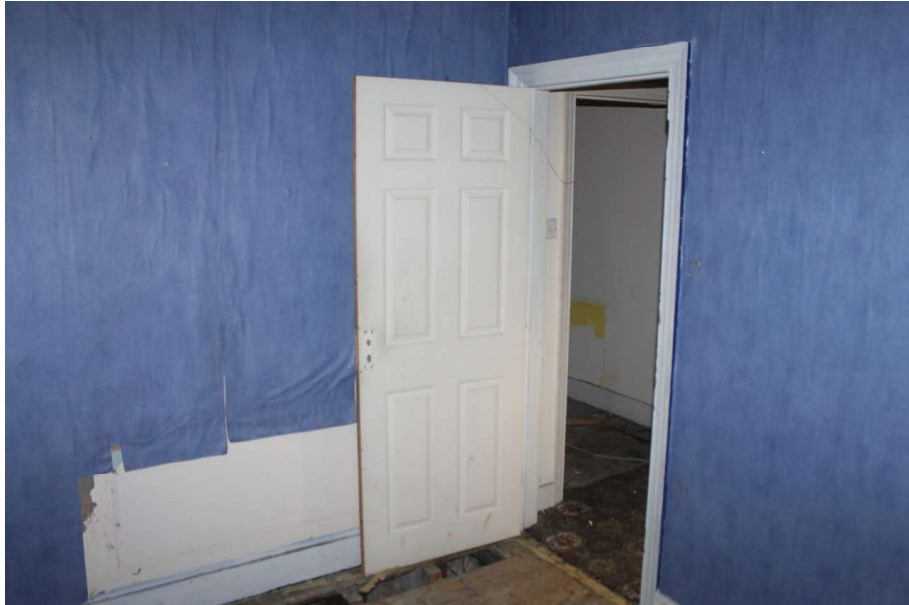
Very few doors survive on the interior of the buildings, and most of ones that do are all modern replacements (Photograph 16). The only exceptions to this are two vertical-planked doors leading into the cupboards under the stairs on the ground-floors of Nos 10 and 11, which are probably original (Photograph 17).

Photograph 16 Modern door leading into southern room on first-floor of No 11. Photograph taken facing north-east.

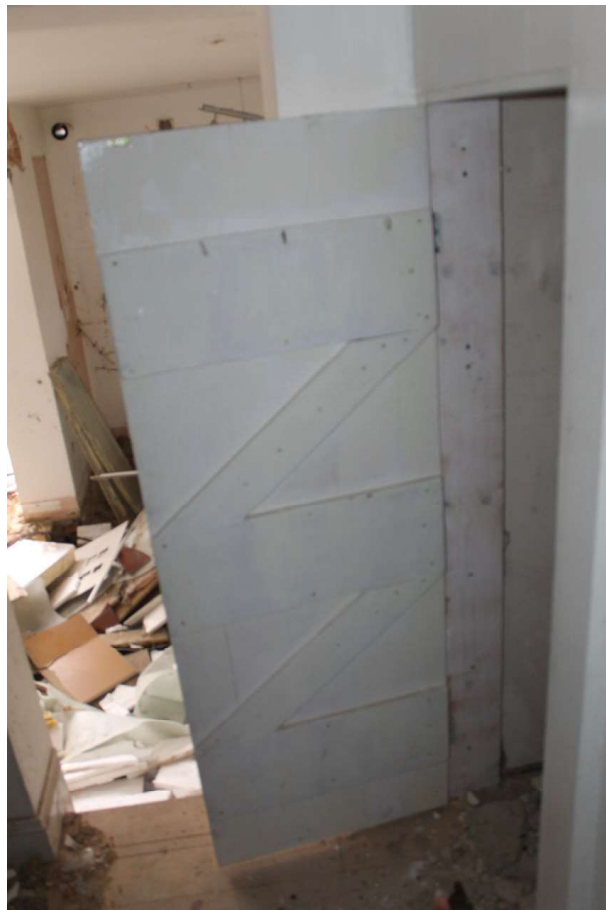
Photograph 17 Surviving vertical-planked door on ground-floor of No 10 leading into cupboard under stairs.

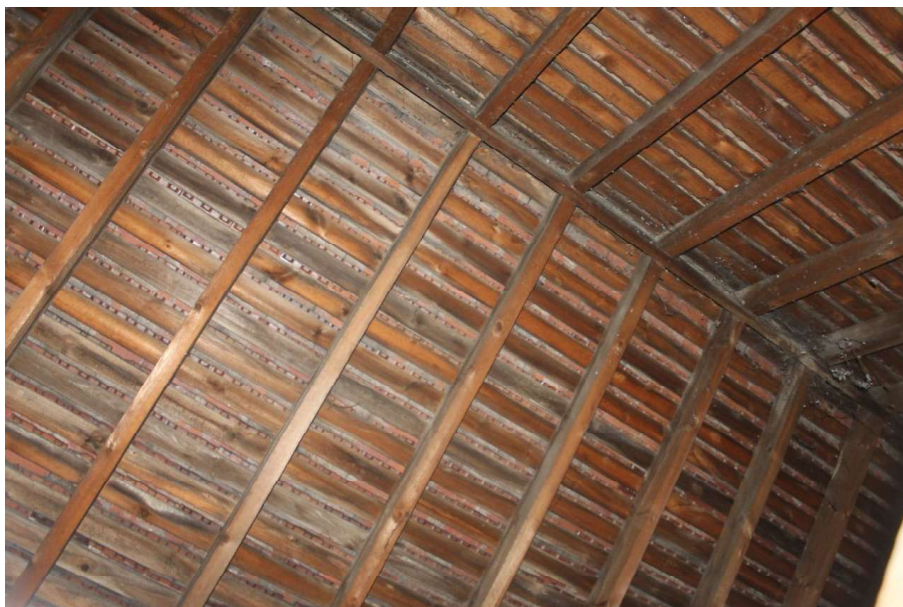
The building's roofs are partially visible through loft hatches, and are constructed of machine-cut rafters rising to a ridgeboard. They have no collars, but each roof is supported by inclined struts rising from the tie-beams.

Photograph 18 Detail of roof structure in No 10, showing rafter pairs rising to a ridgeboard with no collar support.
