Bumpstead Hall Farm, Helions Bumpstead, Essex: archaeological record

CAT Report 443
October 2007

This report provides a written and photographic record at English Heritage (2006) Level 3 of a complex of former farm buildings that includes a grade II listed aisled barn. It is intended to fulfil a condition of planning permission for domestic conversion and has been prepared to a brief designed by the Historic Environment Management team of Essex County Council (September 2006) and an associated Written Scheme of Investigation (CAT, September 2007).

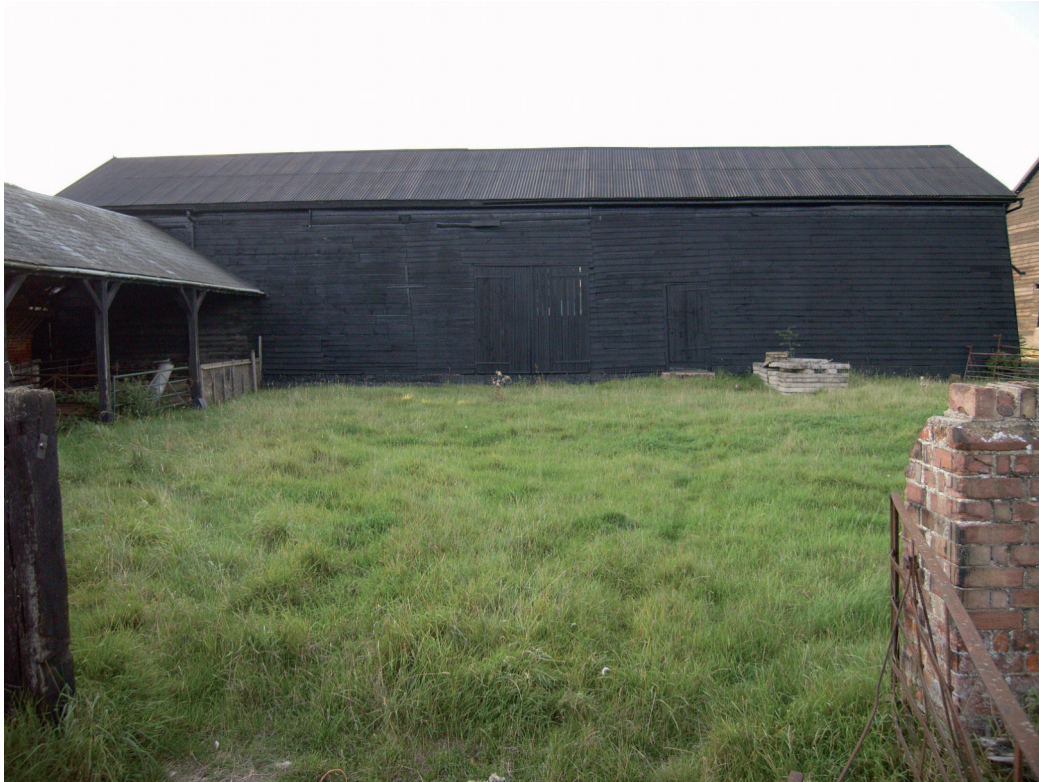
A1.1 Barn 1: exterior from south, showing elevation Q-V.

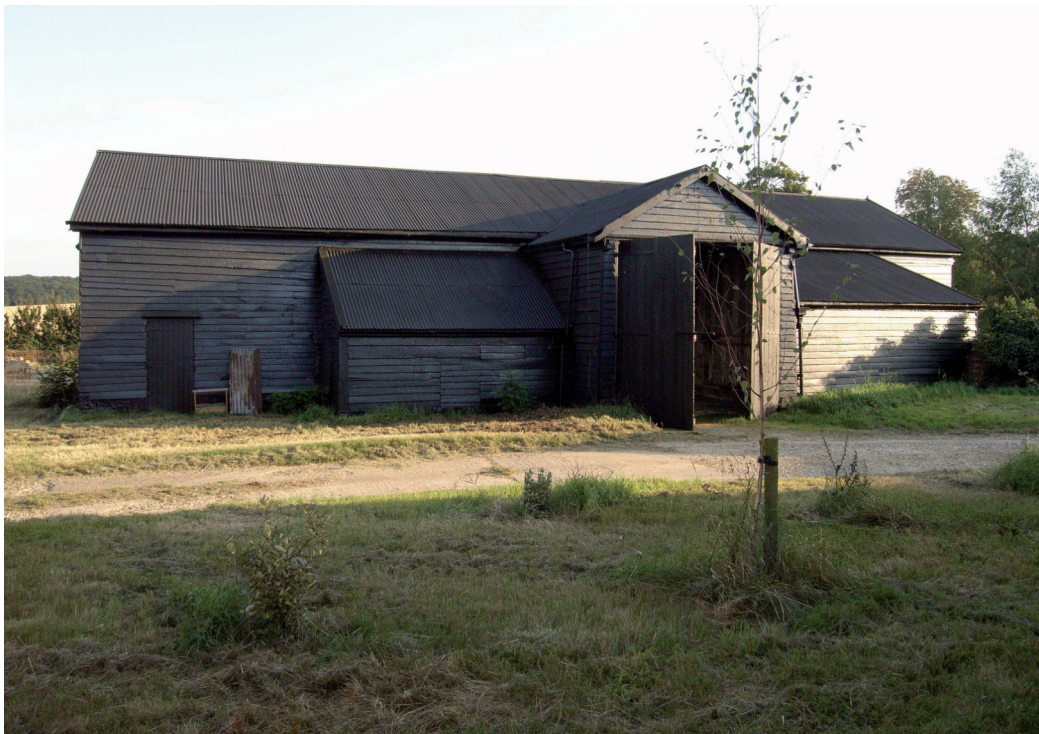
A1.2 Barn 1: exterior from north, showing later porch and lean-to.

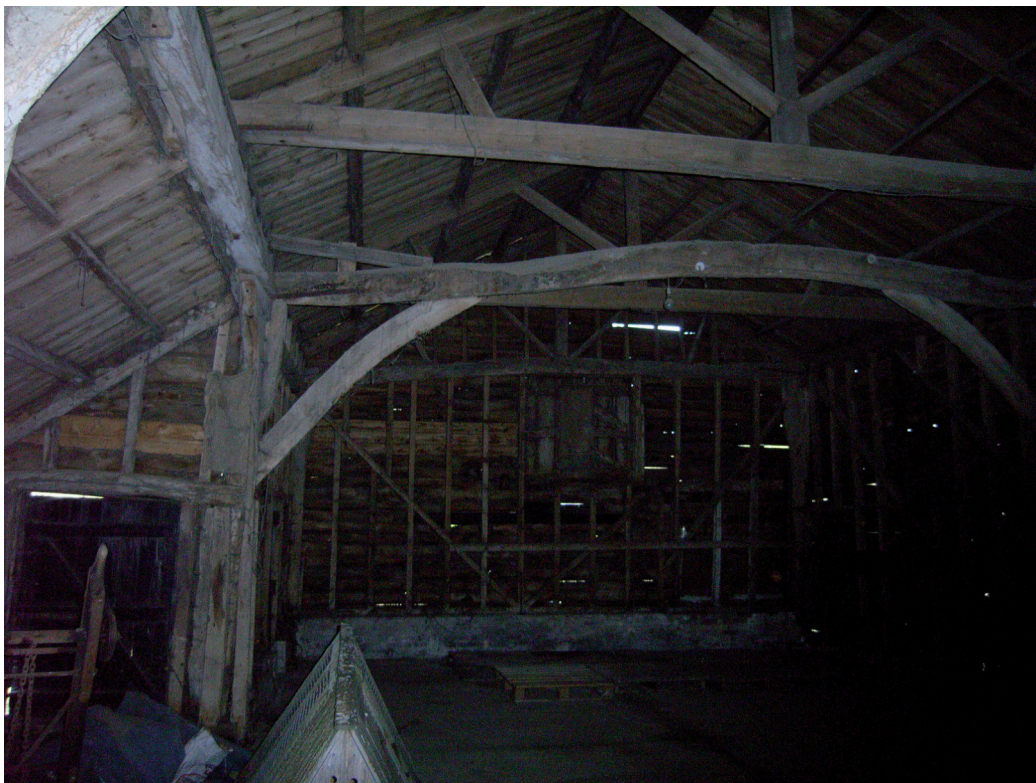
A1.4 Barn 1: general internal view from north-west, showing 1801 lean-to left.

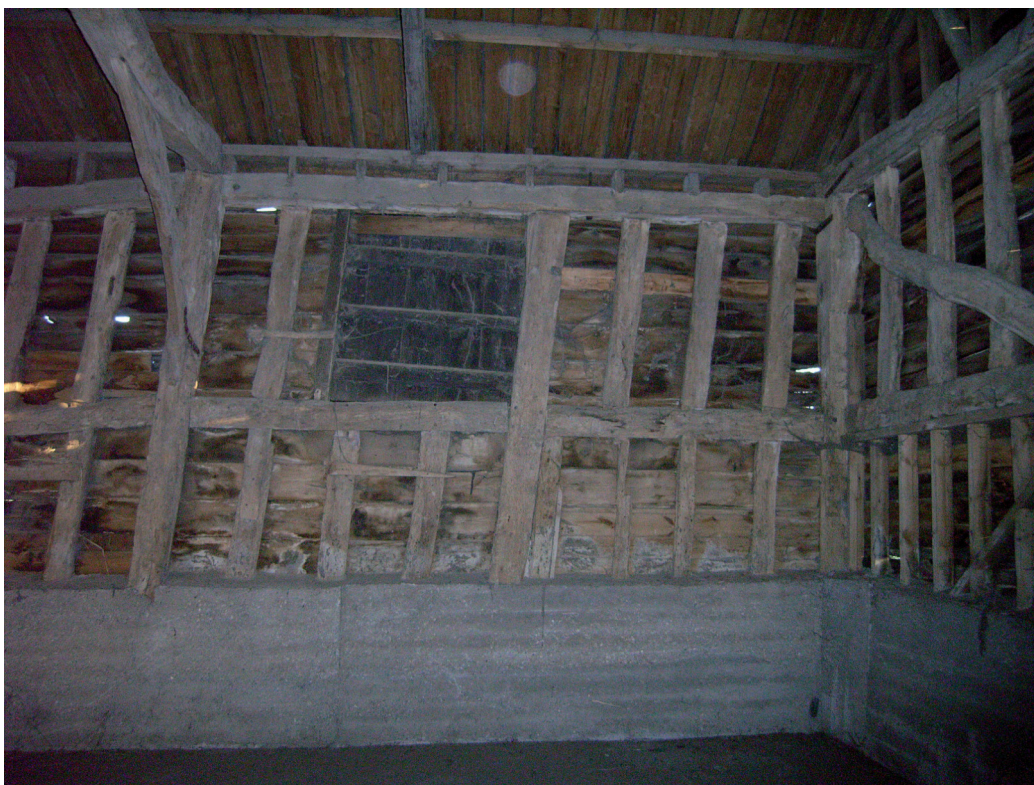
A1.5 Barn 1: internal bay R-Q showing largely original framing and later door above mid-rail (western gable to right).

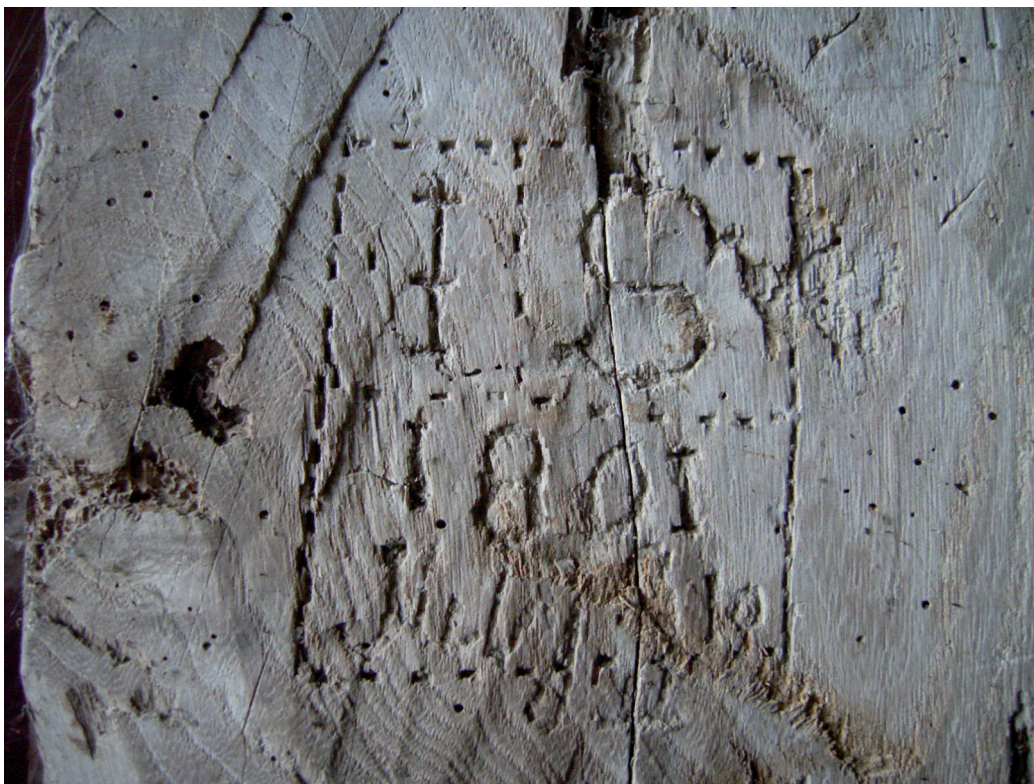
A1.6 Barn 1: detail of carving to western face of post N: 'IS 1801 July 18'.

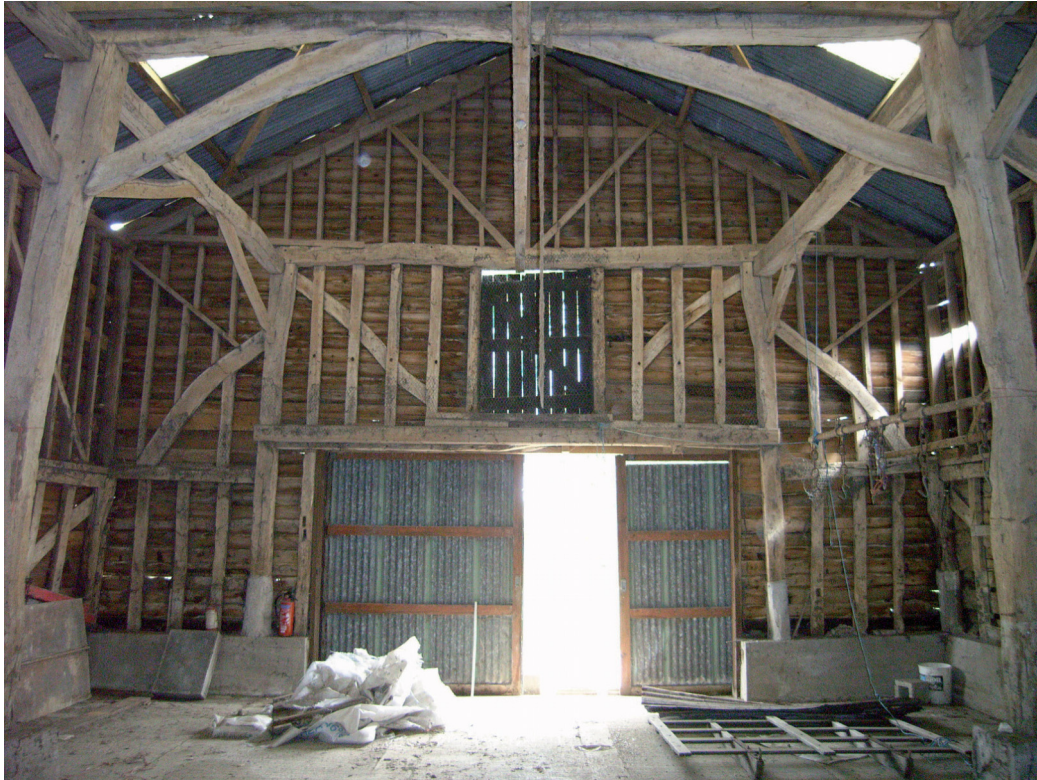
A1.9 Barn 2: interior of gable E-I showing late 20th-century sliding doors below mid-rail with early 20th-century door above.

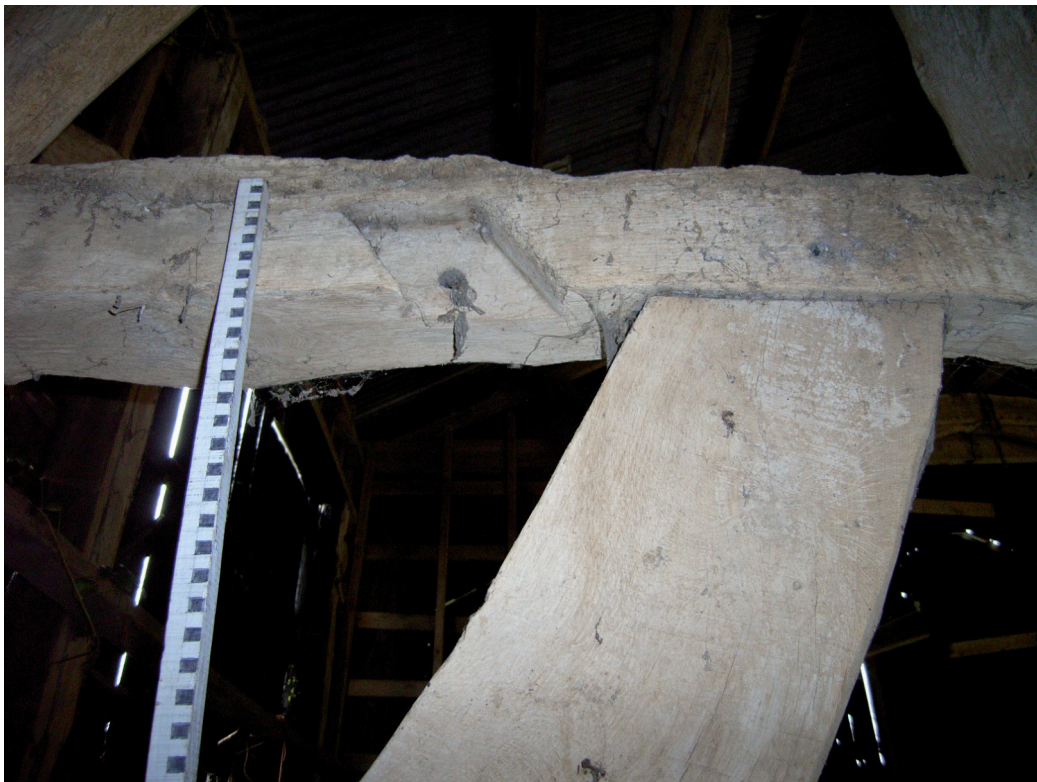
A1.10 Barn 2: detail of empty lap joint in re-used aisle tie to post I.

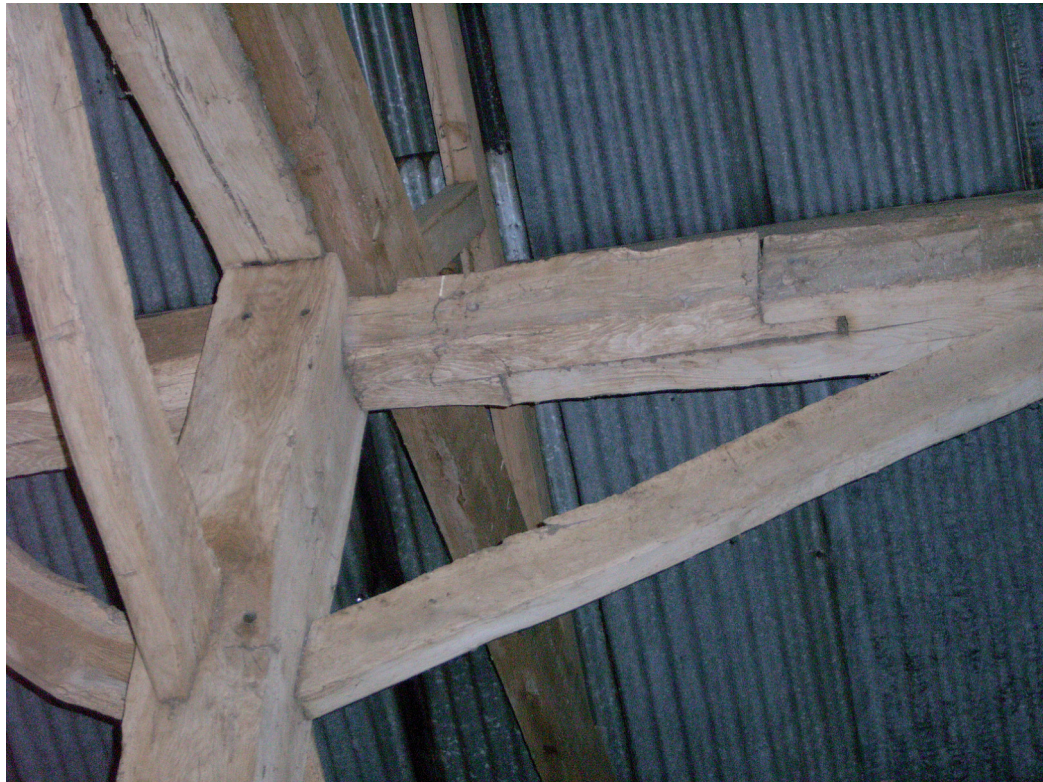
A1.11 Barn 2: detail of face-halved scarf with housed blades in bay I-H.

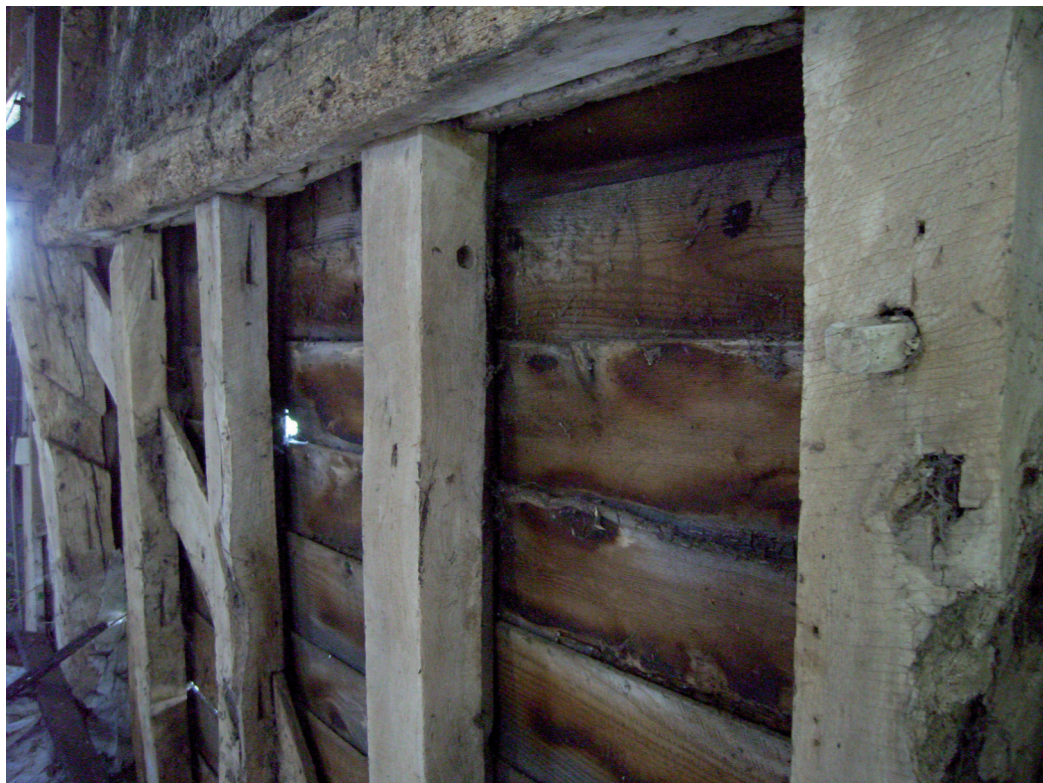
A1.12 Barn 2: detail of original studwork in bay C-D showing infill notches, external brace and passing brace trench in re-used post C to left.

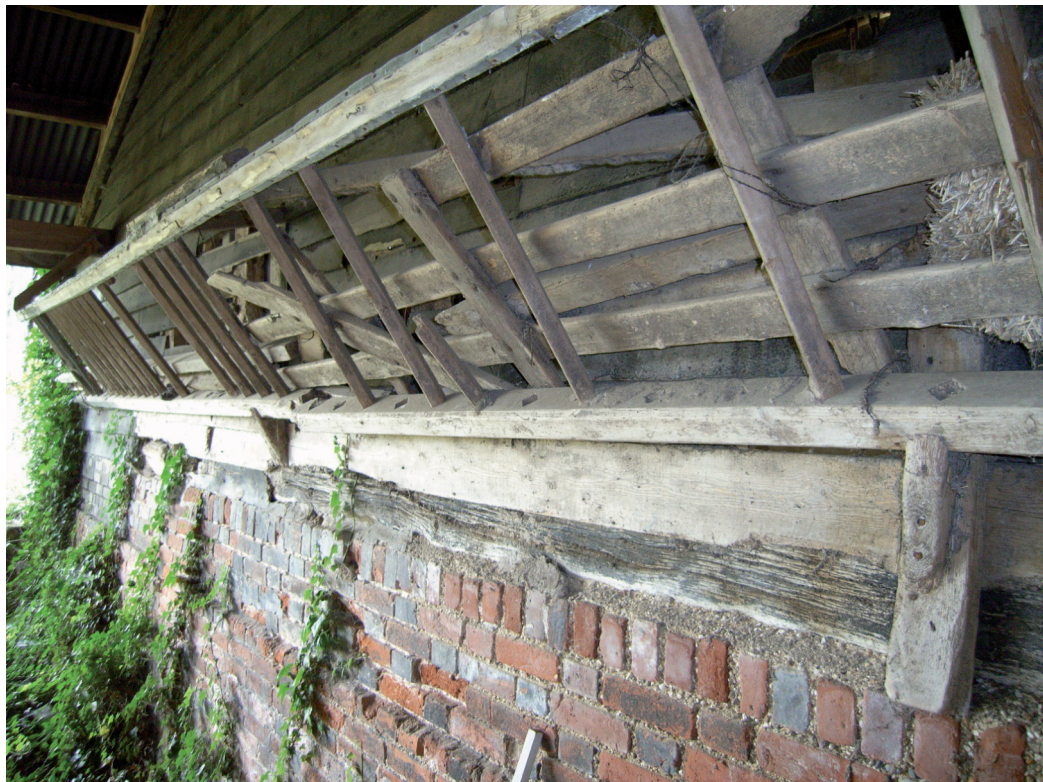
The hay-rack at the shelter's northern end consists of diamond-section rungs in the usual manner, and is 1.6 m (5 feet 3 inches) above ground-level. Its rungs are largely lacking and a number of horizontal rails have been inserted as a repair. Wooden rail fencing and straw bales bear witness to its most recent use as a sheep

A1.16 Shelter 3: detail of hay-rack from south-east showing secondary rack within.

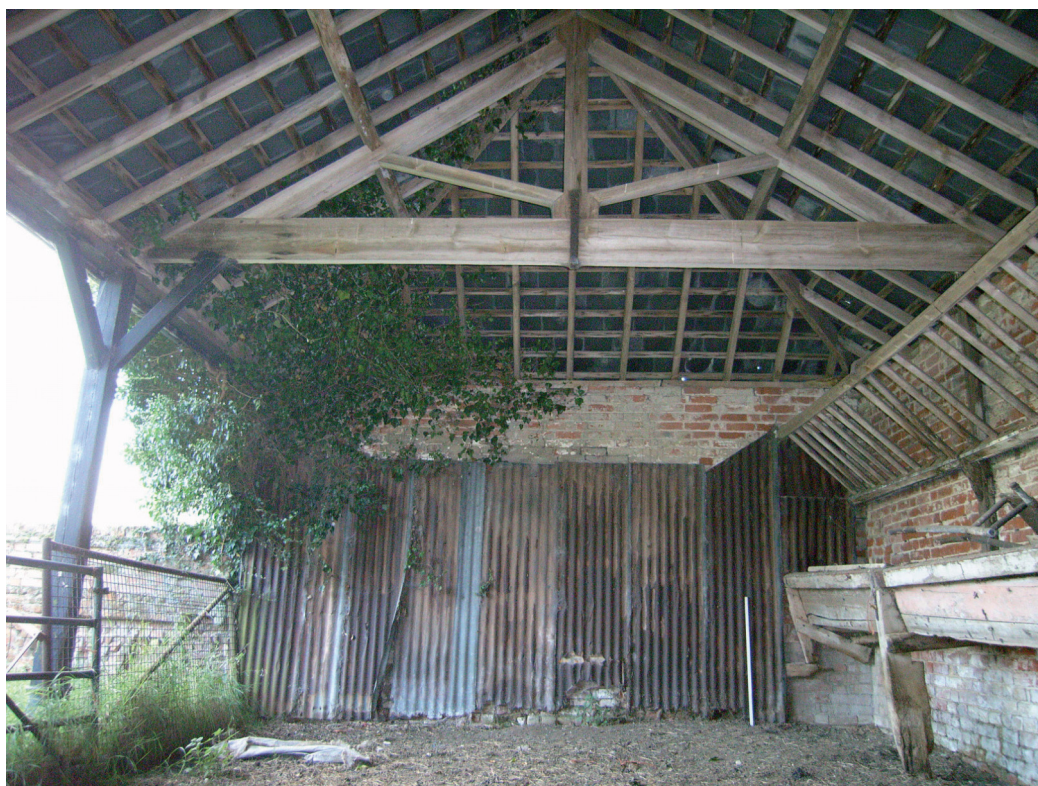
A1.18 Shelter 4: interior of southern gable showing king-post roof, manger and hay-rack.
