**A historic building survey and
archaeological evaluation by trial-trenching at
Belsteads Farm, Belsteads Farm Lane,
Little Waltham, Chelmsford, Essex**

**report prepared by
Leigh Alston, Emma Spurgeon, Adam Wightman**

**on behalf of
the Clifford Group of Companies**

CAT Report 447
December 2007

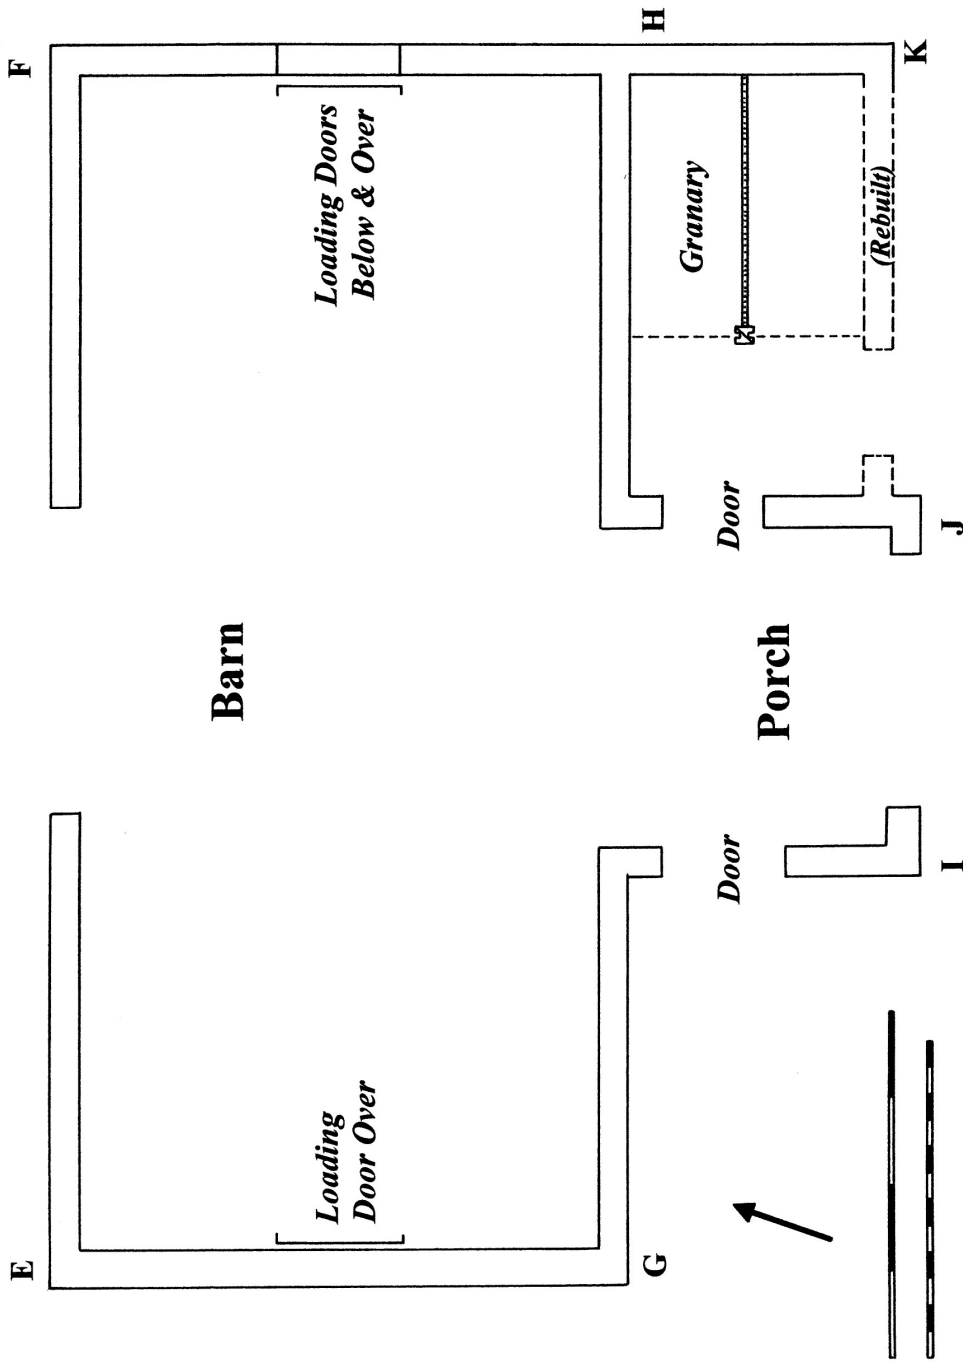
Figure 7. Ground Plan of Building 2

walls has caused structural failure; the southern wall (J-K in fig 7) has in consequence collapsed and has recently been entirely renewed in studwork and weather-boarding, while the eastern gable has split vertically at the junction with the main wall (point H). The remains of a pair of boarded grain bins divided by a central partition can still be seen (as shown in fig 7), with grooves for missing vertically-sliding hatches in the end-post. Given the removal of the southern wall it is now impossible to determine whether the granary was entered only from the porch or possessed an additional external door to the yard (as would be likely).

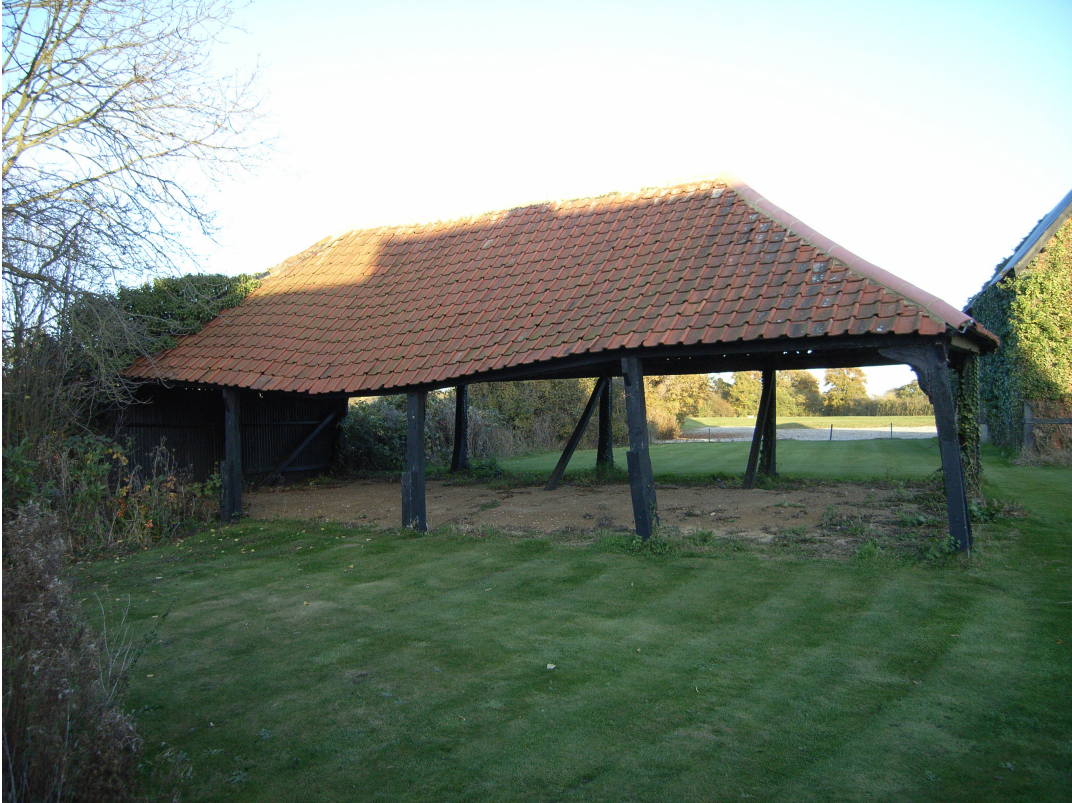
A2.5 Cart Lodge (1). External elevation from west.

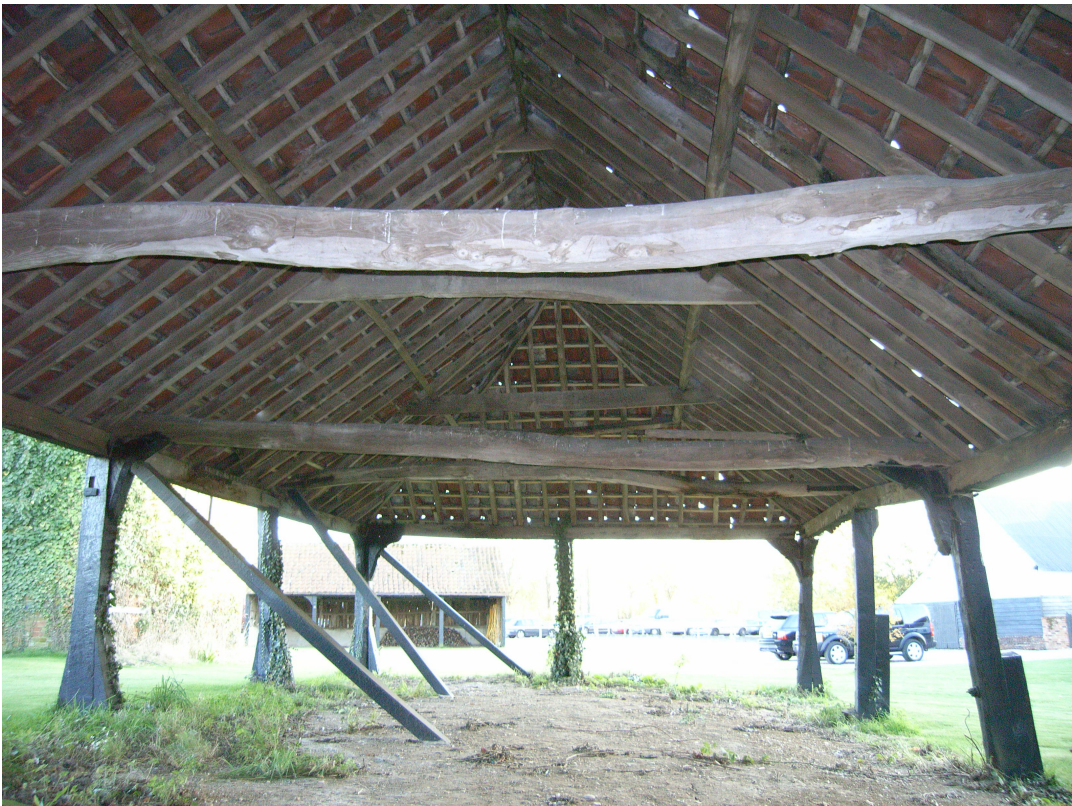
and is aligned on an approximately north-south axis. The building is currently open-sided to the south, west and east, but its northern gable, which adjoins a road boundary, is now enclosed by corrugated iron sheeting. The roof-plates rise 2 metres above the ground and are supported by apparently earth-fast oak posts of square section (15cm/6 ins) which are secured to the gable-plates and the central tie-beam by bolted knee-braces. These plates are of square-sawn elm with neatly cut face-halved-and-bladed scarf joints. The clasped-purlin hipped roof structure, which is covered with red pan-tiles and pitched at 40 degrees, consists largely of sawn softwood with nailed collars and a ridge-board. There is no evidence of any external cladding, apart from the ostensibly recent corrugated iron to the north. The building is largely intact, although various braces have been inserted to prevent collapse.

A2.6 Cart Lodge (1). Interior from north towards gable B-D. The diagonal props are recent.

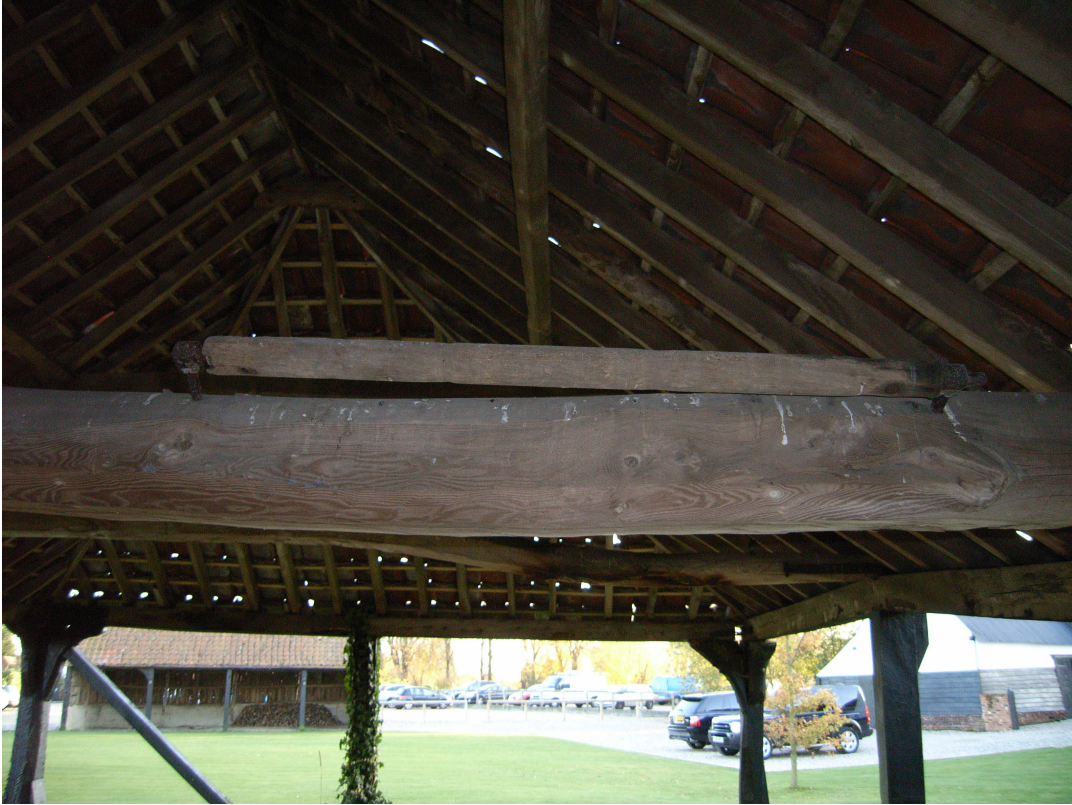
A wooden roller of similar form to that of a modern blind or roller towel is attached by iron spikes to the upper edge of the central tie-beam, as shown in photos A2.7-9. This extends to 1 metre in length and lies slightly to the west of the building's axis, as shown in figure 6. Attachments for a similar feature are visible in the southern tie-beam, but not the northern. Boards and other items were often stored above the tie-beams of open structures such as this, and these rollers, which appear to be original features, were presumably intended to assist in the process of loading and unloading. I am not aware of a comparable example elsewhere.

A2.7 Cart Lodge (1). Wooden roller on central tie-beam seen from north.

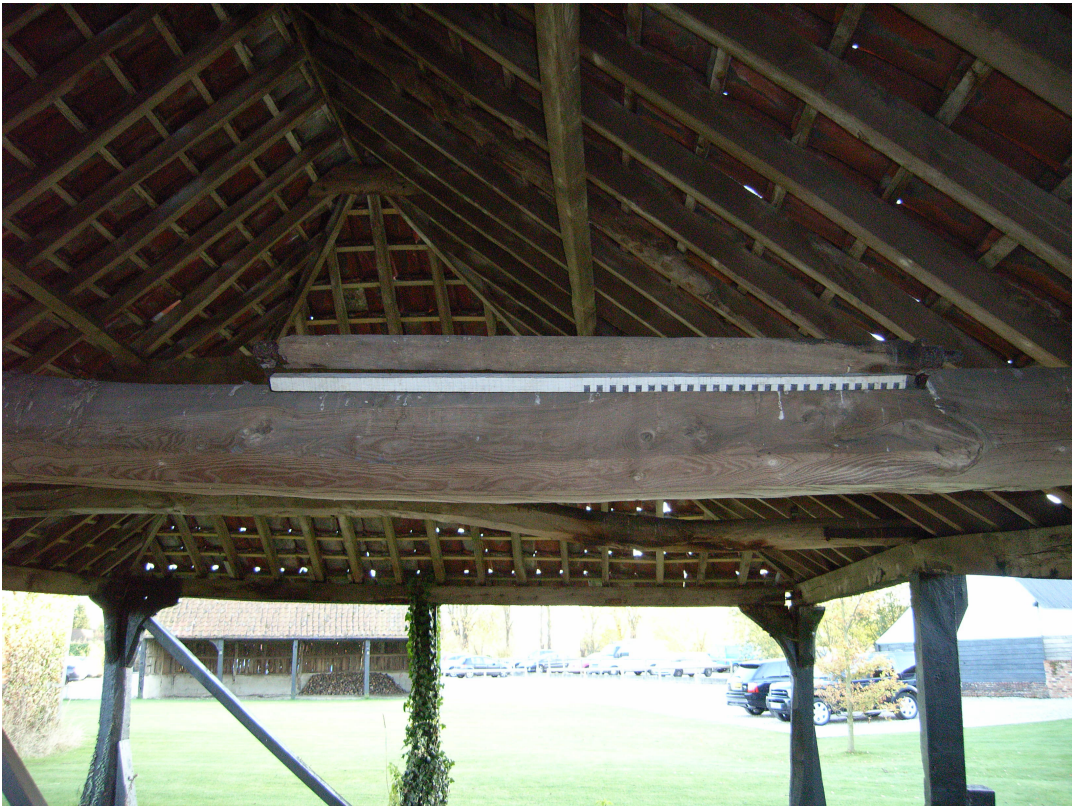
A2.8 Cart Lodge (1). Wooden roller on central tie-beam seen from north with 1 metre scale rod.

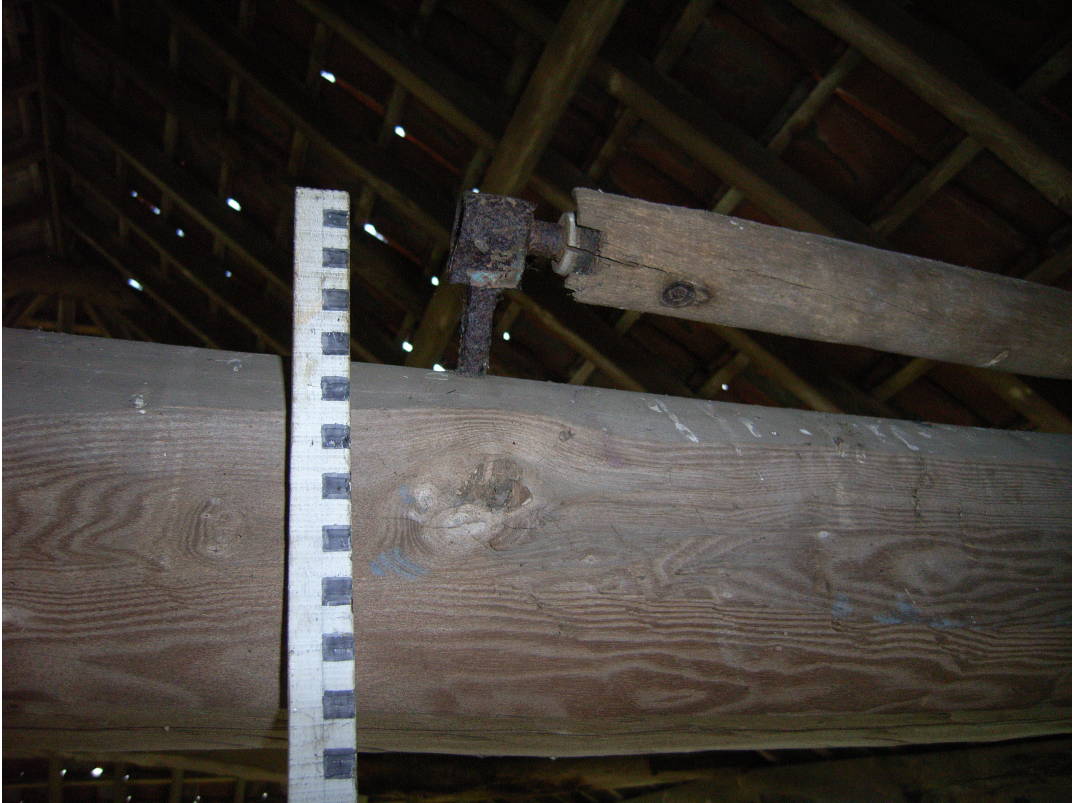
A2.9 Cart Lodge (1). Detail of wooden roller attachment seen from north

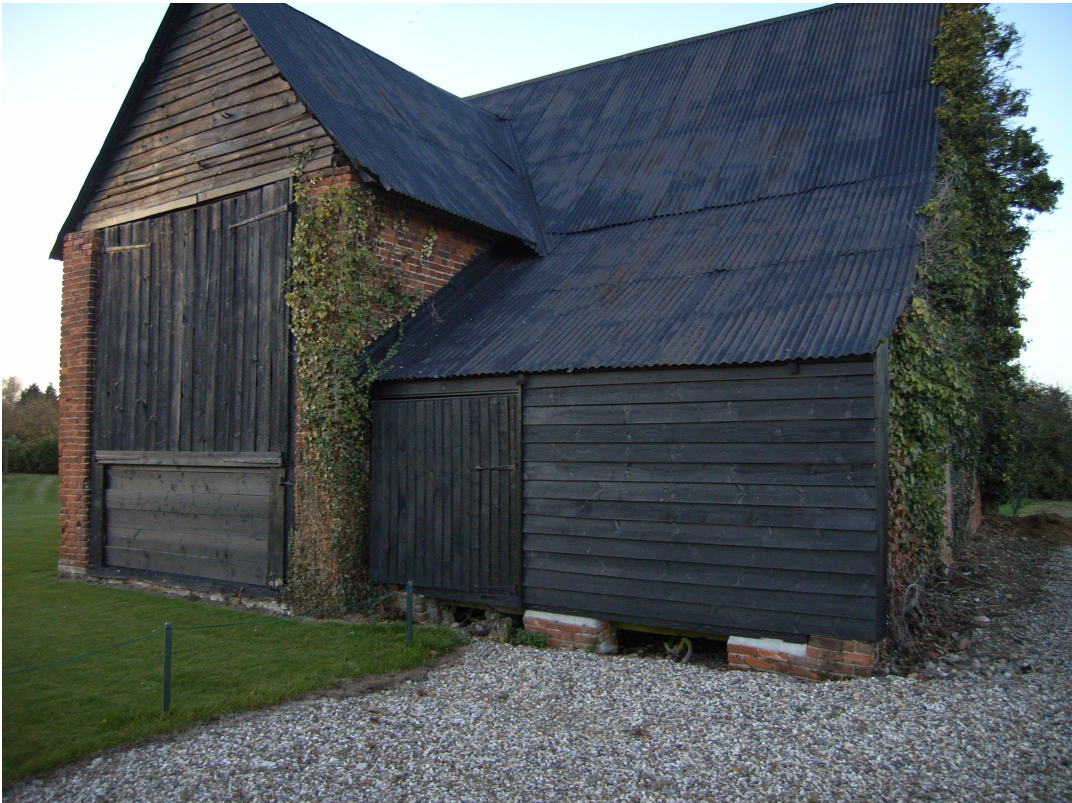
The granary in the south-eastern corner of the building is an original feature that extends to 3 metres in width by 5 in length internally (10 feet by 17). It is contained in a lean-to in the angle of the porch and southern elevation, but its brick walls were a continuation of those which formed the main range. The floor was raised from the ground on brick piers, but the subsidence of these piers under the weight of the

A2.10 Barn (2). Exterior of brick barn with lean-to granary on brick piers in south-eastern corner

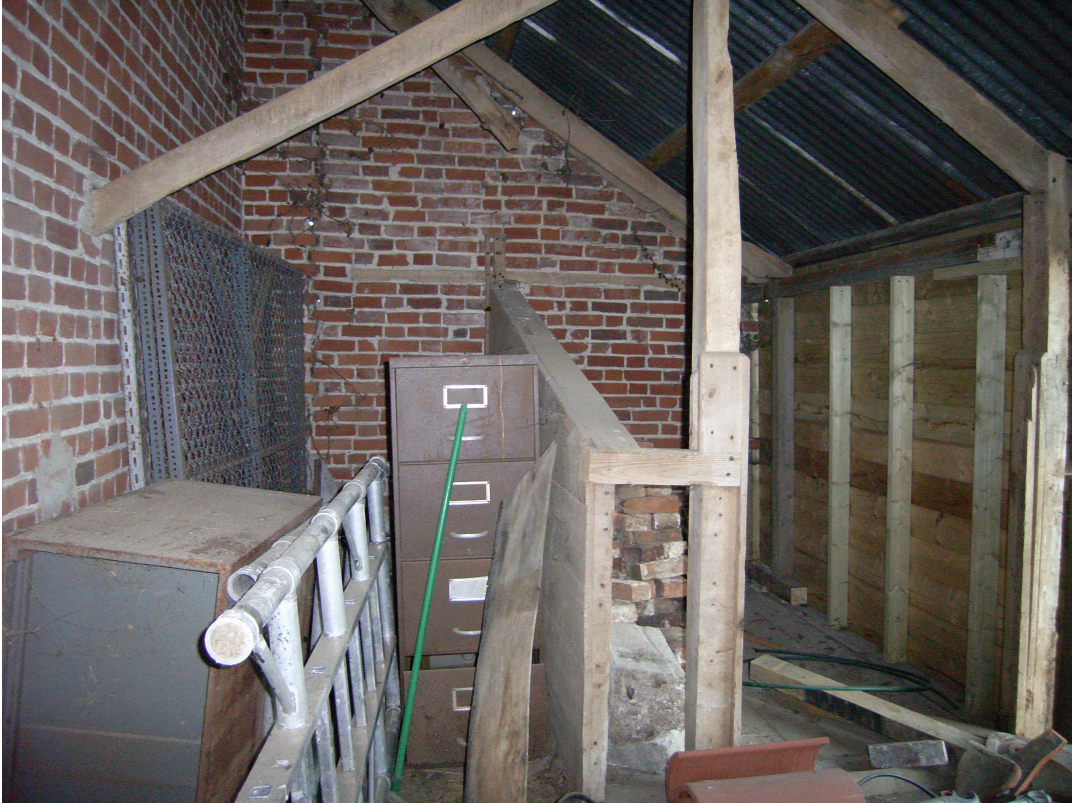
A2.11 Barn (2). Interior of granary from west with remains of two grain bins. The timber wall K-J to right is recent, apparently replacing original brickwork.

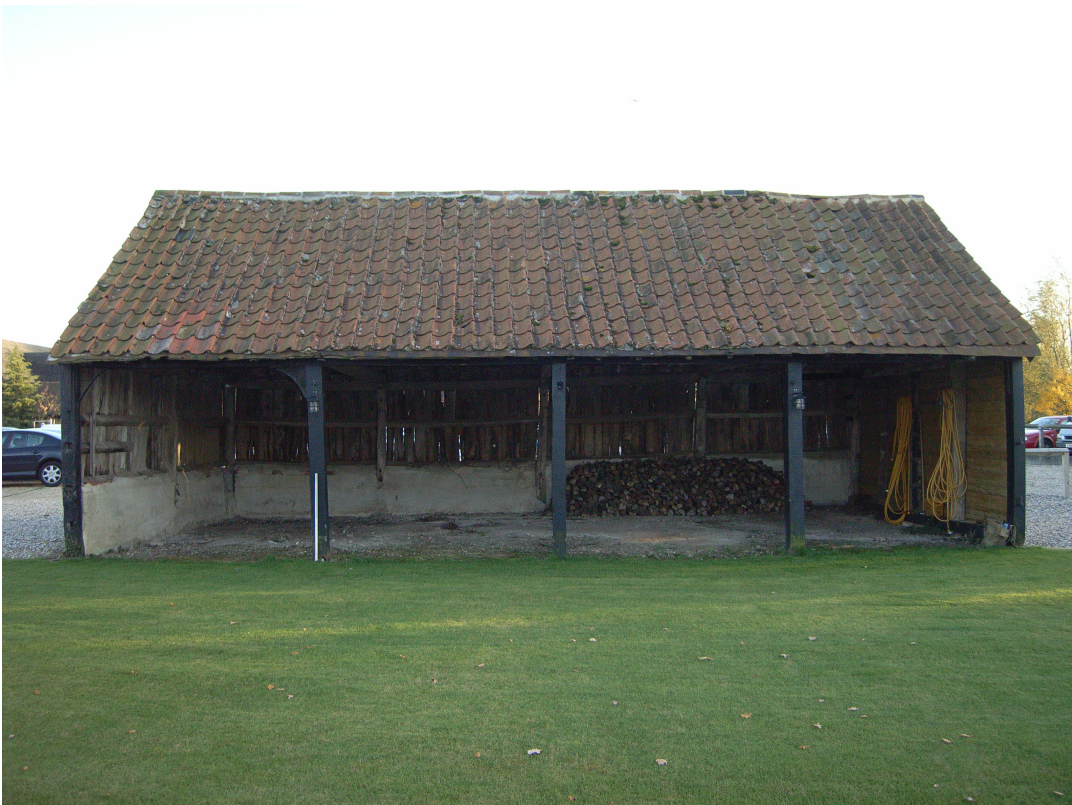
A2.12 Shed (3). Front external elevation N-O from north

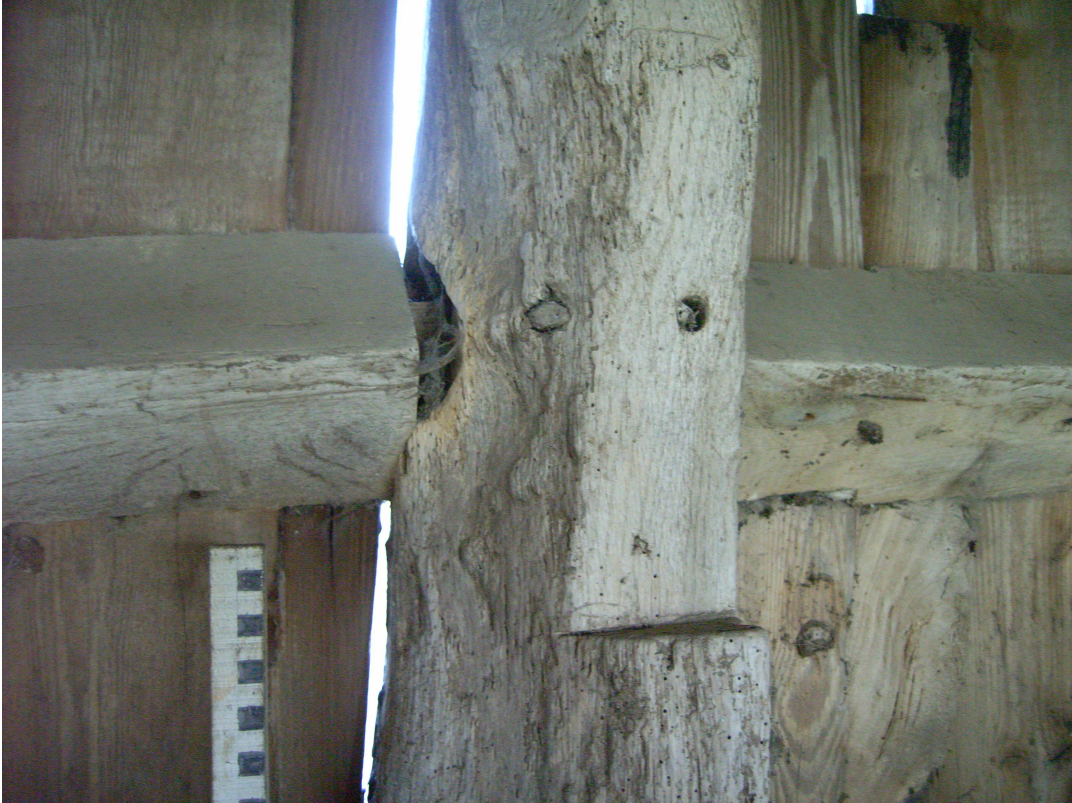
A2.13 Shed (3). Detail of a typical junction of the upper triangular rails with a post of the rear elevation, showing pegged tenons.
