**Historic building recording at
Orchard Cottage, Seven Star Green,
Eight Ash Green, Essex
CO6 3QB**

February 2020

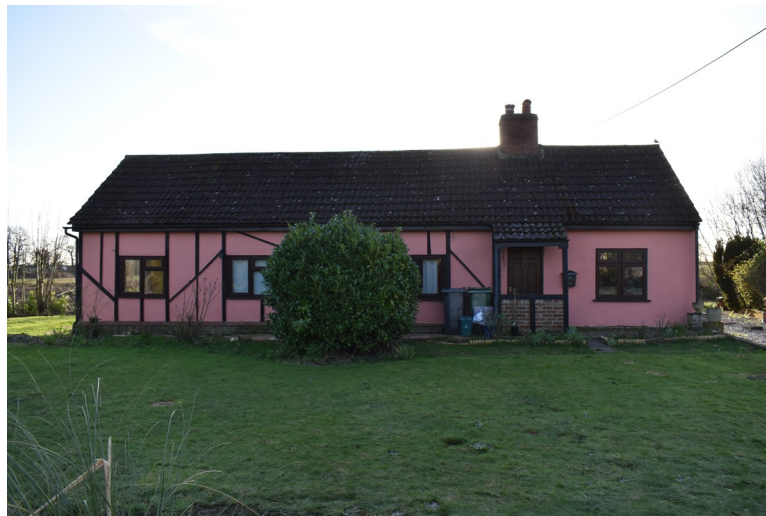
Photograph 1 The north-west elevation of the building, showing imitation timber-framing. Photograph taken facing south-east.

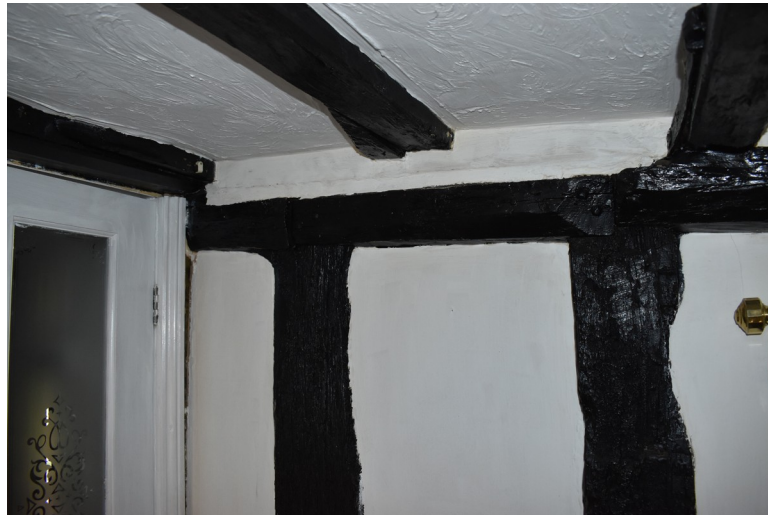
Photograph 15 Detailed shot of western girding-beam in room 8, showing repairs/replacement timbers bolted together. Photograph taken facing west.

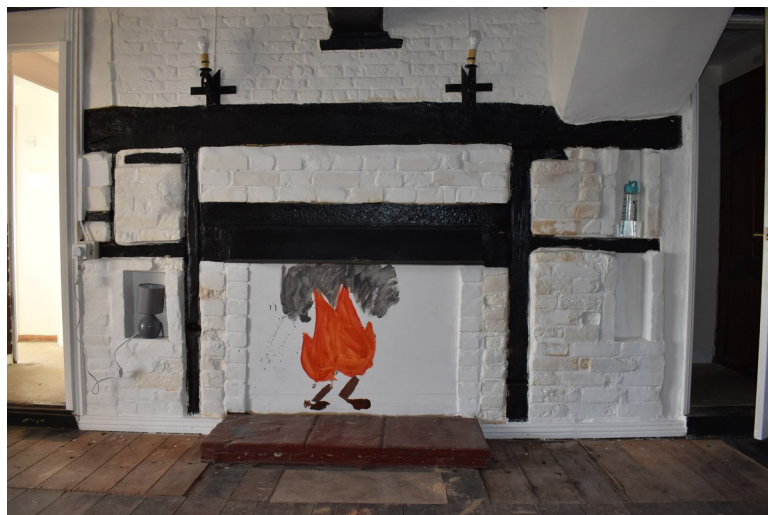
Photograph 16 Fireplace in room 8. Projection for staircase visible in top right. Photograph taken facing south-west.

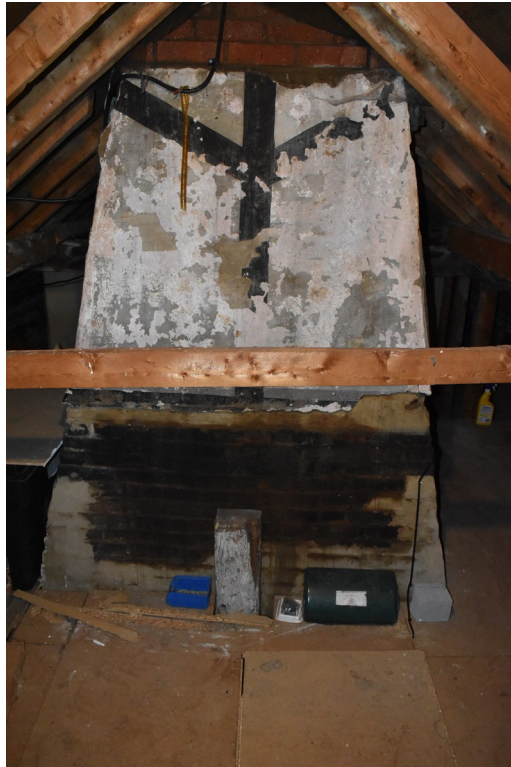
Photograph 24 South side of chimney-stack in room 15, showing exposed original brickwork. Photograph taken facing north-east.

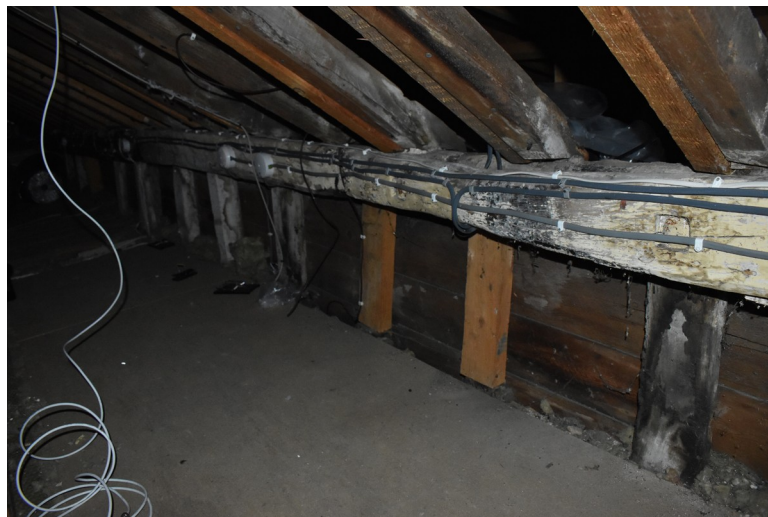
Photograph 25 Detail of eastern wall-plate of the building in the attic. Original studs visible, as well as modern replacements. Photograph taken facing east.

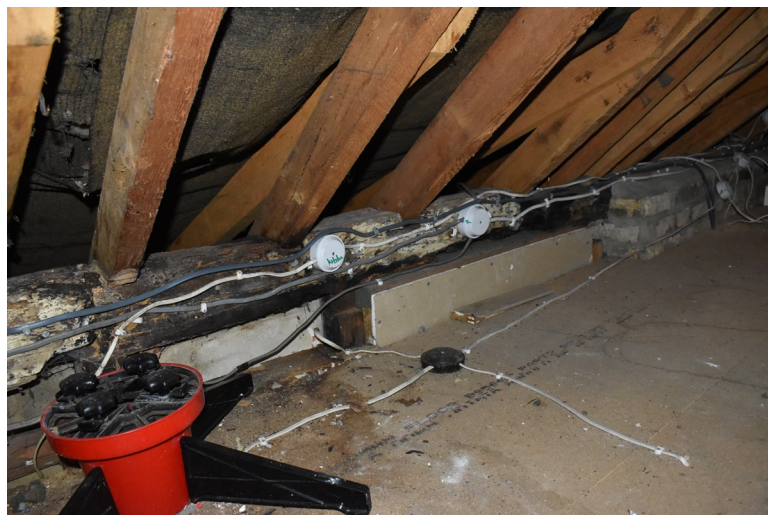
Photograph 26 Showing the end of the eastern wall-plate in the attic, abutting against modern brickwork. Photograph taken facing south.

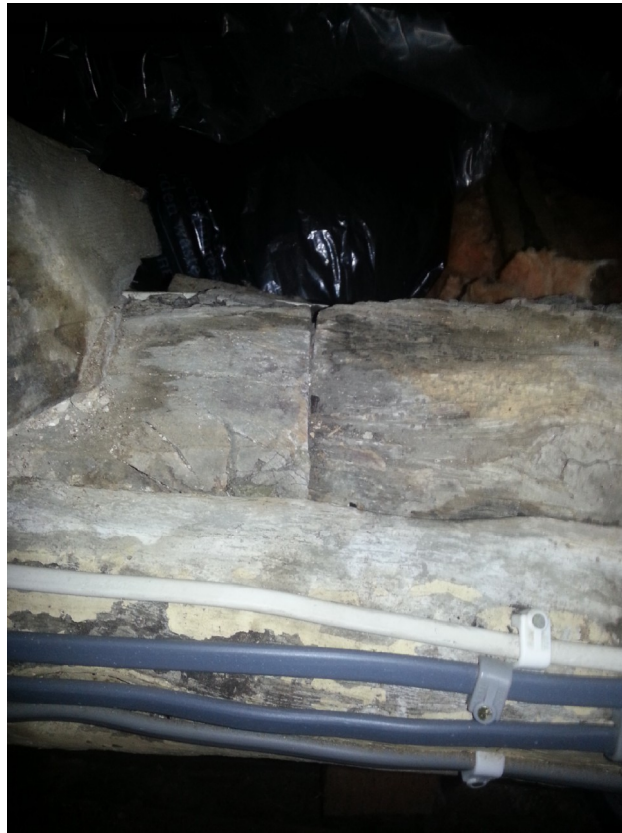
Photograph 27 Detail of possible scarf joint on eastern wall-plate, with timber addition to face of wall-plate visible. Photograph taken facing south-east.
