Historic building recording at Glencoe and Sunnyside, Severalls Hospital, Tower Lane, Colchester, CO4 6DF

June 2020

CAT project ref.: 2020/021
NGR: TL 99216 28807 (c)
CHER number: ECC4442
OASIS project id: colchest3-386741

CAT Report 1589
August 2020

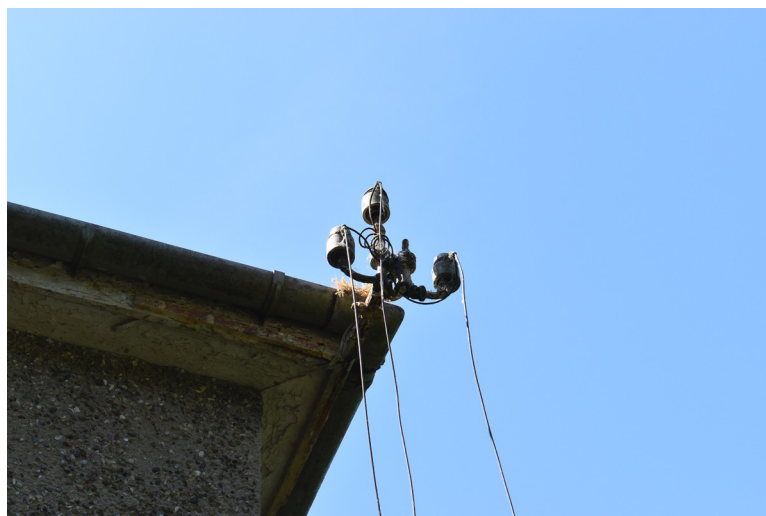
Still surviving on the corners of the building are the original ceramic electrical terminals for overhead power cables (Photograph 6).

Photograph 6 Detail of ceramic terminals on the corners of the building. Photograph taken facing west.

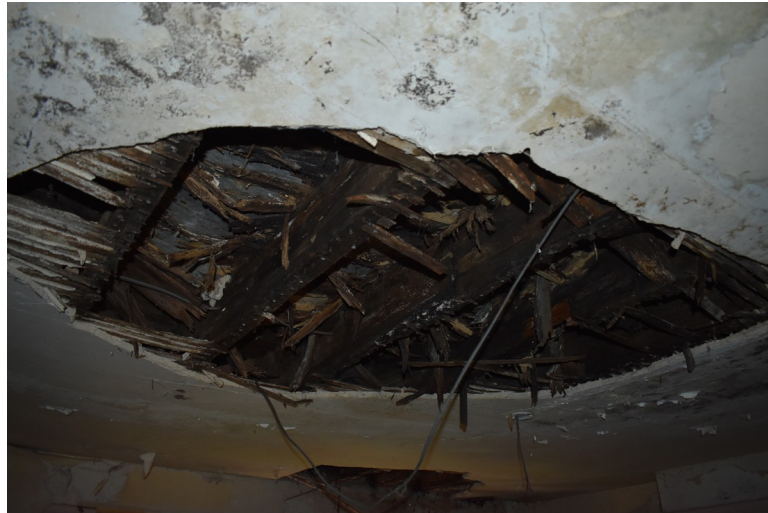
This room is 3.5m x 4m in size and has a chimney-breast on its eastern wall, containing a fireplace with a tiled-surround which is probably a later insertion dating from the 1930s (Yorke 2006, 82). The window in this room, as in every other room in the building, has decorative spiral handles (Photograph 10). This room has a decorative dado rail and picture rail, along with vinyl flooring. Room 1b is identical except the room's fireplace has been blocked and replaced with an electric heater, and it has suffered additional damage due to the partial collapse of the ceiling above, exposing the joists (Photograph 11). Many of the

Photograph 11 Detail of damaged ceiling above room 1b, showing exposed joists. Photograph taken facing west.

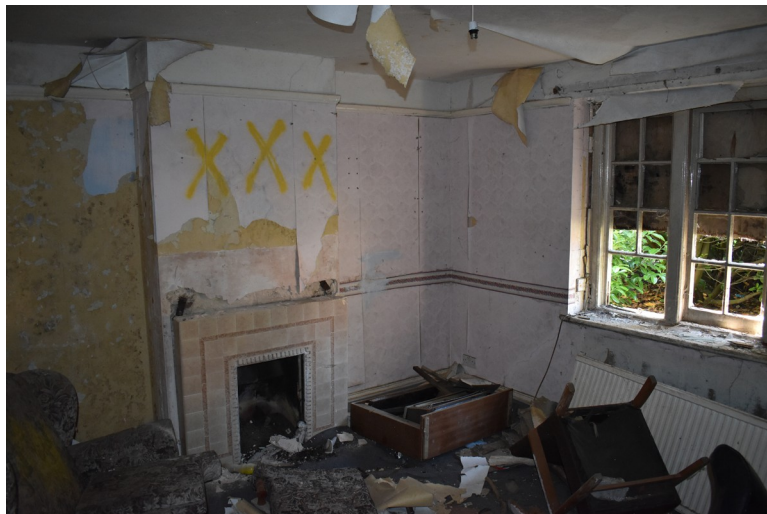
This room is 3.5m x 3m in size and has a chimney-breast on its eastern wall, again containing a fireplace with a tiled-surround (Photograph 12). This room has a decorative dado rail and picture rail, along with vinyl flooring. Room 2b's fireplace has been blocked and on its western wall, south of the blocked fireplace, is a medicine cabinet (Photograph 13). Room 2b has a carpeted floor, but beneath it, partially visible, are vinyl tiles.

Photograph 12 Interior of room 2a. Photograph taken facing south.

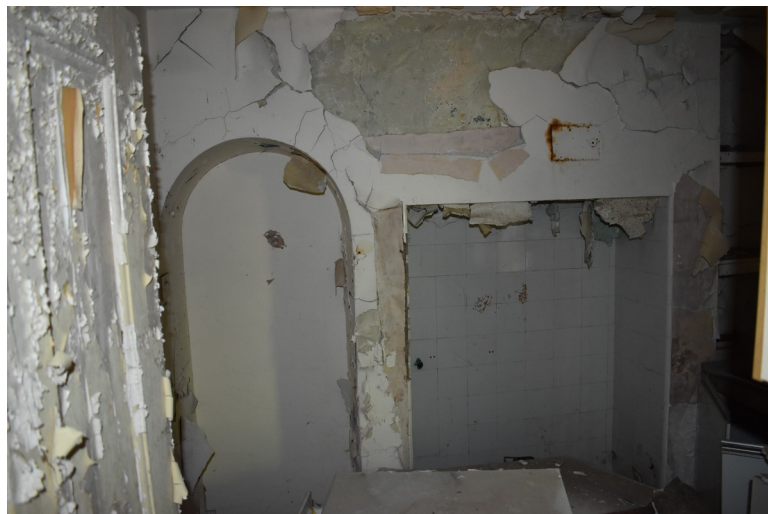
Photograph 15 Room 3b, with stoking hole visible above alcove. Photograph taken facing north-west.

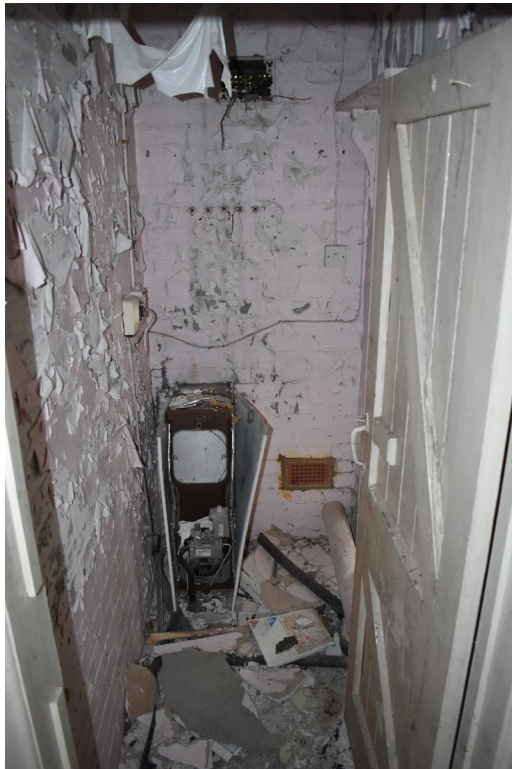
Photograph 18 Room 6a, showing vertical-planked door, visible brickwork and vent. Photograph taken facing north-east.

This room is a small storage/boiler room, measuring 1.9m x 1m in size. It was originally accessed by a doorway from room 5a, but that has been blocked and a new doorway has been made leading into the room 4a (Fig 2). This new doorway is filled by a plank-and-batten door with vertical-planks and cross-bracing (Photograph 18). The walls of this room are painted brickwork, unlike the rest of the building which has rendered walls. The room has vinyl flooring. On the room's northern wall is a small metal vent (Photograph 18). Room 6b still has its original opening (and has no inserted entrance into room 4b) but has been converted in to a shower room with tiled walls.

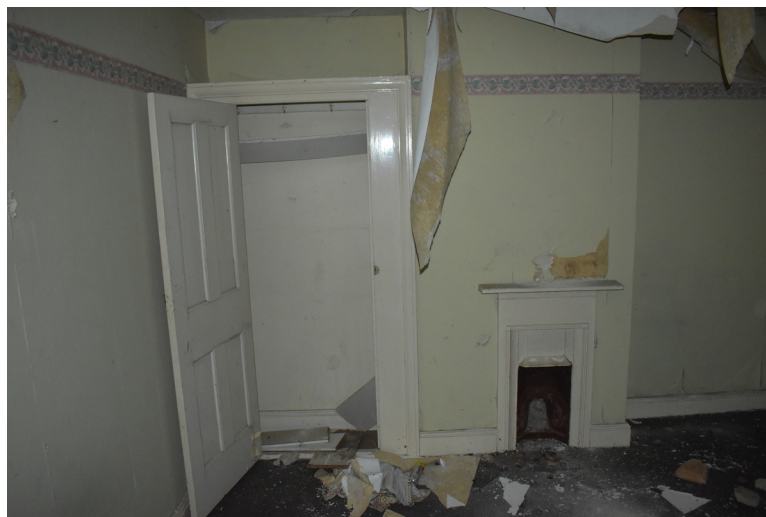
This room is directly above room 1a and is the same size: 3.5m x 4m. The room has a chimney-breast on its eastern wall containing an off-centre small fireplace with a narrow fluted surround and a mantelshelf above (Photograph 19). This

Photograph 19 Room 7a, showing original fireplace and cupboard. Photograph taken facing south-east.

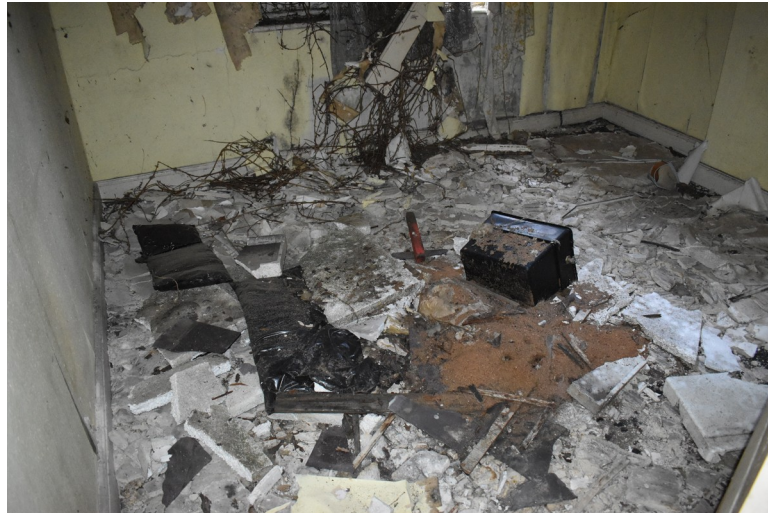
fireplace style is notably different than the 1930s tiled examples on the ground-floor (see above) and is probably original to the building. To the north of the chimney-breast is a cupboard with a four-panelled door, which is also probably original. Room 7b's fireplace has been blocked and the room is also in much poorer condition than room 7a; the roof has partially collapsed, causing significant damage (Photograph 20).

Photograph 20 Room 7b, showing damaged caused by collapsed ceiling. Photograph taken facing south-east.

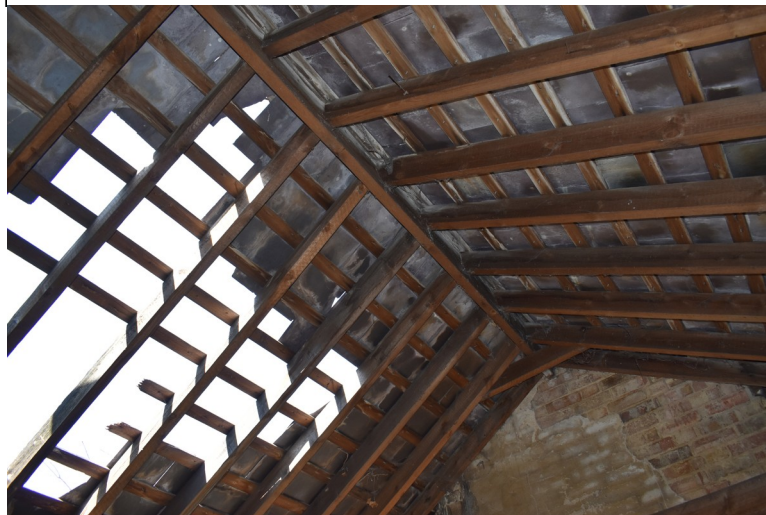
The roof above the western side of the building is substantially damaged, correlating to the damage in room 7b (Photograph 26).

Photograph 26 Roof structure above rooms 7b and 9b, showing damage to roof fabric. Photograph taken facing west.
