**Historic building recording at the
former Great Wigborough Village Hall,
School Lane, Great Wigborough, Essex
CO5 7RJ**

June 2020

CAT project ref.: 2020/05h
NGR: TL 96688 15291 (c)
CHER number: ECC4524
OASIS project id: colchest3-395321

CAT Report 1594
September 2020

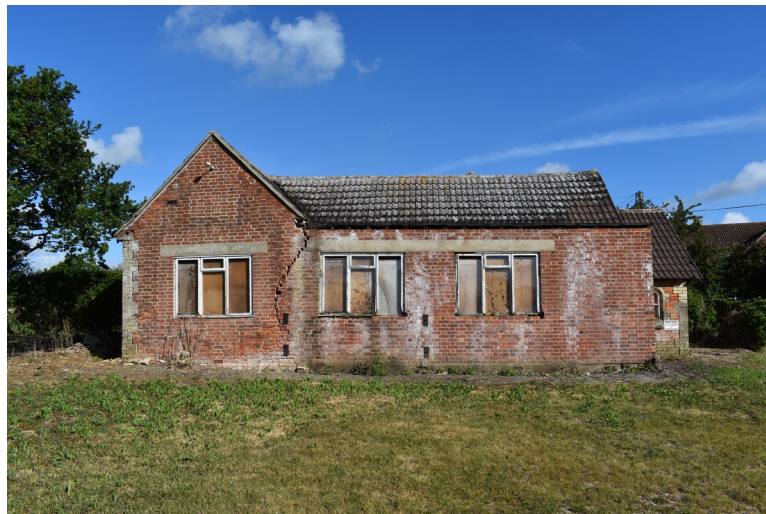
Photograph 8 South-east elevation of building. Note structural damage and modern windows with substantial concrete lintels. Photograph taken facing north-west.

The south-east elevation of the building has three identical casement/awning windows, with substantial concrete lintels (Photograph 8). Four small tie-plates are present on this elevation, and are presumably the result of repair work. They have been limited in their effectiveness, however, as a substantial crack in the brickwork of this elevation is visible in the join between the flat-roofed extension and the gable-end (Photograph 8).

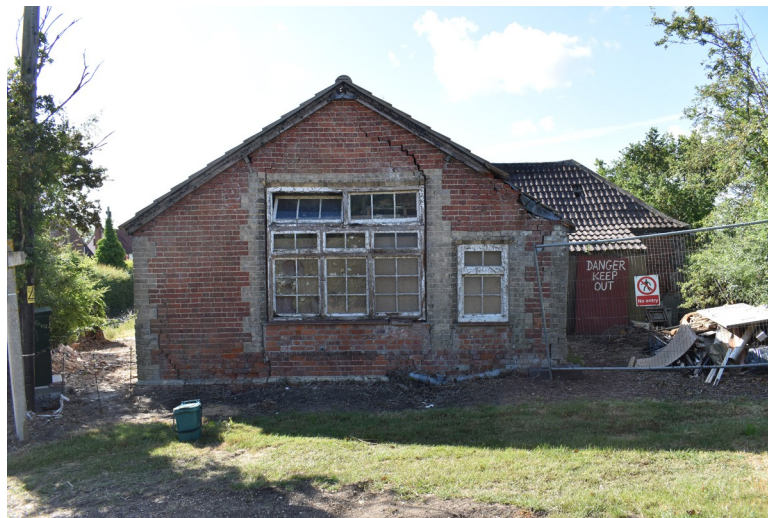
The north-west elevation of the building is dominated by a large 30-light fixed/awning window, again with a moulded yellow brick surround (Photograph 15). Like the dormer window on the north-east elevation, however, the surround continues below the current modern window, with the space below it having been bricked up. There is a smaller six-light awning/fixed window on this gable end with identical bricking-up and surrounds (Photograph 15).

Photograph 15 North-west elevation of building, showing inserted windows in original partially bricked-in window openings. Photograph taken facing south-east.

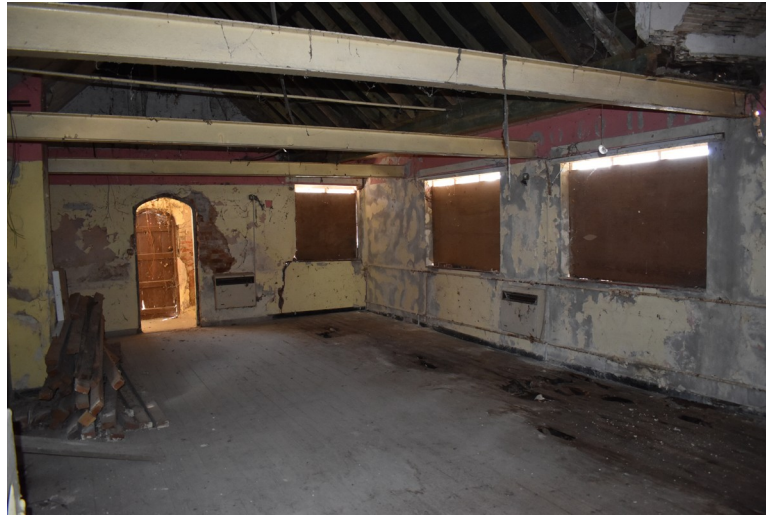
Photograph 16 Southern room of building, showing metal beams and damaged floorboards. Photograph taken facing east.

The southern room is formed by the entire footprint of the cross-wing and south-west range, combined with the flat-roof extension to the south. Any internal divisions have been removed and the room measures 11.1m x 5.8m in size (Photograph 16). The north-western wall of the room has two fireplaces, the eastern one of which is blocked, while the western one contains an inserted modern fireplace (Photograph 17). The floor of the room consists of regularly sized 130-140mm wide floorboards, many of which have been heavily damaged by rot (Photograph 17). The floor of this room is significantly lower than the rest of the building; the doorway leading into the northern room is some 400mm higher than this room's floor-level.

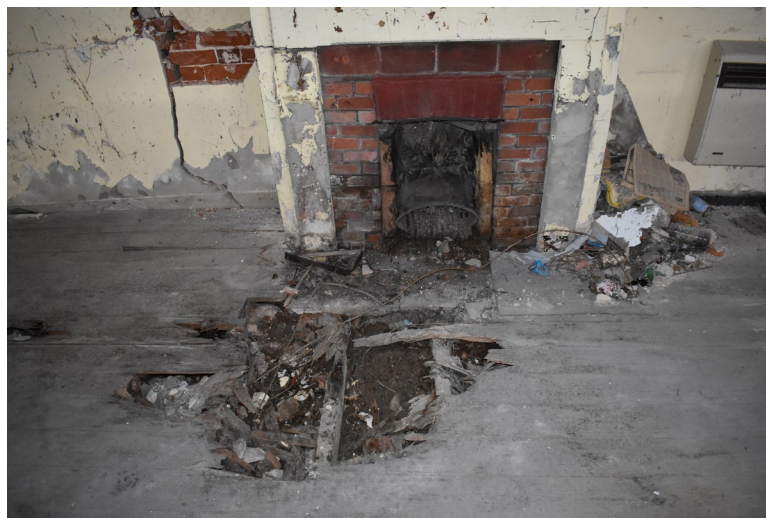
Photograph 17 Detail of inserted fireplace in western chimney-breast of southern room. Damaged section of floor visible in front. Photograph taken facing north-west.

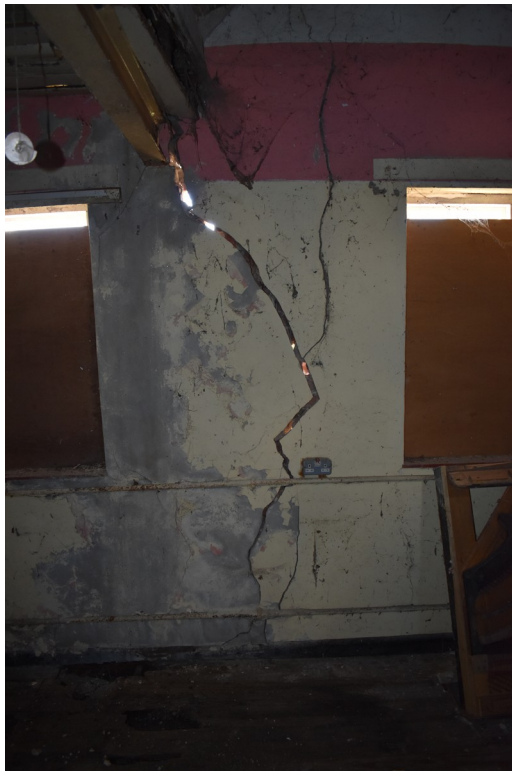
This room, and indeed the building as a whole, has some serious structural issues. Most notably, there are several very substantial cracks in the brickwork on multiple elevations in this room (Photographs 19-20).

Photograph 19 Serious structural problems evident on south-east elevation of southern room. Photograph taken facing south-east.

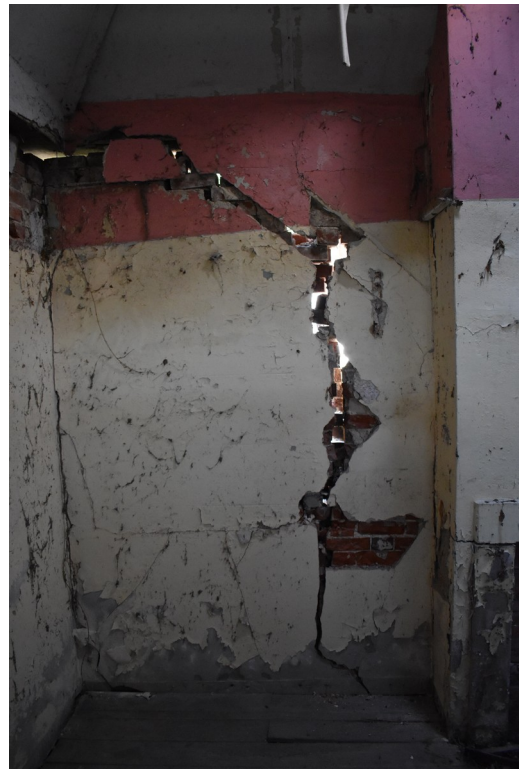
Photograph 20 Structural problems adjacent to western chimney-breast on north-west elevation of southern room. Photograph taken facing north-west.

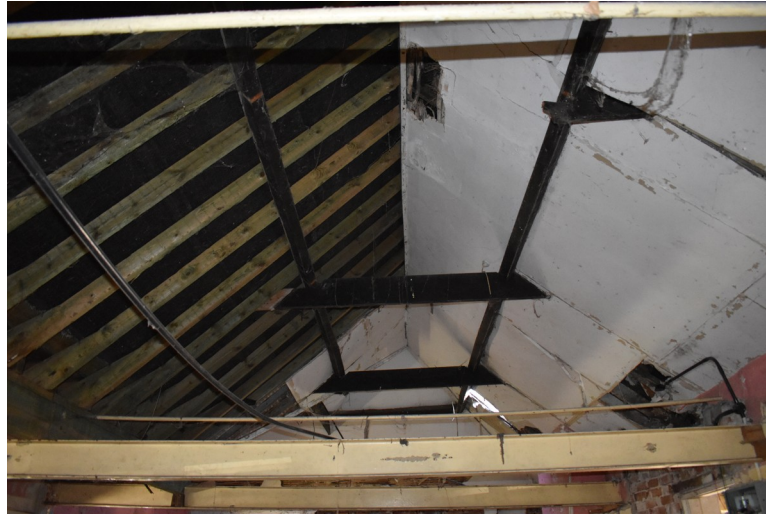
The roof structure of the cross-wing is partially visible and is entirely made-up of machine-cut timber (Photograph 21). It comprises rafters that meet at a ridge-board, supported by partially surviving collars and clasped purlins on each roof pitch (Photograph 21). The southern pitch of this roof appears to have been completely replaced, presumably, again, when the flat-roofed extension was constructed. The rafters of the south-west range are entirely obscured, but the roof structure appears to be identical.

Photograph 21 Detail of roof structure above cross-wing. Rafters on left side are replacement timbers. Photograph taken facing north-west.

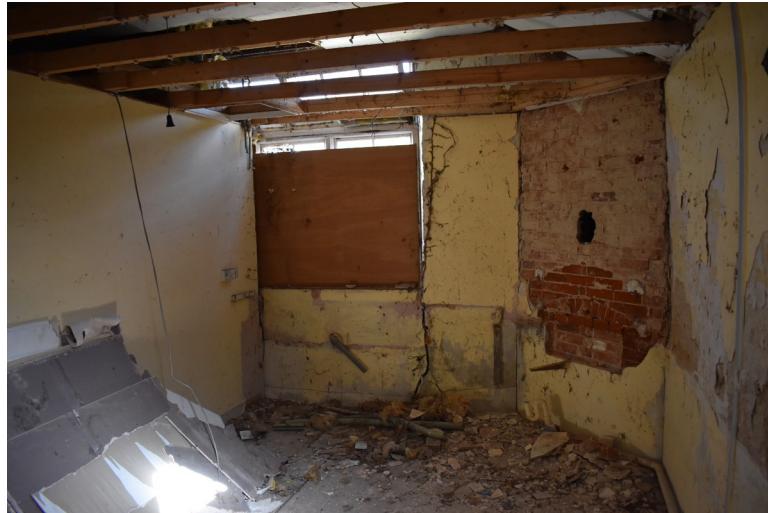
Like the southern room, the structure of this room has been severely compromised. In particular, the brickwork around the window opening on the rooms north-west elevation is cracking quite severely (Photograph 25).

Photograph 25 Northern room of building, showing structural damage evident to room's north-west elevation. Photograph taken facing north-west.

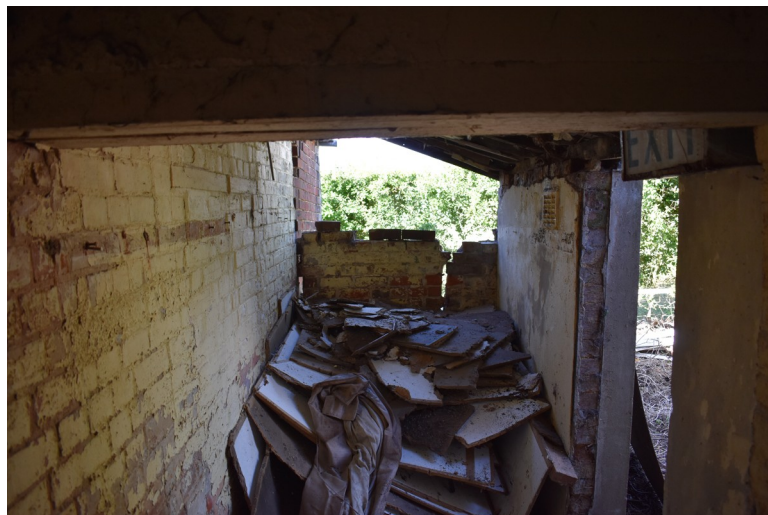
Photograph 26 Interior of western extension, showing damaged north-west elevation. Photograph taken facing north-west.
