**Historic building recording at
St Mary's Church,
High Street, Wivenhoe,
Essex, CO7 9BD**

May 2020

**commissioned by
Inkpen Downie
on behalf of
PCC of St Mary's Church**

CAT Report 1554
May 2020

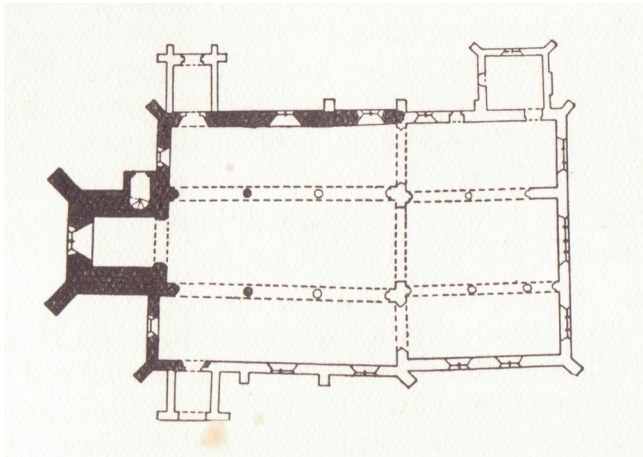
Plan 1 Plan of church showing surviving 14th-century fabric of church in black, with modern additions in white. Taken from RCHME 1922, 233.

However, the fact that the porch, as per the RCHME's plan of the church (Plan 1), appears to 'straddle' an area of original 14th-century fabric and a section of modern rebuilding is of interest. Given that the fabric of the porch appears to post-date both the 14th-century and the modern elements of the south aisle strongly suggests it may in fact be of a later date than the rebuilding of 1859.

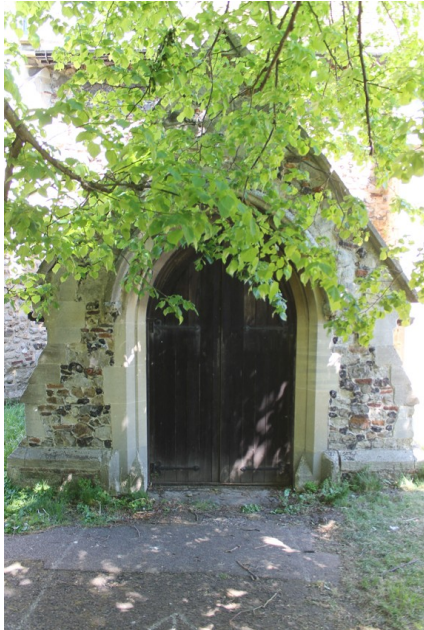
The porch has a gabled roof covered in peg-tiles. It is accessed via a modern vertical-planked double-door on its southern elevation (Photograph 1). The porch's fabric is similar to that of the rest of the church, and includes septaria, re-used Roman tile, ragstone, limestone and flint nodules, all bound in lime mortar (Photographs 2 and 3 and Fig 2).

Photograph 1 Southern elevation of porch, showing doorway and arch. Photograph taken facing north.

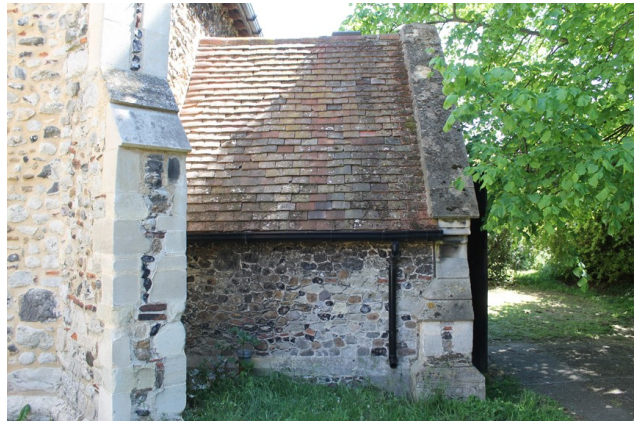
Photograph 2 Western elevation of porch. Photograph taken facing east.

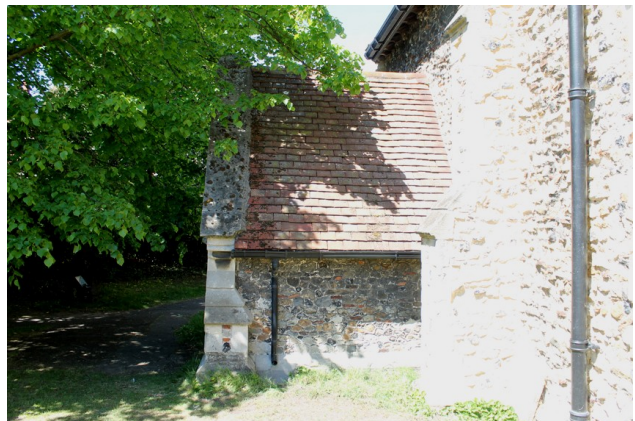
Photograph 3 Eastern elevation of porch. Photograph taken facing west.

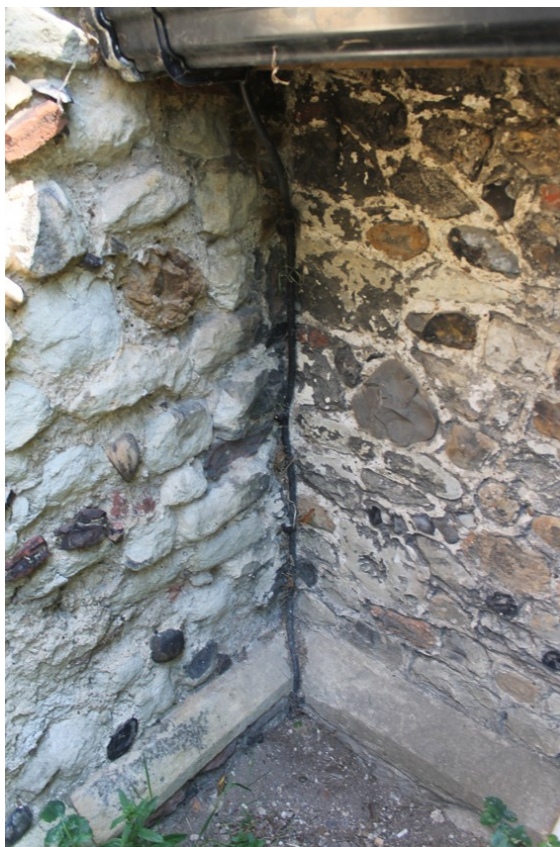
Despite the porch being constructed of the same material as the surrounding church, close examination of the locations where it joins the south aisle clearly show it to be a later addition (Photograph 4). The building stone of the porch is laid much more regularly and compactly than the building stone of the church proper, and is inset far deeper into mortar, contrasting with the partially projecting stonework of the south aisle.

Photograph 4 Detail of join between western elevation of porch (to right) and wall of southern aisle (to left). Photograph taken facing north-east.

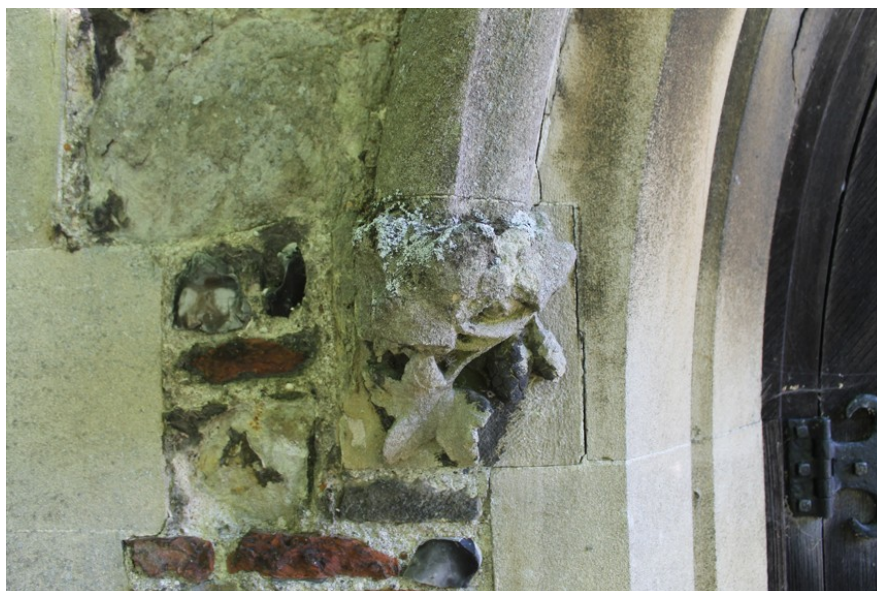
The south-west and south-east corners of the porch are constructed of worked ashlar blocks, with symmetrical designs in both corners. The arch above the doorway on the southern elevation has hood-mould with ornate label-stops, decorated with a leaf design (Photograph 5).

Photograph 5 Detail of decorated label-stop on west side of arch on southern elevation of porch. Photograph taken facing north.

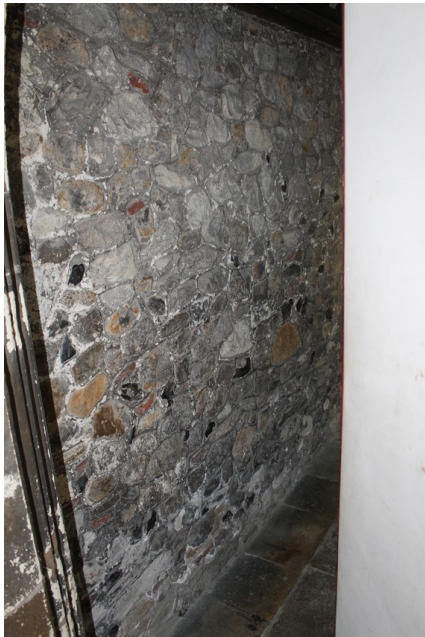
Photograph 6 Detail of eastern wall on interior of porch. Photograph taken facing south-east.

The floor of the porch, where visible, comprises rectangular or sub-square flagstones (Photograph 6).

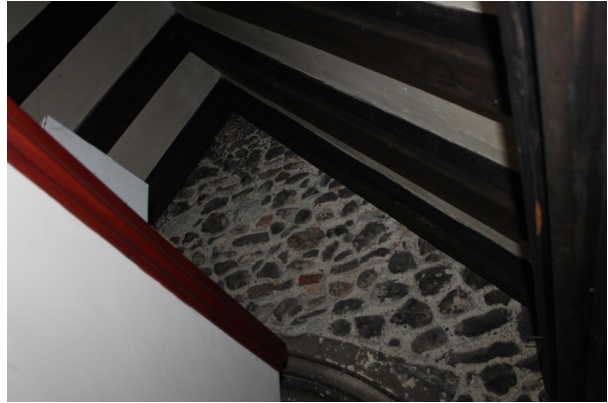
Photograph 7 Interior of porch, showing south wall of church, as well as rafters of porch. Photograph taken facing north-west.

Also visible on the interior of the porch is part the exterior face of the churches south aisle, which is identical in fabric with the face outside of the porches interior, but has clearly been repointed (Photograph 7).

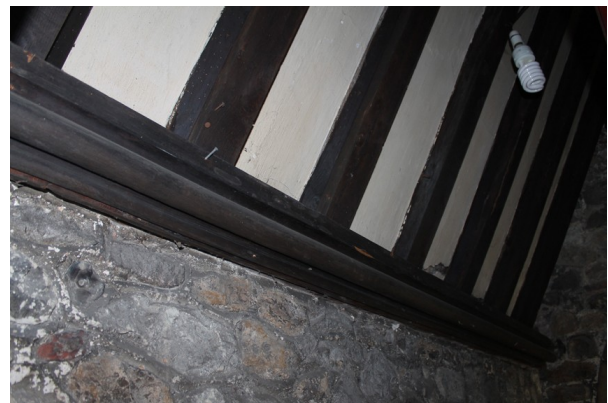
Photograph 8 Interior of porch, showing moulded wall-plate. Photograph taken facing south-east.

The roof of the porch is constructed of machine-cut pairs of rafters that meet at the apex of the roof (there is no ridge-board). These rafters are supported on a wall-plate with prominent torus-moulding (Photograph 8).

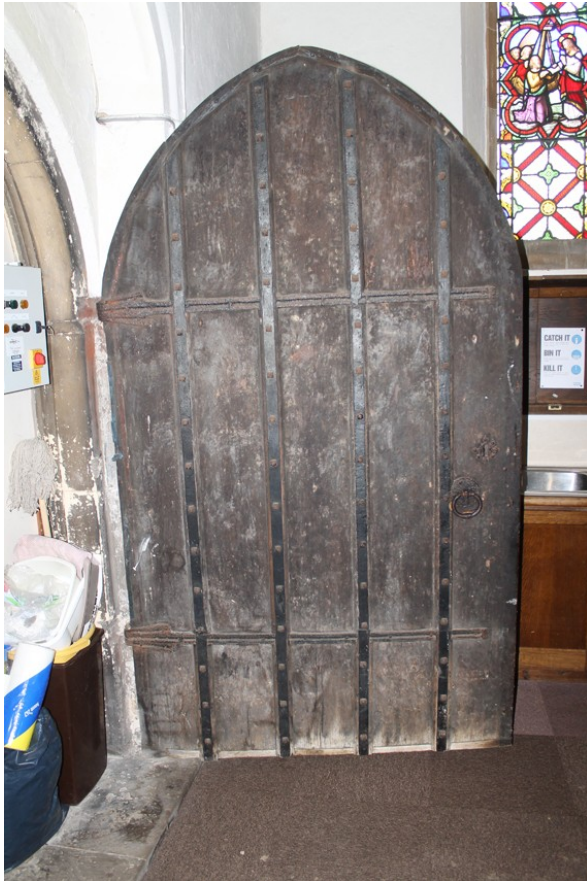
The porch is accessed from the church via a substantial vertical-planked door, with the joints between the wide planks on the outer face covered by ironwork and moulded fillets (Photograph 9). Beneath the fillets are long, but quite plain, iron hinges. The back of the door is covered by much thinner modern panelling, and the lock-plate and latch attached to it appear to be modern replacements (Photograph 10).

Photograph 9 Front of door between southern aisle of church and porch. Photograph taken facing west.

The door leading into the southern porch from the church is worthy of note. Its substantial size and the ironmongery on its outer face strongly suggest it was the southern exterior door of the church, and was in place prior to the porches construction. Assigning an accurate date to the door is difficult, given the modern panelling covering its rear, but its wide planks, the fillets between them and the plain nature of its hinges and iron fillets could suggest it has a late medieval or early post-medieval origin (Hall 2005, 33).

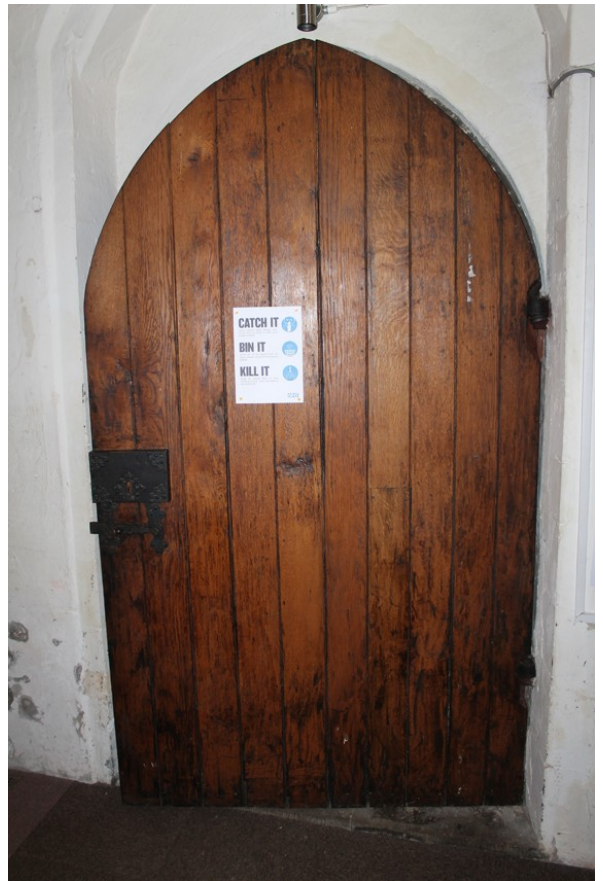
Photograph 10 Rear of door leading into porch from church, showing modern panelling and door furniture. Photograph taken facing south-east.

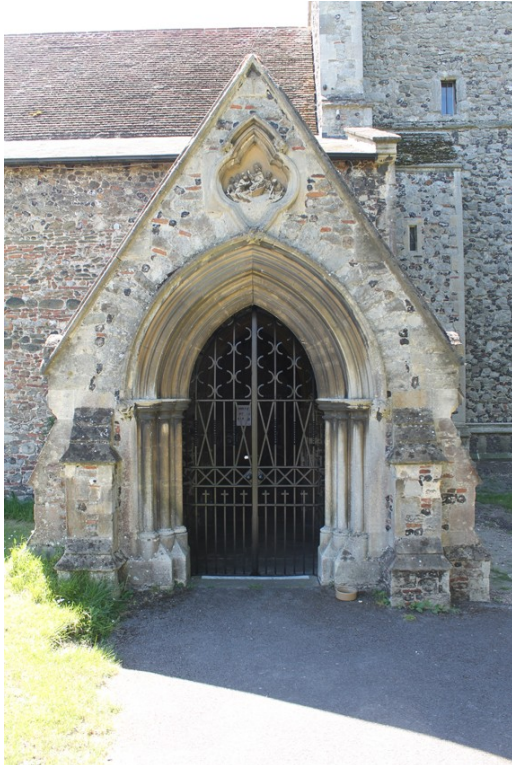
Photograph 11 Northern porch of St Mary's church, showing much more elaborate arches and stonework than the southern porch. Photograph taken facing south.

The heritage statement (Inkpen Downie 2016) draws a comparison between the southern and the northern porches of the church, highlighting that the northern porch has considerably more architectural detailing. This is visible both on the exterior, with the northern porch having a larger arch including more ornate stone-working (Photograph 11), and on the interior, where the roof-rafters of the northern porch are supported by ashlar-posts in a manner similar to the main roof of the church (itself a product of the 1859 restoration). This stark difference between the two porches could, again, suggest that the southern porch is a later, more modern, addition to the building, postdating the 1859 work. Alternatively, however, the difference in architectural detailing between the north and south porch may just be due to the fact that the southern porch of the building is very much the secondary access into the church, with the northern porch being the more prominent, main, entrance.
