**Historic building recording at
Princes Halfyards,
Stebbing Road, Felsted,
Essex CM6 3LG**

**report prepared by
Mark Baister**

CAT Report 1601
October 2020

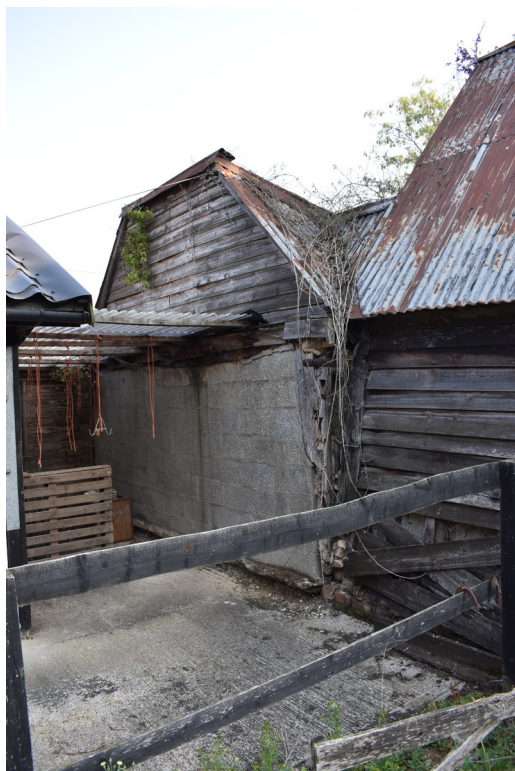
Photograph 2 South-west elevation of outbuilding, bay 1, showing concrete block infilling. Photograph taken facing north.

The structure is in significant disrepair and has been the subject of at least one phase of rebuilding, with the south-east gable-end having been almost completely replaced with concrete blocks and brickwork (Photograph 3). In addition, the south-west elevation of the building's northern bay (where originally it would have joined with the since demolished range; see above) has been in-filled, again with concrete blocks (Photograph 2).

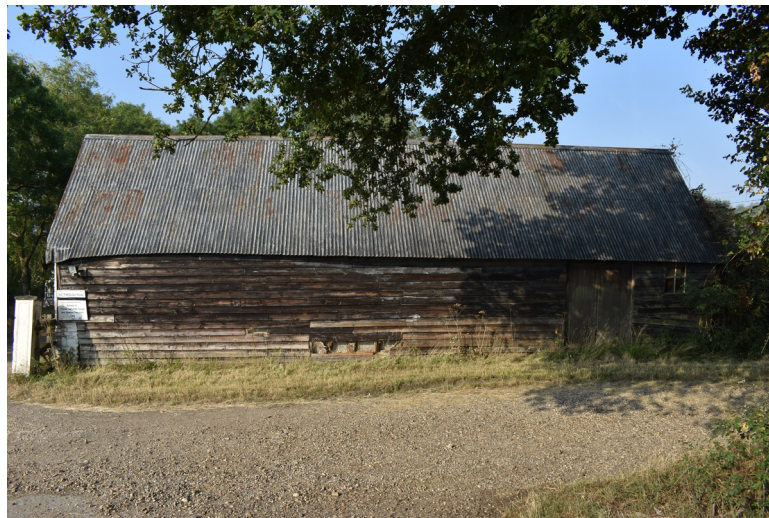
Photograph 5 North-east elevation of the outbuilding. Photograph taken facing west.

The north-east elevation of the outbuilding (Photograph 5) has an entrance filled with a vertically-planked double door, adjacent to a small inserted four-light window (which is boarded up internally).

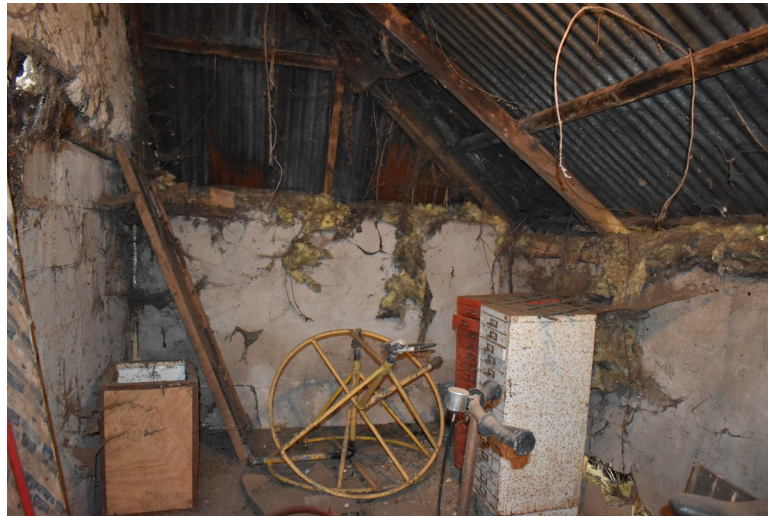
The northern bay (bay 1) is all that remains of the north-east/south-west aligned structure visible on earlier mapping (see above). It measures 4.7m in length and its roof is mostly a single pitch, partially hipped to the south and north, constructed entirely of modern machine-cut timber (Photograph 6). The timber-frame of this bay (below the roof) is obscured by render and concrete additions, but in small sections where it is visible it appears to be constructed of hand-sawn timber (Photograph 7). The floor of this bay is concrete.

Photograph 6 Interior of bay 1. Photograph taken facing north-west.

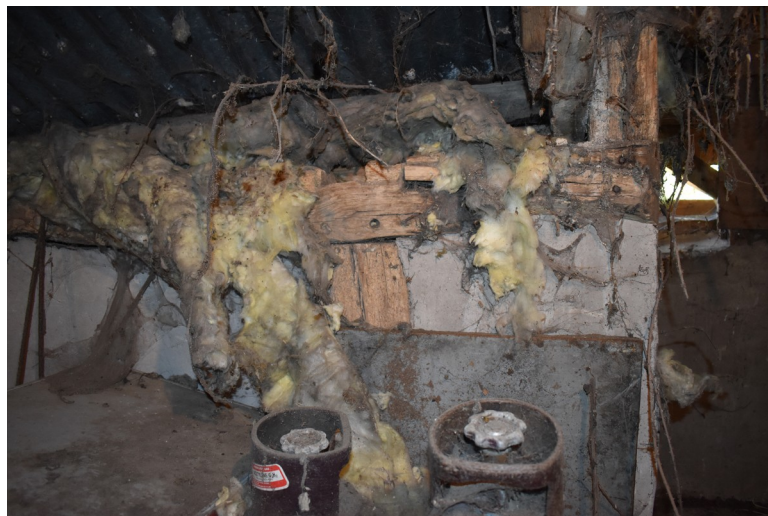
Photograph 7 Detail of small section of exposed ?hand-sawn timber in bay 1. Photograph taken facing north-east.

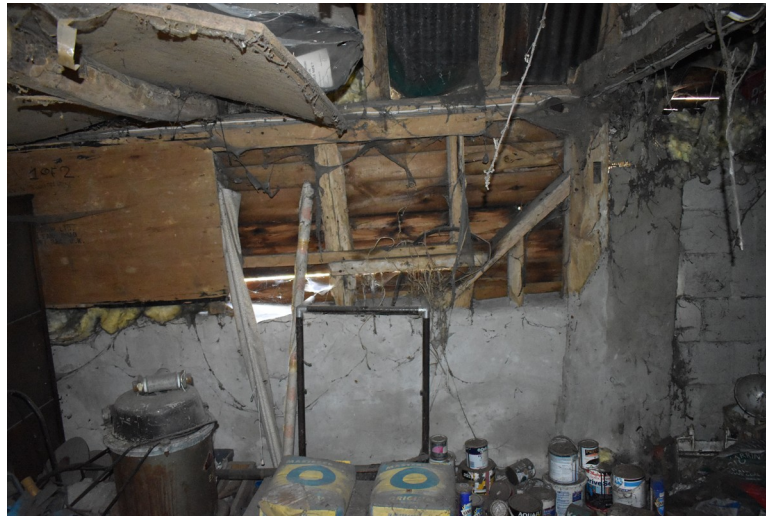
Bays 2 and 3 are both larger than bay 1, both in width and height, and they were originally entirely separate from bay 1. The northern wall of bay 2 has had studs removed to form the entrance into bay 1 (as evidenced by empty mortices; Photograph 8).

Photograph 8 Interior of bay 2, with entrance into bay 1 visible to right, including empty mortices on wall-plate. Photograph taken facing south-west.

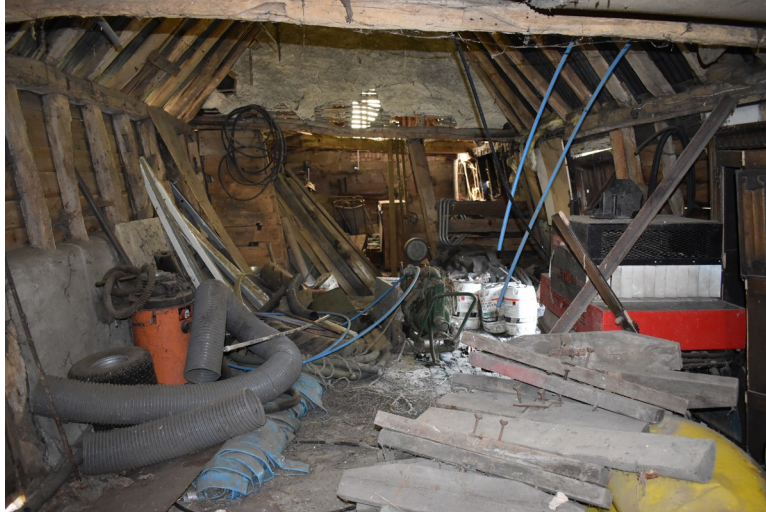
The lower-half of the timber-frame in bay 2, including the sill-beam, is obscured by concrete (Photograph 12). The visible frame comprises studs supported by through-bracing. The two doors into the structure lead into this bay (on the north-east and south-west elevations) and examination of the wall-plate above both of these shows that neither are original entrances into the building; they both have empty mortices above indicating that studs have been removed in order to insert the doors.

Photograph 12 Interior of bay 2. Photograph taken facing south-east.

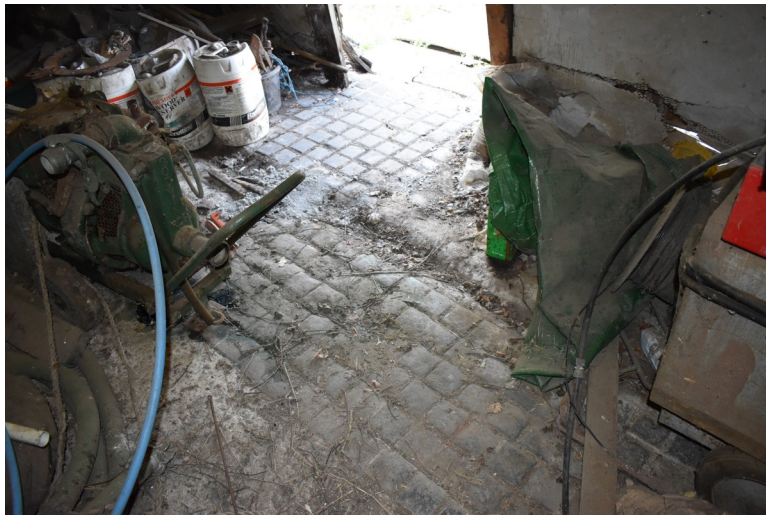
The floor of bay 2 is concrete, with the exception of a section of square-cobbled floor in front of the door on the south-west elevation (Photograph 13). This section of flooring also includes a drainage gully.

Photograph 13 Detail of surviving cobbled floor and drainage run in bay 2. Photograph taken facing south.

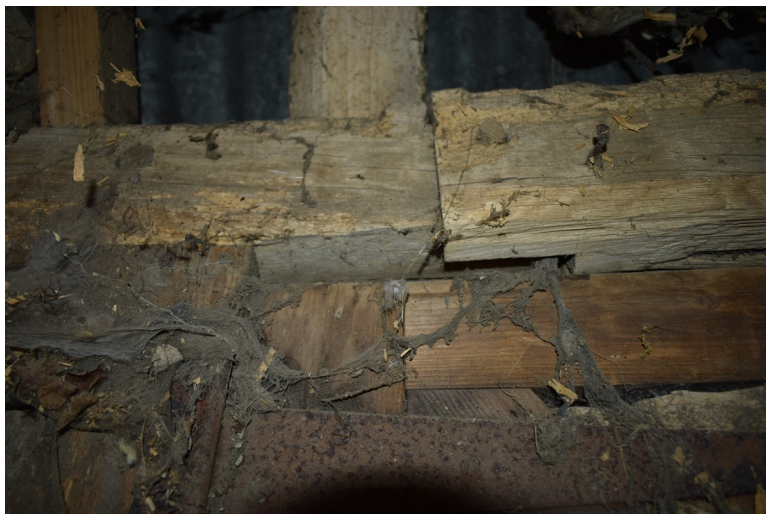
Photograph 14 Detail of face-halved scarf in bay 2, above double-doors on north-east elevation. Photograph taken facing north-east.

Two scarf joints were observed on the wall-plates of this bay. One is above the double-door on the north-east elevation and, although partially obscured, appears to be a face-halved and bladed scarf with two edge-pegs (Photograph 14). The other scarf joint is just to the north of the tie-beam separating bays 2 and 3, and is a much more rudimentary edge-halved scarf with square abutments (Fig 2).

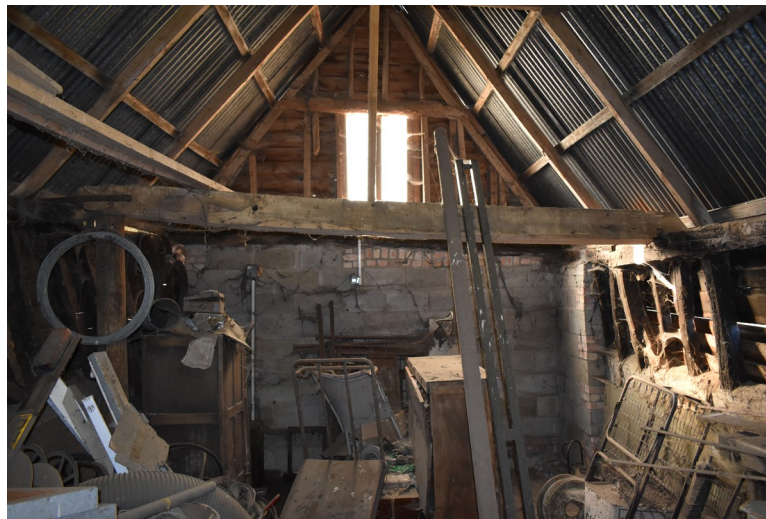
Bay 3 has a lower floor level than the adjacent bay 2, it is still concrete but is some 180mm lower. All of the timber making up bay 3 has been painted black. The roof of bay 3 is entirely constructed of machine-cut modern timber, although the roof's form is identical to that of bay 2 (see above). Similar to the two beams bridging the wall-plates in bay 2, there is a large hand-sawn beam bridging the wall-plates of bay 3, again attached to the frame by metal-straps, and further supported at its north-eastern end by a cut-off telegraph pole (Photograph 15). The remaining timber-frame of bay 3 is hand-sawn with through-bracing, identical to bay 2 (Photograph 16). Additionally, again as in bay 2, the lower-half of the timber-frame in bay 3 is obscured by concrete.

Photograph 15 Interior of bay 3. Photograph taken facing south-east.

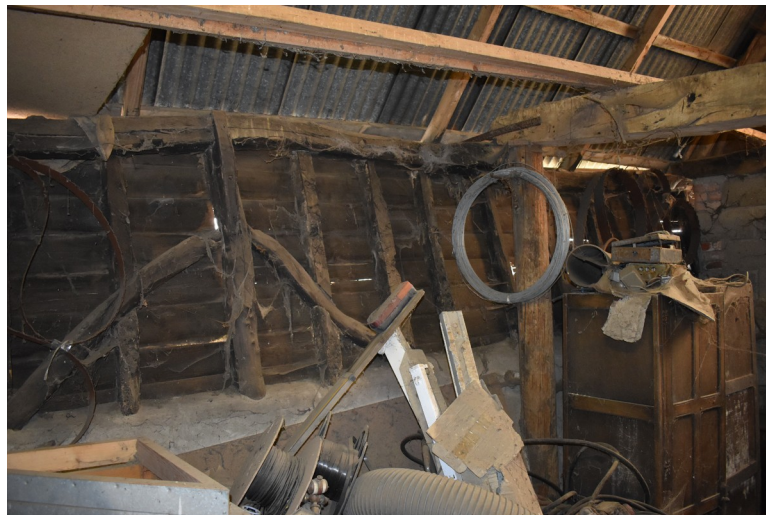
Photograph 16 Interior of bay 3 showing timber-framing. Photograph taken facing east.
