Historic building recording at Crowbridge Farm, Chappel Hill, Halstead, CO9 1JS

June 2021

CAT Report 1686
July 2021

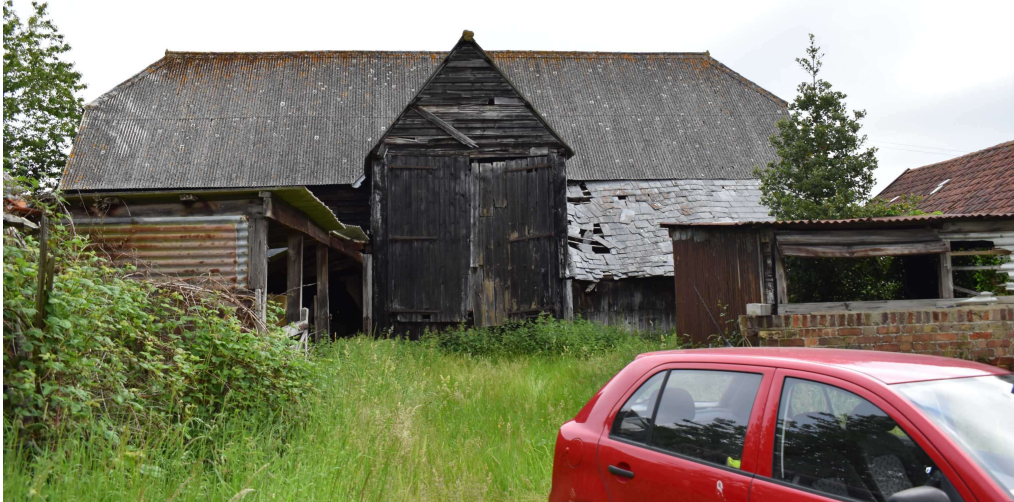
The southern elevation of the threshing barn contains the centrally-located midstrey. The midstrey has an upper and lower set of double doors. Both are vertically-planked. There is a lean-to present on both sides of the midstrey. The western lean-to is constructed of timber covered with corrugated metal. The eastern lean-to is brick-built (Flemish bond with lime mortar, brick dimensions of 230 x 105 x 65mm) with a centrally-located vertically-planked door and weatherboarding on the western half. The roof is a catslide roof covered with imitation-slate.

Photograph 2 Southern elevation of threshing barn. Photograph taken facing north.

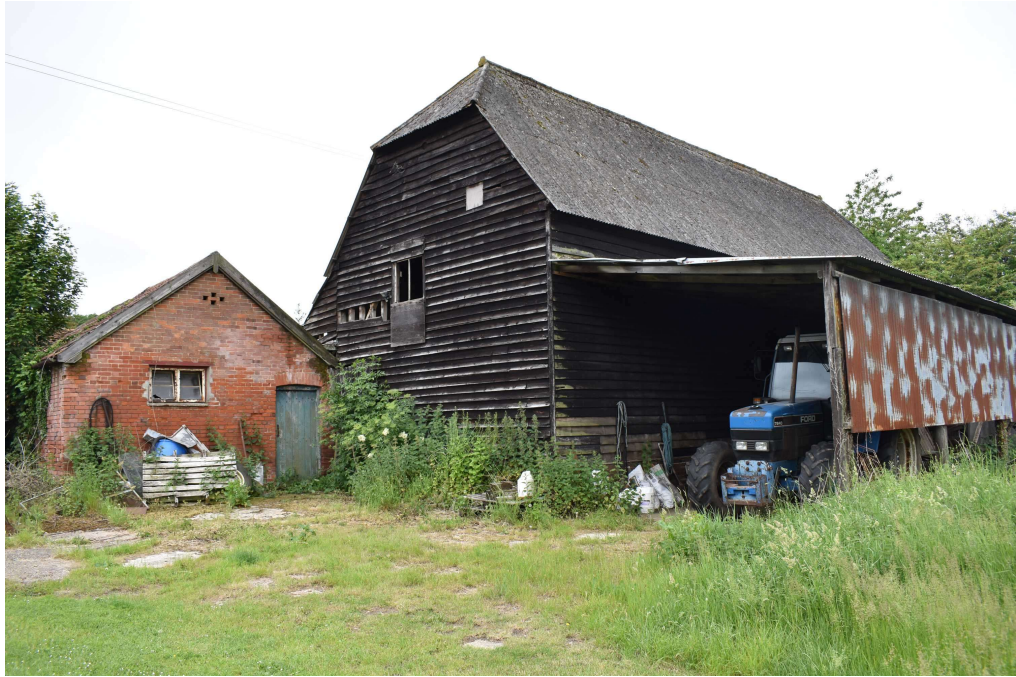
Photograph 4 Eastern elevation of threshing barn. Photograph taken facing south-west.

The eastern elevation has a single vertically-planked door in the southern end of the lower register. In the upper register is a fixed-window with no panes, likely to have been the location of the original pitching door. There are also two small modern openings on this elevation, one in the upper register and one in the lower register.

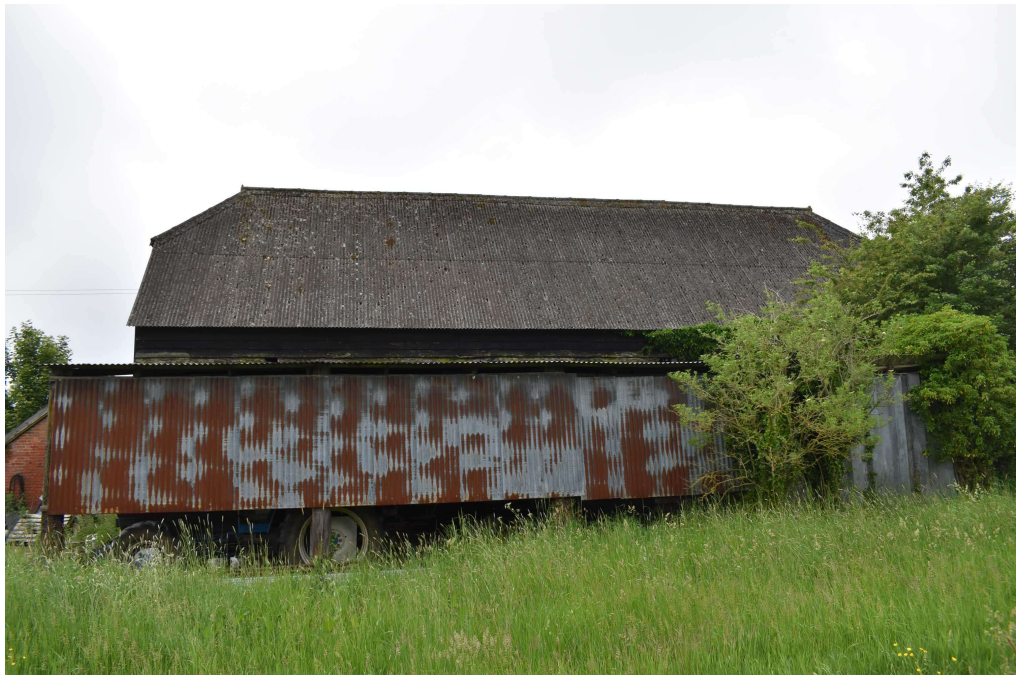
On the northern elevation is a timber-framed lean-to covered with corrugated metal and a small metal shed. Obscured by the lean-to is a large opening. The upper doors of the opening are vertically-planked double-doors and the lower door a large single vertically-planked door.

Photograph 5 Northern elevation of threshing barn. Photograph taking facing south.

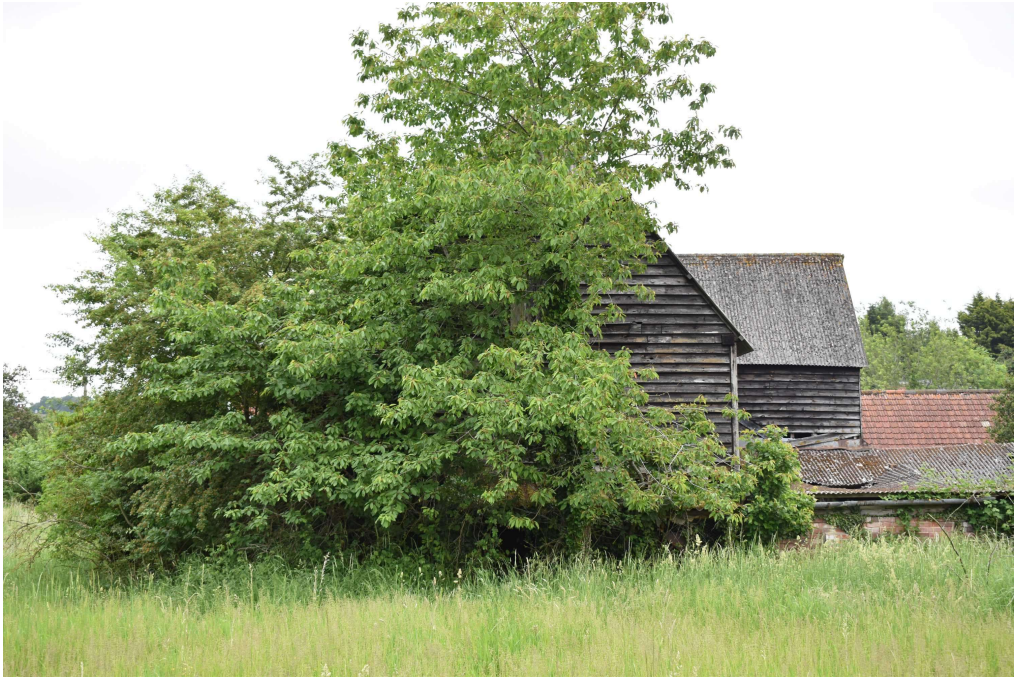
The western elevation has a vertically-planked pitching-door in the upper register and blocked opening in the lower register. There is also a modern chicken hutch at ground-level.

Photograph 6 Western elevation of threshing barn. Photograph taken facing east.

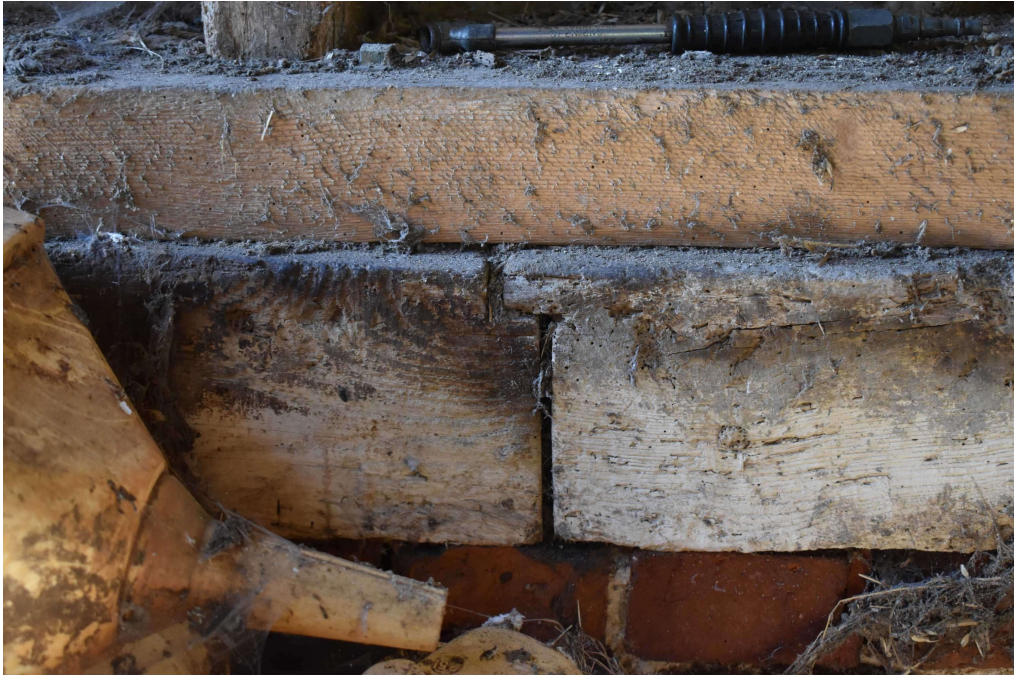
The wall-plate has eight face-halved and bridled scarf joints, one located at each end of every tie-beam. The sill-beam has four straight-bridled scarf joints, two in the northern elevation (bays 1 and 5) and two in the southern elevation (bays 2 and 5).

Photograph 10 Scarf joint in sill-beam on southern elevation in bay 5. Photograph taken facing south.

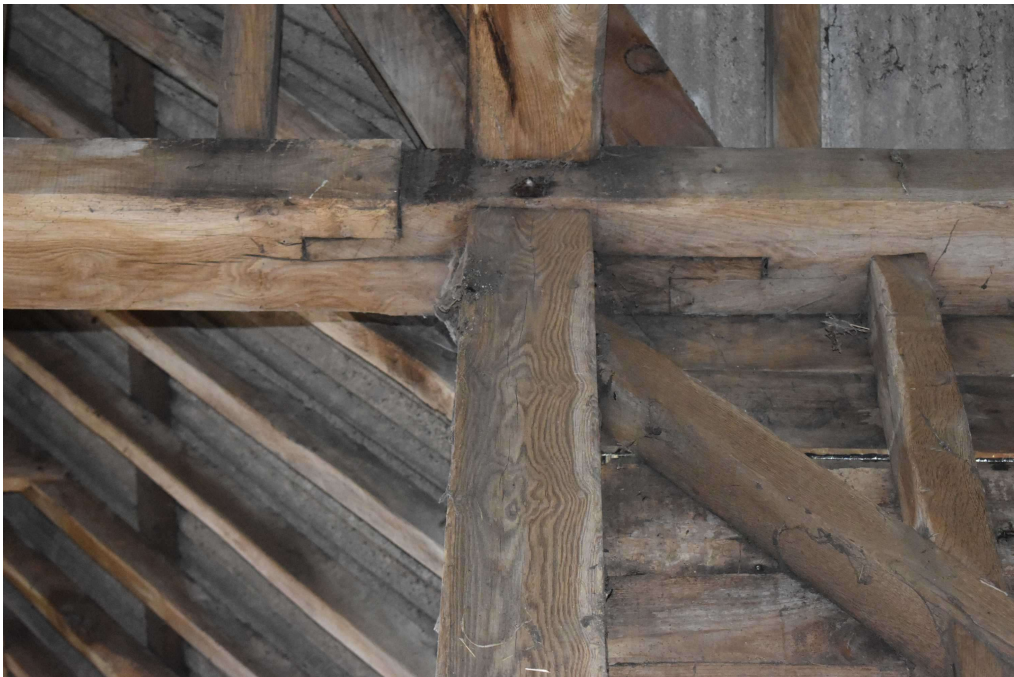
Photograph 11 Scarf joint in southern wall-plate between bays 2 and 3. Photograph taken facing south.

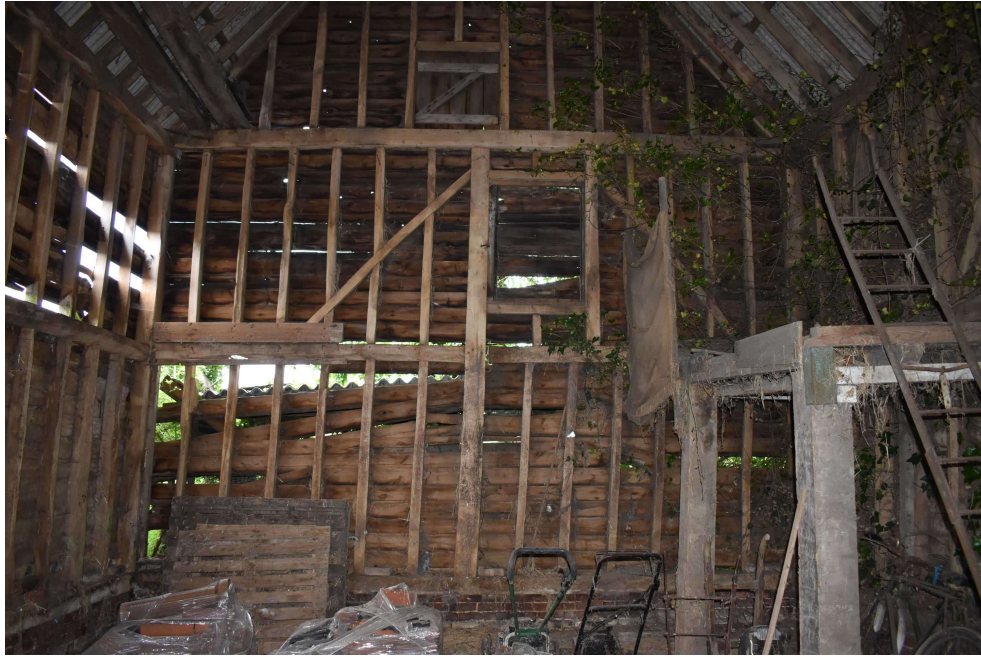
Bay 1 is western most bay of the barn. The upper-register of the western elevation has two openings, the lower of the two being the original pitching door (now blocked). The upper opening is a small modern insertion. There is a modern mezzanine layer in the north-west corner of bay 1.

Photograph 12 Interior western elevation of bay 1. Photograph taken facing west.

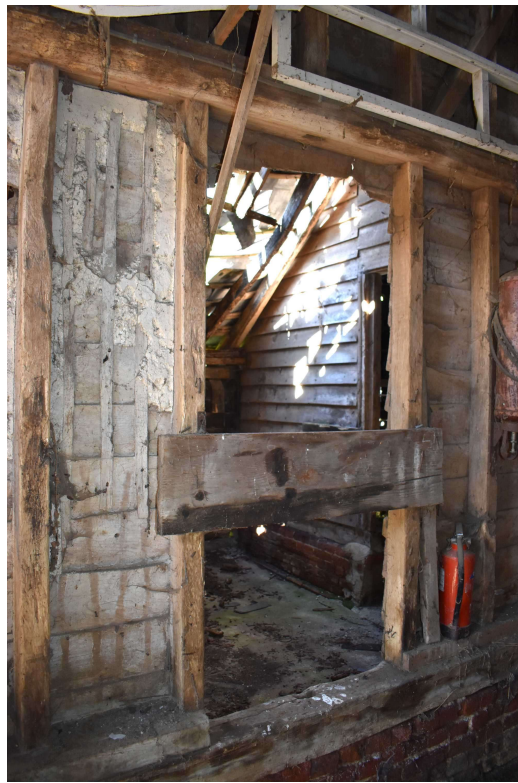
Photograph 13 Detail of opening in southern elevation in bay 4. Photograph taken facing south-west.

In the centre of the southern elevation of bay 4 a stud has been removed to create an opening.

The southern elevation of bays 4 and 5 has the original lath and plaster present between the studs. There is also a secondary modern sill-beam on this elevation, which has been removed in the opening of bay 4.

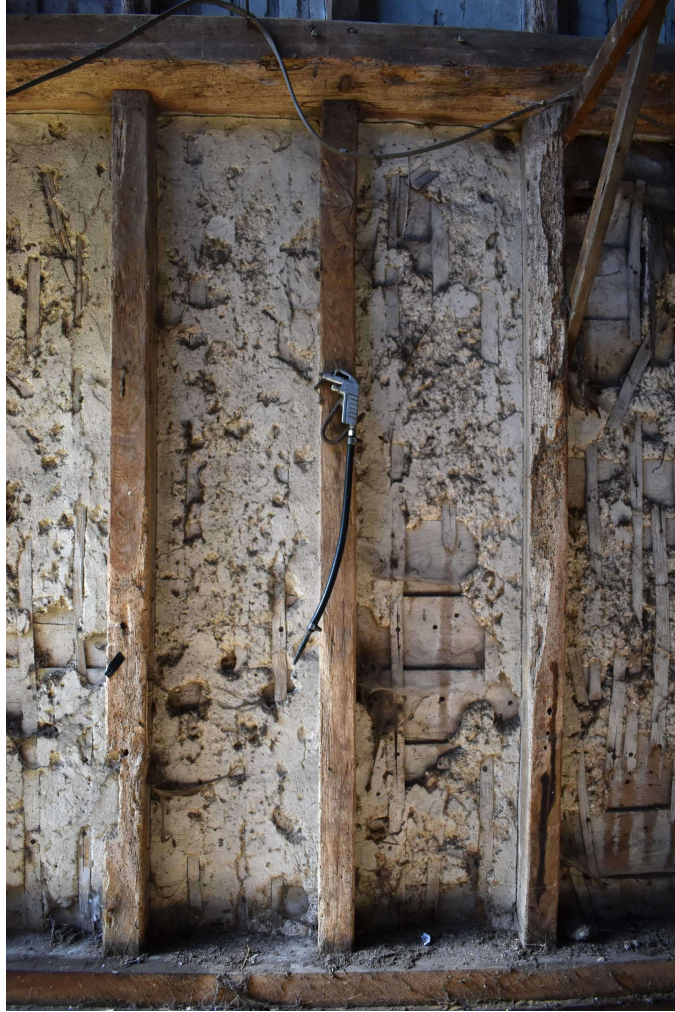
Photograph 14 Detail of lath and plaster in bay 5 southern elevation. Photograph take facing south.

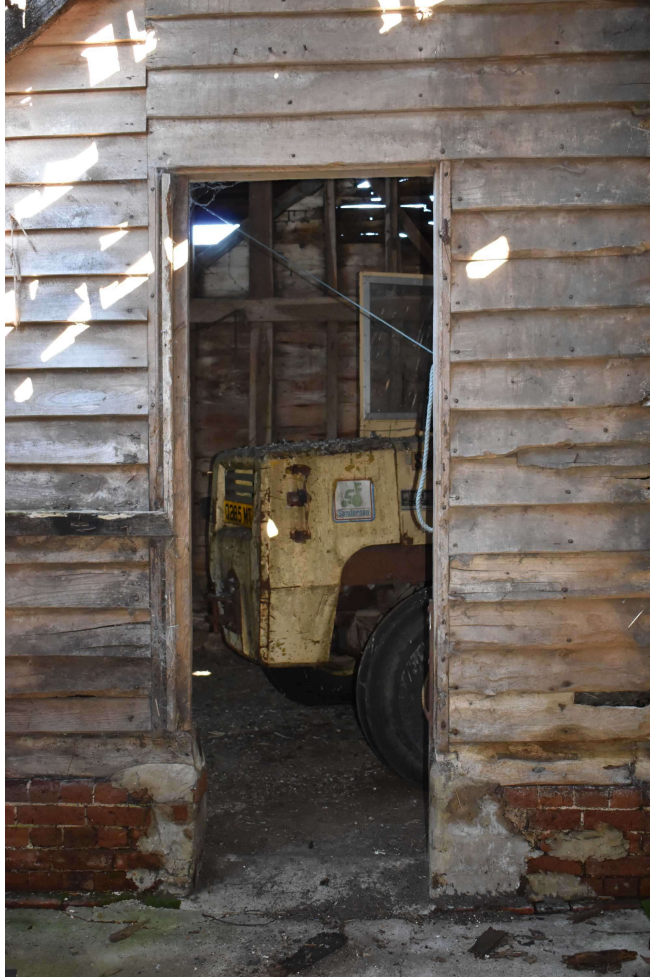
On the eastern elevation of the midstrey is an original opening. In more recent years the plinth and sill-beam have been removed from this opening to increase its size.

Photograph 17 Detail of doorway on eastern elevation of mistrey. Photograph taken facing west.

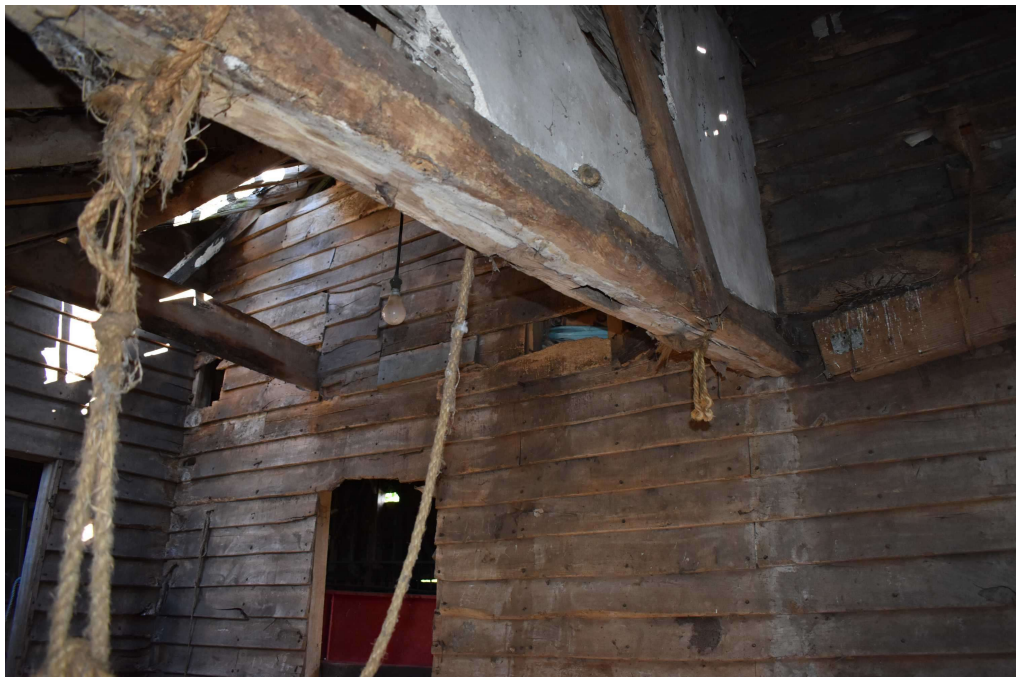
Photograph 18 Re-used timber in lean-to. Photograph taken facing north-west.

To the east of the midstrey is a modern lean-to. It has re-used timbers used as rafters in the roof and lath and plaster infill between the struts on the central tie-beam. There is an empty mortice in north-east corner, on the south face of the corner-post in bay 5 of barn. The lean-to is built on a concrete plinth.

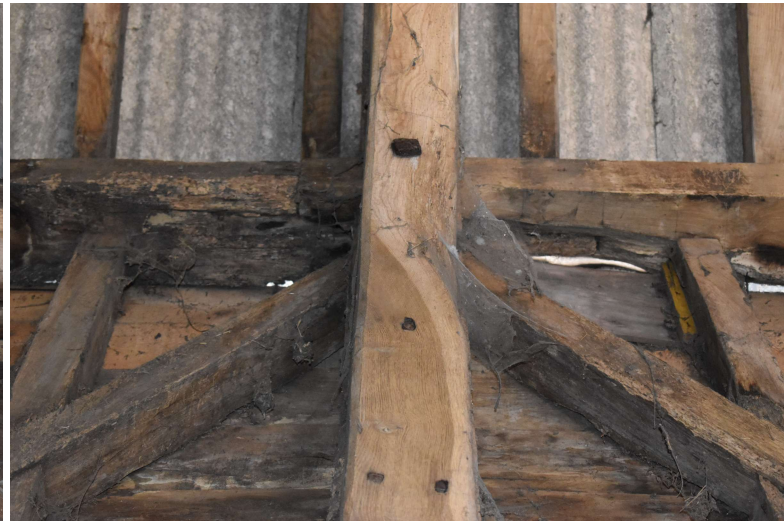
HSCF21_Photograph_060Rotting scarf joint on southern wall-plate between ba...
