**CAT Report 1934
issued May 2023**

**Historic building recording of two WWII-era huts at
Great Easton Manor, Dunmow Road, Great
Easton, Essex, CM6 2DL**

**CAT project ref.: 2023/03f
ECC code: GEAGE23**

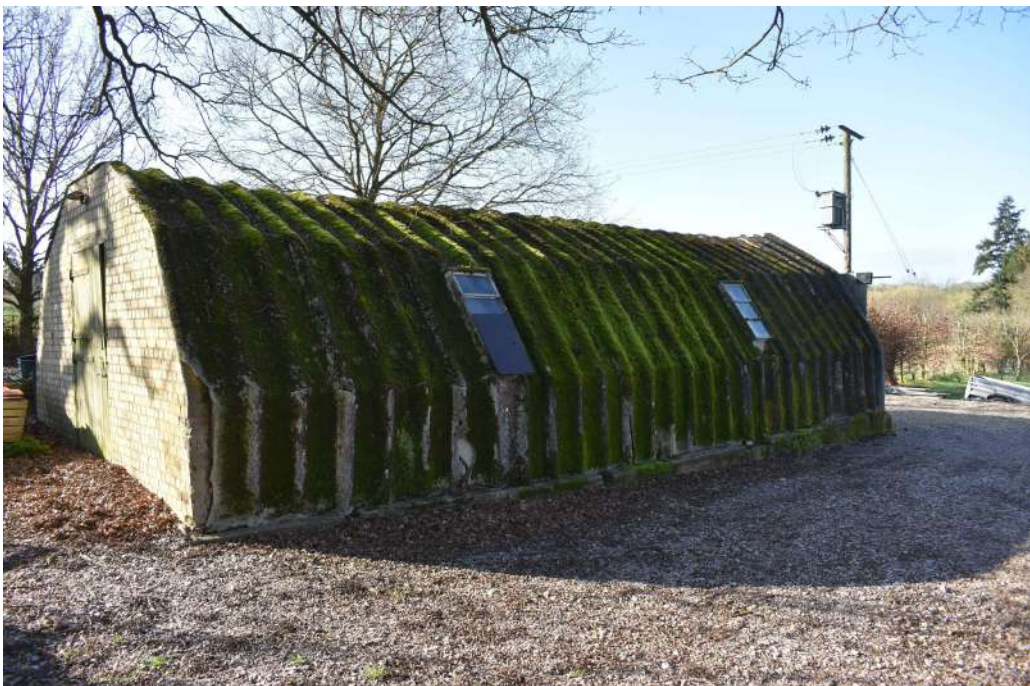
The Handcraft hut is aligned roughly north-east/south-west. It measures 11.43m by 6.45m, covering an area of approximately 74m². It is supported on a concrete plinth on the northern and southern elevations. The main body of the hut is constructed from corrugated concrete-asbestos sheets in a seven-sided arch shape. The eastern and western elevations are constructed from frogged red brick (brick dimensions: 225 x 105 x 65mm) laid in English bond. The brickwork at either end of the hut is not original to hut and was likely added when the hut was relocated. Damage to the brickwork on the western elevation has revealed the brick manufacturer to be Whittlesea Central Brick Company.

Photograph 2 Northern elevation of the handcraft hut. Photograph taken facing south south-west.

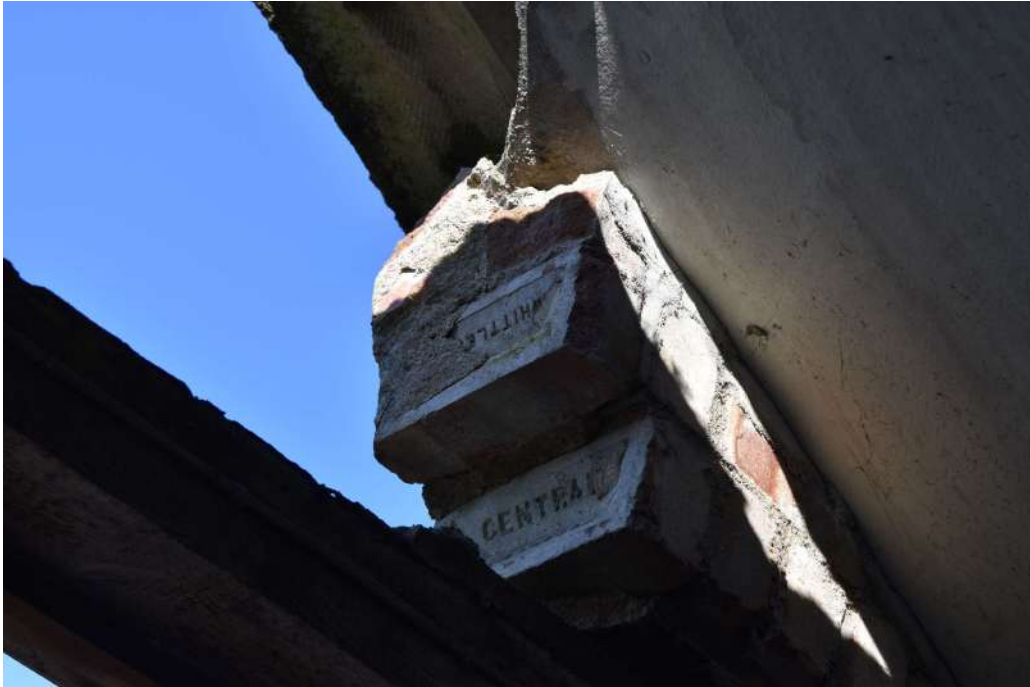
The western elevation is dominated by set of timber double doors, which are strengthened by diagonal wind-braces in the frame. The lintel of the doorway is two rows of brick, laid header bond. The eastern elevation has a single timber stable door with a slightly arched brick lintel. The top course of bricks on both elevations are stretchers laid on edge.

Photograph 3 Detail of bricks above door of western wall of the handcraft hut. Photograph taken facing west.

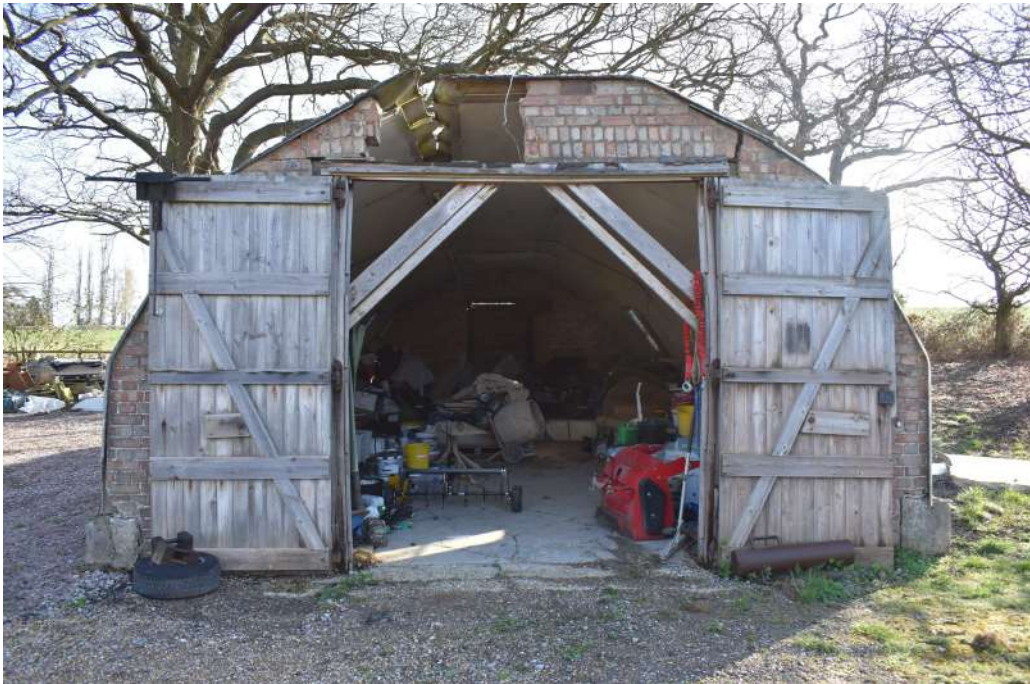
Photograph 4 Western elevation of the handcraft hut. Photograph taken facing north-east.

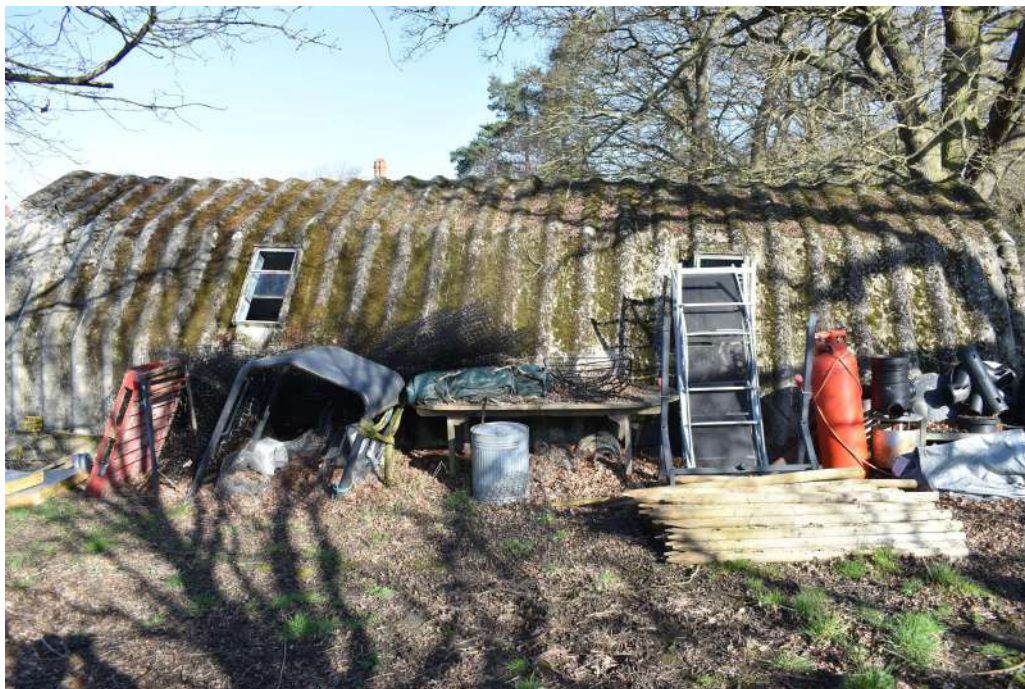
Photograph 5 Southern elevation of the handcraft hut. Photograph taken facing north-west.

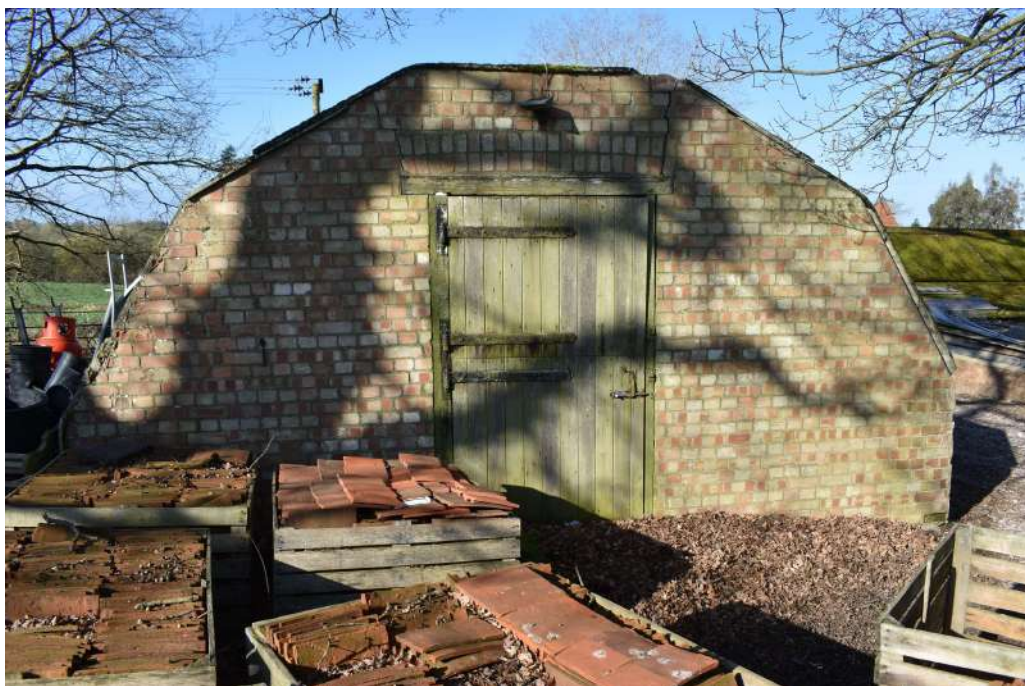
Photograph 6 Eastern elevation of the handcraft hut. Photograph taken facing south-west.

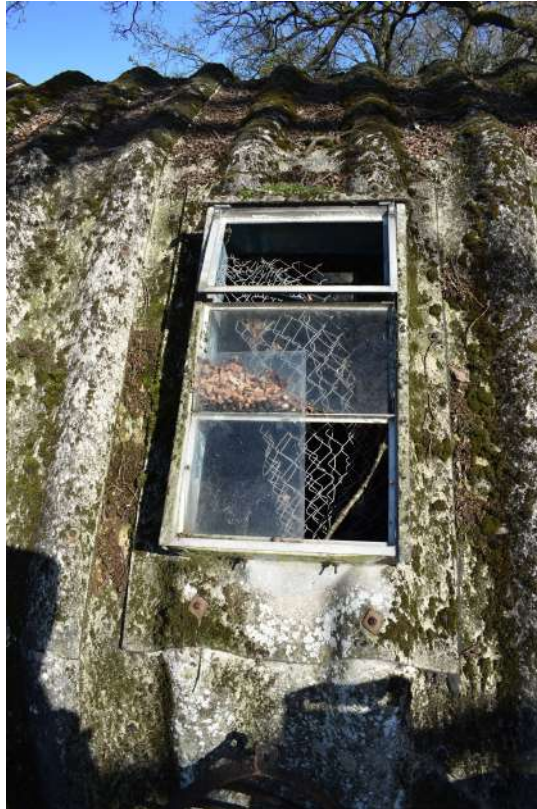
The northern and southern elevations both have two metal framed windows. They are all three-light with a top awning opening and appear to be original to the hut.

Photograph 7 Detail of window on southern elevation of the handcraft hut. Photograph taken facing north-west.

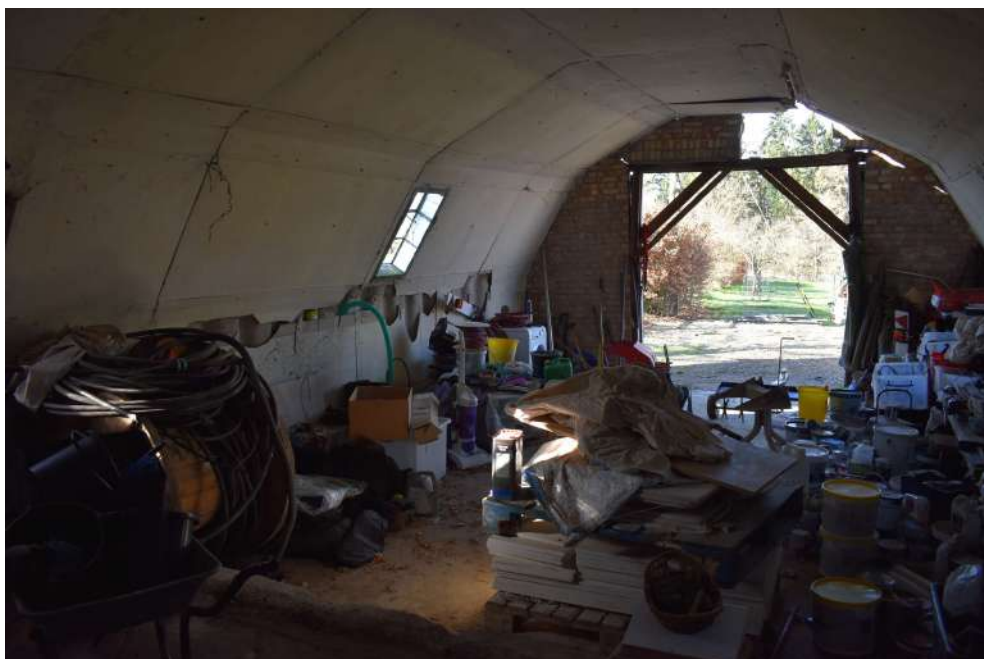
On the interior, the arch of the Handcraft Hut is lined with the original asbestos-cement sheeting, while the eastern and western walls are plain brick. The floor is poured concrete with a step at the eastern end. There are four windows – two in the northern wall and two in the southern wall. There is a door at the eastern and western ends of the hut.

Photograph 8 Internal view of the handcraft hut. Photograph taken facing south.

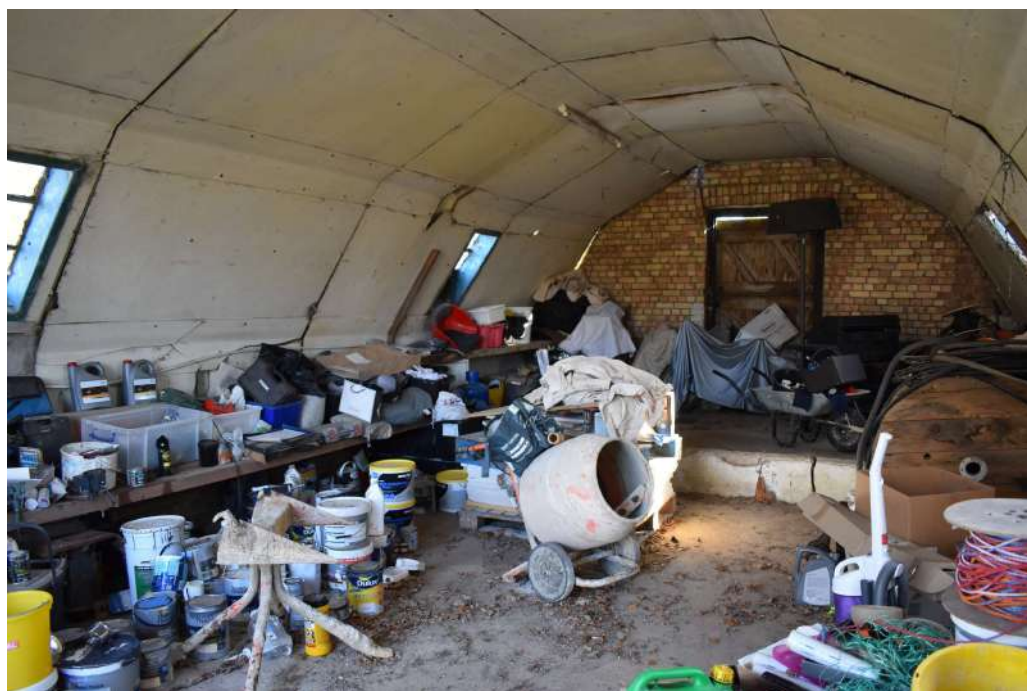
Photograph 9 Internal view of the handcraft hut. Photograph taken facing north.

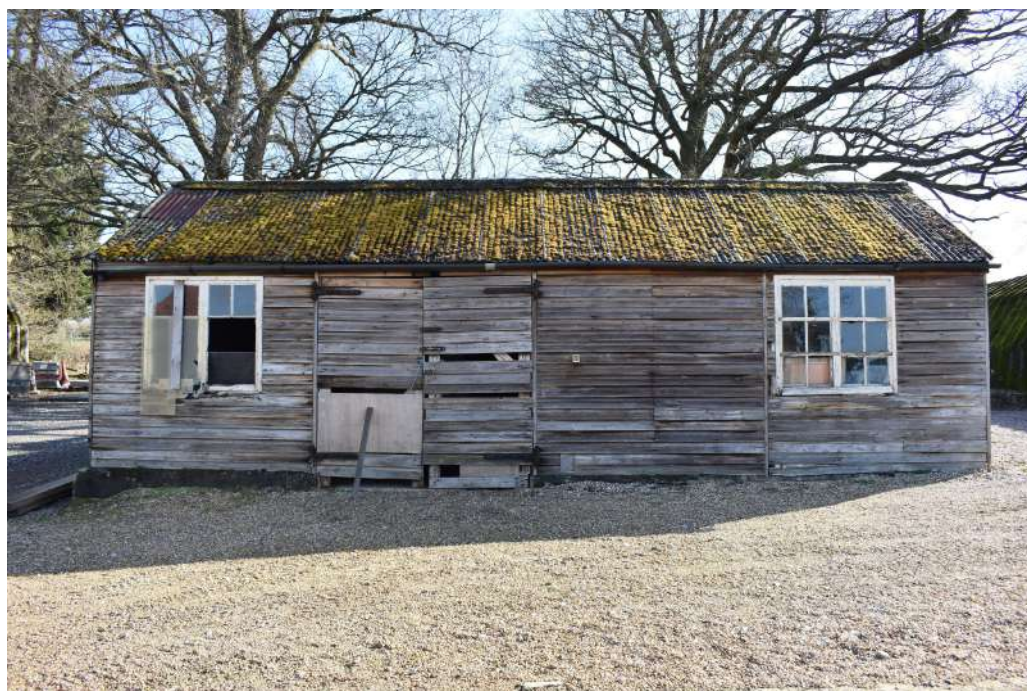
Photograph 10 Western elevation of the sectional timber hut. Photograph taken facing north-east.

The western elevation is clad in weatherboard. There are two twelve-light casement windows, one at each end of the elevation, and a set of double timber doors which are offset from the centre. The doors and windows are all replacement.

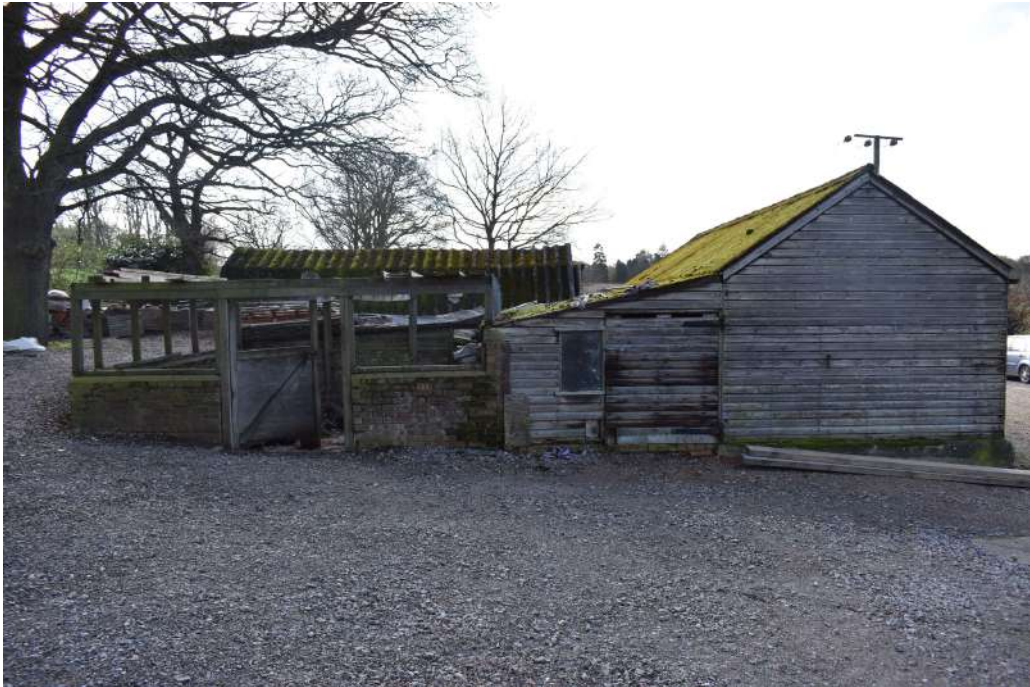
Photograph 11 Northern elevation of sectional timber hut. Photograph taken facing south-east.

On the northern elevation, the sectional timber hut and extension 1 are clad in weatherboard. Extension 1 has a single timber door and a single-light fixed window. The lower half of extension 3 is red brick laid in Flemish bond (brick dimensions: 225 x 110 x 65mm) and the upper is a timber frame covered with chicken wire. There is a single door in the centre of extension 3.

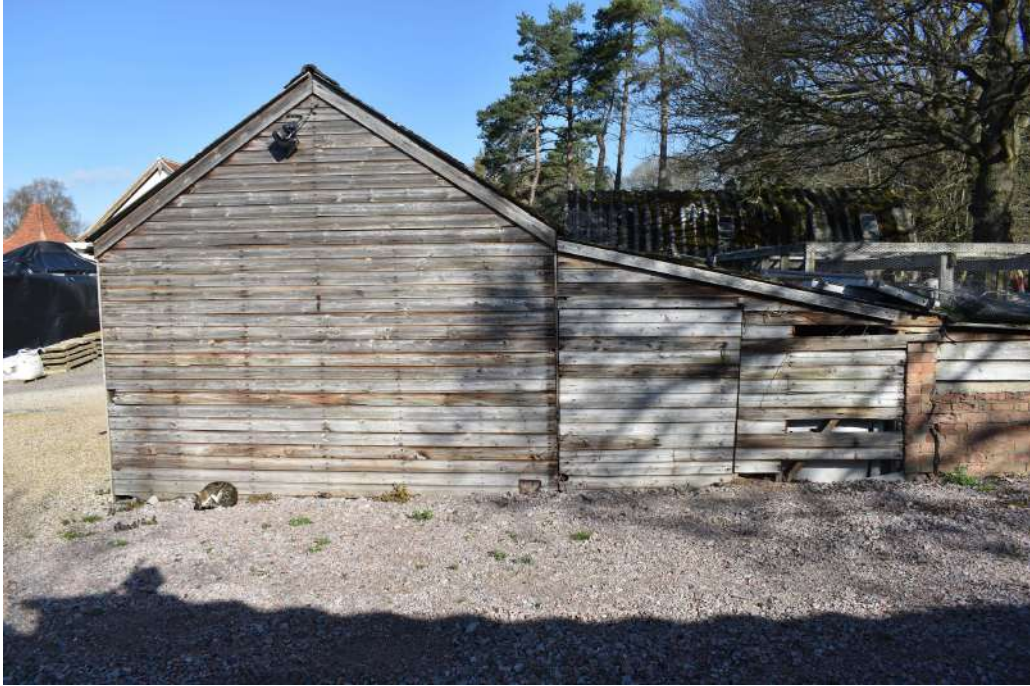
On the southern elevation, the sectional timber hut and extension 1 are clad in weatherboard. Extension 1 has a single timber door. Extension 2 is red brick laid in Flemish bond with weatherboard above.

Photograph 12 Southern elevation of the sectional timber hut. Photograph taken facing north-west.

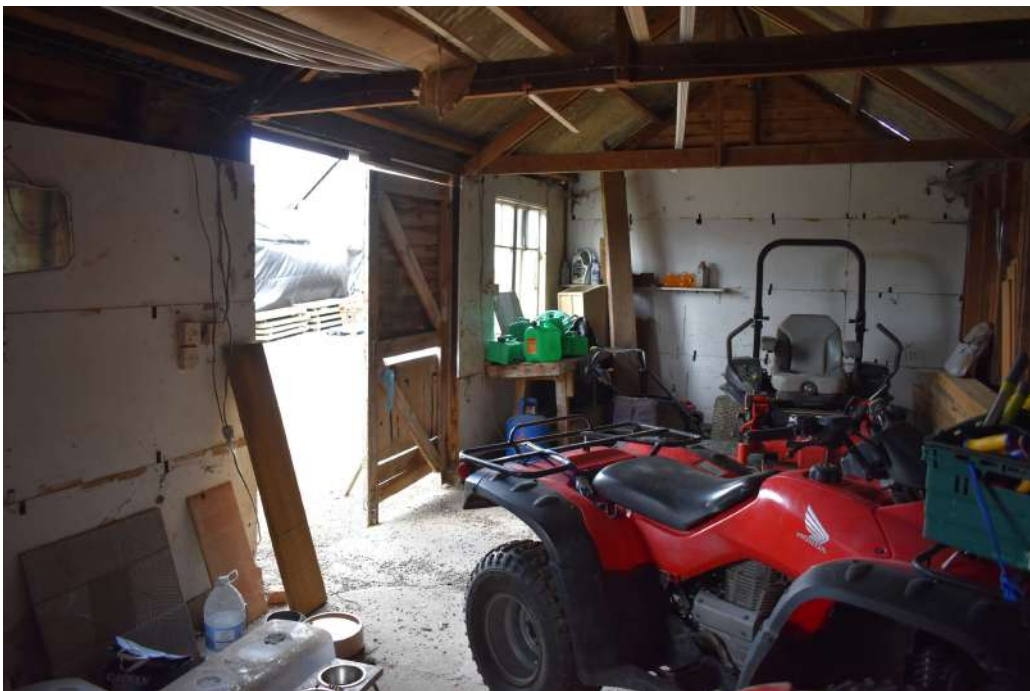
The roof of the sectional timber hut comprises pairs of double rafters, which straddle the tie-beams and rise to meet at the apex of the roof. There are three through-purlins on each roof pitch and king posts rising from the tie-beams. The tie-beams are supported on wall-plates on both walls. All of the timbers in the frame of the sectional timber hut are machine cut.

The northern, southern and western walls are clad in white fibreboard while the eastern wall is the bare timber-frame. There is a door and two windows in the western wall and an inserted door in the eastern wall. The floor is poured concrete.

Photograph 13 Internal view of sectional timber hut. Photograph taken facing north-west.

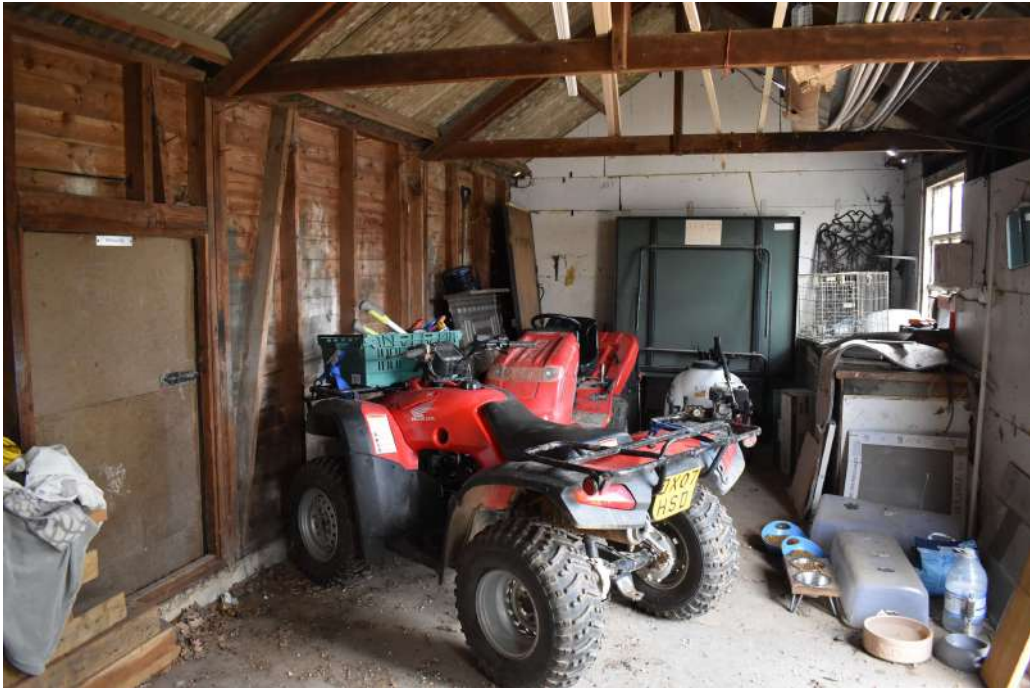
Photograph 14 Internal view of sectional timber hut. Photograph taken facing east.

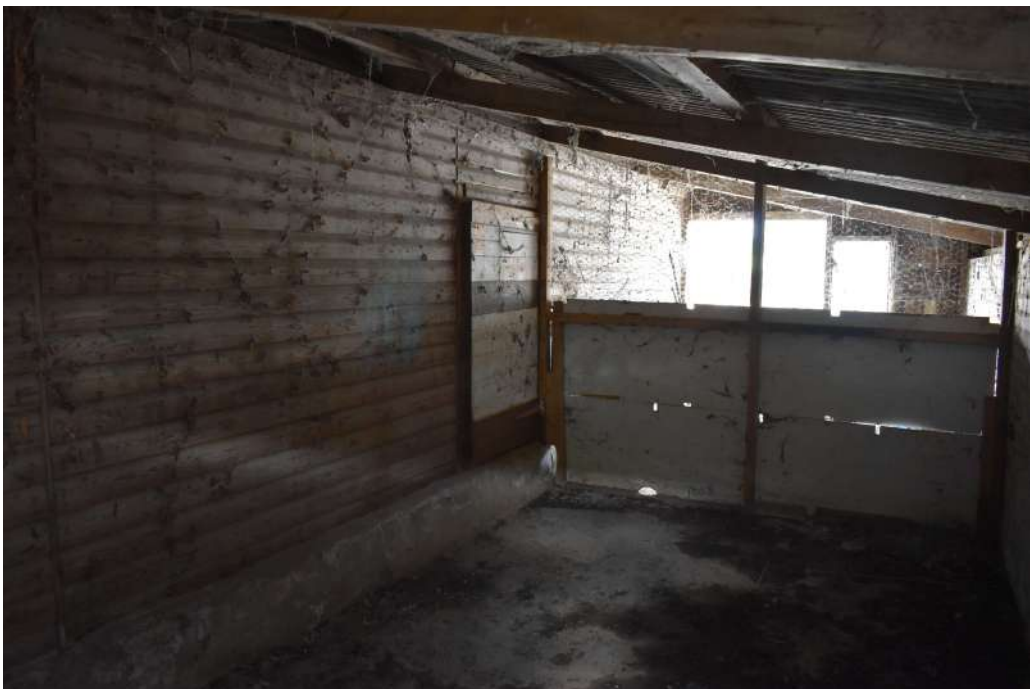
The roof of extension 1 consists of single rafters rising from the eastern wall plate to meet the western wall, with two through-purlins.

The western wall is the original eastern elevation of the sectional timber hut and is clad in weatherboard, while the eastern wall is red brick in a rough Flemish bond. There is an inserted door in the western wall. The northern and southern walls are both timber. The northern wall has a door and window and the southern wall a single blocked doorway. There is a crude dividing wall, constructed from timber, chicken wire and fibreboard, segregating roughly the north third of extension 1. The floor is poured concrete.

Photograph 15 Internal view of extension 1. Photo taken facing north-west.
