Tighchuig (Eagle Brae) Struy, Strath Glass

Watching Brief Report

Report No.	HAS110902
Site Code	EBR11
Client	Eagle Brae
OS Grid Ref	NH 389 377
HCAU / Planning	07/00727/FULIN;
Ref	10/04562/FUL
Date / revision	14/10/2011
Authors	P Higgins and J
	Wood

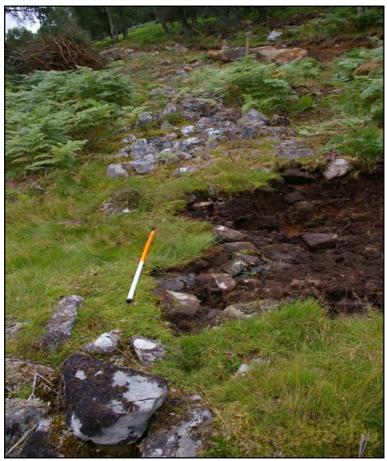
Plate 1 Stripping between F9 and F10 shows the gap to be superficial

Both sections were found to comprise uncut boulders between 0.3m and 1.2m across. When the area of the cabin stance was stripped the two features proved to be one continuous dyke. These features, together with F21 were found to form one long, tumbled wall, running upslope at its northern end before turning to run southwards along a false crest, doglegging around rocky outcrops at the junction with F21. The new access road crossed the line of F9/F10/F21 at two points, and ran alongside it for some distance, so the wall has been damaged not only at the crossing points but also where the road impinged on its western side. The spoil heaps were sited to avoid further damage occurring when they are removed at a later date.

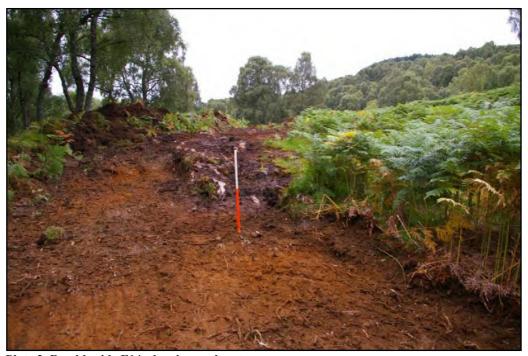
Plate 2 Road beside F14, showing rock outcrops

This clearance cairn proved to extend south-westwards further than first thought, and measured c.11m N/S by c.6m E/W. The exclusion zone, marked out on the basis of the earlier dimensions, was not large enough to contain the feature, and the road now lies within 2.2m of its south-west edge. No part of the feature was observed in the road area, however, and the feature remains undamaged.

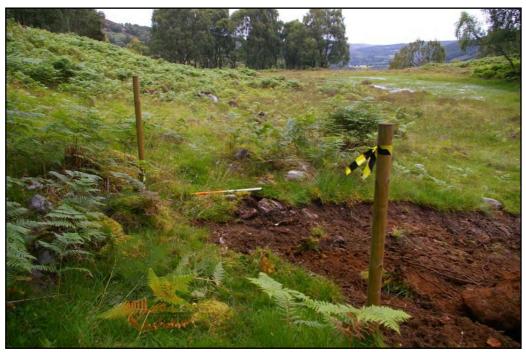
This large feature, c. $63m \times 5m$, comprises mainly stones greater than 0.4m below a spread of smaller stones, mainly between 0.15m and 0.5m. The large stones form a tumbled wall running approximately north/south, with clearance deposits added after it tumbled, and connected to feature F10 by a short wall, forming a dog leg around an area of large rocks. A mound of the smaller stones lies against and above the larger stones, forming a small spur projecting eastwards from the dog leg.

Only the east end of the spur was disturbed by groundworks. The observations of different stone sizes were obtained by examination of parts of the feature lying outwith the groundworks area.

Plate 3 East end of F21, exposed during stripping cabin stance

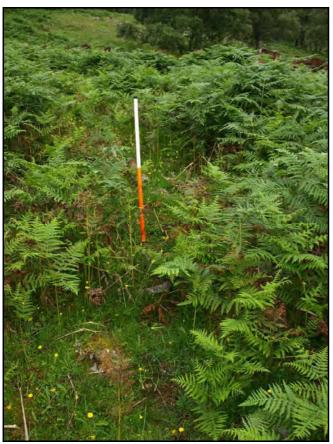
A new feature was noted during the watching brief. Low linear mounds of rubble outline a rectangle measuring 8.2m N/S by 4.1m E/W. However it was not affected by the present works.

Plate 4 Feature F24 in deep bracken, looking W

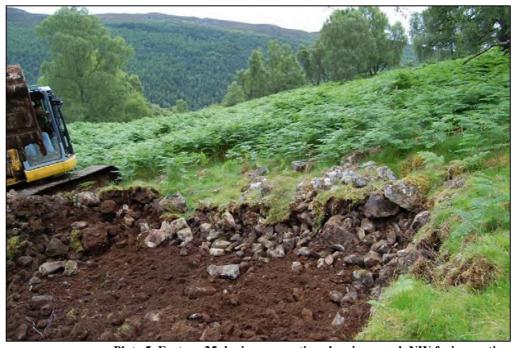
A new feature was noted during the watching brief. This had been obscured at the time of the survey. A low clearance heap, which could not be avoided, lay at the base of the natural slope. It was triangular in section and measured about 7.7m x 3.8m x 0.4m at its deepest. The cairn was carefully removed under archaeological supervision (see Plate) although owing to the nature of the material a straight-edged ditching bucket was not used until the stones themselves had been removed. The stones were from 0.1m to 0.3m across. There were no signs of multi-phase clearance or of archaeological features or artefacts.

Plate 5 Feature 25 during excavation showing rough NW facing section.
