Highland Archaeology Services Ltd

Millness Drumnadrochit

Upgrade of 11,000 volt OHL

Site Safeguarding

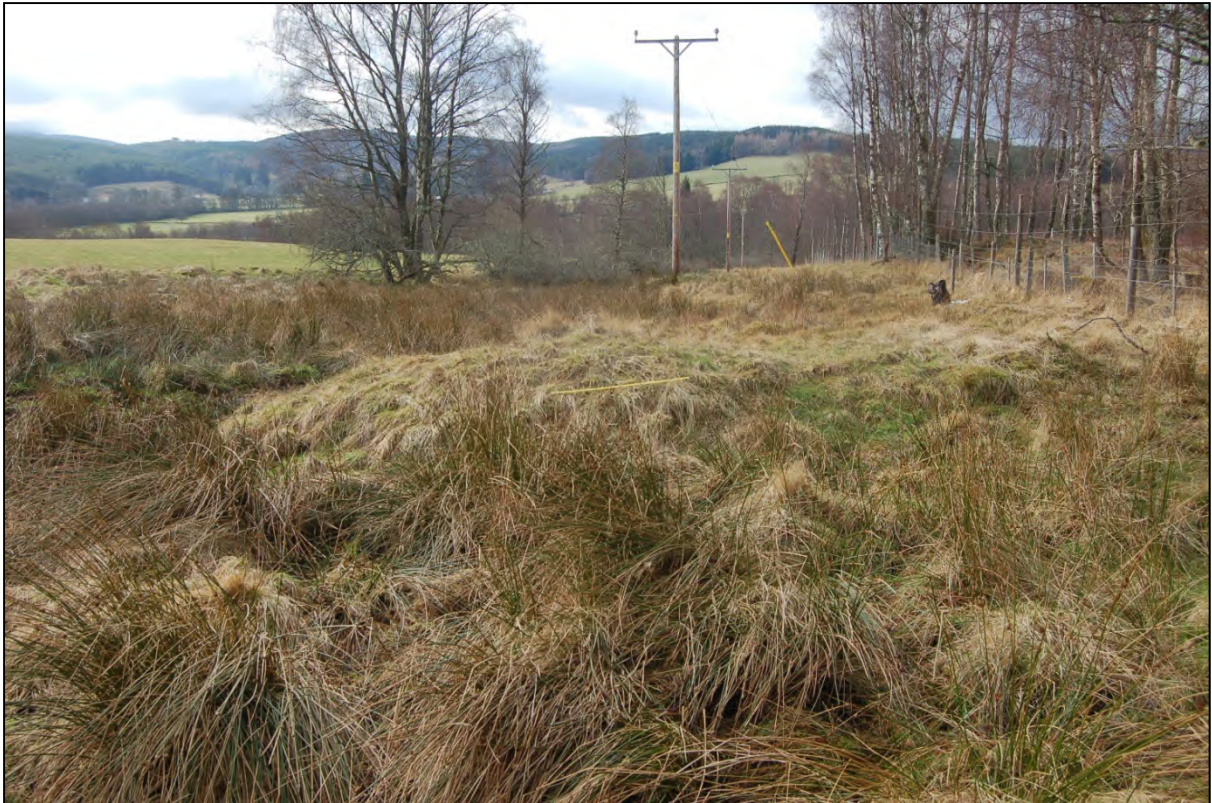
The dimensions have not changed a great deal (see plate1) as it is still measures 4.5m transversely, 0.7m in height but it has been truncated to c.8m along its NE to SW axis, due to animal erosion of its SE end (see plate 2). The field clearance noted on RCAHMS visit is still evident and does indeed obscure the mound as you approach it.

Plate 1 General view of the burnt mound, looking SW (MHG47199)

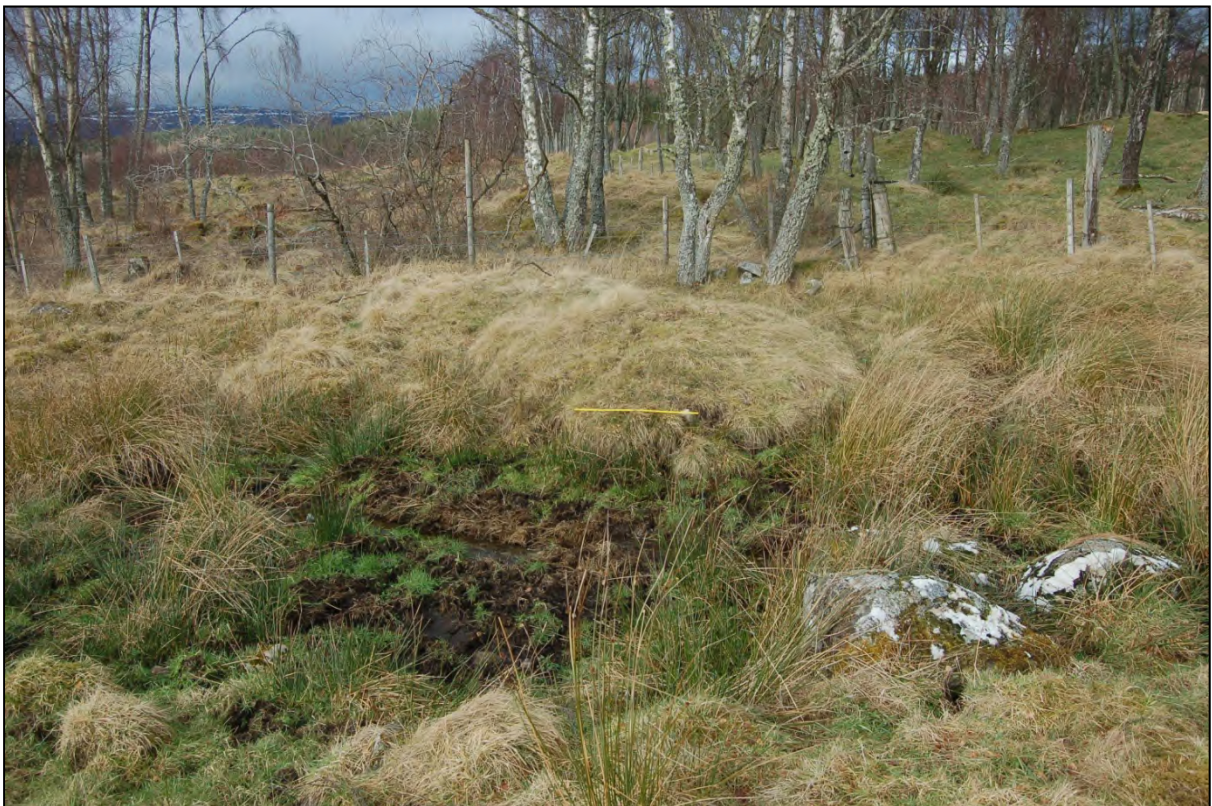
Plate 2 View of burnt mound showing erosion at its SE end, looking NNW (MHG47199)

The results of the visit to both sites show that elements of both have been destroyed by erosion or obscured by vegetation growth. The burnt mound has been reduced in size by 0.5m at its SE end due to animal erosion and small amounts of sediments from the mound are now visible. Although the hut circle's physical dimensions remain the same the bank is now covered in grass and has numerous trees growing out of it. The associated bank cannot be identified with any certainty.

Although not a matter for SSE, provided these features are safeguarded, as a general recommendation to the Highland Council we would draw attention to the ongoing erosion of the burnt mound,

especially the **exposure of sediments on its SE edge**. A small-scale survey and excavation might be advisable at some stage to monitor this and record any evidence before it is lost.

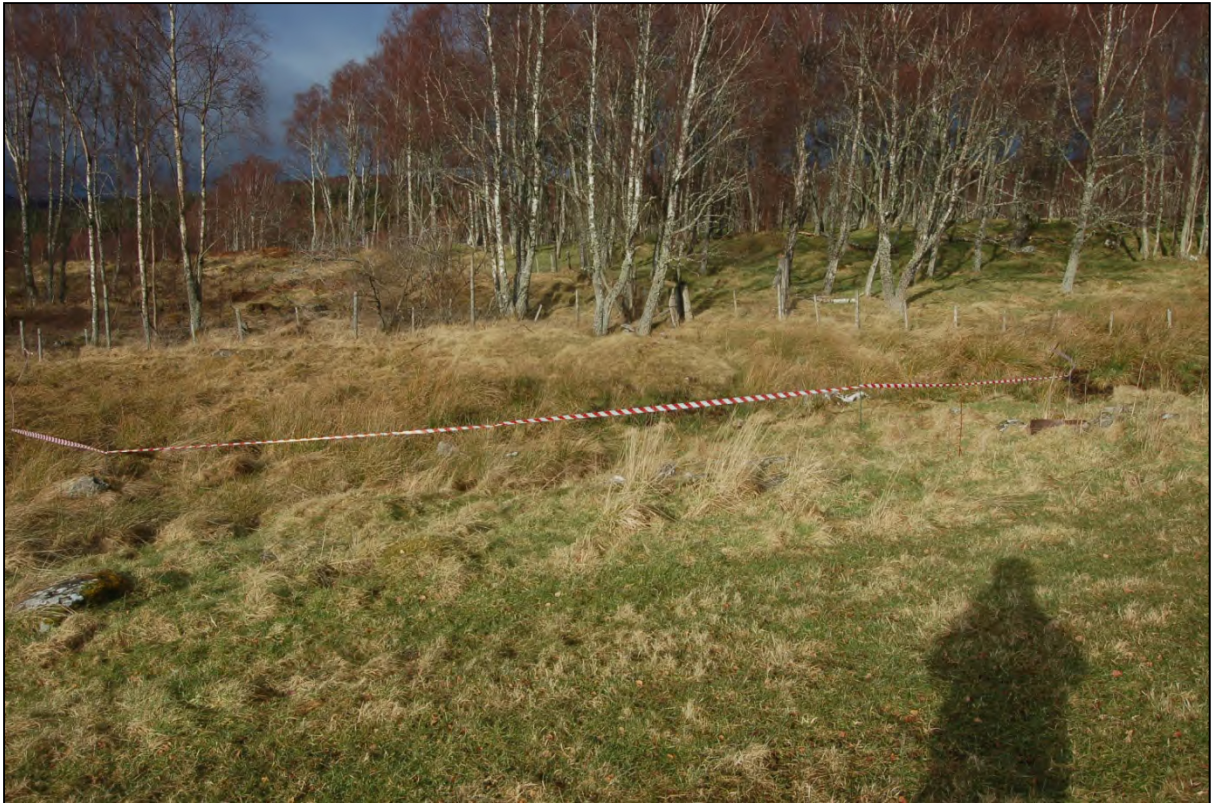
The site was marked off with canes and barrier tape, incorporating a 10m buffer zone from the nearest visible edge (see plate 3). This buffer zone runs underneath the existing overhead line, but should not be impacted directly by the line upgrading work as the site for the proposed new pole lies some 30m WSW of the mound.

Plate 3 View of burnt mound as taped off, looking NNW (MHG47199)

The method of marking-off was carried out on the understanding that upgrading works are likely to take place imminently. The tape is not designed to be left for an extended period and if overhead line work is delayed in this area the barrier should be checked and if need be strengthened or renewed.

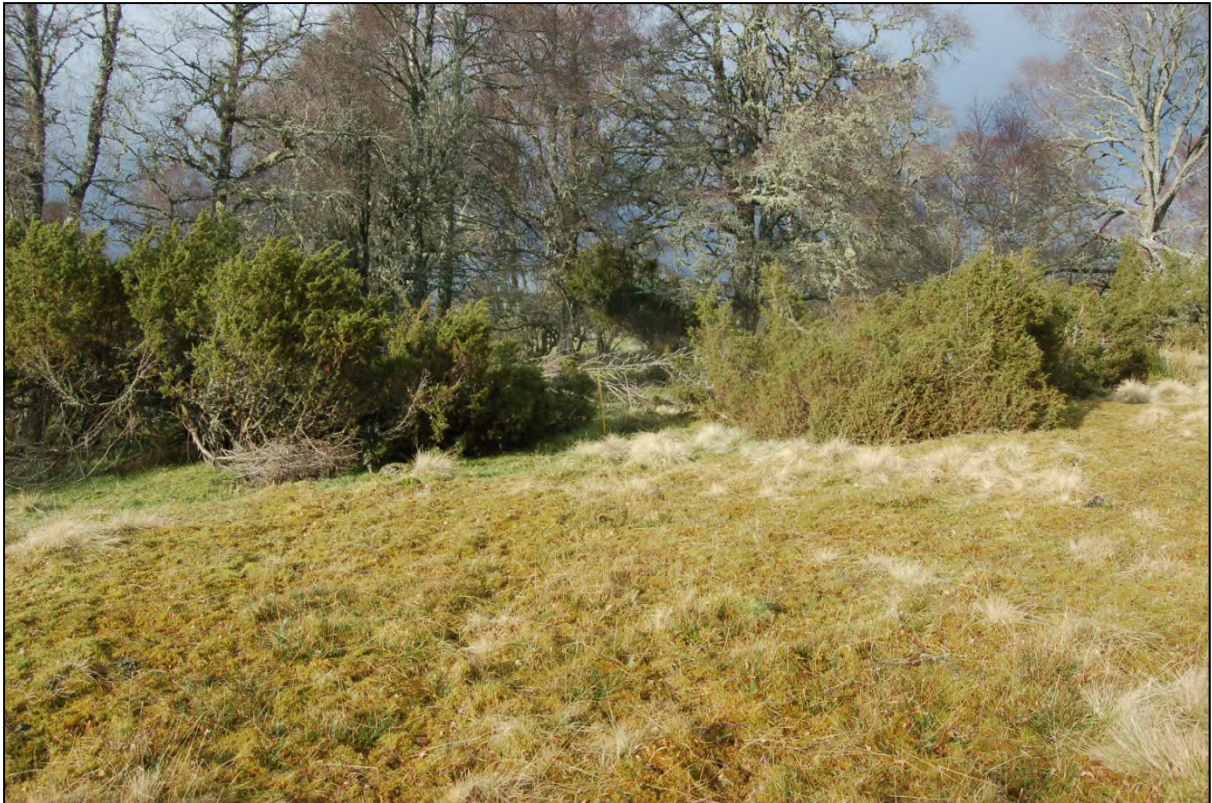
The dimensions of the hut circle have not changed, although it has become difficult to identify because of the trees growing out of the bank (see plate 4). The bank itself has become completely covered in rough grass save for a few stones that are still visible on the outer edge of the bank (see plate 5).

Plate 4 General view of hut circle showing trees growing out of the bank, looking NNW (*MHG47200*)

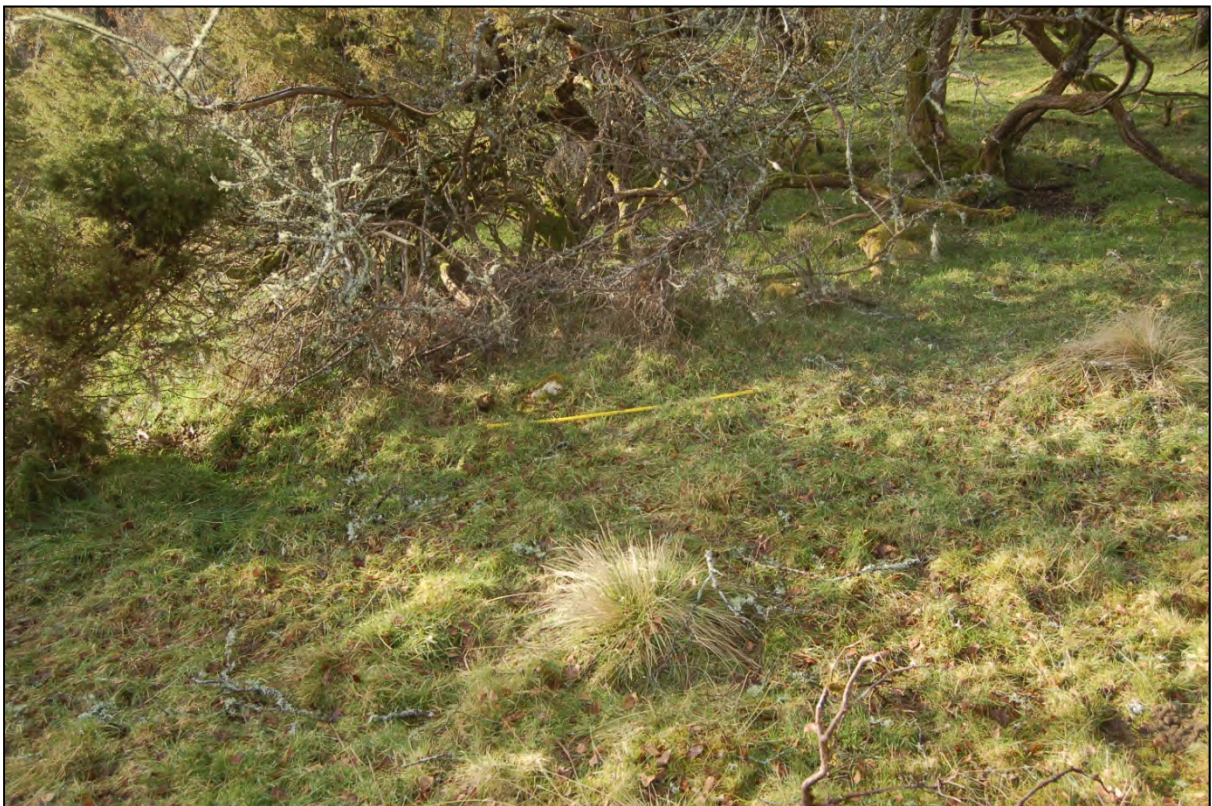
Plate 5 Exposed stone in the bank of the hut circle, looking E (*MHG47200*)

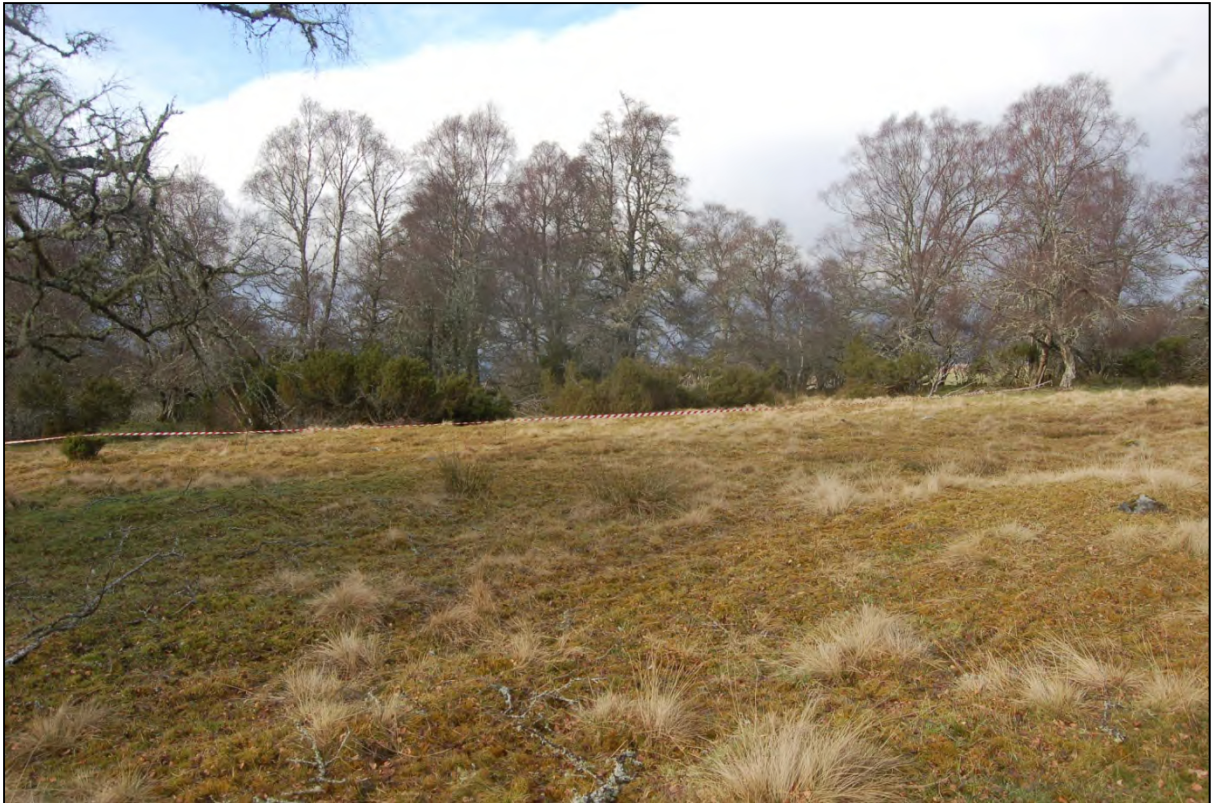
This site was marked off with canes and barrier tape, allowing a 10m buffer zone from the nearest visible edge (see plate 6).

Plate 6 View of hut circle as taped off, looking NNW
