## Bruiach Farm, Kiltarlity

## Desk-based Assessment and Building Recording

Report No.	HAS120301
Site Code	KBF12
Client	J Martin
OS Grid Ref	NH 5014 4118
HCAU / Planning Ref	06/00273/OUTIN
Date	30/03/2012
Author	L McKinney

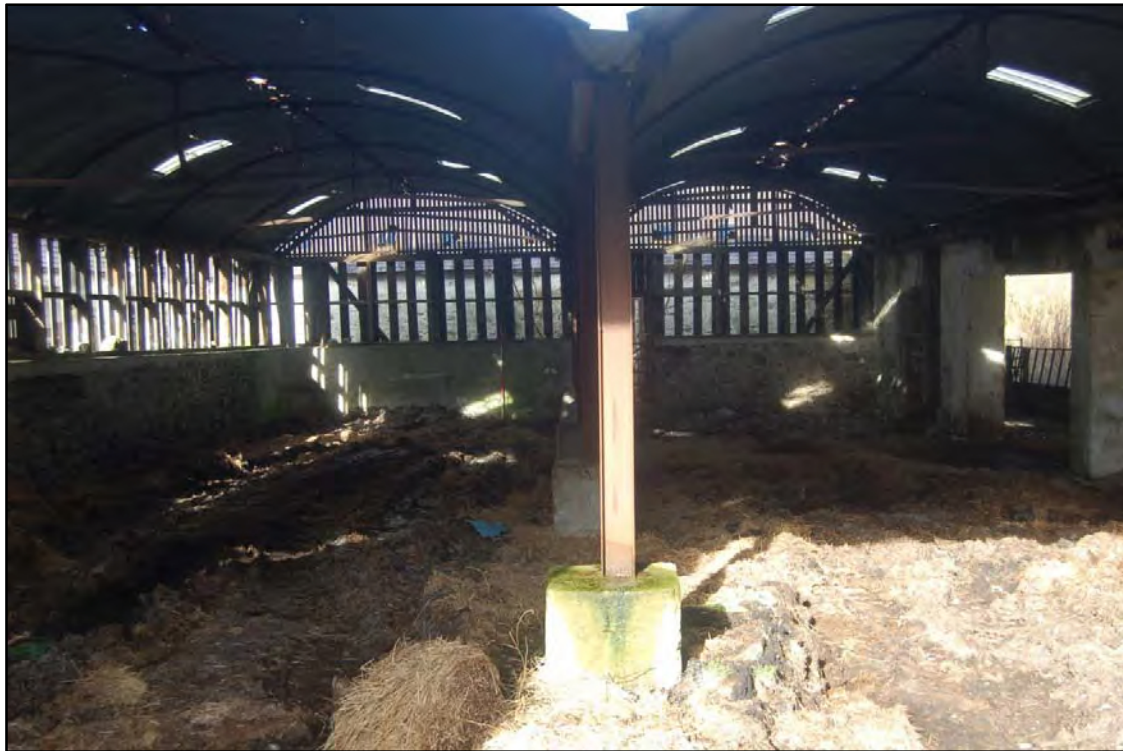
Plate 3 Barn 1 – interior

A large Dutch barn situated between house 9 and house 7. It is formed by a metal frame which supports a corrugated iron roof. The metal frame is carried by the E elevation of house 7 and an L shaped wall that abuts the S end of house 7. This L shaped wall is a rough rubble built wall 1.2m high and 0.6m wide, that first appears on the OS 2<sup>nd</sup> edition map 1904. The top of the wall has been capped with concrete to form a stable base to carry the metal frame of the barn. Parts of the interior face of the wall have been rendered with a cement skin and a modern concrete cattle trough has been added to the E section of the wall. The flooring material cannot be seen as it is covered in straw and manure. It seems that this structure has been used for stock control in recent times. . (Plate 3)

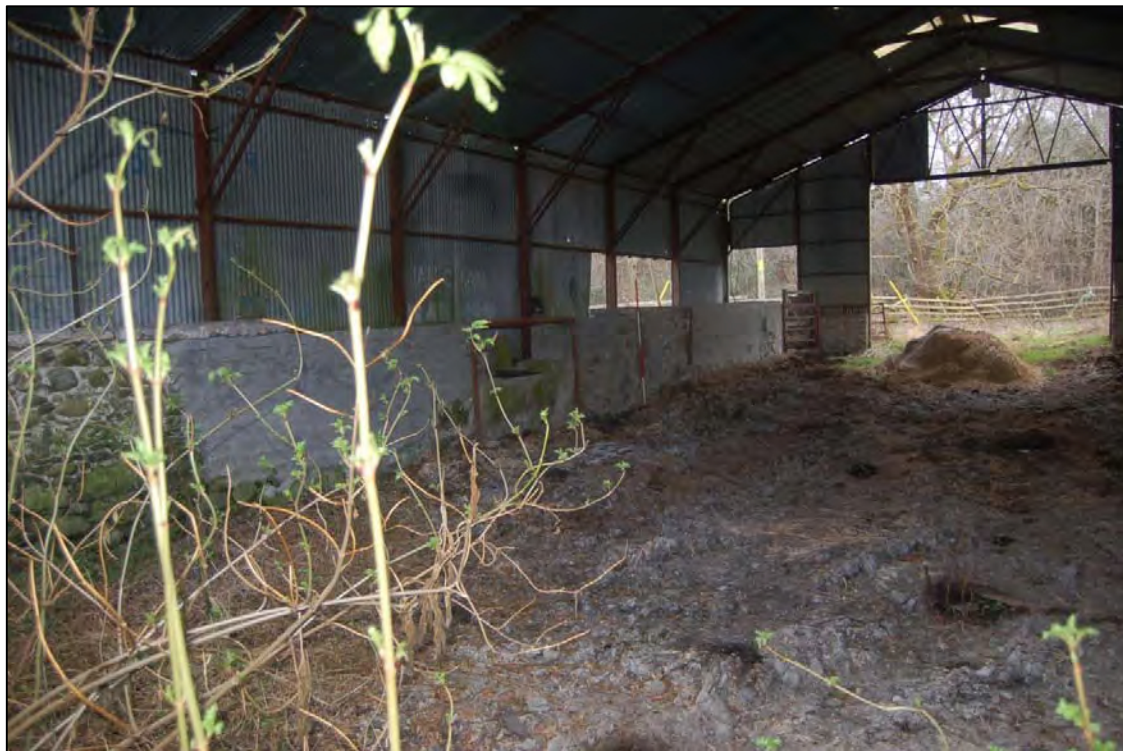
Plate 4 barn 2 – interior

A large Dutch barn situated between 7 and house 6. It is a freestanding metal framed structure clad in corrugated aluminium and roofed in the same material. Contained within the barn is a section of rubble built wall running N-S, which first appears on the OS 2<sup>nd</sup> edition map 1904. This wall is tied to the S elevation of house 6. The wall is 1.4m high and generally 0.6m wide. This wall has been repaired with a section of modern block and cement. It has also had a modern concrete cattle trough added to it as Barn 1. As with Barn 1 the flooring material is obscured by straw and cattle manure. It seems that this structure has been used for stock control in recent times. . (Plate 4)

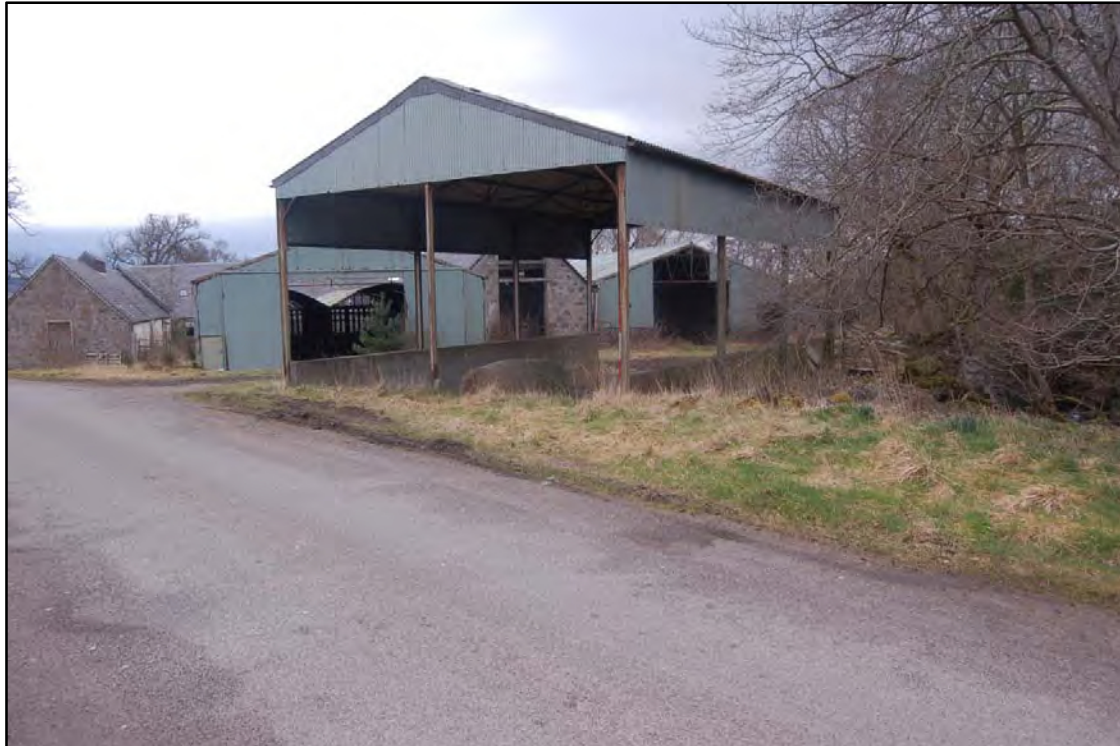
Plate 5 Barn 3 from SSW

A large Dutch barn lying c.20m S of house 7. It is a freestanding metal frame structure with a corrugated aluminium roof. The metal structure is carried by concrete walls, 1.3m high and 0.3m wide. It has a poured concrete floor and is currently used for bale storage. . (Plate 5)

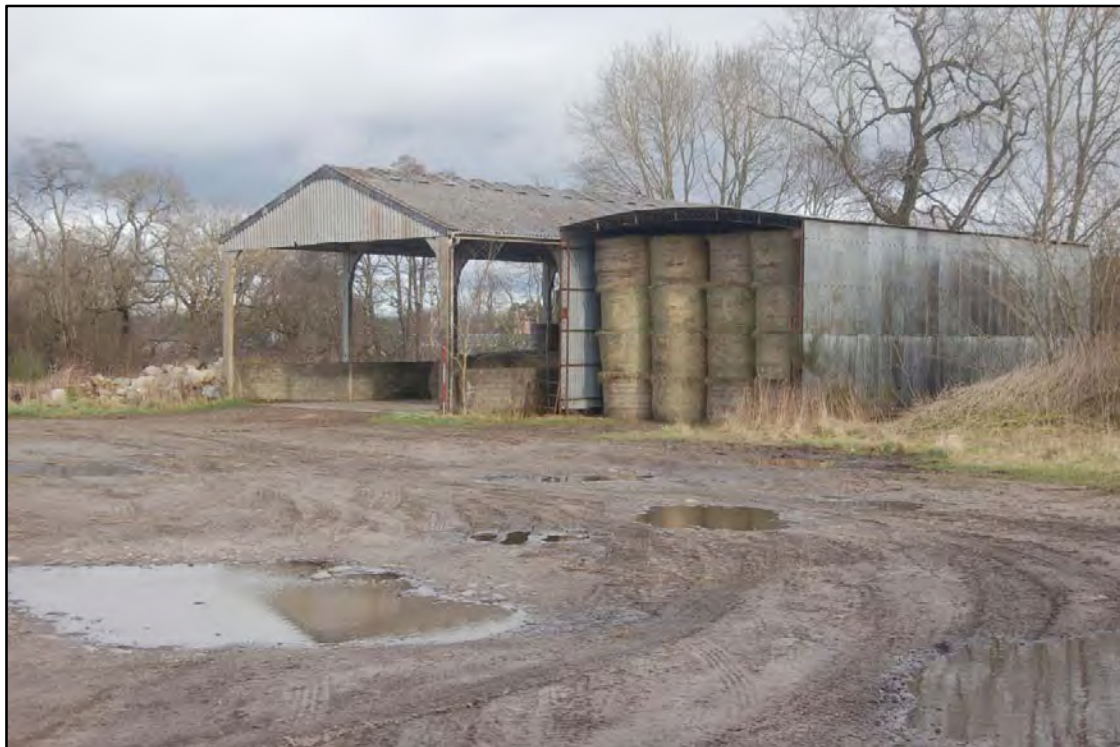
Plate 6 Barn 4 and Shed 4 from SW

A large Dutch barn located c. 45m S of house 6. It is constructed completely of concrete. It has a concrete base and two concrete walls 1.3m high and 0.2m wide which support a series of concrete pillars. These pillars carry pairs of concrete trusses that are tied at their apex. The Barn is roofed in a corrugated material that could not be identified from the ground although it did resemble asbestos. . (Plate 6)

Shed 4 is situated parallel to Barn 4. It is a freestanding metal frame structure with a corrugated aluminium roof. It has a dirt floor and no evidence of footing can be seen at the surface although some form of concrete foundation is likely beneath ground. It is currently used for bale storage. It could not be entered as it was full of bales. (Plate 6 above)

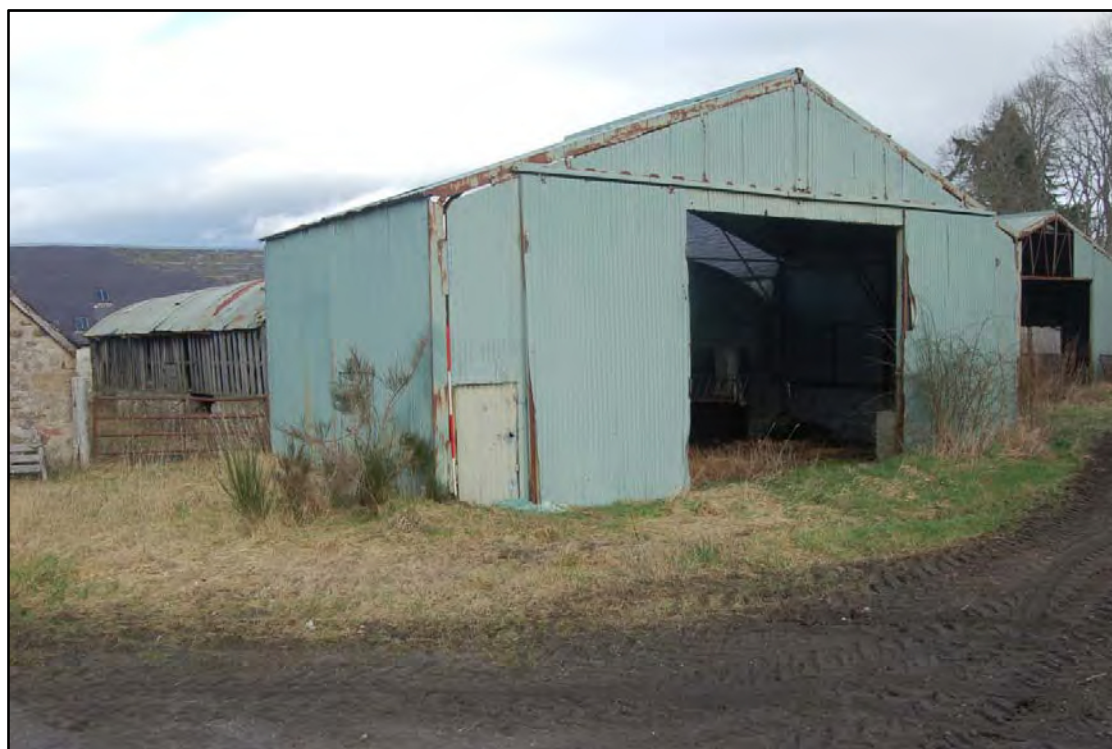
Plate 7 Shed 1 from SW

Shed 1 form a small extension to Barn 1. The shed is formed by a metal frame clad and roofed in corrugated aluminium. This is supported by two L shaped sections of modern block built concrete wall either side of its entrance. The E section of modern wall abuts the rubble wall which carries Barn1. The W section of the modern wall abuts the E elevation of house 7. (Plate 7)

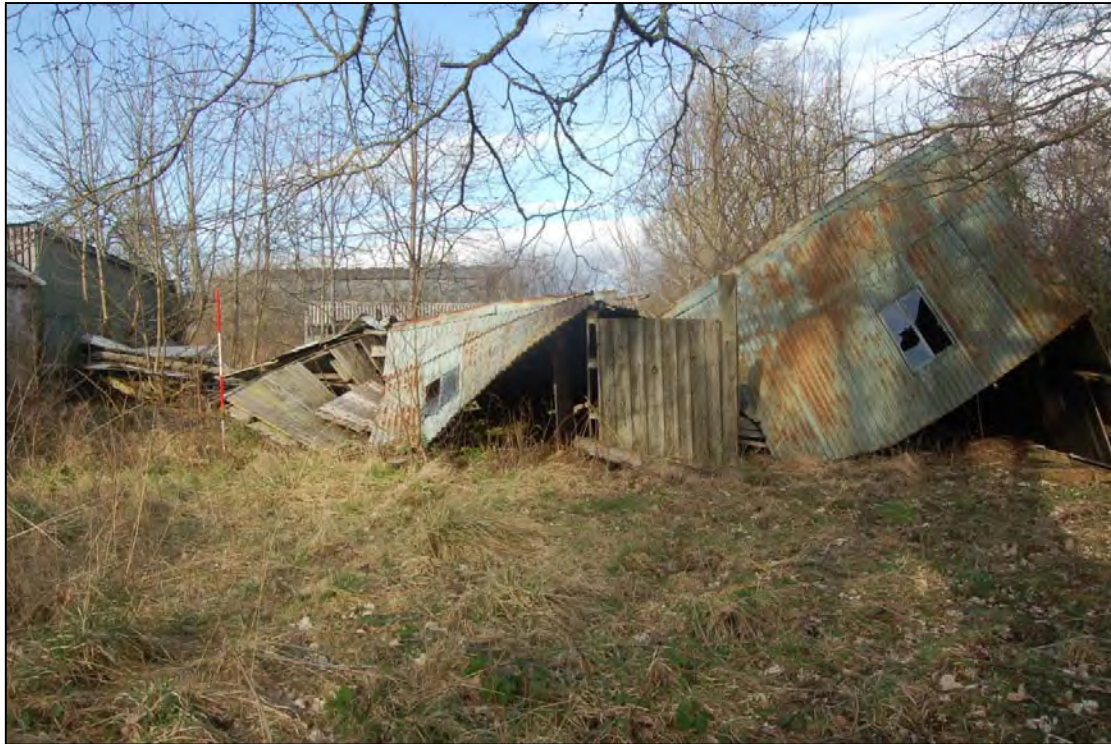
Plate 8 Shed 2 from S

Shed 2 is a collapsed wooden structure with a corrugated iron roof. It was deemed unsafe and not entered. . (Plate 8)

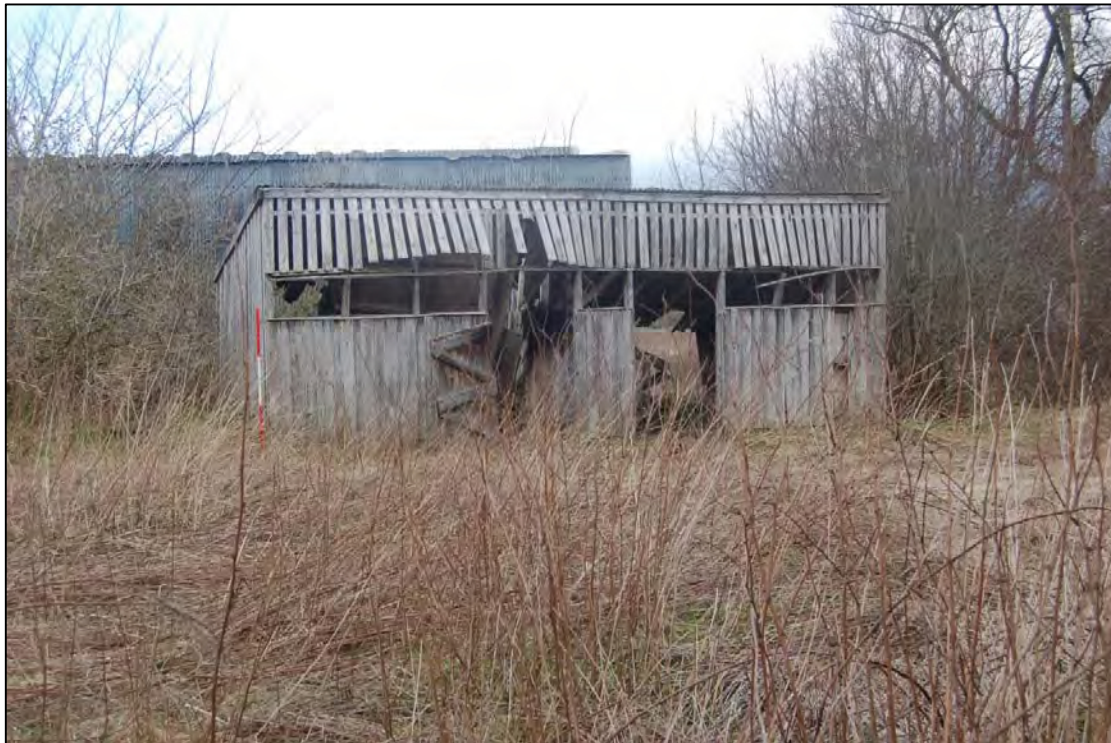
Plate 9 Shed 3 from E

Shed 3 is located c. 20m S of house 6. It is a timber built structure on a concrete floor which has been divided into 2 equal size stalls possibly for horses. It is roofed in corrugated asbestos and its N elevation has collapsed. It was deemed unsafe and not entered. . (Plate 9)

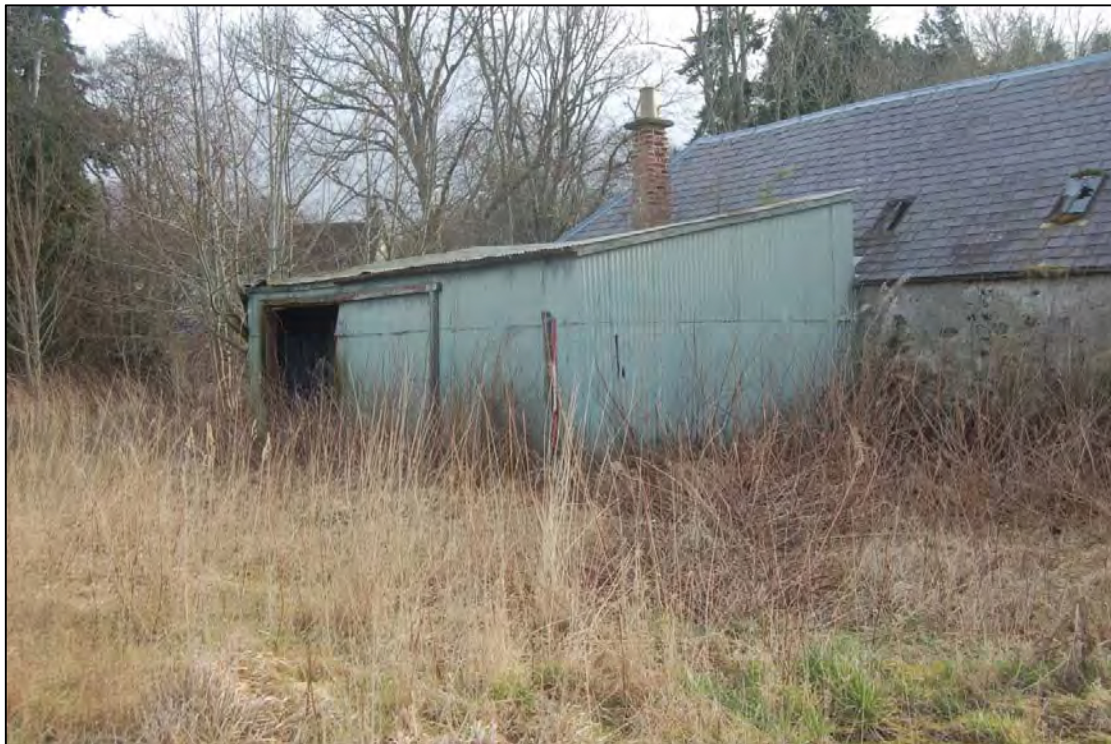
**Plate 10 Lean-to 1 from NNW**

This is a timber frame structure, clad in corrugated and roofed in corrugated aluminium. It has a dirt floor and is located adjacent to the N entrance to house 6. It was not entered due to the unstable nature of the surrounding outbuildings. (Plate 10)

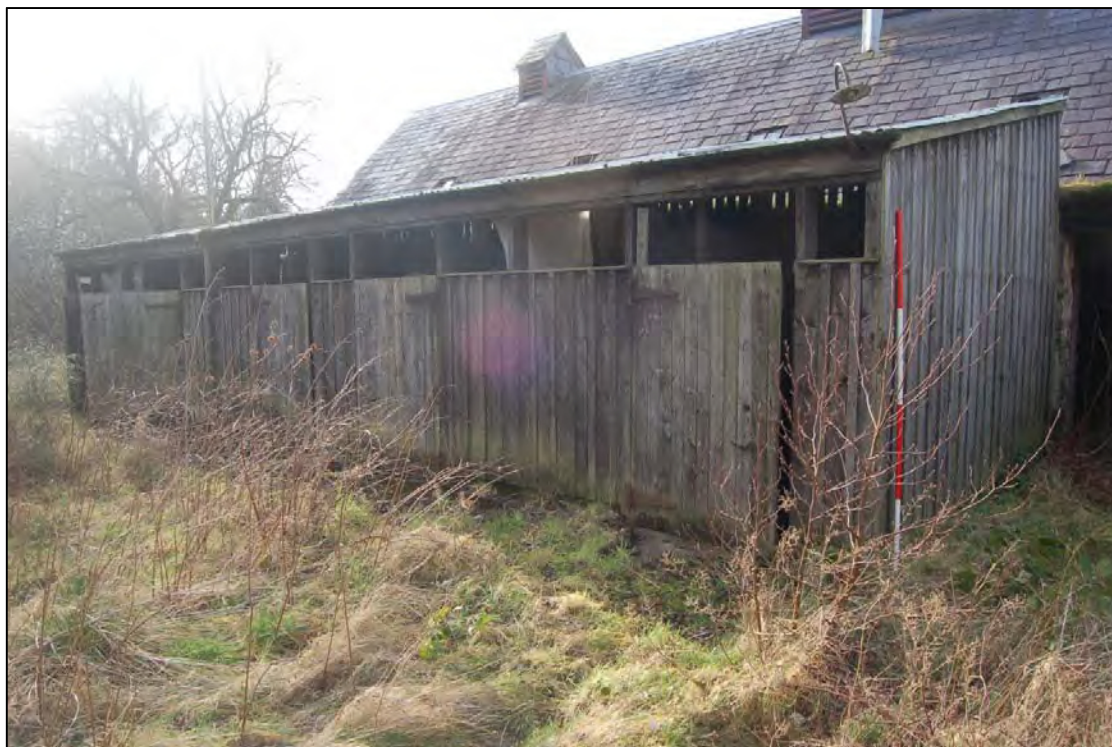
Plate 11 Lean-to 2

It is a timber built shed adjacent to the W elevation of house 6. The shed has a concrete base and a corrugated iron roof. The structure is divided into 5 identical stalls, probably for stabling horses at some point. It is currently used for storage of various farming implements. (Plate 11)

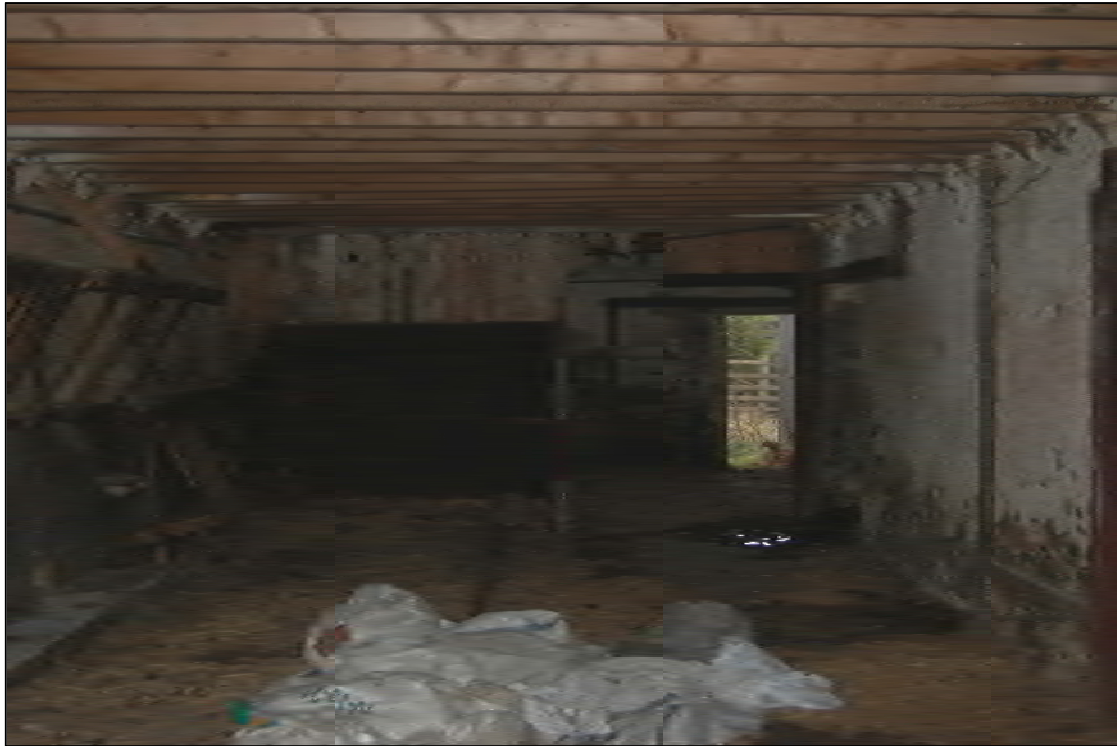
Plate 13 House 6: internal partition

The interior has been split into two sections by the addition of a timber partition (Plate 13), one section running E-W (12.5mx 6m) the other N-S (19.3m x 6m). The N-S section has openings in each gable. The entrance in the S gable has been extensively repaired with modern block work and the lintel has been replaced with a concrete substitute. The interior junction between the E and S elevations has also been subject to repair with modern concrete block work (Plate 14). The internal render is a patchwork of original white lime render and modern cement repairs with some stonework exposed.

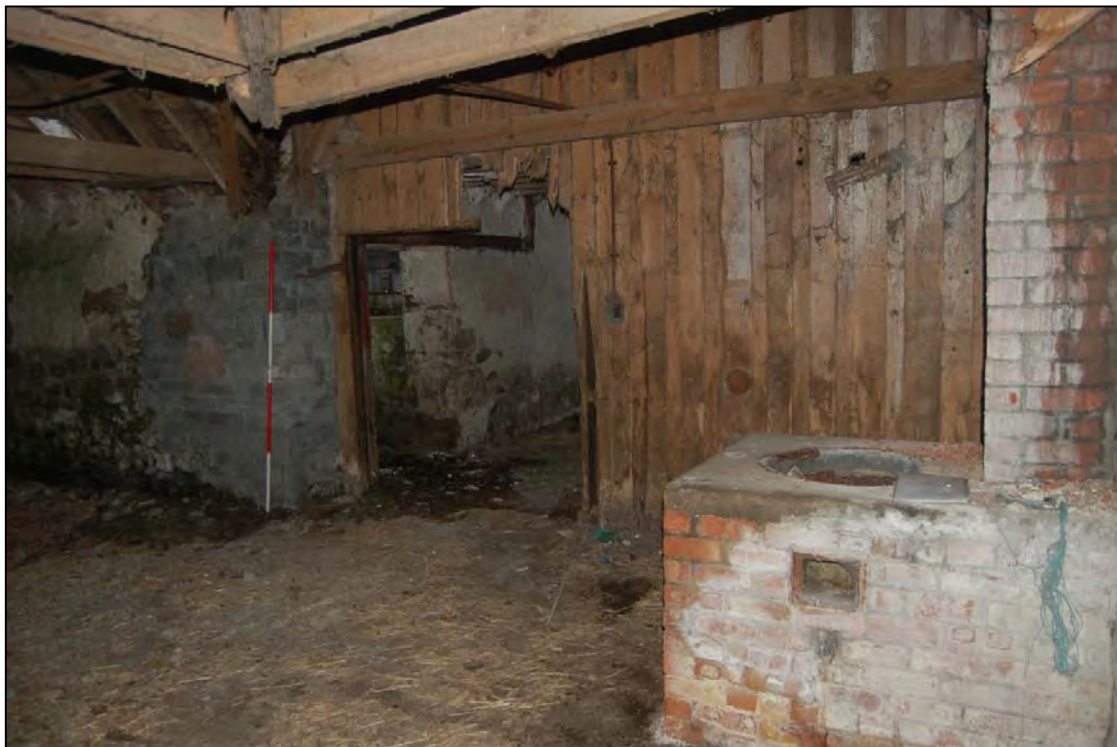
Plate 14 House 6: modern block work repair and wash boiler

Attached to the W side of the N interior gable wall a rectangular, red brick wash boiler (Plate 14) is located (1.4m x 1.1m x 0.65m high). A red brick chimney exits this against the N gable wall and exits through the roof.

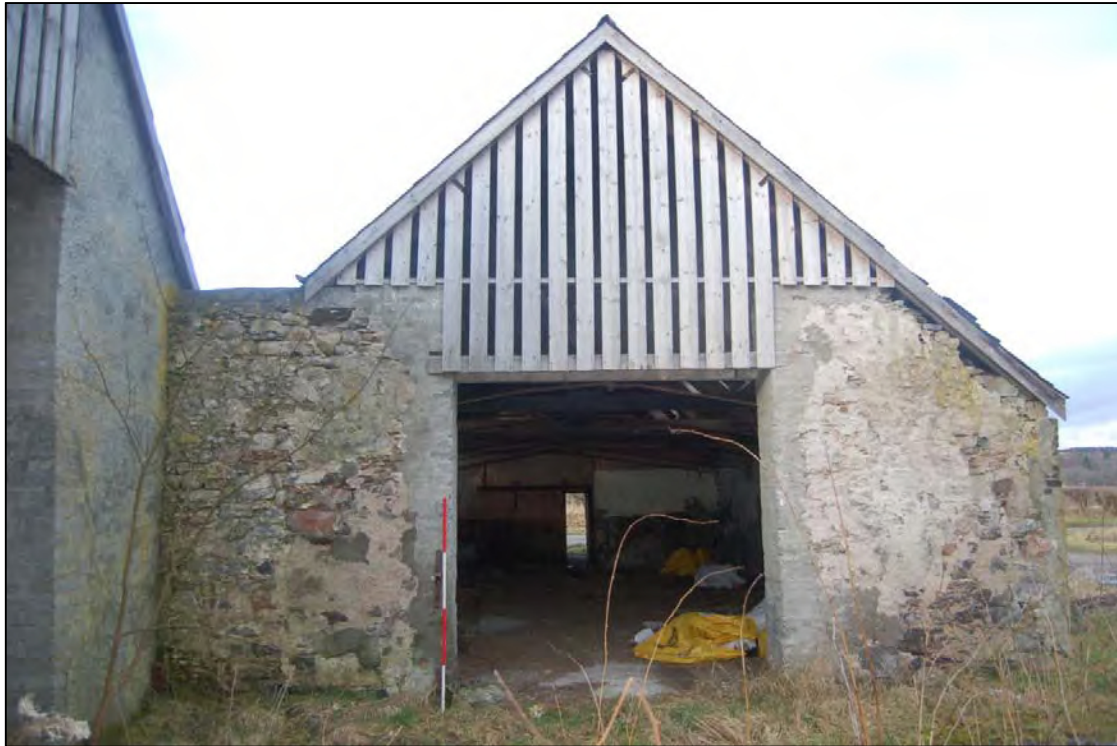
Plate 16 House 8, E gable showing original wall

The external elevations are exposed stone, with evidence of repairs on both the N elevation and E gable. The entrance in the E gable has been repaired with modern block work, and the corner where the E gable and N elevation meets has been rebuilt with brick, as the N slope of the roof appears to have been extended. The east gable entrance wall is also most likely part of the large structure shown on the 1<sup>st</sup> edition map running N-S that is now to become house 7. The west gable has a large entrance (2.7m wide) that is apparently in original condition with no evidence of repair.

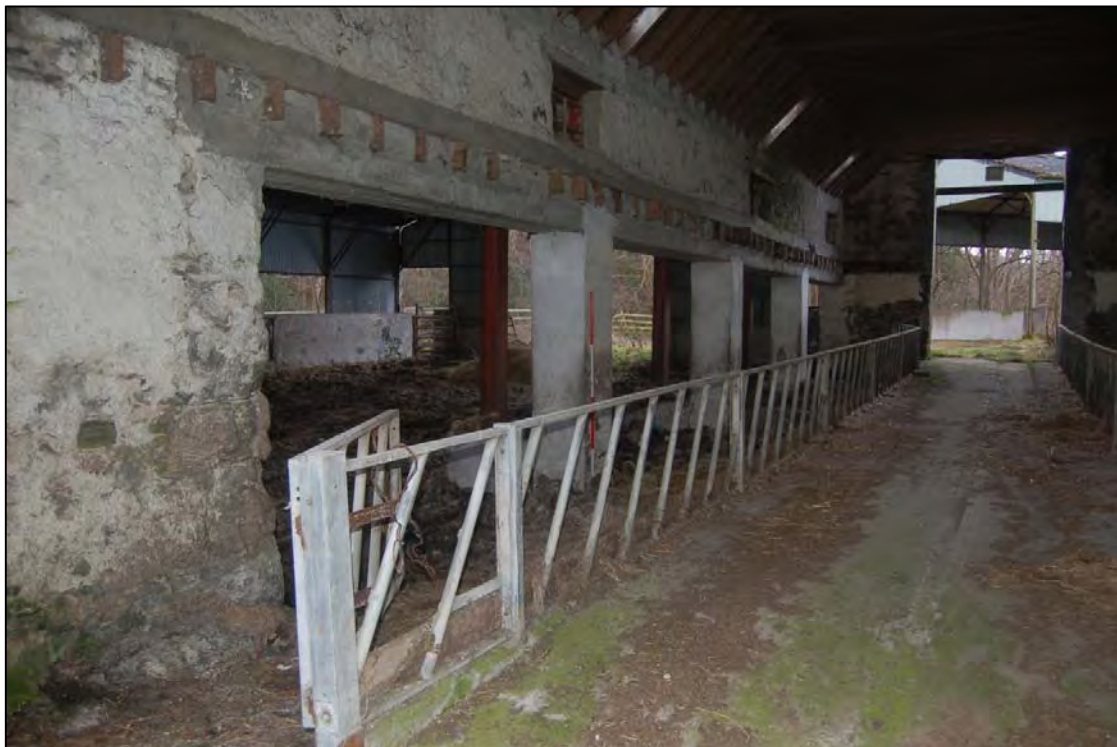
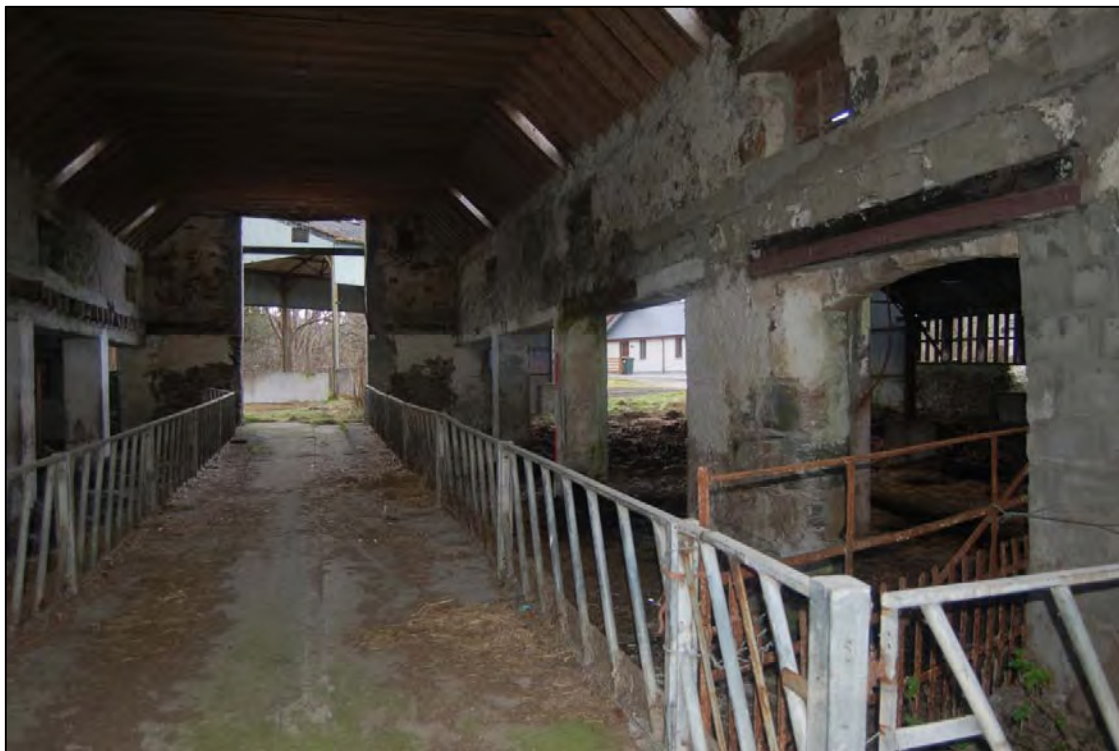
Plate 17 House 7, interior E elevation, showing replacement concrete pillars to carry upper wall and roof

The interior of the building has also been heavily repaired. The walls that form the multiple openings in each elevation have all been replaced with the exception of the two most N in each elevation. The other 6 have been replaced with concrete pillars (0.6m x 0.6m) and concrete lintels supporting the walls above the openings (Plates 17-18).

Plate 18 House 7, internal view of W elevation, showing replacement concrete lintels over openings

Above these lintels in the E elevation cut timber joists are visible and in the W elevation sockets for the joist have been filled. This may have supported a second floor at some point, possibly a hay loft; this seems likely as each gable opening extends to the roofs eaves which would have given easy access to a second floor. (Plates 17-18)

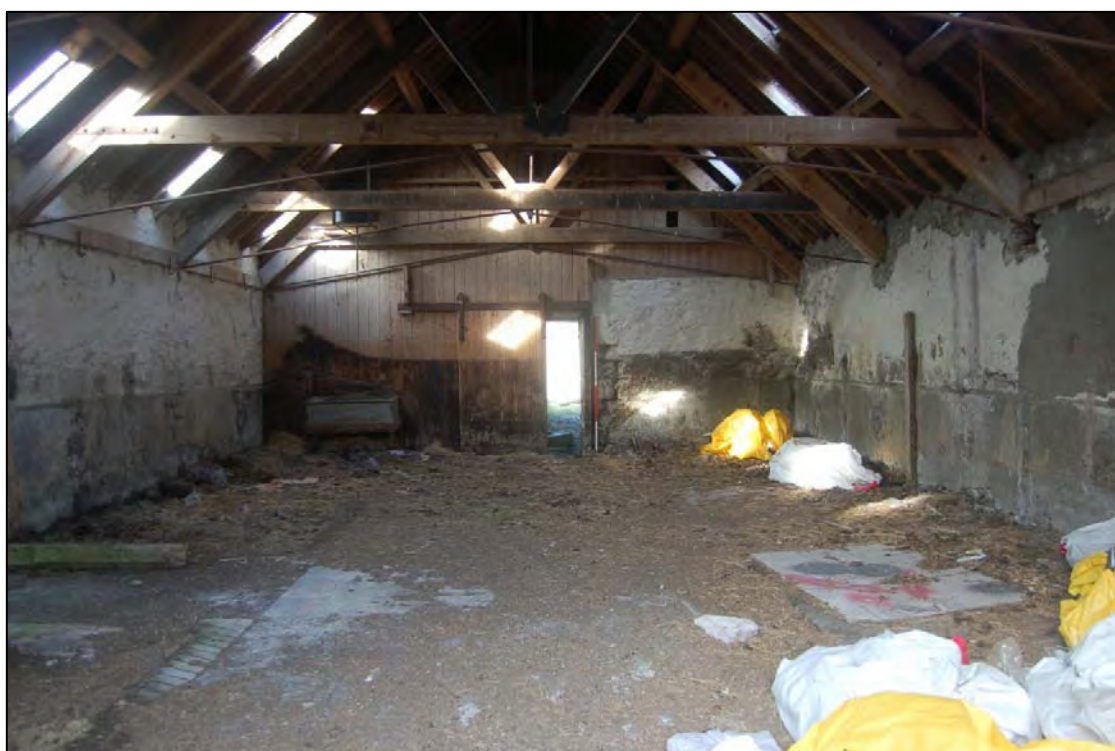
**Plate 20** House 8, internal partition extended to roof, forming first floor loft

The roof is slate carried by a typical A frame timber construction. The trusses tie into the wall head in what appear to be modern slots knocked out of the wall and then filled with cement. This along with the generally good condition of the roof indicates that it has been replaced recently. These trusses are only visible in the E section of house 8. The W section of the building has timber floor joists tied to the walls and a timber partition wall is visible forming a first floor room or loft (Plate 20). These first floor

The small first floor loft above parts of house 8 and 9 could not be accessed. It may be part of the earliest surviving phase since the access is through what would seem to be an original door in the west elevation of house 9, and we would recommend a supplementary visit at an appropriate stage to photograph the interior if possible.

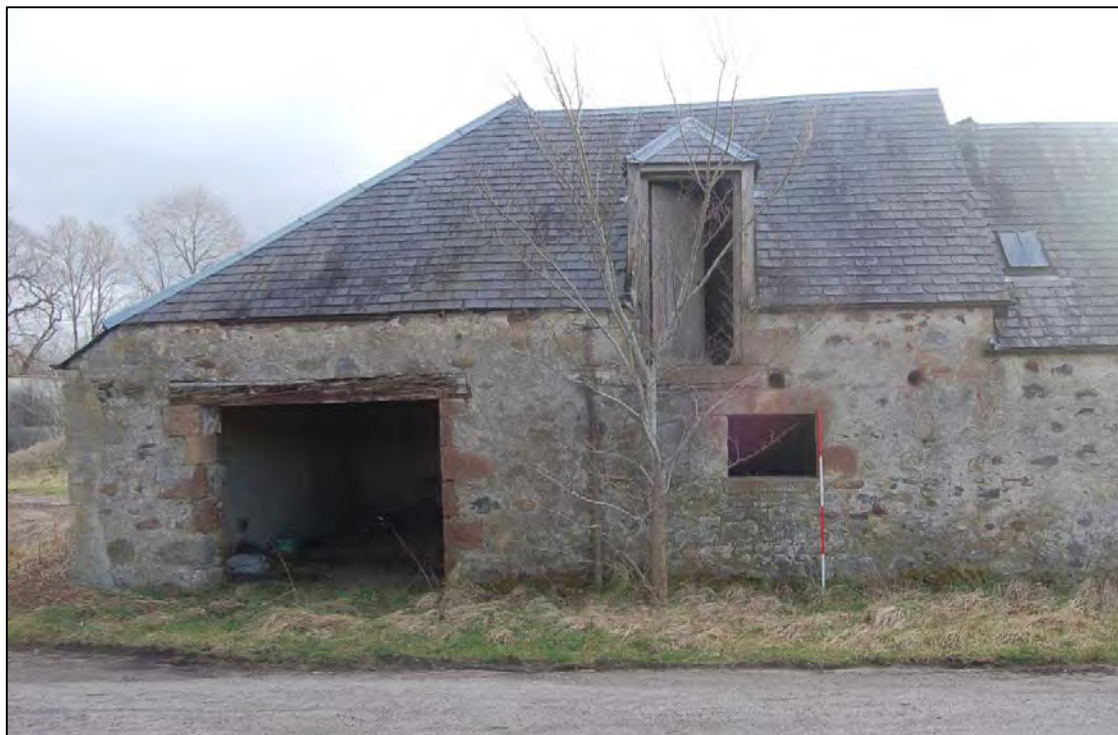
joists continue into the N room of house 9. The only access seems to be via a dormer type door in the west elevation of house 9. (Plate 21)

Plate 21 House 9, W elevation showing dormer doorway to upper floor loft

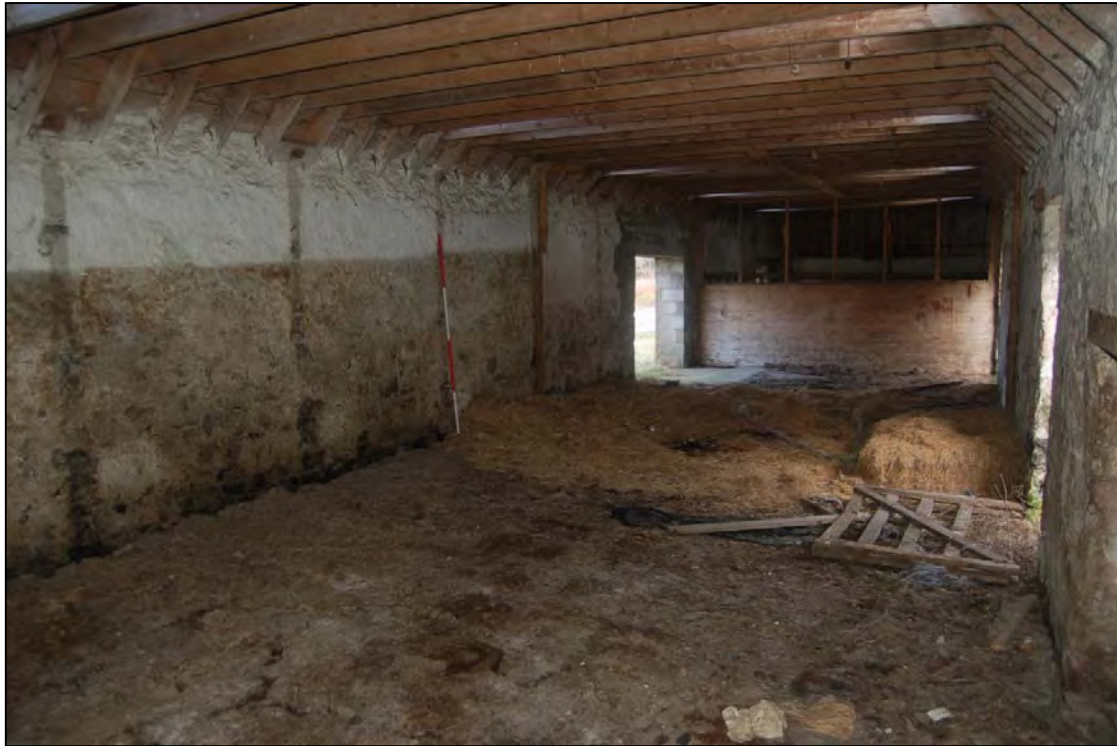
Plate 22 House 9, internal timber partition

Internally the structure has been split into a north and south section by the addition of a half-height wooden partition (Plate 22). The northern room is the smaller of the two, being roughly square (5.2m x 5m) and the southern room being rectangular (19m x 5.2m).
