Cromarty East Church

Archaeological Evaluation

May 2007

Report No.	HAS070611
Project	HAS-CEC07
Client	Scottish Redundant Churches Trust
Planning Ref	N/A
Date / revised	13 July 2007
Authors	Gemma Shannahan and John Wood

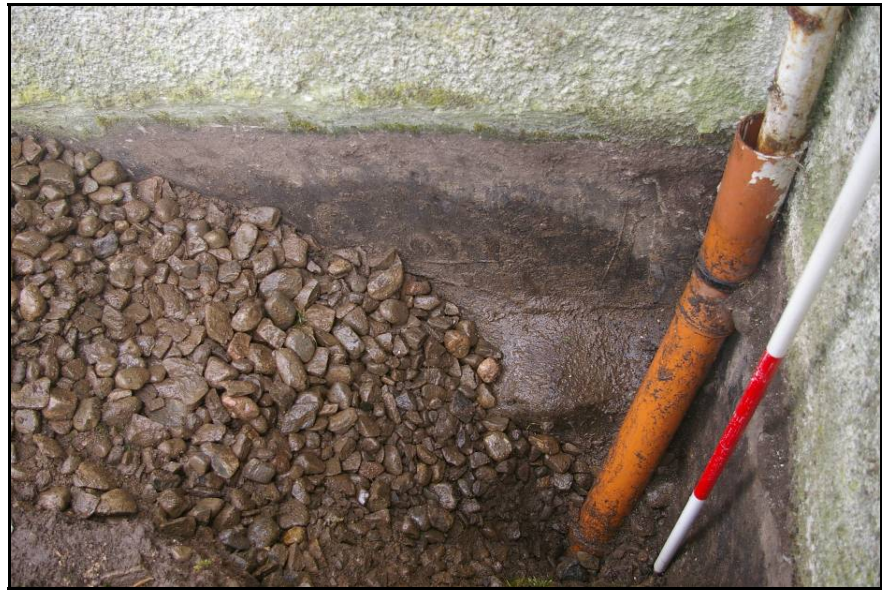
Figure 3 Trench A: excavated to c.1m below present ground level only

The church foundations were seen to be made of large sandstone blocks which have been concreted over and covered in a black waterproofing substance (see Fig 3).

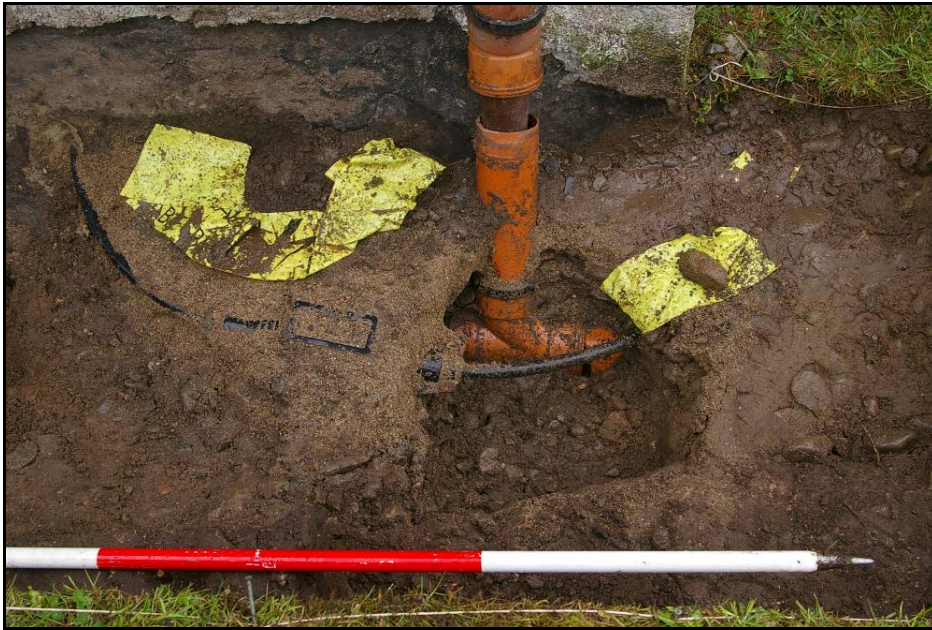
Figure 5 Trench B: downpipe running into perforated pipe and electricity cable

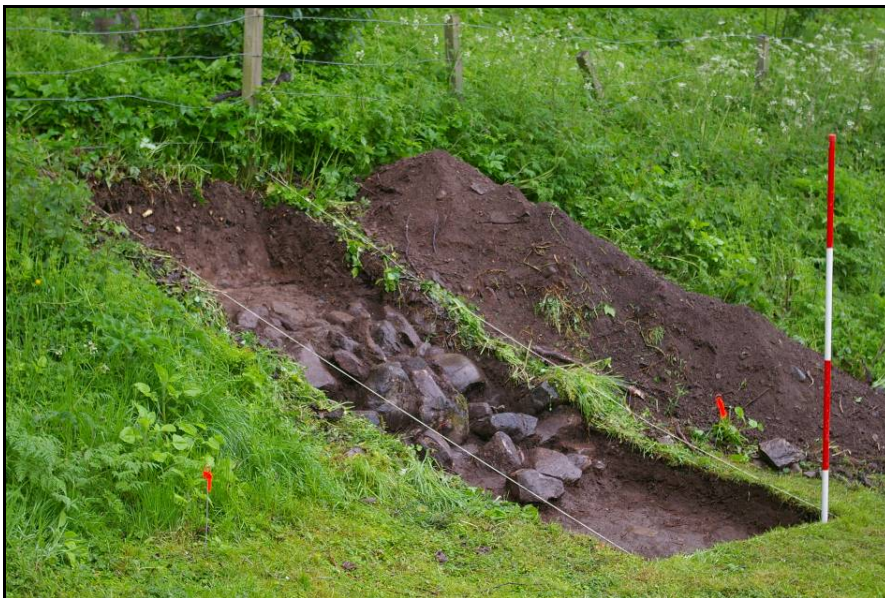
Figure 10 Trench D after removal of topsoil showing rubble spread [12]

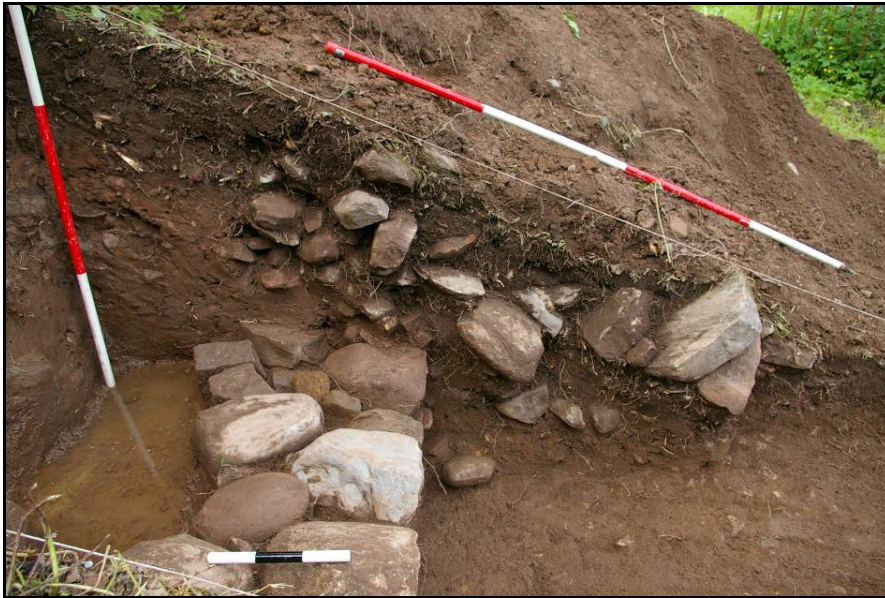
Beneath the stones [12] were the foundation courses of wall [17]. This may be faced on the downhill side only (see Fig 11) – if this is correct perhaps the wall was built at least partly torevet the slope. It soon became clear, particularly when looking at the sections, that [11] had slumped onto and partially over the wall, probably causing its collapse [12]. Also beneath the wall tumble, to the east of [17], is a reddish coloured re-deposited soil [18], with some red/orange clay inclusions as well as charcoal, coal, pot, bone and slate fragments. To the west of the wall feature [17], in the north west corner of the trench is a small area of silty mid-brown soil [19] with some clay inclusions.

It should be noted that the area to the west of wall [17] was waterlogged during the excavations, with water actively seeping from the hillside, and the contexts here could be difficult to distinguish owing to the amount of moisture in the ground.

Figure 11 Trench D as excavated, showing wall footings, rubble in section, and water seeping from slope and collecting behind wall

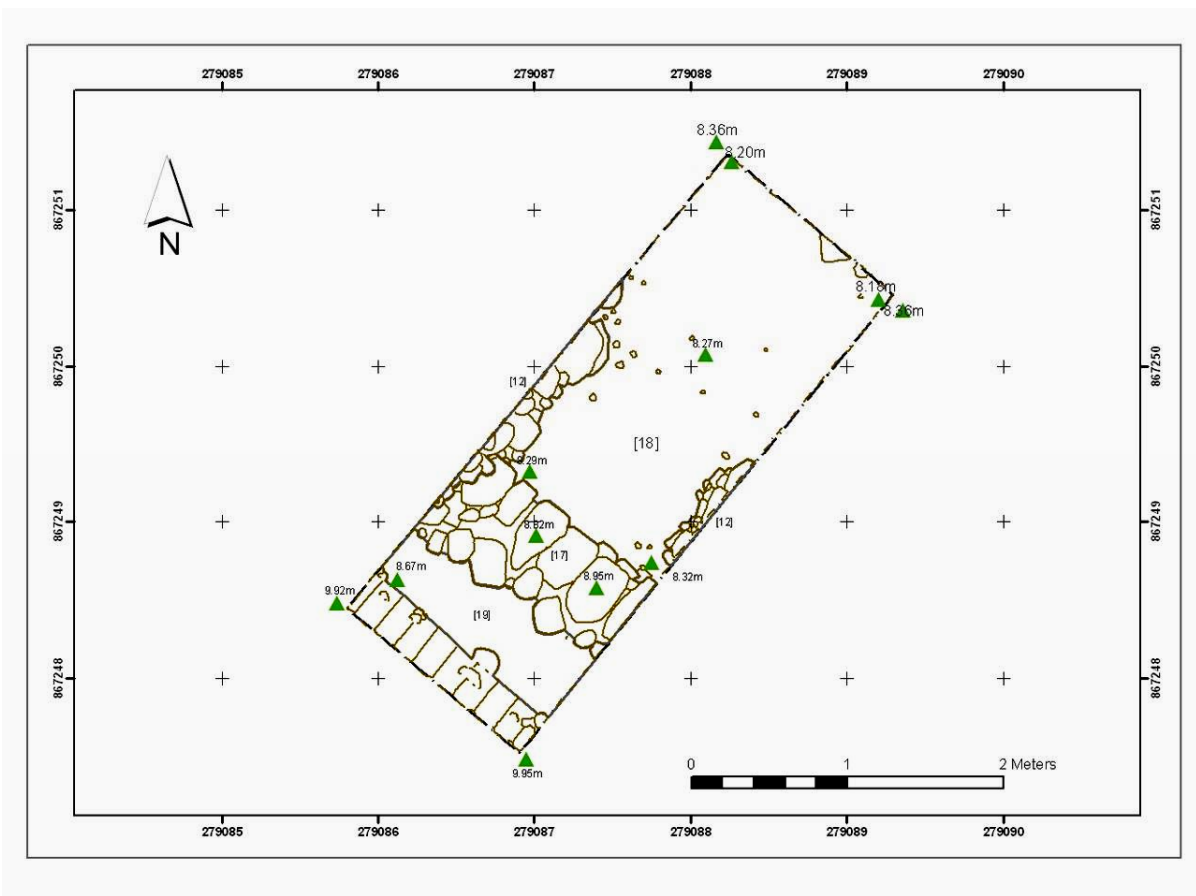
Figure 12 Trench D as excavated

The boundary wall discovered to the south west of the church in Trench D measures approximately 0.65m in width and appears to continue along the boundary. It does not appear to be a particularly strong or substantial wall. There is little evidence of any binding material, although a small band of lime mortar [21] was seen in section 2 and a little in the trench. It appears that the wall may have been destroyed by a landslide following which rubble was heaped up to retain the rest of the slope. So far the date of this event is not clear but it may have occurred during the catastrophic Cromarty floods of 1940. Between the two World Wars the brae south of the church seems to have been terraced and cultivated, which may have contributed to its instability.

Trench 4 was excavated only far enough to clarify the nature and location of the churchyard boundary wall. It is possible that graves could exist below this level if slope material has come down over the centuries to cover former graveyard areas. Nevertheless a considerable amount of water could be seen in the trench seeping from the base of the slope and ponding back behind the remains of the wall foundations after a period of rain, and there are several known springs along this line at other places in Cromarty, so some form of intervention drain may be advisable. If this is decided on, an archaeological watching brief should be maintained to record any evidence that is uncovered.

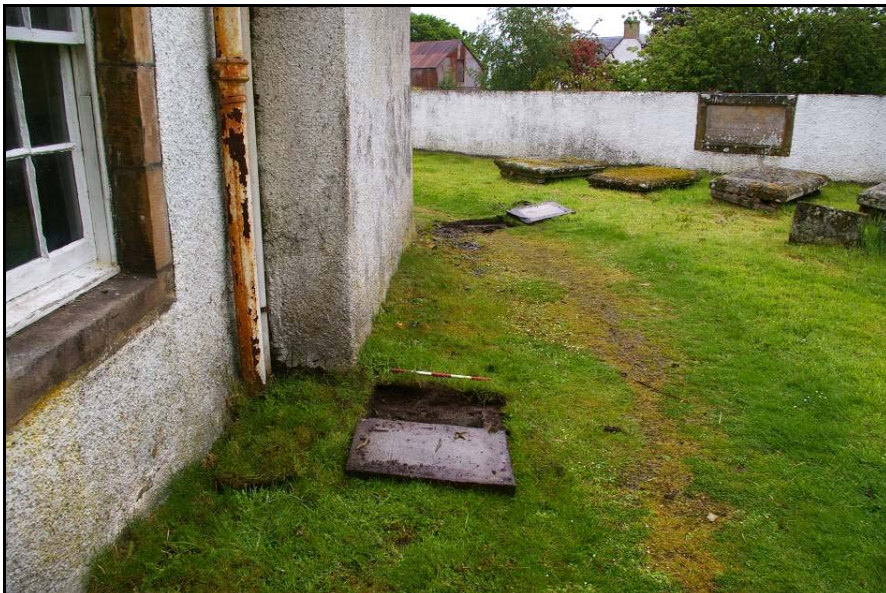
The inspection covers on the drain running along the footpath (east of the church) were lifted to check the drains. Water was found to be running, apparently from the downpipes and wall drains. The combined drain appears to follow broadly the line of the path to the churchyard gate.

Figure 15 Drain covers lifted outside E wall of church.

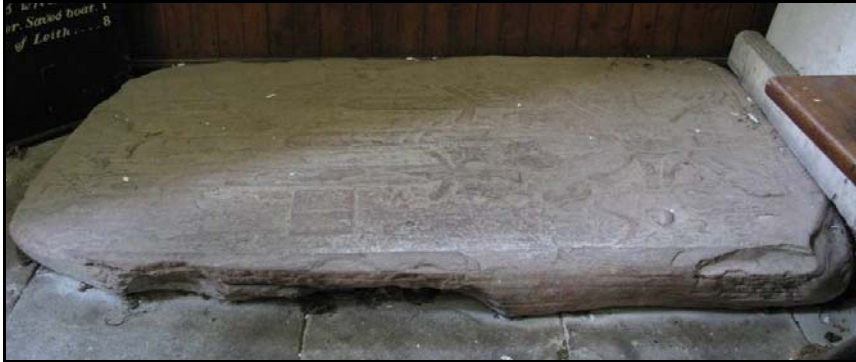
Figure 16 Medieval gravestone in west porch

The sandstone grave slab is lying on the floor in a corner of the west porch. The underside and left and top edges could therefore not be inspected. The slab measures 1750mm long, 950mm wide and 110mm thick, with an approximate weight of 420 kilos.

The carved surface is heavily weathered and decayed, but considerable detail is still visible even in poor light. The ornamental stepped cross and sword symbols are relatively rare for the eastern Highlands, but bear a marked resemblance to those on grave slabs from Cullicudden which have been dated to the 14th century, although the slab itself is quite different in size and shape.

In view of the condition of the slab it would be desirable to commission a stone conservation specialist to carry out remedial conservation work and advise on moving and mounting it. This would be likely to cost between £2000 and £4000.

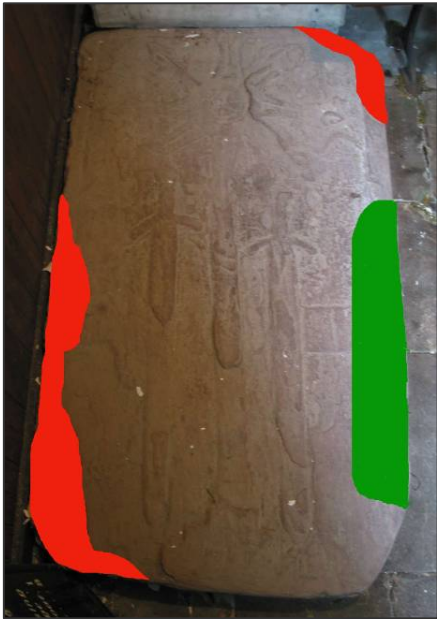
The sandstone is severely laminated, due to general weathering and frost damage. This has resulted in the loss of large areas of the top surface, in some places down to a depth of several centimetres. The worst areas are shown in red overleaf, but most of the surface has suffered some degree of flaking and consequent loss of detail.

Along the right edge there is an area where there has been a major loss of material below the surface, shown in green. Some edges of the damaged area are loose and there will be further loss unless the area is stabilised. The surface which projects over this area is very vulnerable to further damage. There may be similar areas of damage on the left and top edges which are hidden at present.

- Before moving the slab it will be necessary to lift it to inspect the underside. This needs to be done very carefully and as far as possible without putting any pressure on the edges. If there are any cracks or other evidence of structural weakness on the underside, I strongly recommend that a stone conservator is called in before any further work takes place.

- Once the slab has been partly lifted it should be possible to slide in some wooden supports underneath. The slab can then be lowered back down and framed on the front and edges, which should be protected with Plastazote or similar inert foam to avoid abrasion. The purpose of the framing is to protect weak areas, particularly the edges, and to strengthen the slab for lifting.

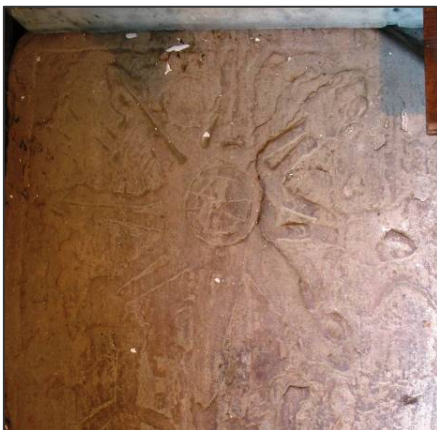
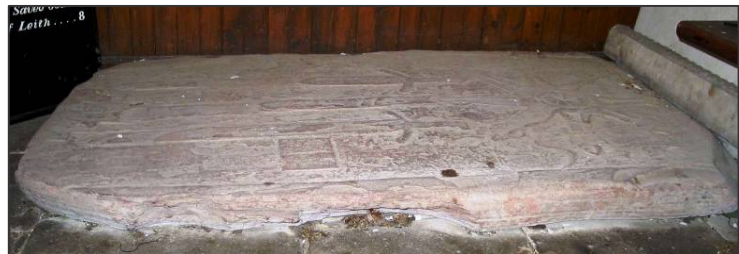
The location of the slab on the porch floor puts it at risk of further damage by being knocked or stepped on, and there is another gravestone resting on it at the top end. The stone is also very dirty. Dust, cobwebs, leaves, flakes of paint and other material are on and around it, making it more difficult to see, potentially causing further deterioration, and devaluing its significance to users of the church.
