# **Chequers Dredging Work, Buckinghamshire**

## **Interim Archaeological Watching Brief Report**

**December 2019**

**Client: The Chequers Estate**

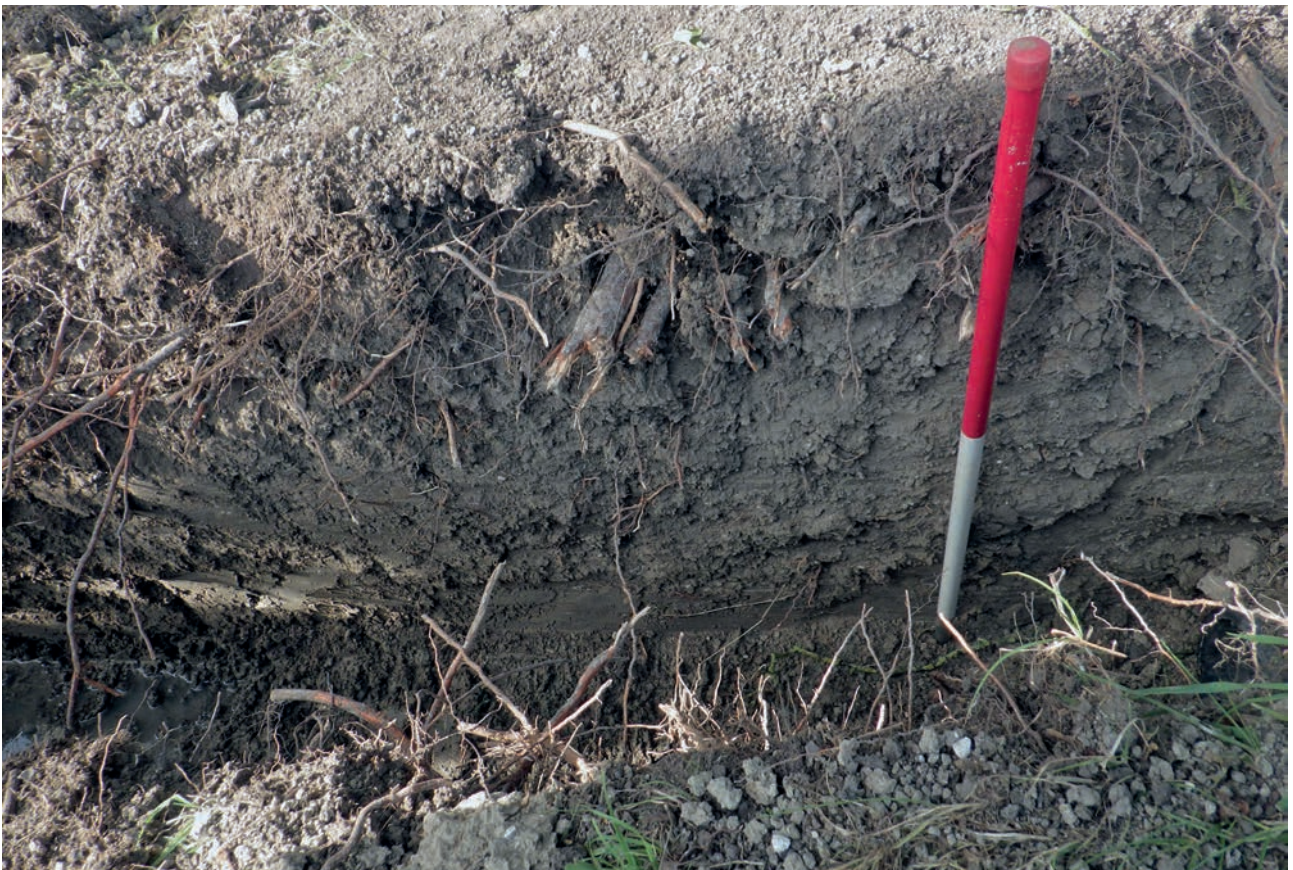
- 3.2.3 During the works no archaeological features or deposits were identified.
- 3.2.4 The deposit sequence recorded along the length of the drainage channel was fairly uniform. A light yellowish-white clay silt chalk deposit was overlain by a mid greyish-white clay silt chalk which in turn was overlain by topsoil (Plate 2).

Plate 2: Channel deposit sequence

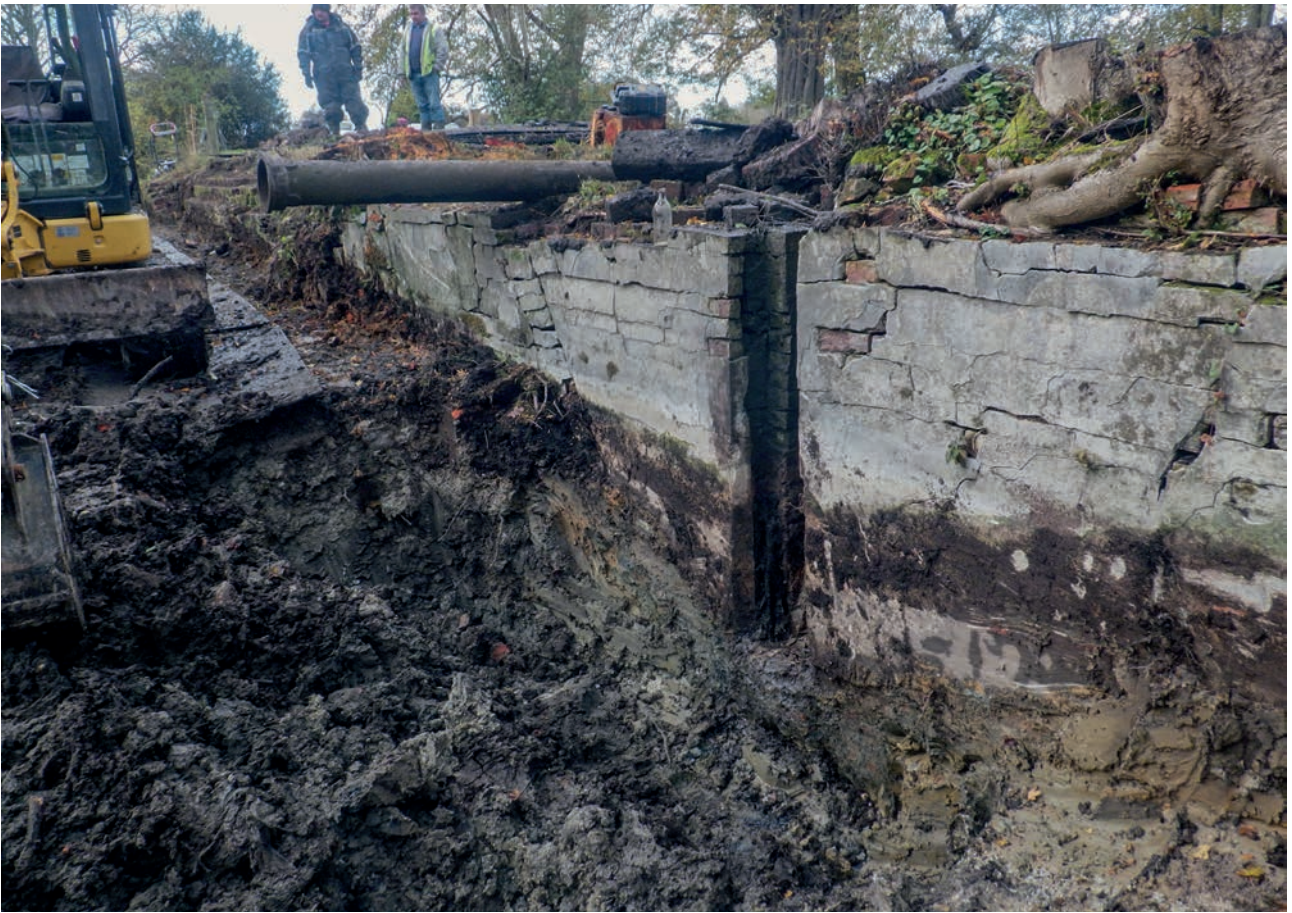
- 3.3.1 Once drained, silt deposits from the rear of the dam were removed to enable the structure to be inspected. The works comprised the removal of fluvially accumulated silts by mechanical means. An area 2m wide extending from the face of dam was reduced to the base of the structure.
- 3.3.2 The deposits removed comprised clay silts (Plate 3). The light blueish-yellow alluvial clays were exposed at the base of the structure and were overlain by a blue-grey silty clay which in turn was overlain by a dark grey-brown silty clay rich in organic material (predominately tree branches).

Plate 3: Deposit removed during dredging works

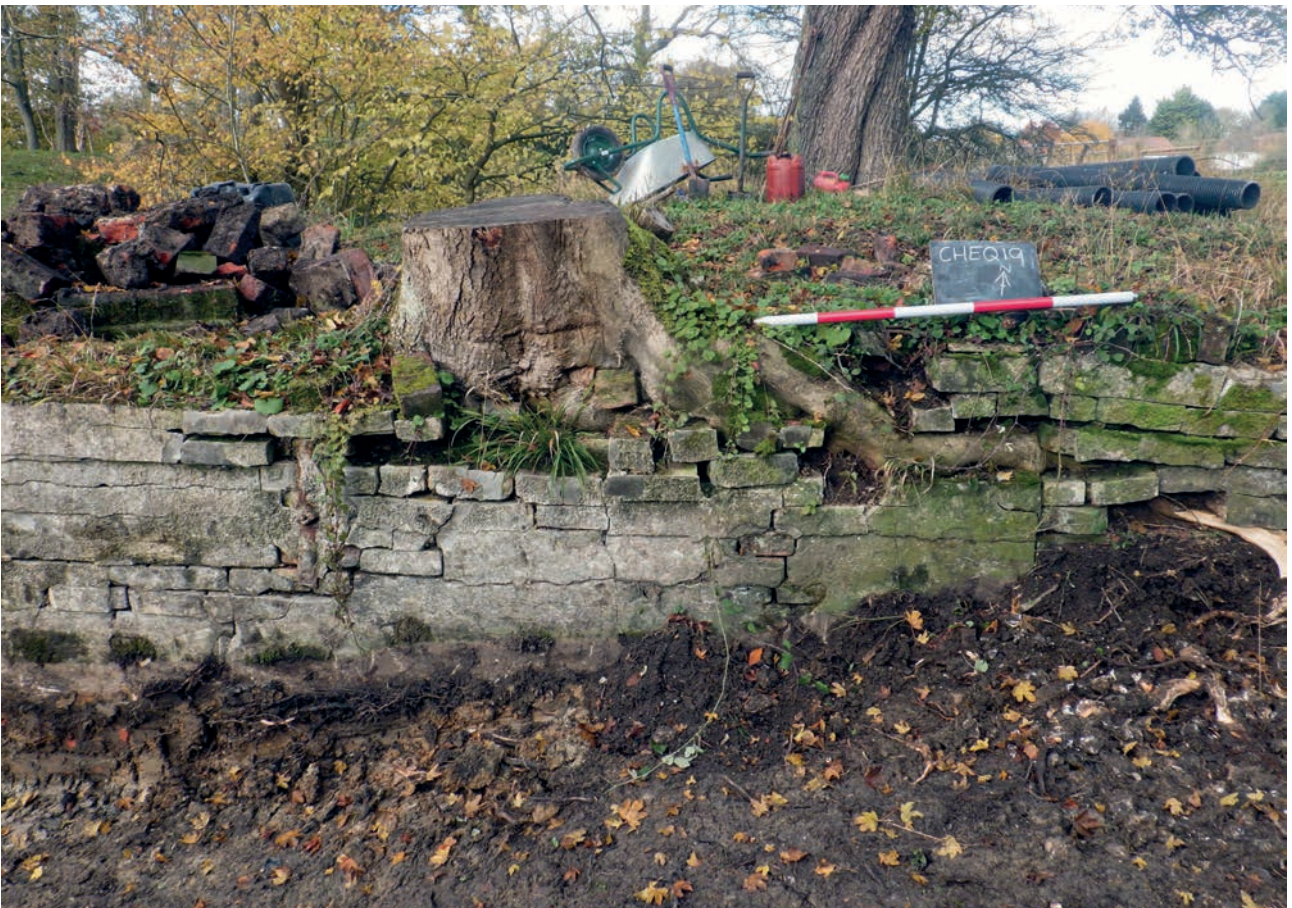
- 3.4.1 No archaeological deposits were recorded during works.
- 3.4.2 The exterior face of the dam was successfully exposed to enable further assessment.
- 3.4.3 An initial assessment made by the attending archaeologist concluded that the extent of root damage to the southern side of the structure could clearly be seen, with the absence of mortar between many of the bricks, extensive warping of the dam wall at its eastern extent (Plate. 4), and complete loss of a section of the western wall (Plate 5). The lower part of the wall is considerably better preserved and has suffered less impacts from roots (Plate. 3). Less significant cracking of the rear dam wall appears to have occurred compared to the front, although cracks are clearly visible.

Plate 4: Root disturbance at eastern end of dam wall

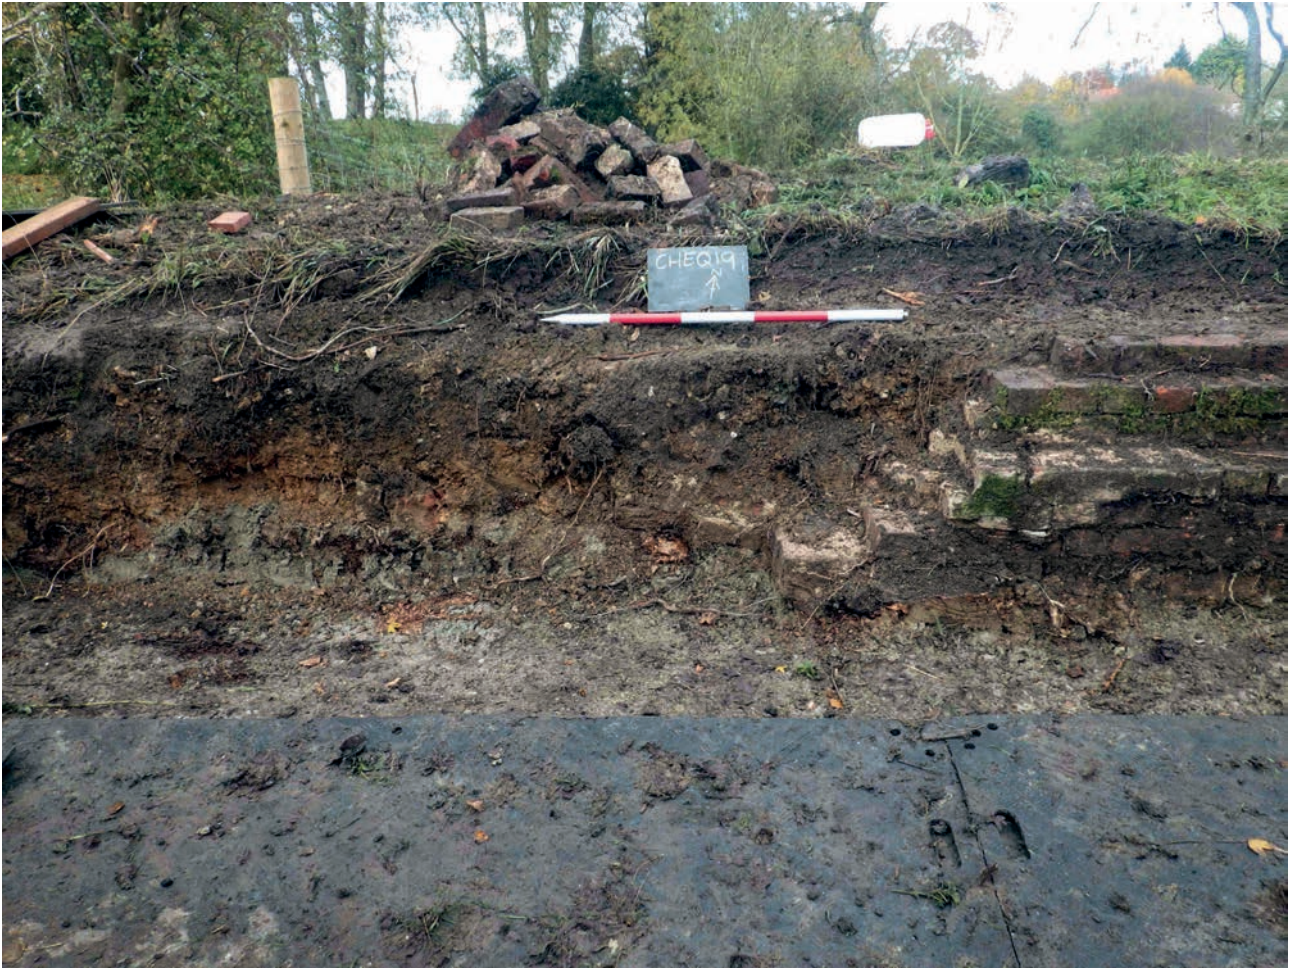
Plate 5: Missing section at western end of dam wall
