St Laurence Church

West Challow

**Historic Building Assessment
and Recording**

September 2006

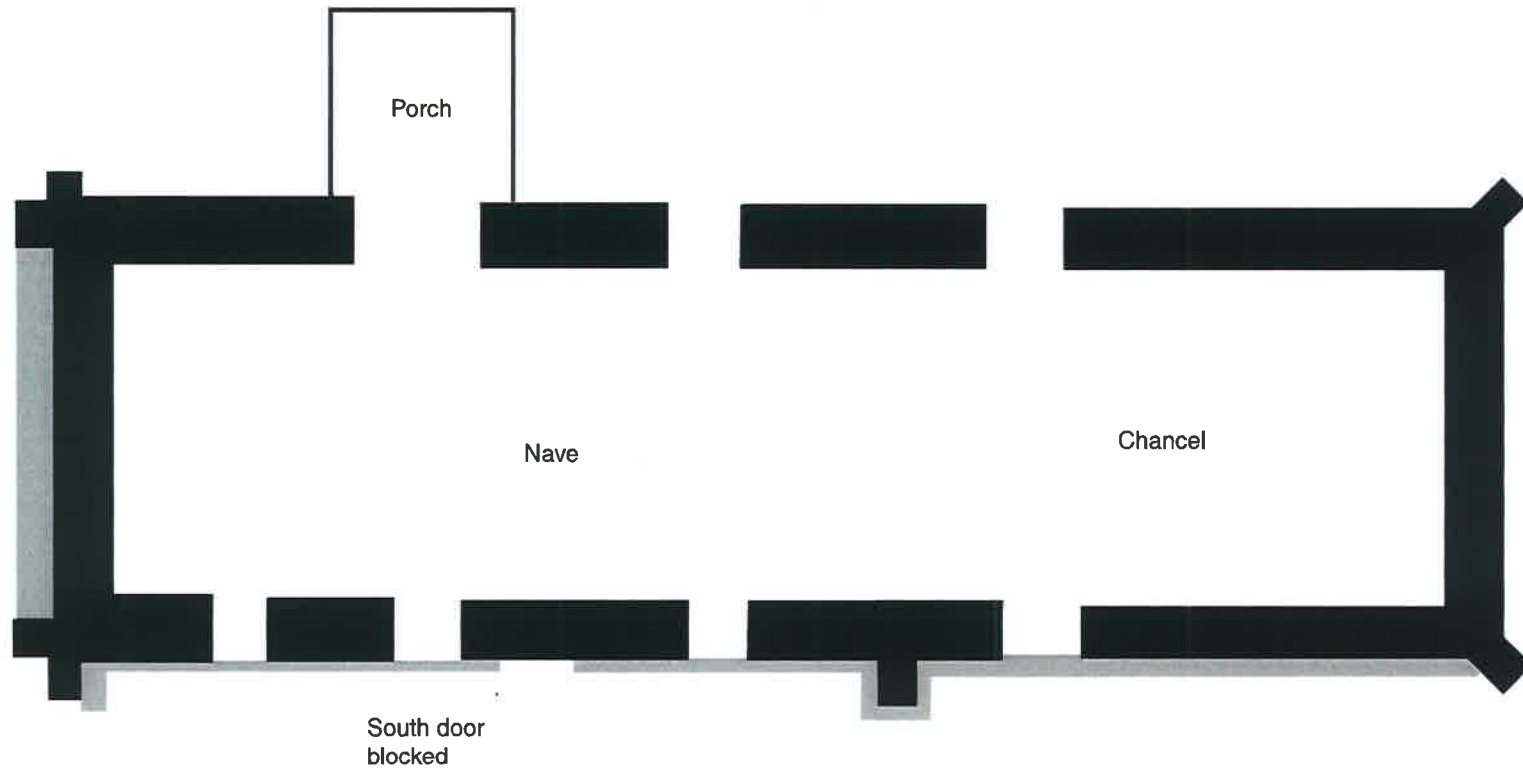
Figure 2: St Laurence's Church, West Challow Site Plan

1.1.2 The project consisted primarily of surveying the area around the church before installing a French drain system. The trench was excavated as some stones were found when constructing the drainage system which were believed to be an extension of the nave (fig 2).

New drainage trench

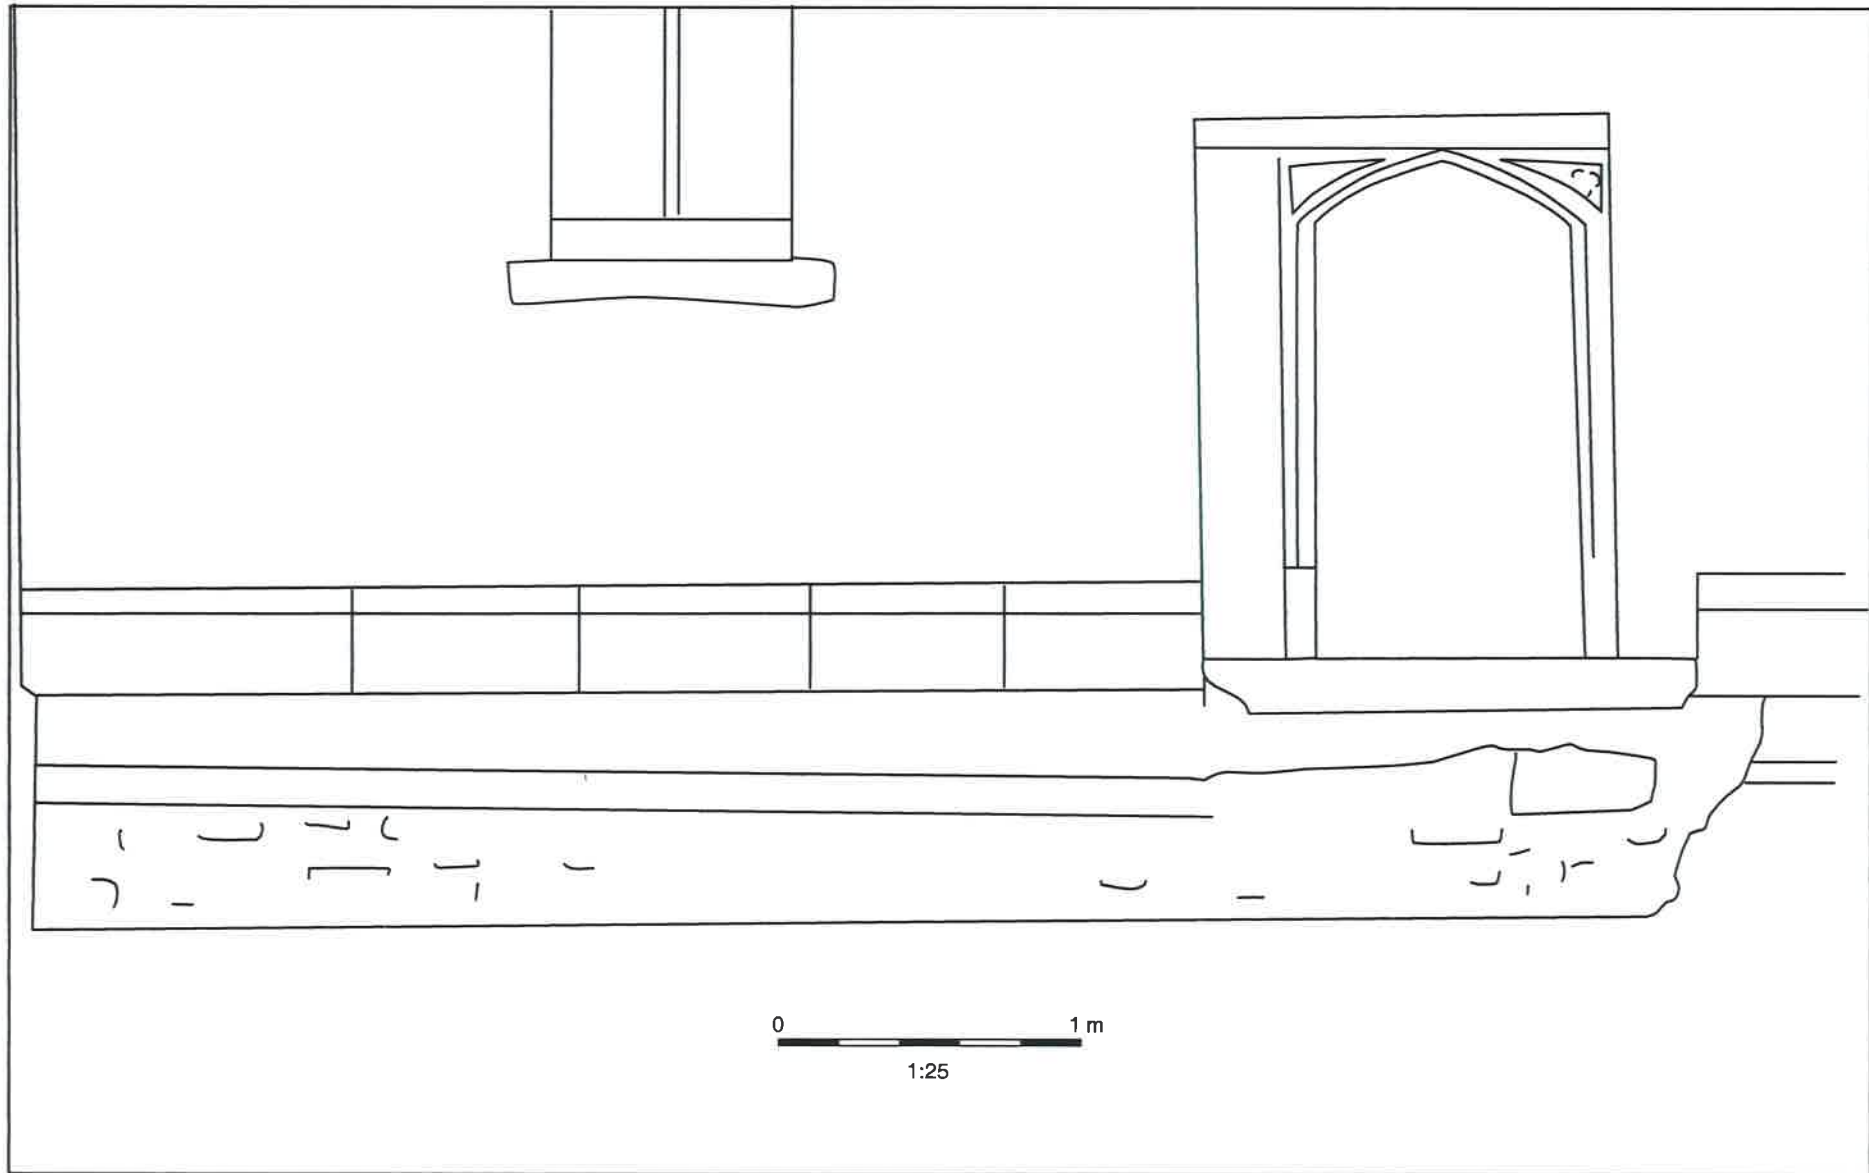
Figure 3: Saint Laurence's Church, West Challow. Elevation of South Wall

- 3.1.4 The buttresses at the west end have rubble foundations under the ashlar (plate 5).
- 3.1.5 The foundations of the church are exposed on the south wall which shows the former ground level was higher than now and the presence of noble foundations beneath the ashlar plinth (plate 6).

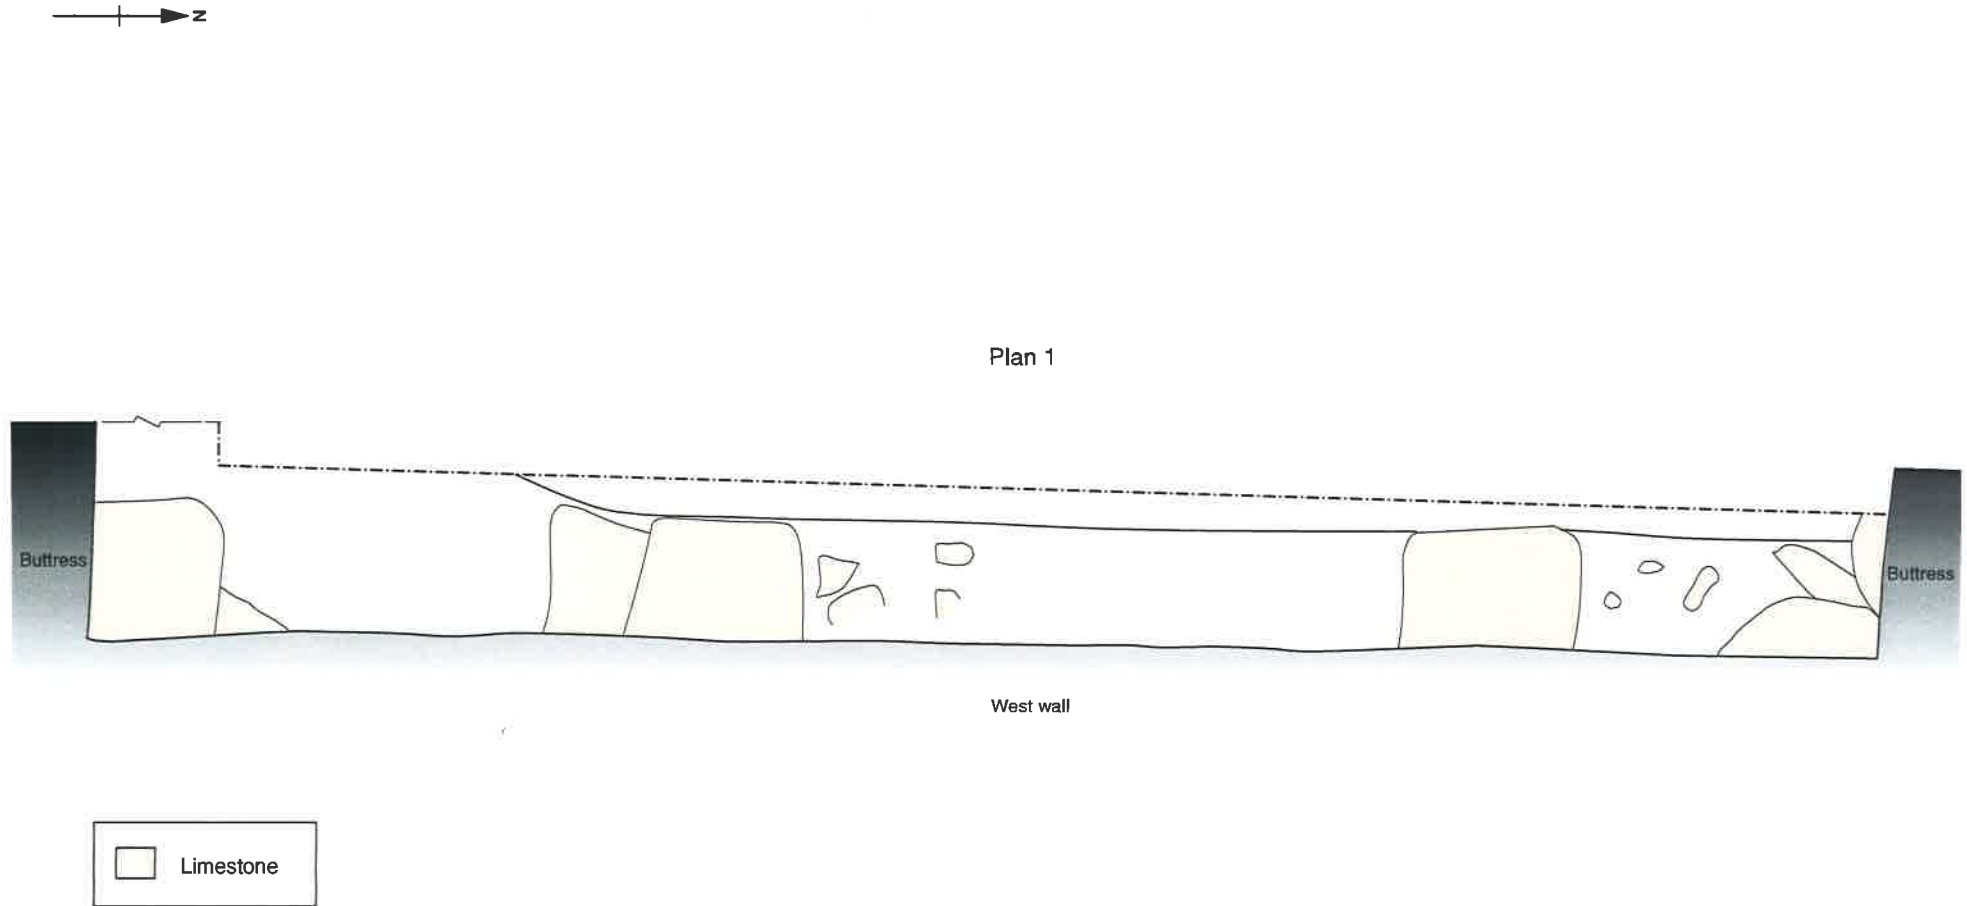
Figure 4: Saint Laurence's Church West Challow, Plan of West End

- 3.1.2 In the trench along the west wall two limestone blocks were discovered. Each block measured 0.50m in width and more than 0.30m deep (more detail cannot be given as the structures disappear under the main structure of the church). A further two blocks are spaced 1.60m apart at the west end of the church. The blocks are positioned 0.16m below the base of the church (fig 4).

- 4.1.1 No firm conclusions can be made regarding the date of the stones, however assumptions can be made regarding their purpose.
- 4.1.2 The distance the blocks are set apart would indicate that they are foundations for an archway or tower structure. Another possible scenario could see the limestone block foundations supporting a redundant door.
- 4.1.3 The stones are unlikely to be an extension of the nave as they stand out from the west side of the church. The possibility of the stones being part of an earlier structure is best suited to the evidence provided by the spacing and positioning of the stones.
- 4.1.4 There is no evidence beneath the south wall of any clear phasing or building breaks.

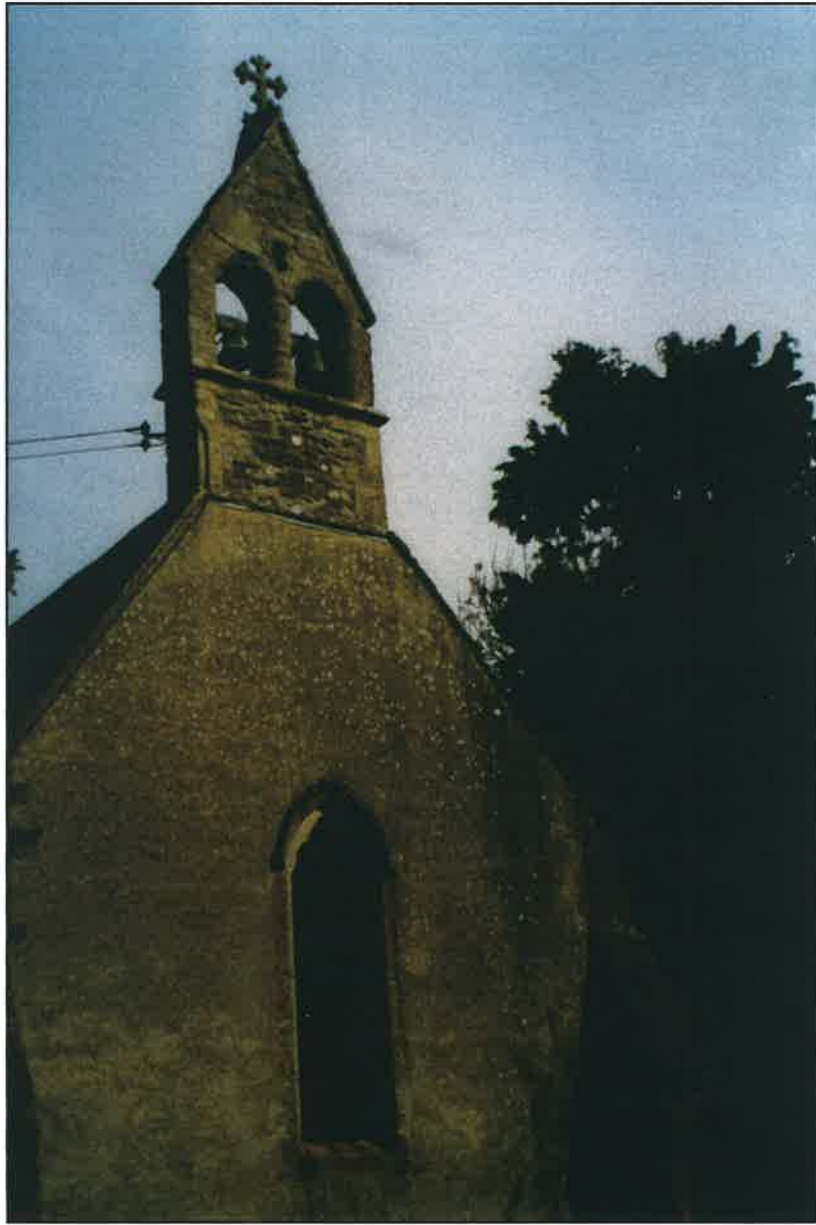
- 2.1.3 The walls are covered with rough-cast with stone dressings and the roof is covered with stone slates. The west window and bell turret (plate 1) are of 14th century date while the chancel windows and the porch belong to the 15th century. The chancel was probably also rebuilt or added at that period and further restoration was undertaken to the building in 1892.

Plate 1: General view of west window and tower

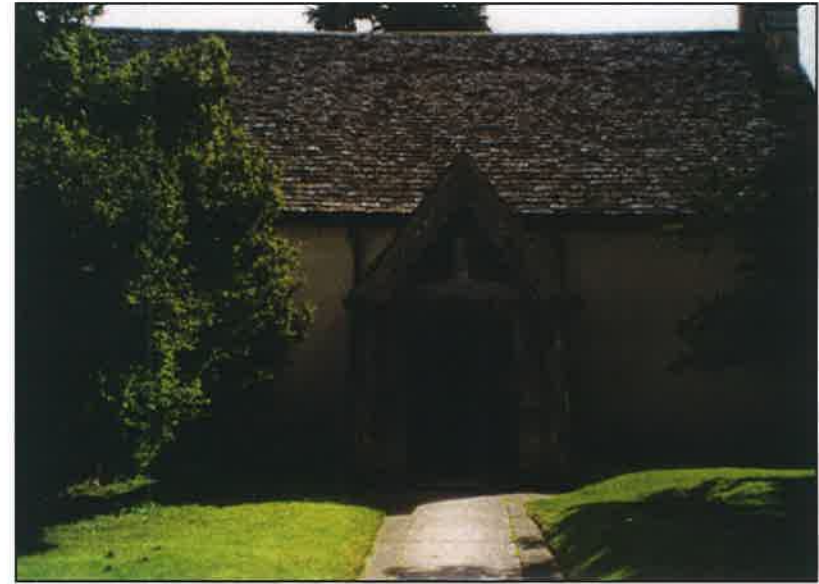
- 2.1.5 The porch is made of timber set on a stone base, however the sides have undergone restoration. The general timber work of the front remain a strong example of 15th century construction (plate 2).

Plate 2: General view of North front

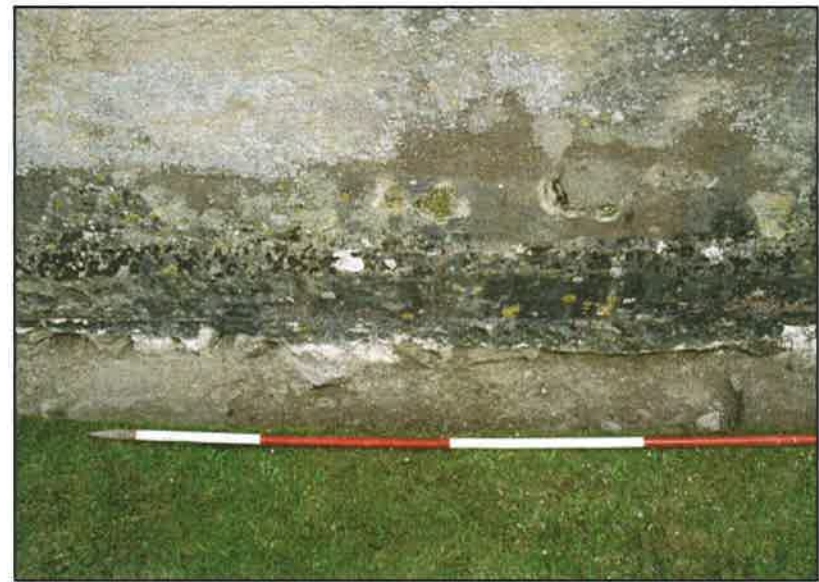
- 3.1.1 The trenches along the south and west walls were dug in order to lay the drainage pipes for the building. The drainage ditches were positioned 0.30m out from the edge of the church. The west wall (plate 3) showed evidence of stone remains which were perceived as being a continuation of the nave. Drawings of both plans and sections were compiled in order to illustrate the purpose of the stones.

Plate 3: View of west wall

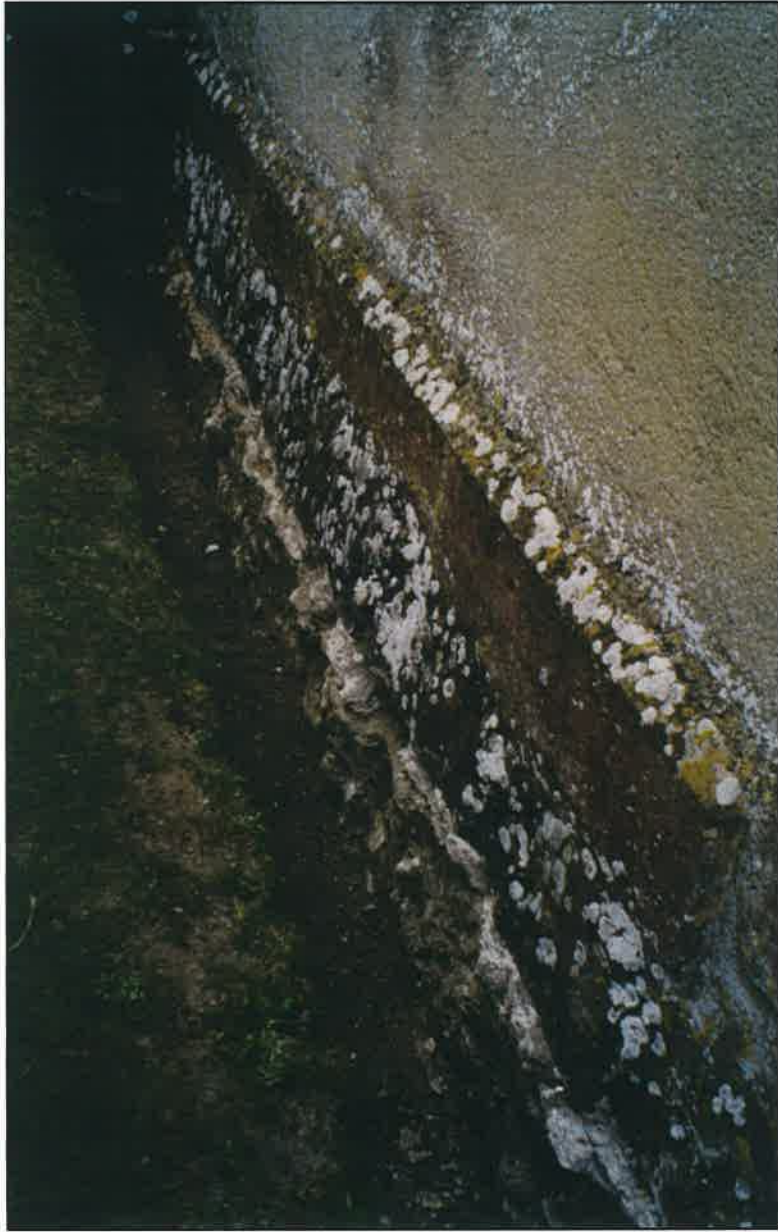
- 3.1.3 The fill surrounding the structure showed evidence of limestone deposits. The limestone deposits showed abundant evidence of backfill surrounding the larger more practical limestone blocks. There is also evidence of modern gravel around the limestone blocks (plate 4). Some soil from the neighbouring graveyard was found under the limestone blocks.

Plate 4: South wall

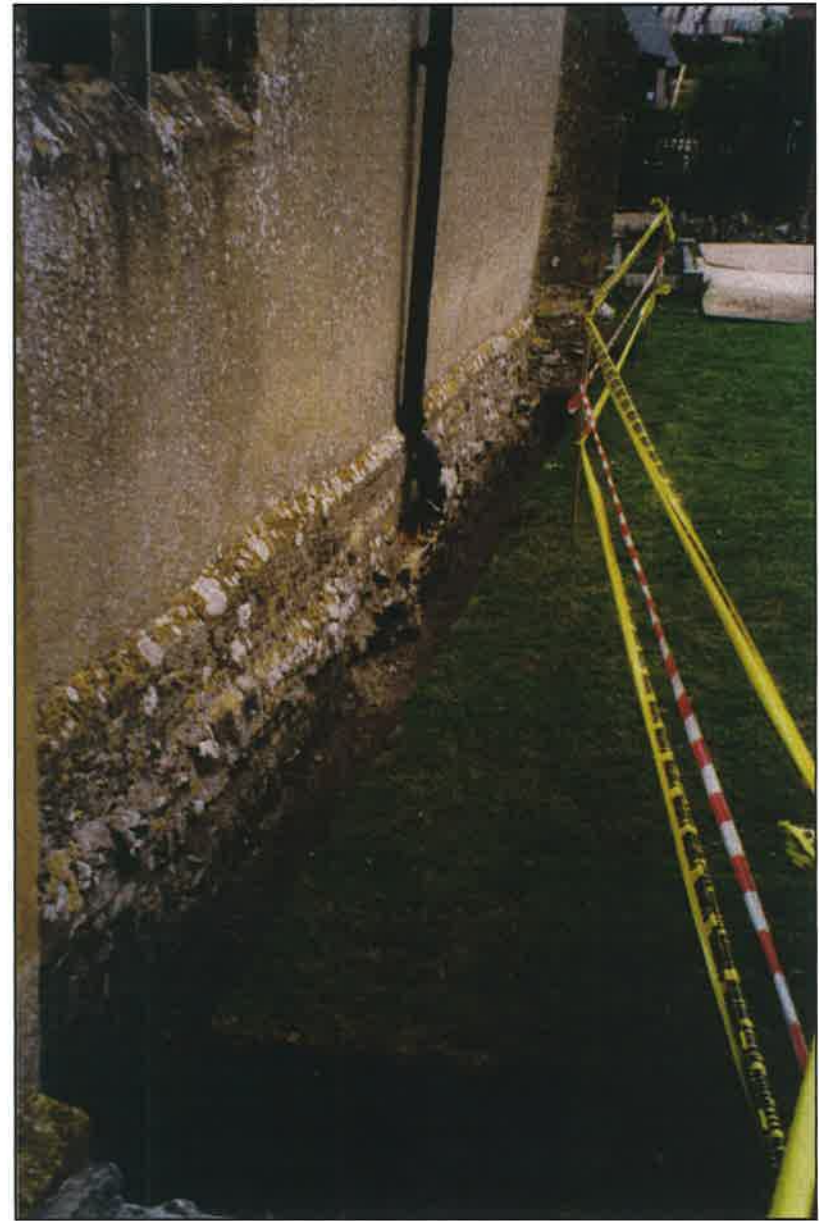
Plate 5: South wall looking east

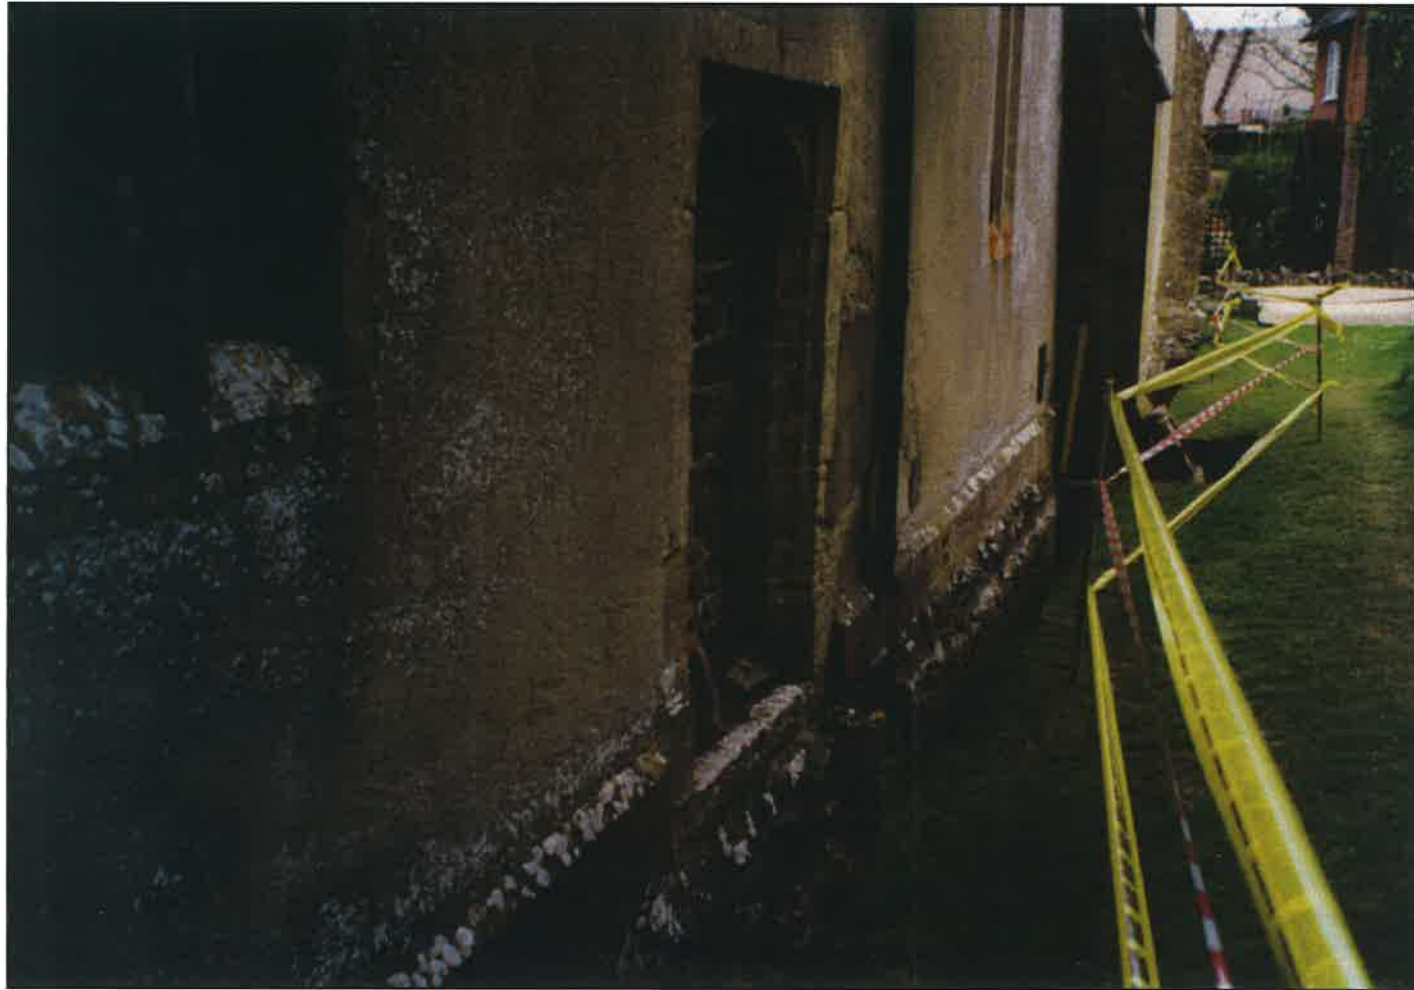
Plate 6: Blocked door at the east end of the south wall
