Repairs to the Castle Mill Stream Wall Paradise Street Oxford

Archaeological Watching Brief Report

April 2011

Client: St Peter's College

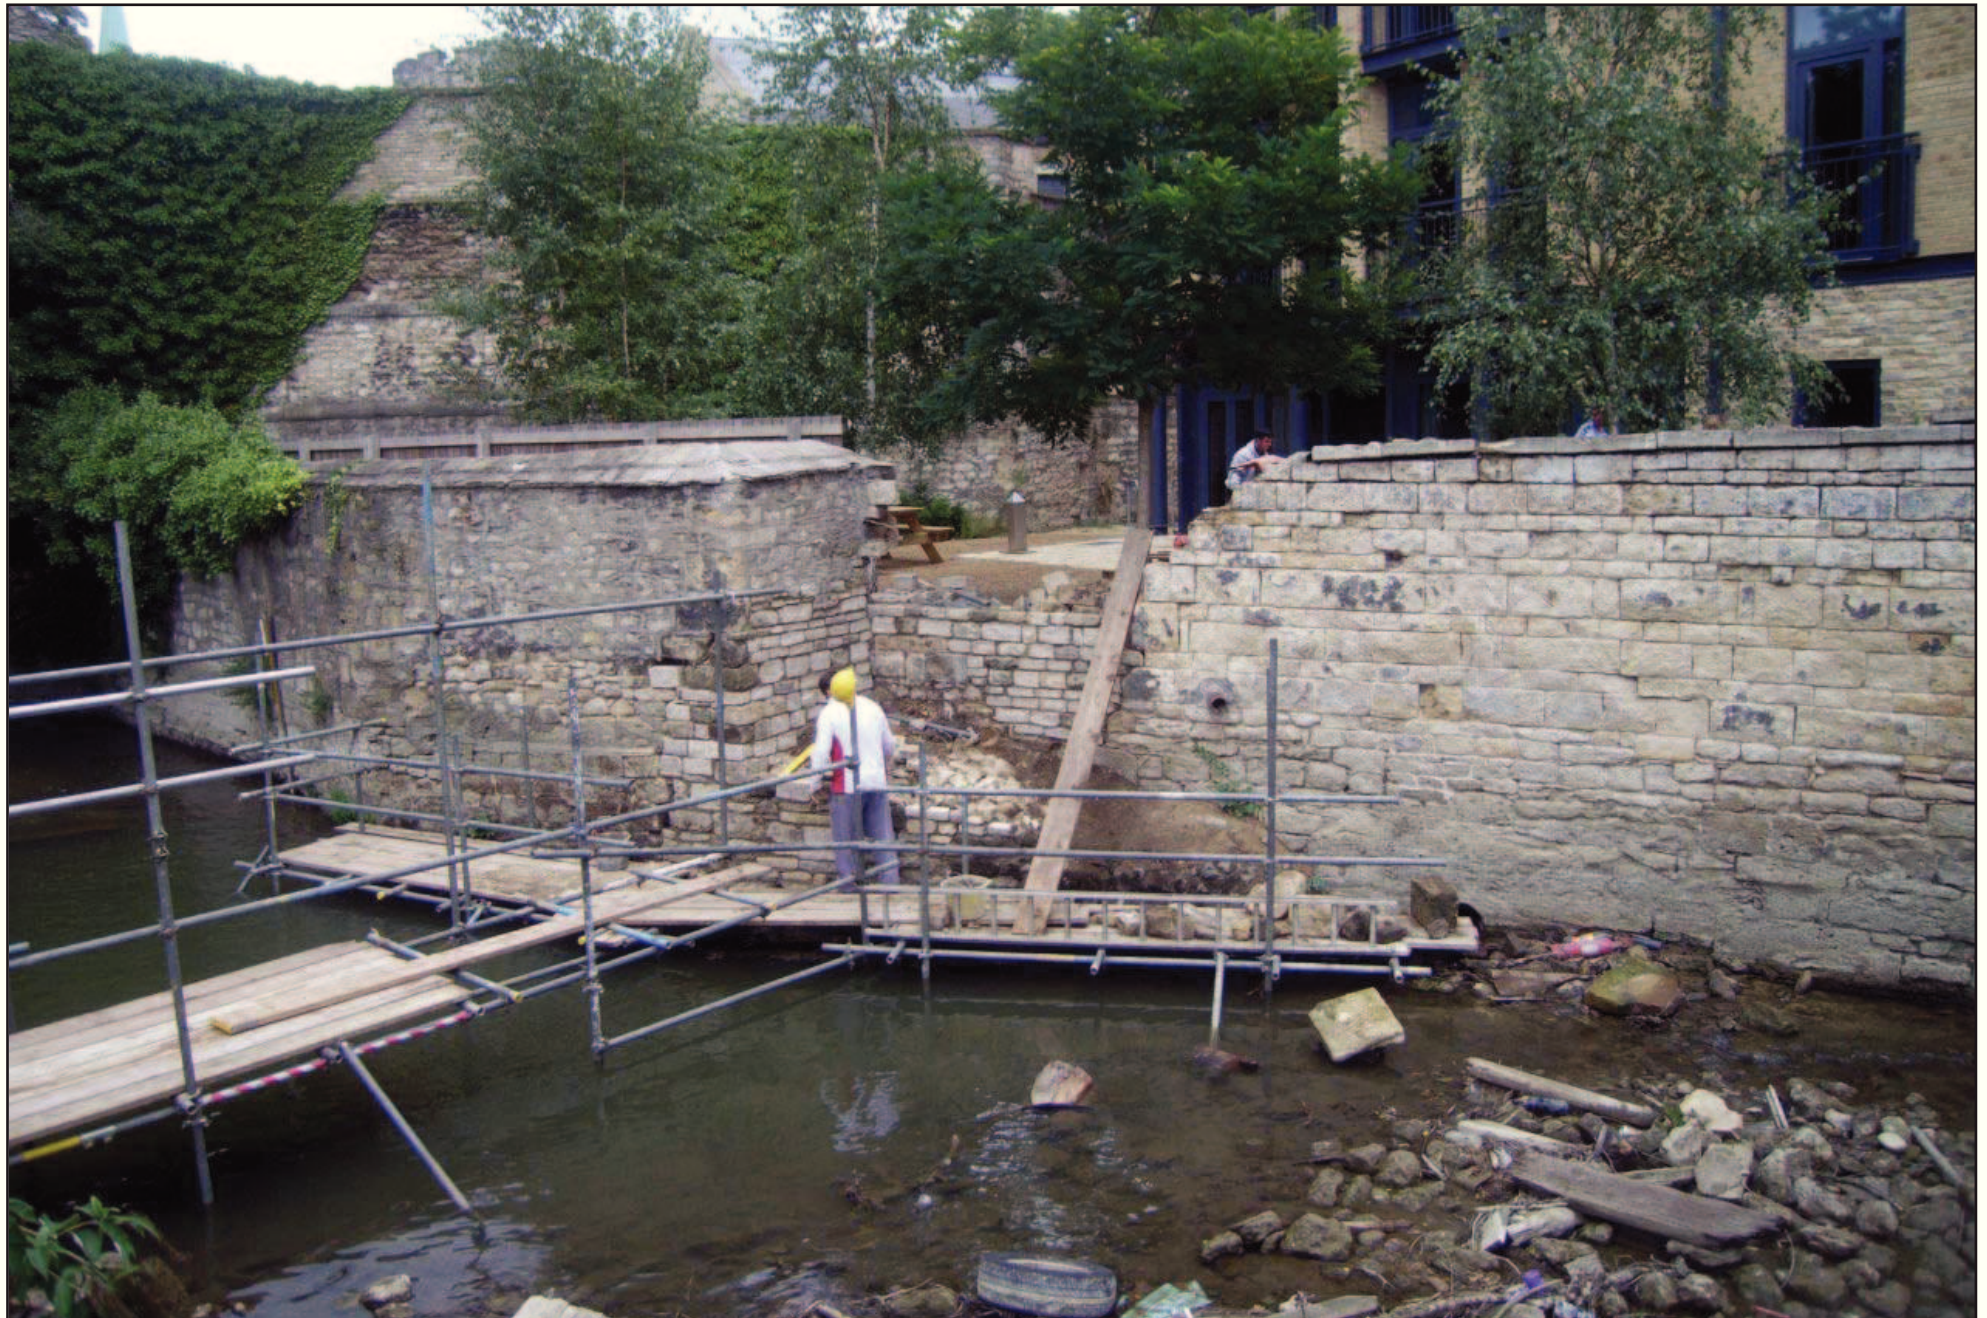
Plate 1: Repair work underway

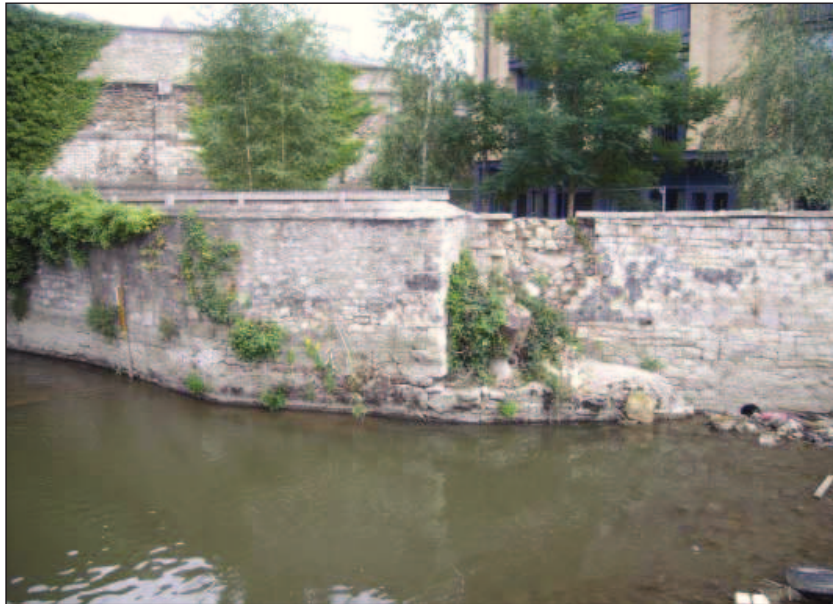
Plate 3: General view of wall prior to start of conservation works

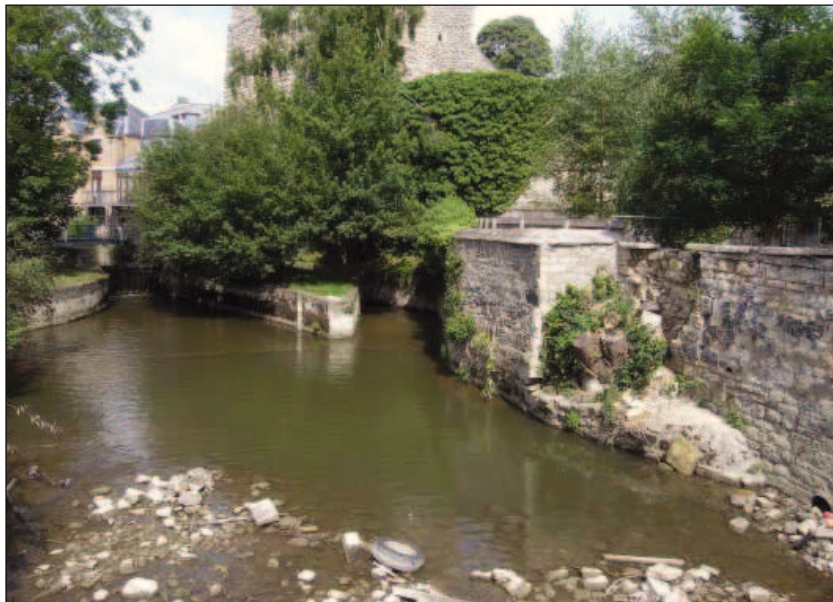
Plate 4: General view of wall from south with St George's Tower in background

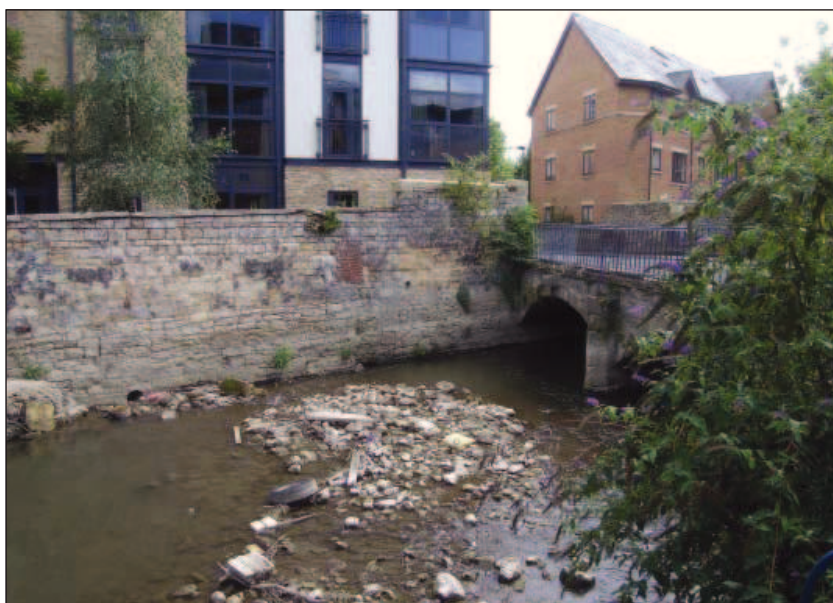
- 4.1.6 The revetment wall along the eastern side of the streamway south of Swan Bridge shows similarity of construction and that it is possible that the two lengths of wall together with Swan Bridge may represent a major reconstruction of the area around Paradise Street.

Plate 5: Revetment wall to south of current area

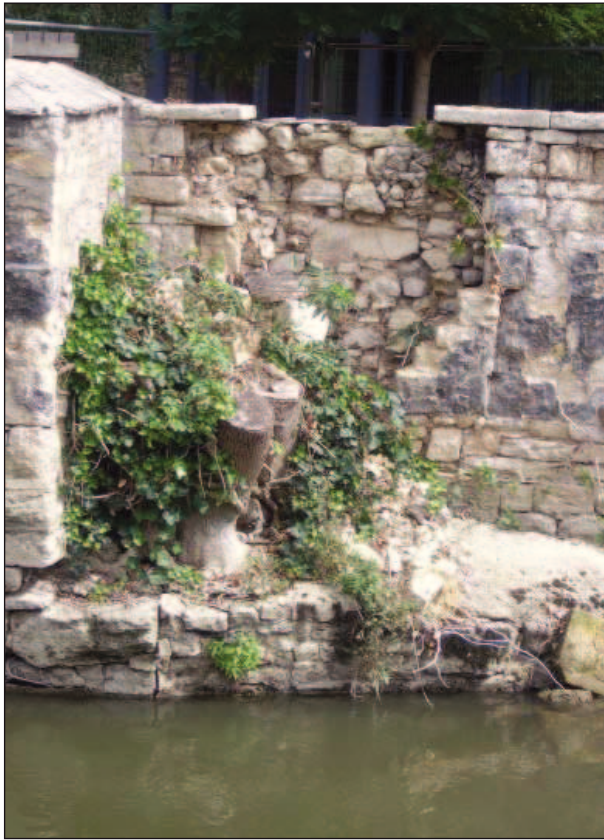
- 2.2.1 The work was undertaken to make good displacement of the stones caused by a tree stool growing out of the wall and whose stump and roots had dislodged many stones, tumbling some into the stream. The wall consisted of two parts: the stream wall, which steps back approximately 1 m from the main line of the stream at this point, and a triangular stone 'bastion' or robin which butts up against the wall protecting the step from erosion. The top of this bastion was originally smoothed off with cement but cracking had allowed silts and seeds to collect. A tree had grown within the cracks and over time its roots had lifted the courses of both the bastion and the wall behind it causing it to become unstable and part of it to tumble into the stream bed. The remedial works undertaken before the wall was reconstructed included the grinding out of the tree stump and diverting the stream flow around the site allowing the tumbled stone to be retrieved.

Plate 6: View of area collapse prior to conservation

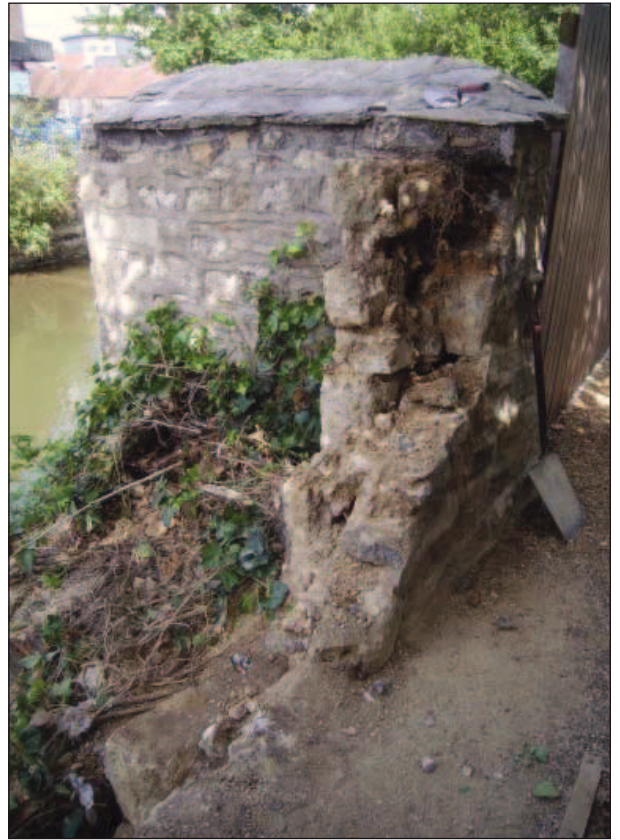
Plate 7: Core of wall during dismantling (north side)

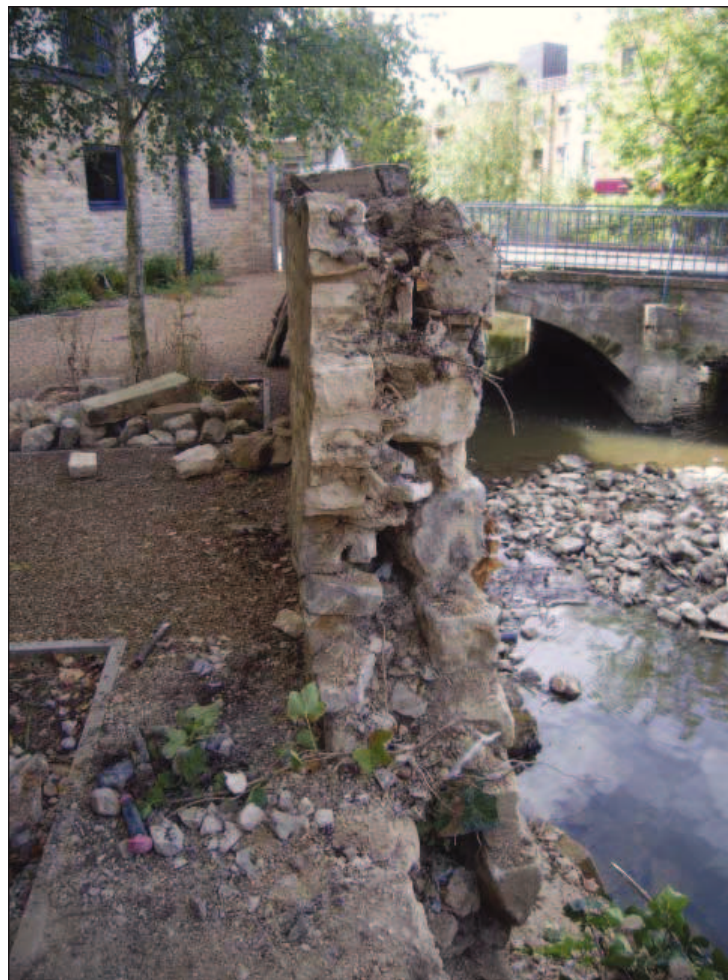
Plate 8: Core of wall during dismantling (south side)
