Navapan Hall

27 Holywell Street

**Historic Buildings Recording
and Watching Brief**

September 2011

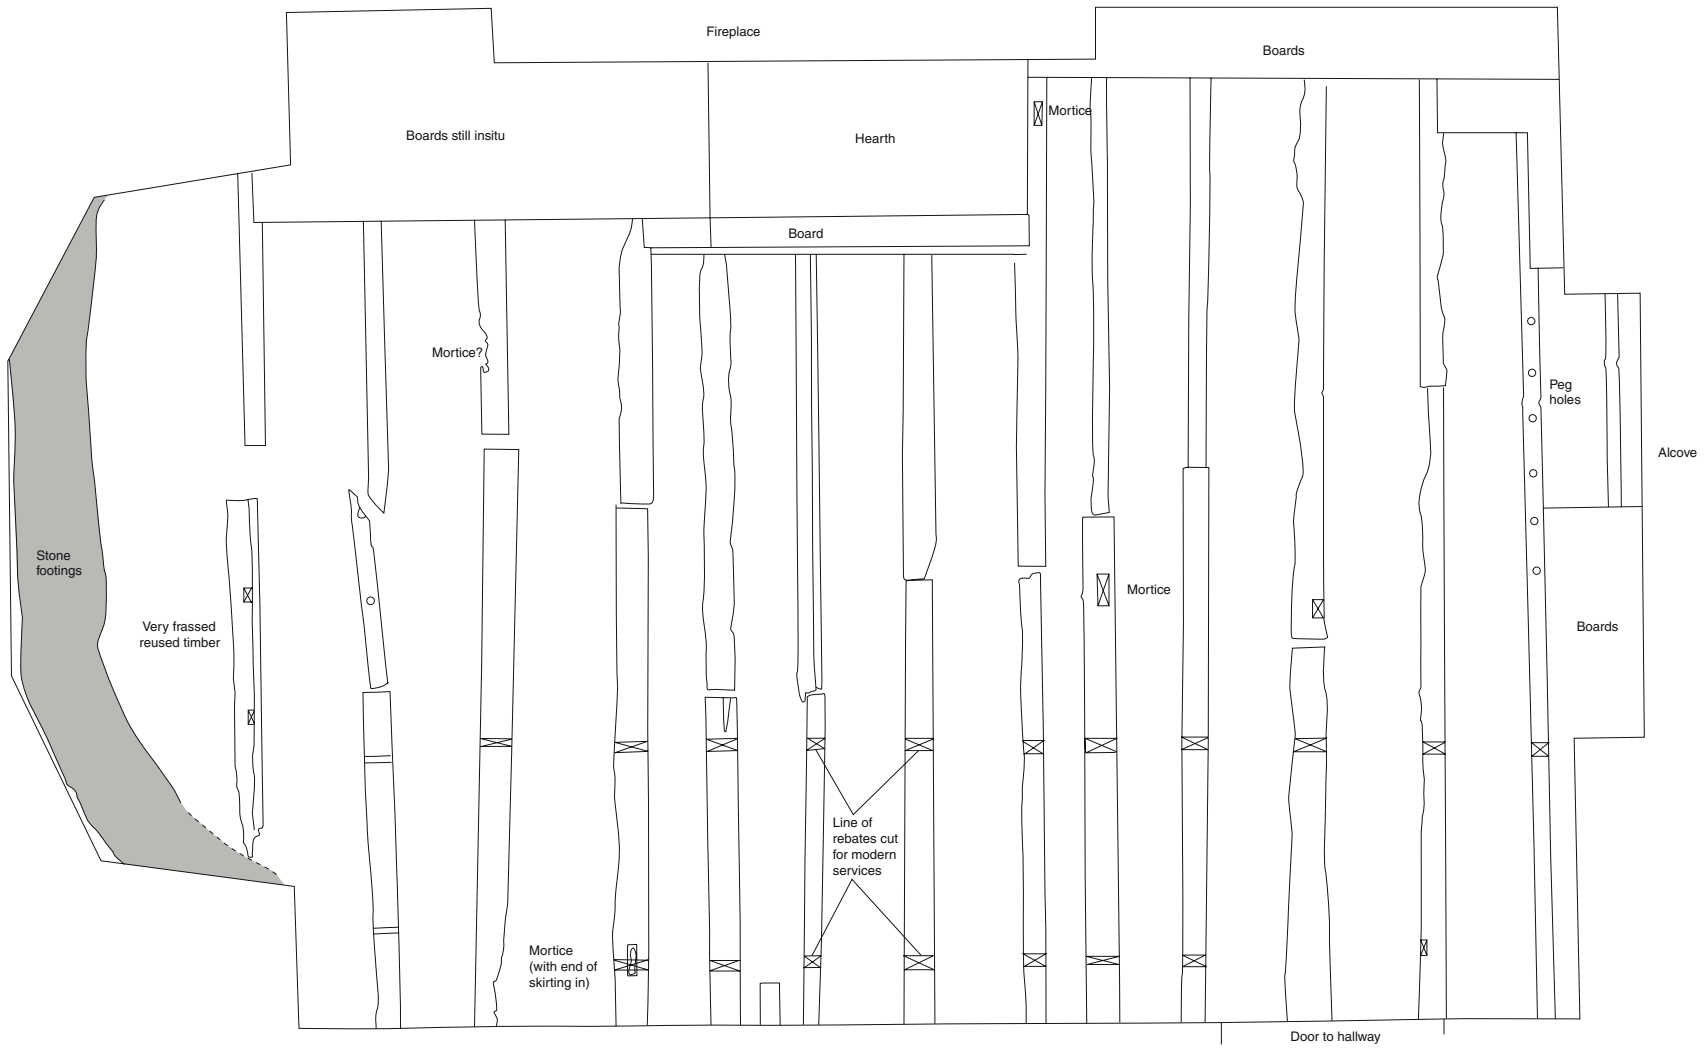
Figure 4: Plan of floor joists following removal of boards - ground floor south east reception room

4.1.1 Removal of boards within the southern reception room on the ground floor revealed a series of joists that were laid in an east/west direction onto a loose sandy soil/ rubble level (Figure 3). The vast majority of these joists are not jointed instead lay loose upon the fill level. Most joists showed signs of reuse, with socket holes and peg holes in the upper and side faces of the visible timbers. Many timbers appeared hand sawn but a large quantity appear older with waney or hand sawn edges, the appearance suggest a 16th of 17th century date. Lying adjacent to the bay window was the stone footing of another possible bay window. The footing consists of a 100mm deep wall of course stone bonded with a friable dark cream coloured mortar. The footing generally followed the course of the existing bay window. As the frontage of no. 27 is currently slightly stepped forward into the street compared to other houses in this row it is possible that this represents the early extent of the house at this point. The bay shape would be unusual for pre- 18th century housing. Removal of the panelling beneath the bay windows shows that the existing walling is also of stone with inserted timbers providing additional support.

N.B.
Joists are not fixed to walls or each other but remain loose upon a sandy soil fill

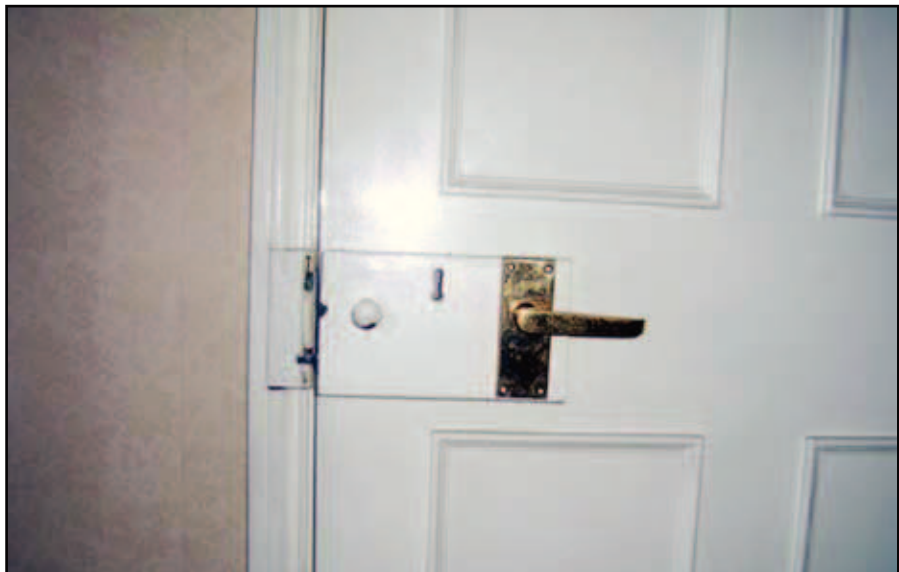
3.2.9 The rear eastern room is laid out as communal shower and wc area. The many partitions are of 20th century date and are to be removed as part of the works. There is a large 16 light sash window in the north elevation. The rear western room is used as a bedroom and has an arched opening leading into the top floor of the adjoining extension. This smaller room is set out as an ensuite bathroom with small sash window without glazing bars. The bedroom has a blocked fireplace with a wooden fire surround and there are two cupboards recessed into the wall. The door is of 20th century date however it has an early 20th century lock case which has been reset upside down and has had a modern handle added to it (Plate 11).

Plate 11: 27 Holywell, first floor reused door furniture

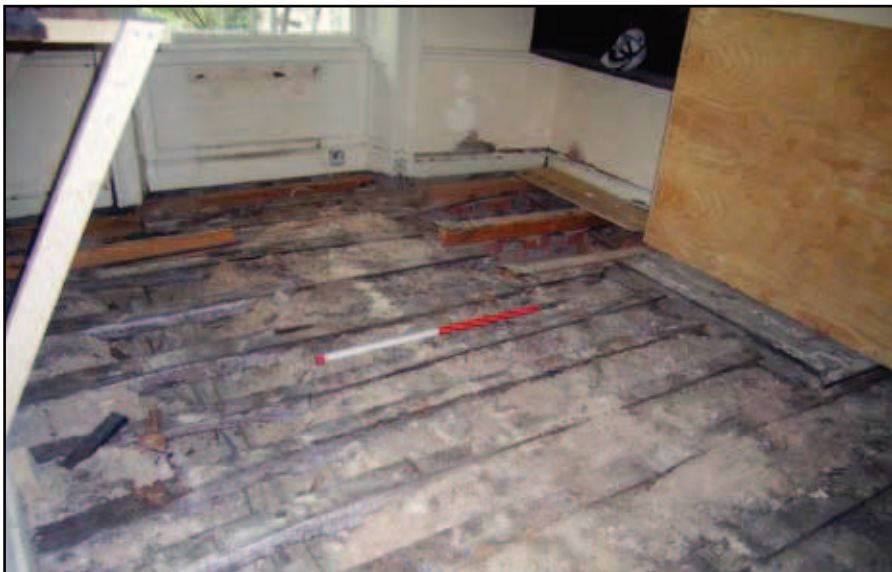
4.1.2 Removal of boards within north eastern reception room revealed a section of modern timber joists mounted on modern brickwork in the north eastern corner of the room. The remaining joists are much older in date with obvious reused timbers with rebates, pegholes and empty mortices visible, and are laid on a soil fill as seen in the southern reception room. The soil fill had been excavated in part to allow for the insertion of utilities cables. The older joists are laid roughly with spaces of between 230mm and

Plate 19: 27 Holywell, ground floor north east reception room after removal of boards

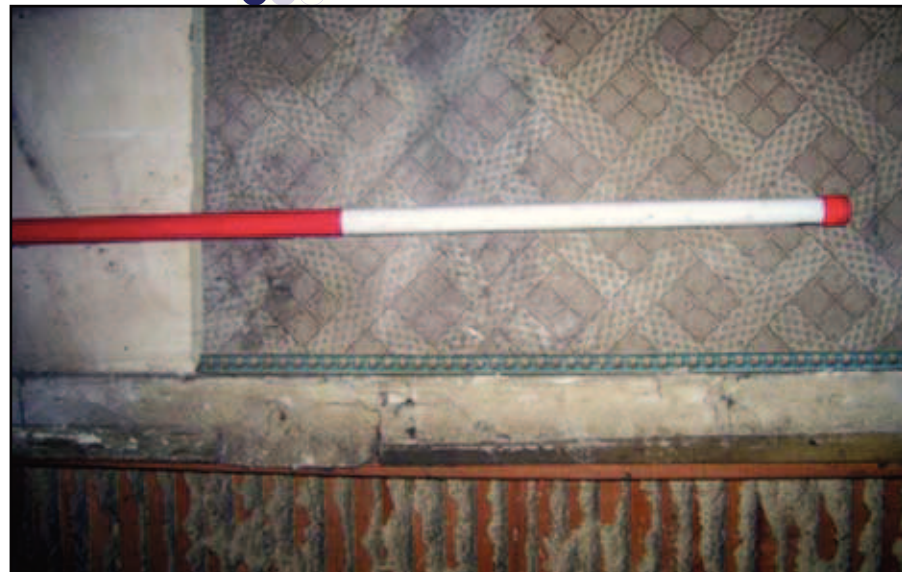
- 4.2.2 The hallway panelling removal revealed large areas of an early decorative scheme using wallpaper (Plate 20). The decoration consisted of a repeating pattern of angled squares outlined in dots and surrounded by strips of a small scallop pattern with further black dot details. The main design colour is taupe and the edges of the paper wall covering are lined with a turquoise blue and taupe coloured bead design border. The border frames the wallpaper at the top and bottom of the wall and also around any features insitu at the time of decoration including the infilled doorway discussed above. The paper also covers the section of panelling which forms part of the cloakroom walling in the entrance hall (Plate 21). The wallpaper covers the majority of wall with obvious gaps for the skirting board at the base, the dado rail and the cornicing at the top of the wall. This decorative scheme for the hallway clearly predates the infilling of the doorway leading into the current cloakroom and the addition of panelling to the ground floor and stairs, but postdates the additional panelled walling to the cloakroom. The design of the wallpaper is suggestive of many patterns dating from the mid 19th century to the early 20th century.

Plate 20: 27 Holywell, ground floor detail of hallway wallpaper

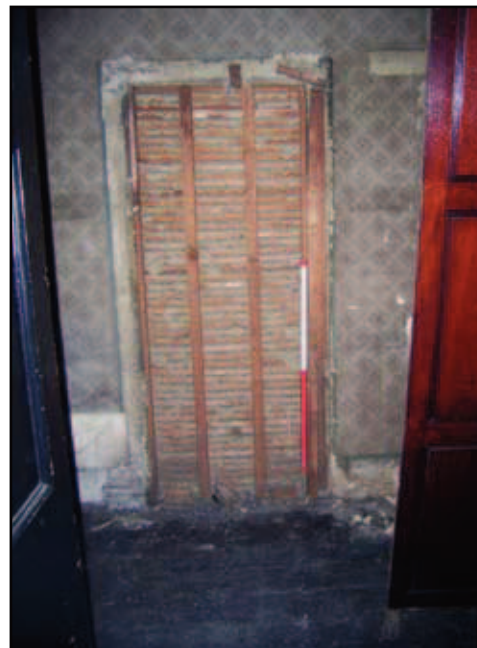
- 4.2.1 Removal of panelling within the hallway revealed several unseen features. A blocked in doorway was revealed in the south eastern hall wall. This blocked door was positioned opposite the entrance to the ground floor southern reception room and had been infilled with timber frame supporting lath and plaster to the eastern face of the wall. The doorway clearly had a small decorative frame on the west elevation as the outline of the opening has some horsehair plaster exposed around it and before the wallpaper discussed below begins.

Plate 22: 27 Holywell, ground floor blocked doorway

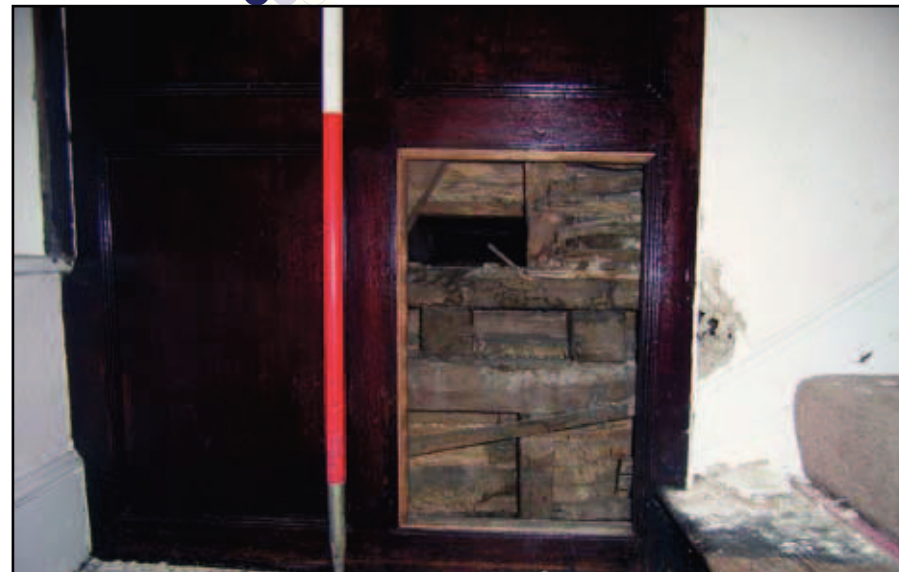
- 4.2.3 The panelling removal continued up the stairwell and there were two areas of interest. The removal of timbers around the doorway on the mid stairwell leading to the first floor of the rear extension that is to be demolished revealed the stonework of the primary construction. The west jamb is entirely of stone construction but the eastern jamb has a mix of stone and brickwork, the brickwork probably added to repair the jamb at the same time as the opening was created (Plate 23). The stonework has clearly been cut back to form the opening and the faces within the reveal are heavily scarred by chisels marks. Also beside the stairwell at first floor level some panelling had been removed revealing a section of the floor construction for the adjacent bedroom (Plate 24).

Plate 24: 27 Holywell, detail of floor construction of first floor

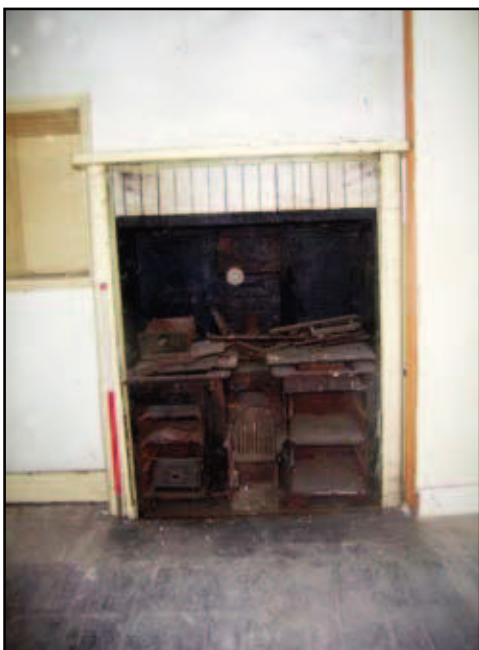
- 4.4.2 A section of dry wall lining was removed revealing an iron range still in situ from when the room was used as a kitchen. This iron range is rusting away in parts but will be kept in situ and blocked up again as part of the building works. The range has the inscription 'by royal letters patent EAGLE RANGE' and 'ATTWOOD, Holywell Street'. This tells us the range was purchased from Mr EW Attwood who resided and ran his business from no. 14 and 15 Holywell street and is listed on the 1911 census as an ironmonger, gas and hot water fitter. He is listed at this address until 1926.

Plate 25: 27 Holywell, ground floor early 20th century range oven

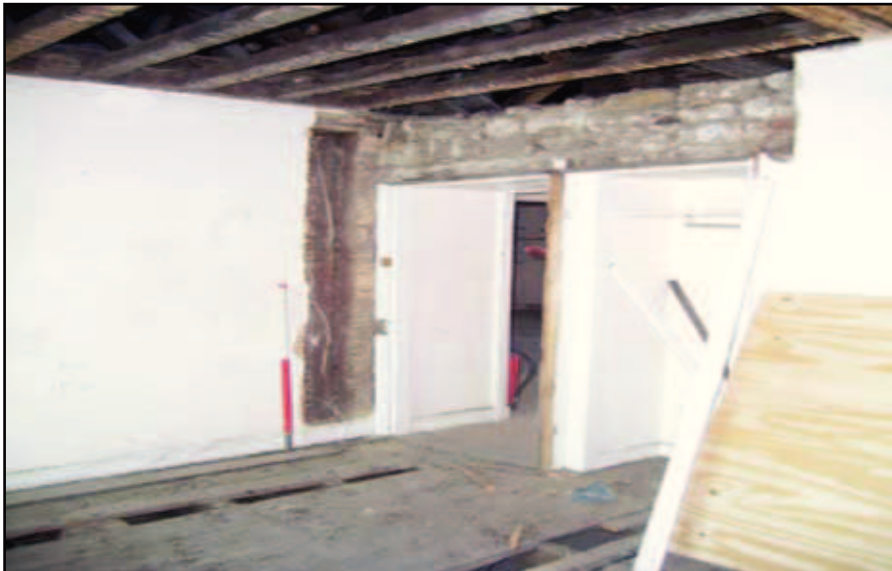
4.7.2 Removal of plaster above the doorway in the south eastern room revealed the partition wall to be unusually of stone construction. The stonework was fairly rough in appearance but had been laid in consistent courses, one brick can be seen amongst the stonework. A small section of wall plaster was also removed from the southern elevation revealing similar stonework however the wall appears to be timber frame at this level. The adjoining partition wall between the two southern rooms was timber frame with lath and plaster covering.

Plate 31: 27 Holywell, second floor detail of partition walling

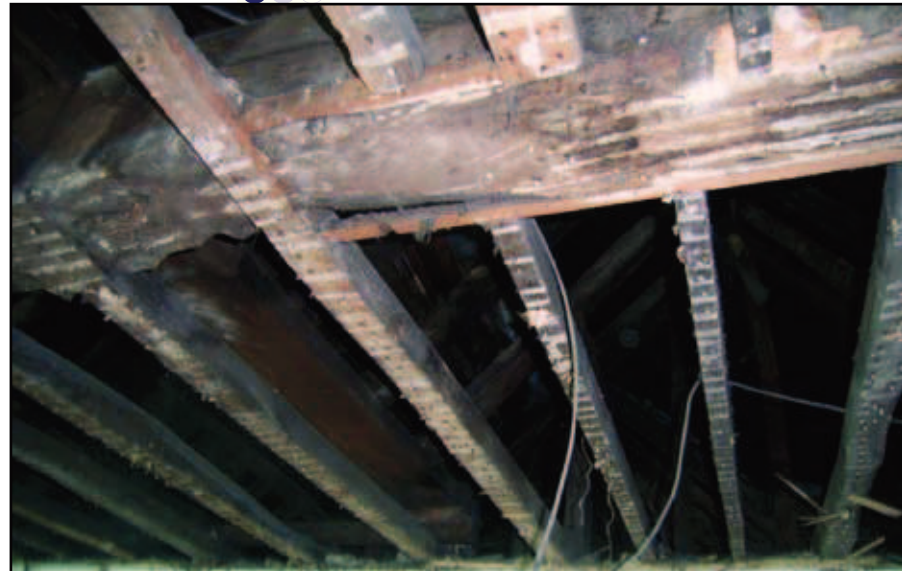
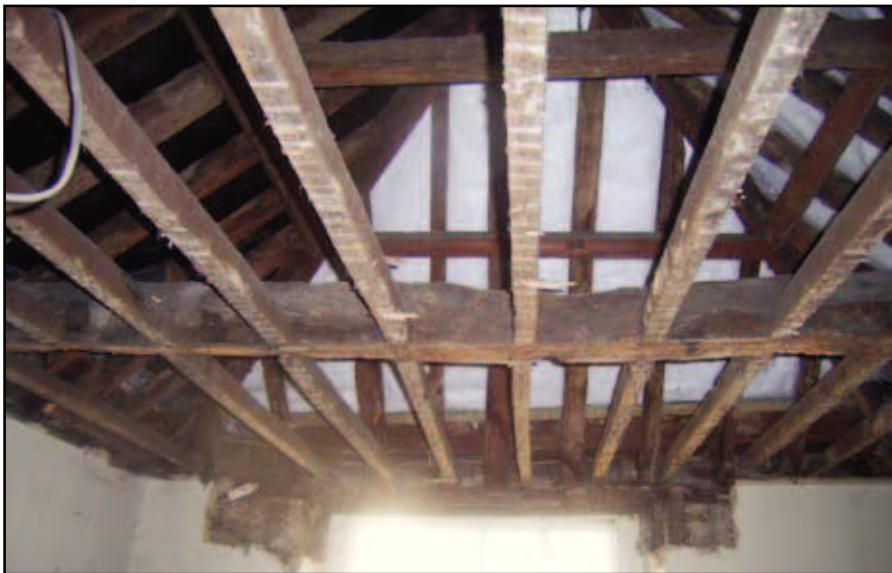
- 4.6.1 The ceiling plaster was completely removed as part of the works revealing the extent of the timber frame roof. The south eastern room has a central beam running north - south into which the ceiling joists (running east - west) are tenoned. This beam has been strengthened by the addition of smaller timbers fixed either side using large nails and bolts. A small lead strap is also fixed to the beam using nails and is connected to the major roof support above. The central beam has been reduced from beneath and there is evidence of former mortice holes showing the beam has been reused and therefore may not be in original situ. The ceiling timbers bear the marks of the removed lath and plaster ceiling with distinctive stripes and many nails. The M shaped roof above this room has a wide valley directly above the central beam, the roof timbers are all softwood and appear to be of the same date - probably 19th century. The roof timbers rest on plates situated on top of the surrounding partition and main external walls. The joists are inserted into mortices in the wall plate above the west partition wall and above this is a further timber which has some visible empty mortices on the underside onto which the rafters are placed. On the east wall the joists sit on top of the wall plate and the roof joists are rebated into a timber that is on top of the wall plate. The roof sections are clearly hipped to the front (Holywell Street) elevation but not to the centre of the property as a short section of pitched roof runs east west at this point. The position of a brick chimney stack at this point suggests the short section of east west pitch roofing was inserted to accommodate this. The brickwork is red brick of a consistent size and style laid in a varying bond with creamy coloured mortar and probably dates to the 19th century.

Plate 32: 27 Holywell, exposed roof timber frame

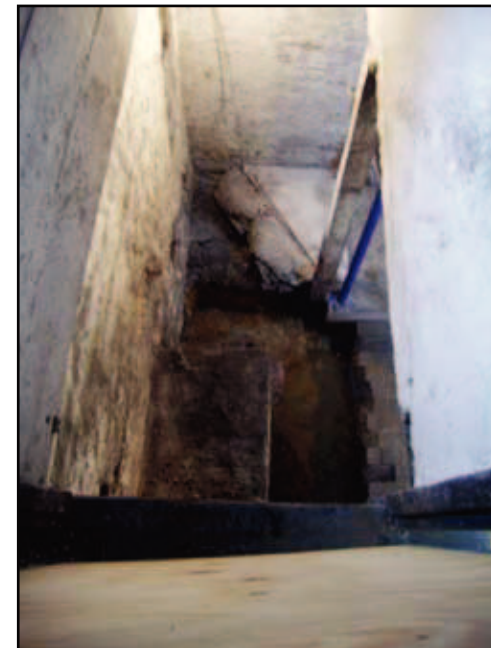
4.8.1 The stairs leading down into the north cellars were removed during the works and the brick floor beside the stairs was lifted and the ground excavated to approximately 35mm. The fill excavated was all of the same type - a brown coloured sandy soil with mixed inclusions - and contained no finds of archaeological potential. The layer appeared to be a consolidation fill for the flooring. Also seen at the base of the removed staircase was a small area of rough stonework approximately 200mm from current floor level which may represent an early floor level of the cellar.

Plate 34: 27 Holywell, cellar following stair removal and excavation
