St. Mary's Church Guildford Surrey

Archaeological Investigations

August 2012

**Client: PCC St Mary's Church,
Guildford**

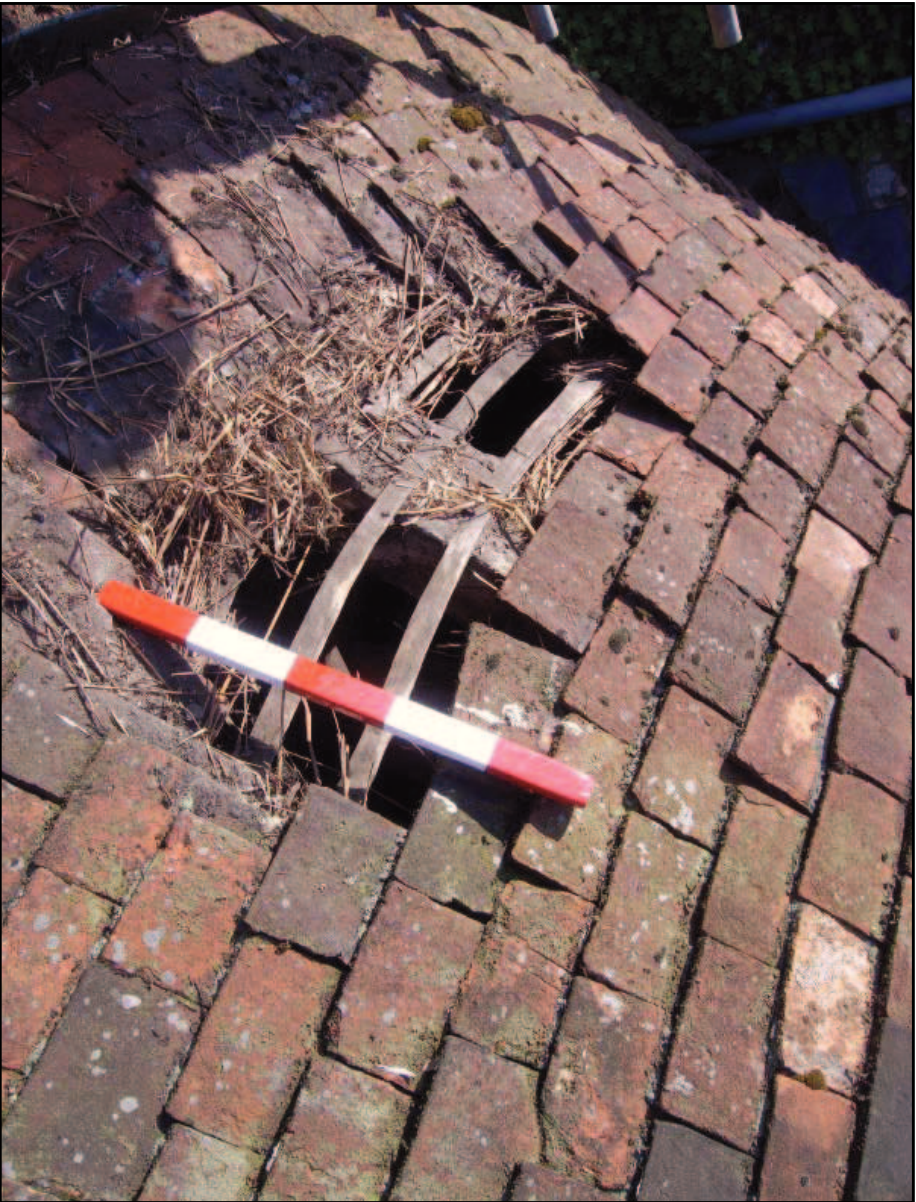
Plate 3: St. Mary's Church roof, showing straw packing

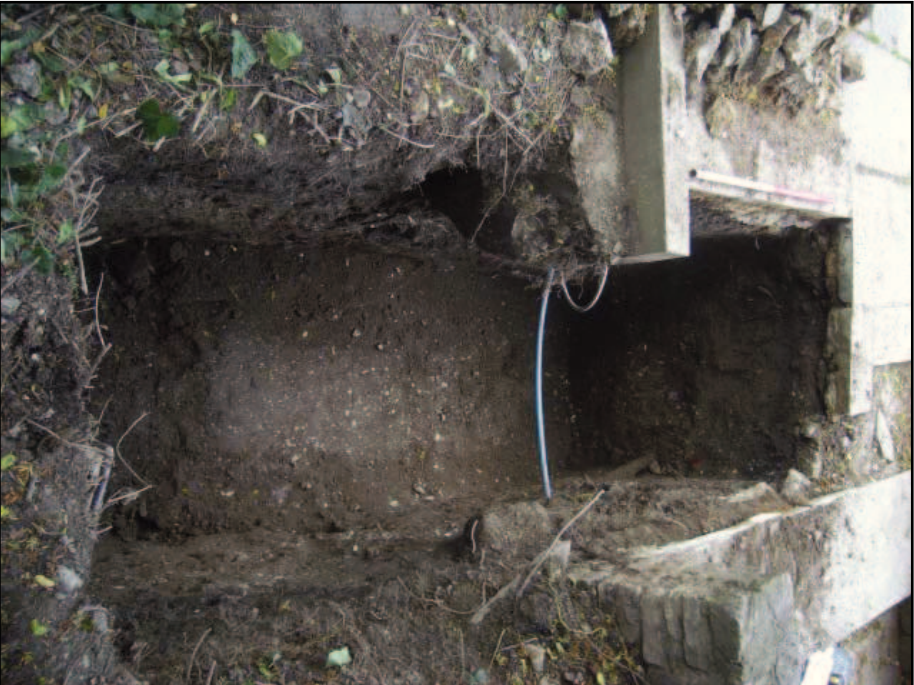
- 3.2.1 Trench 1 was located to the south-west of St Mary's Church (Figs. 2 and 3) It was aligned NE-SW and measured 3.1m by 1.2m (Plate 4). Prior to the excavation of the trench flagstone paving, some kerb stones and their footings had to be removed from the north-eastern half of the trench. The south-western half of the trench was excavated through the churchyard's topsoil which was also present in Trench 2.
- 3.2.2 A north-south aligned extension to Trench 1 measured 4.3m in length, 0.4m in width and up to 0.8m was dug for the drainage pipes. Flagstone paving slabs and their bedding also had to be removed from this extension

Plate 4: Trench 1

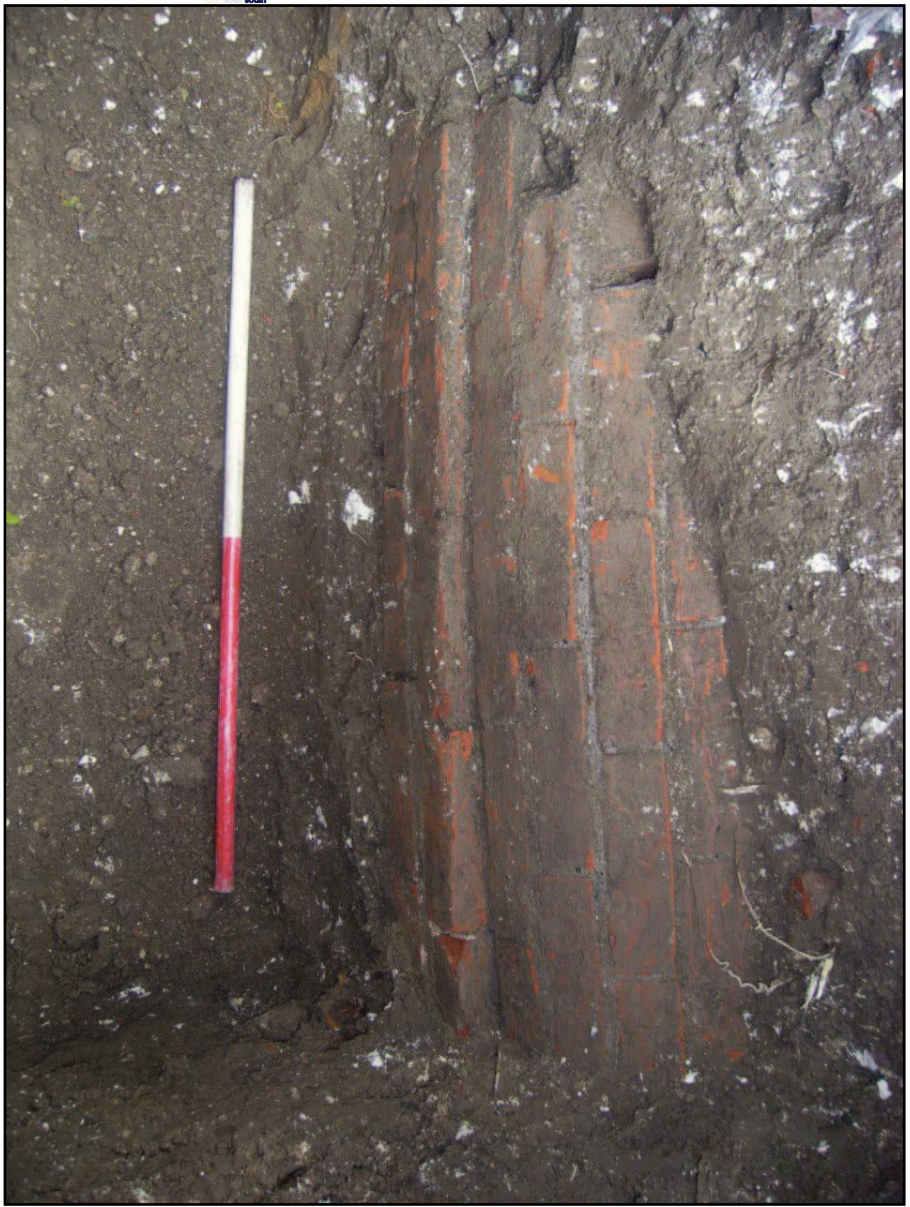
- 3.2.4 Excavation of the trench revealed two features (Figs 3 and 4), the first was a NW-SE orientated modern service trench (3). This cut extended across the trench and measured 0.42m wide and had its base 0.8m BGL. The second feature (8) was located in the north-eastern corner of the trench and was only partly uncovered. It extended for 1m along the northern side and 0.16m on the eastern side and was 1.52m deep. The fill of the cut (9) was identical to burial soil (1) making the feature very hard to see. At its base was a brick structure (7) which took up the entire revealed length and breadth of the cut and stood 0.44m high (Plate 5). It consisted of six courses of brick, two of which made up the walls whilst the other four made up the revealed portion of a vaulted roof. Whilst originally thought possibly be a brick lined and vaulted shaft tomb the further investigations show that it was a post-medieval culvert.

Plate 5: Culvert 7

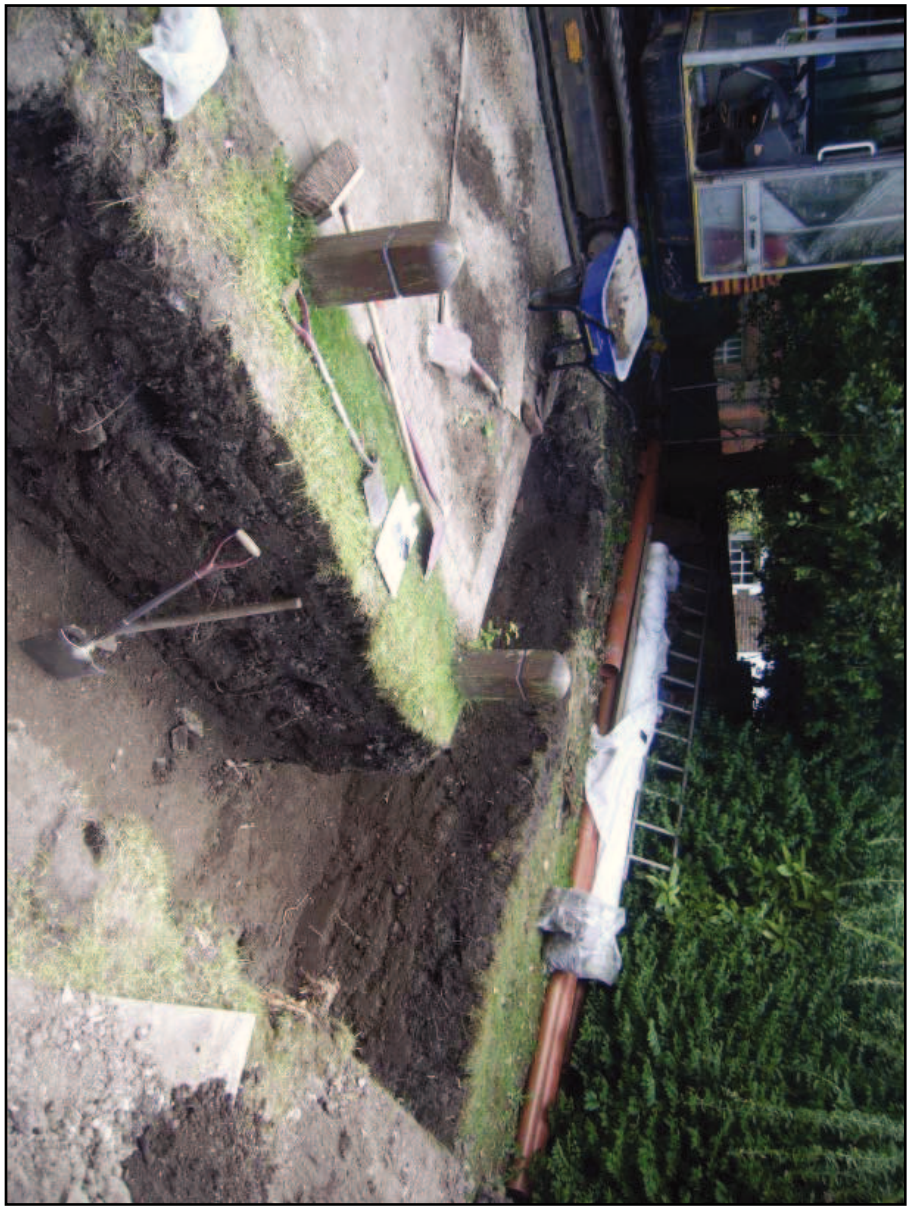
- 3.2.8 The shape and target depth of Trench 2 was altered to allow the necessary volume of the soakaway to be constructed without disturbing any more burials or damaging the Church's car park. An extension was excavated on the western end of the trench measuring 4.0m in length, 1.3m wide and orientated north-south, making Trench 2 into an L shape in plan (Plate 6).

Plate 6: Trench 2

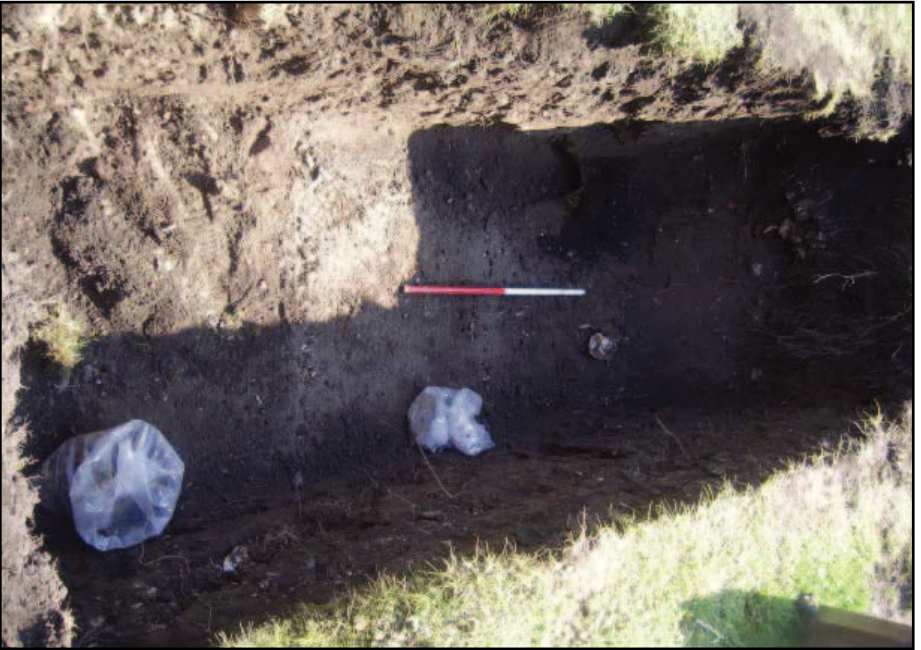
- 3.2.7 At a depth of 1.3m BGL two human skeletons were partly uncovered (skeletons 10 and 11) (Plate 7). The skeletal remains of a juvenile (11) were located central to the trench and an adult skull along with the decayed remains of a coffin (10) were located next to the eastern end of the trench. Neither skeleton was fully excavated and were covered over to prevent any further damage or disturbance to them. The grave cuts could not be seen due to the similarity between the backfill and the surrounding soils and as such were not recorded.

- 3.4.3 Despite their shallow depth of burial at only 1.3m BGL it is likely that the two burials from Trench 2 (**10** and **11**) are post-medieval. This is due to evidence of a coffin with SK 10; the practice of placing the corpse within a coffin for burial was relatively rare in the medieval period (Gilchrist and Sloane 2005), but became increasingly popular from the seventeenth century, and ubiquitous from the early eighteenth century onwards (Litten 1991). Given the good condition and low degree of fragmentation of skeleton **11** it seems unlikely that is of a medieval date and it is entirely possible that it was too interred in a

Plate 7: Burials 10 and 11

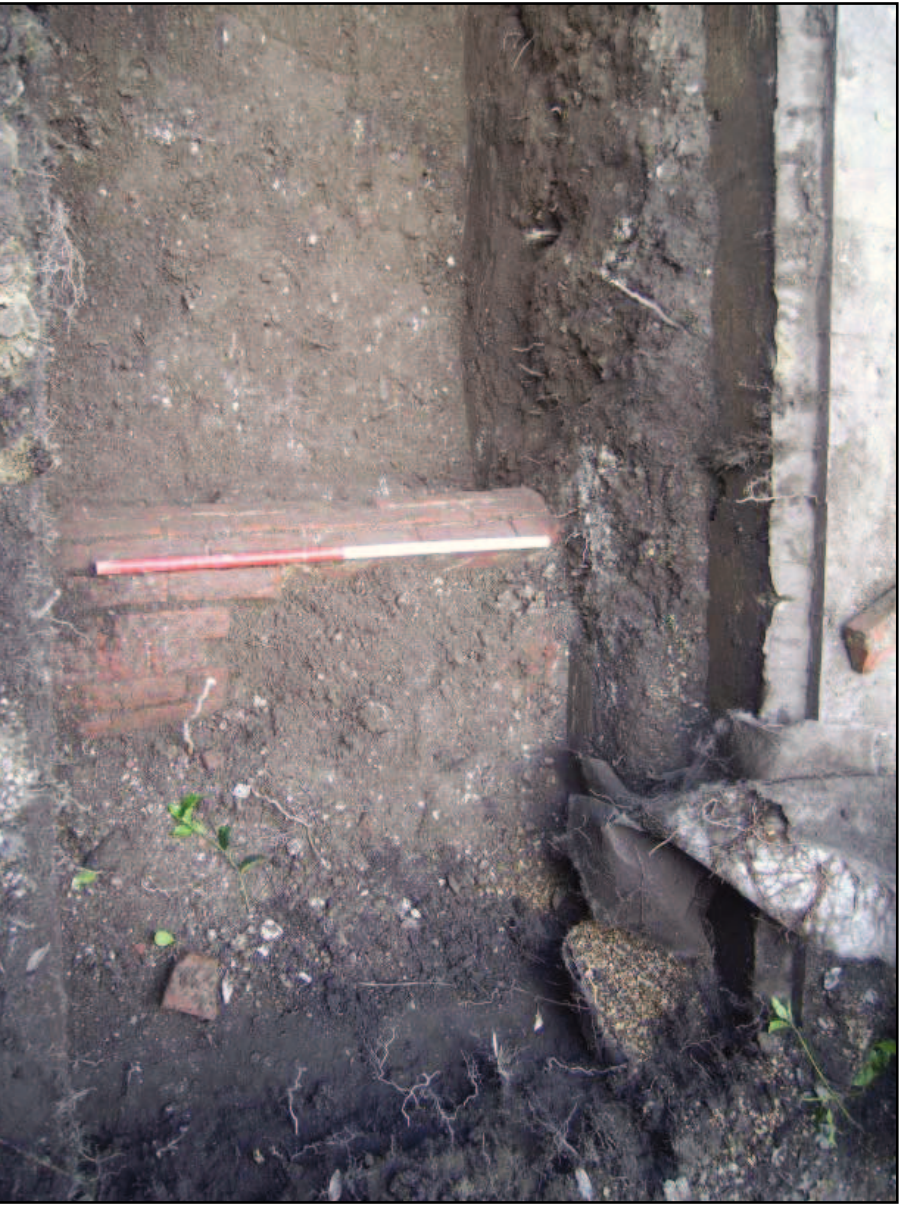
- 3.2.9 No further burials were uncovered during the extension of Trench 2, but a post-medieval brick culvert was uncovered (12) (Plate 8). It was orientated on an east-west alignment and measured 0.44m wide and 0.44m high. Its construction was found to be identical to culvert (7) in Trench 1. Once it was established that it was fully out of use it was demolished to allow for the construction of the soakaway. A target depth of 1.3m was obtained without the discovery of any further archaeologically significant deposits.

Plate 8: Culvert 12

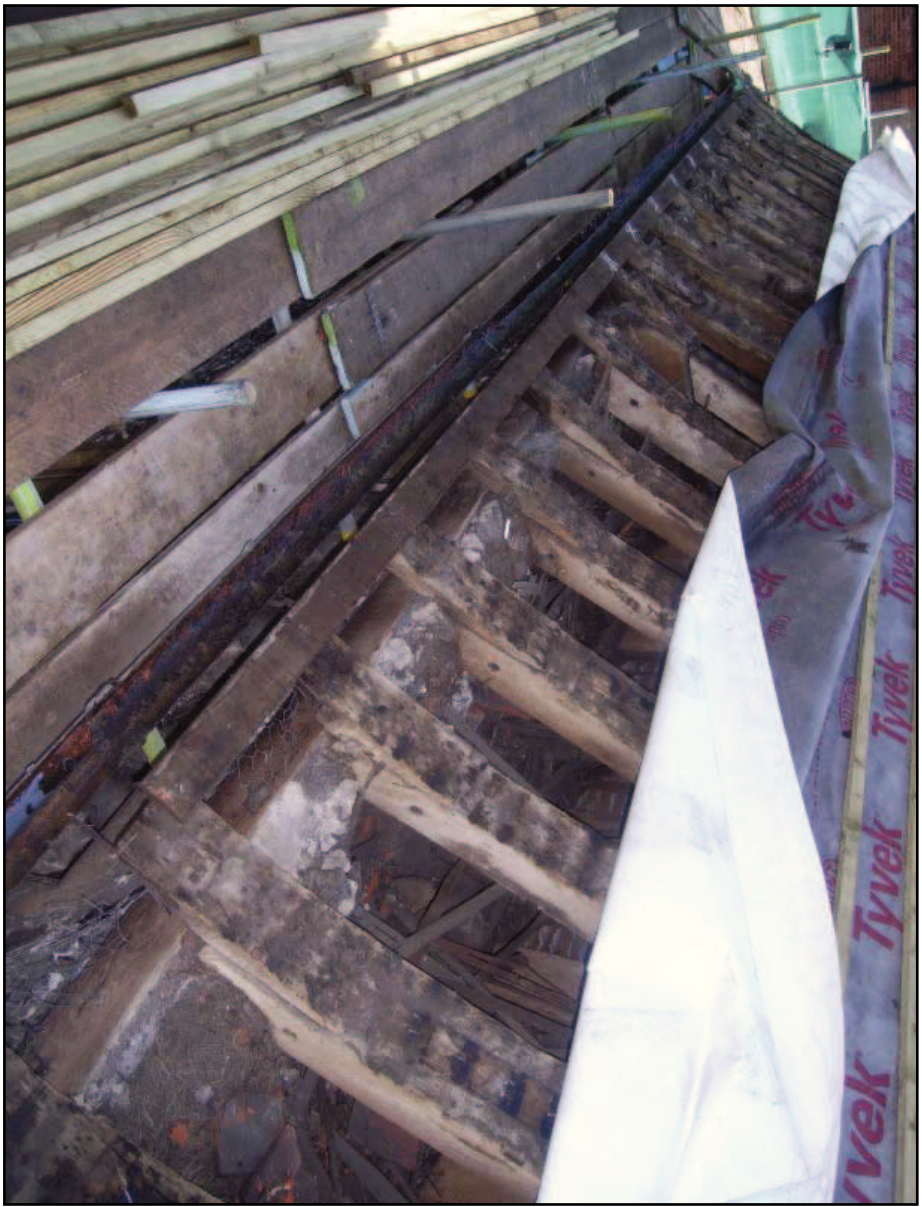
- 4.2.8 One minor feature of some interest in the roof is a single circular hole visible in the east side of almost all the rafters, c.20 cm up from the base (Plates 10-11). The holes are c. 2.5 cm in diameter and they are generally just in the east side so they clearly don't extend right through the rafters. Similar features have been noted by OA and other buildings archaeologists in other historic roof structures and their function has been the subject of speculation in a number of articles (see Johnson B, 1987). It is believed that they may have related to the initial temporary setting out of the roof timbers on the ground before all the joints are firmly fixed together. It may be that there were small ties in these holes to hold the roof together.

Plate 10: Rafter feet exposed on north side of roof

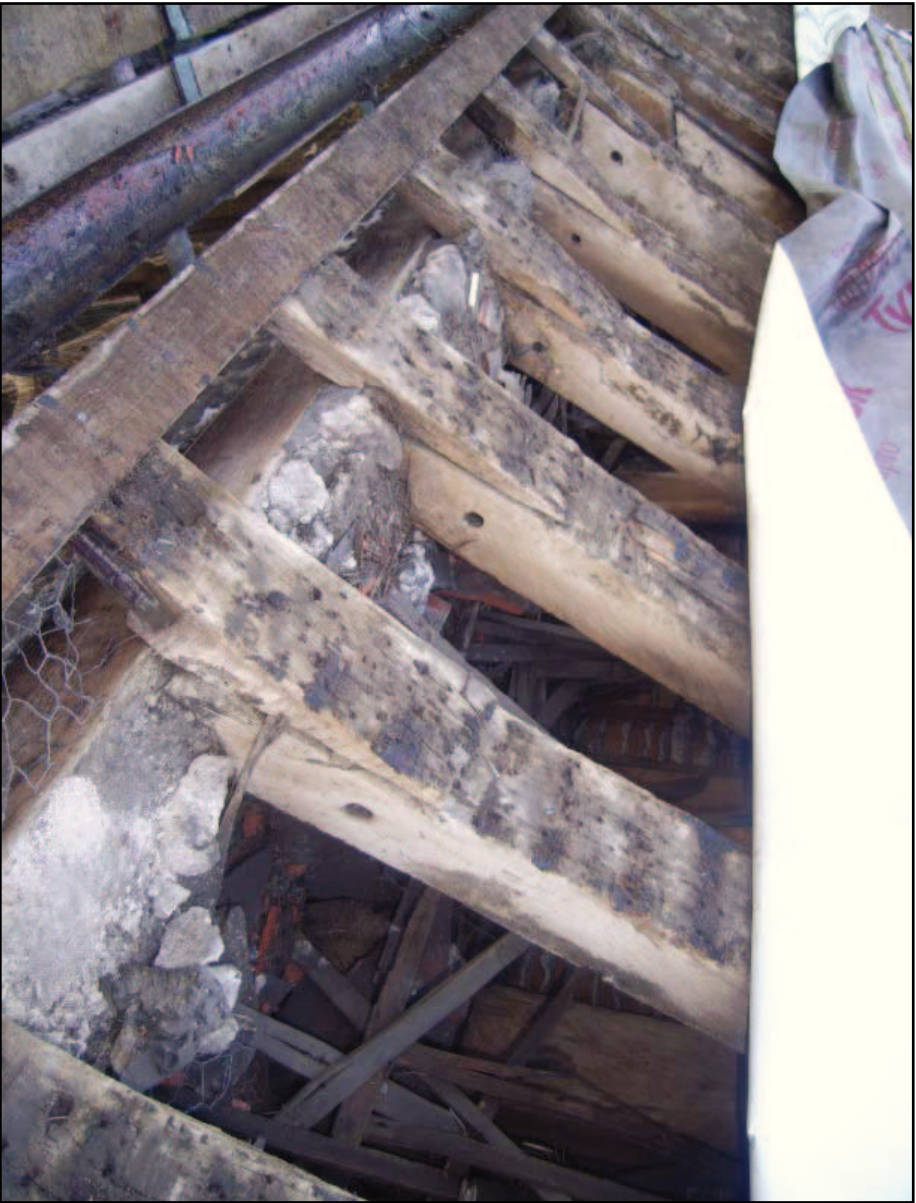
Plate 11: Rafter feet exposed on north side of roof

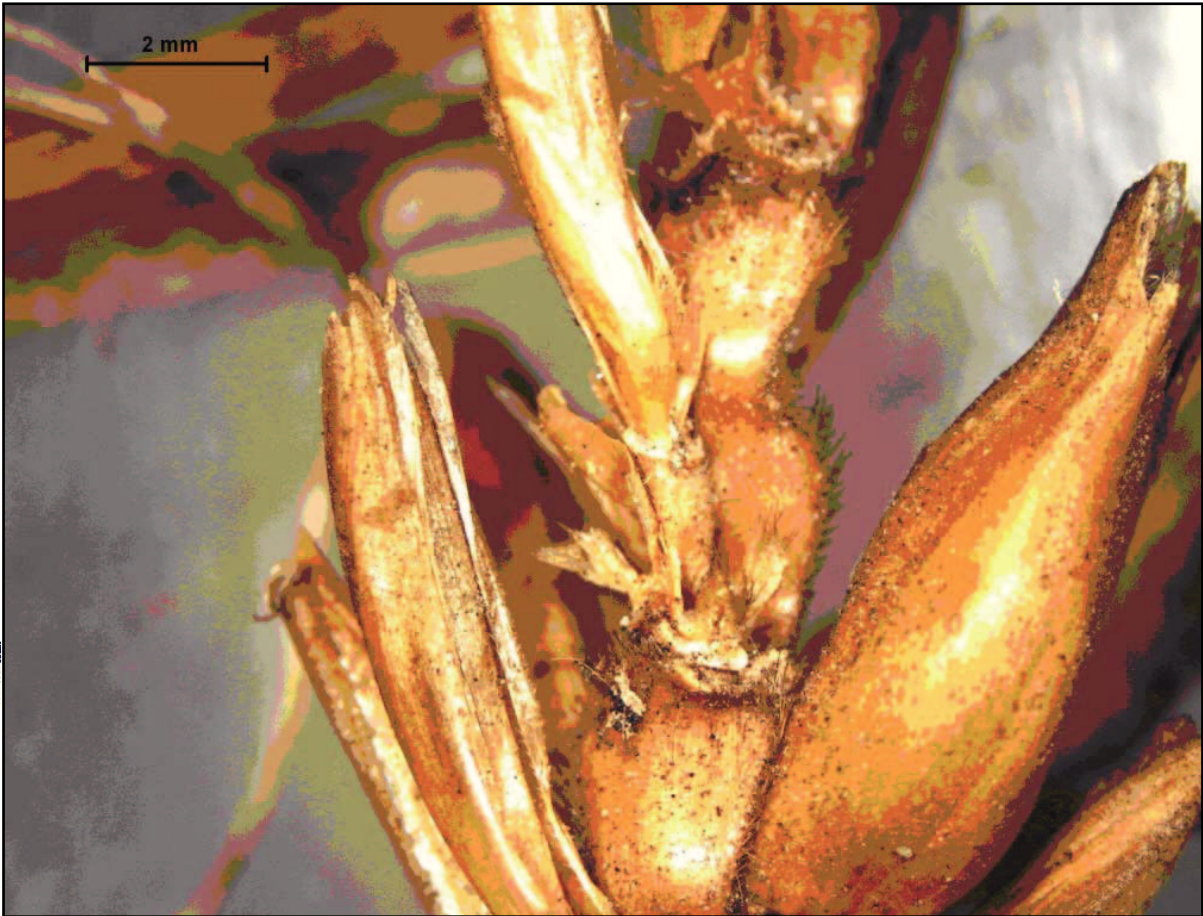
Plate 29: Bread wheat rachis segments from the tile packing in the east end of the north chapel roof

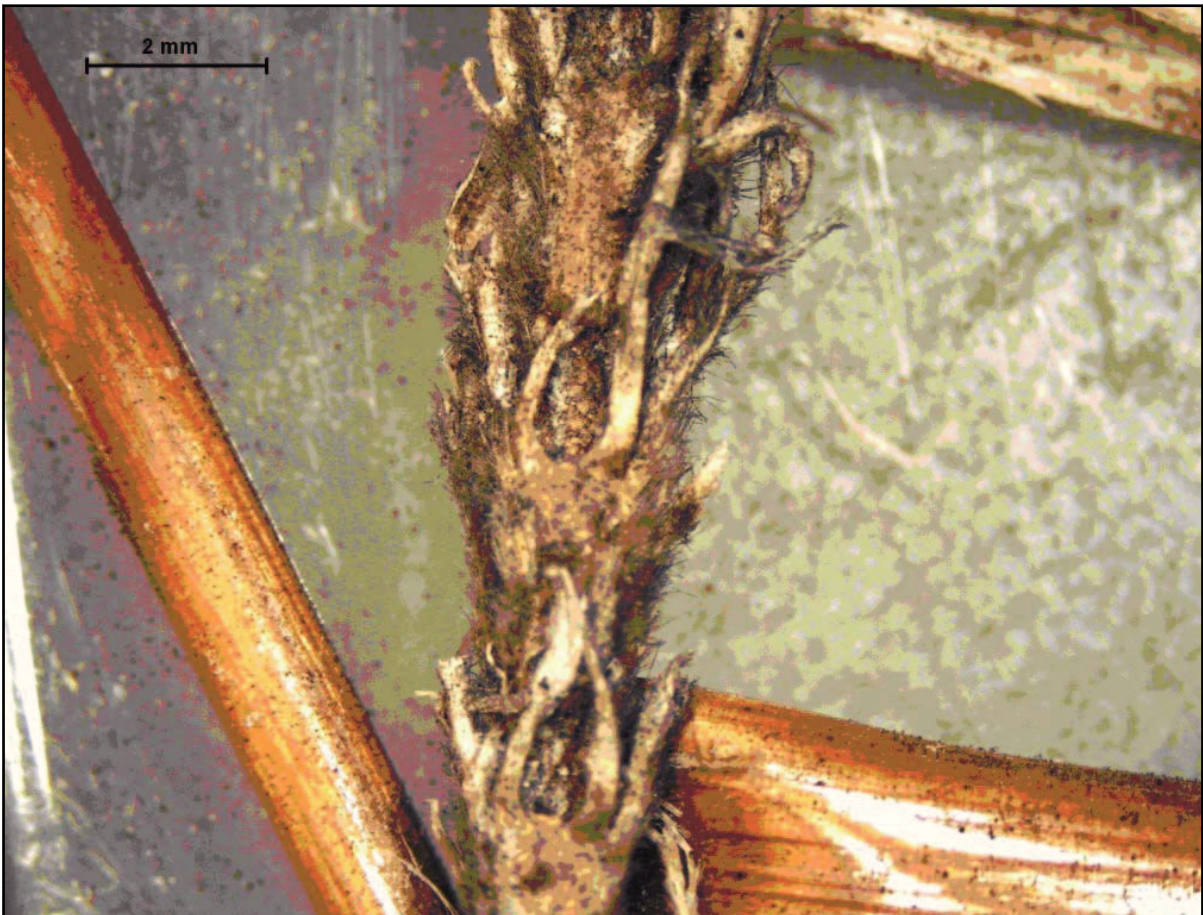
Plate 30: Rye rachis from tile packing on north side of Chancellery roof
