# The Tiltyard Tower Hampton Court Palace

## Historic Building Recording

February 2006

**Document Type:** Historic building investigation and recording

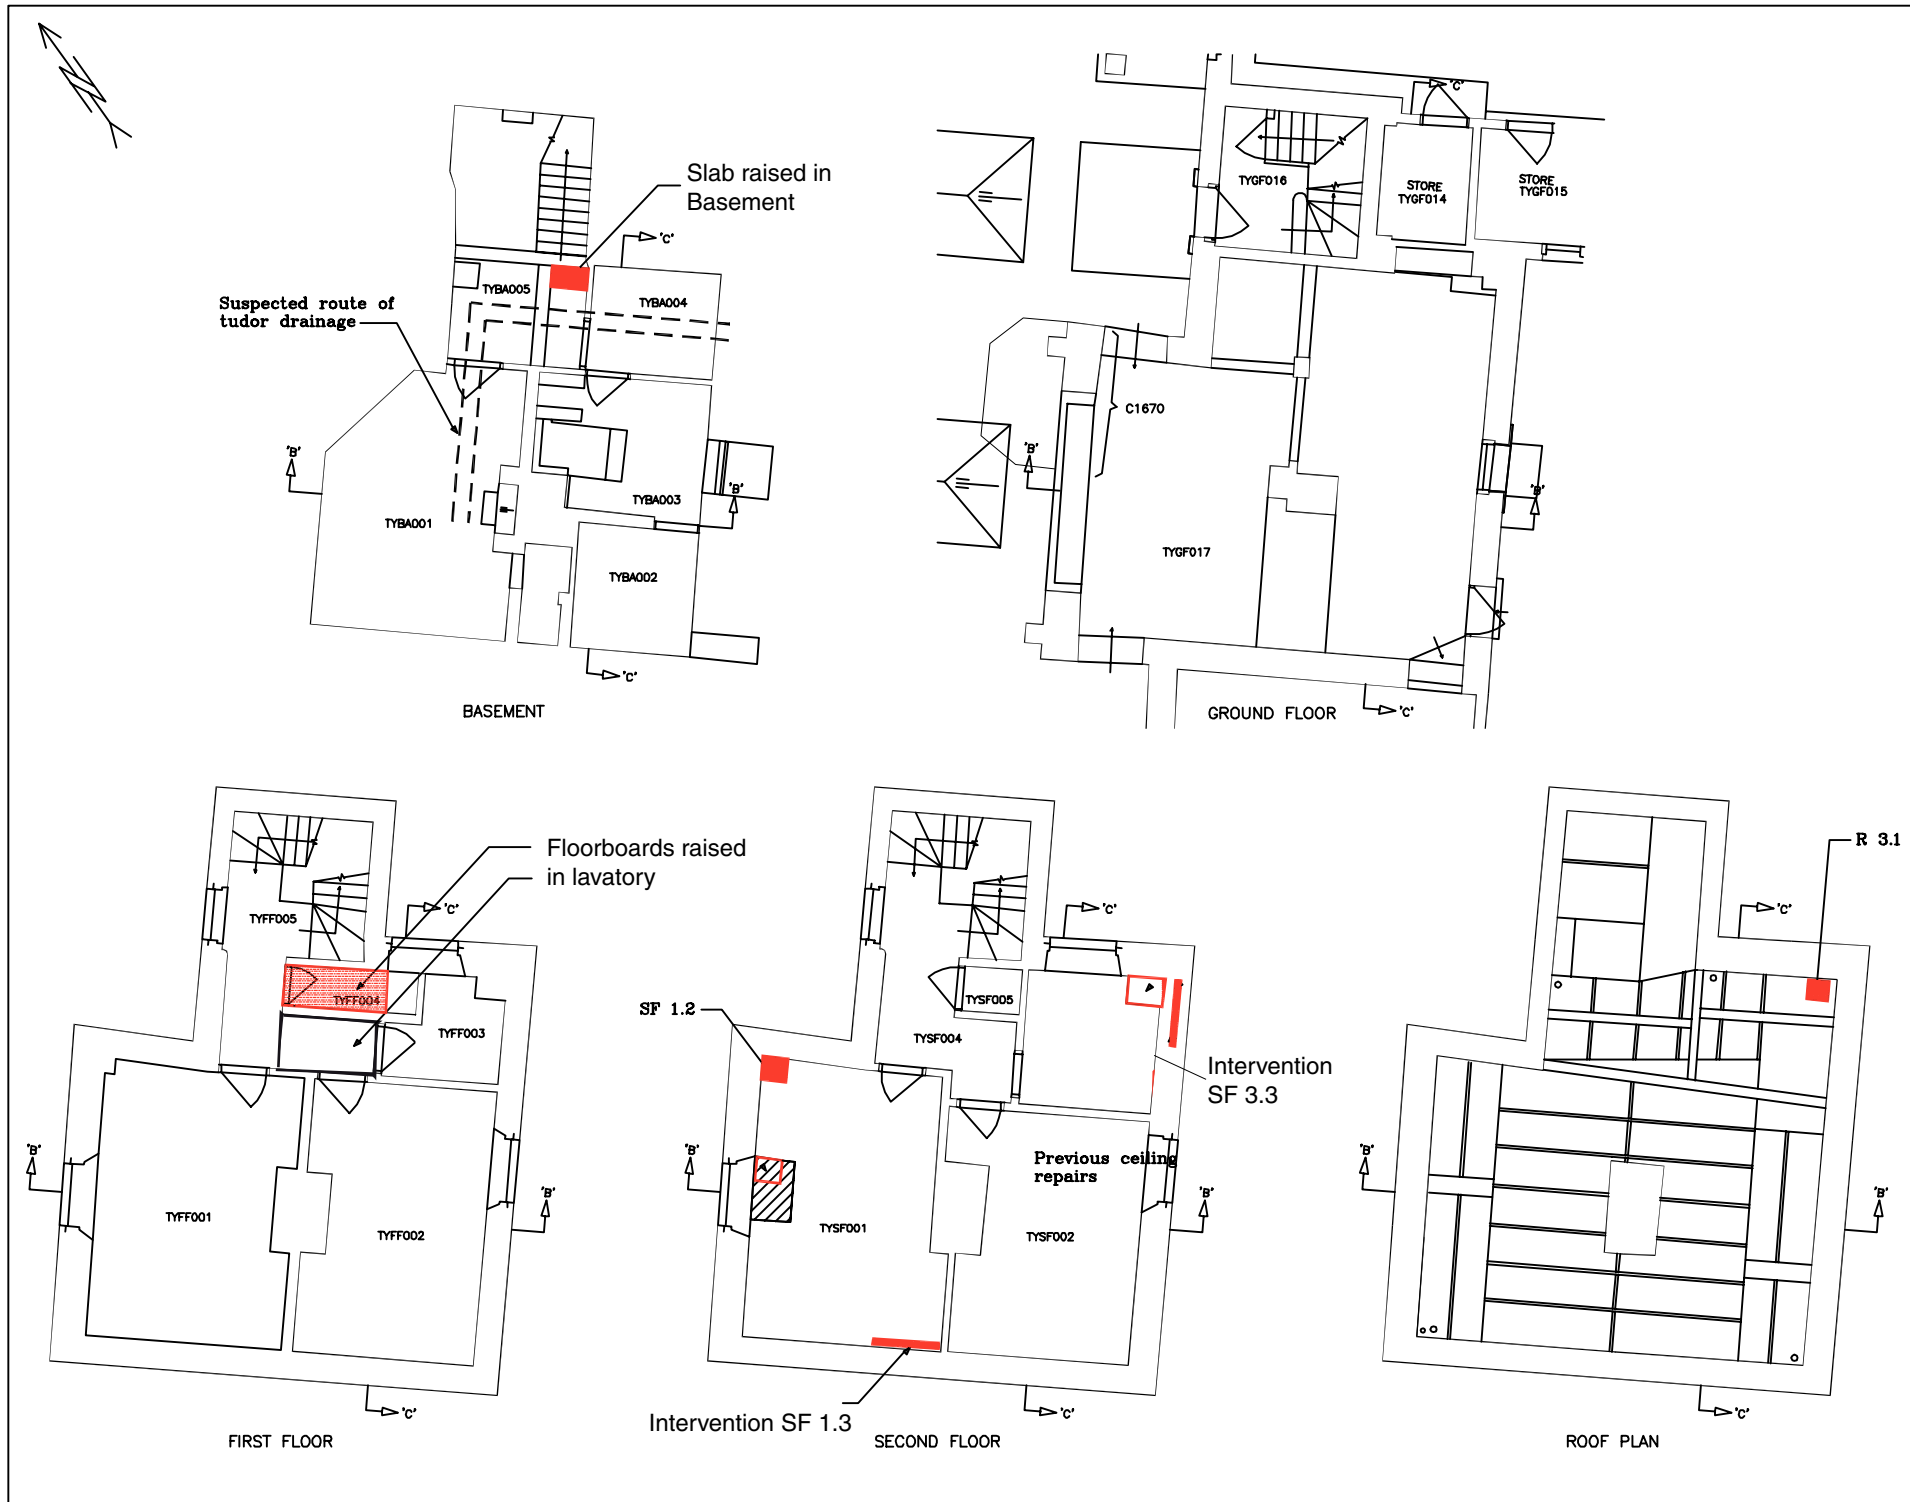
Figure 2: The Tiltyard Tower floor plans

- 3.1.3 As part of the investigations a single paving slab was removed and the void beneath it inspected before the slab was replaced. The slab was sited at the base of the modern stairs on the junction of the stone flooring and the brick flooring (see Figure 2). This flag was lifted to assess the nature of the void which was known to lie beneath it.

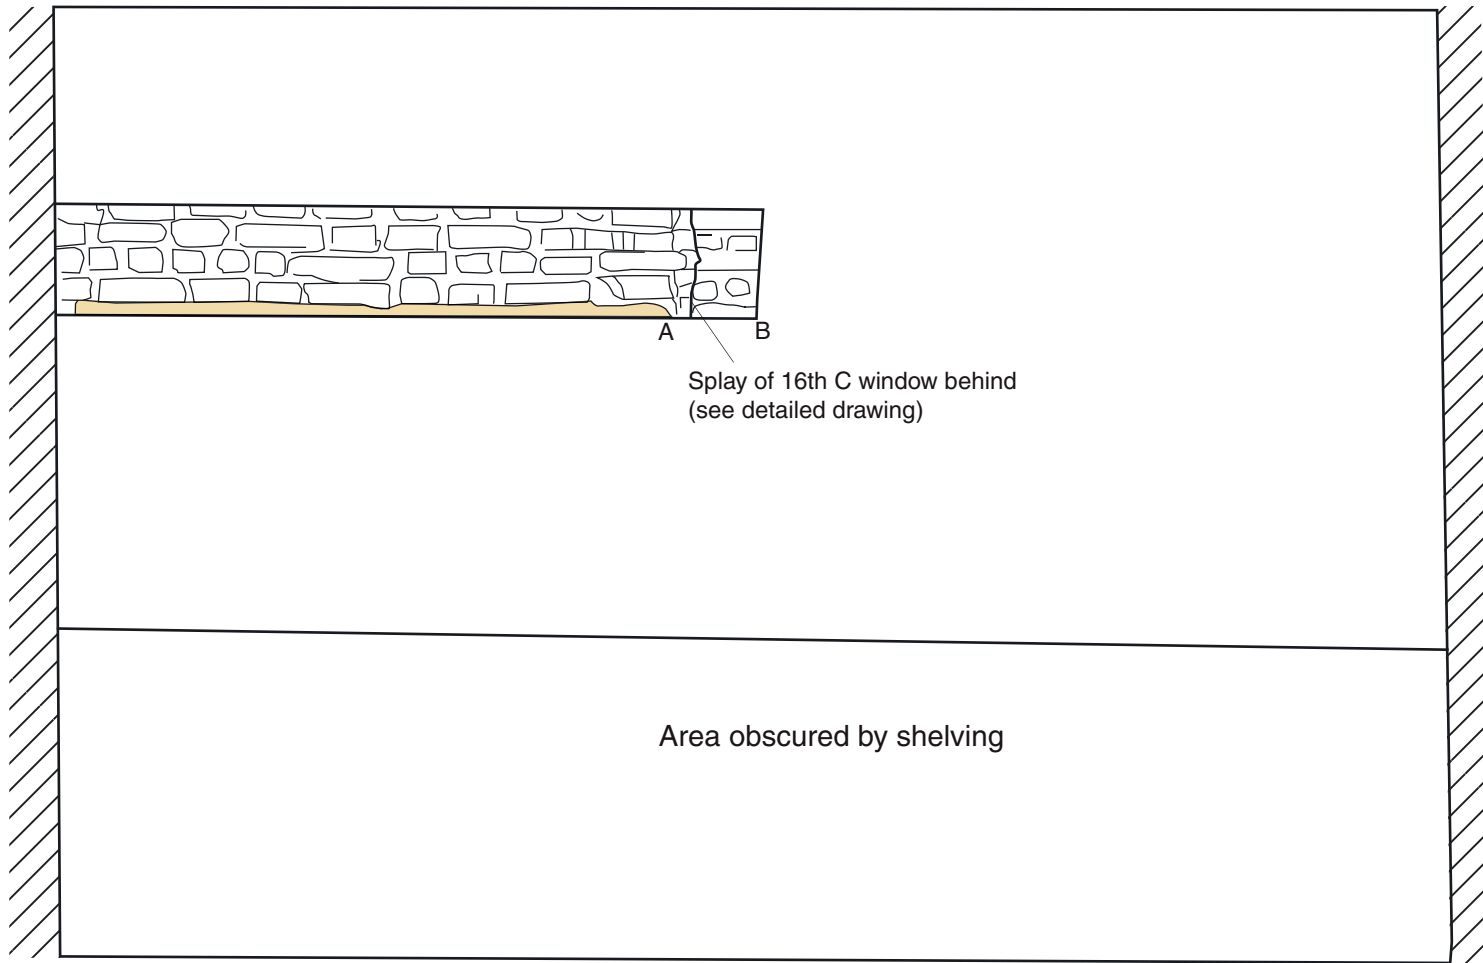
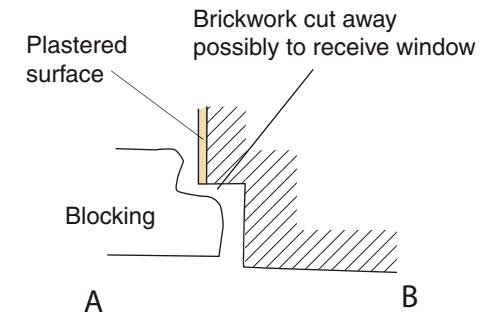
Figure 3: Hampton Court Palace, Tiltyard Tower, Room SF001, Interventions December 2005

3.1.21 As part of the investigations a strip of plaster was removed from the south wall of the locker room (TYSF001). This investigation was designed to pick-up on areas of differing brickwork visually identified by HCP (Foyle 2001). This brickwork had been identified as including primary 1530s work, 17th century blocking and 18th century alterations.

- 3.1.22 Across the whole of the investigated area there were three layers of plaster (all from one phase). This consisted of a scratch coat, base coat and top coat. Paint-work consisted of brown and then white emulsion, overlain by white paper.
- 3.1.23 Although the investigated area was targeted on the three phases of brickwork which are visible on the exterior, there were only two (rather uniform) phases on the interior. The reasons for this are obscure at the time of writing. It is possible that later (now blocked) sash windows on the outside of the wall may have had large external frames and yet small internal ones.
- 3.1.24 The splay of the Tudor window was located and it was noted that it retains its plaster on the jamb. As with the window reveal in the store room the edge had been cut away (perhaps to allow blocking).

Splay of 16th C window behind  
(see detailed drawing)

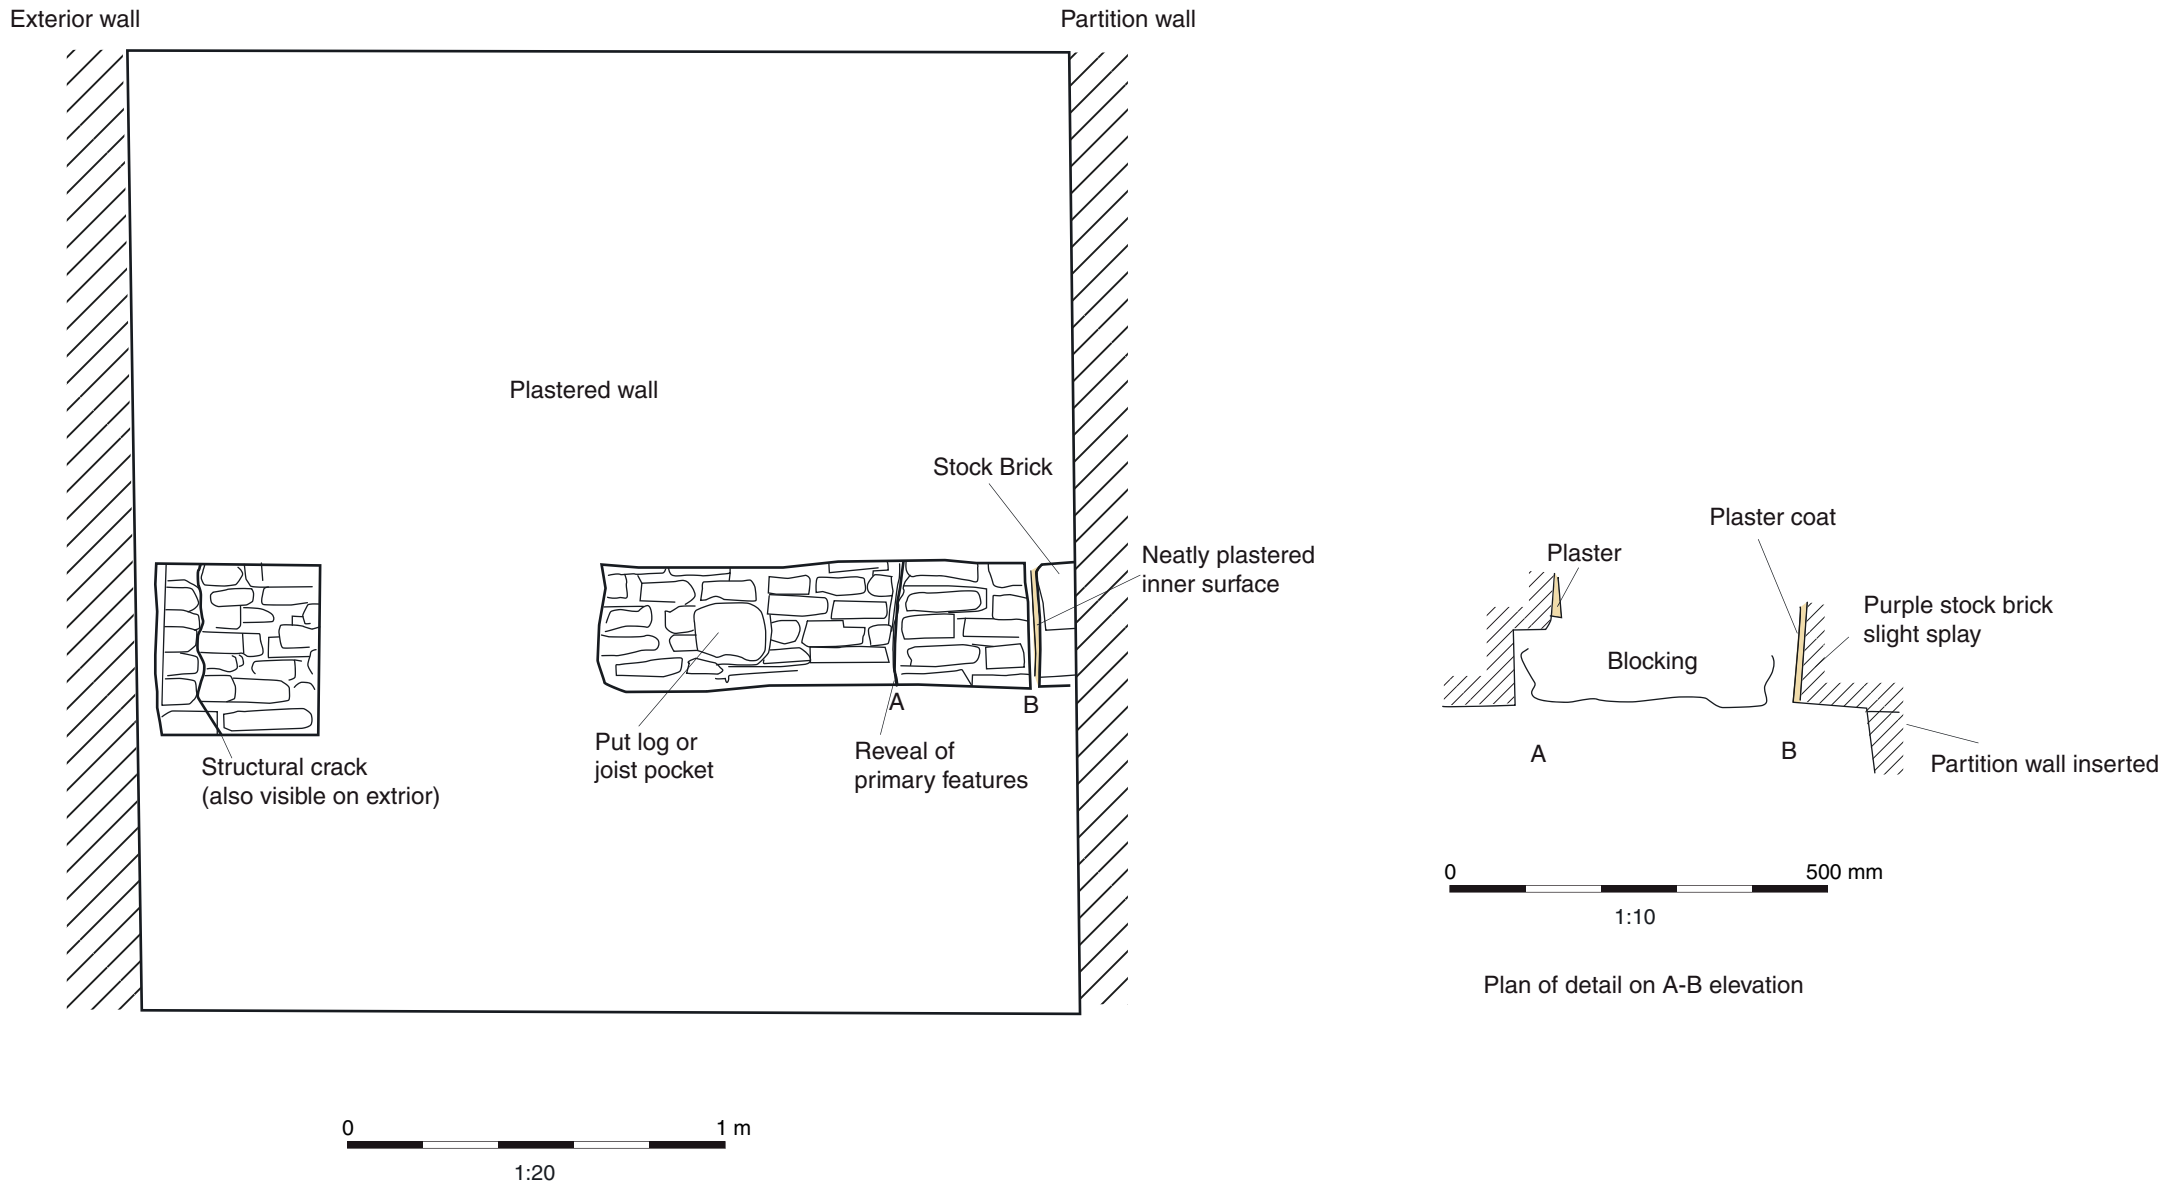
Figure 4: Hampton Court Palace, Tiltyard Tower, Room SF003. Interventions December 2005

3.1.14 Two areas of plaster were removed from this wall. Both were made up of a thick base coat of rough plaster with a fine top coat painted with brown then green emulsion. There was no sign of successive layers of early plasterwork or paint.

3.1.15 On the southern side of the wall several features were revealed within the investigated area. These were: a small joist pocket or put-log (blocked with the same mortar as the surrounding wall), the reveal of a Tudor feature and the reveal of a later feature.

3.1.16 The Tudor reveal had been crudely cut away at its junction with the wall (this may have occurred to facilitate blocking). Parts of the plastered interior of the splay were visible but were not sampled during the investigation. The splay may relate to a window or possibly an integral cupboard within the thickness of the wall.

3.1.17 The blocked later feature was unsuspected and no sign of it may be discerned on the exterior elevation. The jamb was made up from stock bricks (18th or 19th century?) and retained its plaster coating within the splay. Without further investigation it is difficult to understand how this feature related to the Tudor splay next to it. It appears as if they once formed the sides of a very narrow slit like window which was in turn the result of the partial blocking of a larger Tudor window and that this small window was later blocked. Only further and wider investigation would reveal the actual sequence of events and explain the lack of visible features on the exterior elevation.

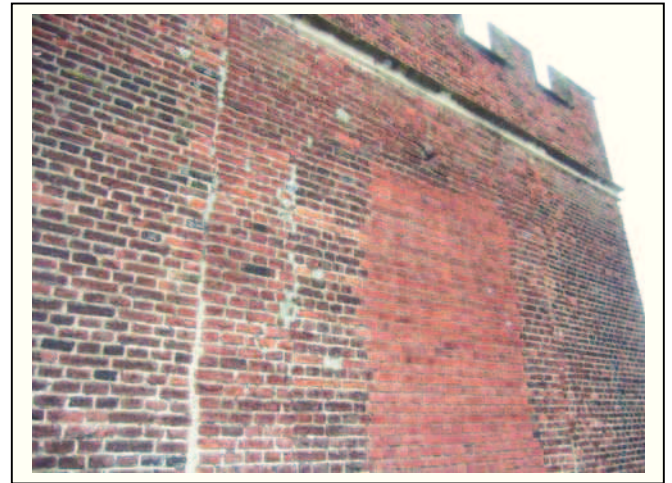
Plate 2: Blocked features on the south wall investigation focused on the area above the large blocked window.

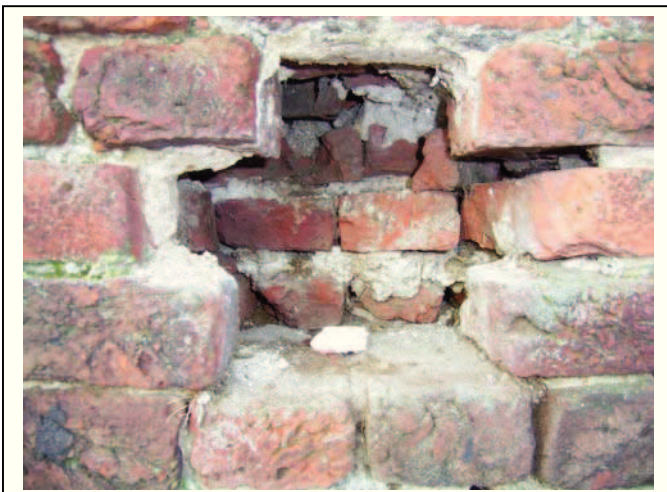
Plate 3 External intervention showing core of south wall.

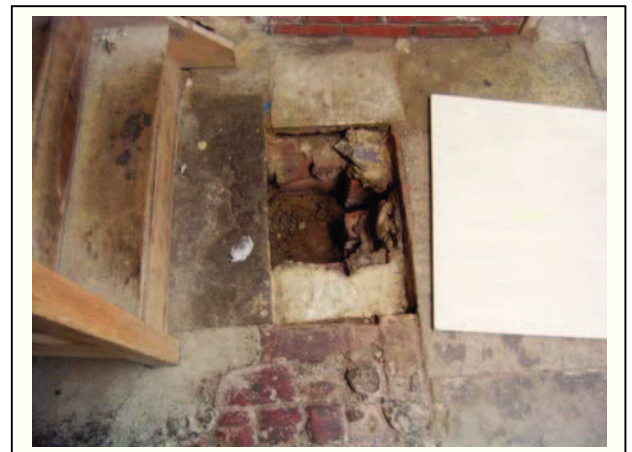
- 3.1.4 Raising of the slab revealed a narrow drain lined with brick and filled with silt. The underside of the slab was levelled with roof tile and slate. It was noted that the drain narrowed considerably on both sides and appeared to be more of a soak-away rather than a main drain. The bricks used in the culvert were of a 16th or 17th century type and were similar to the earliest fabric of the tower's main walls. The drain was almost entirely filled with silt and only a small part of the upper surface was visible. It was outside of the scope to excavate the fill of the drain and therefore recording was limited to photography.

Plate 4: Raised slab in basement showing drain beneath.
