Hampton Court Palace The Tiltyard Tower

**Historic Building Recording and
Investigation**

July 2008

Client: Historic Royal Palaces

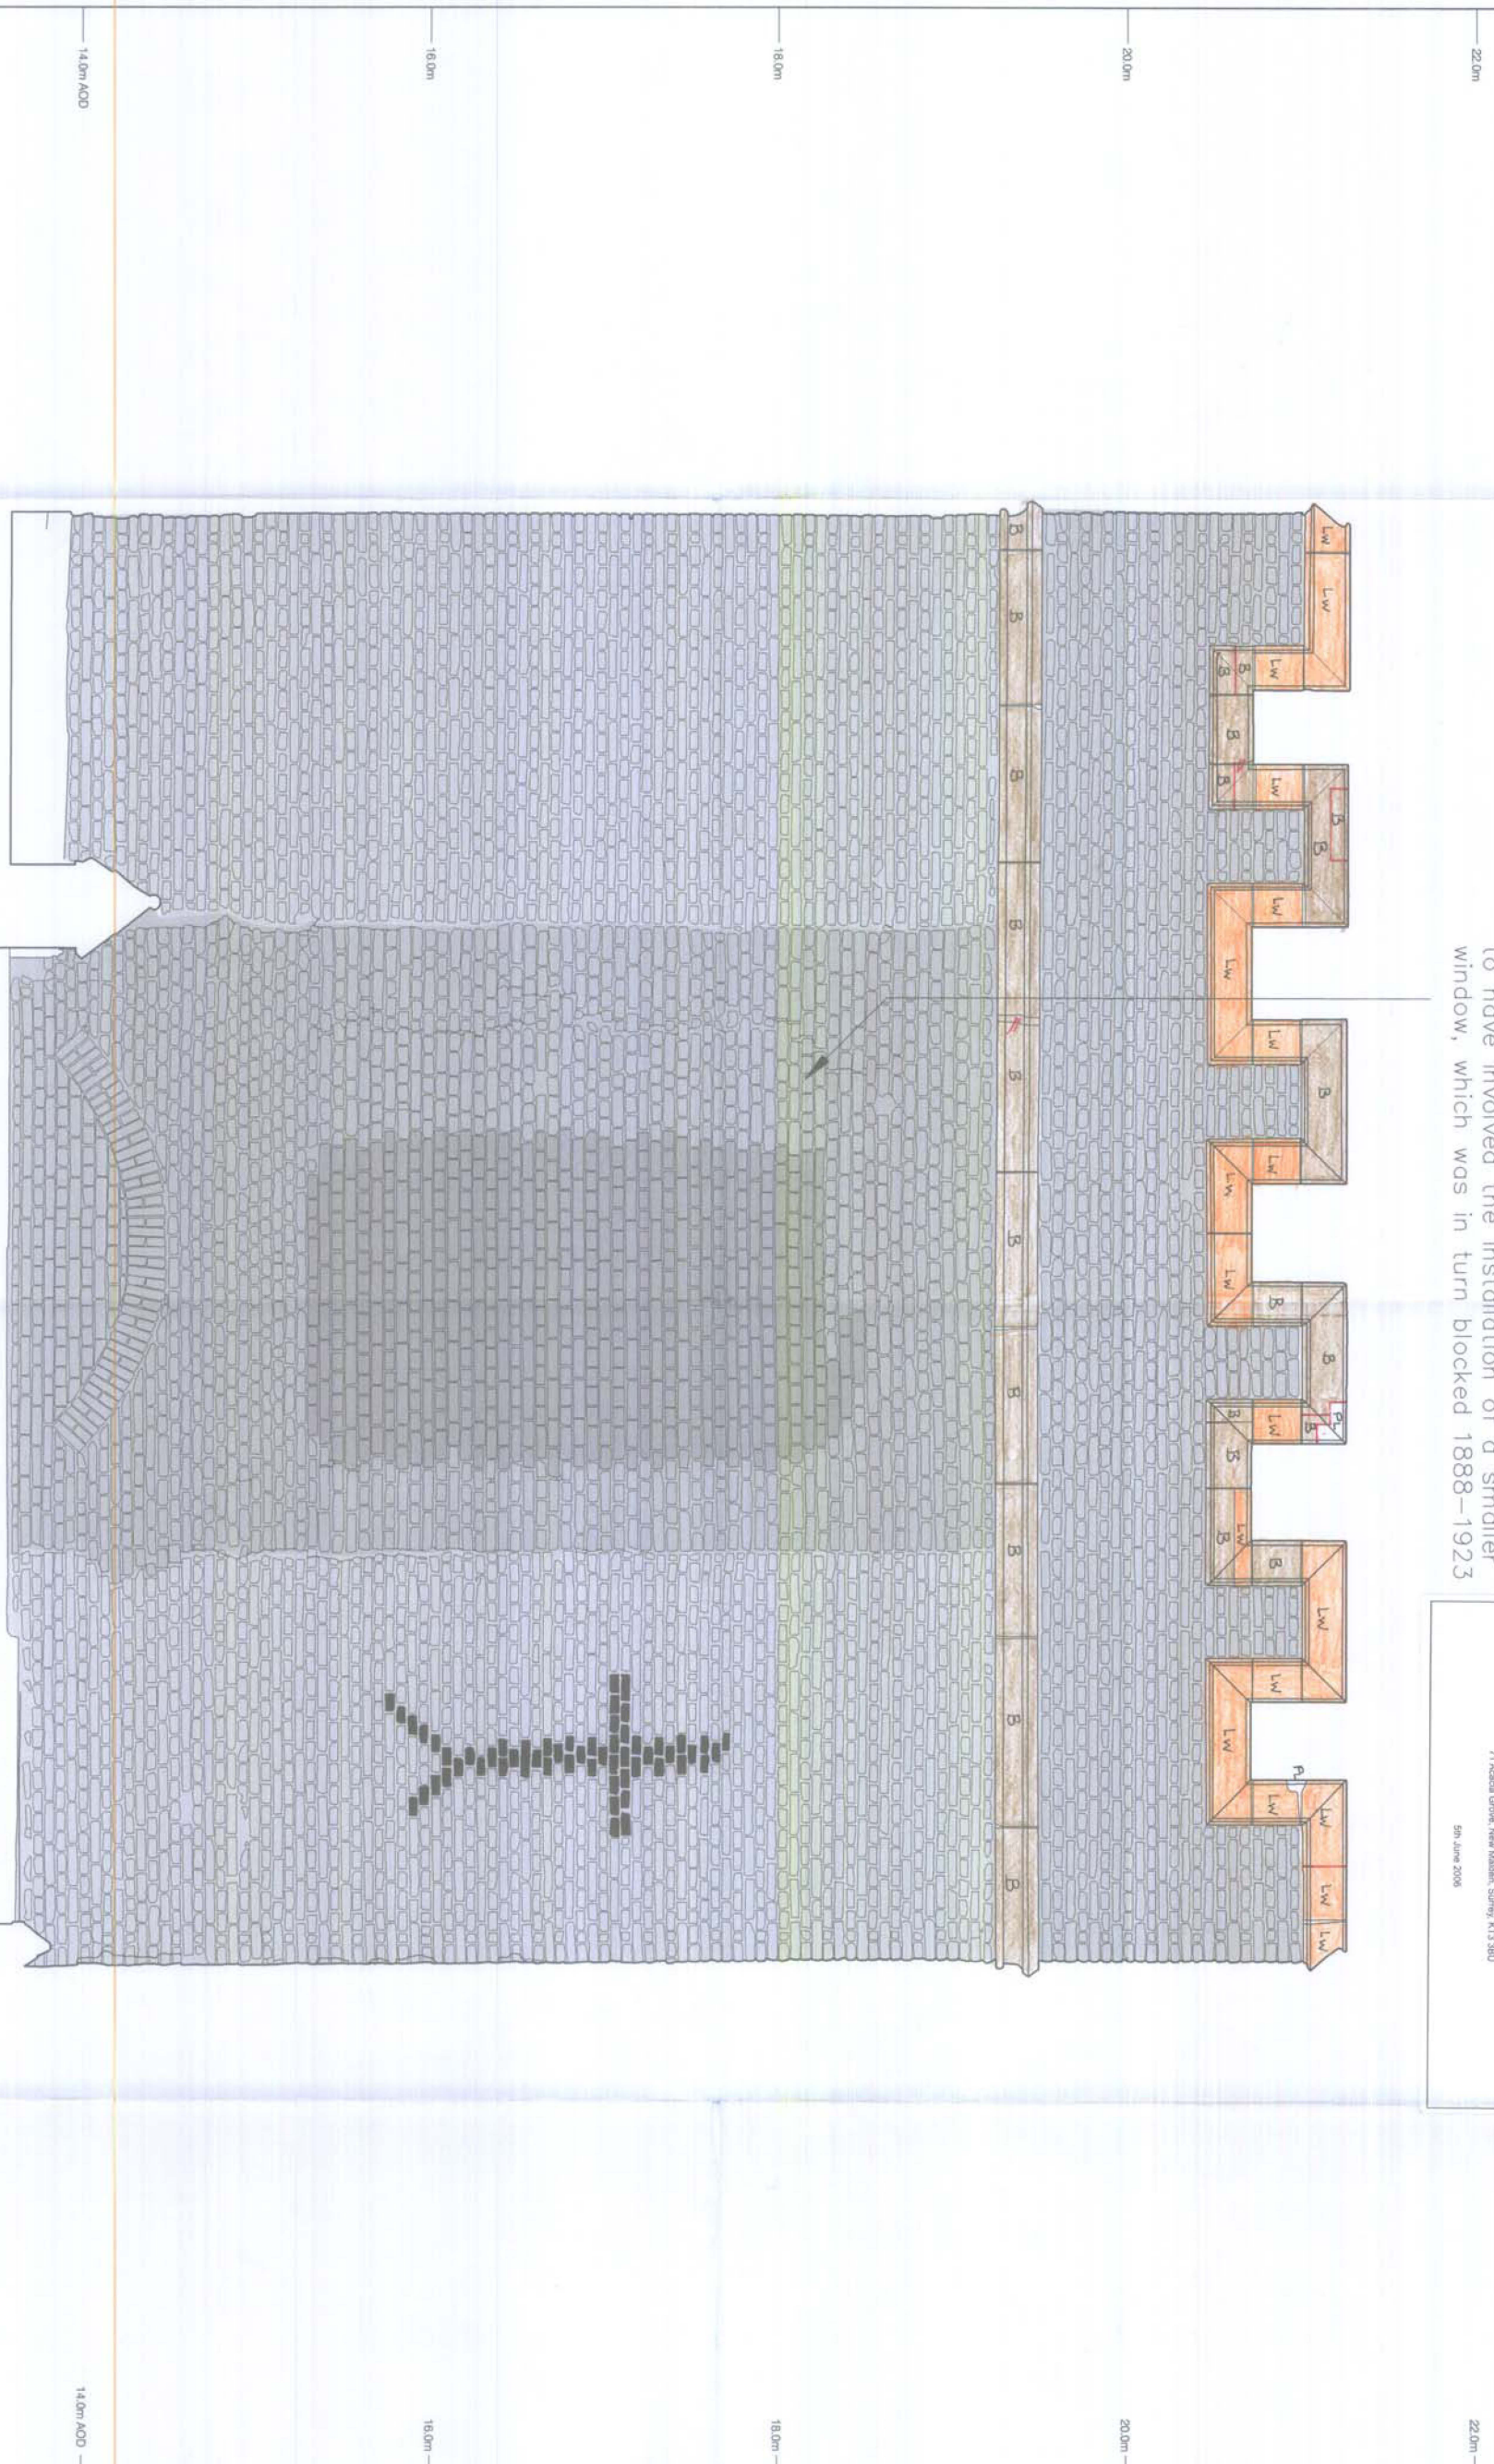
There is no information on the Tudor fenestration. This could represent the demolition of a Tudor bay window or blocking for reinforcement. That there is no bonding makes this unlikely, however.

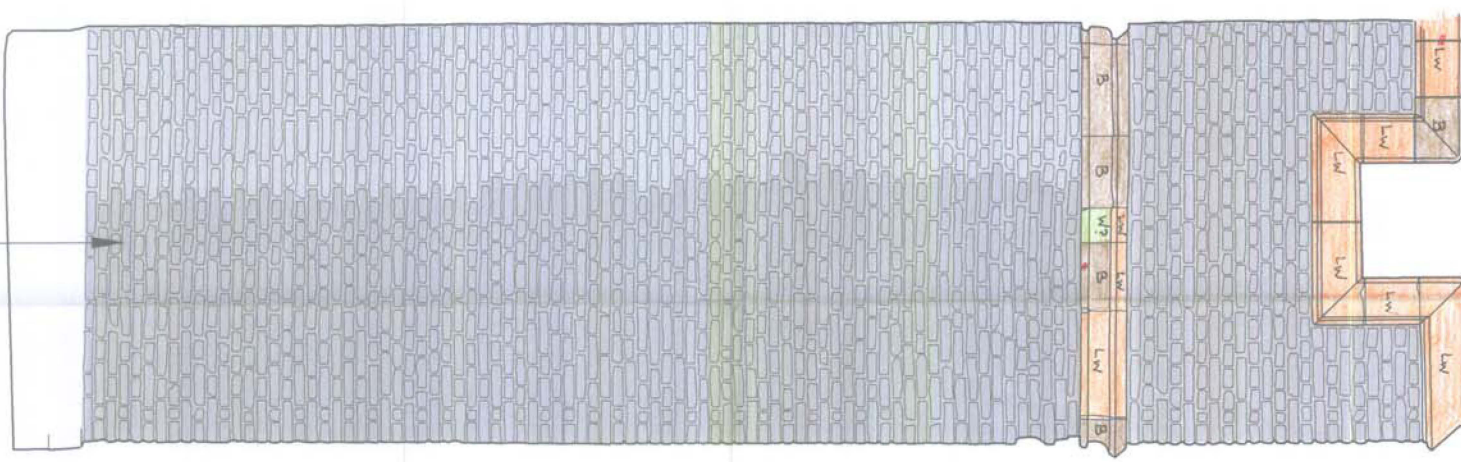
A

C18th repair to crack caused by differential settlement at the junction of the brick corner of C.1670 that replaced the Tudor stair turret.

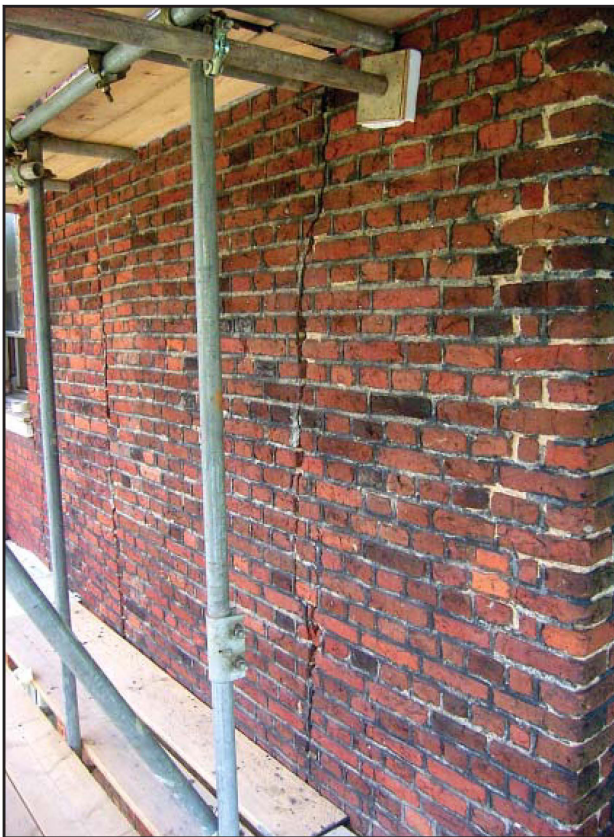
Plate 4: East elevation, external view, illustrating Tudor brickwork and phasing break to north of the window (the jagged break is structural)

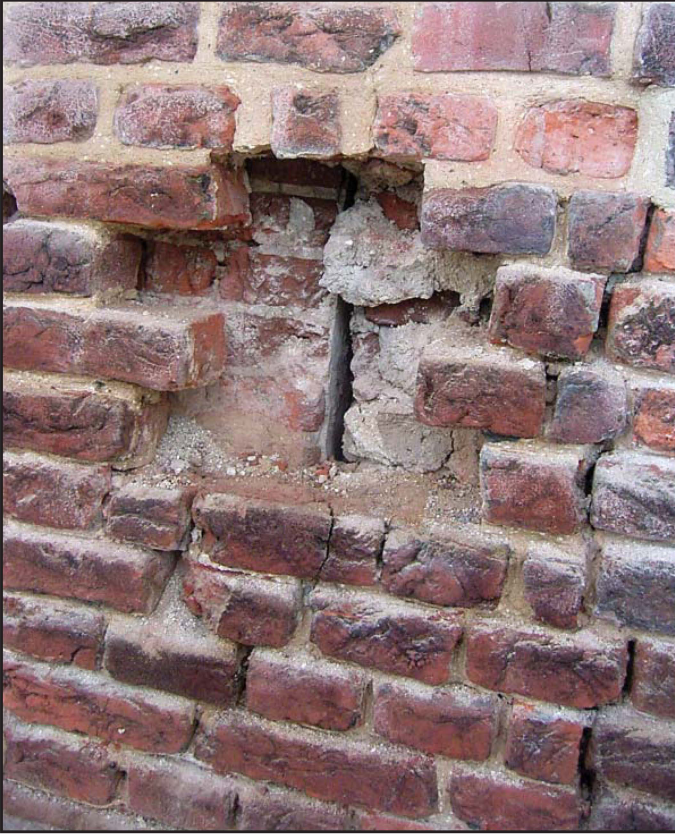
5.6.4 External investigations during brick replacement of the **south elevation** identified window plaster at the west (Plate 6). The surrounding brick construction was not

Plate 6: South elevation, external view, showing Tudor plaster reveal

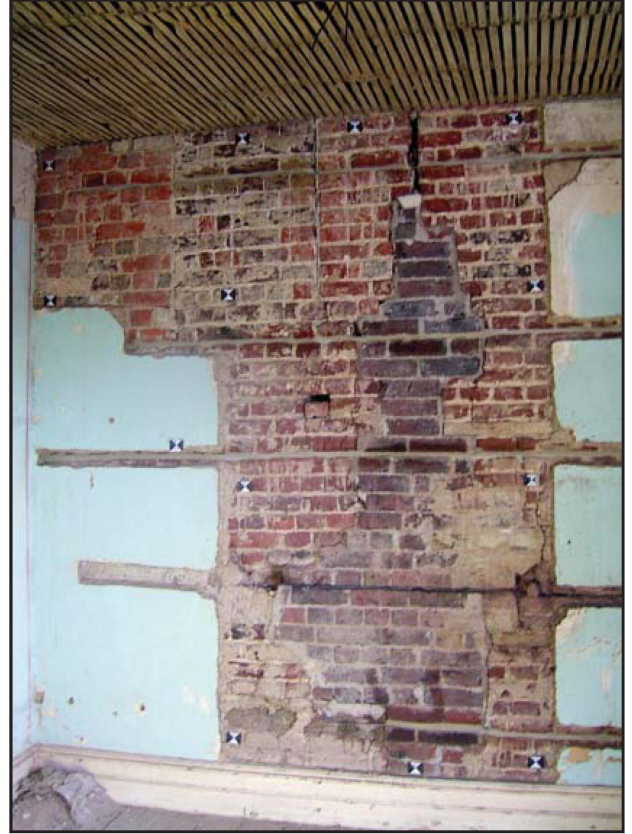
Plate 7: South elevation, internal view, first floor, illustrating Tudor break below ceiling and 20th century patching

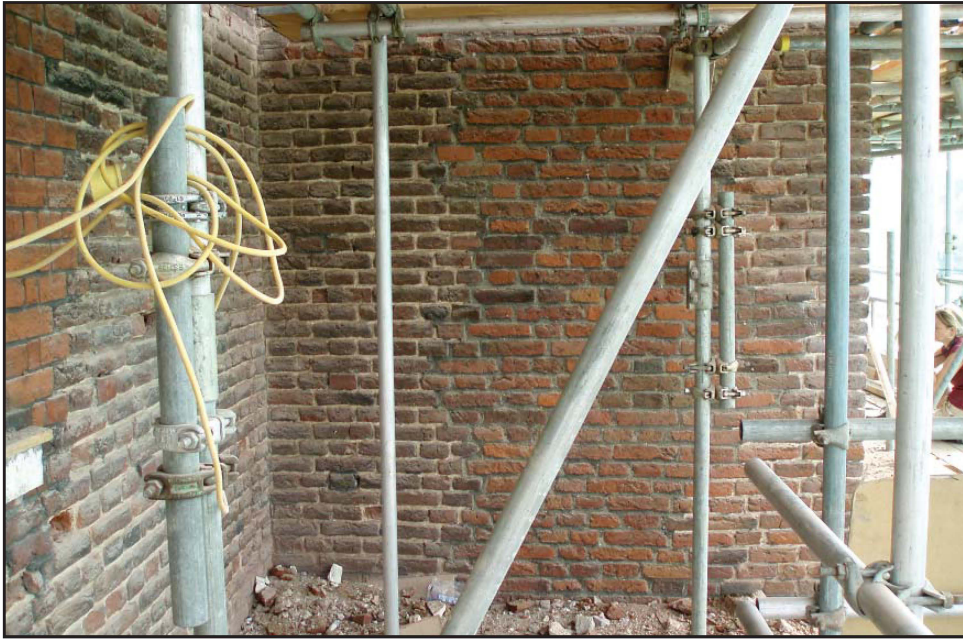
- 7.4.9 The central panel of the west section of the north elevation has been repaired with late 17th to early 18th century brick (see Plate 12). It is possible that this was in order to repair cracking that occurred because of the removal of the stair turret. Works at parapet level however revealed a feature which appears to be an outlet (measuring 0.34 m by 0.33 m) (Plate 34). It is situated roughly centrally between the crenellations just above the roof floor level and infilled with a rubble, cementious mix.

Plate 12: North elevation, external view, second floor, showing central panel of 18th century patching

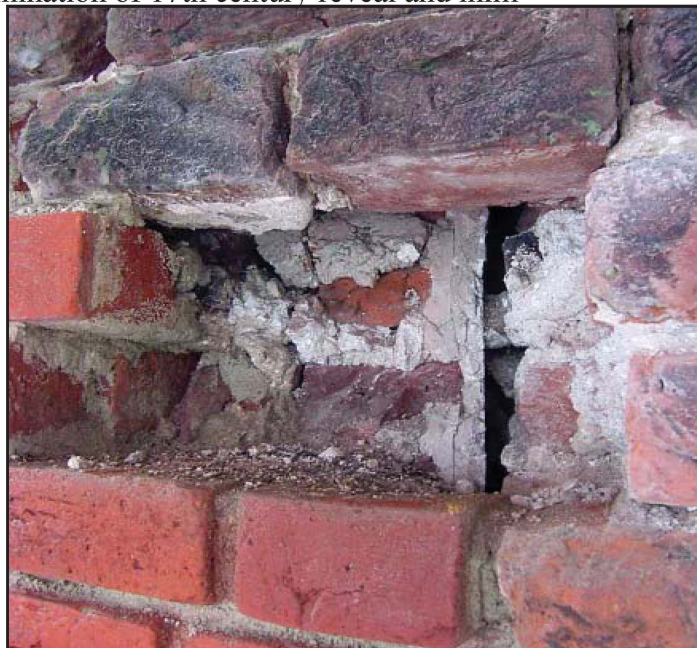
Plate 24: South elevation, external view, second floor, showing 17th century window reveal identified during brick replacement

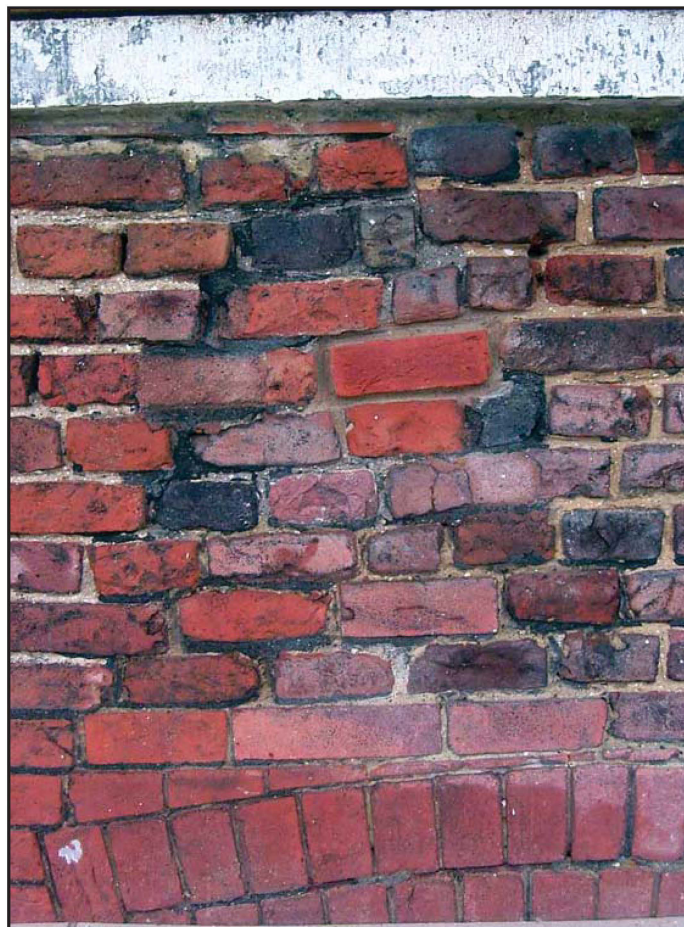
- 6.5.16 The later insertion of the windows means that the alignment is only visible between the first and second floor windows, and this has become disturbed as a result of this later fenestration (Plate 29). The area includes a mixture of phases including later c.19th century bricks (Type T), 16th (Type C) and 17th century bricks (Type R) and varying mortars are also evident, in particular a significant patch of 18th century ashey mortar. Within the north elevation the 17th century infill may formerly have extended further to the north, although repair to this area in the 18th century means that this alignment is lost.

Plate 29: West elevation, external view, between first and second floors, showing mixed phased patching at break between Tudor and 17th century brickwork

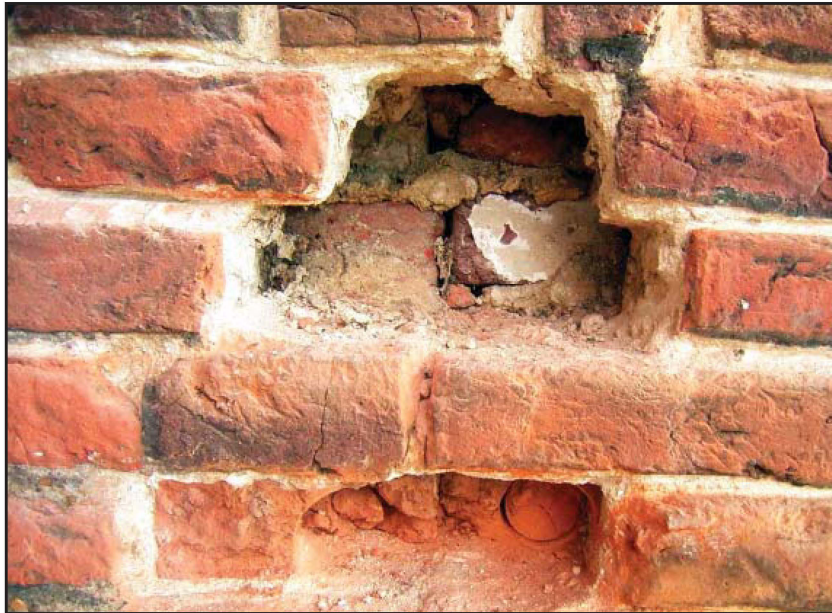
- 7.4.12 Brick replacement in this area provided some further insight, and those removed below the parapet showed that the second skin of brickwork is constructed from reclaimed bricks. White paint is visible on the surfaces, which conforms with those identified internally at first floor level (Plate 36). This suggests that much of the inner core of this elevation has been rebuilt, although internal investigations show that Tudor brickwork also survives (Plate 37).

Plate 36: North elevation, second floor, exposed brickwork during brick replacement, illustrating reclaimed bricks on second skin

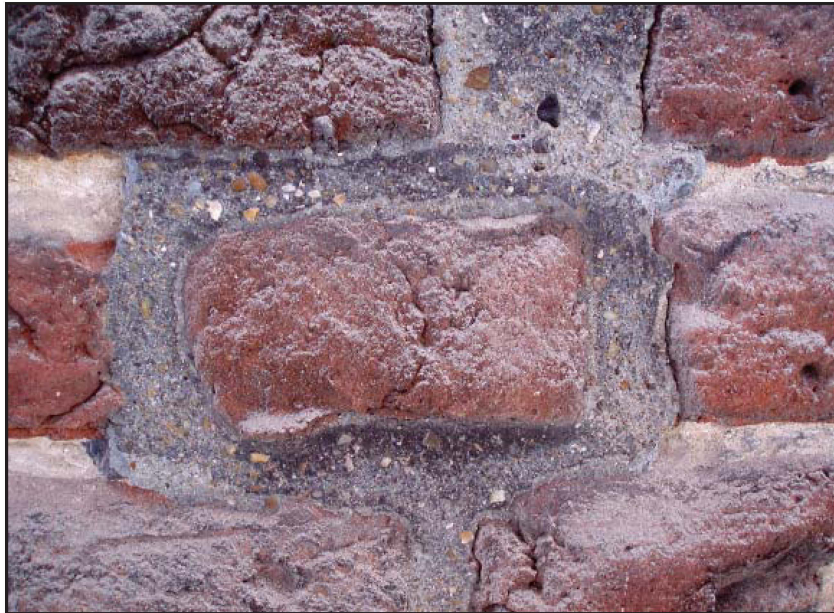
7.4.15 Raking out of the central section of the north elevation revealed seven features which follow the same alignment as those found in the remaining elevations relating to former floor levels (Plate 39, Fig. 2). There are repairs to bricks with grey ashy mortar (of varying colour depth) at three levels (c and d are at the same level), listed from top to bottom below:

Plate 39: North elevation, first floor, external view, showing brick repair

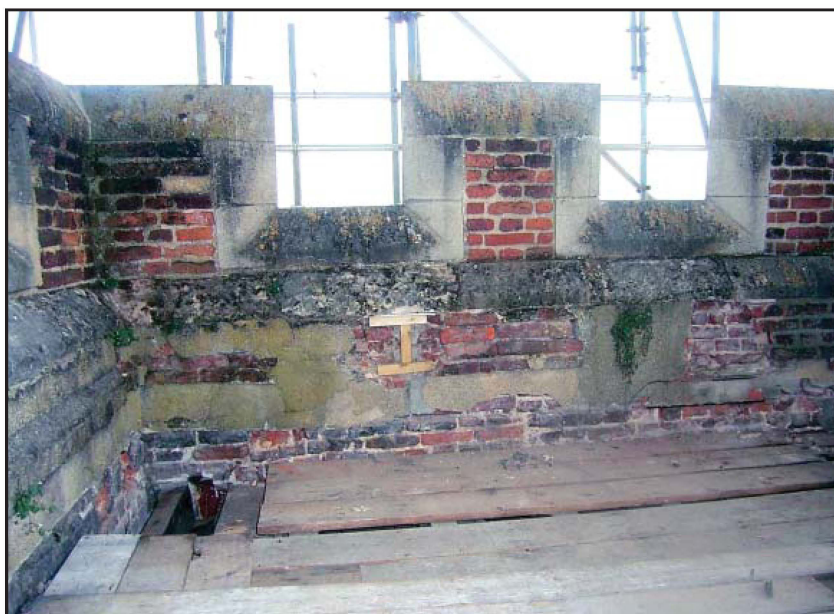
Plate 41: East parapet, internal face, north end illustrating earlier consolidation

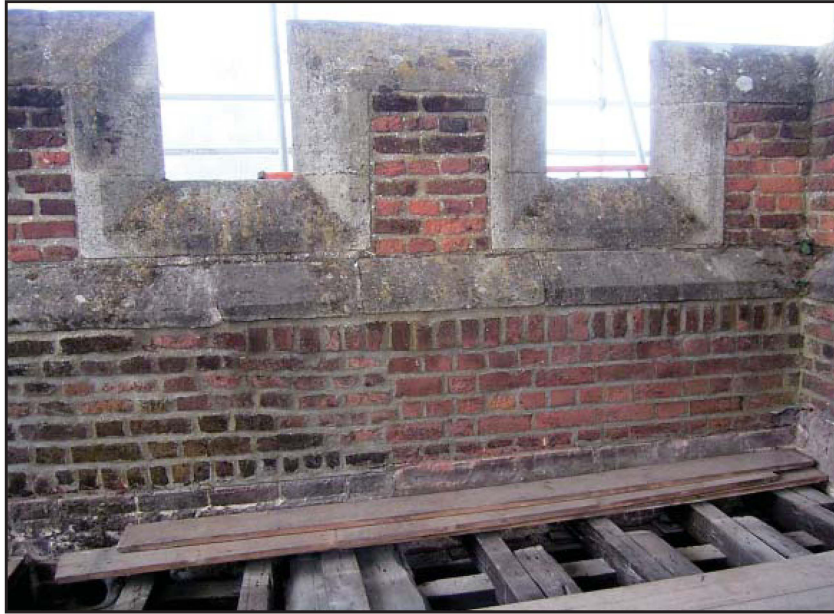
Plate 48: West parapet, internal face, showing 20th century rebuild (to right of picture)

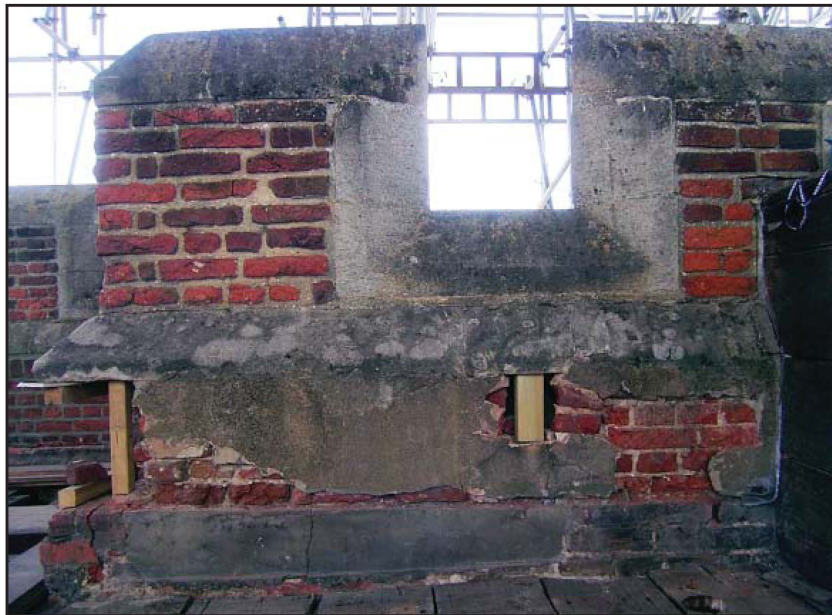
- 8.4.11 Investigation of the *west parapet* show that the crenellations are Tudor bricks with some later replacements (about five). Internally, at the north end, there is a clear break with an area of much later stock bricks, and at this time the whole area has been repointed in a 20th century cementitious mortar (Plate 48). To the south of this break the bricks are largely reused Tudor although a few later bricks are evident. In the north section of the elevation, directly to the south of the stair entrance, cement render (used to previously consolidate the brickwork) was removed below the crenellations. This exposed poorly coursed brickwork and it is evident that an earlier attempt has been made to repair this area. A clear break is visible and earlier Tudor brickwork is visible immediately to the south of the stairwell entrance (Plate 49).

Plate 49: West parapet, internal face, showing consolidation and Tudor brickwork

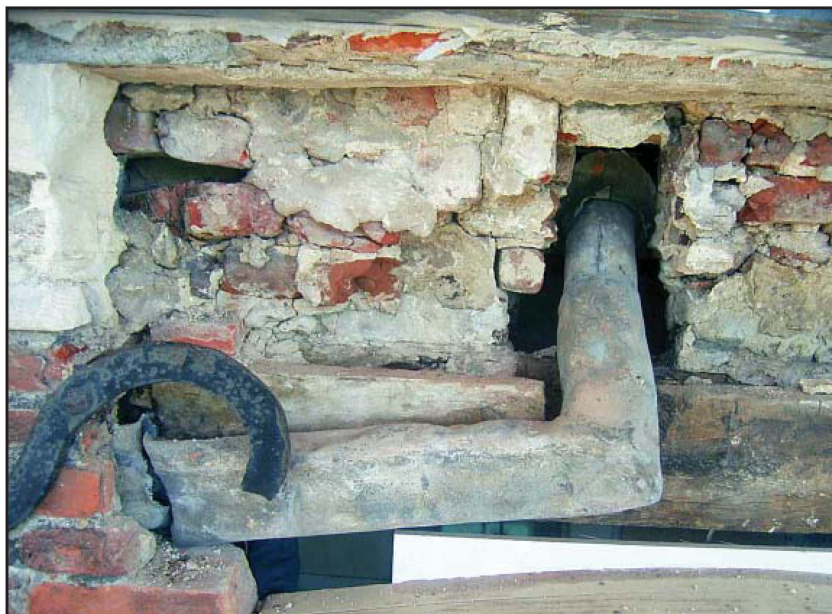
Plate 54: West elevation, external view, second floor, illustrating lead pipe squashed behind brick

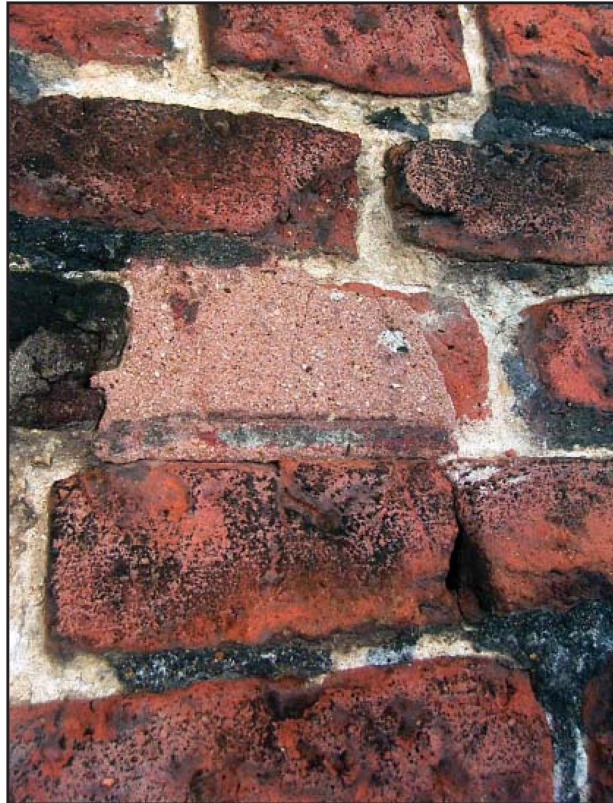
Plate 65: West elevation, ground floor, external view, illustrating repair to bricks and penny roll pointing
