# The South Porch All Saints' Church Cuddesdon Oxfordshire

## Archaeological Watching Brief Report

April 2013

**Client: All Saints' Church Parochial  
Church Council**

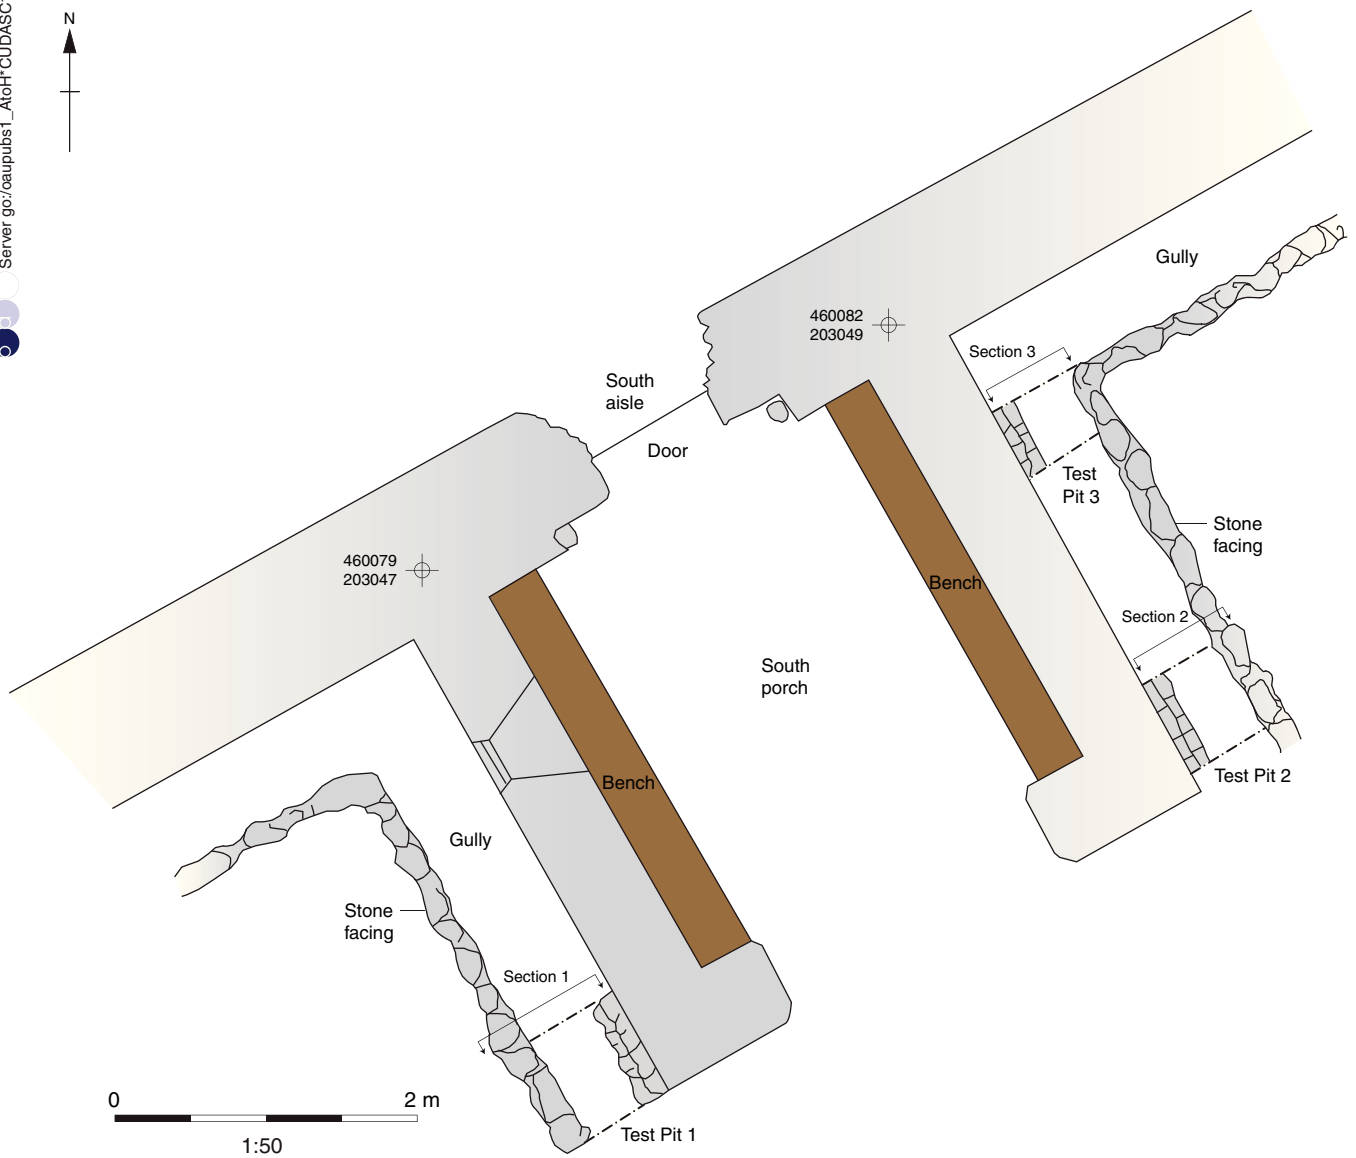
Figure 2: Location of the south porch and test pits

2.2.1 The watching brief observed all groundworks that had the potential to affect or reveal archaeological deposits. These works consisted of the excavation of three test pits, each measuring approximately 0.6m x 0.6m and up to 0.8m in depth (Fig. 2).

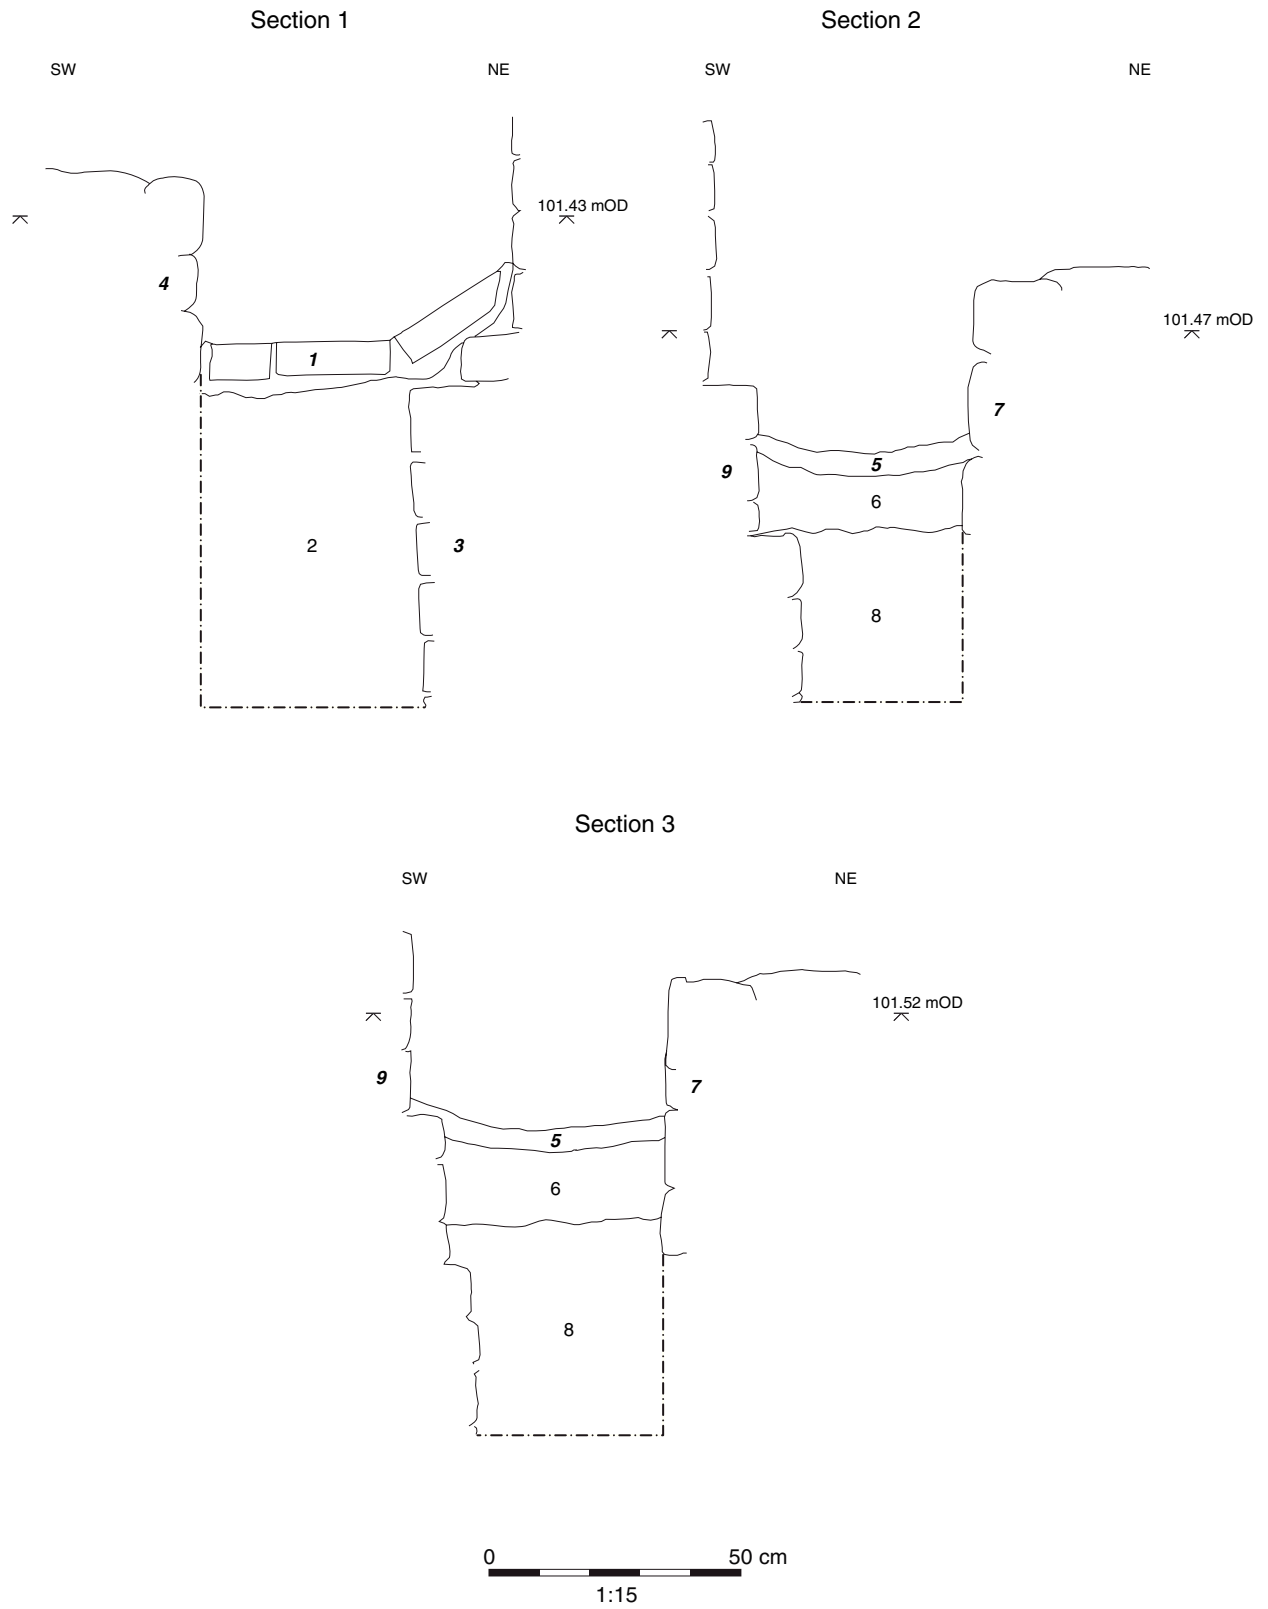
Figure 3: Sections 1-3

3.1.2 This test pit was located adjacent to the south-west corner of the porch (Fig. 2 and Fig. 3, Section 1). The top of the foundations of the west wall of the porch (3) was exposed on the eastern side of the pit. This had been constructed using roughly dressed and squared blocks of local limestone bonded with lime mortar. Two outward steps and six courses of stonework were observed, but the bottom of the foundations was not exposed at a depth of 0.8m below ground level.

3.1.3 No evidence of a construction cut could be observed and a layer of yellow-brown silty clay loam (2) could be seen to butt directly onto the stonework. This layer could be seen to be in excess of 0.6m deep within the section and contained fragments of sub-angular stone.

- 3.1.6 Test Pit 2 was located on the north-east corner of the porch (Fig. 2 and Fig. 3, Section 2). The top of the foundations of the east wall of the porch (9) was exposed at approximately the same level as on the western side of the porch in Test Pit 1. Though this had been constructed using similar roughly dressed and squared blocks of local limestone bonded with lime mortar as wall 3, the second outward step was an additional two courses below that observed in Test Pit 1. As in Test Pit 1, two outward steps and six courses of stonework were observed, but the bottom of the foundations were not exposed at a depth of 0.8m below the existing ground level.

- 3.1.7 Again, as with Test Pit 1, no evidence of a construction cut could be observed and a layer of yellow-brown silty clay loam (8) could be seen to butt directly onto the stonework. This layer was in excess of 0.35m deep within the section and contained fragments of sub-angular stone (as in Test Pit 1).

- 3.1.10 This was located adjacent to the north-west corner of the porch approximately 0.5m out from the aisle wall (Fig. 2 and Fig. 3, Section 3). The stratigraphy (Section 3) exposed was the same as that recorded within Section 2. The maximum depth of excavation was 0.9m below the current ground level but did not expose the base of the foundations.

- 4.1.3 The recorded stone foundations of the porch (3 and 9) appear to be original both in the stone and the mortar used. The slight differences in their construction are most likely due to different masons being used to complete each side.

- 4.1.4 The drainage channels appear to be a post-medieval attempt to drain water away from the church walls, to alleviate damp problems encountered as a result of the rising churchyard levels from burial activity over the years. It is probable that the brick channel, 1, pre-dates that cement channel 5
