Privy Garden Collapse

Hampton Court Palace

Archaeological Evaluation Report

June 2010

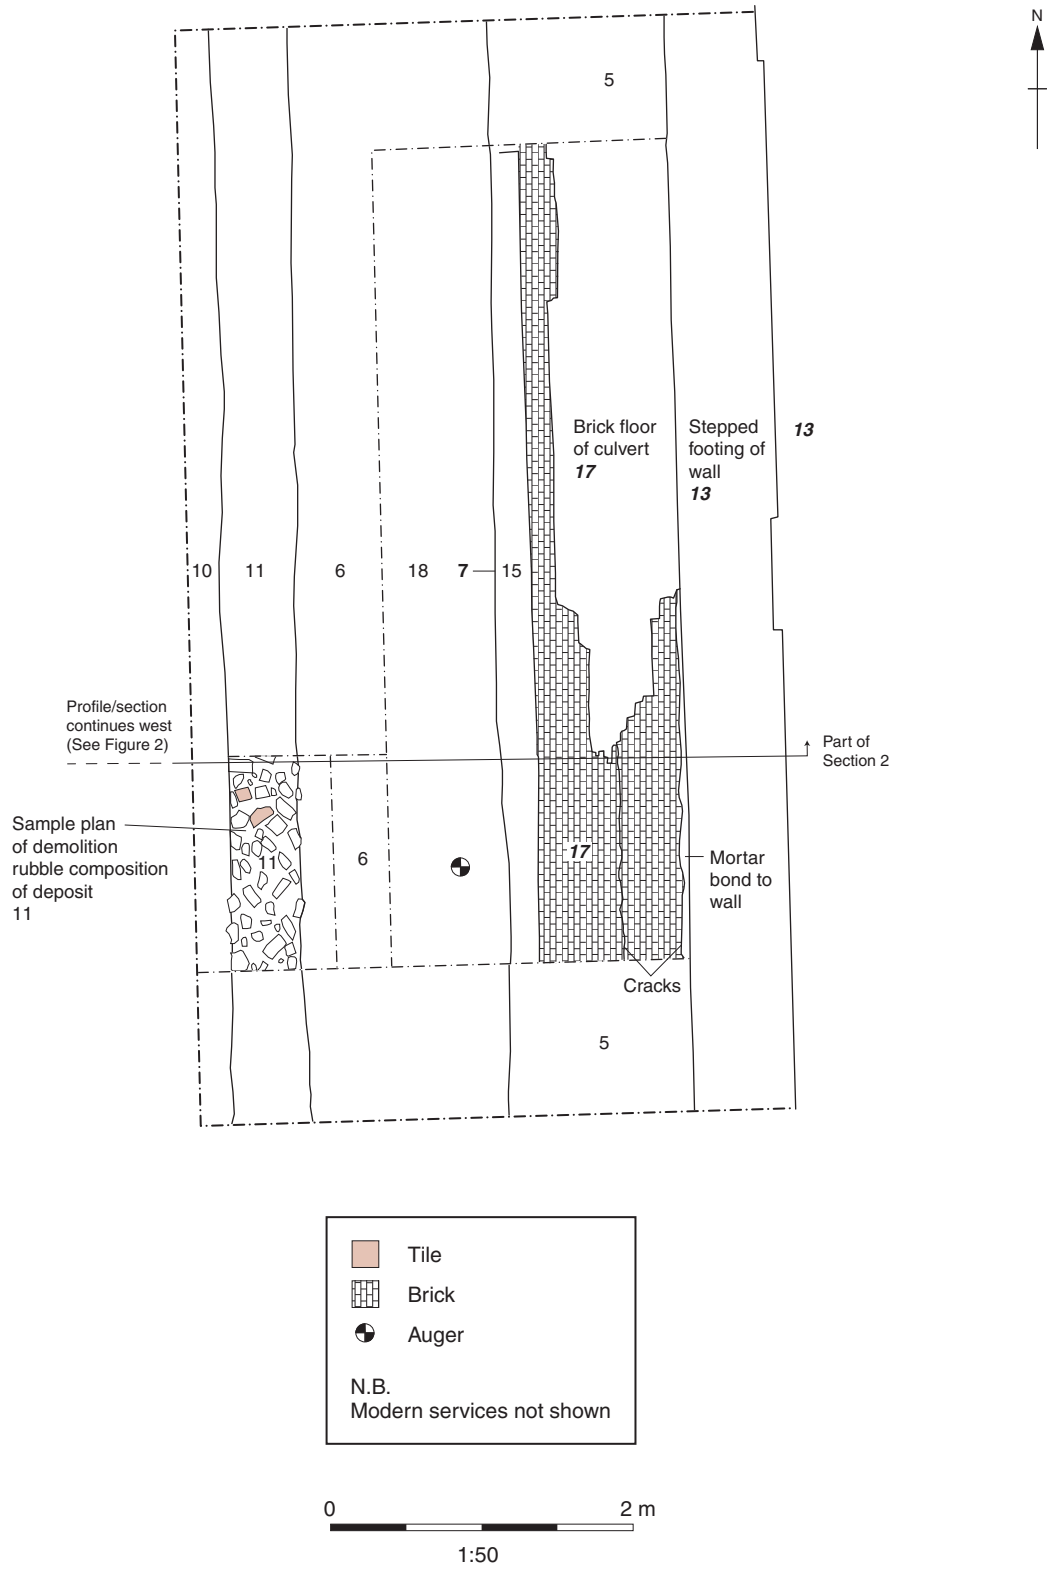
Figure 3: Trench plan

- 3.3.3 These deposits were truncated by the construction cut (7) for the brick culvert (17). The cut was backfilled by a series of deposits, predominantly originating from the re-deposition of the material through which the construction trench cut. The culvert itself was constructed in a stretcher bond with a double skin of brick and a brick base. The bricks are tentatively identified as Type G in the Hampton Court Typology (Ford 1991),

dating to the late 17th or early 18th century, see Appendix 3, Table 3. To the north of the trench, the culvert had been rebuilt using modern brick ("MARSTON BESERES 32"), with a *in-situ* formwork comprising a corrugated tin lining. The inner skin of the collapsed part of the culvert appeared to be overlain by a very fine sandy silt deposit, which was in turn overlain by the collapse of the outer skin. This would suggest that the inner skin of the culvert had collapsed prior to the recent failure.

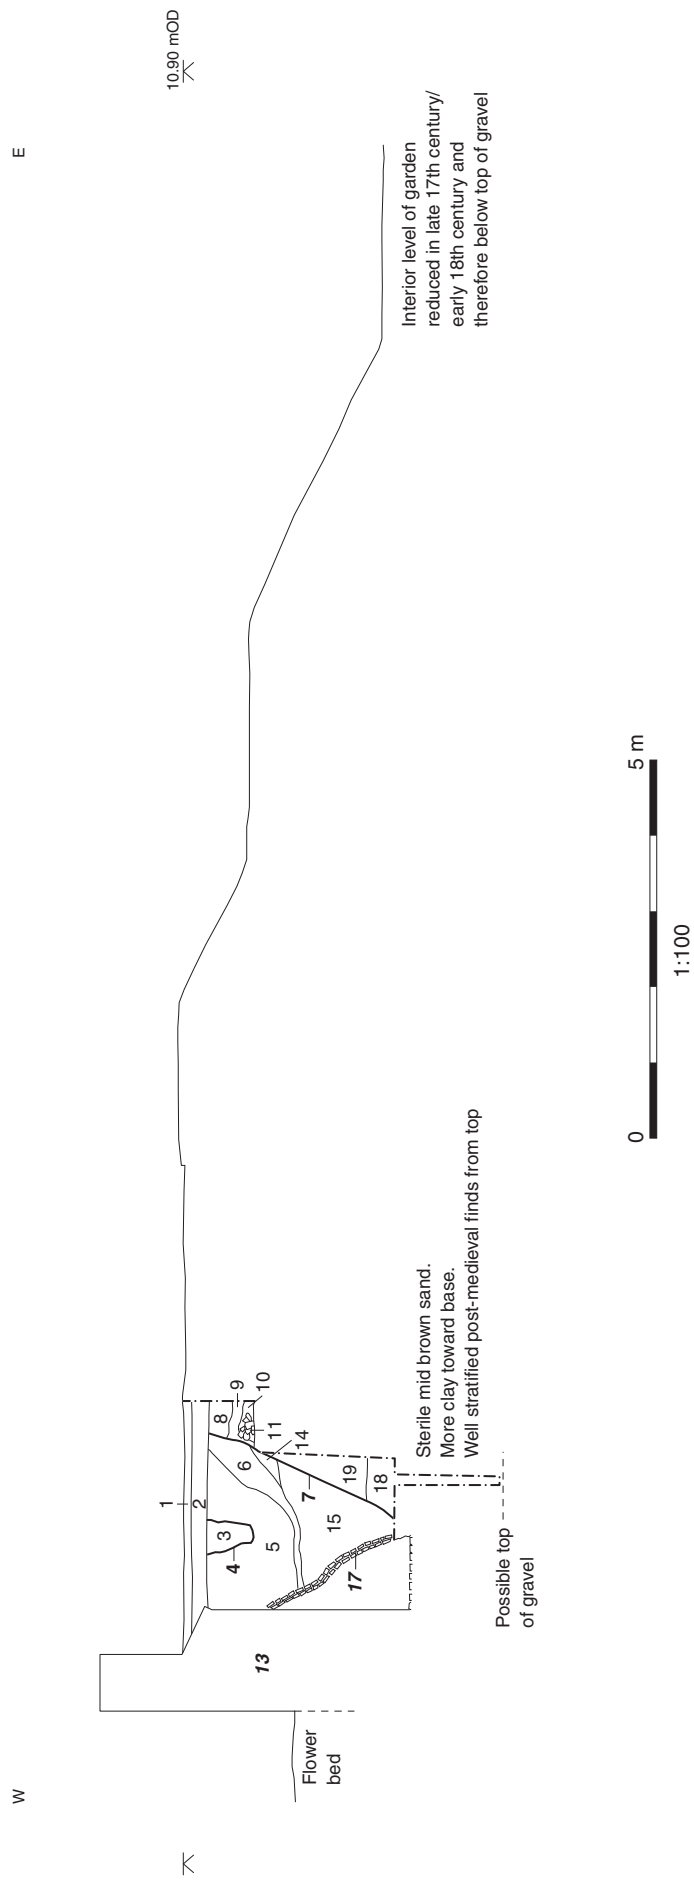
Figure 4: Section 2: Profile showing topography of garden and stratigraphy in trench

- 3.3.2 The earliest deposit, encountered at approximately 8.50m OD, comprised a friable reddish brown sand with little or no variation in composition (18), but with clay pipe throughout. The sterility of this deposit compared with the overlying rubble rich layers (see below), suggested that it may represent a buried soil horizon pre-dating the creation of the existing terrace. This horizon was overlain by a series of deposits (19, 12, 11, 10, 9 and 8) which contained re-deposited 16th century building materials (Sections 3.4.6-10; Appendix C, Table 3), together with 17th century clay pipe and other later artefactual material. It seems likely that these deposits are associated with the landscaping undertaken in the later part of the 17th century or very early 18th century, and that the building material originated from the demolition of elements of the Tudor palace. It is possible that deposit(s) 11/12 - which were comprised almost exclusively of brick/tile and mortar - represent a rudimentary revetment along the eastern face of the mound.
