St Dunstan's Church Cranford Park London Borough of Hillingdon

Historic building recording

October 2013

Document Type: Historic Building Recording
Issue Number: 1

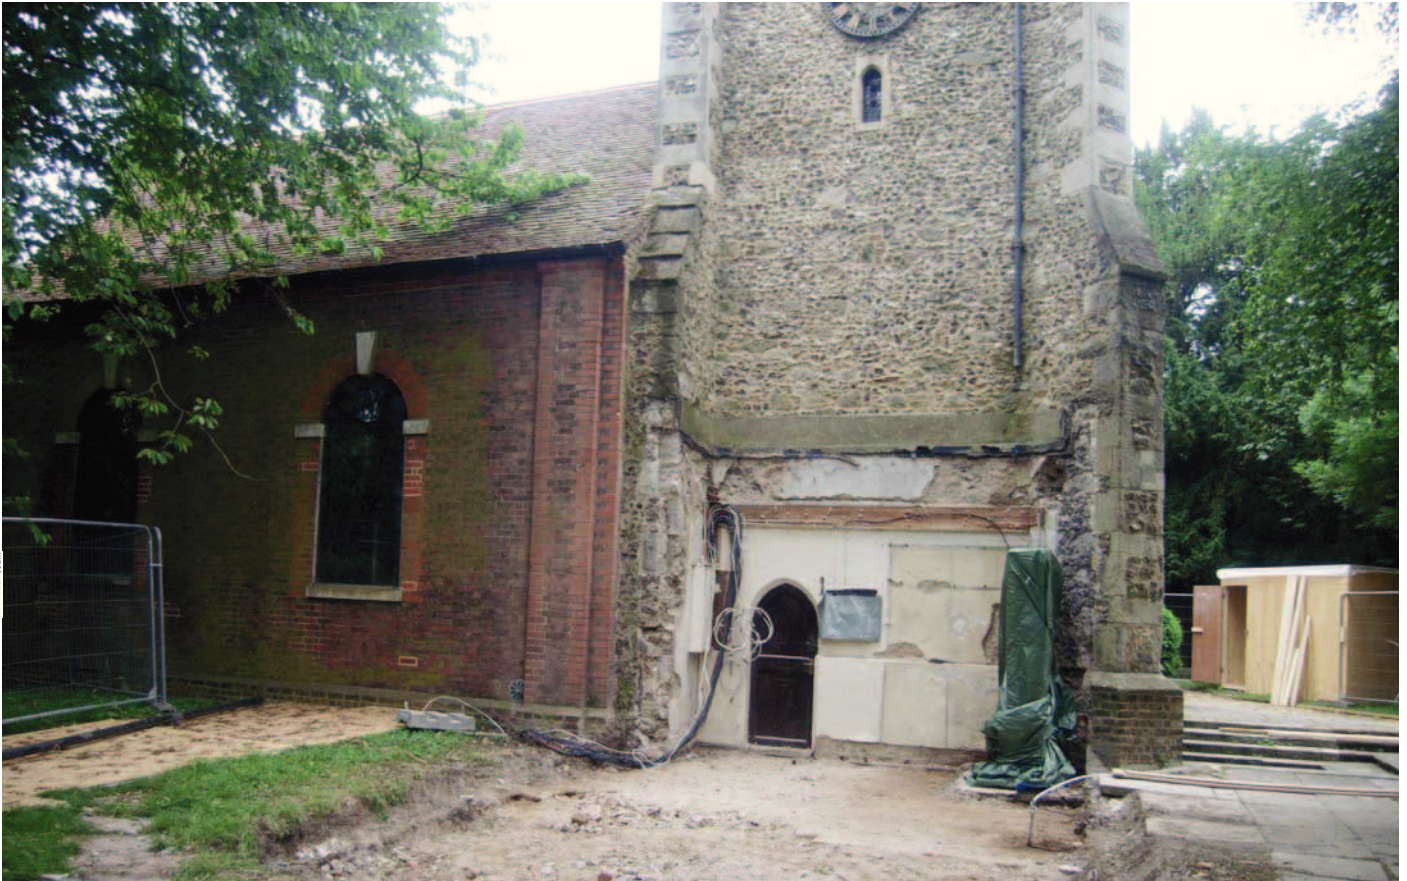
Plate 1: General view of church from NW after demolition of 1950s vestry

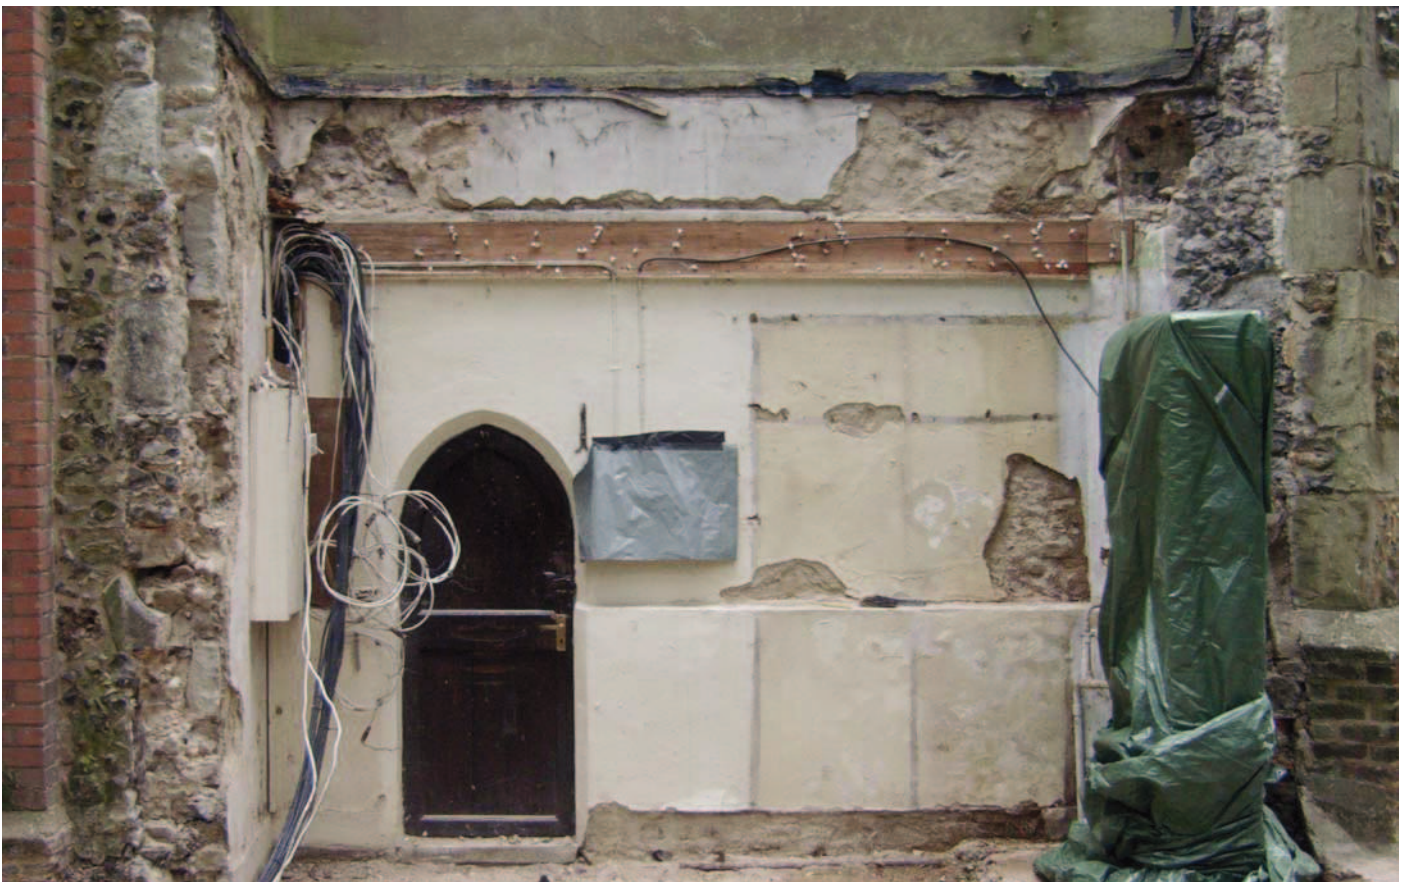
- 1.4.1 Following the removal of the mid 20th-century vestry much of the plaster/render from the vestry remained in-situ covering the north side of the tower at ground floor level. The main feature in the wall was the arched doorway between the tower and vestry while there was also a clear step or shoulder c.1 m above ground at the same height as the brick plinth in the north-west corner of the tower. The render was cement based but not particularly hard and it extended down from ceiling level to ground level. The render had been lost in a number of small patches and this revealed the primary face of the wall behind with flint and some stones mixed in.

- 1.4.2 At the east side of the tower there was a stub of timber at ceiling level which entered the buttress and would clearly have formerly extended immediately in front of the tower because at the west side of the tower there was a corresponding empty socket. This timber was presumably a bearer for the vestry roof or possibly for an earlier lean-to. Towards the top of the render, and immediately beneath the height of the former timber bearer, was a horizontal board which was presumably the rear face of a long cable box

Plate 2: North wall of tower in area of removed vestry

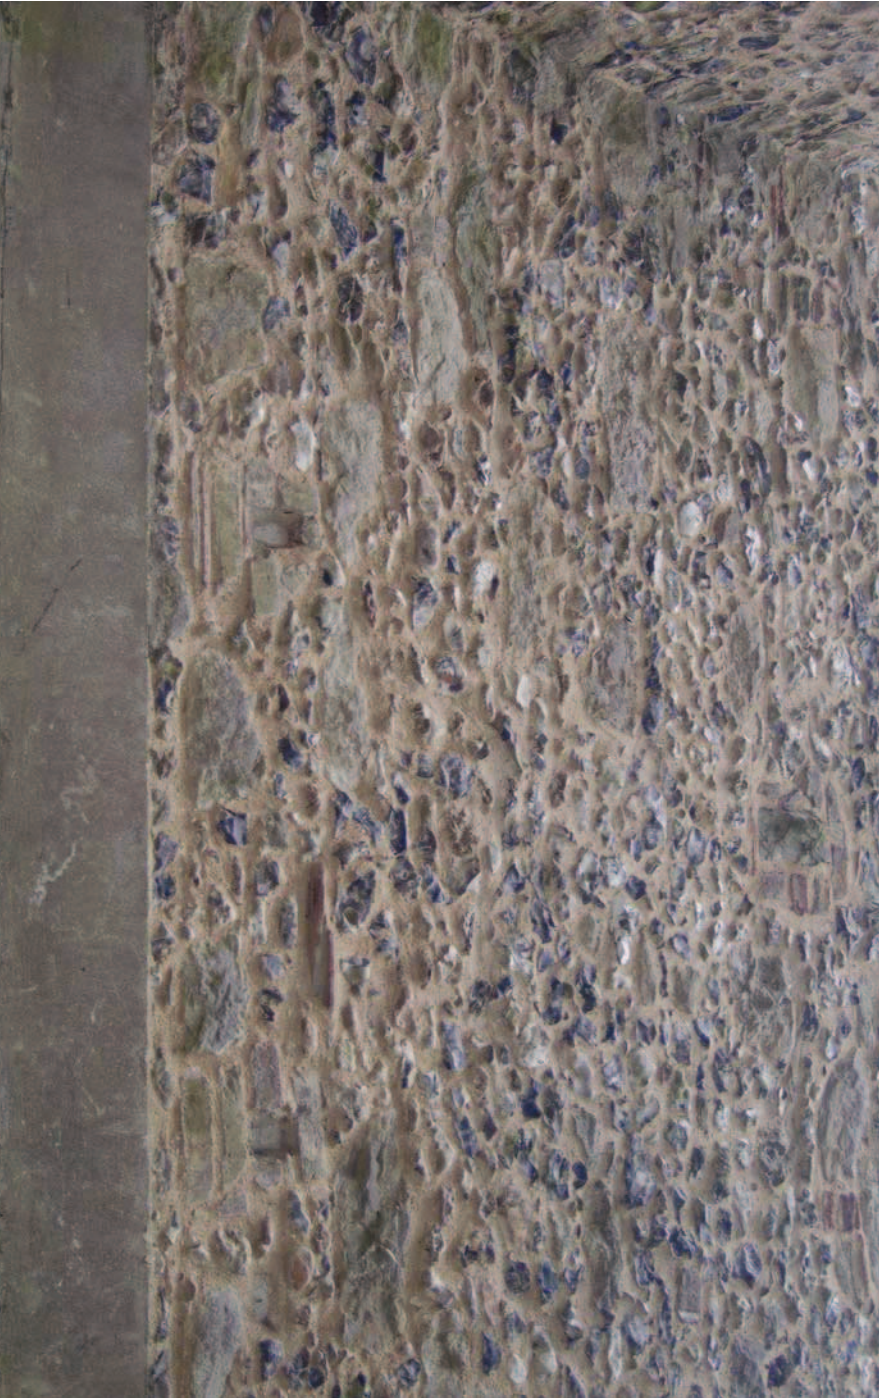
- 1.4.5 Above the flashing and rendered band the primary wall was visible and this area must have been effectively obscured from view (although not directly abutted by the modern fabric) following the construction of the 1950s vestry. The main tower wall was constructed from uncoursed flint but there were a greater number of more substantial stones towards the lower area (just above the modern rendered band) and these seem to

be part of a distinct horizontal feature. Presumably this was just a distinct 'lift' in the tower or a phase of the construction and it also incorporates two clear infilled holes that could have been put-log holes although they are lined secondary brick. Further up the wall other features such as blocked openings are also visible but investigating these was beyond the scope of the current project.

Plate 4: North wall of tower above former vesty

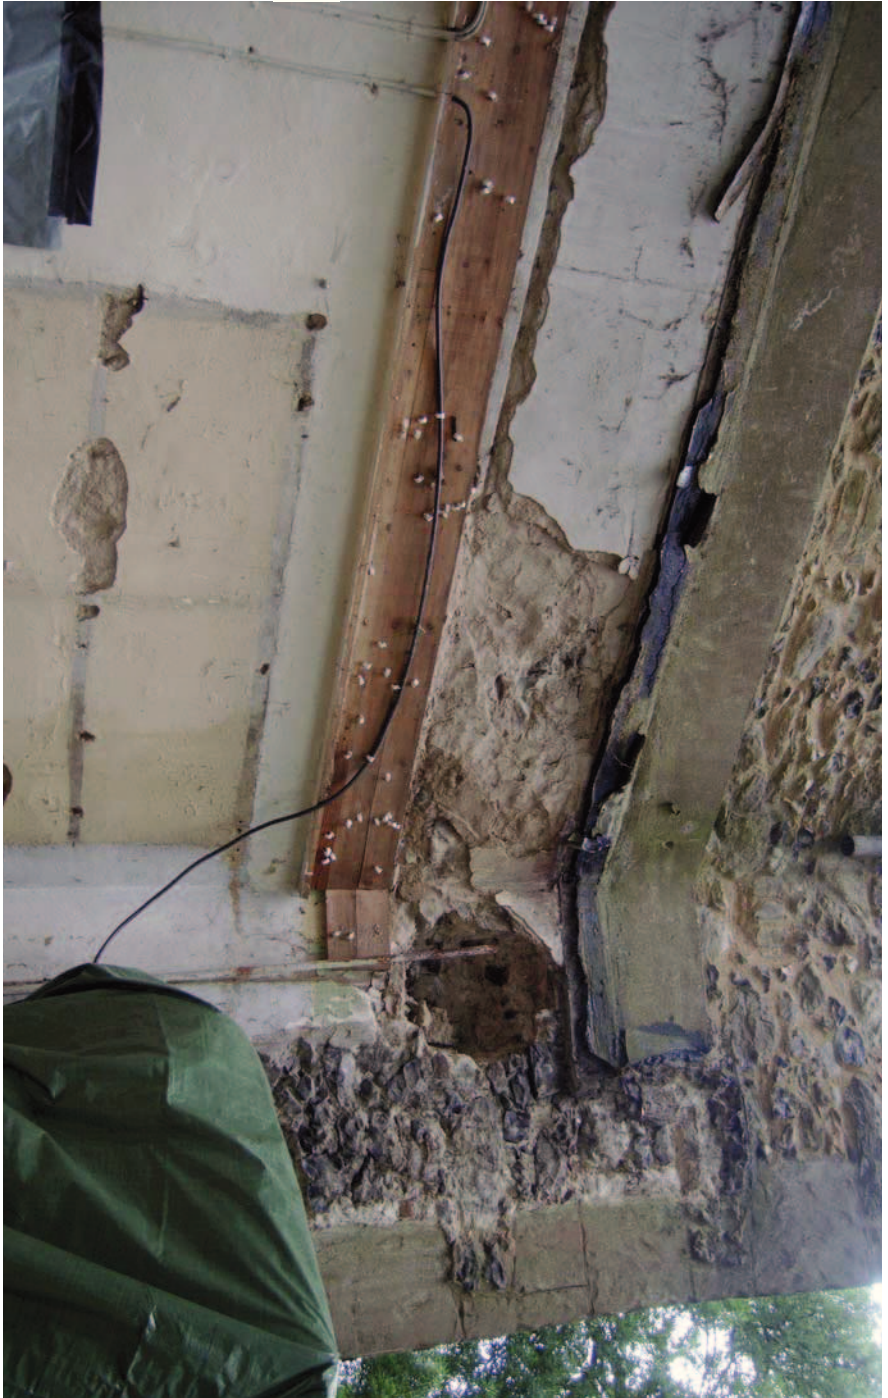
- 1.4.4 The western edge of the area examined was partly obscured by a tall electrical board that could not be moved during the recording. Immediately behind this the plinth of the buttress had been previously truncated and the base reformed with various 19th and 20th-century bricks.

Plate 3: Detail of NW buttress
