South Hill Park Bracknell Lake Dam Culvert Investigation

Archaeological Watching Brief Report

March 2015

South Hill Park, Bracknell: South Lake Sluice Investigation

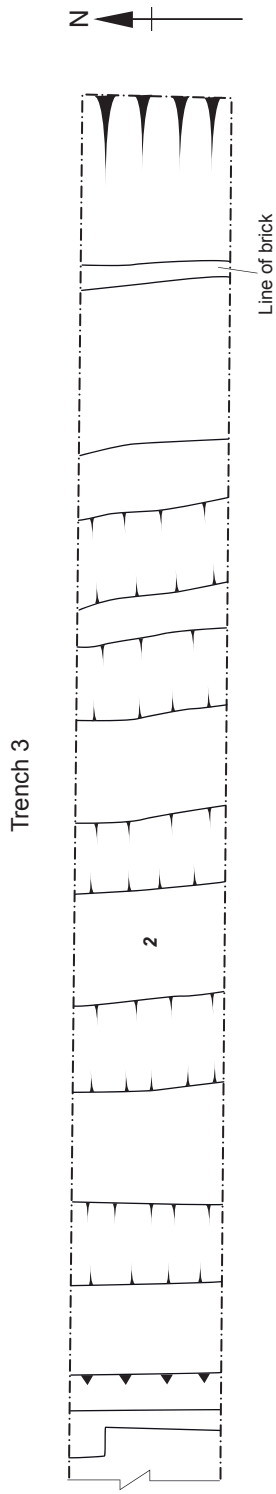
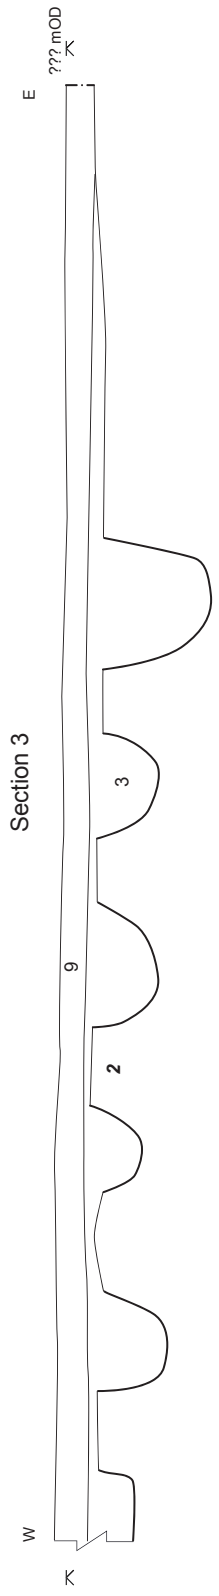
Figure 3: Plan and section of Trench 3

- 2.1.5 **Trench 3** extended for a distance of 13m in an easterly direction from Trench 1, along the top of the upstream side of the dam. It was excavated to a maximum depth of 0.74m. The trench was excavated through the modern path surface (context 9), which comprised a very dark grey pebble and sand mix with a surface of yellow sand. This overlay a loose, mixed soil (context 3) which covered and infilled a series of parallel brick channels (context 2). Context 3 produced a single sherd of red border ware pottery, which has a date range of c 1700-1850.

- 2.1.6 The brick channels (context 2) had an approximately U-shaped profile up to 0.8m in diameter and 0.75m deep. They all appear to be of the same period and the unfrosted bricks are consistent with a late 18th century date. The channels appear somewhat irregular in their spacing and dimensions, possibly as a result of subsidence (Fig.3, Plates 5, 6 and 7). They were generally constructed in English style bonding although the uppermost layer was in headed bond. The mortar was somewhat degraded.

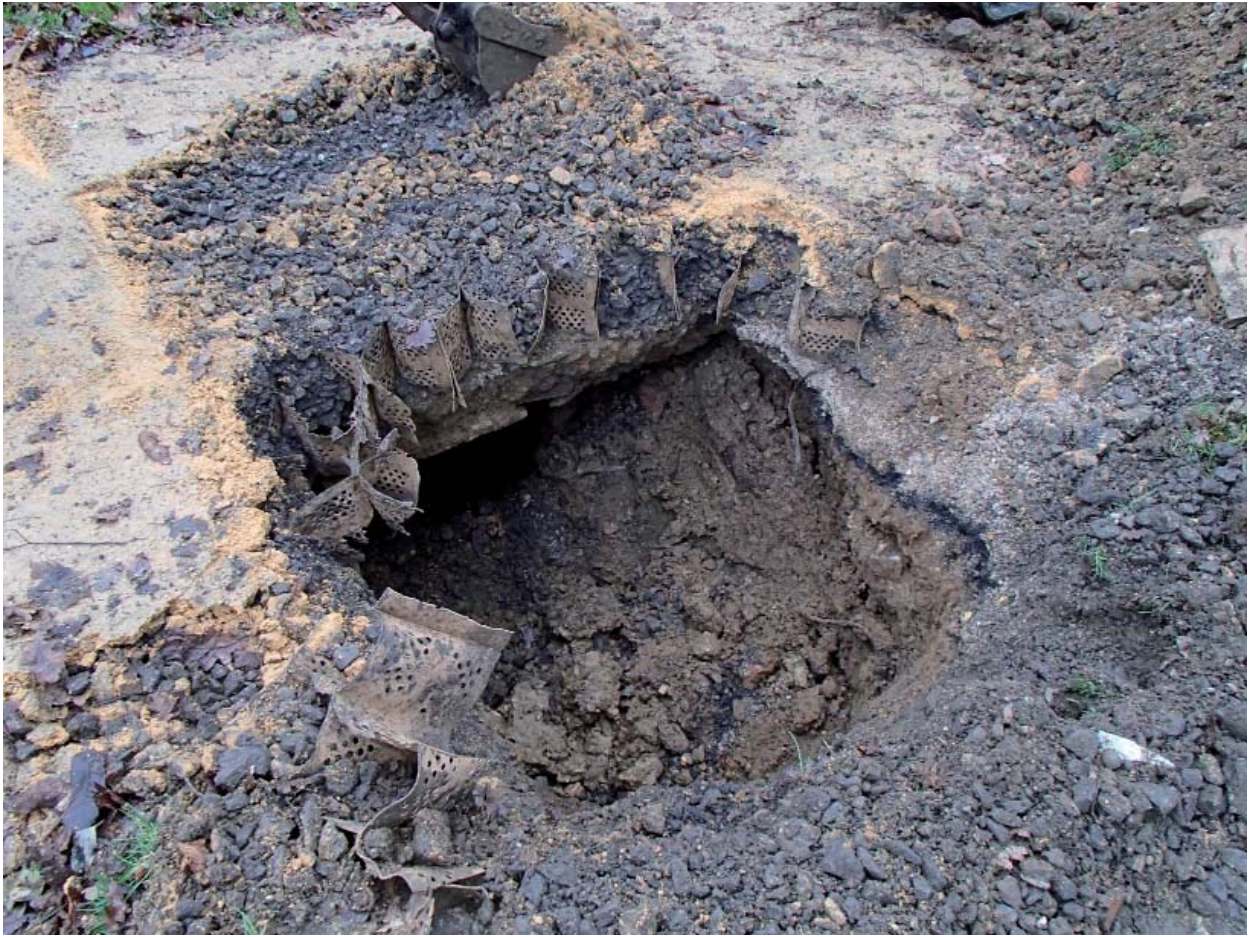
- 3.2.1 The collapsed section of path coincides with both the original collapse in the culvert arch and the subsequent modern repair. There appears to be evidence of water getting past the metal seal of the culvert and into the cavity under the concrete slab, which in turn may have affected the supporting material for the path. The condition of the metal (both sheeting and supports) within the capping structure was found to be badly degraded, with the metal sheeting providing almost no support to the concrete.

Plate 1: Showing collapse of path

- 3.2.6 Because the path is used to allow trucks, as well as pedestrian traffic, into the grounds, the engineer recommends that the collapsed inspection manhole is not reinstated. The following repair method will be followed:

1. Remove, completely, the concrete and steel supports over the upstream end of the culvert. Take additional photos of the exposed upstream end of the culvert behind the headwall.

2. Move the rubble which is currently filling the excavation up towards the headwall to expose the collapsed end of the culvert. Take a downstream photo of the inside of the culvert.

3. Protect the top of the culvert by laying a sheet/sheets of Richard Lees Holorib over the top, supported on either side of the culvert by carefully graded hardcore.

4. Pour concrete grade GEN 3 on top of the steel sheet to a depth of 150mm. This will protect the culvert from further collapse.
 5. Once the concrete has gained sufficient strength, after approximately 14 days, the excavation will be backfilled with the material which was removed, and compacted in 150mm layers using a wacker plate.

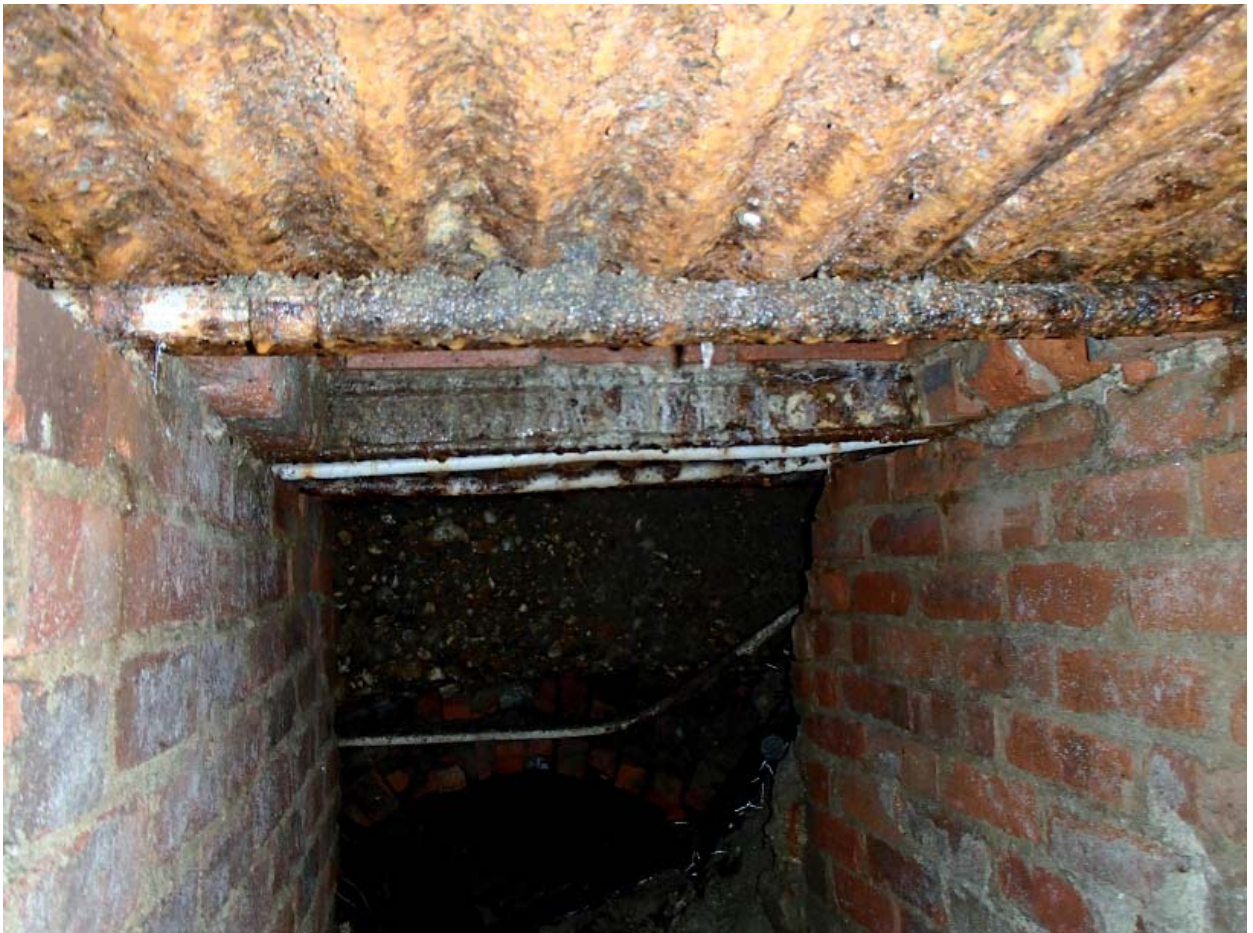
Plate 2: State of corroded concrete slab

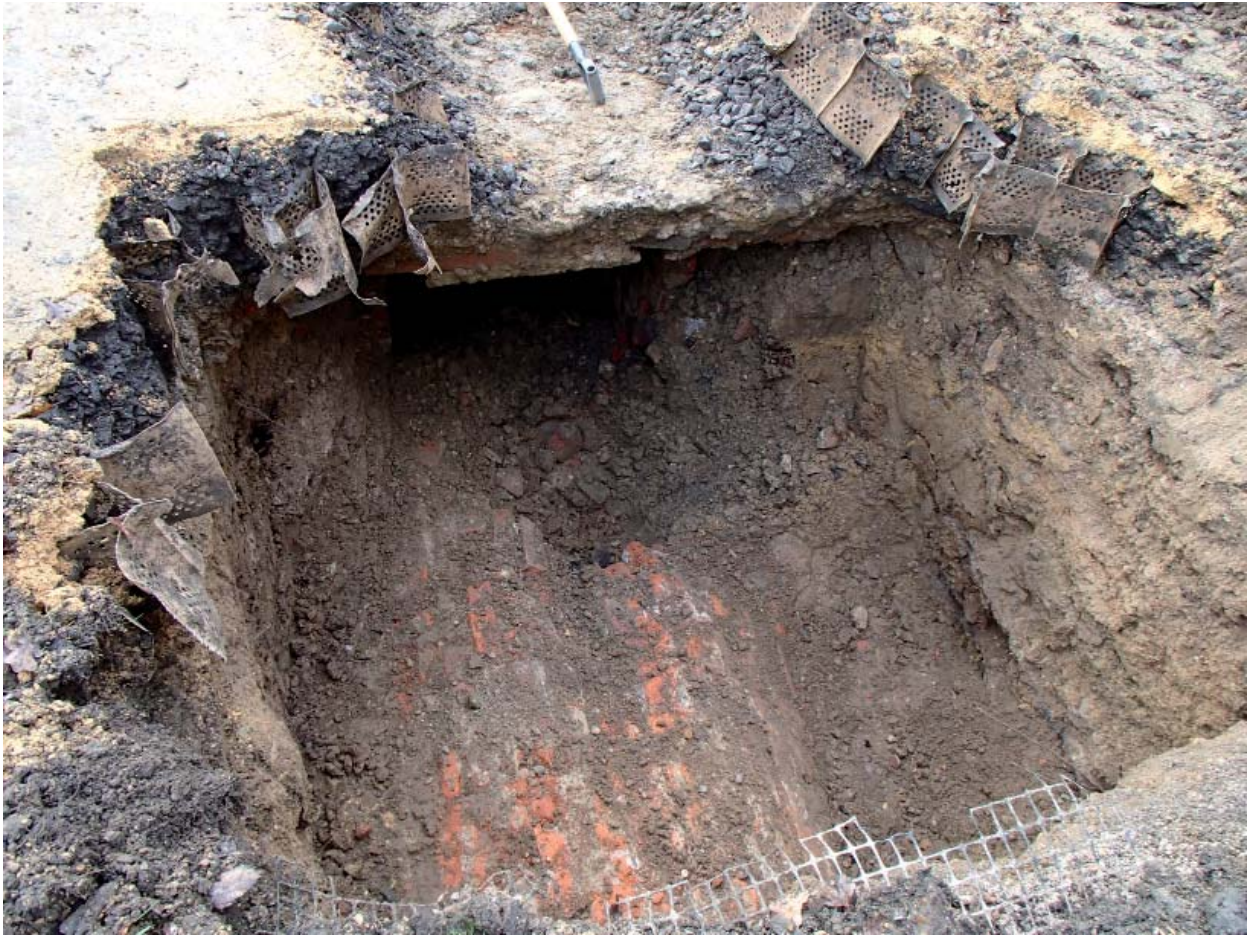
- 3.2.3 The base of the original culvert was largely obscured by a build up of mud/silt, to the extent that the full depth could not be established. The top of the culvert arch was 1.06m below the path surface.

Plate 3: Showing state of condition of culvert

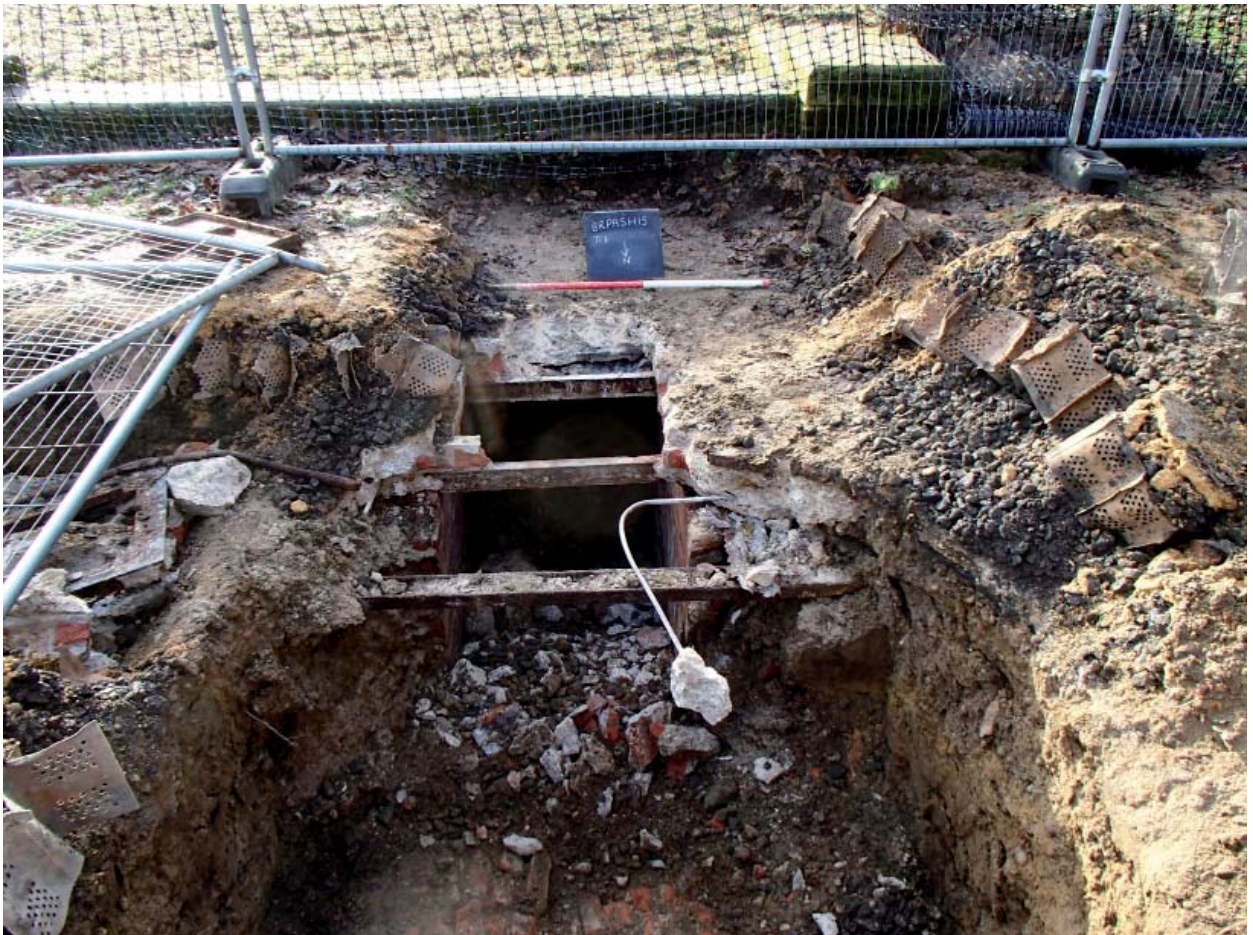
2.1.2 A section of the culvert adjacent to the headwall had collapsed previously and been repaired in recent years with a pair of parallel, single skin brick walls, constructed with modern frosted bricks. Steel support bars and metal pipes were placed across the gap between the walls, supporting a roof of corrugated metal sheets, which were in turn covered with a 0.20m thick layer of poured concrete. An inspection hole had been built into this structure.

Plate 4: Concrete slab and inspection hole
