School End Farm, Great Horwood

Historic Buildings Recording and Archaeological Watching Brief

Client Name: Mrs Chrissie Cheshire
Document Title: School End Farm, Great Horwood, Buckinghamshire

Document Type: Historic Building Recording and Archaeological Watching Brief
Issue Number: 1

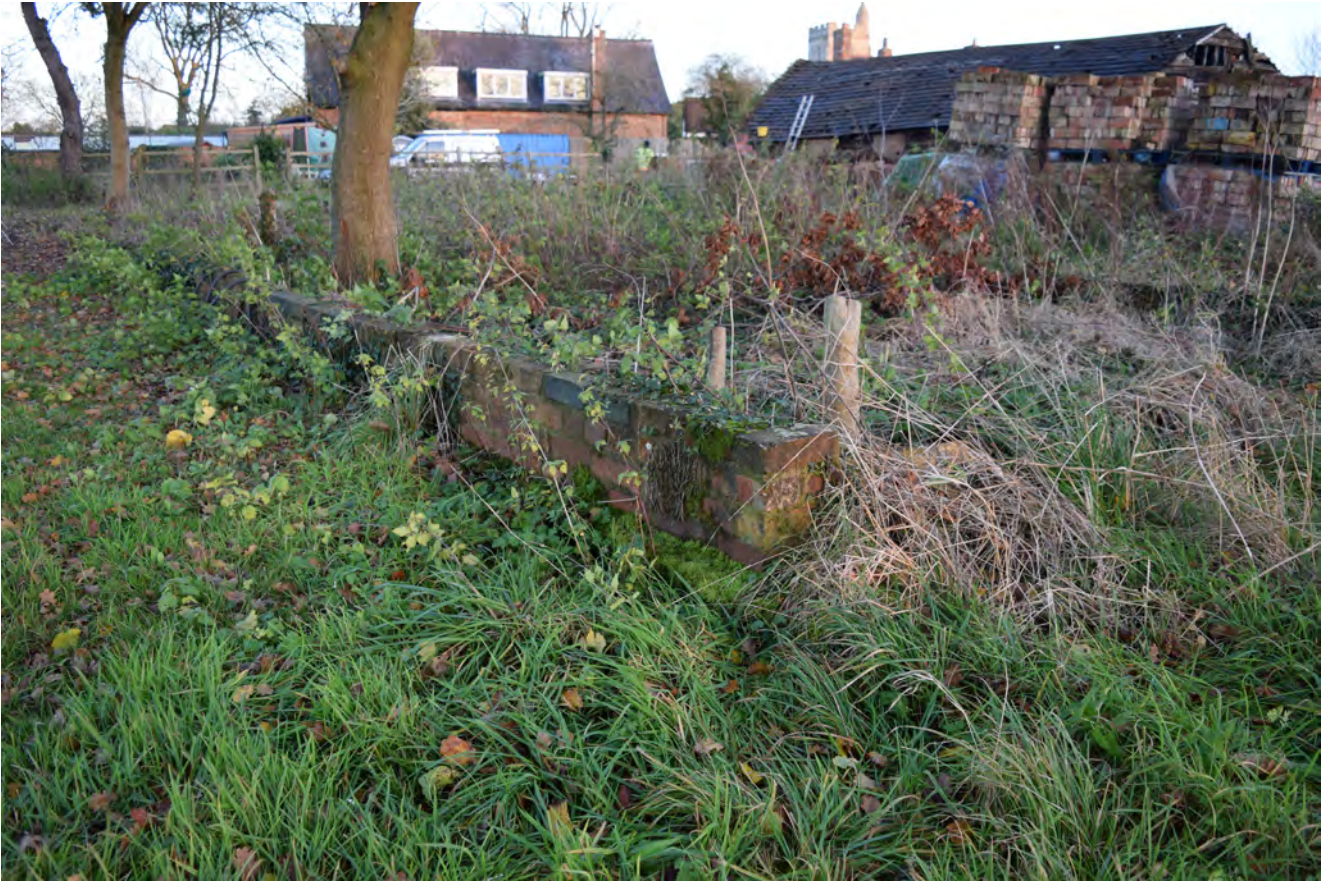
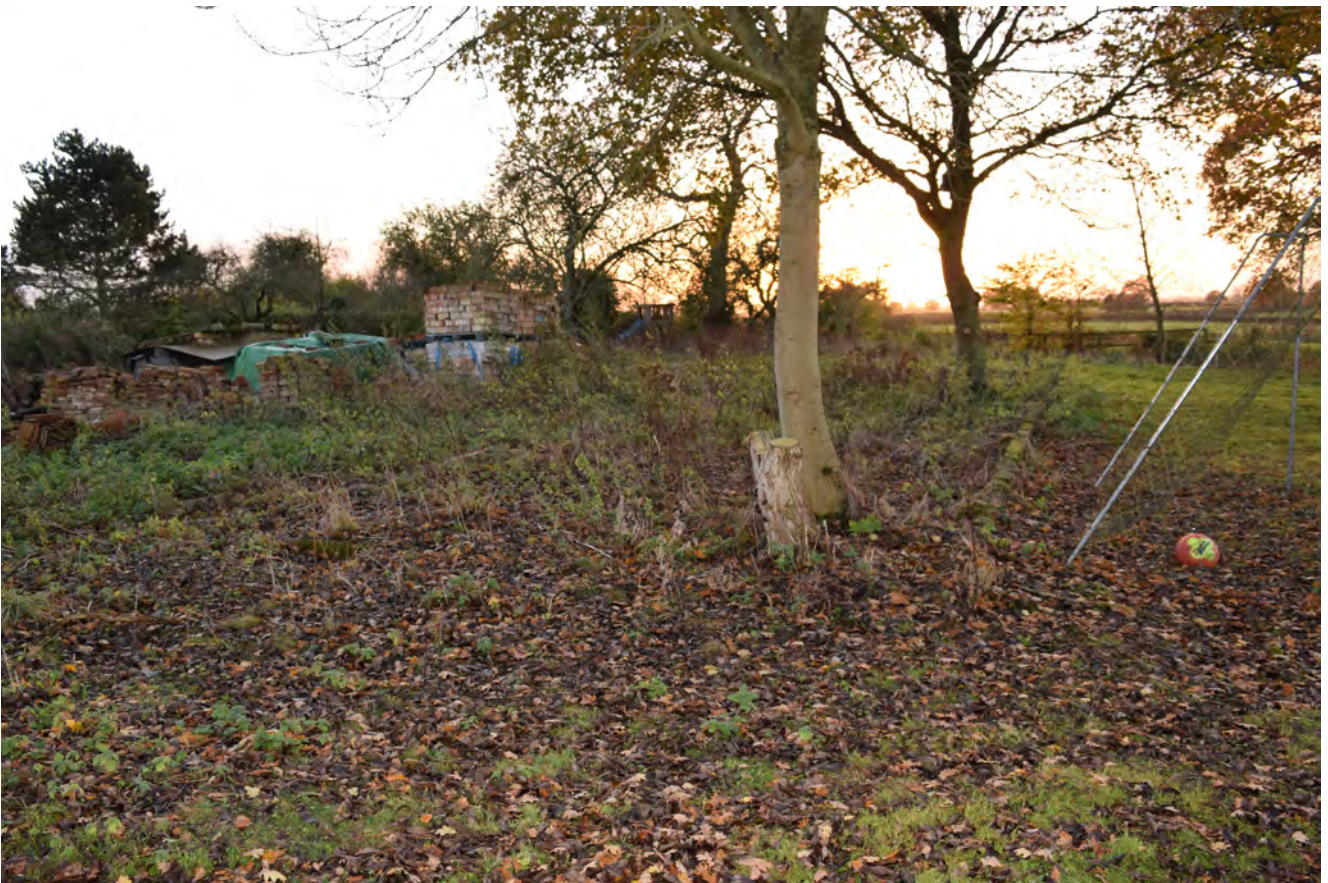
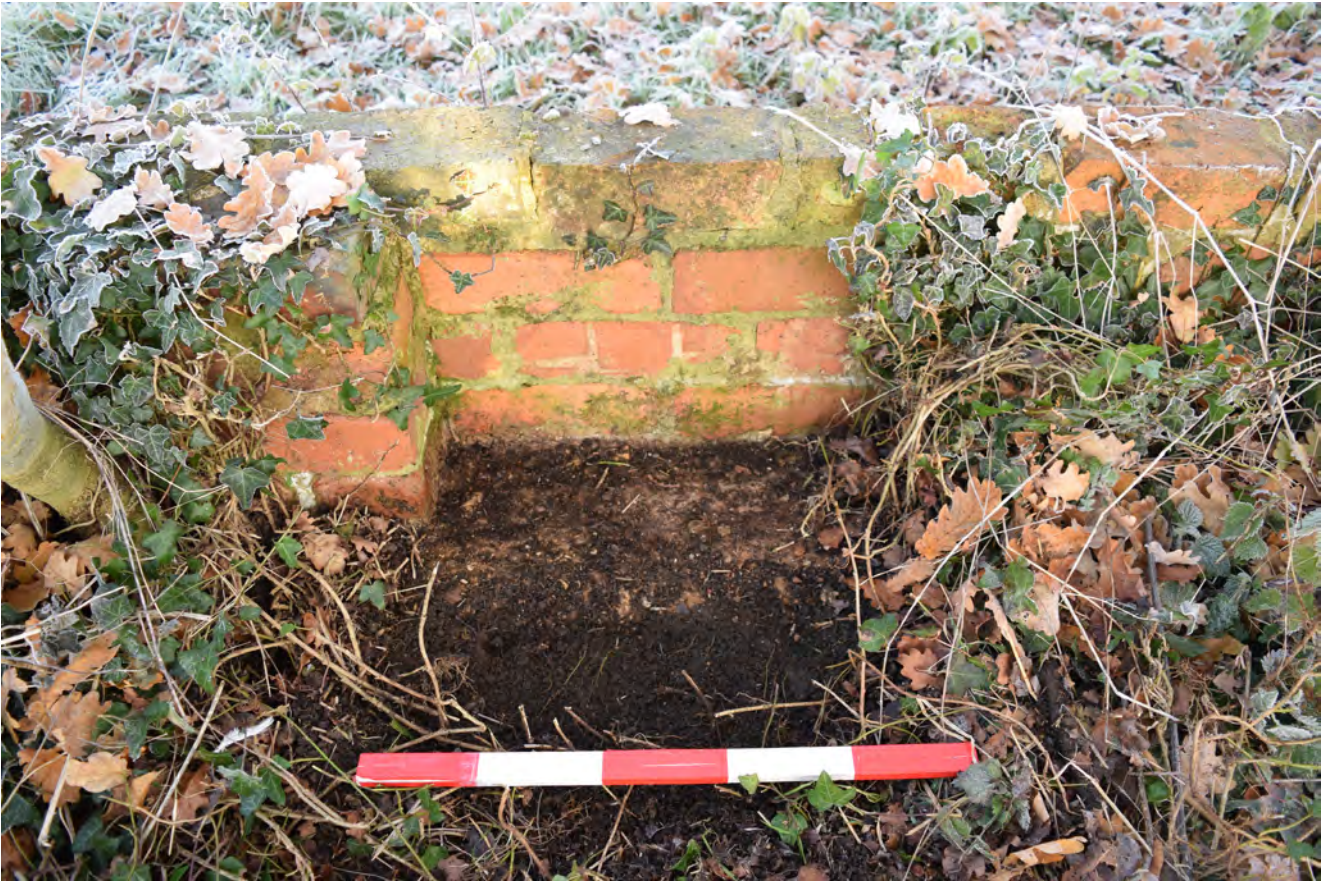
- 4.2.9 Upon inspection, the remains of the structure referred to was found to be a four course high, half-brick-thick base wall of a greenhouse upon a shallow concrete foundation (PIs 1-3). No mortar had been laid on the upper surface of the brickwork and so it is probable that a light frame was supported by the brickwork. Humic soil and shards of glass panes are in the interior of the structure, and no floor surface was observed. The bricks and cement mortar are consistent with the period of the Second World War, but any association with the RAF which was based to the south of the village was not readily apparent from the remains of the structure.

Plate 1: The remains of the possible WW2 building. Looking south east

Plate 2: The remains of the possible WW2 building. Looking west

Plate 3: An example of the brickwork and base in the possible WW2 building

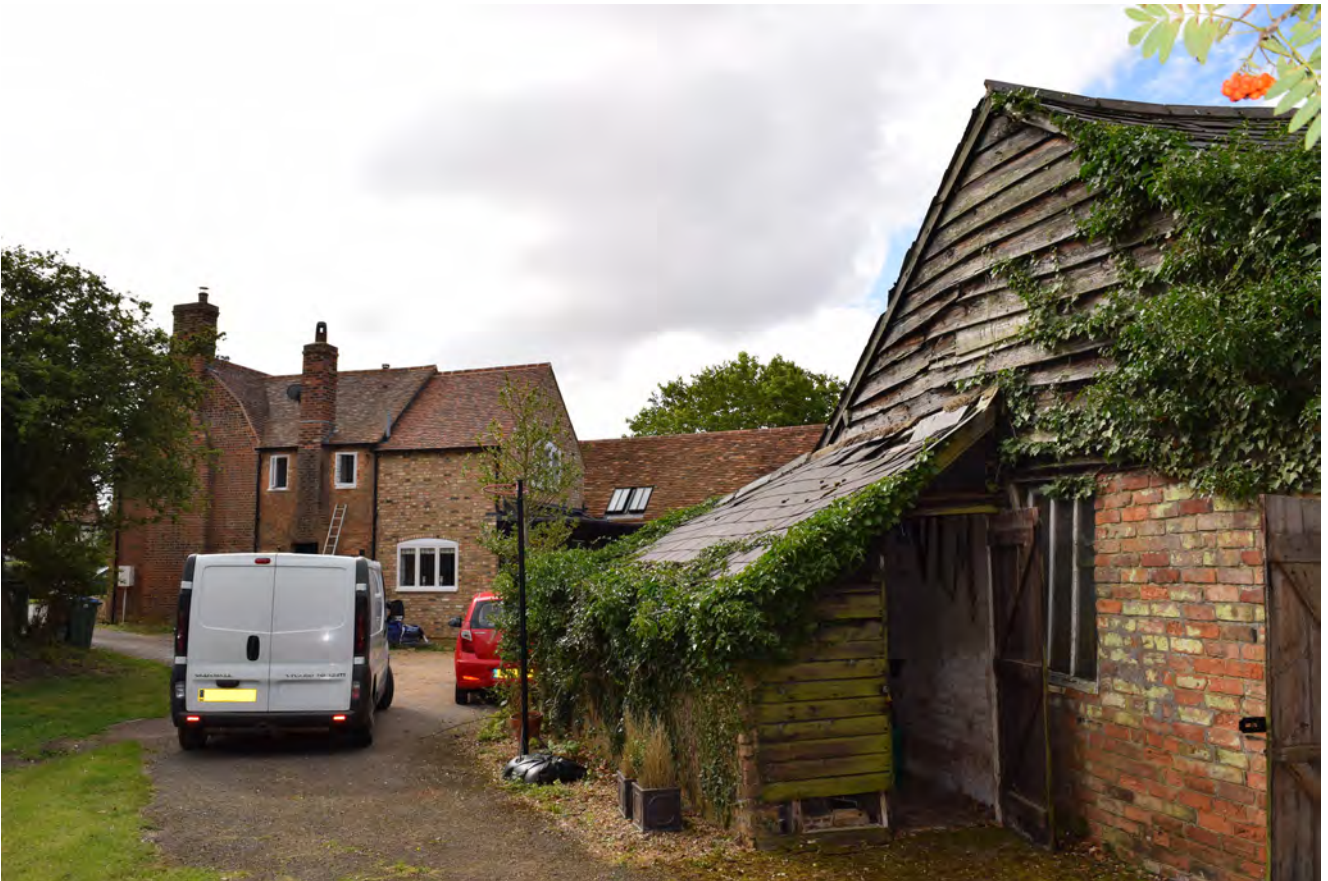
- 4.2.10 The farmhouse has been extensively renovated recently following many years of being in poor repair. It is a Grade II listed, brick-built house dating to the late 18th to early 19th century, according to the listing description. The house and the long range of outbuildings to its rear, extending to the west, since converted to domestic use, form the southern boundary of the site (PI 4).

Plate 4: The north elevation of the farmhouse in relation to the drive, parking area and barn

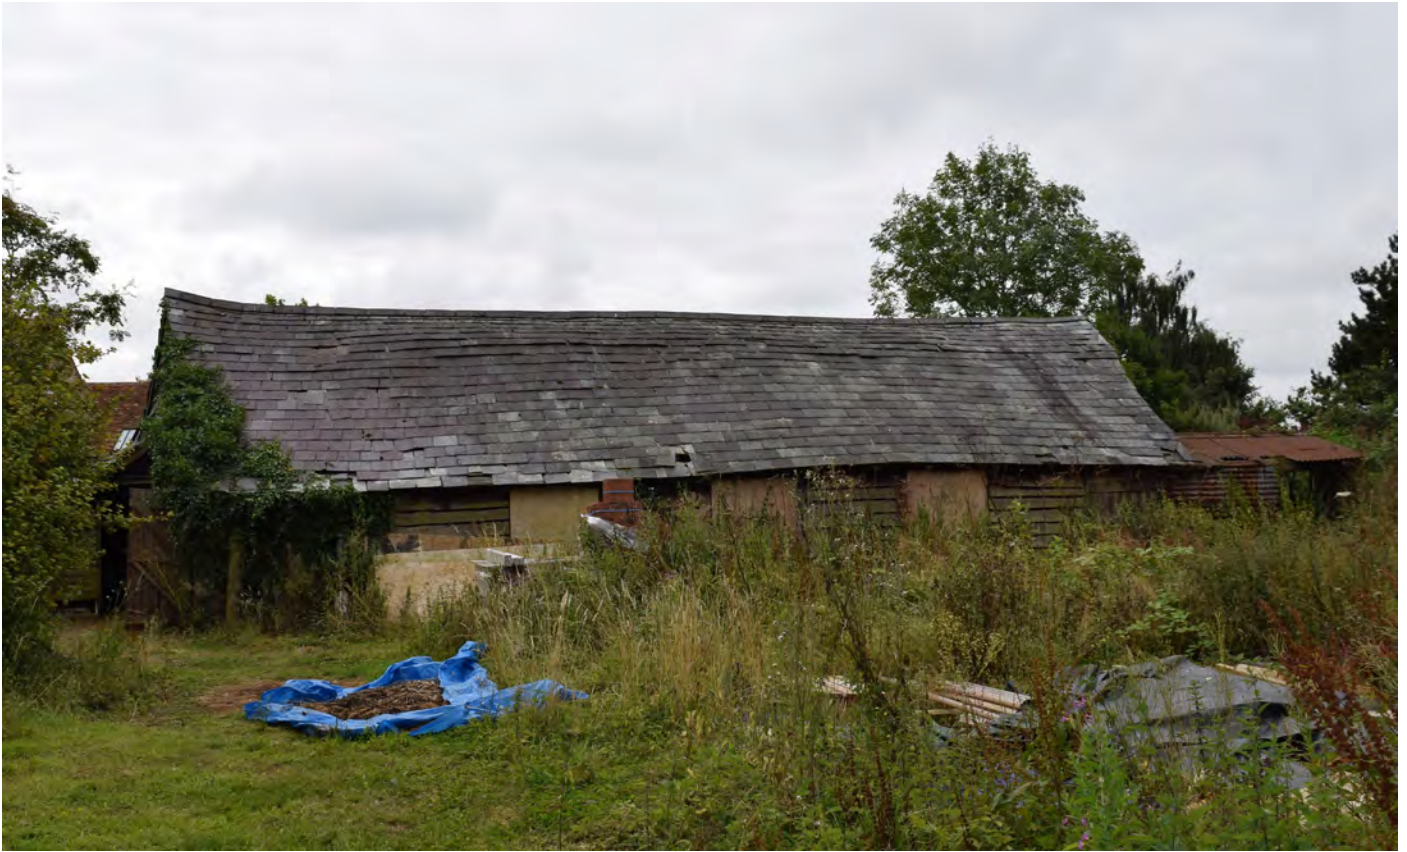
Plate 7: The north elevation of the barn

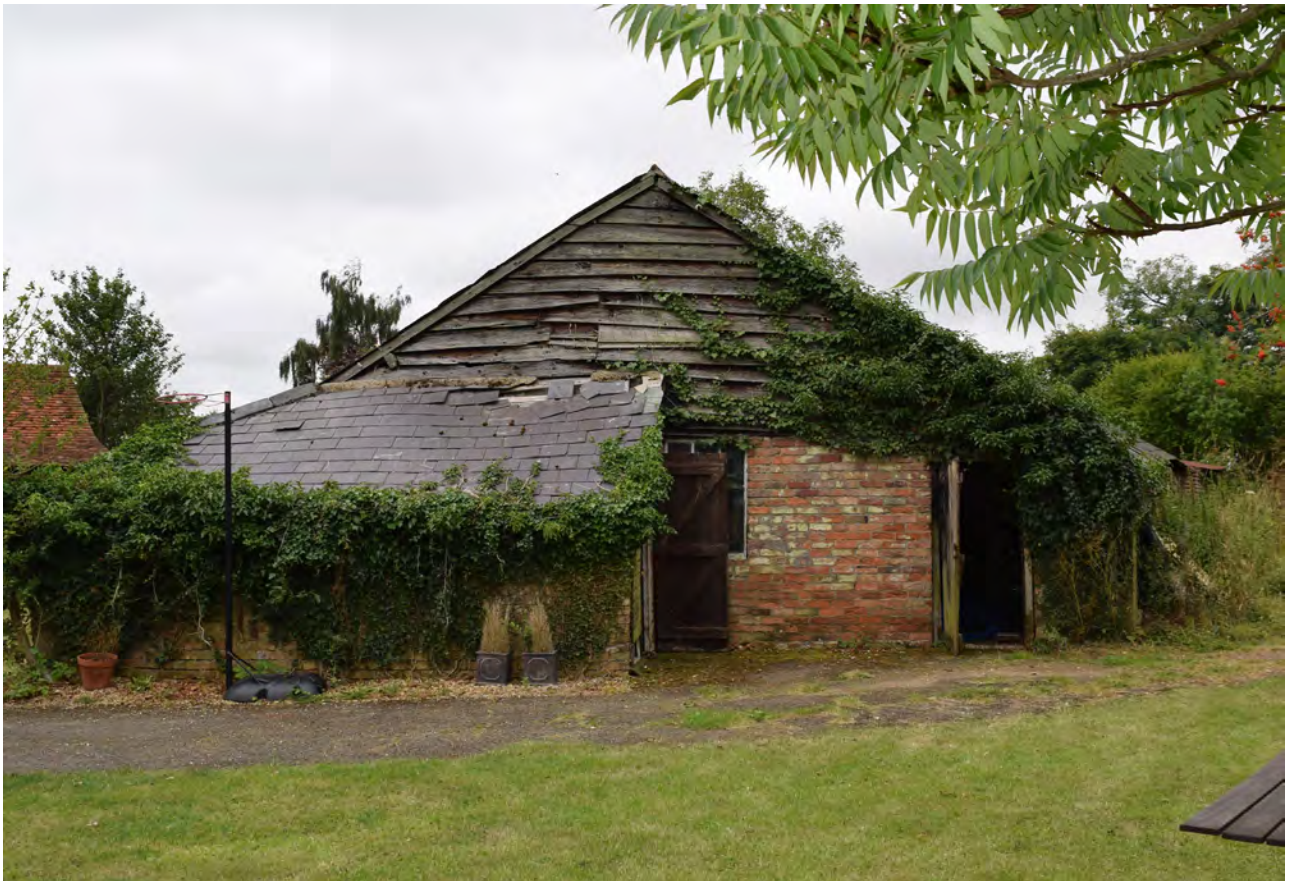
- 5.2.3 The north, south and west elevations of the main body of the barn are clad horizontally with fairly modern softwood boards; the exception is the east end which has been re-built in brick up to eaves-level with the softwood cladding extending to the apex. The west end has a brick plinth of approximately 8 courses. The north has a low brickwork plinth which has been built up around the frame. The base of the modern concrete floor of the southern half of the barn is visible where the cladding has been removed and replaces or obscures any former brick plinth.

Plate 8: The east elevation of the barn

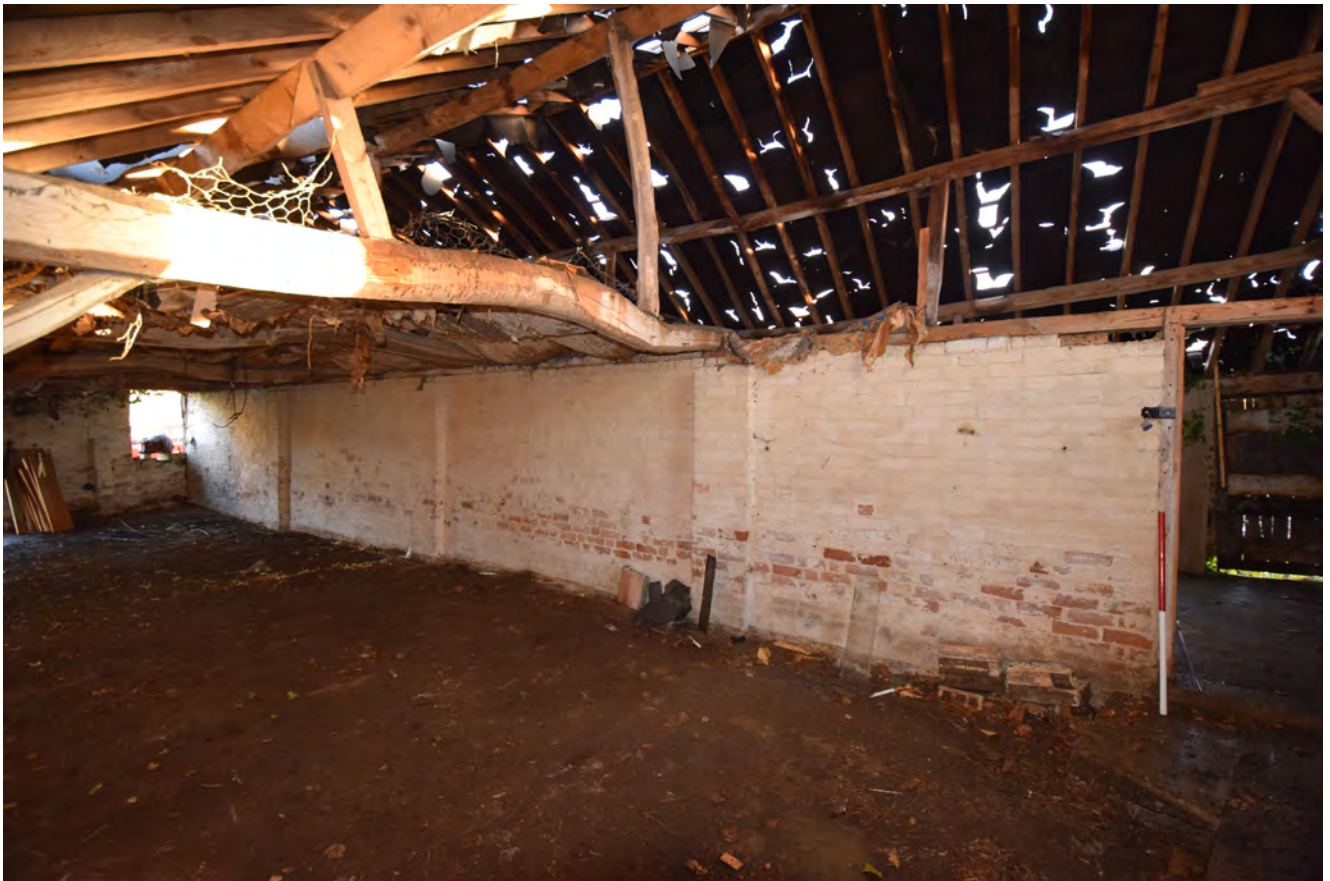
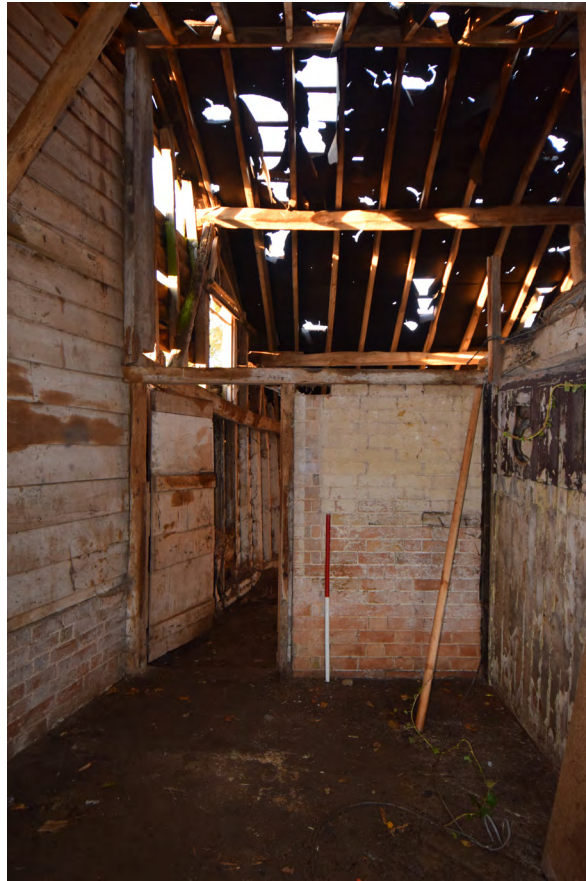
- 5.3.1 The main space of the barn is divided by a brick-built supporting wall running east to west along the approximate centre of the building, the southern half is further divided at the western end bay to create a small workshop (Pls 10&11). The bricks in the central wall are solid, handmade, and well fired; they measure 225mm x100mm x70mm and are bound with lime mortar. The interior of the frame is clad in softwood boards, with multiple repairs using other softwood boards and corrugated metal (Pls 12&13).

Plate 10: The brick wall along the centre of the barn. Looking south east

Plate 11: The workshop in the west bay of the southern half of the barn. Looking north

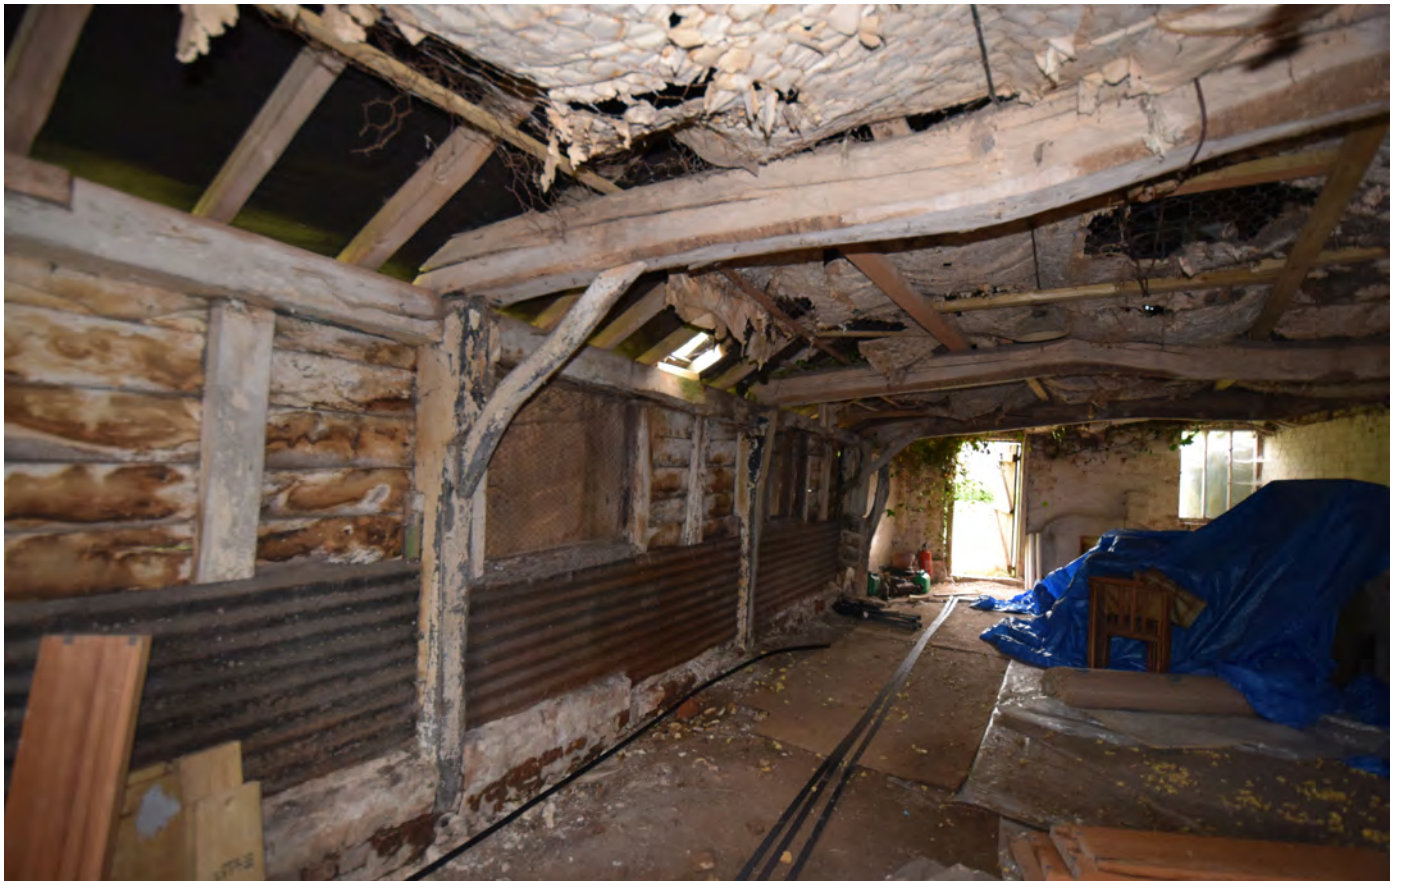
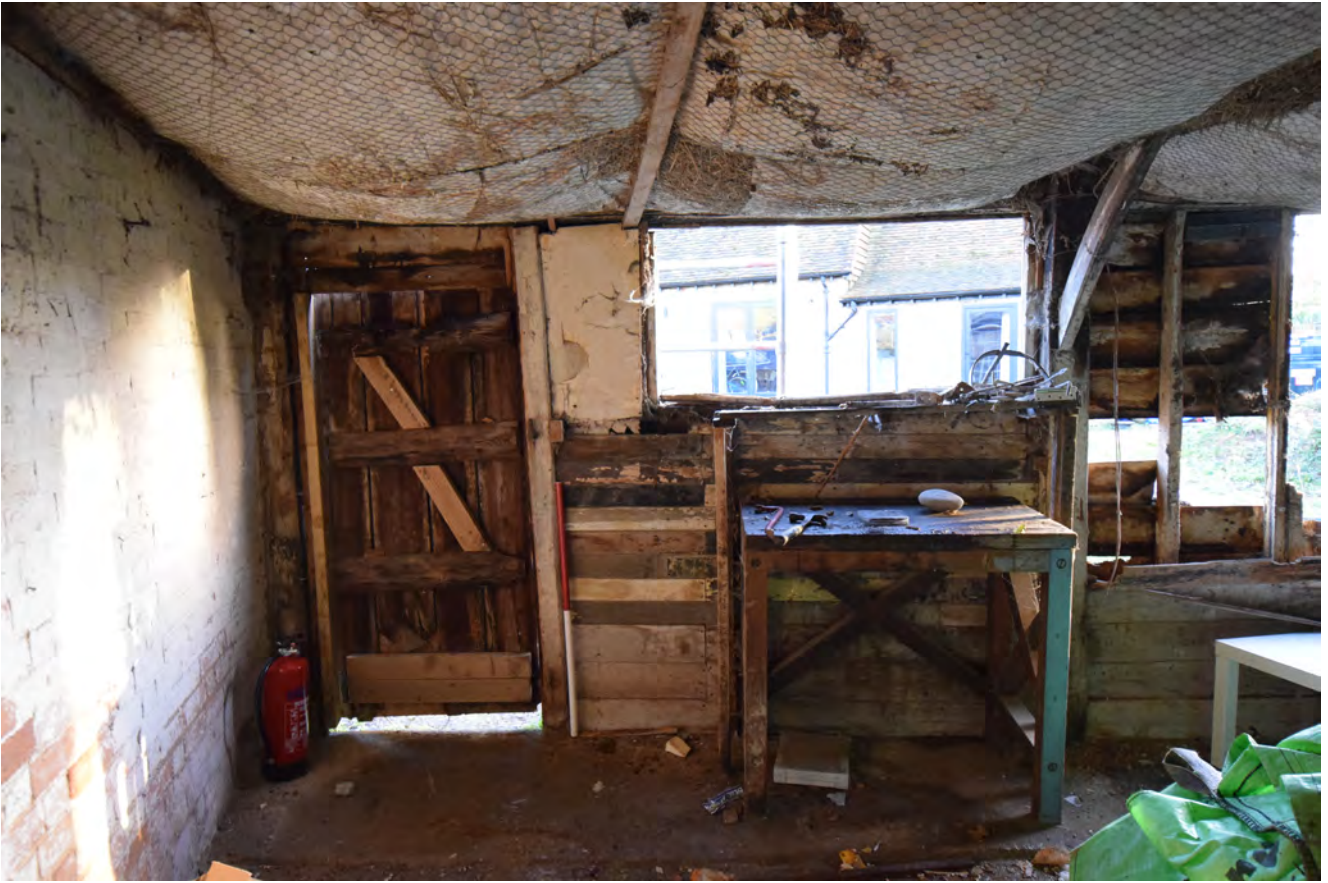
Plate 12: The north wall of the north half of the barn, before stripping

Plate 13: The south wall of the east bay of the barn. Looking south

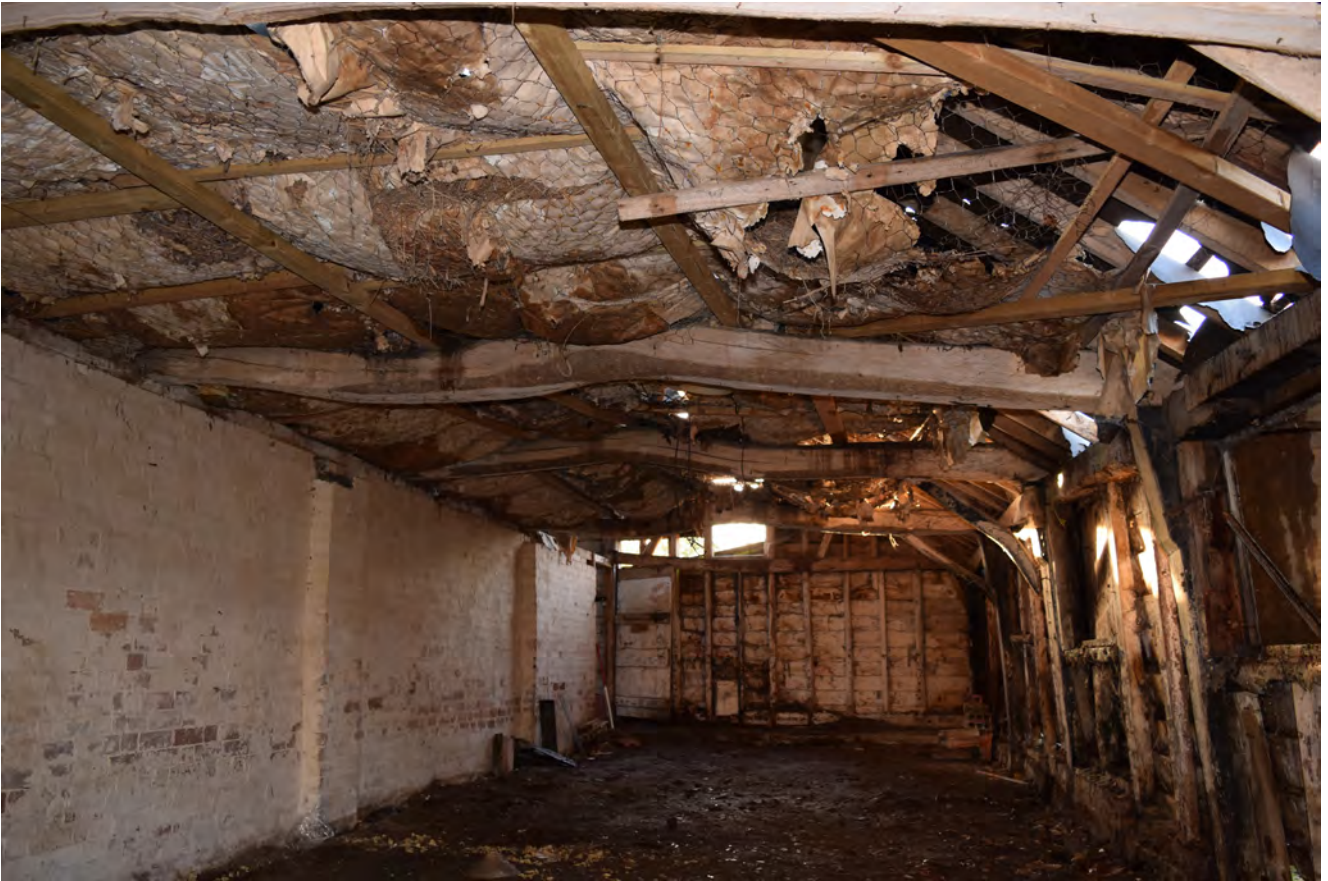
- 5.3.4 These later alterations, replacements and repairs are machine-sawn, straight and square softwood, whereas the tie beams and the wall frame are earlier, waney and mostly of elm, with the occasional reclaimed piece of timber reused in the later alterations, for instance in the braces between the beams and purlins (PI 17).

Plate 17: The north half of the barn including the waney, irregular tie beams. Looking west

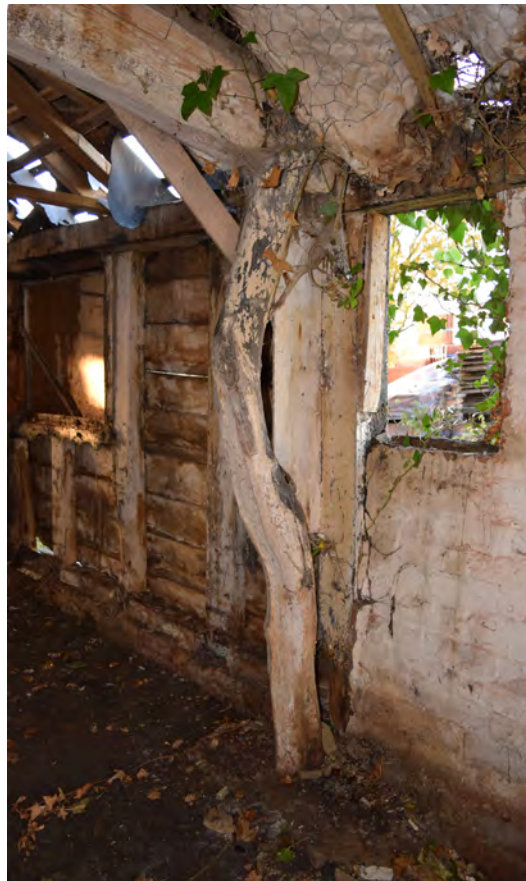
Plate 18: Irregular timber brace.
Easternmost bay, north half of the barn

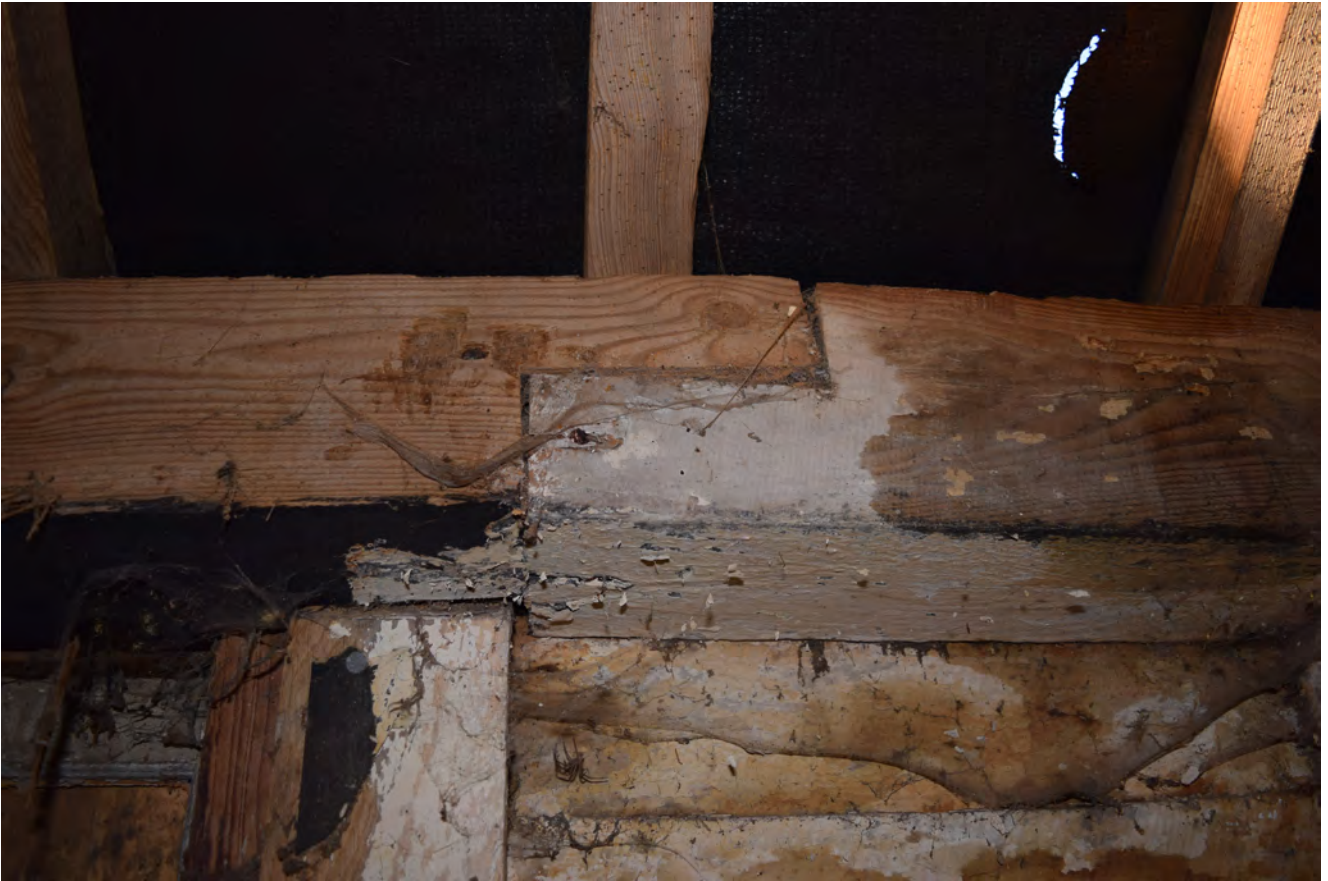
Plate 19: Example of the rough scarfing of the wall plate

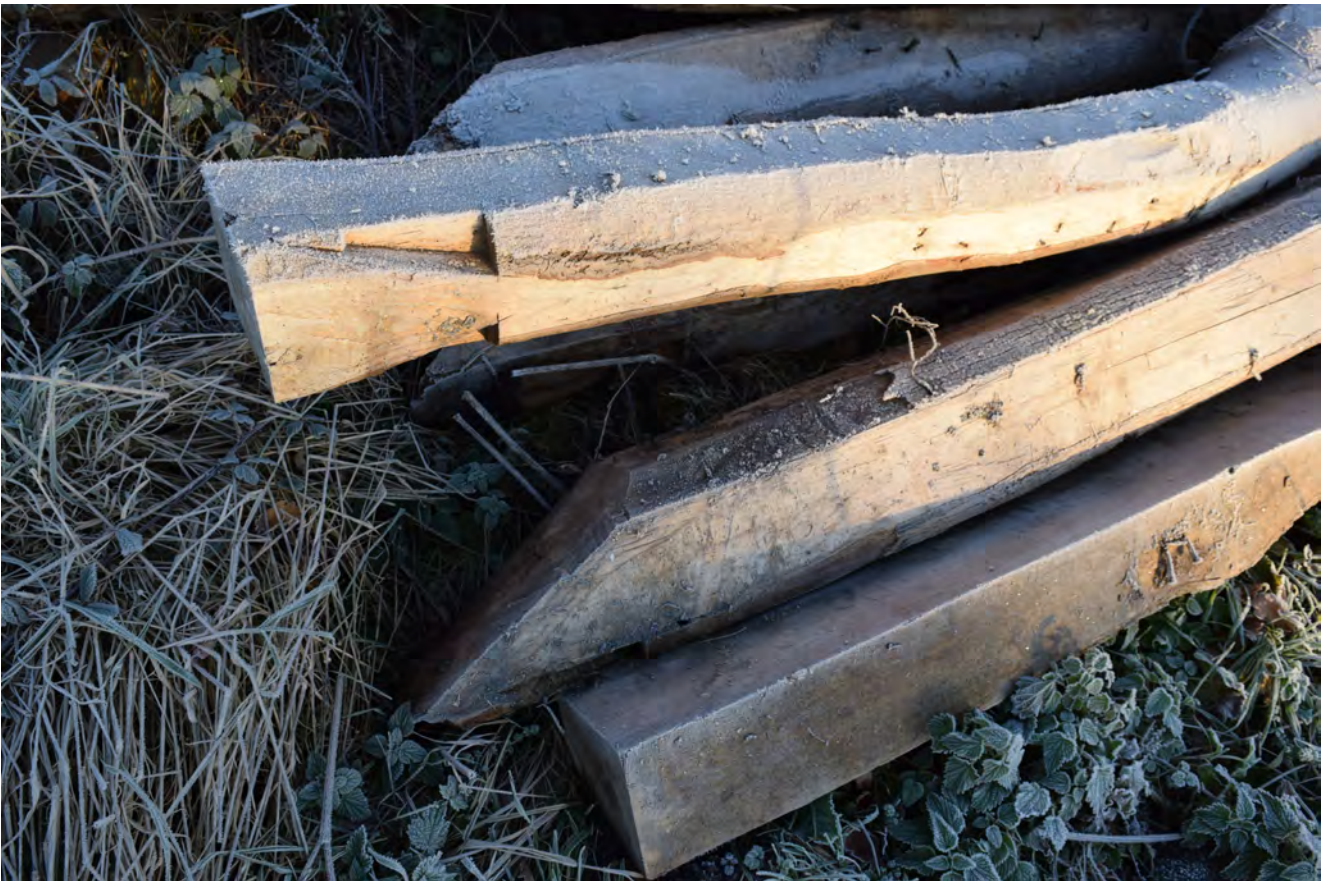
- 5.3.6 Following demolition, it was noted that most of the tie beams have lap dovetailed joints at either end, a common joint used in beams for centuries and until the decades surrounding the construction of this barn (Pl 20). The fact that carpentered joints are resting upon the top of the brick wall indicates that they are reused or the building has undergone extensive alteration.

Plate 20: Example of the lap dovetail joints in the beams

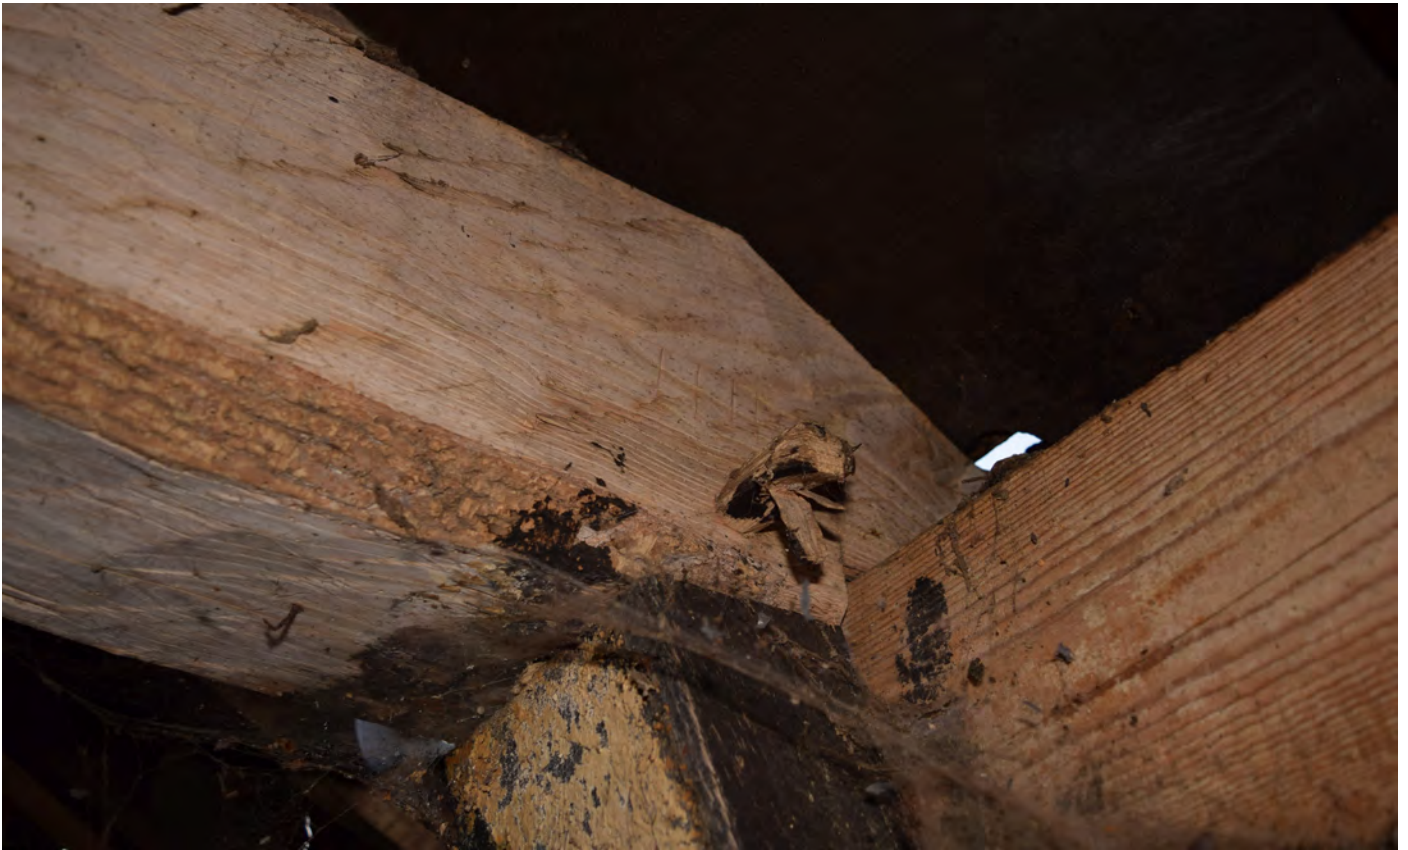
- 5.3.7 No carpenters' marks are in the modern timber, nor are any within the dismantled joints. Only one carpenters' mark was observed in the standing frame, but this did not correspond with the adjoining timbers, nor was it in a sequence with the adjacent bays, again suggesting reuse of timbers (Pl 21).

Plate 21: A carpenter's mark which does not appear in the adjacent timbers

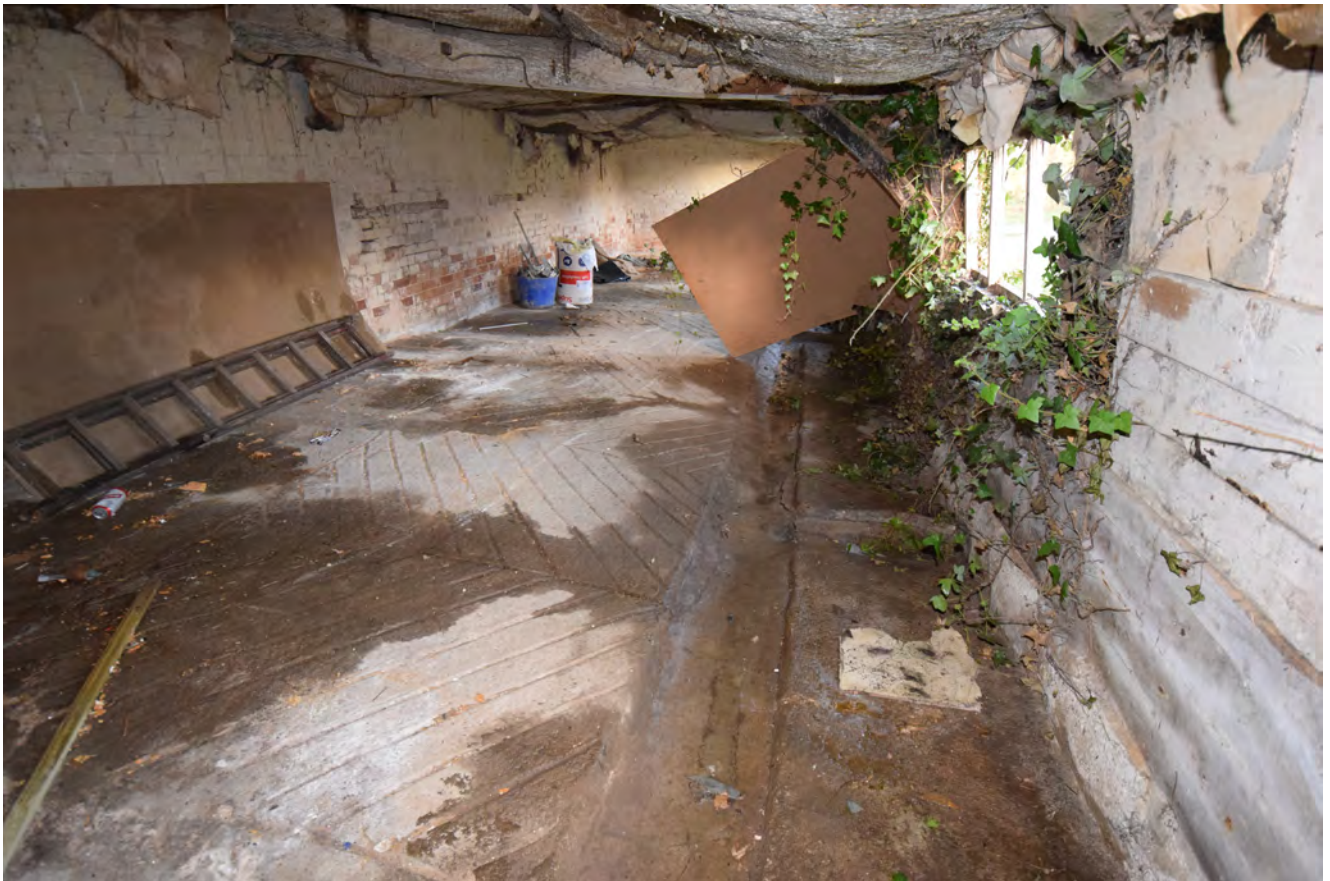
- 5.3.8 The floor of the northern half of the barn is a fairly compact earth floor with a patch of concrete inside the doorway at the east end and a narrow path of concrete between the doorways at either side of the western end. The floor of the southern half of the barn is modern concrete with drainage channels formed during the pour (Pl 22). Following the removal of the concrete floor, it was observed that no earlier floors were present.

Plate 22: The modern concrete floor in the south half of the barn. Looking east

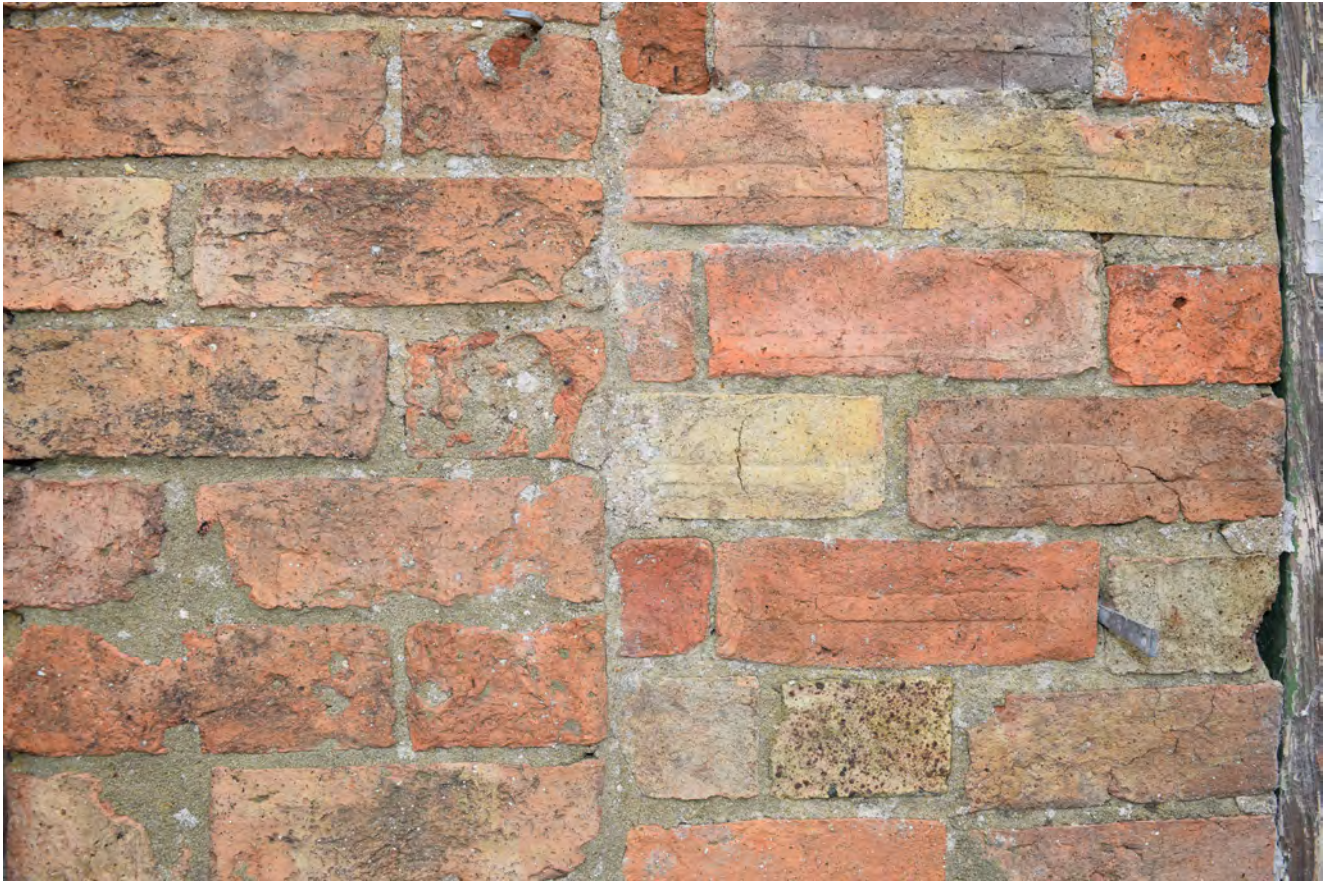
Plate 23: The bricks of the east wall of the barn and the repair of the lean-to. Looking north

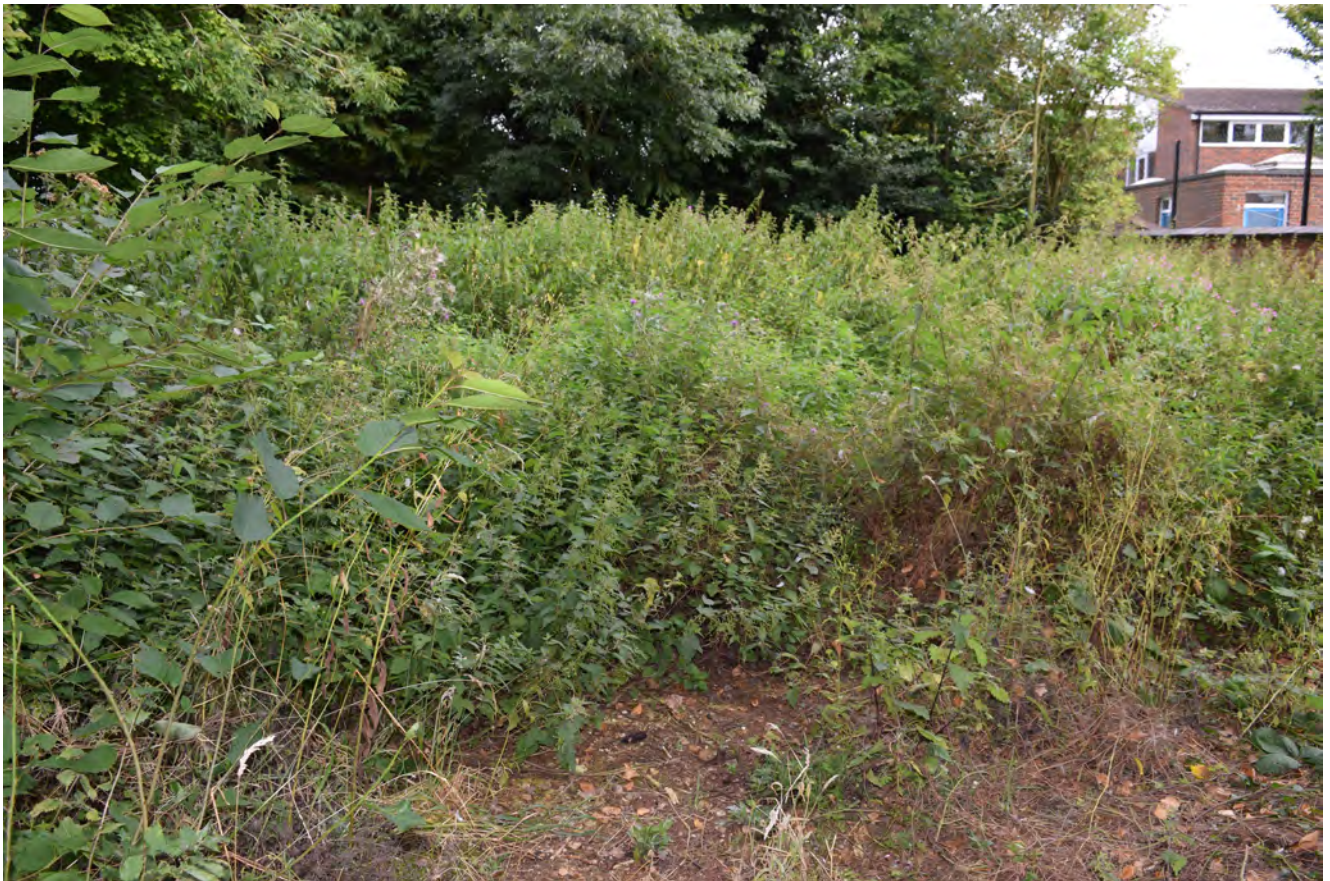
- 6.1.1 The site had been overgrown for several years at the time of the initial survey and fairly well-established shrubbery was across the northern part of the site (PI 27). Once the site was stripped of foliage, the topsoil (001) proved a rich, humic, fairly deep layer consistent with the former use as gardens (PIs 28&29). A concrete path was to the eastern edge of the site, between the foundation trench and the wall and the modern broken brick hardcore and concrete remains of what may have been the base of a small item such as an ornamental feature or compost bin. The path is in the location of the path on the 1880 map, but is a fairly modern replacement. There were no other indications of any features in the ground surface.

Plate 27: The site of the new building prior to stripping. Looking north east

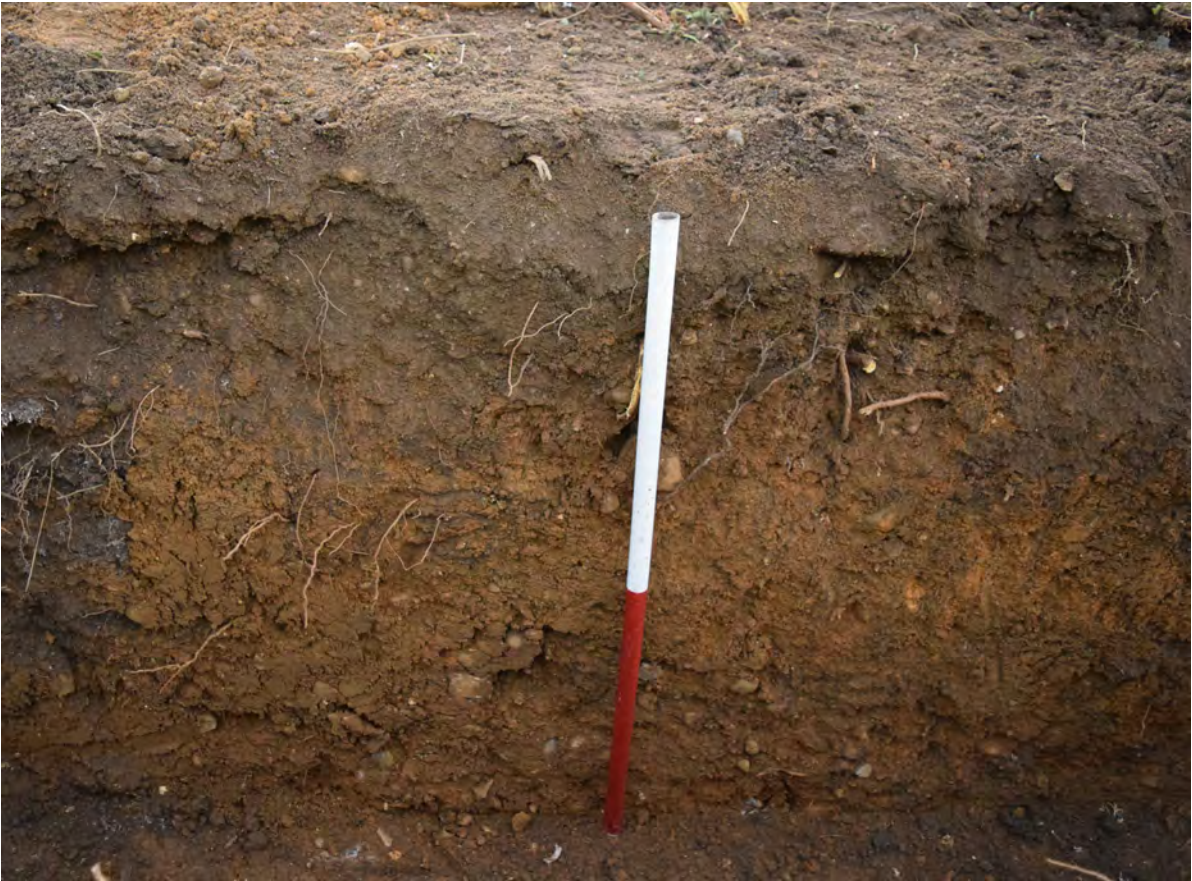
Plate 30: A typical example of the section, with some root disturbance. Looking north
