School End Farm, Great Horwood

Historic Buildings Recording and Archaeological Watching Brief

Client Name: Mrs Chrissie Cheshire
Document Title: School End Farm, Great Horwood, Buckinghamshire

Document Type: Historic Building Recording and Archaeological Watching Brief
Issue Number: 1

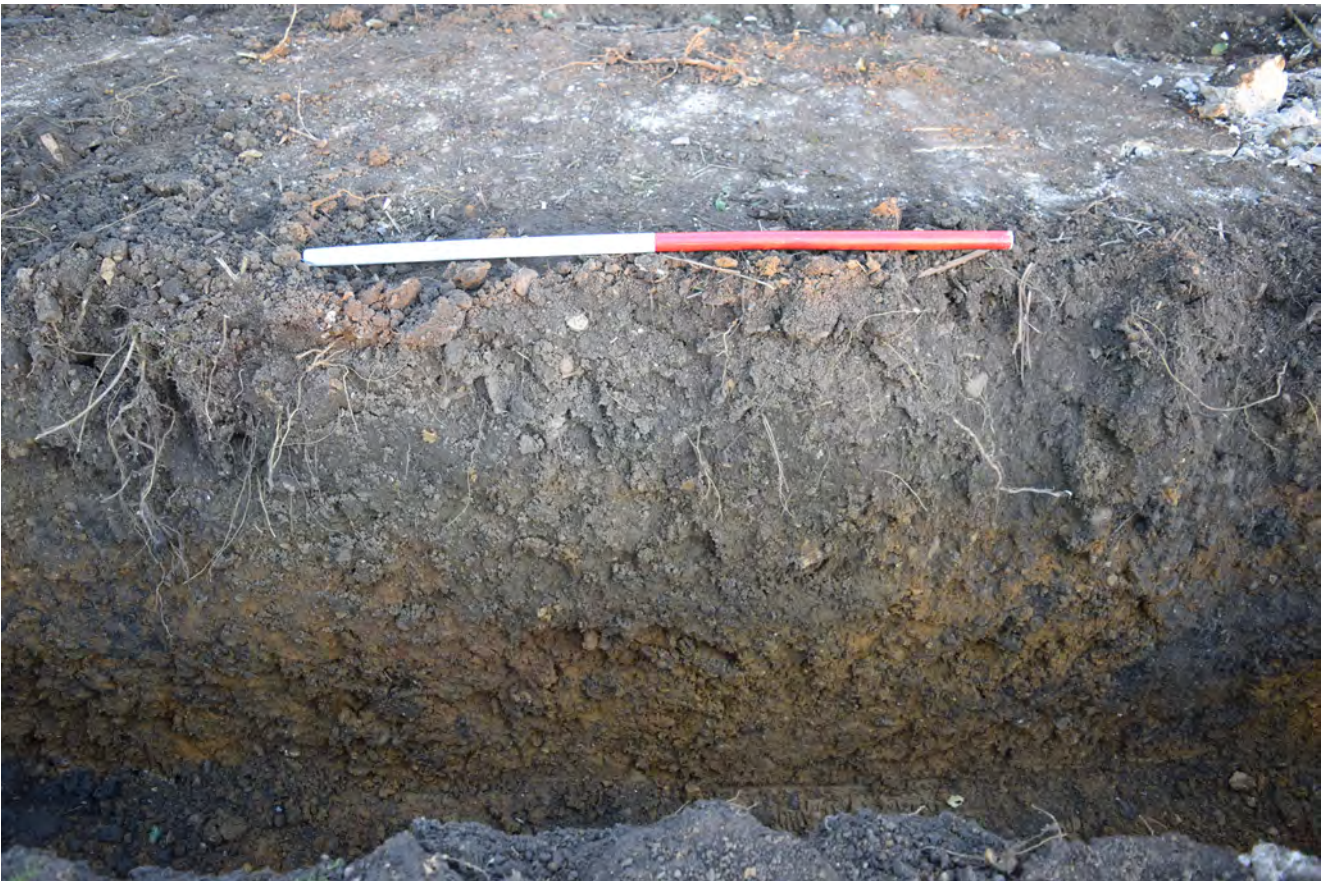
Plate 31: The possible post hole [004] and the later concrete path. Looking east

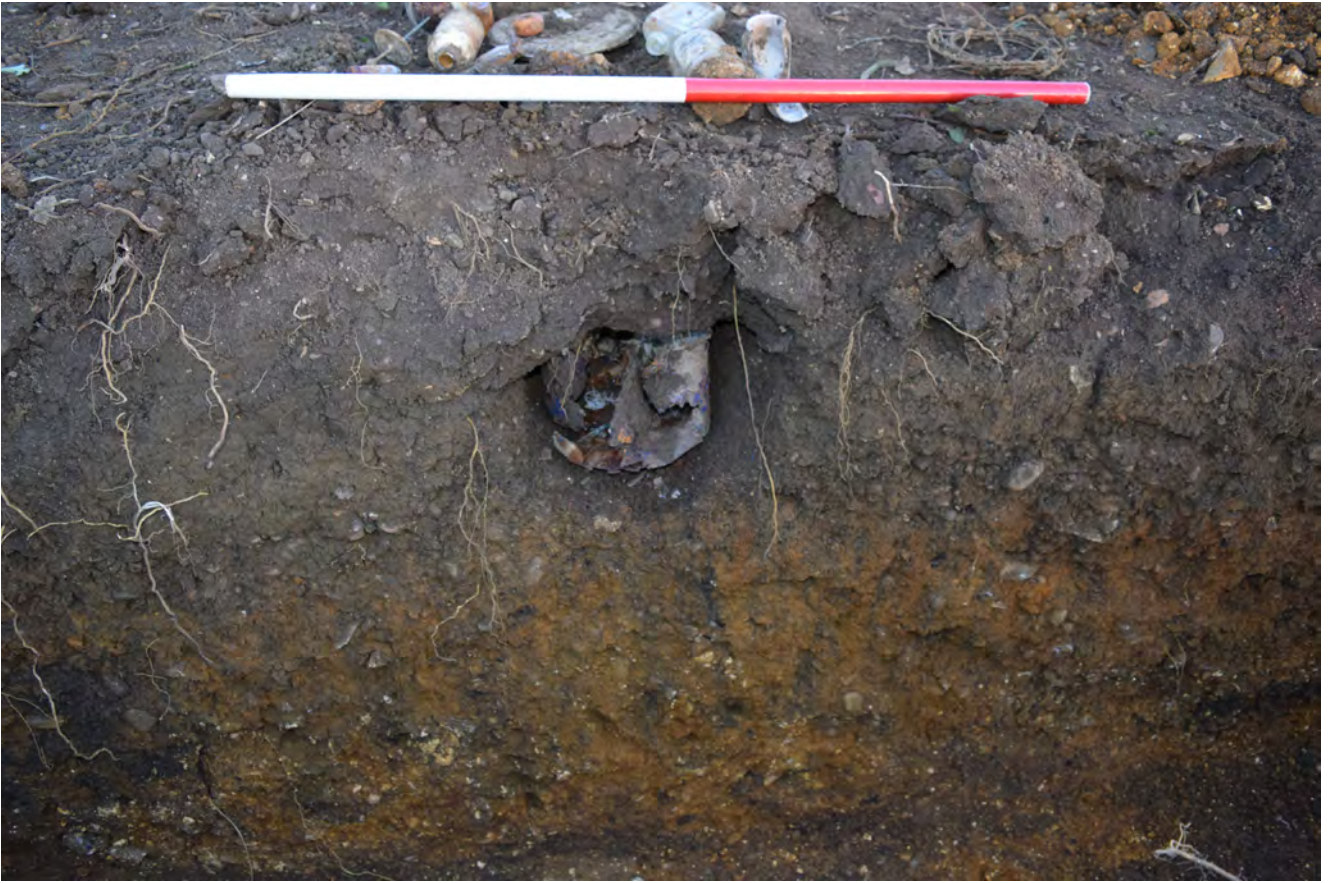
- 6.1.5 The items found in pit [006] consisted of broken crockery, glass and stoneware bottles and jars and a small metal bucket. The remainder of the fill was topsoil, all of which was loose and dislodged by the bucket of the machine (PI 32). Due to their age, dating to the 1930s or 1940s, none of the finds were retained.

Plate 32: The heavily disturbed edge of the rubbish-filled pit [006]. Looking east

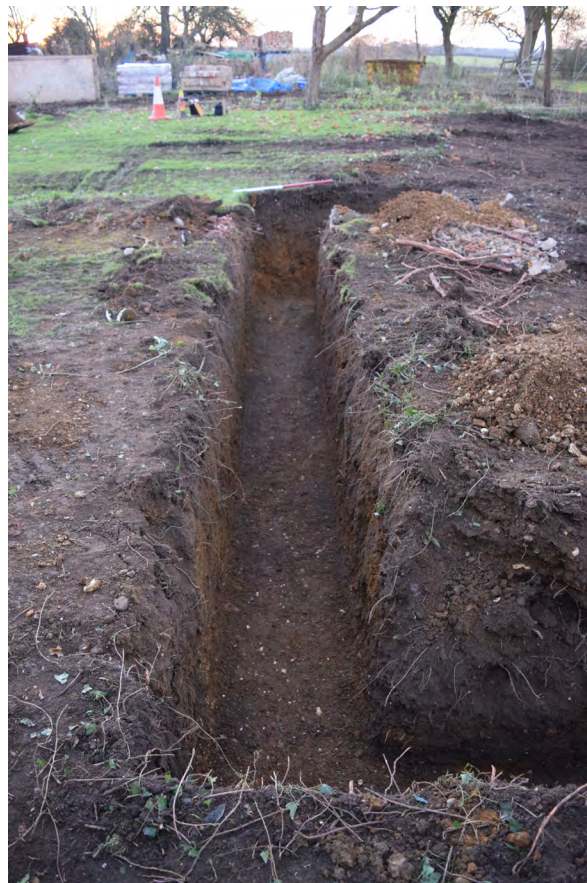
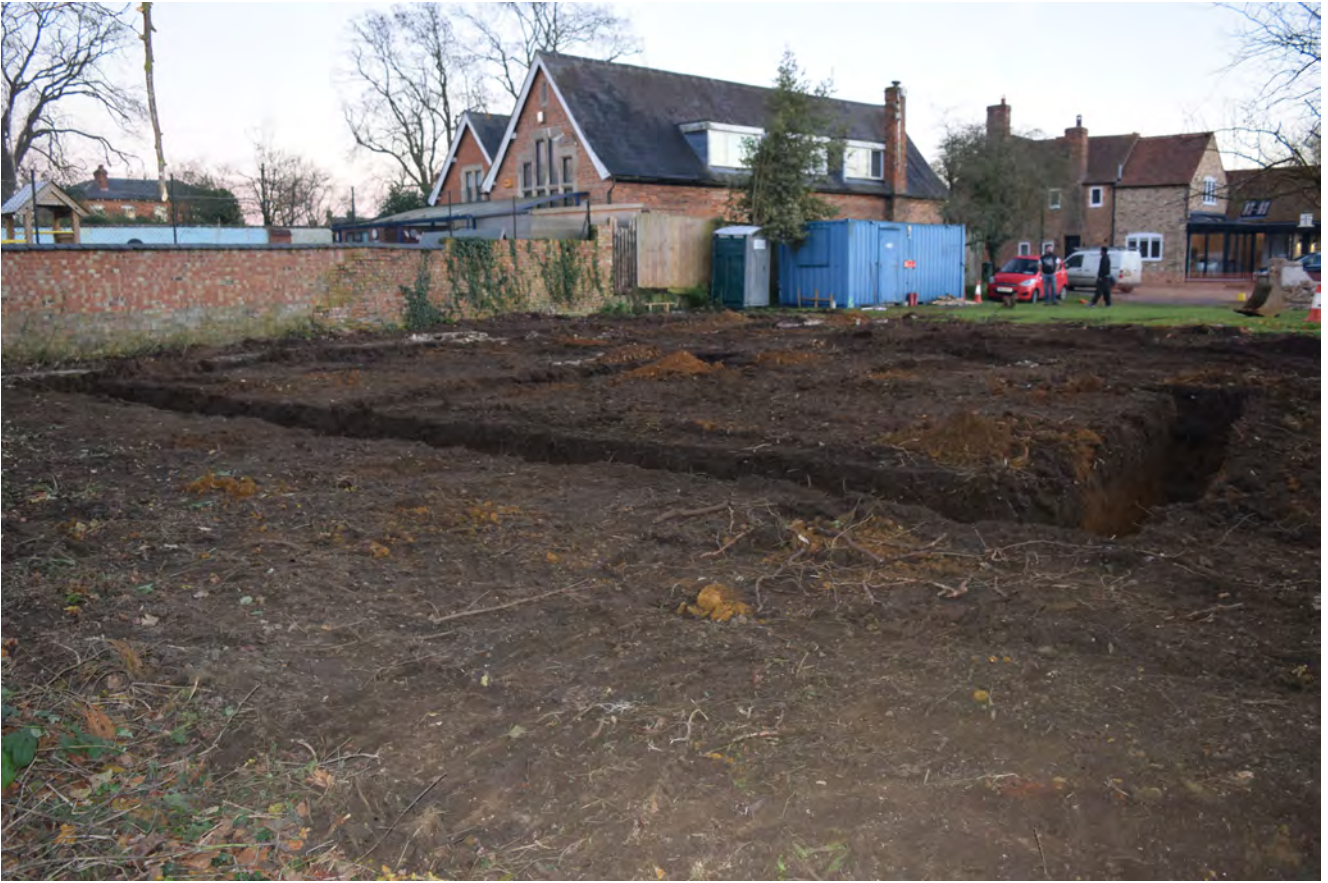
- 6.2.2 The foundation trenches were cut well into the underlying natural gravels and the subsoil was largely undisturbed (Pls 33&34). The garden was well-drained and the topsoil was deep and well fertilised, some deep-rooted plants were removed; a small root-bole was reused as a rubbish pit and re-cultivated. The area was allowed to become overgrown in recent years and occasional pieces of rubbish from recent decades were in the topsoil. No finds were retained.

Plate 33: A typical featureless foundation trench cut well into the natural. Looking west

Plate 34: The site following excavation, prior to concrete pouring. Looking south east
