Baldwins Farm P e b w o r t h Worcestershire

Historic Building Recording and Archaeological Watching Brief

July 2007

Client: Dean Park Contracts

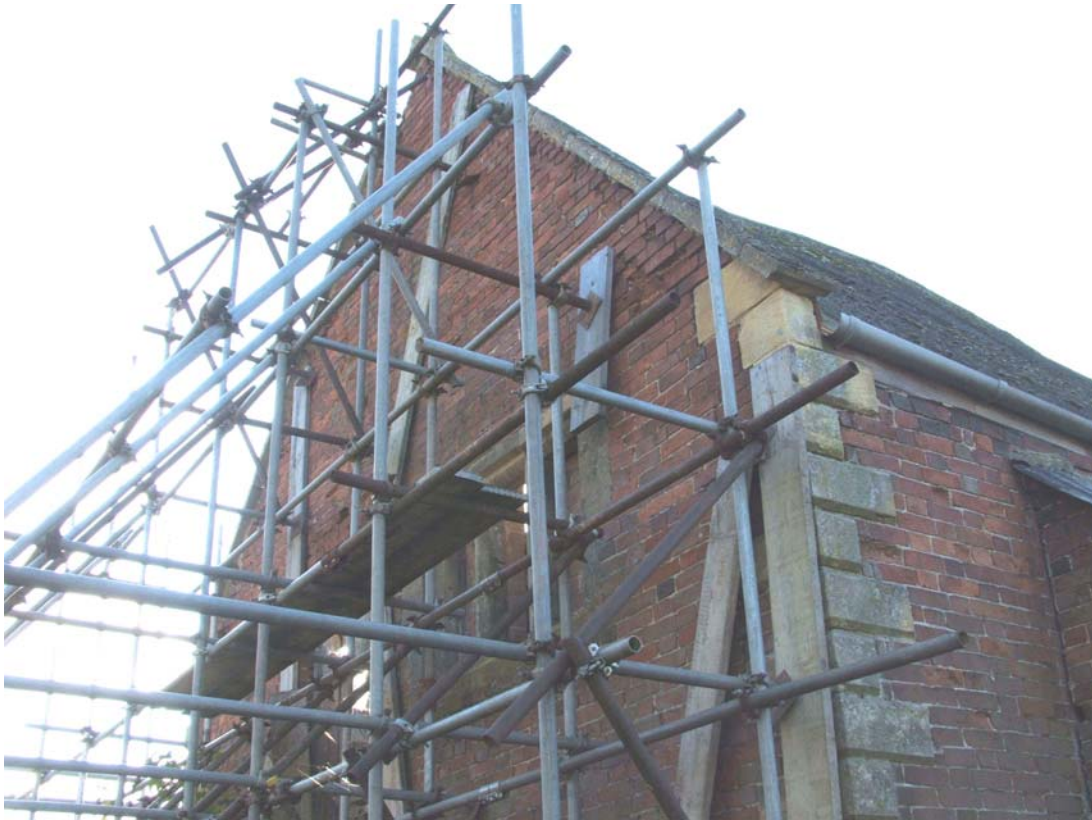
Plate 3: Block A, East elevation

- 3.1.7 *East Gable Elevation*
- 3.1.8 The east gable wall was of brick as the rest of the building with rusticated smooth stone quoins with chamfered joints. The parapetted gable had plain kneelers and plain stone coping with a detail of gablets on the finial (Plate 3).

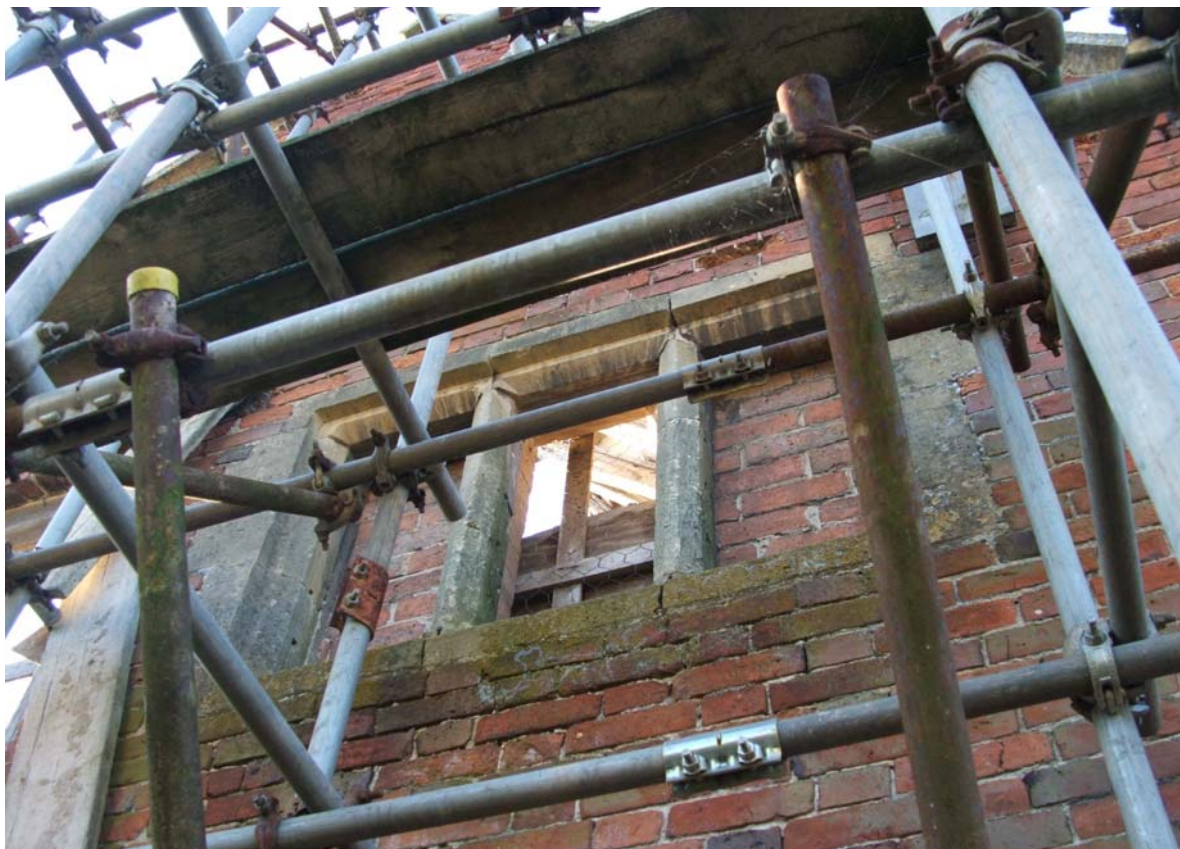
Plate 4: Block A, East window

- 3.1.10 North of the door there was a three light mullioned window in the first floor. The window had a frame and mullions in stone with plain chamfers (Plate 4). The door and window suggest this floor may have incorporated or been used as a 'barrack room' for the carters and horsemen (Brunskill 1978, 156) as well as perhaps being a hay loft which was suggested by the low upper opening in the south wall.

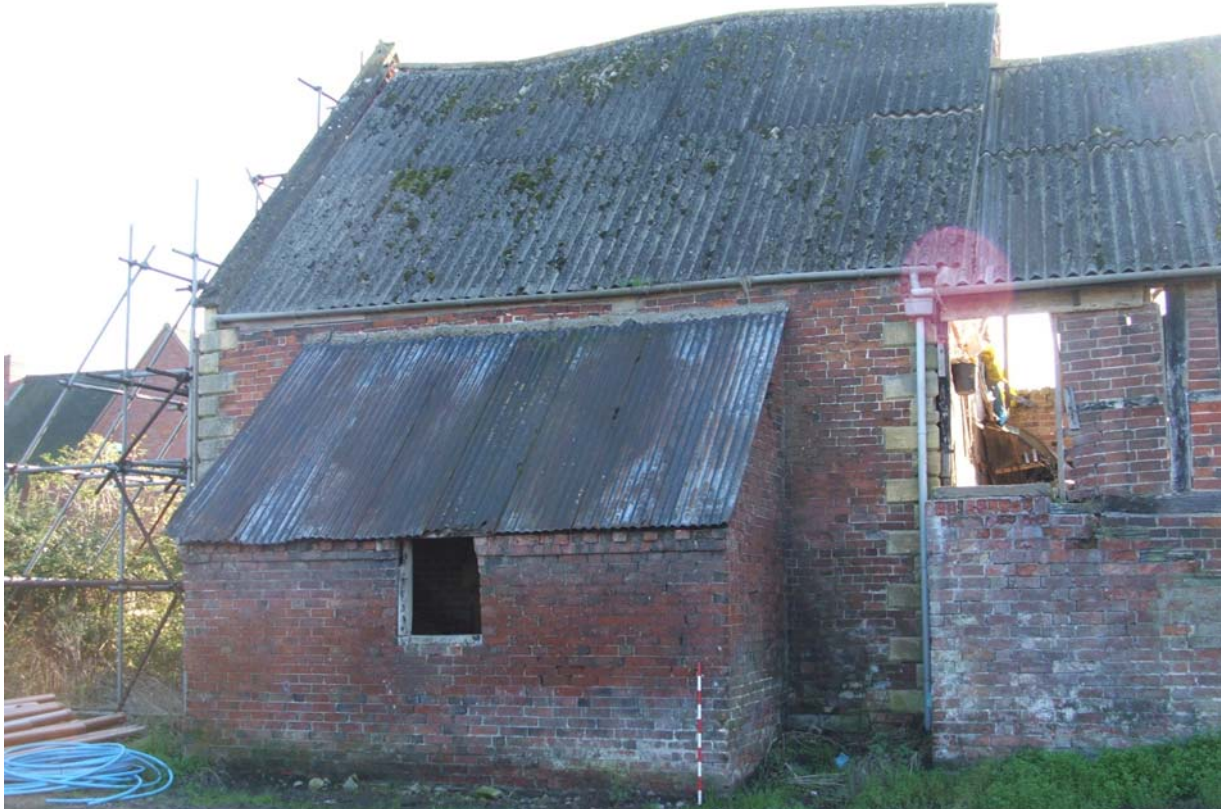
Plate 5: Block A, North elevation

- 3.1.11 *North Elevation*
- 3.1.12 The north wall was mostly concealed behind a later lean-to brick extension. This was constructed in red brick laid in Flemish garden wall bond with corbelled and dentilled eaves courses. There was a central square window opening with the remains of a wooden frame. The lean-to roof was clad in old galvanised corrugated iron sheets (Plate 5).

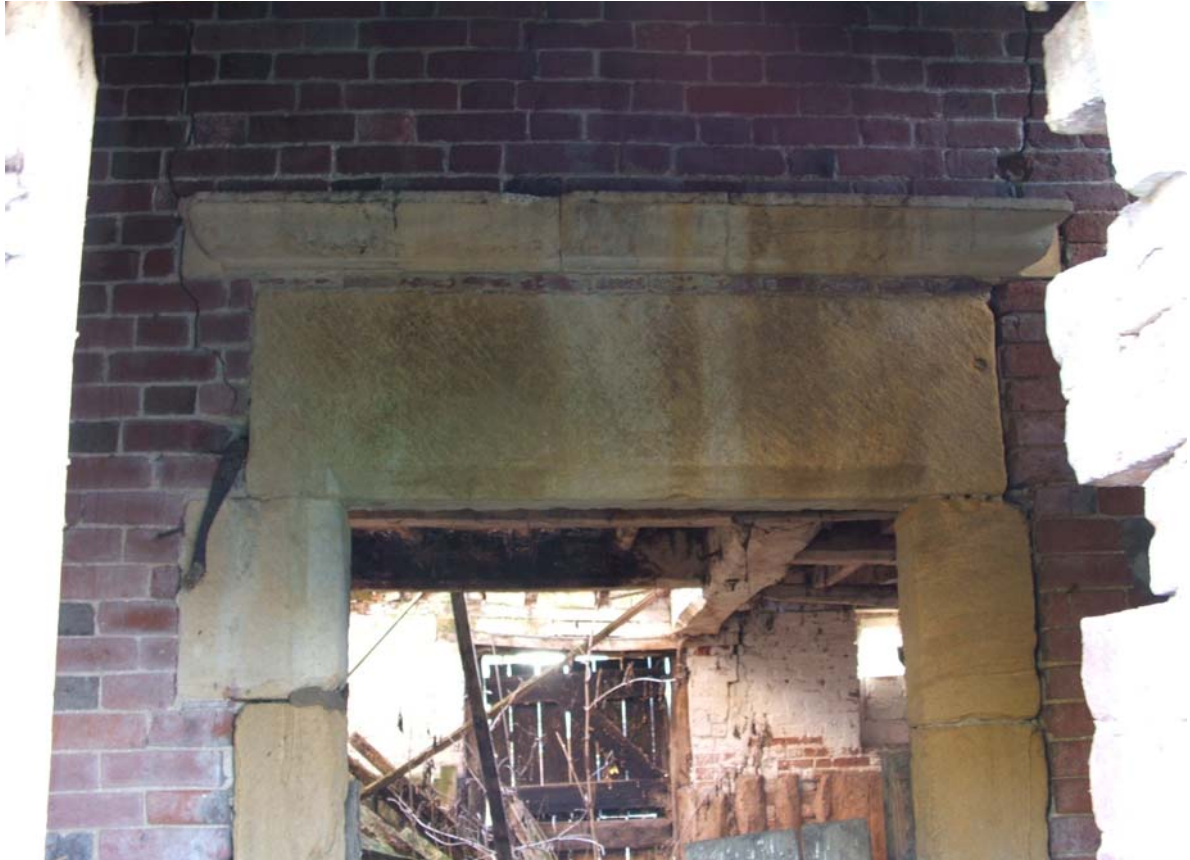
Plate 6: Block A, North door

- 3.1.14 *Interior*
- 3.1.15 The interior could not be safely accessed but it was possible to see some of the interior through the north extension (see Plate 6). The south door had an inner wooden lintel set into the wall either side of the doorway and this was bowed with the weight of bricks over it. Immediately west of the door and resting on

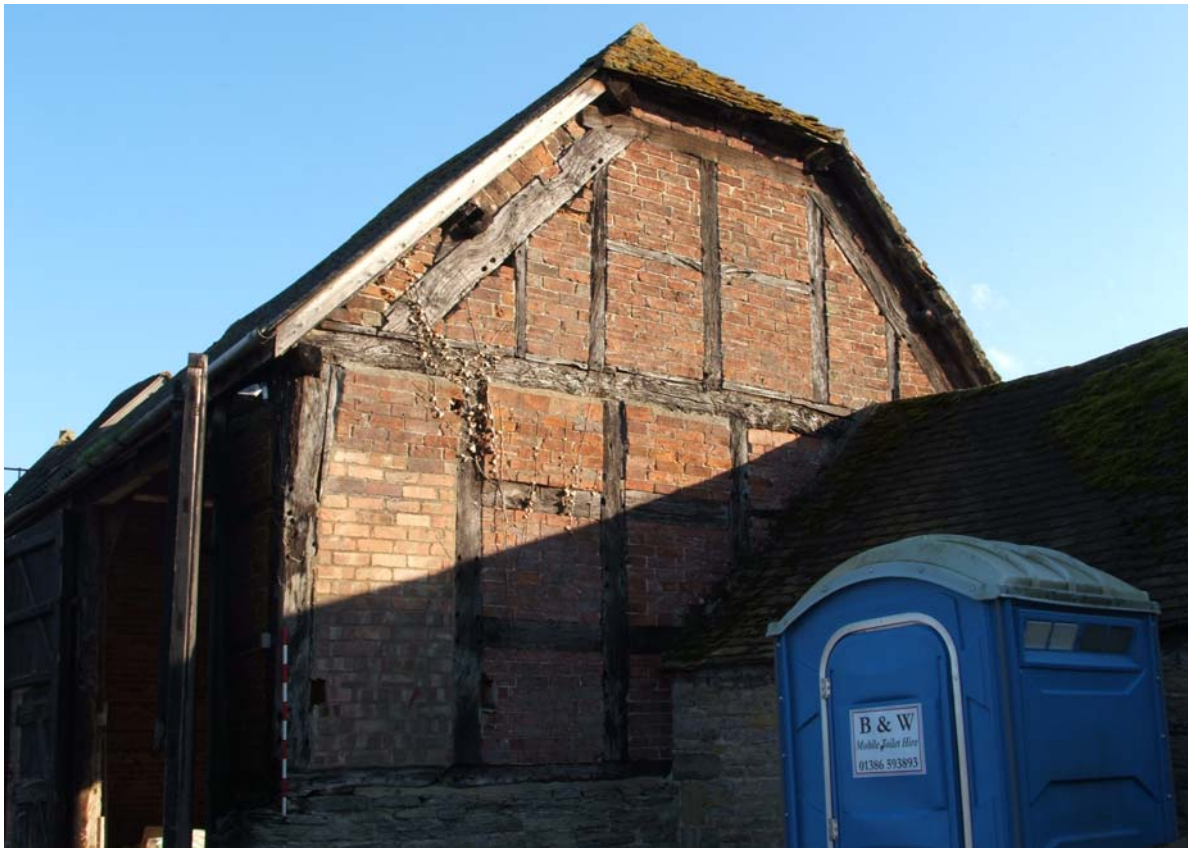
Plate 7: Block B, West elevation

- 3.2.5 A plinth of roughly dressed and coursed local blue lias, bonded with lime mortar, survives intact in the west wall and is 1.5m in height. Above the plinth the west gable wall retains a square panel timber frame but this contains many reused timbers and may have been rebuilt (Plate 7).

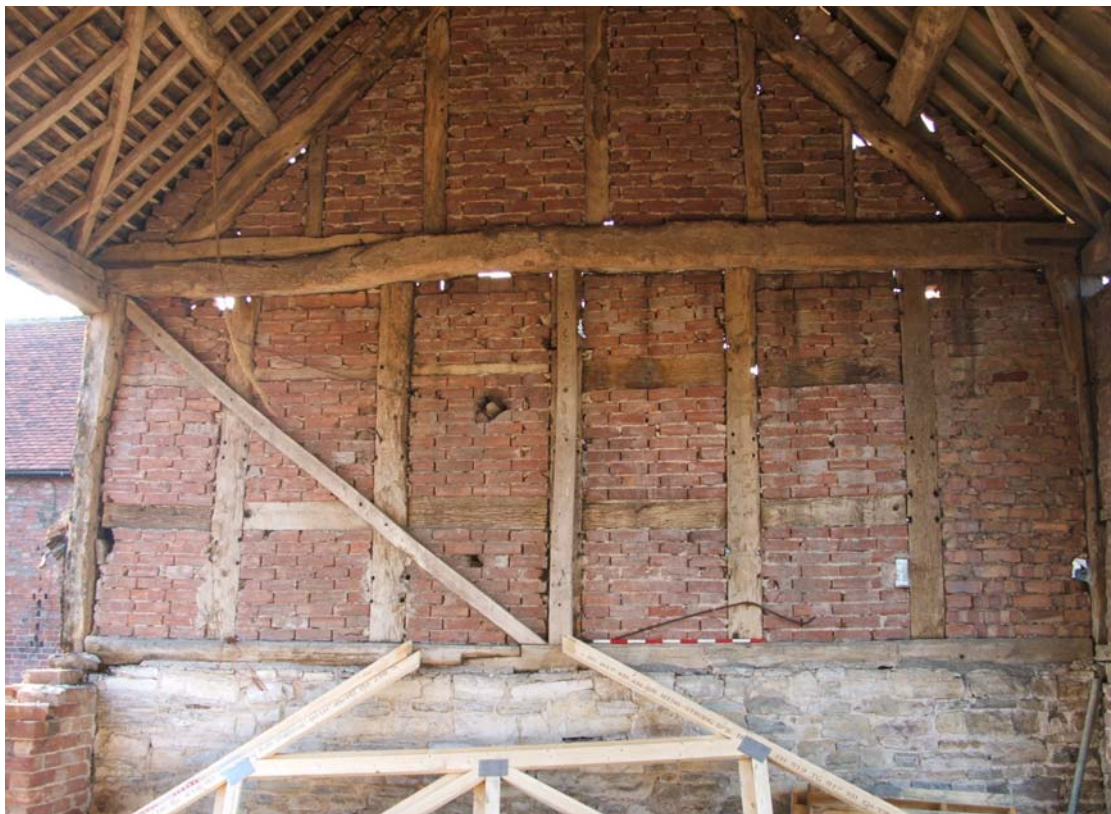
Plate 8: Block B, Interior of west wall

- 3.2.6 The lower timber frame consists of two jowled main posts rising from the plinth to support a tie beam and a sill plate laid on the plinth between the two posts. The posts contain redundant mortises for braces which are not mirrored in the tie beam, indicating reuse. The sill contains an edge-halved scarf and on

the exterior the north part of the sill has an angled rebate for a brace and a series of closely spaced now redundant pegs indicating it also has been reused (Plate 8).

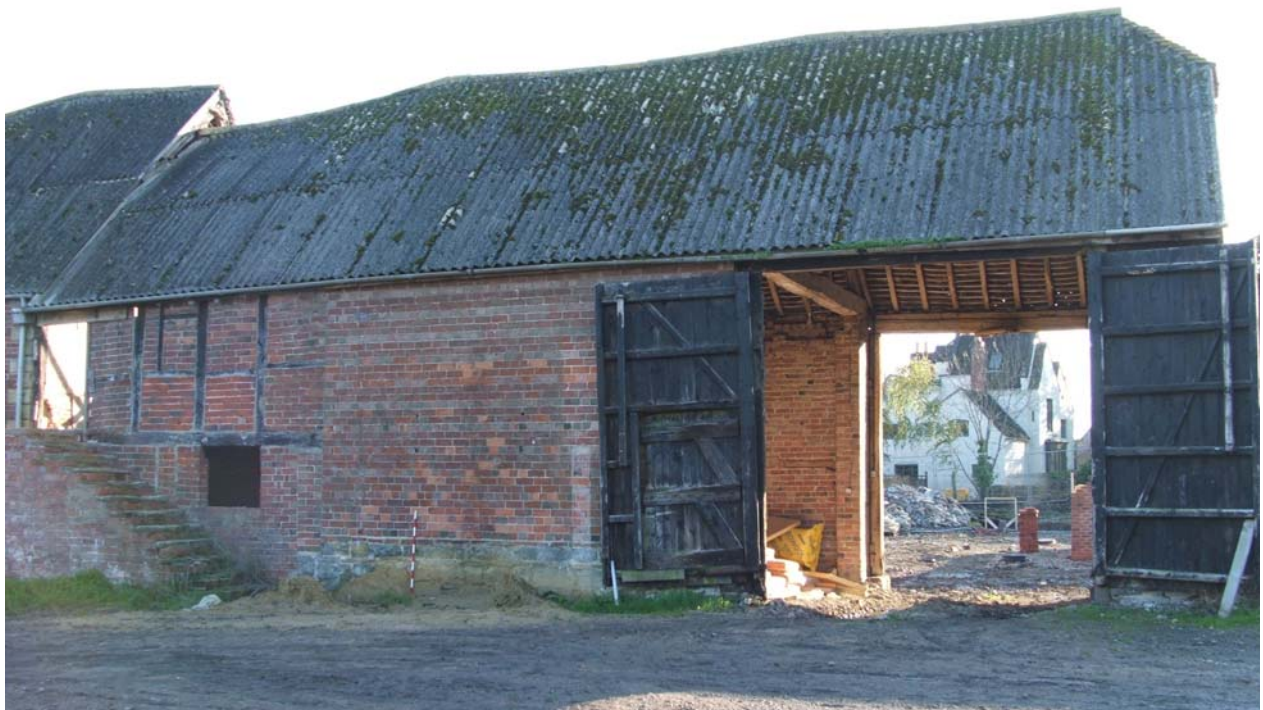
Plate 10: Block B, North elevation

- 3.2.11 *The north wall*
- 3.2.12 The north wall has a cart door at the west end and red brick masonry in the central bay. West of the door is a short section of wall with original full height blue lias plinth and timber framed panels infilled with brick nogging in stretcher bond (Plate 10).

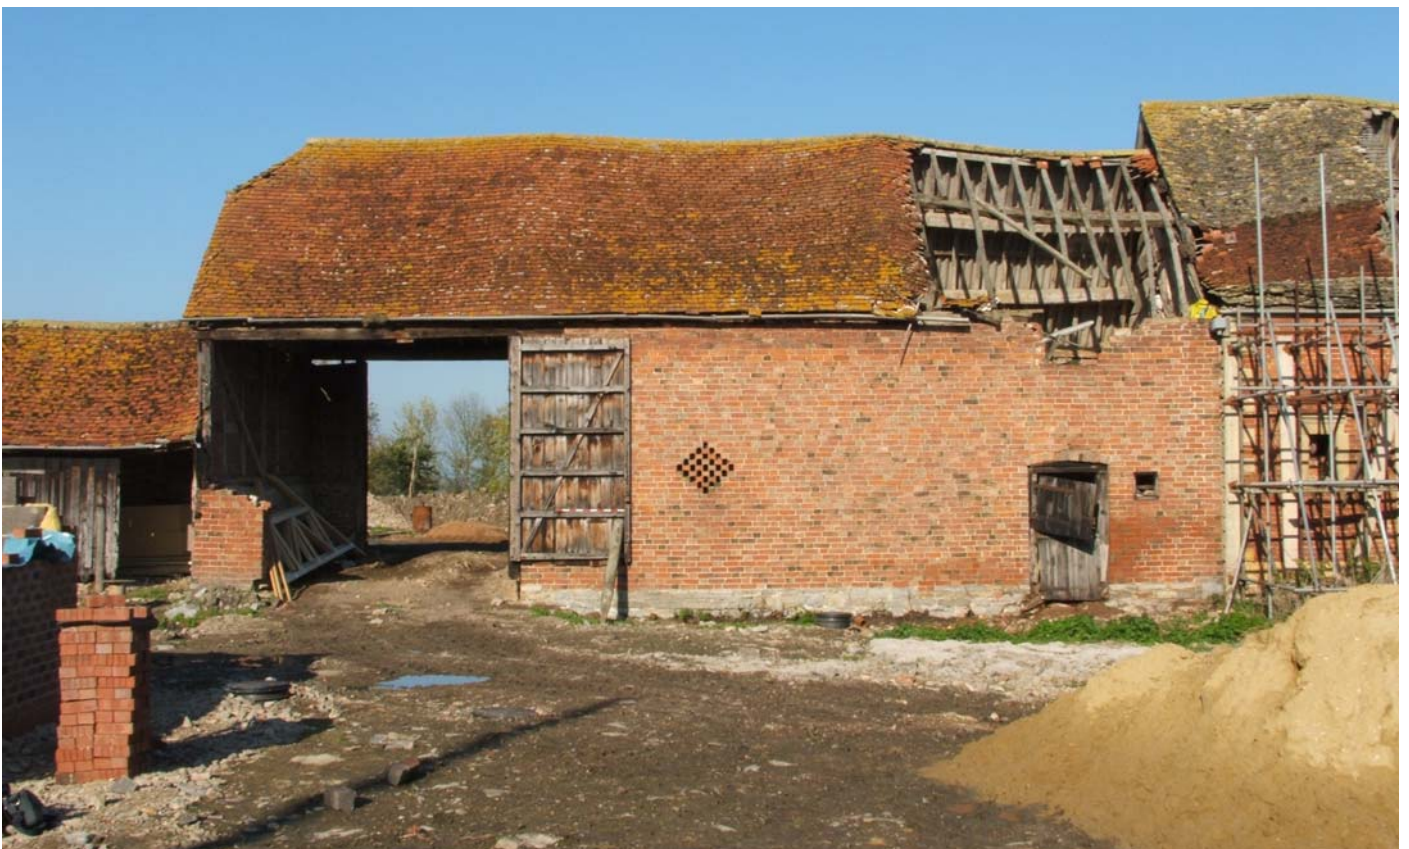
Plate 12: Block B, South elevation

- 3.2.15 *The south wall*
- 3.2.16 The exterior south wall has been rebuilt in red brick laid in a slightly irregular version of Monk bond set on a low plinth of blue lias which is probably a remnant of the original plinth. There are cart doors at the west end of the wall into the west bay and west of these a short run of wall which also sits on a low stone plinth and abuts the higher original plinth of the west gable wall (Plate 12).

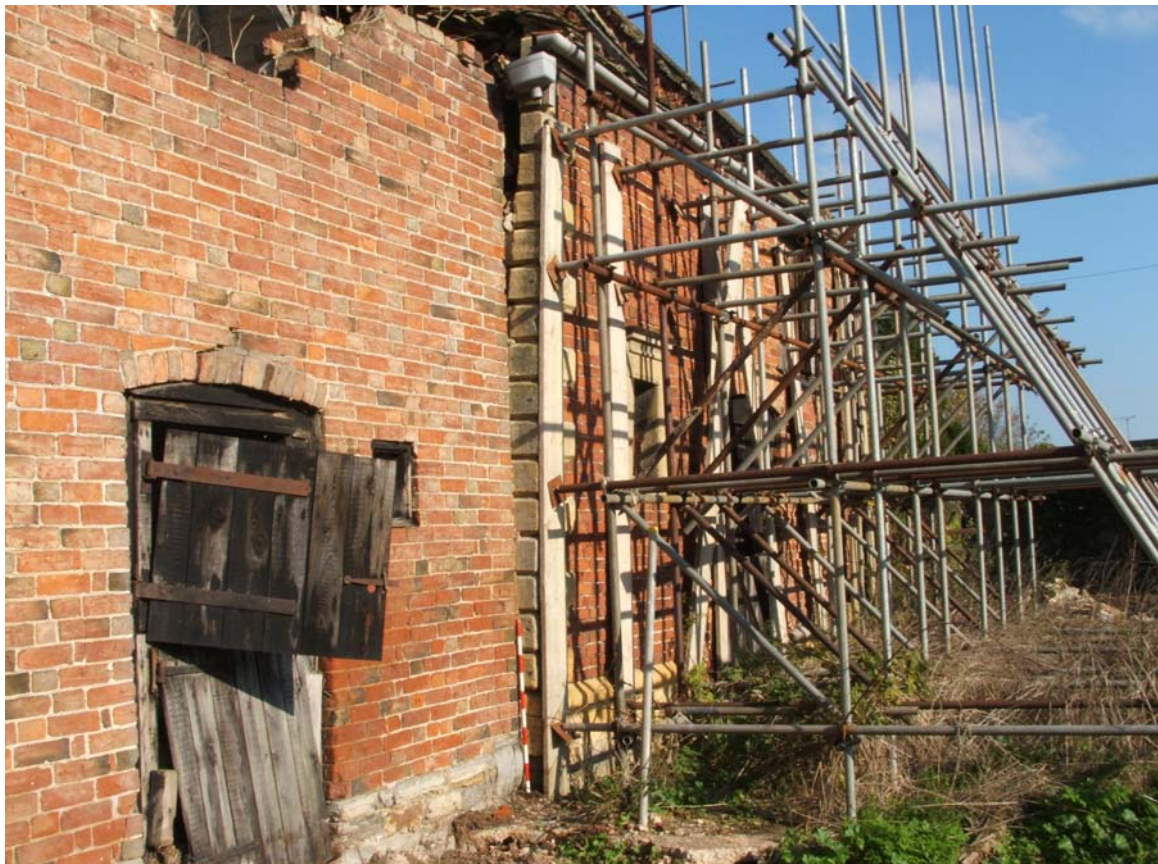
Plate 14: Block B, South wall abutting Block A

- 3.2.17 The wallplate running above the doorway has redundant rebates for braces on outer face so is probably reused or is a survival from the earlier barn. Immediately east of the cart door the south post of the central truss has been replaced in the rebuilding by an internal brick pier. The door post is set on a padstone made from a reused dressed stone (Plate 13). Just east of the doors is a diamond shaped chequerboard pattern of ventilation holes in the exterior brick fabric. In the east end bay (now demolished) there was a stable door with a shallow segmental arched head with a very small square window opening just east of it and at the east end the rebuilt wall abutted the stone quoins of Block A (Plate 14).

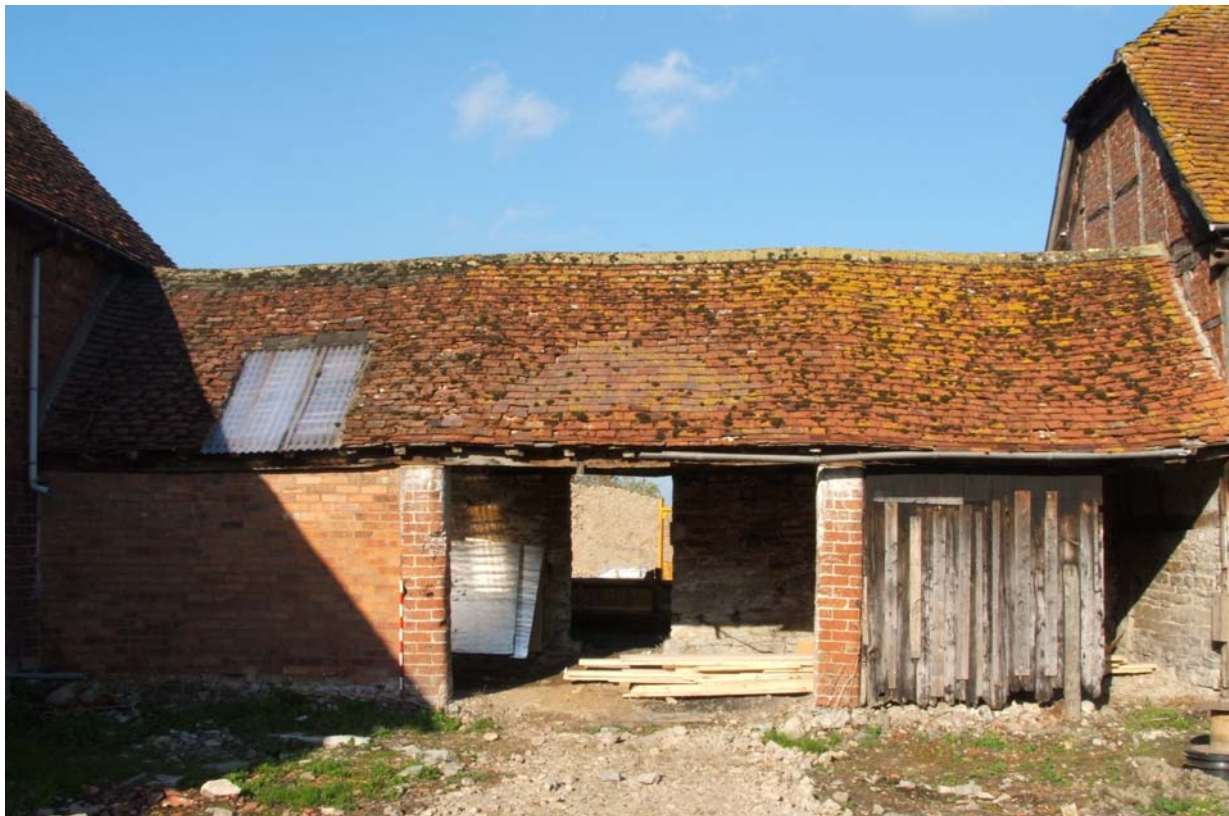
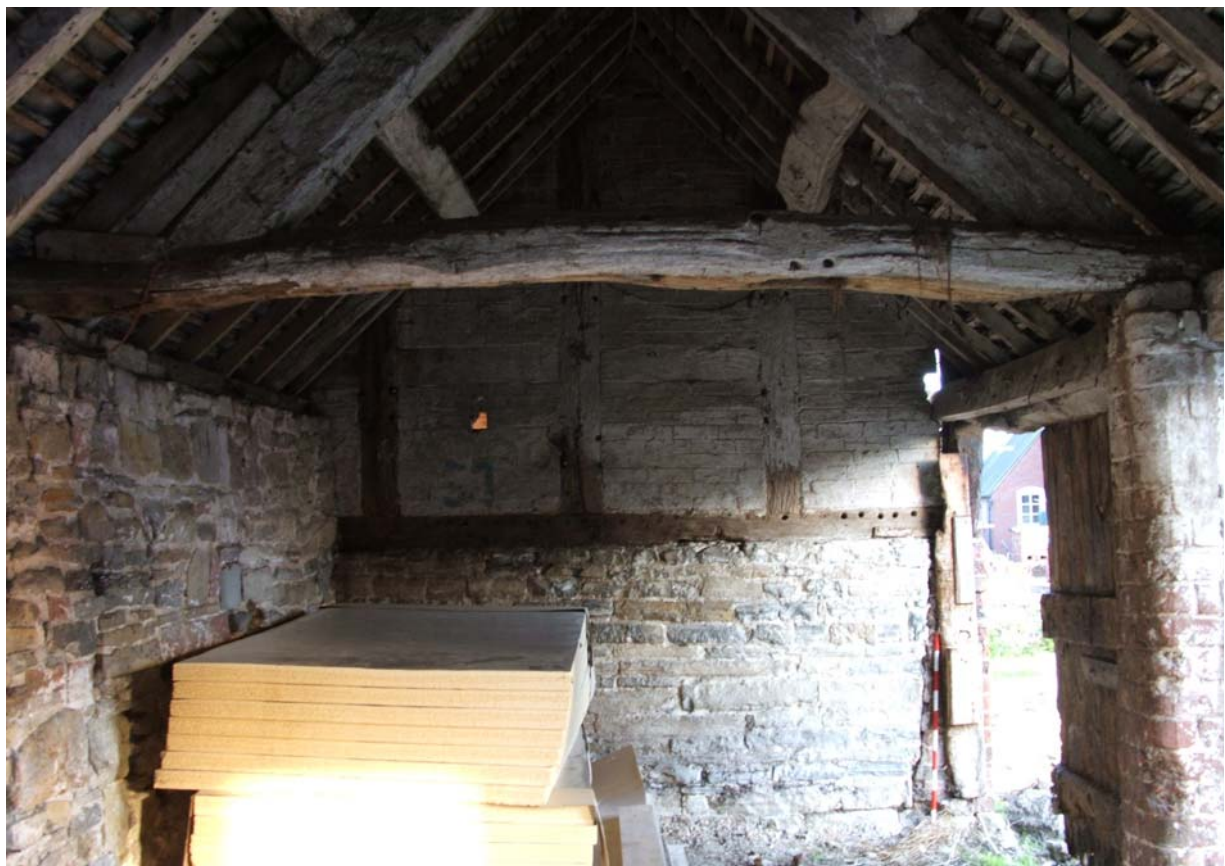
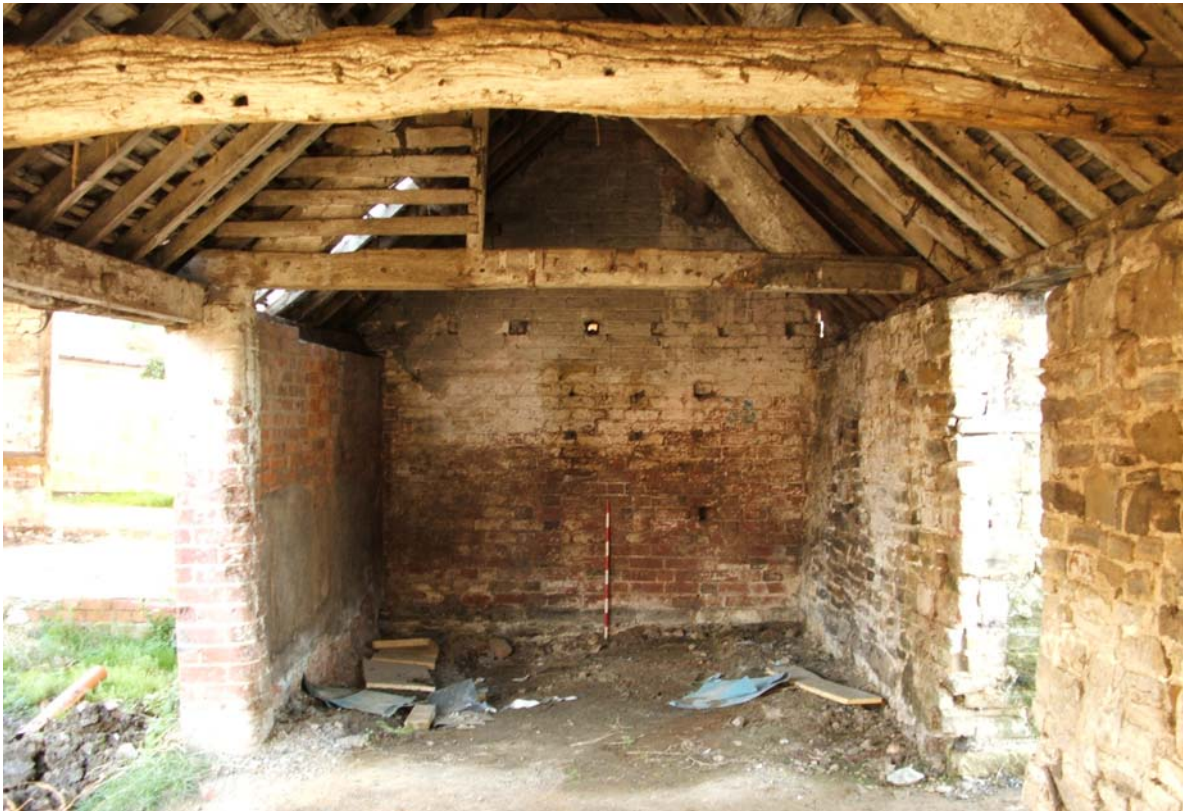
replaced. It is clearly later than the original barns but it is not absolutely certain whether it predates or postdates the 1831 reconstruction but it seems most likely it is later (Plates 20-22).

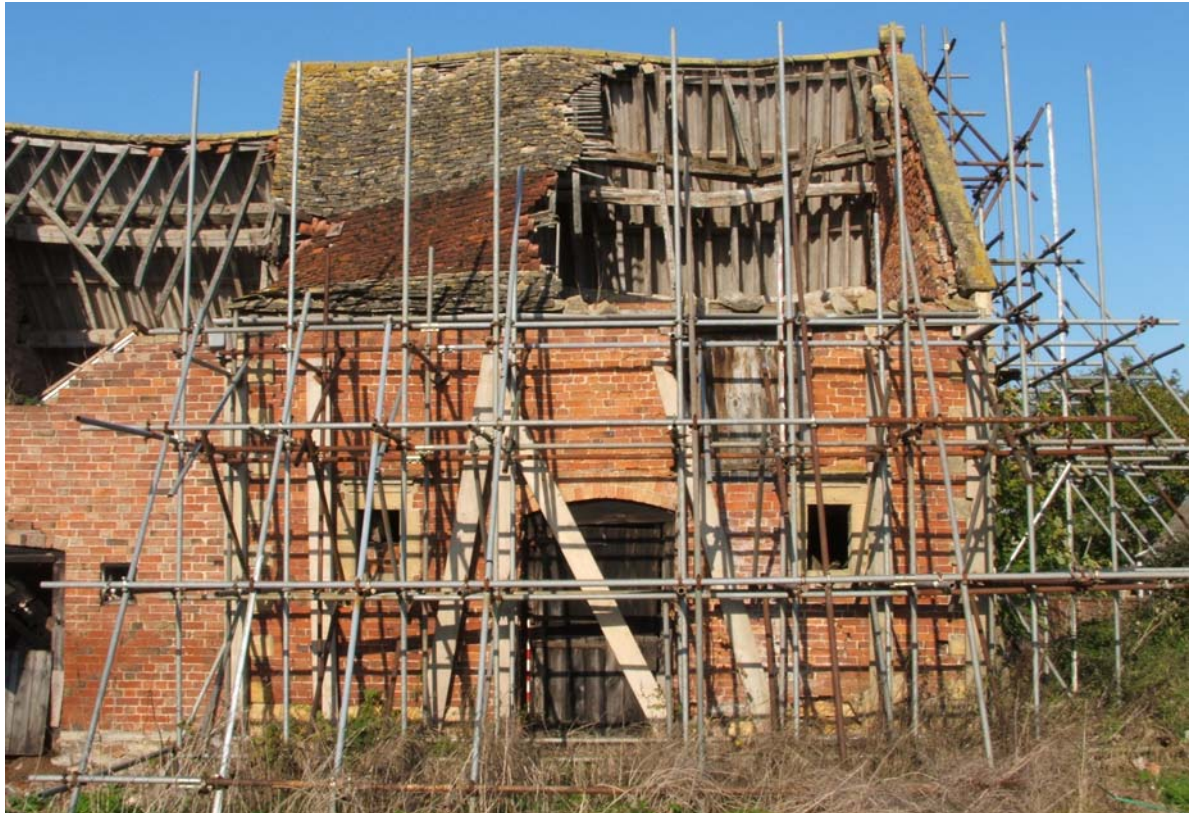
Plate 1: Block A, South elevation

- 3.1.5 The main front of the building faced south into the yard and had a central wide stable door with a small rectangular stone surrounded window to either side (Plate 1). The door had a segmental brick arch which was a later insertion. The stone window surrounds consisted of a single sill block with a chamfered splay and plain jambs and a lintel each of one block with a slight beading detail (Plate 2). Above the plain lintel was a slightly wider stone over lintel or cornice with a decorative projecting compound moulding which effectively functioned as a drip moulding. The window openings measured 0.38m x 0.50m and were not glazed but there was evidence that there had formerly been two vertical iron bars set into the surrounds. These may have been glazing bars or just security bars. The lower half of the west window had been blocked later in brickwork.
