# Vanners, Bucklebury

## Historic Building Recording

May 2017

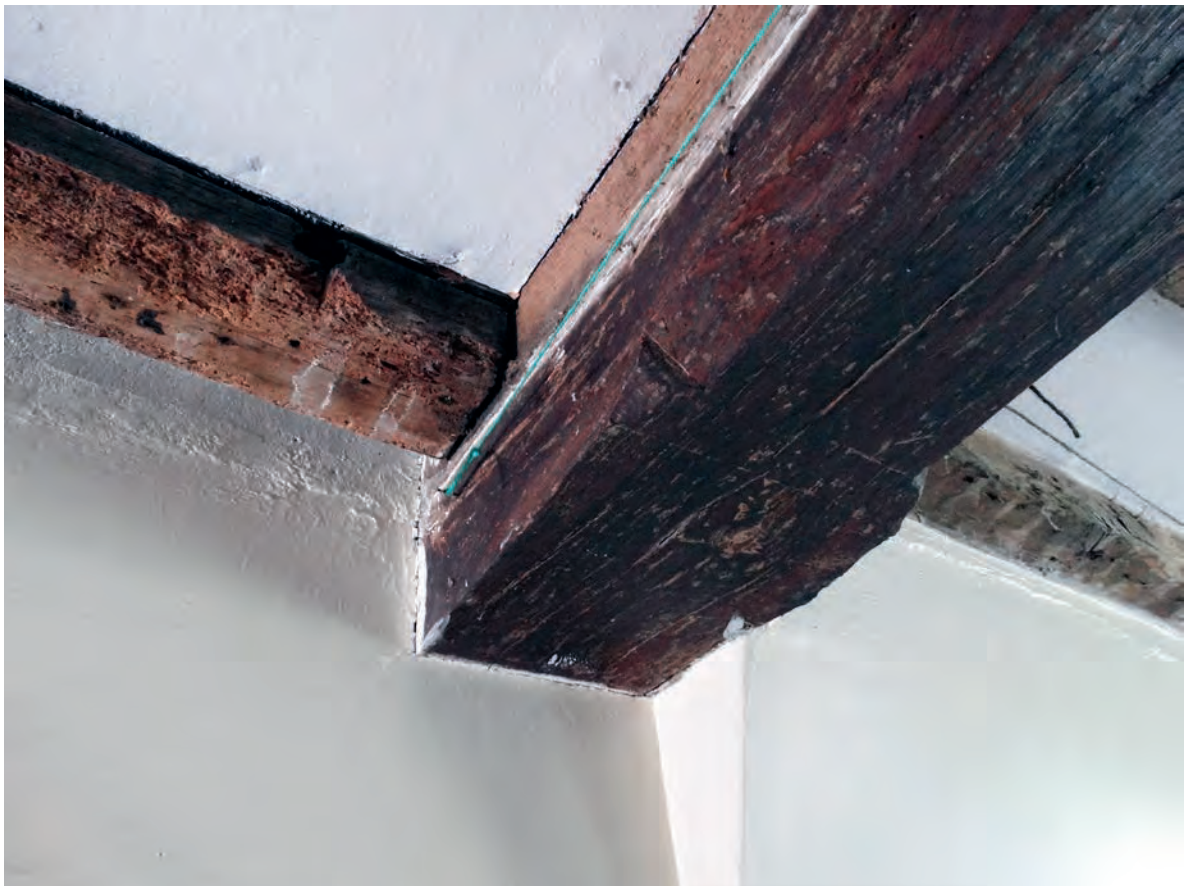
Plate 23: The chamfered and stopped beam above the fireplace

The staircase in the south-east corner was added in the mid-20th century, necessitating the cutting of the axial beam and end joist and propping of the beam with a modern post (Pls. 21 & 22). The axial beam is chamfered, with lamb's tongue stops to the surviving end at the chimney breast (Pl. 23). The pit- or frame- sawn joists are not chamfered or stopped and the staining patterns to the beam and joists show that the ceiling was previously lath and plastered, the joists being exposed and the ceiling installed at a higher level at an unknown date. The joists are not continuous to each side of the beam and those to the east of the beam are narrower and more uniform than those to the west (Pl. 24). There is no indication of alteration or reuse, other than to a joist to the west of the beam, adjacent to the chimney breast, which has several redundant mortices and what may be a very damaged chamfer and stop.

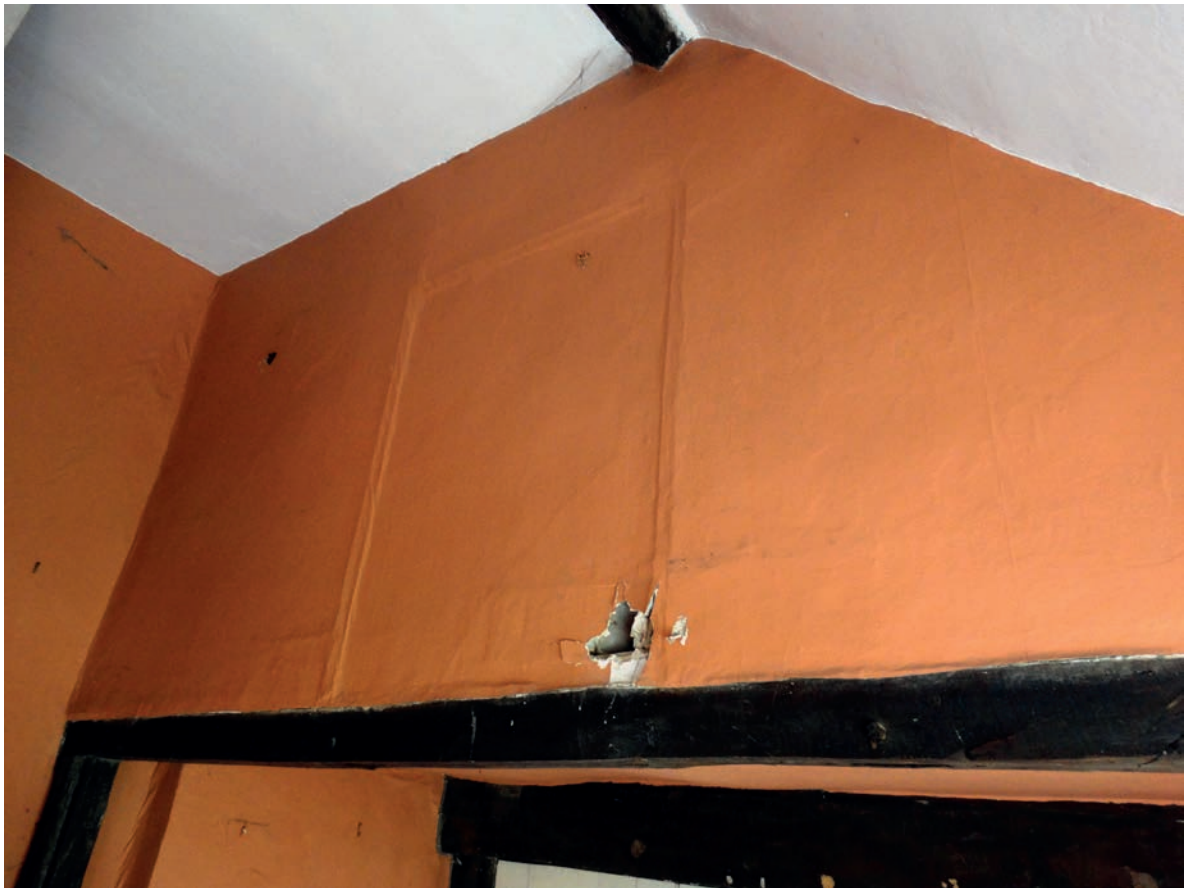
Plate 123: The blocked up water tank cupboard in bedroom 5

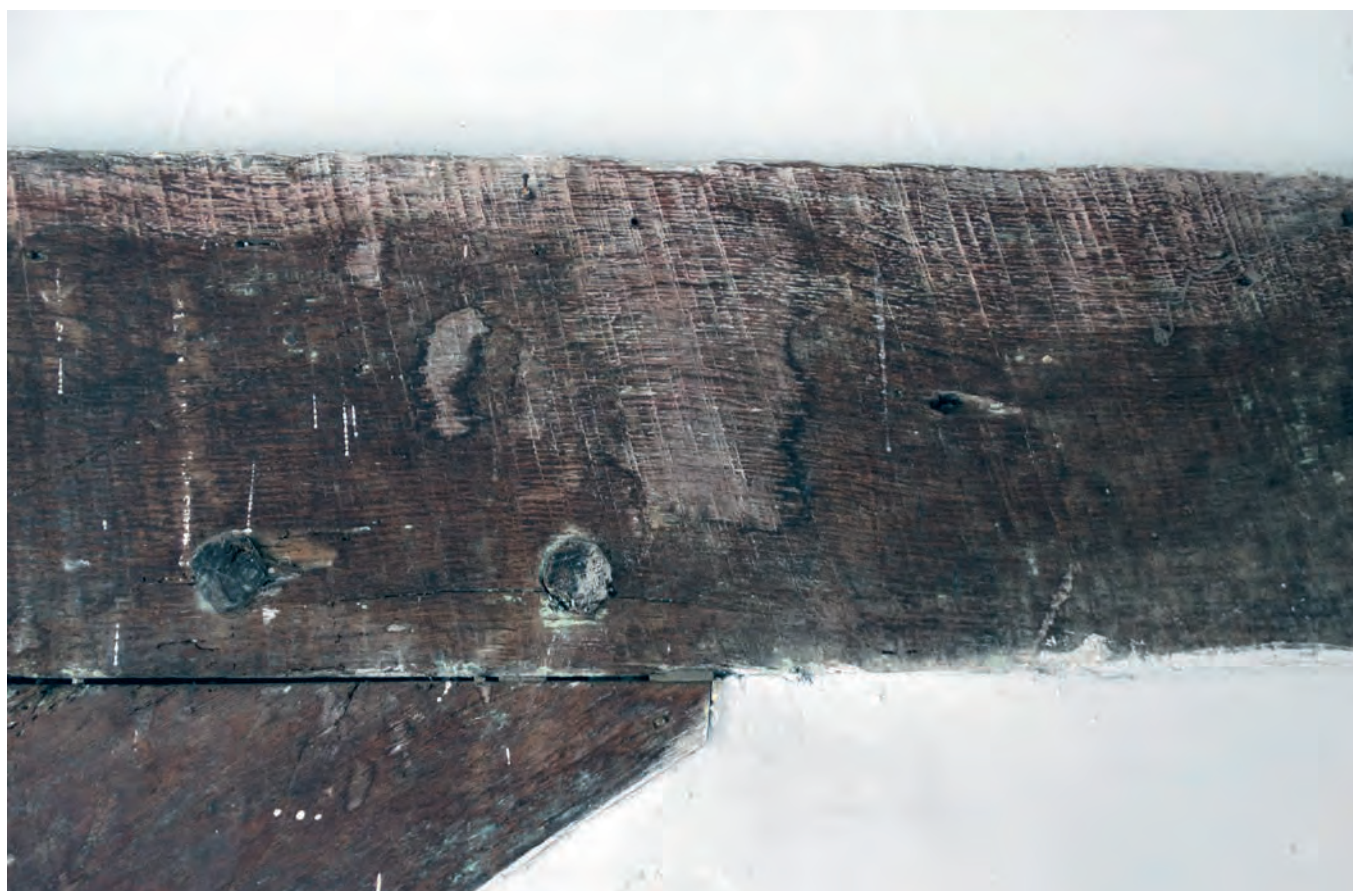
The north wall is plastered above the tie beam up to the ceiling which spans between the purlins. The tie beam is exposed across the entire frame, slightly curved upwards in the centre. Two studs form the door jambs; although the shelf above the door partially obscures the joints, they appear to be original to the frame and so blocked and re-opened with the conversion of the building to cottages and vice versa. The posts and braces are visible to each end of the frame and carpenter's marks – the only ones observed in the house – are visible at both joints between the brace and post. The crescent-shaped marks are stamped with a gouge: one each side of the joint at the west end and two each side of the joint at the east end (Pl. 135). The timbers exhibit the same diagonal pit or frame saw marks as the majority of the timbers in the frame (Pl. 136).

Plate 136: The saw marks

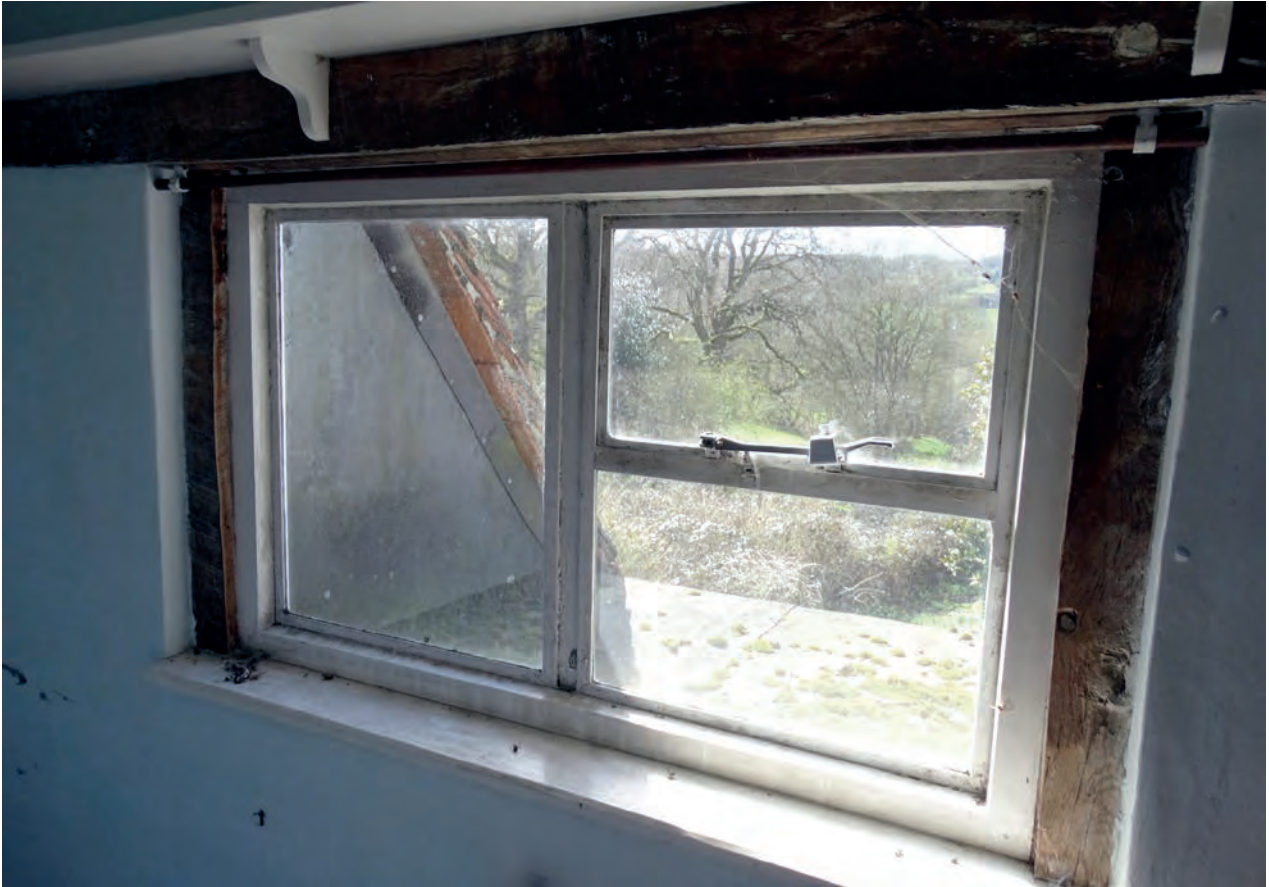
The landing window is of the same type as the study, with two lights with one small top-hung opening light with an aluminium peg stay (Pl. 139). The window in the bedroom, in the east wall, is the same wooden-framed window as the study, although one of the peg stays has been replaced with a steel 20th-century stay and one of the handles has been replaced with a plain iron catch, similar to those in the earlier window in sitting room 2 (Pl. 140).

Plate 139: The window of the southern landing
