# The Abbey Sutton Courtenay Vale of White Horse Oxfordshire

**Historic Building Investigation  
and Recording**

October 2007

**Client: Westwaddy ADP for  
The Abbey, Sutton Courtenay**

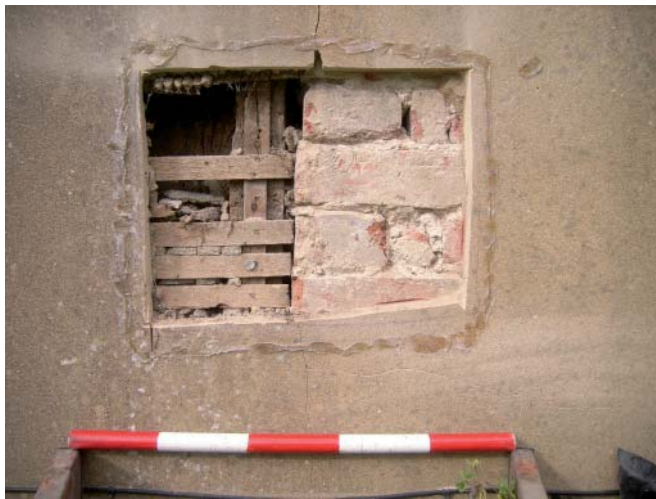
Plate 15: FI 30

- 3.4.9 **FI 30.** Below 31 halfway up the elevation. This reveals an old probably primary timber post behind later levelling up battens and laths applied over it and to the west. There is later brick infill east of the post.

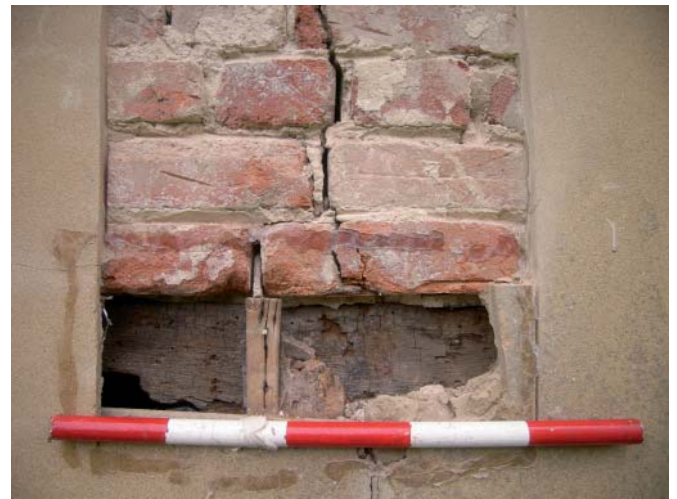
Plate 16: FI 31

- 3.4.8 **FI 31.** East of 35. This shows a small part of the wallplate with later brick raising or levelling above which here is about 0.6m high to the eaves board. The brickwork is vertically cracked here.

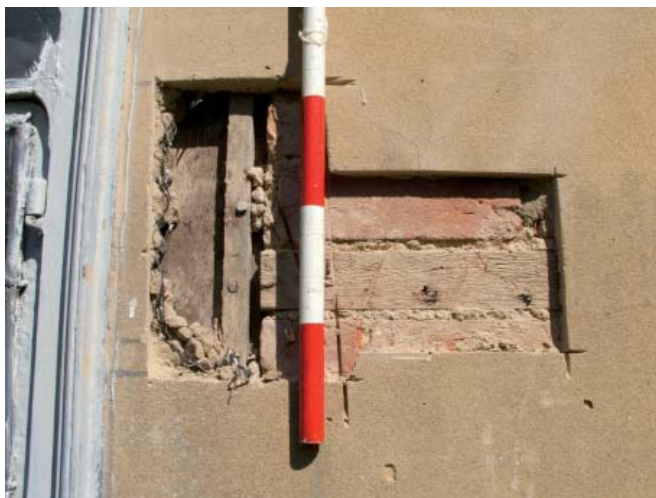
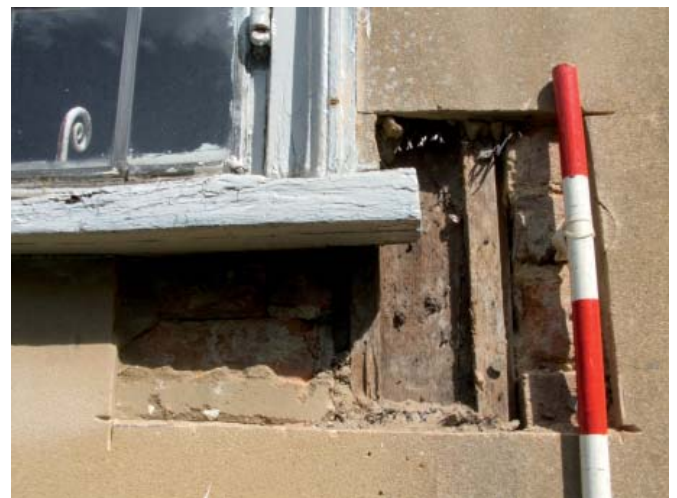
- 3.4.5 **FI 33.** East of 34. The upper investigation (A) on the east side of a first floor window showed no early fabric. There was a late post east of the window and a rail east of this with brick infill above and below, all perhaps of later 19th or earlier 20th century date. The lower investigation (B) at the lower east corner of the window showed a part of the same post with brick infill to either side.

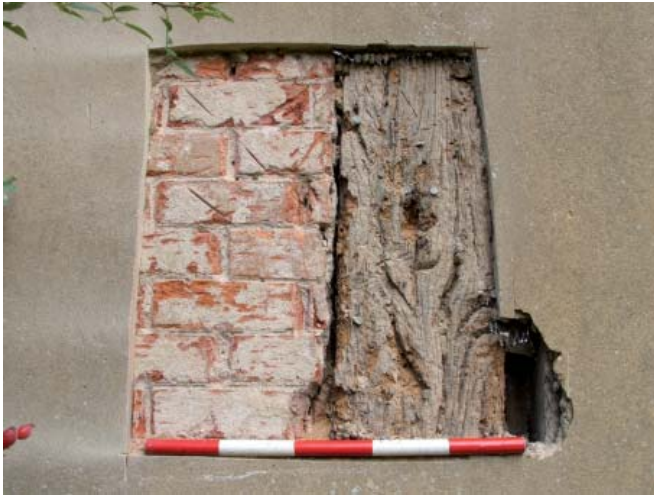
Plate 19: FI 34

- 3.4.4 **FI 34.** This shows a 60cm long section of a large main post halfway up the elevation. The post is 23cm wide in fair condition with no joints in this section. There is later brick infill to the west of the post and a small gap and then a later timber just visible on the east side.

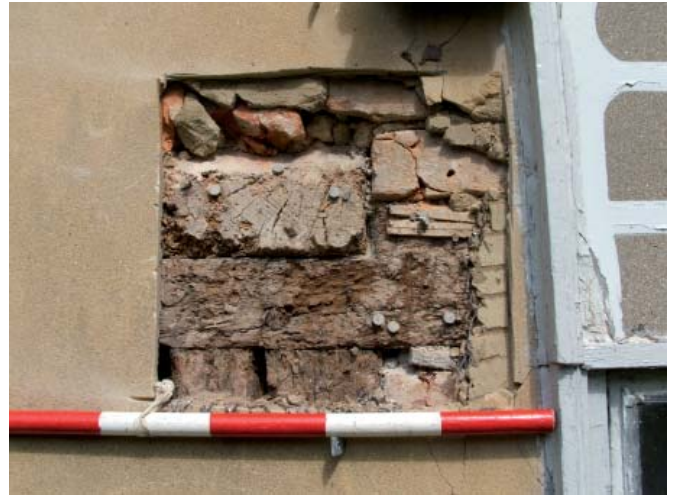
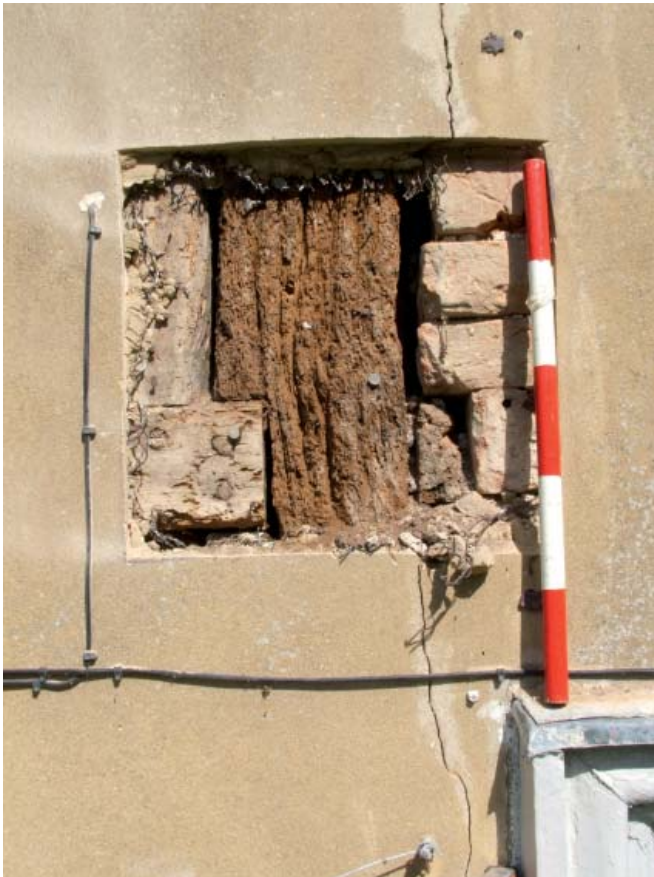
- 3.4.6 **FI 35.** East of 33. The upper panel (A) showed the junction of post, wall plate and tie beam. The post was tenoned and pegged to the plate, it had a shake in it and was about 20cm wide. The timbers and joint appeared in sound condition. The wall plate is now some 80cm below the eaves, the wall has been heightened with brick above it as this has not been done on the north side of this range (south courtyard elevation) one assumes the frame rotted and dropped (see comments under FI 36 and FI 37). There was also brick between the post and adjacent window. The lower panel (B) halfway down the wall showed a 40cm high section of the same post, 18cm wide at this point. To the east was brick infill and on the west side some later framing had been inserted. The east end of a rail had been halved into the post and pegged to it and rising from this immediately west of this old post was a post contemporary with the rail. Precisely what this corner of framing represents is uncertain, it could be part of a later window now blocked or may have had some other function such as remedial work after frame had dropped. Dating is also difficult on such a small piece, it could be anything from 17th to 19th century in date.

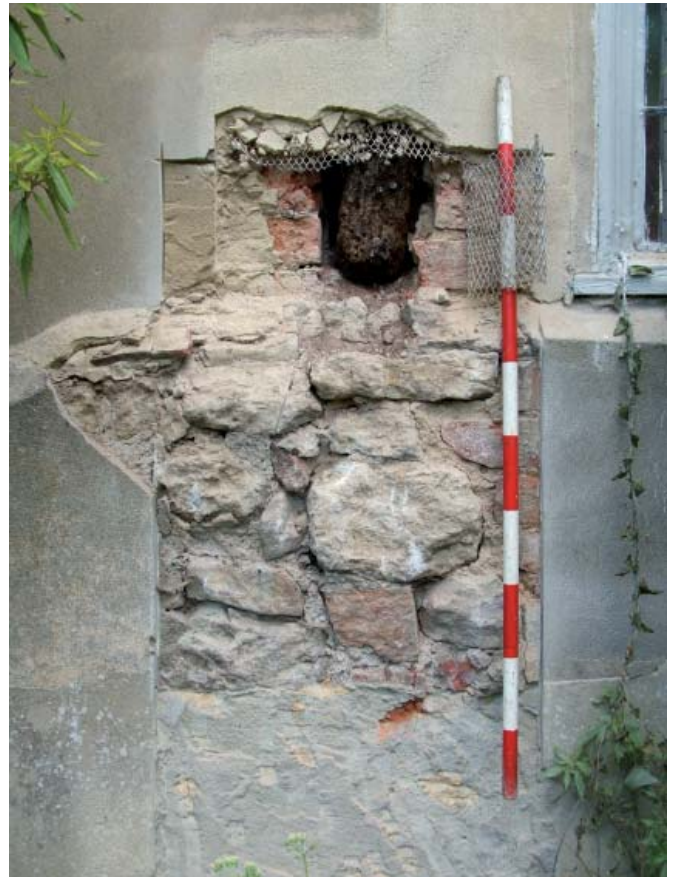
Plate 22: FI 36

- 3.4.7 **FI 36.** .At base of wall below 35. This shows the base of the post seen in 35 resting directly on the stone plinth with no sign of a sill plate and no sign of a joint or peg hole. The sill plate presumably rotted and perhaps this side of the structure dropped and this is why the wall has been built up above the wall plate, for on the courtyard side of this range the wallplate is at eaves level and the sill beam resting on the stone plinth survives. (see **FI 38**). The base of the post has rotted and is not in very good condition, there is later brick infill to either side of the post. The plinth which is 1m in height above present ground

level is of random rubble with occasional fragments of brick or other ceramic building material bonded with lime mortar.

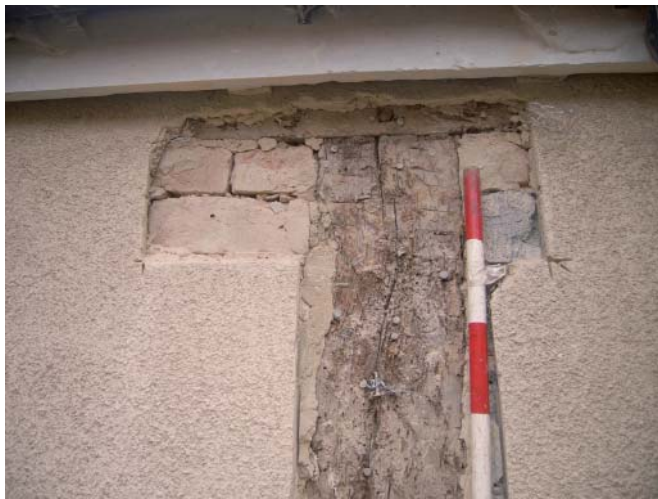
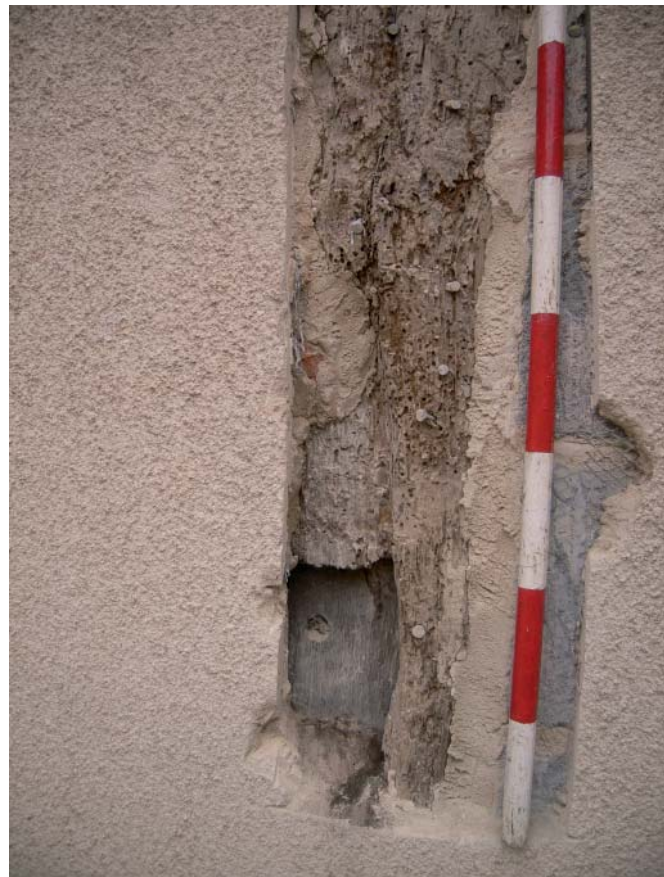
- 3.8.1 **FI 37.** This was sited on a main truss line immediately west of the door at the east end of the south courtyard wall. The top metre or so of the main post was exposed and its junction with the wallplate. The wallplate here is at eaves level and the post is tenoned into it and pegged. This is the north side of the truss seen in FI 35-6 on the south elevation where the upper investigation (35/A) showed the wallplate (with tie beam and post) about 0.8m below the eaves, built up with brick above, and the lower (36) showed the post with no sill beam on the stone plinth. The frame presumably rotted on the south side here and dropped or was lowered and the eaves built up in brick to compensate. How far this extended on the south is uncertain. The effects and compensatory alterations must be visible on the interior but this was not investigated in depth as part of this study.

- 3.8.2 Near the base of the exposed section of post about a metre below the plate there is a horizontal mortise extending right through the post with a peg hole on either side. The mortise is open on the east the front being broken or cut off. Presumably this was for a mid rail to either side subdividing the first floor panels vertically. As the 1980 sketch shows (Fig. 1) there are mid-rails at this level in the two panels to the west of the one west of the post seen here. or it is a reused timber The panel west of the post is infilled with concrete block Munby noted this in 1980 and it was probably done at that time. East of the post (at the top) there is brick infill, this panel is not annotated in the 1980 sketch.

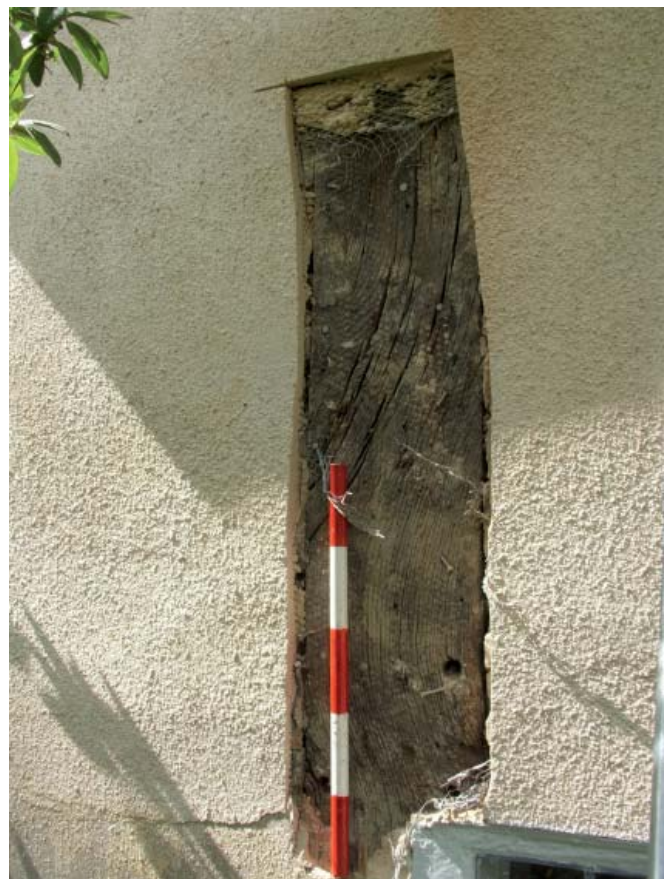
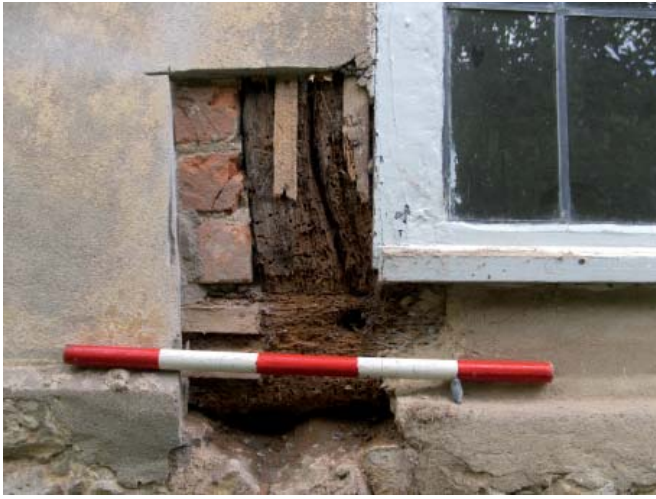
- 3.5.1 **FI 40.** This shows the first post north of the end of the elevation. The upper investigation (A) shows 1m or so of the post above the frieze window and it appears in good condition here and measures 0.25m in width. This post is also the south jamb of the window which extends across four panels with the next three posts acting as mullions between the square lights.

- 3.5.2 There is a mid-rail at the top of the window and peg holes on both sides of the post mark where this is mortised to it. There is a second peg hole on the north side about 11cm above the first. The photograph from 1982 (fig ) shows that this is redundant. It may therefore indicate re-use.

- 3.5.3 The lower investigation (B) shows the base of the post below the window and the sill plate into which it is mortised. The faces of the timbers and the soffit of the plate are somewhat eroded, but they are still tightly joined and appear relatively sound. The sill beam sits directly on the high stone plinth and some of the later brick infill was exposed to the south.

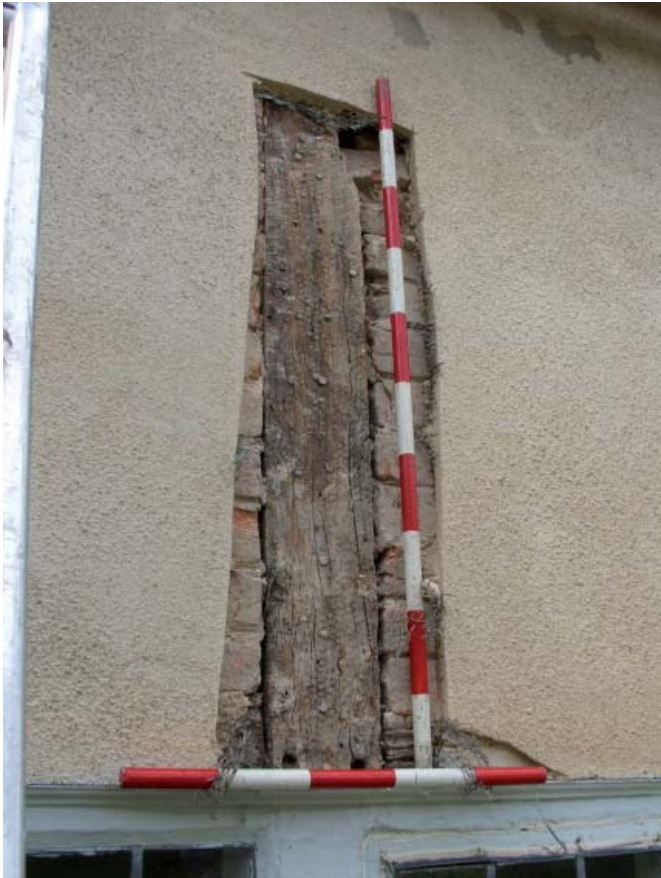
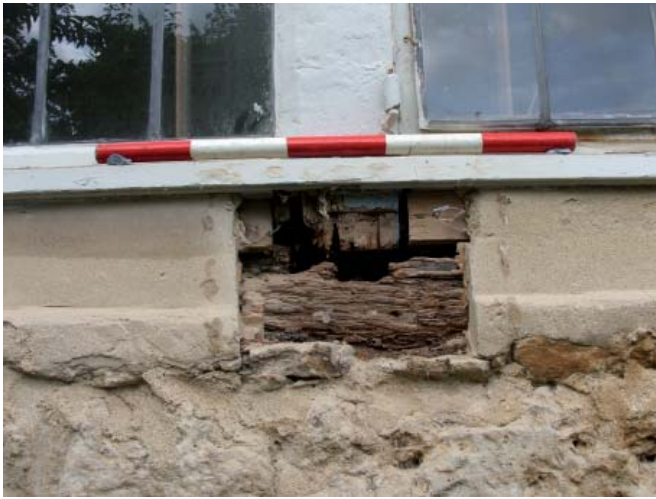
- 3.5.4 **FI 41.** This shows the fourth post from the south end of the elevation. The upper investigation (A) shows about a 1m of the post above the window. This measures 15cm in width and is in good condition, the brick nogging of the panels to either side was partially revealed. The tops of the mid rails mortised to the post were also exposed and appeared sound. Below the rail there are window panels to either side of the post and the outer surface is exposed and painted as part of the window. Below the window the lower investigation (B)

showed the join of post and sill plate. Unlike no 40 this joint was badly eroded but the timbers were still relatively sound.

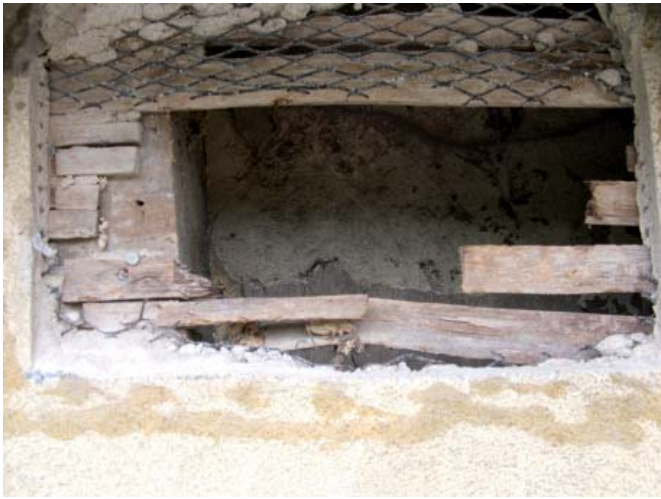
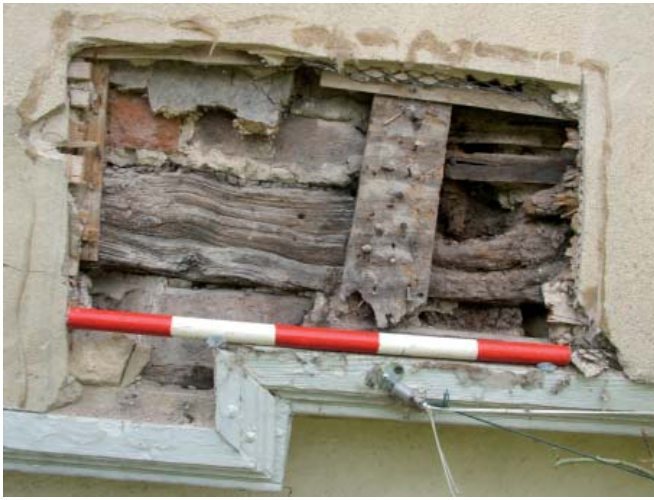
- 3.5.6 **FI 42.** The upper investigation (A) just below eaves level shows the old surface 15cm behind the modern render. This had been levelled up with substantial battens and laths to which the expanded metal had been fixed. No primary or early timbers were exposed. At the lower investigation (B) the jetty plate and the end of joist supporting it were visible and a post rising from the plate above the joist. The plate was quite eroded around the joint. The plate was not large being only about 12cm wide on the outer face. Brick nogging was exposed in the panel above the plate and south of the post. North of the post there appeared to be old laths over, or integral with, old daub and over this were later laths, expanded metal and the modern render.

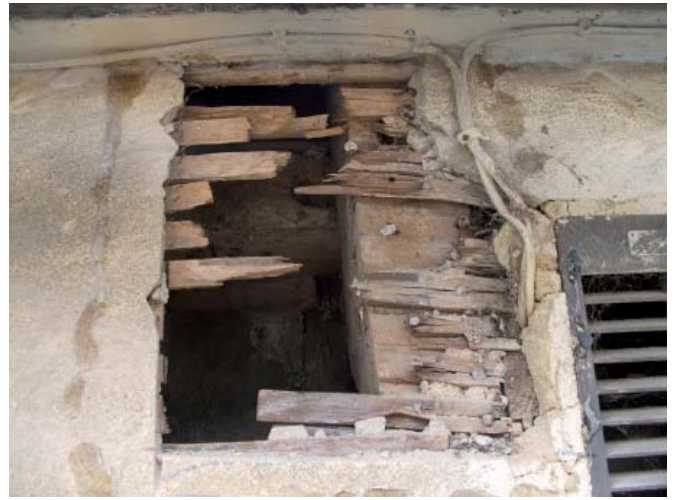
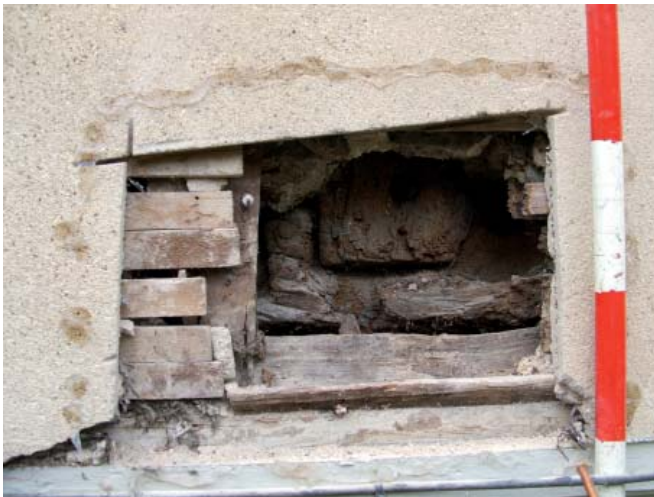
- 3.5.7 **FI 43.** The upper investigation (A) showed the old lime infill surface 25cm behind the modern render. An old post was just visible behind a later post. The surface had been levelled up with a timber framework of substantial rails and battens which had been lathed over this may have been 19th century in date. The modern expanded metal had been nailed to the earlier levelling and then rendered. The lower investigation (B) showed the base of the post jointed to the jetty plate. The tenon was exposed, the front part of the plate was either eroded or this was a lapped joint. The north end of the joint was empty and the north side of post slightly angled as though there may have been a brace extending up and north but it may just have indicated decay of the post base. Just south of the joint the end of a face-halved scarf in the plate was visible. There were the remnants of earlier laths and daub or lime mortar which appeared to have covered the post. These in turn were overlaid by later, possibly 19th or early 20th century, laths and then the modern render.

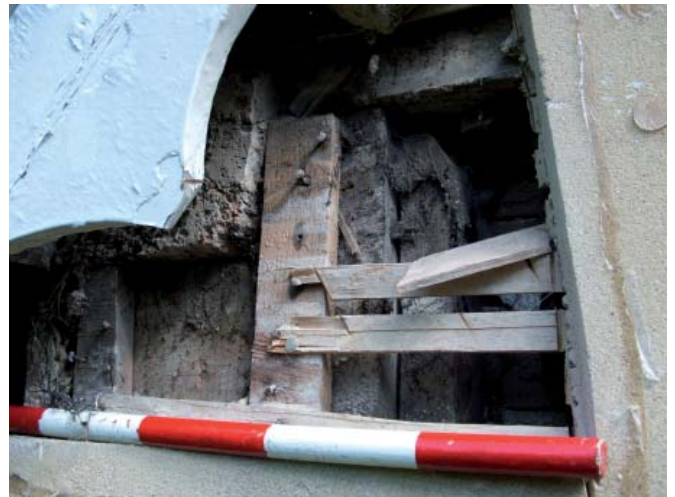
Plate 34: FI 48/A

- 3.3.1 **FI 48/A.** This shows the junction of mainpost wall plate and tiebeam on the north side of the west facing gable at the south end of the hall range; the former service wing. The tie beam is above the wall plate as usual in English timber-framing (normal assembly). The post is not jowled but passes the wallplate to join to the tie beam as well. The post is partly obscured by later battens but is no more than about 0.22m wide.

- 3.3.2 The wallplate overhangs the post on the north side (outside) and later battens fill out the wall to the north to take the surface beyond the face of the plate. The overhang on this side and opposite (see 49) is the result of using a non-jowled post to create a joint to both wallplate and tie, this could possibly indicate later insertion. The joint cannot be seen in detail but the timbers seem in fairly good condition.

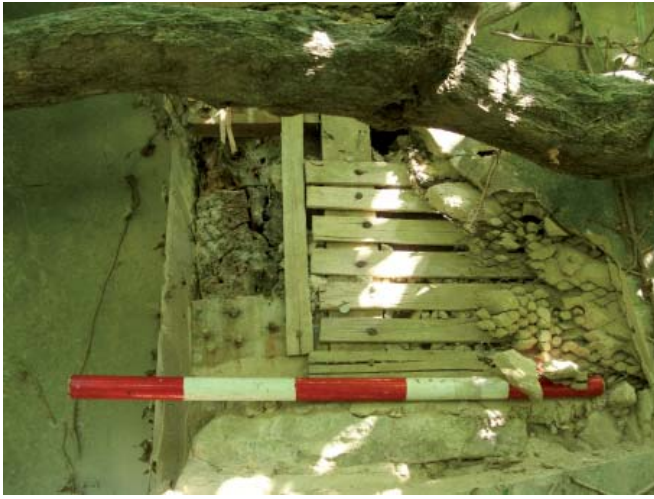
Plate 35: FI 48/B

- 3.3.3 **FI 48/B.** Below 48/A; this shows a sill plate and corner post (base of post in 48/A) at first floor level seated on the ground floor stone wall.

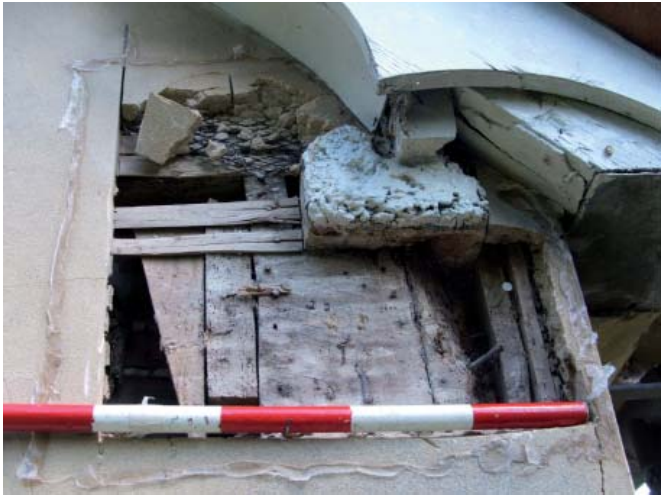
Plate 36: FI 49

- 3.3.4 **FI 49.** This shows the junction of mainpost wall plate and tiebeam on the south side of the west facing gable (opposite from 48/A) at the south end of the hall range, the former service wing. The post is not jowled but passes the wallplate to join to the tie beam as well. The wallplate overhangs the post on the south side (outside) but an old timber batten has been inserted under the wallplate and there is further later levelling which takes the current south wall face out beyond the face of the plate. The joint cannot be seen in detail but the timbers seem in fairly good condition.

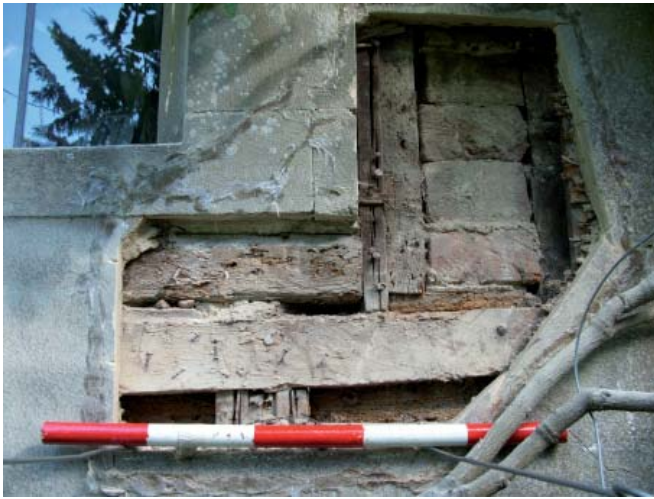
Plate 37: FI 50

- 3.3.5 **FI 50.** At the lower south corner of the first floor window in the west facing gable south of the hall. This shows the stone surround of the window is built within a timber surround which is just above a large timber plate, the plate is largely obscured by later levelling battens but is at the same level as the plate in FI 50 and is presumably a sill beam resting on the lower stone wall. South of the window support framing there is a narrow panel of brick infill and a later timber upright south of that. The timber window surround may have been the surround for an earlier timber window or may have been inserted later to support the stone window.

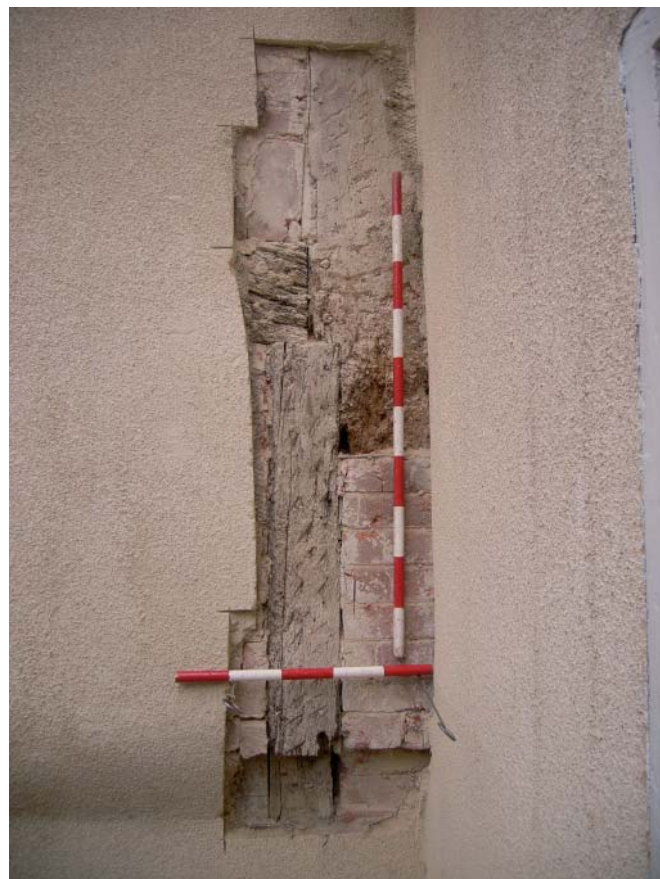
Plate 40: FI 51/B

- 3.8.6 **FI 51/B.** Below 51/A this shows a long lower section of the main post. A main rail at first floor level is mortised into the post and the joint is held with two pegs. The post is 25cm wide and the rail is 22cm wide. East of the post and above the rail there is brick infill. About 25cm below the rail the post has been truncated perhaps because of early decay and there is brick infill below it. A later post has been inserted on the west which has been partially cut into the primary post so that its upper surface is bearing against the post and the rail, although later this post is still of some age and like the primary post and rail its surface has been lightly axed to key a coat of render.

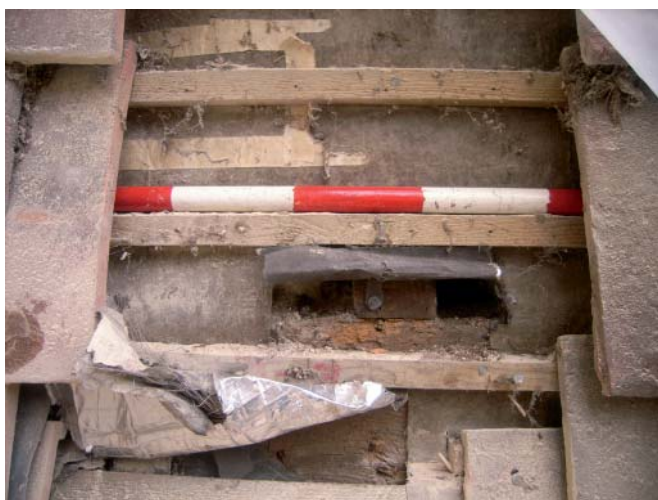
Plate 41: FI 52

3.7.1 **FI 52.** Located at the extreme south end of the elevation on the east facing wall of the service wing. This was at the base of the tile hung gable and beneath the tiles a small section of an old plate was exposed which had a V-section slot in its upper surface; this may have been for inserting staves to take an earlier daub infill. The base of a post or stud seated on the plate was seen and this may have been a later insertion as no joint was visible but only a small area was exposed.

3.7.2 A photograph taken about 1981 during works to the house shows that this section had been within a lean-to addition which was removed at that time and

was subsequently tile hung to match the upper gable. Several intermediate posts can be seen rising from the substantial plate. The wall below the plate is infilled with concrete blocks and possibly this had been open into the lean-to but previous to the lean-to being added there would have been some framing here (Plate 66).

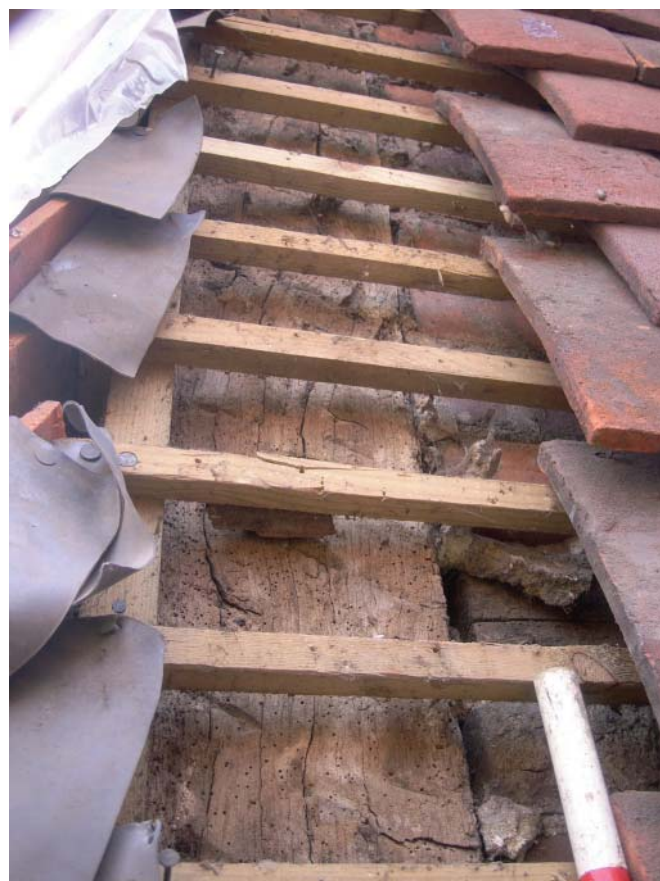
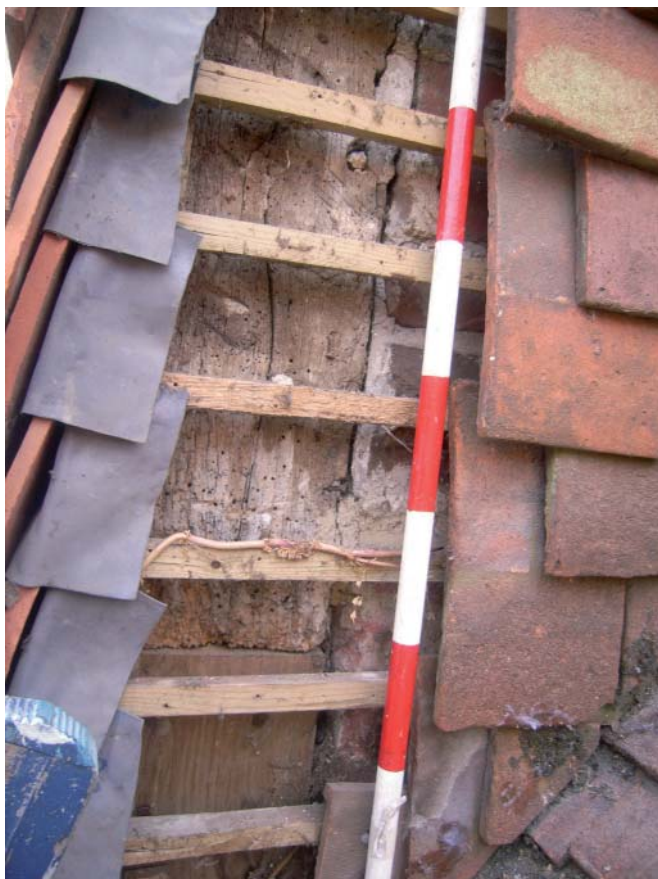
- 3.8.9 **FI 54.** This was located on the east end of the tile hung north wall of the service wing adjacent to the east slope of the hall roof. This exposed a large area of the corner post and wallplate which were joined and pegged. The lower part of the post had been replaced by a later softwood insert. Above this a peg hole on the west side of the post may indicate the former position of a rail, there was a carpenter's mark in the form of four parallel incised lines below the peghole. There was brick infill west of the post with a later horizontal timber in the brickwork abutting but not joined to the post.

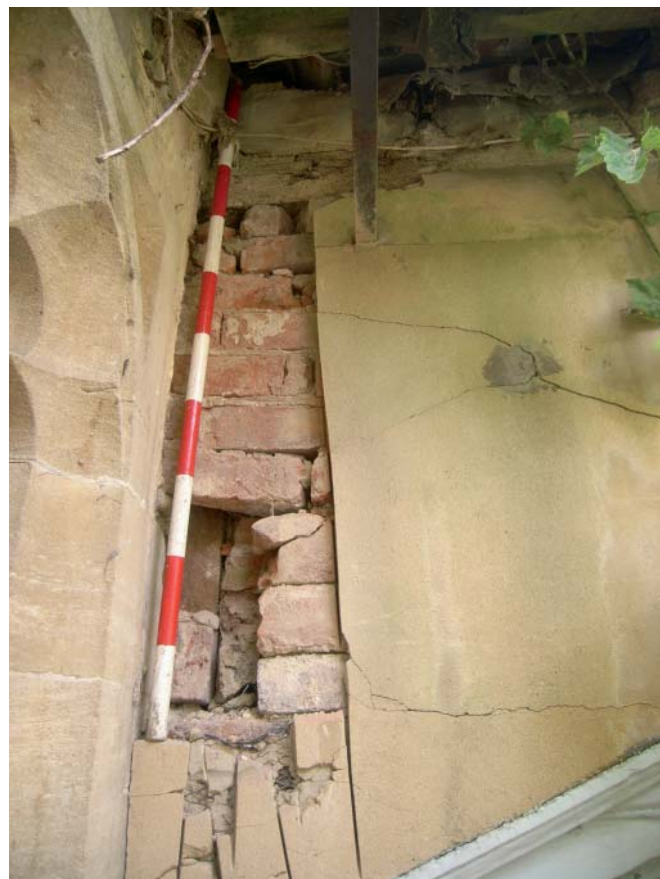
Plate 44: FI 55/A

3.6.1 **FI 55 A.** Located at the west end of the elevation above the door in the outshut leading to the stairs to the upper chamber. This showed the wallplate of the outshut with brick infill below abutting the wall of the hall.

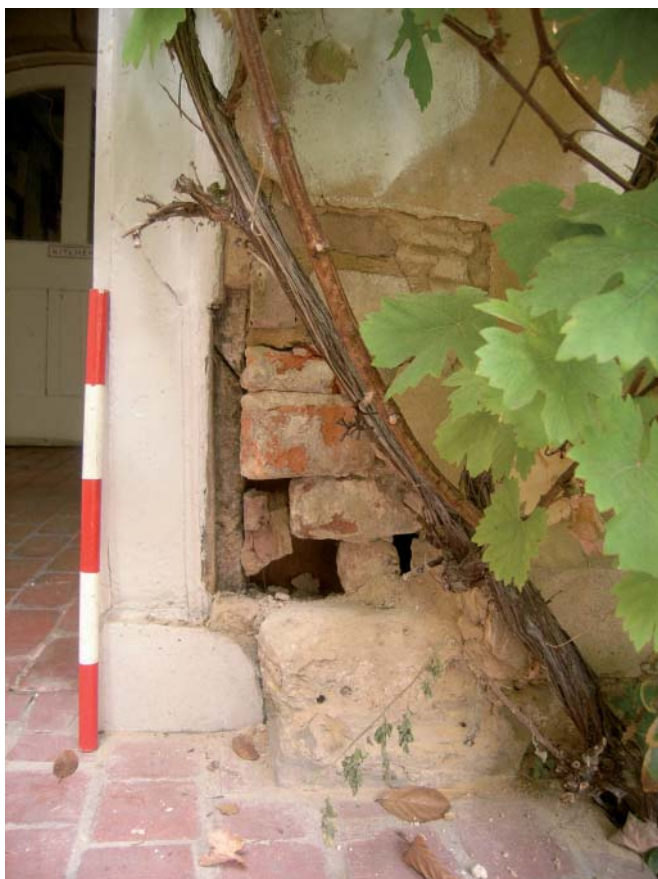
Plate 45: FI 55/B

3.6.2 **FI 55 B.** On the east side of the outshut door at the base of the wall; this showed the doorpost has a splayed joint where a new lower section has been scarfed in. There is brickwork east of the door sitting on a low stone plinth with no sill beam.

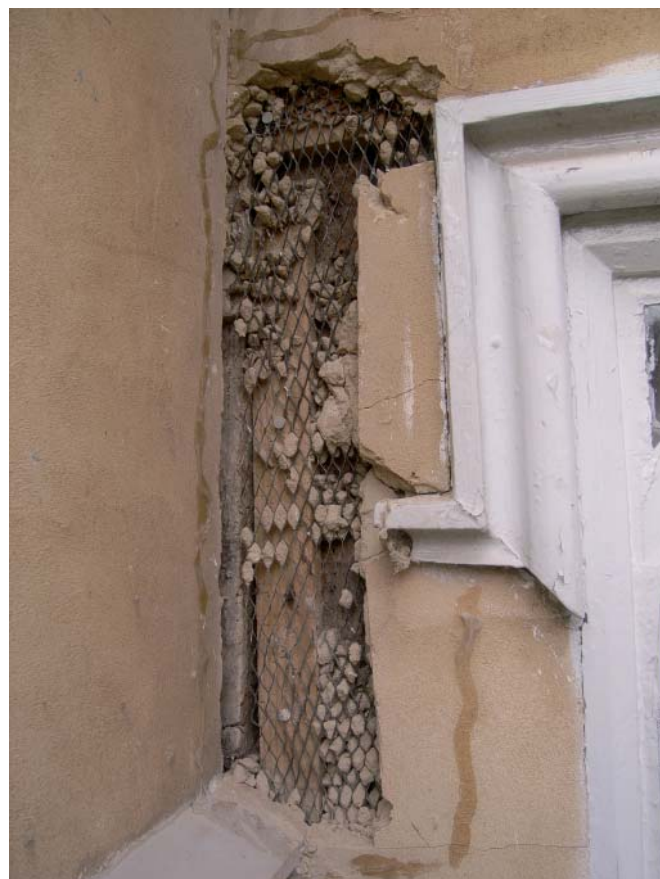
Plate 46: FI 58

3.6.3 **FI 58.** This at the angle of the courtyard wall of the north range and the outshut over the stairs, west of a first floor window. An old post was visible behind modern levelling battens and metal mesh. This is probably the corner post of the later timber-framed east end of the north range where it abuts the earlier stone masonry of the high chamber.

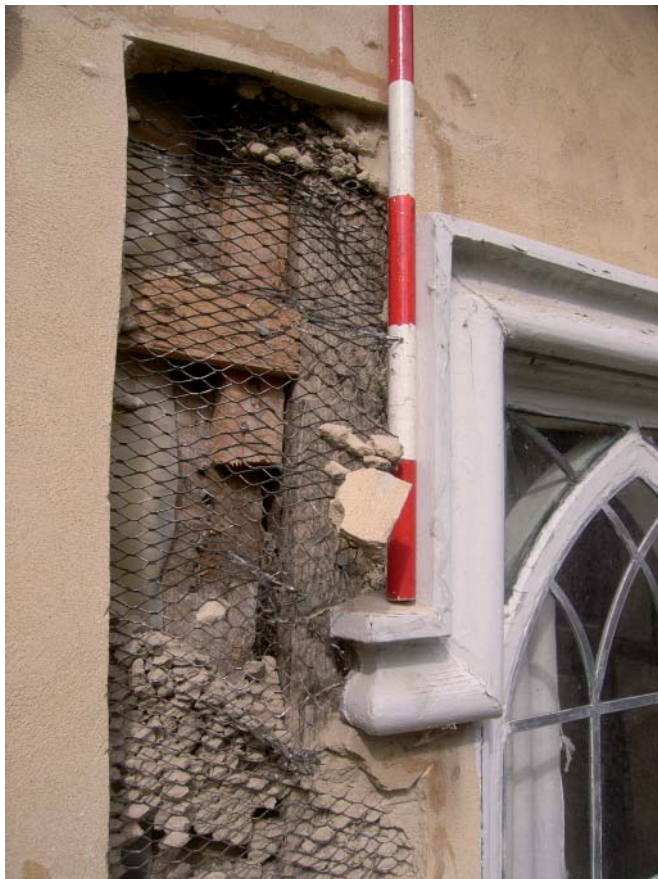
Plate 47: FI 59/A

3.6.4 **FI 59/A.** To the west of the east first floor window. This is on the line of a main cross frame and revealed a post immediately west of the window which is probably a primary post. Another upright was abutted to the west side of it and set back which is probably a later insertion. Modern battens to level up the face and metal mesh and render were affixed over the older timbers.

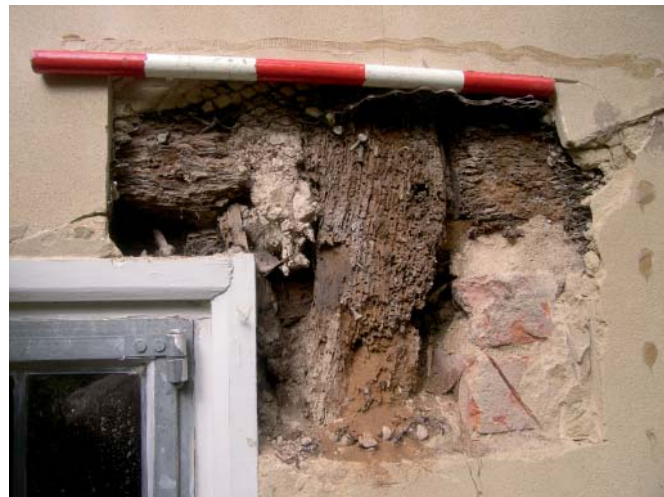
Plate 48: FI 59/B

3.6.5 **FI 59/B.** Below 59/A at first floor level and at the top east corner of the ground floor window. This shows a post with the first floor plates mortised in to either side of it. The post is about 14cm wide. The timber is quite eroded around the joint and the post is decayed and powdery below the joint. The panel below the plate and west of the post has later brick infill.

3.6.6 There was a small empty mortise about 6.5cm long in the soffit of the west plate just west of the joint. This may indicate reuse or perhaps there was an early window in this panel but this is very speculative until further evidence is uncovered.

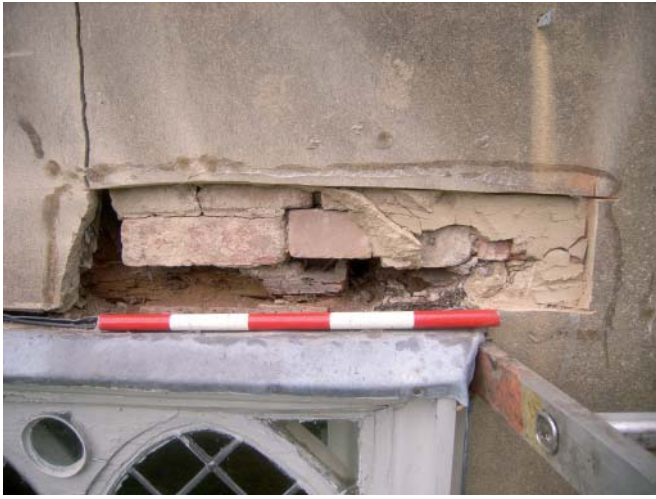
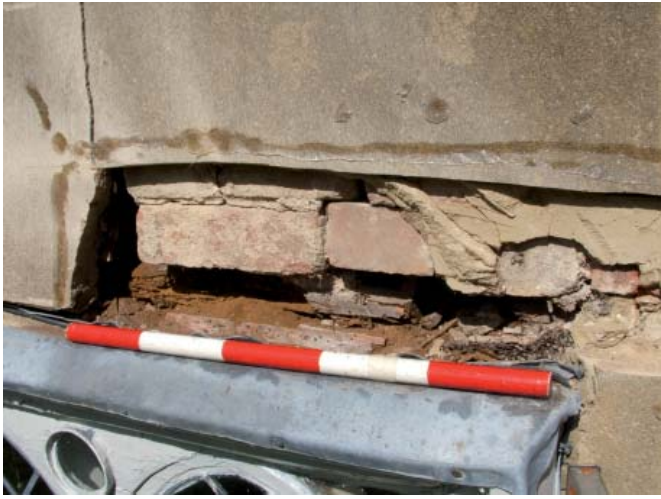
- 3.4.10 **FI 63A.** At east end of south elevation above the east ground floor window. This reveals the timber plate or lintel over the window with brick infill above it. The timber is in extremely poor condition crumbling to powder. However portions of the outer face survive and exhibit remains of what appears to be red paint, specialist investigation would be necessary to identify whether this is an early colour scheme and may not be appropriate for this one timber. Later large scale exposure of the historic fabric may reveal the full extent of this treatment.

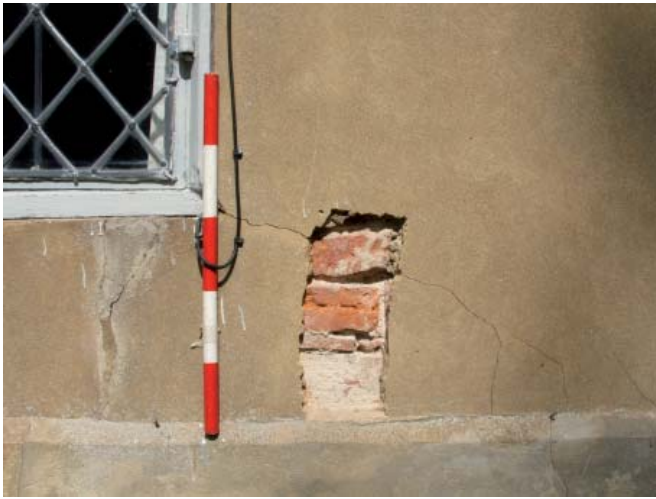
Plate 53: FI 63/B

- 3.4.11 **FI 63B.** Below 63A just away from the lower east side of window reveals a small area of brick masonry incorporating some fragments of tile.

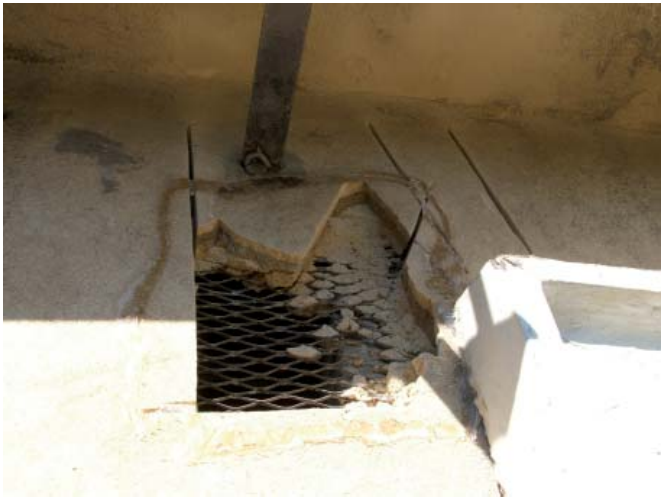
Plate 54: FI 64/A

- ### 3.4 **South Elevation** (*Further Investigations 30-1, 33-6 and 63-4*).
- 3.4.1 **FI 64/A.** This was at the top of the south wall of the service wing south of the hall, on the west side of the first floor window. Behind the modern expanded metal the west side of a post was visible which was 0.14m deep. The window clearly abutted the east side of the post. There was no infill west of the post but there was lath and plaster on the rear face so the panel here must be hollow between the modern render and older lath and plaster.

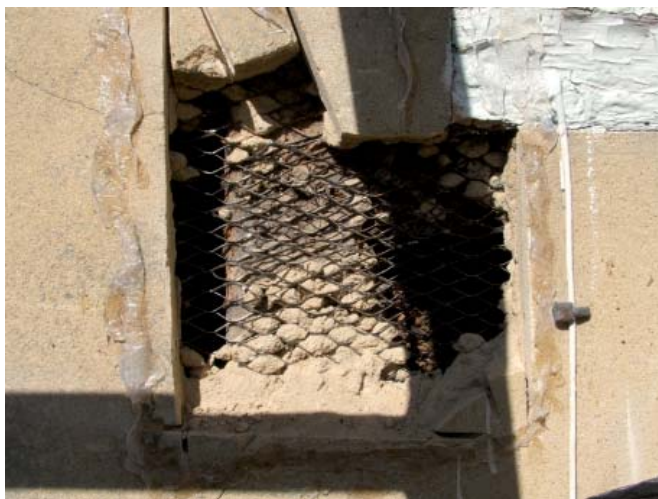
Plate 55: FI 64/B

- 3.4.2 **FI 64/B.** Below 64/A at the lower corner of the same window. There was a post on the west and a rail below the window, the post was 14cm deep and about 17cm wide. It appeared to be badly eroded and no longer supporting the rail as originally intended. No infill could be seen west of the post or below the rail.

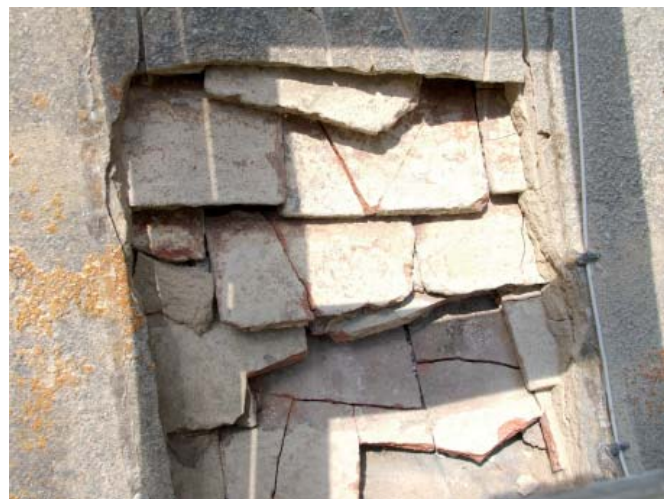
Plate 56: FI 64/C

- 3.4.3 **FI 64/C.** This was below 64/B at first floor level where there is an offset in the wall and revealed the base of a tile hung facade of the first floor which had simply been covered over by the modern render. The tiles exposed were plain red tiles and there were no decorative elements.

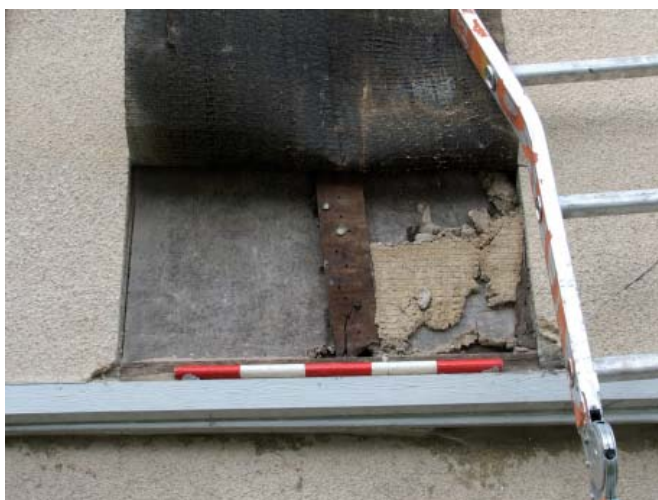
Plate 57: FI 65

- 3.5.5 **FI 65.** The former surface of lime plaster or render was exposed below the modern render above the plate at the south end of the shallow jetty. Roofing felt had been hung on the old surface over some later levelling battens and odd patches of mortar. The old surface leans back from the vertical and was levelled up by the present rendering. The exposed top of the plate was in good order.

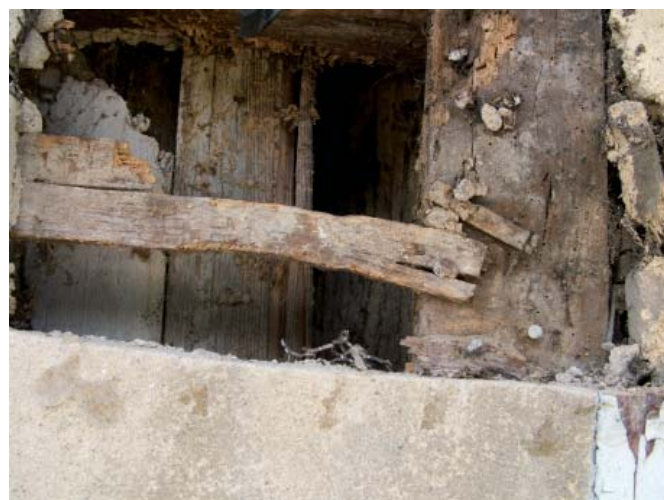
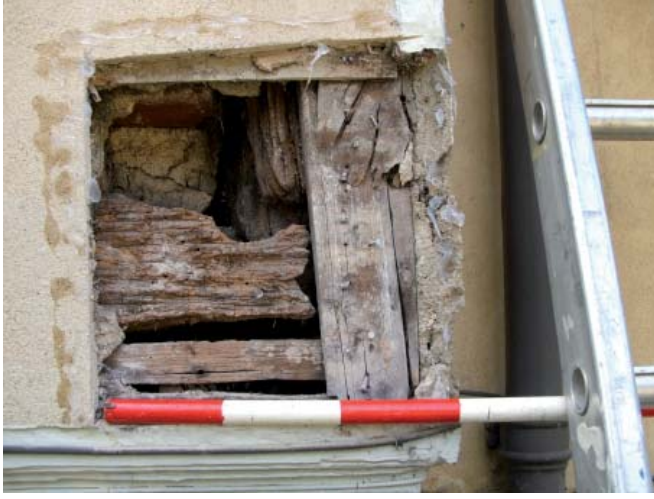
- 3.5.8 **FI 66.** The upper investigation (A) did not appear to reveal any primary fabric but exposed later levelling up of the facade as seen elsewhere, with the present render on expanded metal sheeting nailed over earlier laths. The lower exploration (B) exposed the original jetty plate and corner post of the jettied section, the joint was eroded and open. Some brick infill was visible and where a brick was missing some internal lime plaster or mortar was exposed. There were later levelling battens and lath over the early fabric.

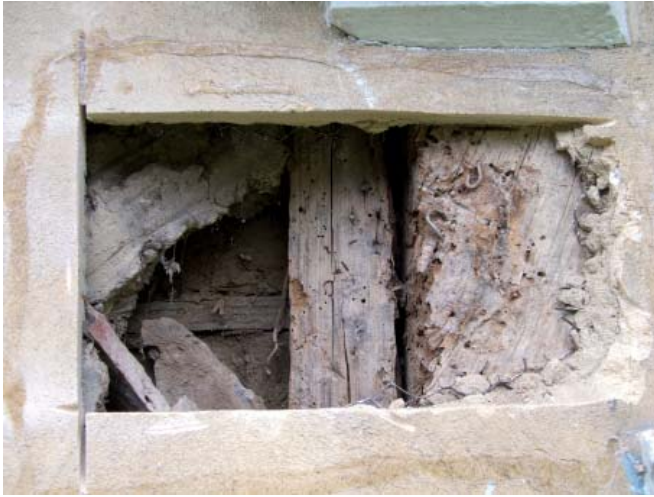
Plate 61: FI 67 (north)

3.2.1 **FI 67(north).** This is on the east side of the first floor window at the east end of the north elevation just below the east dripmould. On the west side of the investigation is an old post and east of this a smaller timber batten. The back of an internal lath and internal daub coating were visible. Immediately behind the modern outer render were displaced pieces of daub and broken plain tiles.

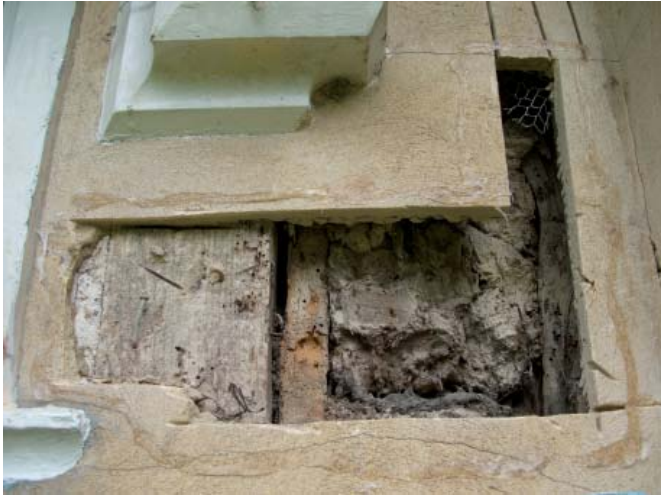
Plate 62: FI 68/A

3.2.2 **FI 68A** On the opposite side of the window to 67. Above 68B just below the lower end of the window dripmould. This showed another section of the upper post revealed in 68B, 12cm wide and in sound condition as far as could be seen. West of this was a narrow strip of timber and then a narrow section of old daub type infill with the corner of another old timber of unknown size on the west of the exposed section. This is either the post seen in 68C with the rail seen at 68B joined to it or it is above that post with rail between them.

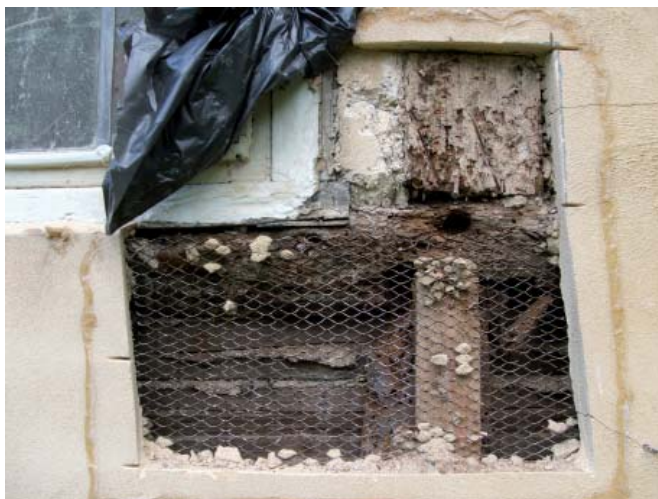
Plate 63: FI 68/B

3.2.3 **FI 68B.** Below 68A at bottom west corner of first floor window. This showed a rail beneath the window with posts above and below it west of the window. The top of the lower post was badly eroded, the base of the upper post was sound and seated squarely on the rail. The posts were about 12cm in width. Internal lath and plaster was visible on both sides of the lower post, there was then a cavity and no infill between this and the modern expanded metal mesh and render. Between the upper post and the window frame was a narrow strip of lime infill.
