# The Abbey Sutton Courtenay Vale of White Horse Oxfordshire

**Historic Building Investigation  
and Recording**

October 2007

**Client: Westwaddy ADP for  
The Abbey, Sutton Courtenay**

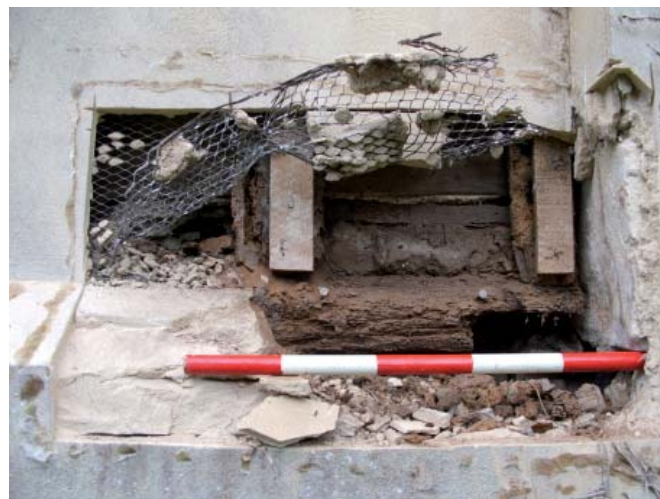
Plate 64: FI 68/C

3.2.4 **FI 68C.** At the base of the timber-framed first-floor east corner section below 68B. This revealed the old sill plate seated on the stone ground floor wall with two posts rising from it. Old laths were seen on the inner side of the posts with some old daub infill adhering to them. On the west the plate had a lower face halving as though for a scarf joint but here was hard up against stonework which extends up to the eaves. The present render was on mesh nailed to battens fixed to the early posts. The old timber was in quite poor condition, powdery in places.
