Dorchester Abbey Dorchester on Thames Oxfordshire

Historic Buildings Analysis

Oxford Archaeology

July 2004

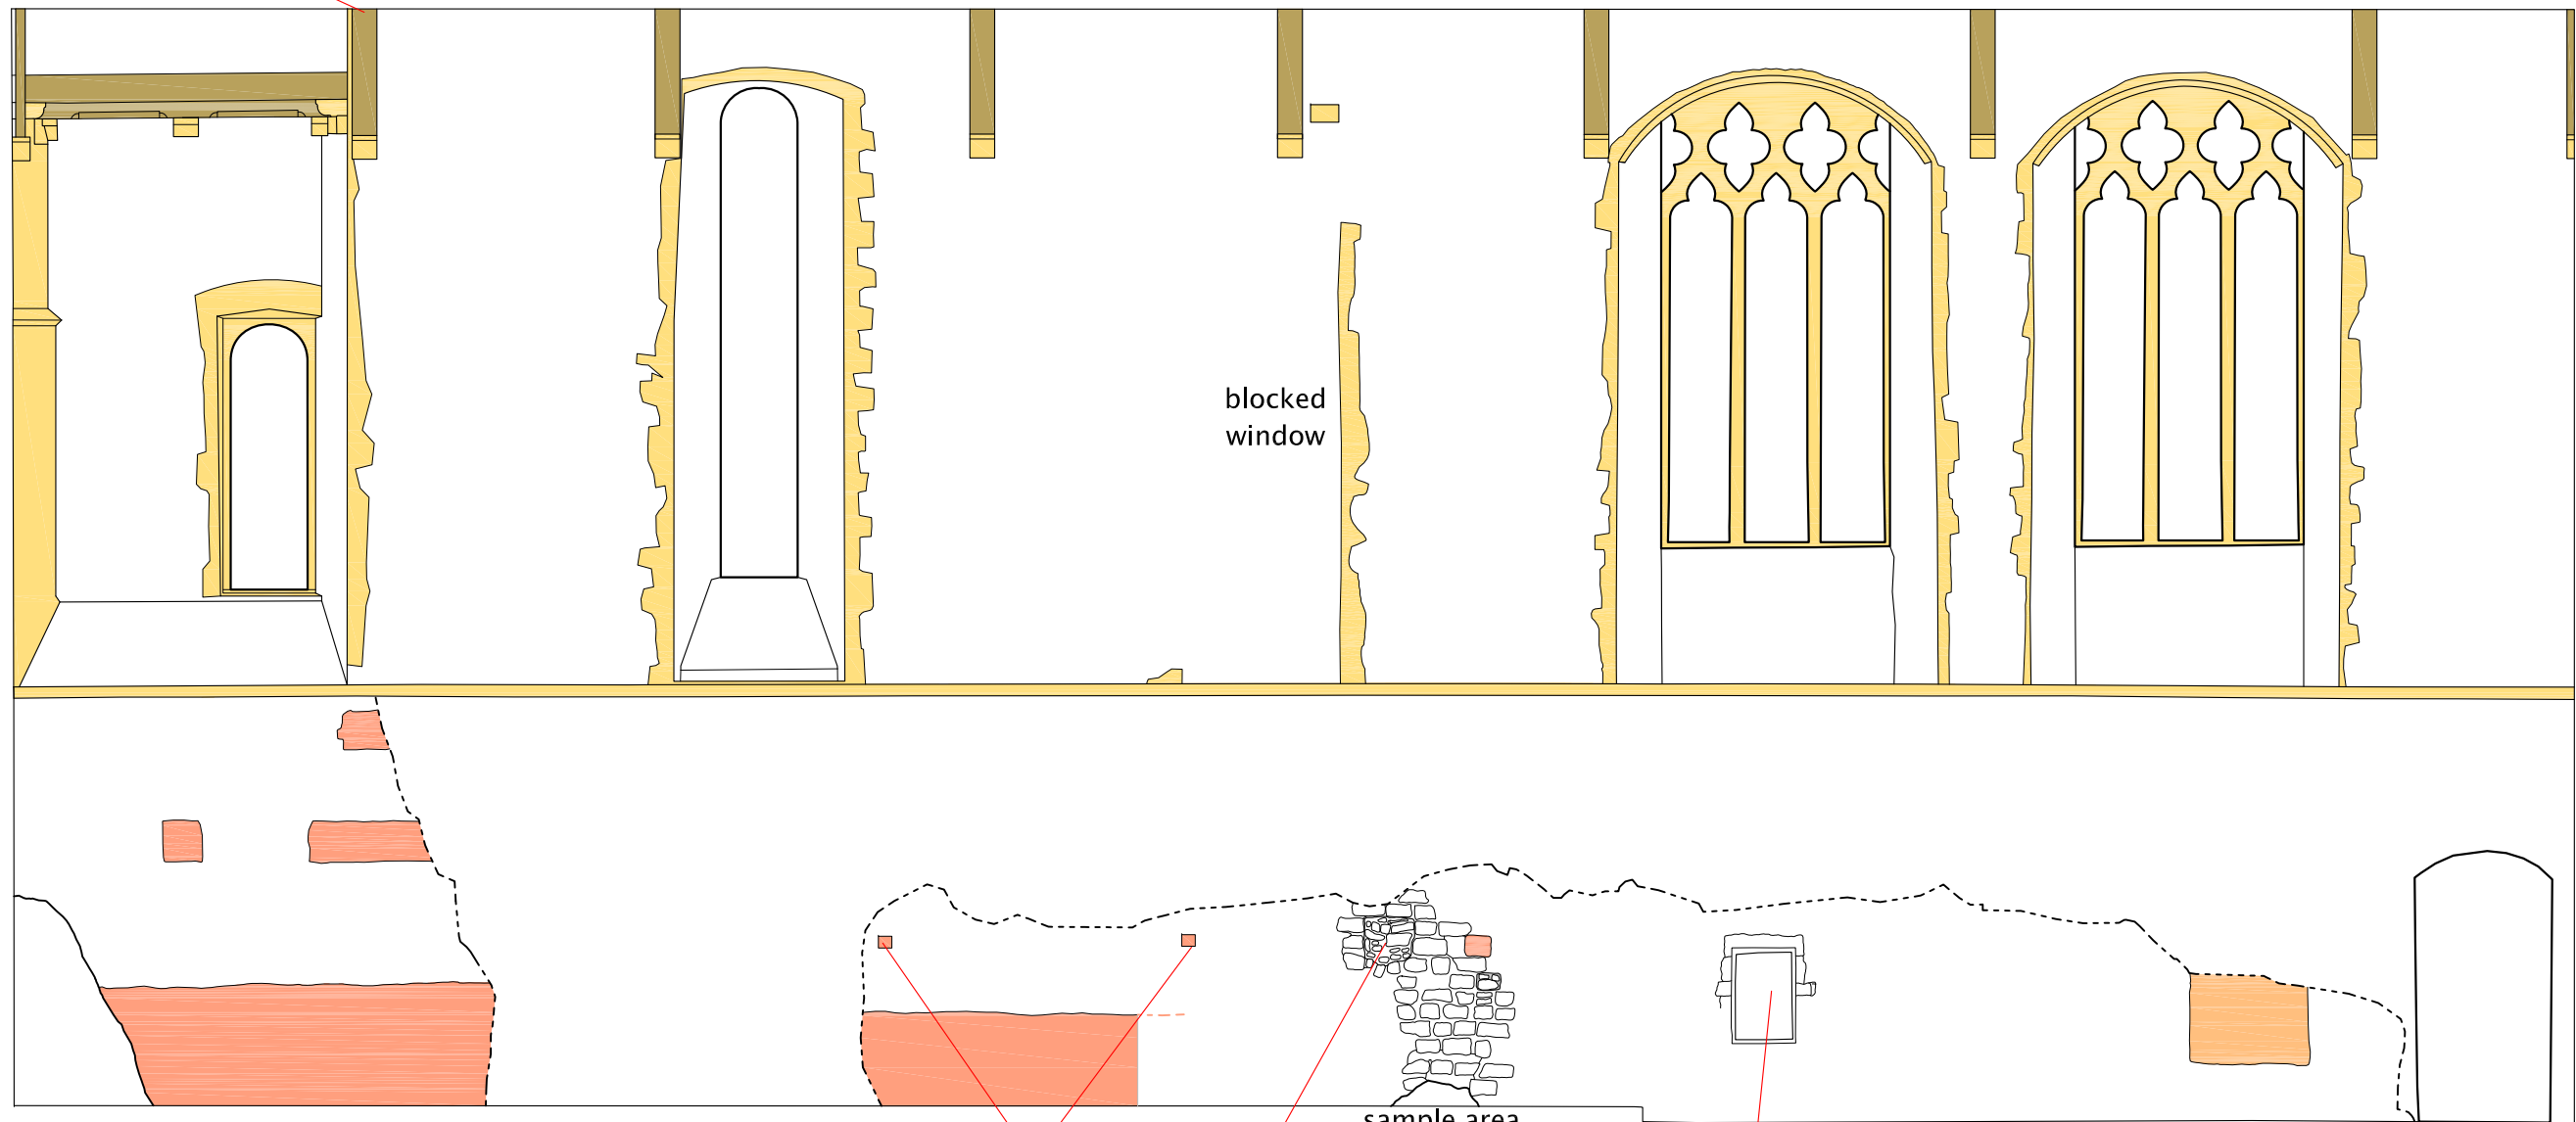
blocked putlog or joist holes

blocked feature

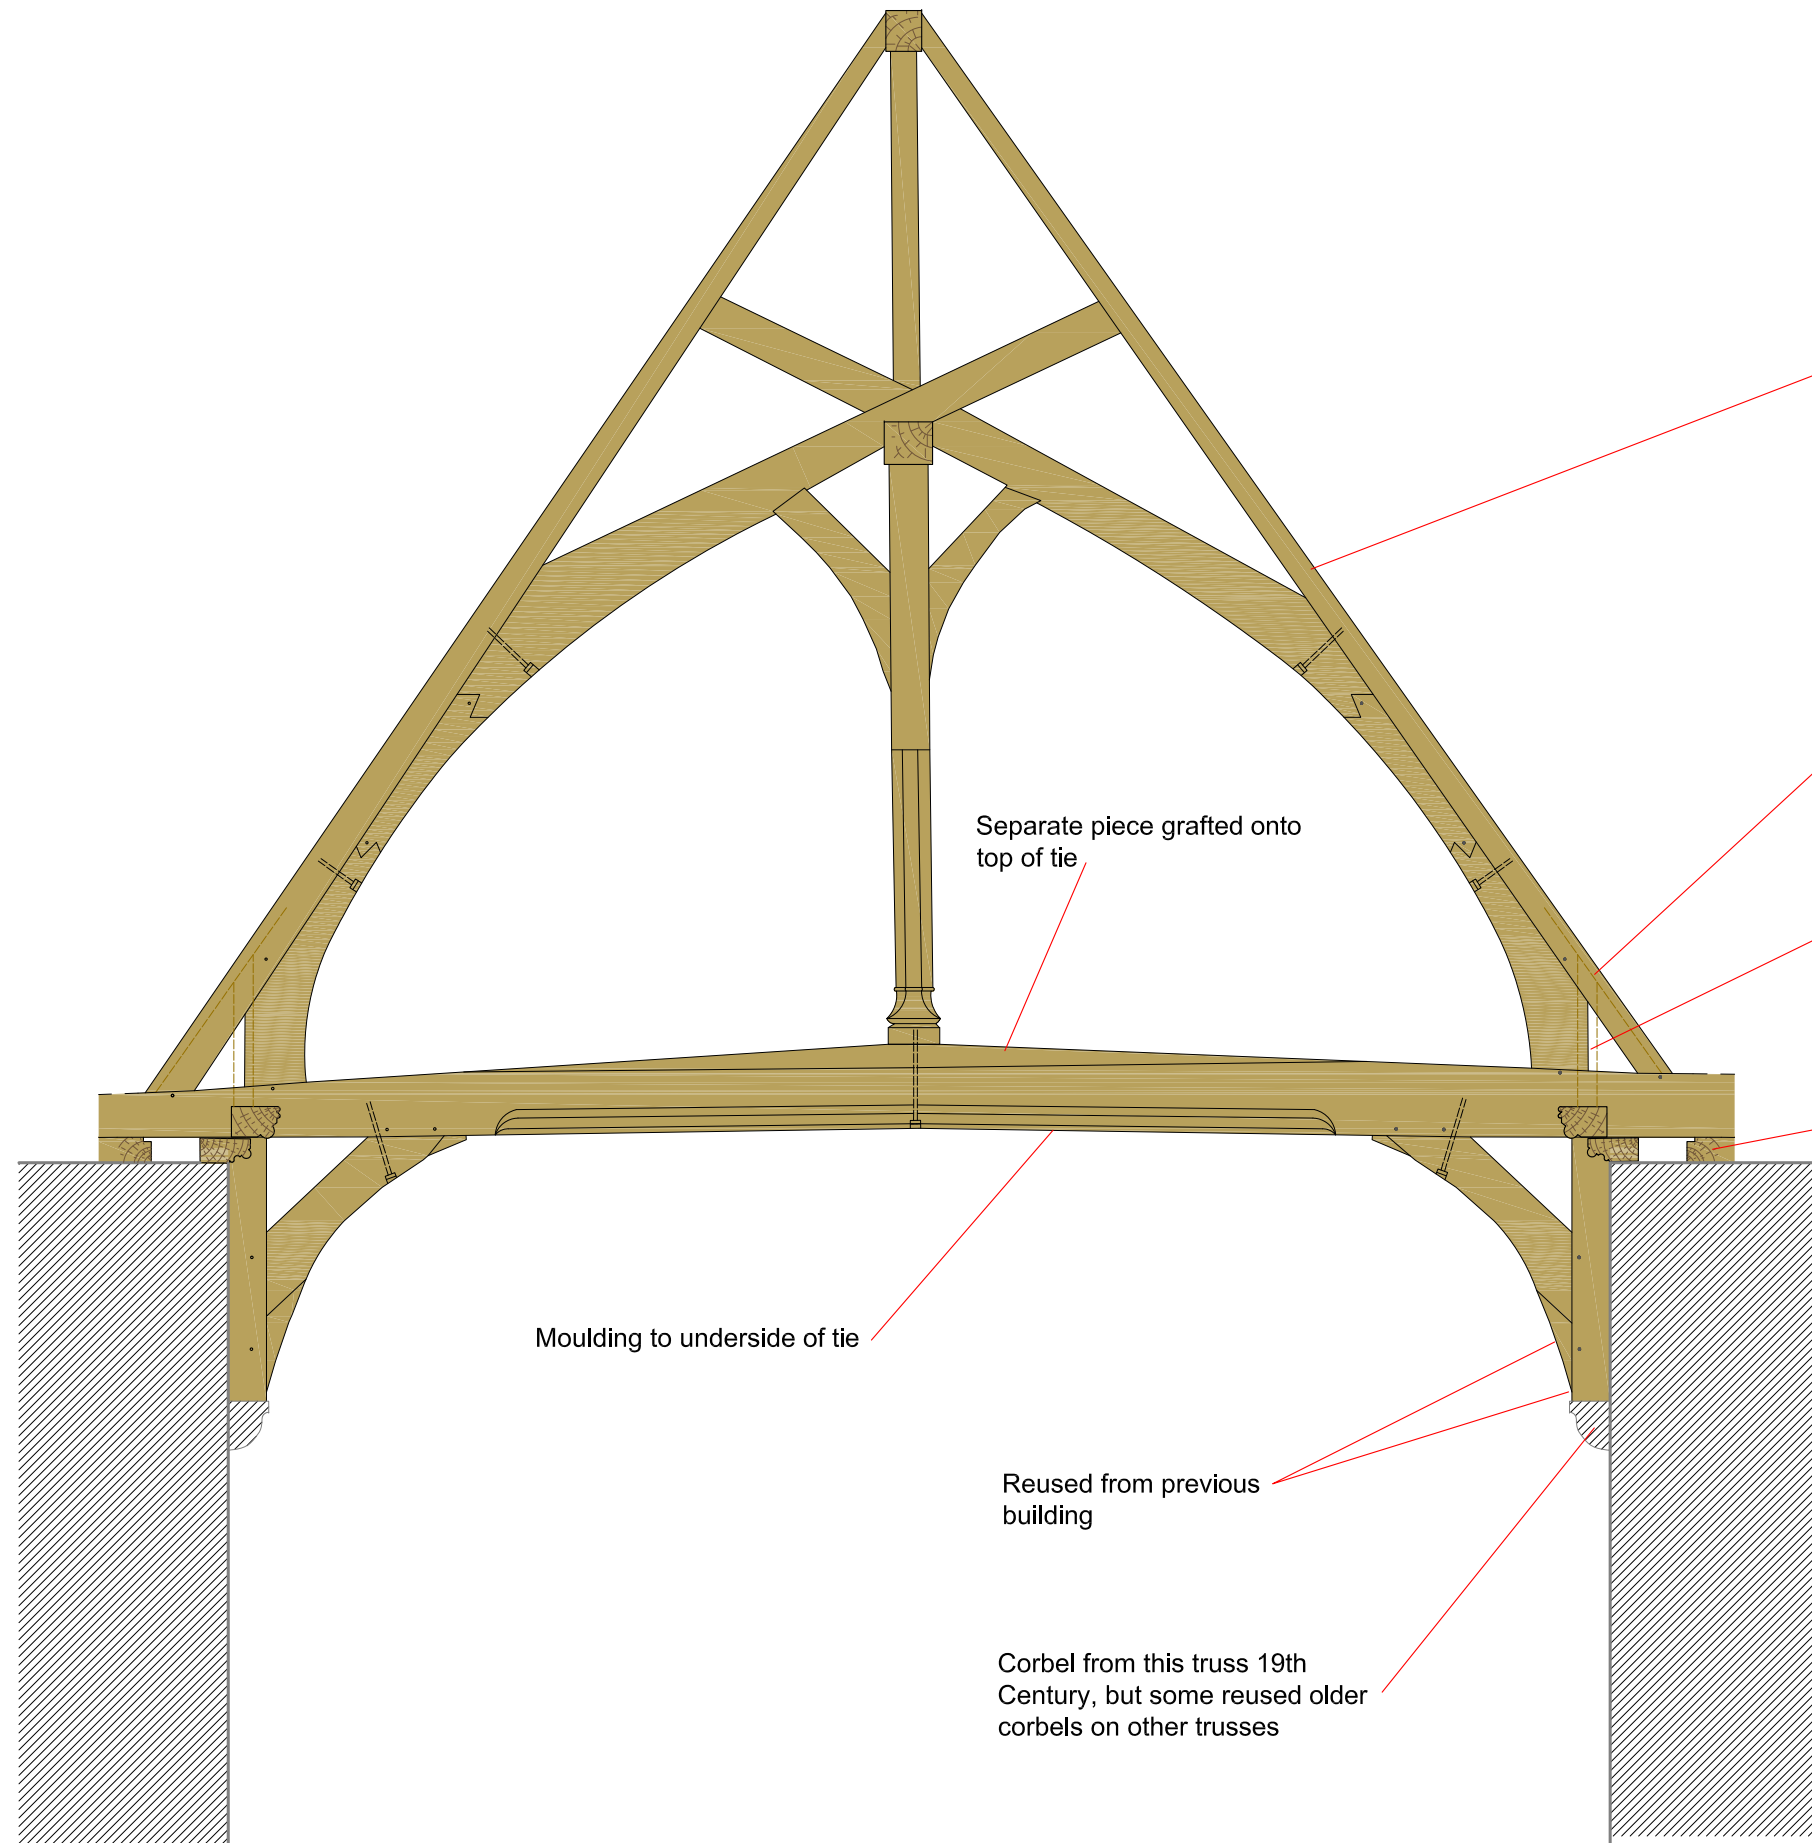
- 3.4.10 *Roof (Figure 4)*
The roof is made up of a number of oak trusses each supporting a crown post. The largest element of the restoration was the repair of the roof. After investigation it was ascertained that the wall plates were damp and decayed and that even the great trusses of the roof itself had suffered from serious decay and the insides had almost entirely rotted away. Access to the roof allowed dendrochronological dating to be carried out (see 4.3). This established that despite appearing to be an entirely 19th century roof, large elements of the 17th century roof had been retained and reused. None of the timbers tested were of medieval date however.
