Stoneleigh Abbey River Landscape Warwickshire

**Archaeological Recording and
Investigation of River Structures**

February 2013

Client: CGMS Limited

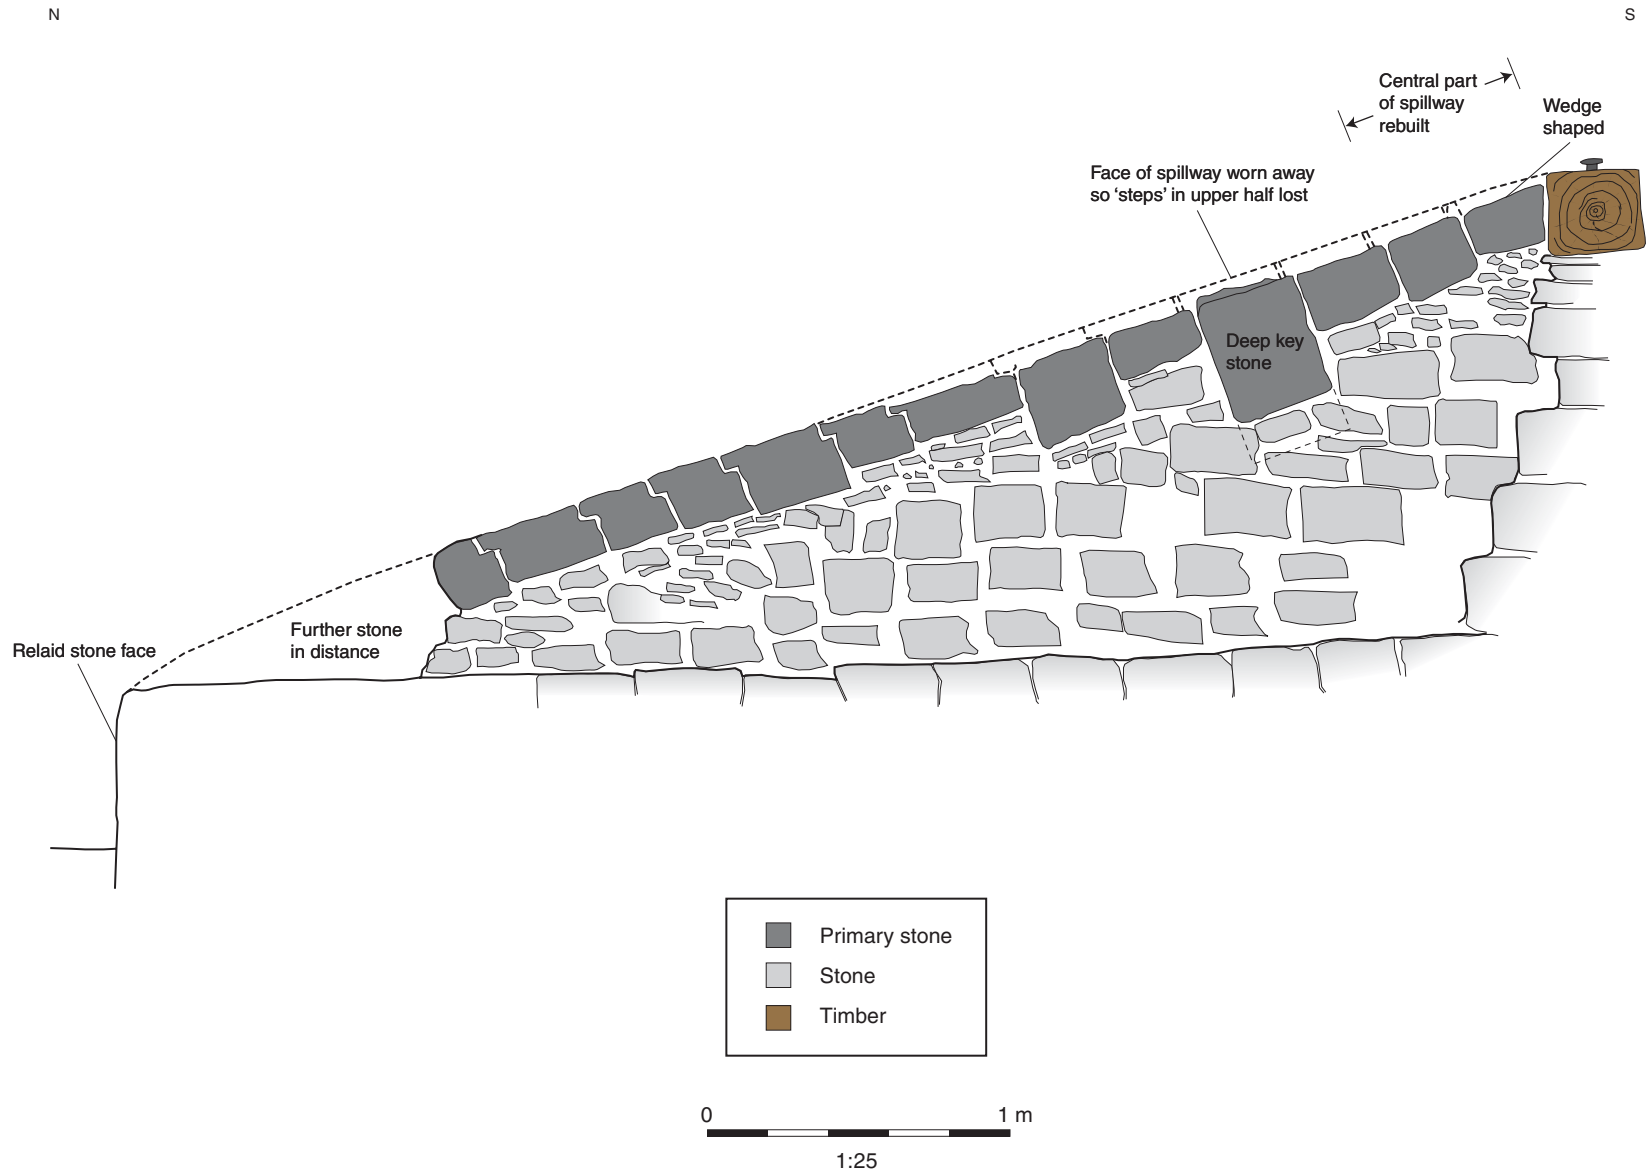
Figure 4: West park weir, exposed section on east side of spillway

4.4.5 The eastern edge of the surviving spillway face had an irregular form and in many areas the substructure immediately beneath was visible. Further to the east the substructure had also largely collapsed and been worn away by the flow of water although the wall to the east partially survived. The substructure construction was of interest and was largely

formed from limecrete with a base of larger stone blocks below this which appear to be set horizontally in contrast to the limecrete structure and facing stones which are set at the angle of the spillway. There were patches of clay roofing tiles set in lime mortar added on the top of the limecrete but this was clearly a levelling device to fill gaps rather than a full layer of tiles beneath the main stones. The use of these was inconsistent and in parts there were a number of tiles on top of each other. A similar use of tiles in this way was also noted in the Island Weir.

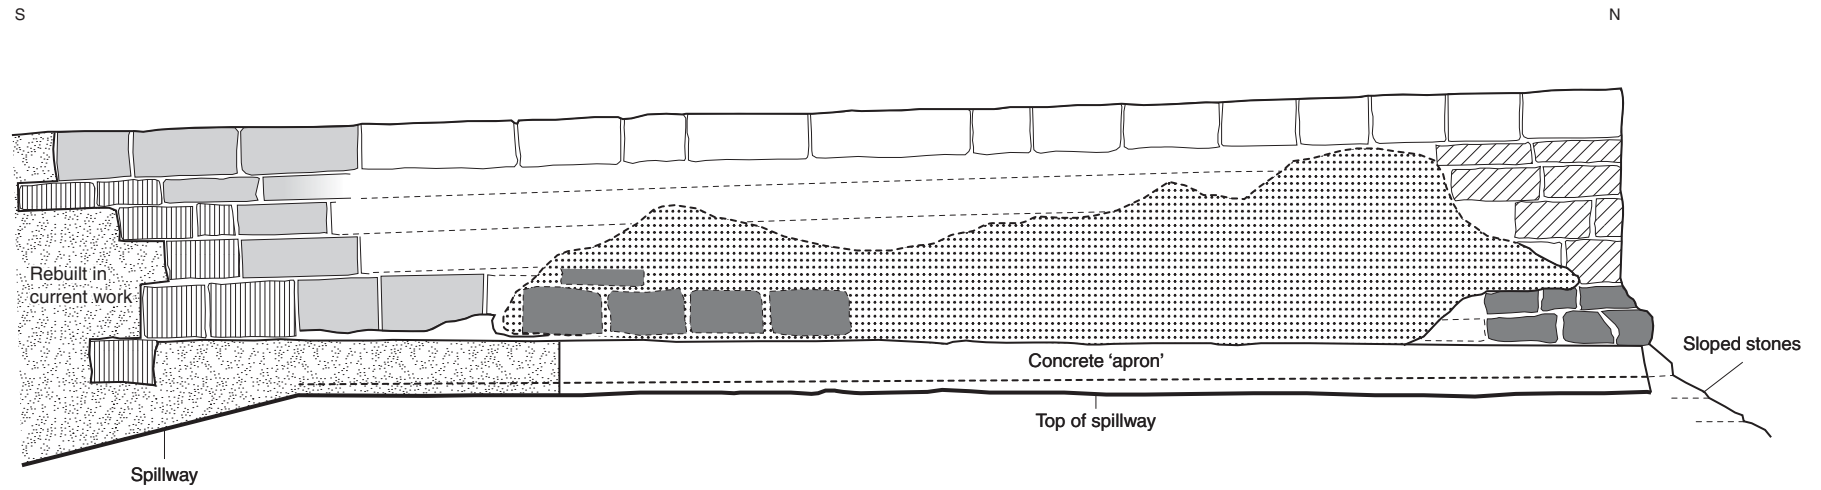
Figure 5: West park weir, west wall above spillway

- 4.5.4 The **west wall** by the channel above the spillway was in better condition than the east wall with less cracks and movement and only the southern section towards the sloped spillway and the rebuilt C-shaped retaining abutment has this wall been reconstructed in the current project.

- 4.5.5 The main wall was constructed of coursed stone, including various sections with distinct types of tooling strongly suggesting various phases of rebuild. The blocks towards the northern end tended to have a rough herringbone tooling similar to some found on the corresponding wall to the east, while further to the south and along the coping the stones tended to have a dimpled face. At the southern end, adjacent to the section where the wall has been rebuilt in the current project the stones tend to have a vertical-line tooling.

- Distinct dimple faced stone
- Apparently remains of earlier phase of wall. Stones at north end appear to be the heavily eroded remains of a sloped plinth around corner.
- ▨ Stones with vertical line tooling
- ▧ Stones with herringbone tooling
- ▤ Large area which appears to be consolidated remains of former wall, partly obscuring later wall on top.

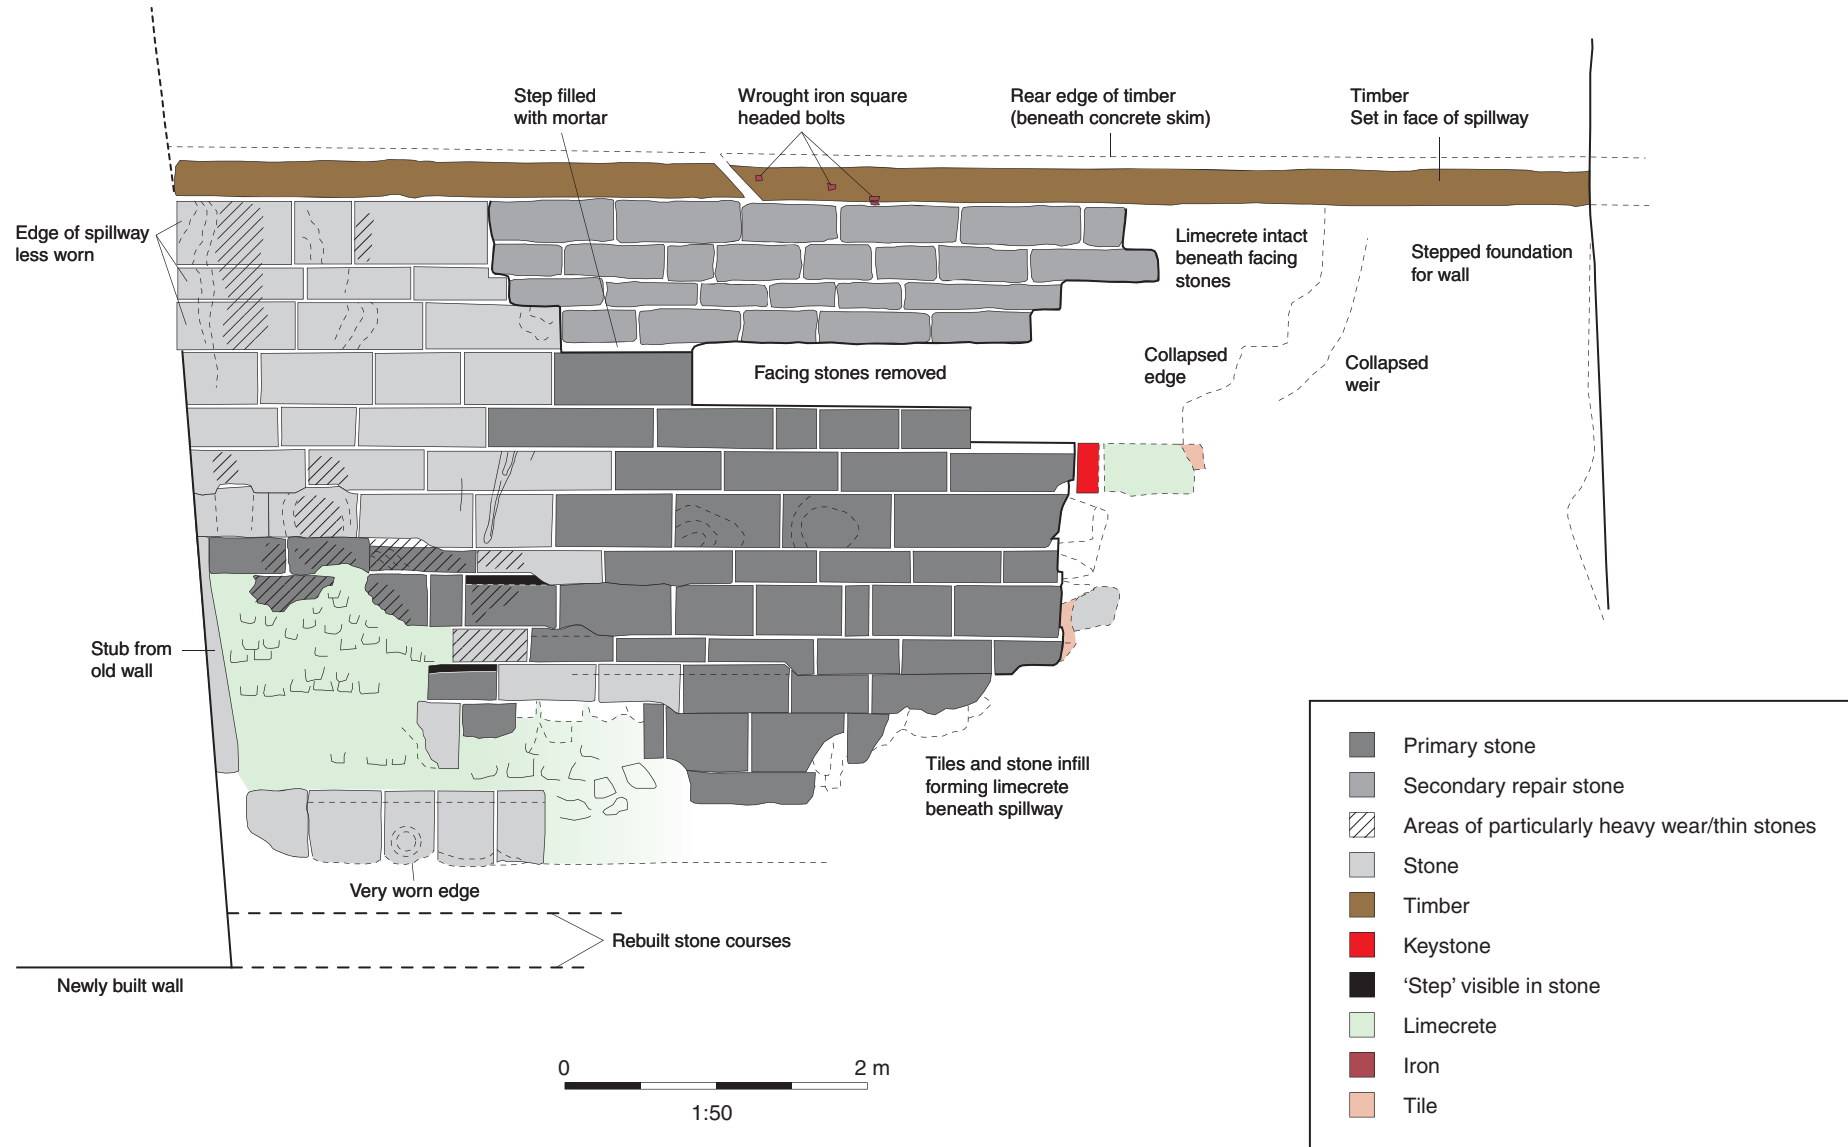
Figure 6: West park weir, plan of spillway

4.4.1 The sloped spillway, down which water overflows from the higher channel, is the central focus of the West Park Weir, both functionally and visually, and its conservation has been one of the key issues of the current project at Stoneleigh Abbey. The spillway is an elegantly constructed structure with an upper face of fine-jointed interlocking sandstone blocks (c.25-40 cm deep) but its condition had deteriorated greatly prior to the current project (probably gradually throughout the second half of the 20th century) to the extent that many facing stones had been lost and much of the eastern half of the spillway had collapsed.

4.4.3 The one clear area of significant previous repair to the spillway was towards the upper part of the centre where there is a large section of facing stones (c.4 m x 90 cm) which have been replaced with cruder non-interlocking stonework with a character similar to that used in the walls and possibly of a later 19th-century date. This central area may have seen particularly heavy erosion thus necessitating its replacement.

- 4.4.9 **Current works:** Due to the partially collapsed nature of the weir and the necessity to return it to being a fully functioning river structure, it was ultimately decided that the entire spillway would have to be taken up and replaced by a matching structure in the current conservation project. The limecrete base was left in-situ and built-up by adding a new similarly constructed base in the areas which had been previously lost. The profile of the new facing stones matched the original stepped profile of the old stones but clearly the new structure lacks the patina of age and historic character of the previous spillway. In the current works concrete was also poured to form a buttress in front of the spillway and stretching around the base of the east wall.

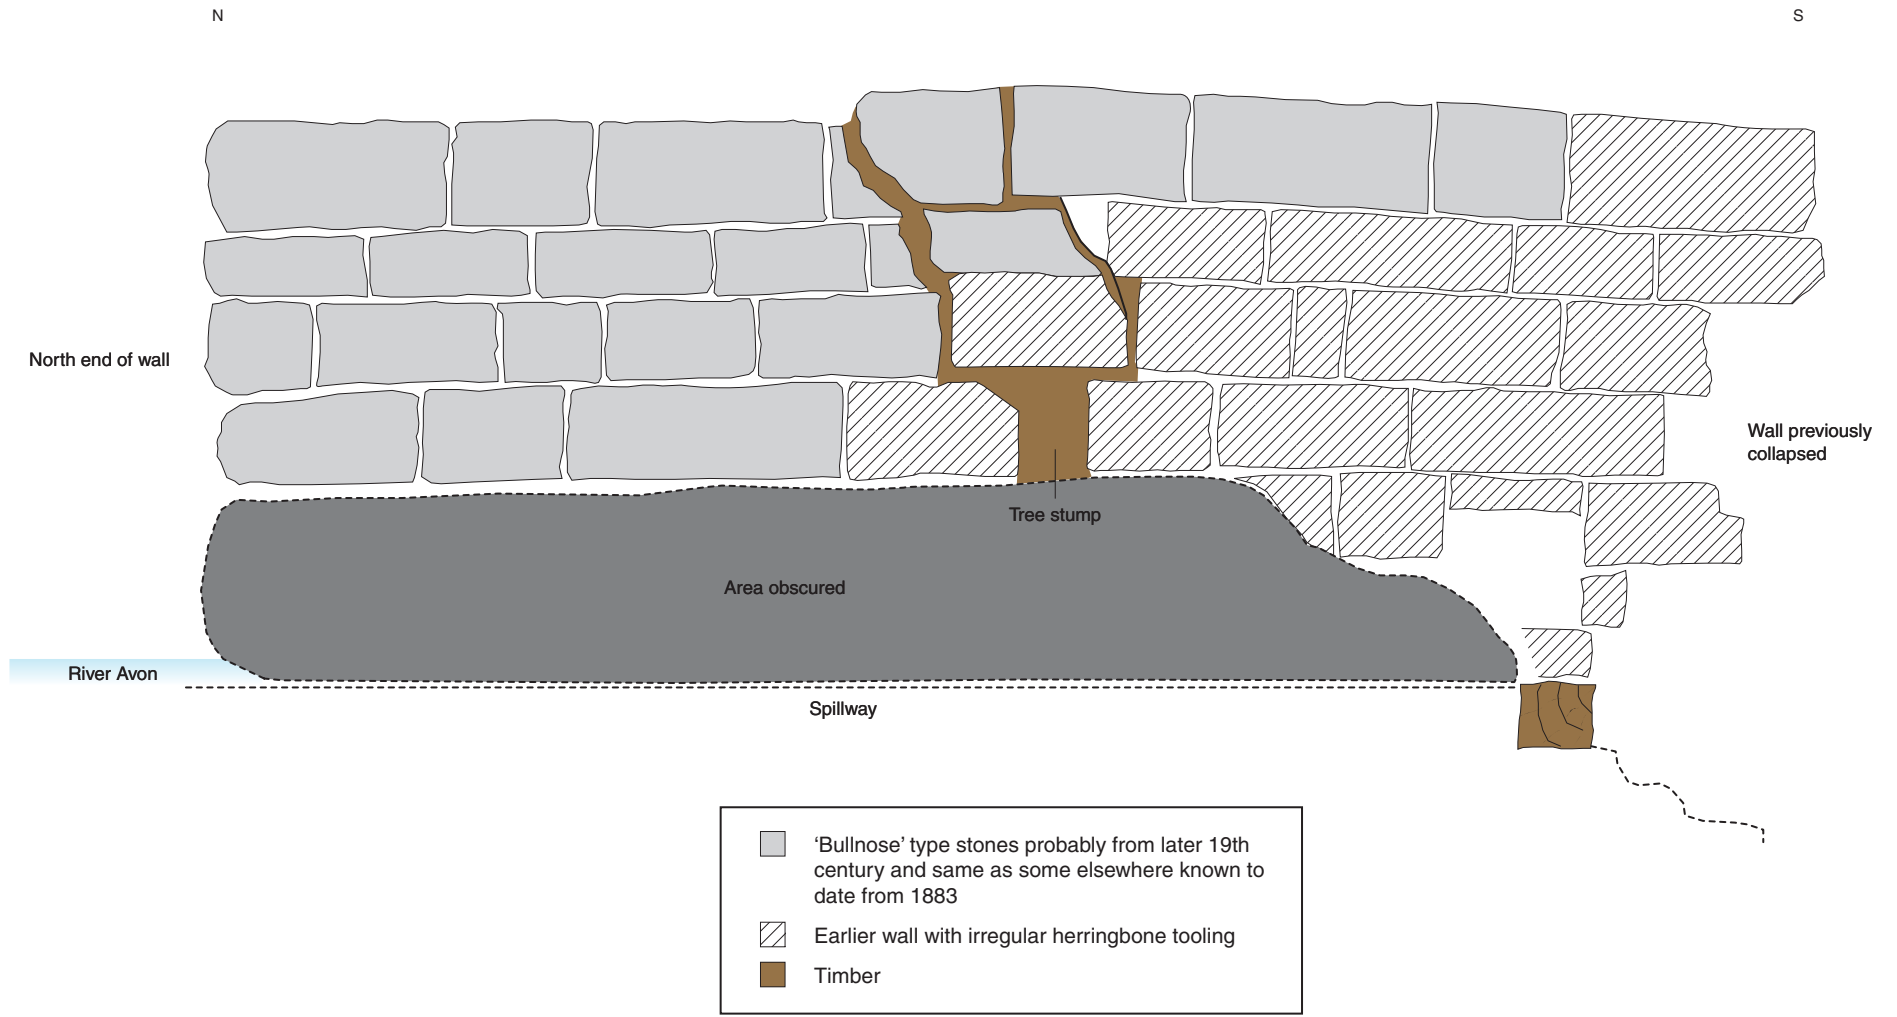
Figure 7: East wall above spillway

- 4.5.1 To the *east side* of the sloped spillway the facing wall had fully collapsed, probably some years prior to the current recording, and been replaced by large modern gabion cages used to temporarily retain the bank. The section of historic wall to the north of this, adjacent to the flat-based channel above the spillway, did survive when the recording was undertaken although it was in very poor condition having been penetrated by extensive roots, and it has been rebuilt in the current project.

- 4.5.2 This surviving section of wall was c.8 m wide and constructed from coursed stone. The southern half was older (possibly 18th century) and comprised stones with a rough but distinct herringbone type of tooling to the face while the northern half of this wall had been rebuilt with grey bullnose type stones. These bullnose stones were the same as those in a larger section further south in the same wall which is known to have been built in 1883 (detailed further below). The largest cracks in this wall were within the 1883 section.

- 4.5.3 There was a pebbly limecrete observed within the east wall behind the facing stones and there was a clear difference between the limecrete in the upper 40 cm to that below. The upper section of limecrete was a pink colour whereas that below was a whiter colour. The lower half of the visible section of exposed wall core was of coursed stonework with lime mortar while towards the top of the wall there is pebbly limecrete to the core.

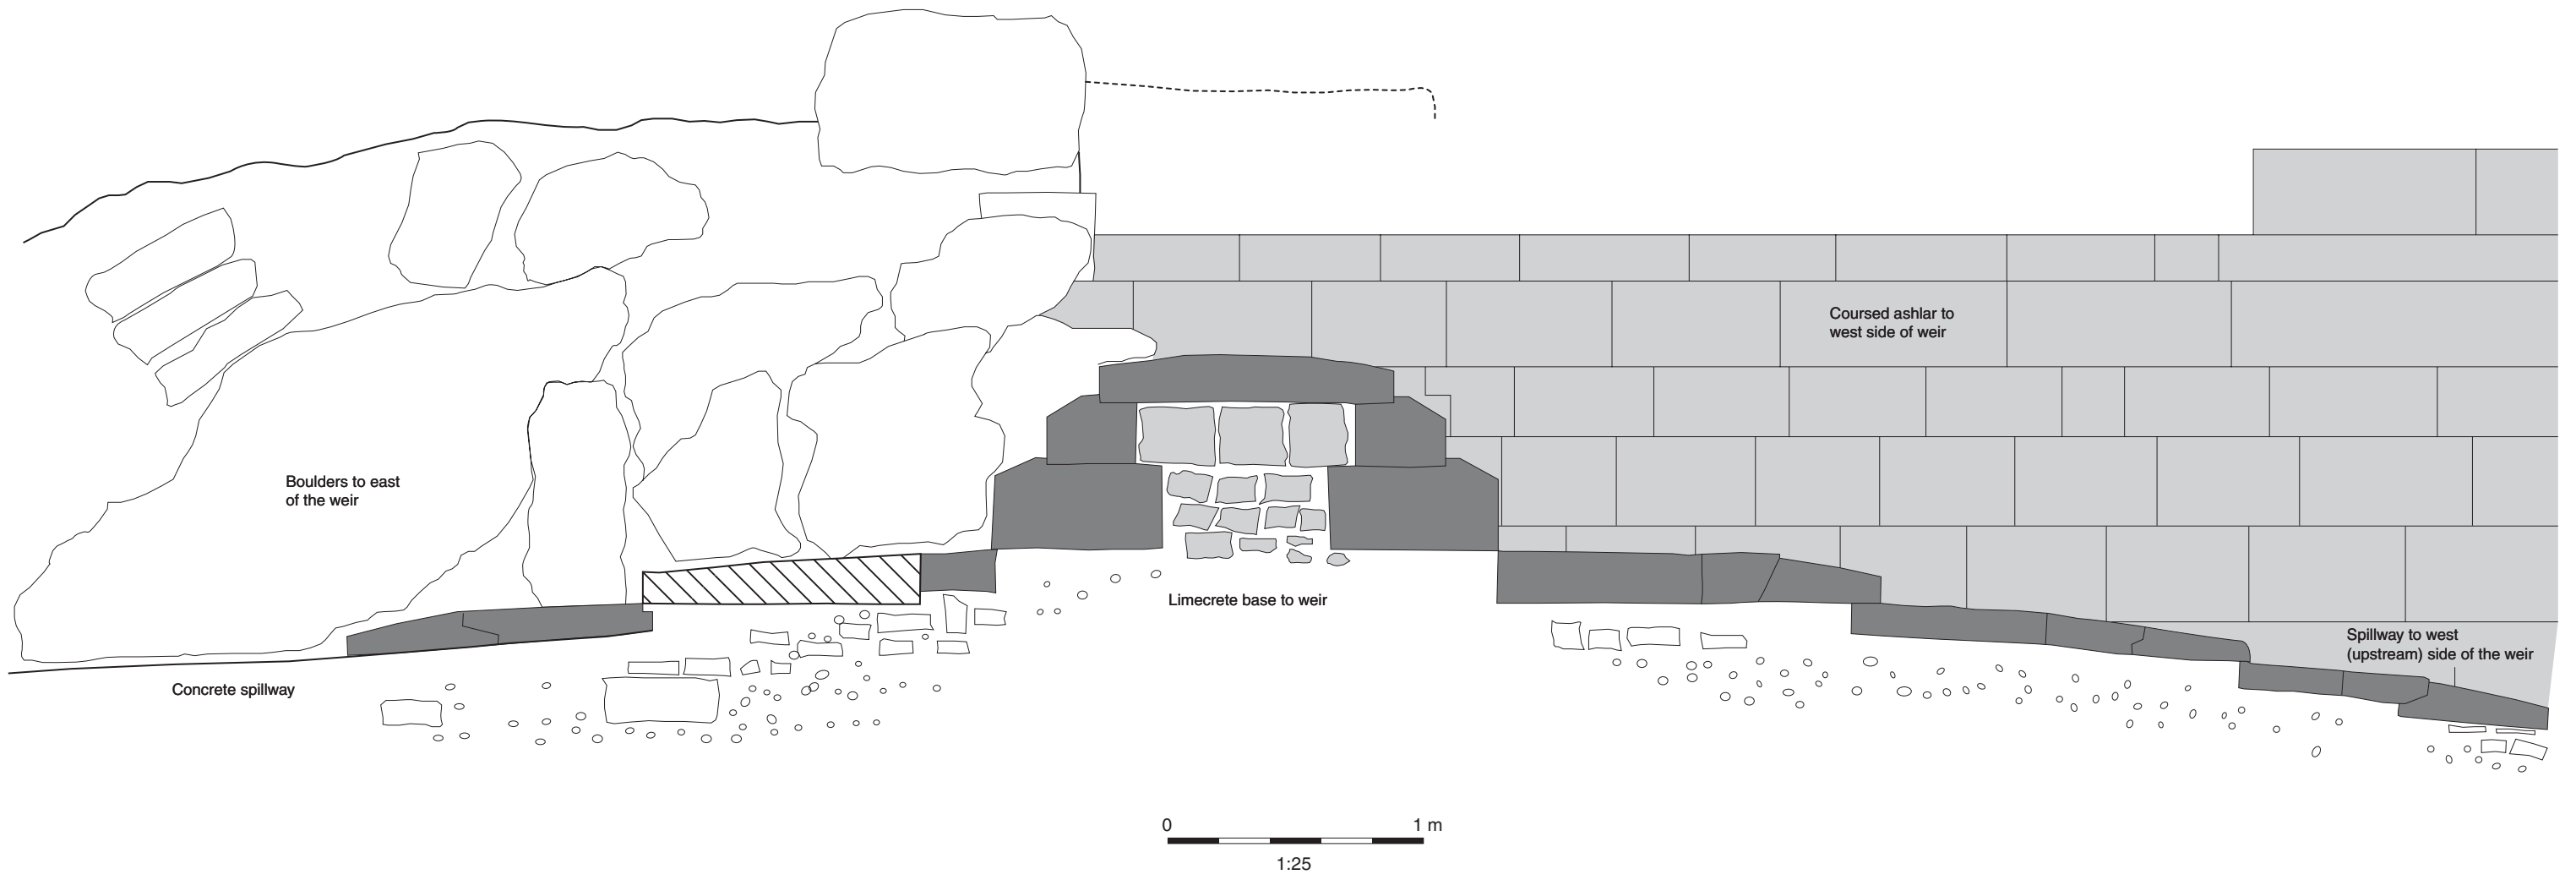
Figure 9: Island weir, section through weir looking to south-west

- 5.3.7 The base of the dam was formed from a large mass of consolidated, pebbly limecrete which also extended beneath the spillways.
- 5.3.8 At the southern end a long section of concrete survived on top of the coping and this was presumably added in the 20th century as a crude repair or protective cap. This has been truncated and would have continued further to the north across the top of the weir.

- 5.3.9 *Current works:* In the current conservation project the surviving southern half of the historic dam has been retained while the northern half has been replaced by a new structure with a reinforced concrete core and interlocking stonework to match the original.

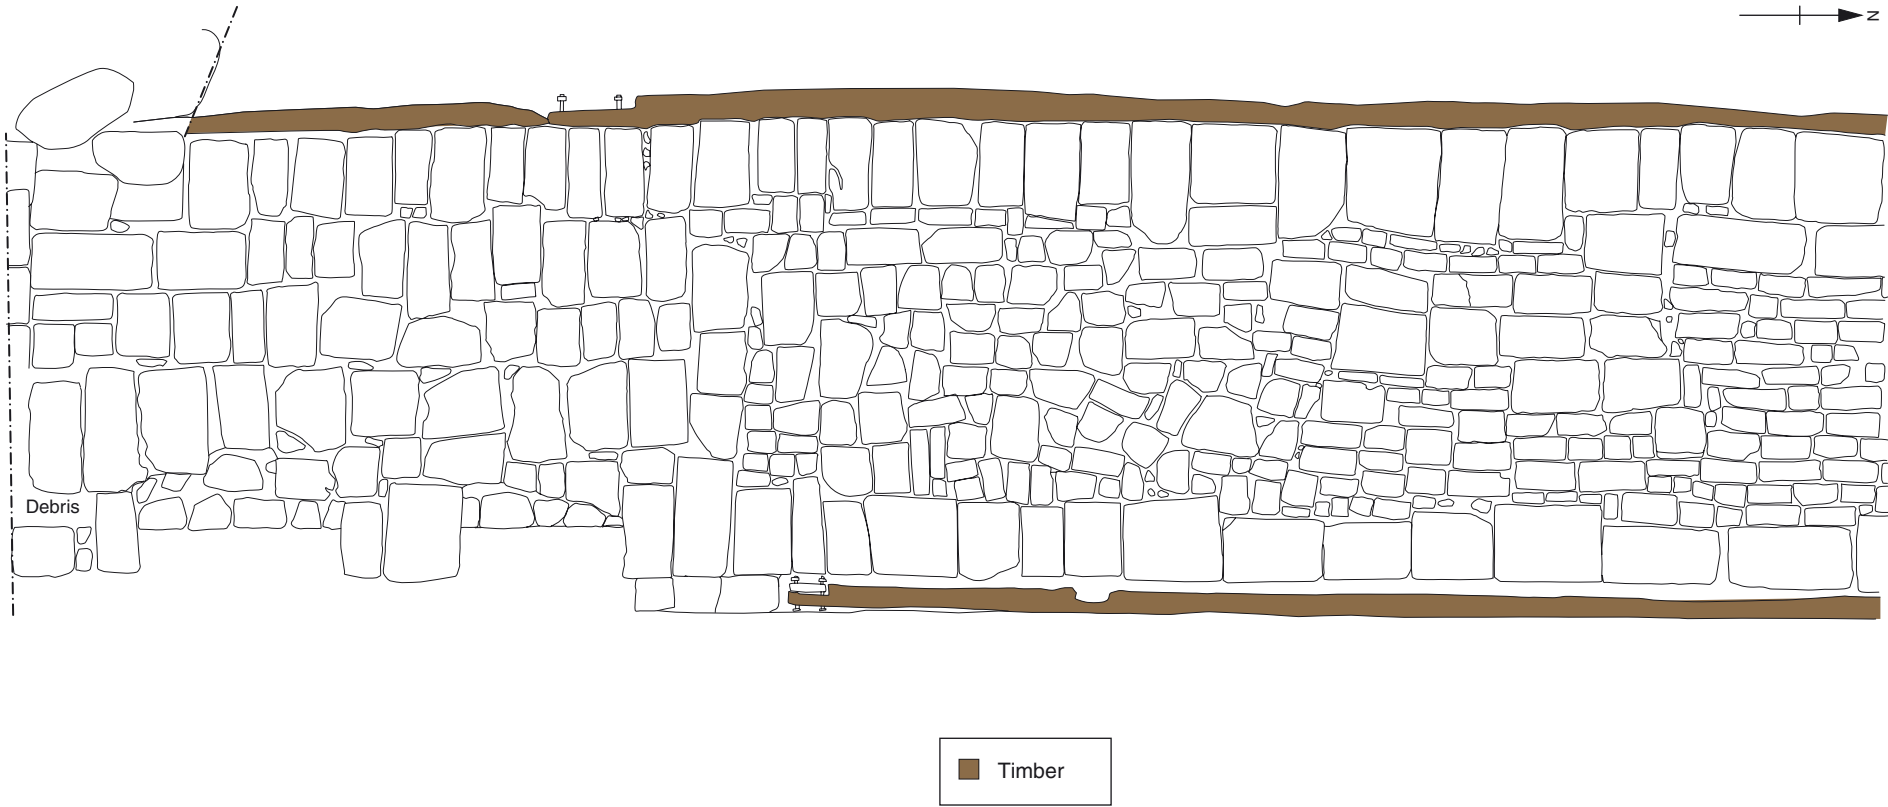
Figure 10: Island weir, plan of lower spillway

- 5.3.13 The *downstream spillway* to the east side of the dam was wider than that to the upstream and even the surviving section on the southern half of the weir had been substantially altered through the replacement of much of the surface with concrete. The spillway again comprised three gently sloping sections with a step between each but on this side of the weir most of the upper and lower sections of stone had been replaced by a concrete surface. A small number of primary stones did survive within the largely concrete areas to confirm the original construction and other than in the northern area where the whole weir had collapsed the stonework entirely survived in the central part of the spillway. The stonework in this area followed a pattern and there was a slight shoulder where the angle of the slope alters.

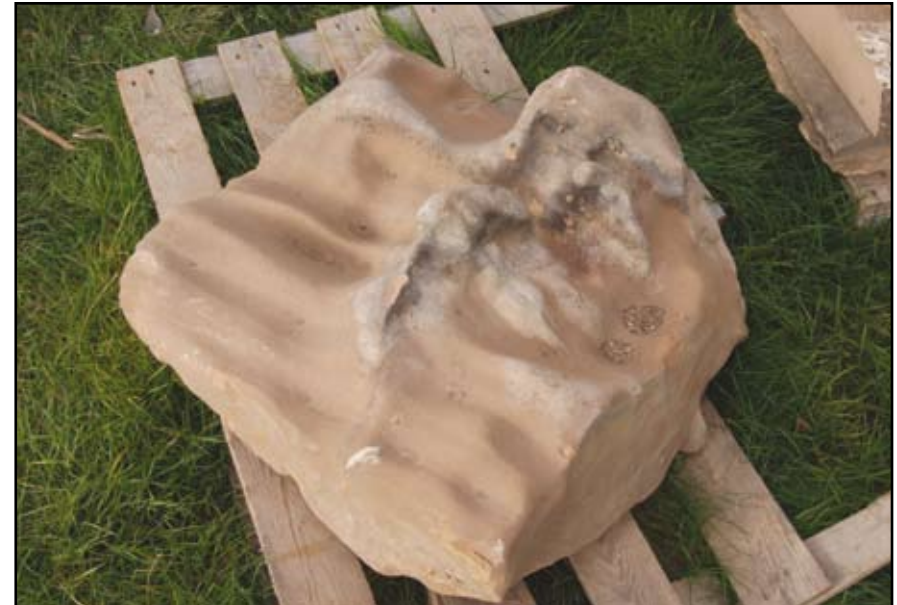
Plate 100: Stone retrieved from Island Weir heavily worn by water flow
