Archaeological Investigation and Surface Remains Survey at Betteshanger Colliery Deal Kent

Archaeological Investigation Report

March 2008

Client: SEEDA

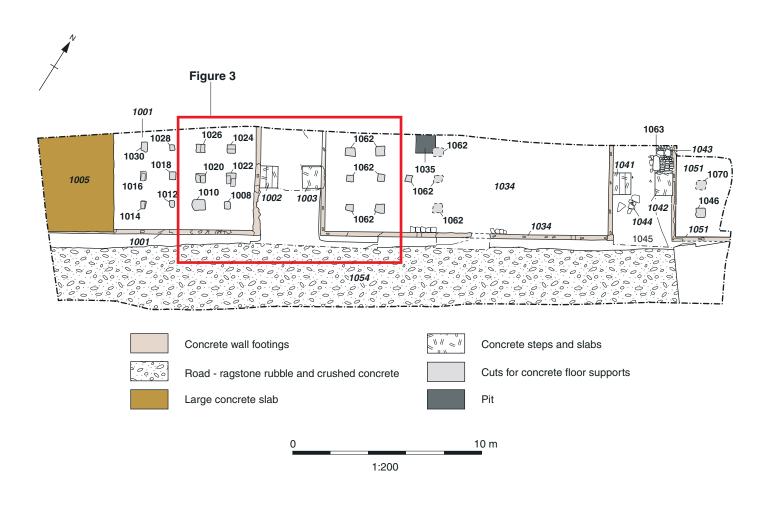
Figure 2: Plan showing main features of the three structures excavated in Area iii

- 2.4.6 Running the whole length of the structures was a roadway made of ragstone rubble and crushed concrete (1054) (Fig. 2). A deposit of coal derived material (1039) had accumulated within the gap between the road and the adjacent wall footings (Fig. 5).

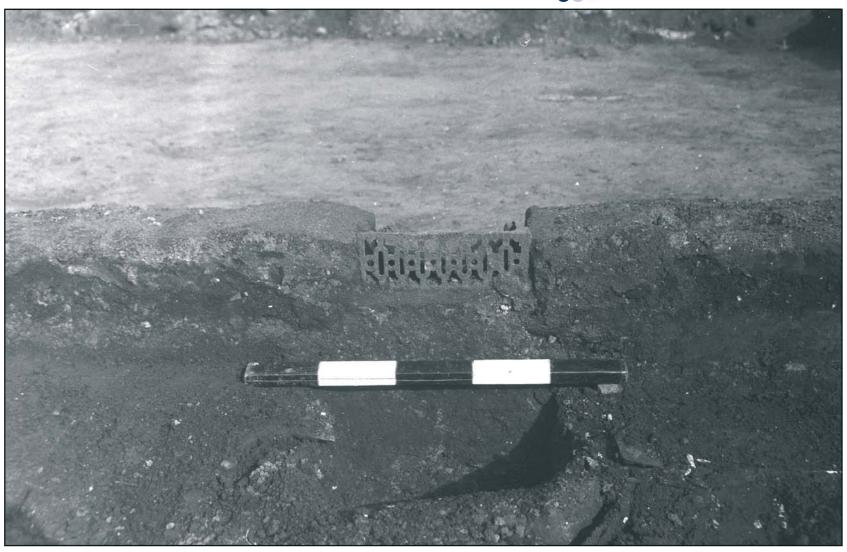
- 2.4.2 The foundations of all three structures were formed by concrete set within a construction trench (1000, 1033 and 1050) and overlain by wooden cill beams. At regular intervals (approximately every 1.6 m) rectangular slots were identified within the top surface of the concrete (Fig. 3). The slots were undercut so that the bases were larger than the tops. In some cases the slots were covered by remnants of the overlying wooden cill beams, and therefore cannot have been to hold vertical supports as first thought. Instead, it is suggested that wedge-shaped pieces of wood were inserted into the wet concrete, with the horizontal cill beams secured on top by the use of nails (Fig. 4). At the time of excavation, three of the slots still contained corroded nails and traces of timber. It is likely that the walls for the structures rested on top of the wooden cill beams and were supported by vertical posts, which may well have been inserted into the horizontal beams. Cast iron vents (for instance cxt 1055, Pl. 1) were identified in three places within the exposed footings (one in structure 1001 and two in structure 1034). One of the voids also had a rubber lining, presumably to protect the foundations from excess moisture. These vents would have ensured some degree of ventilation under the internal floor.

- 2.7.1 The foundations of three buildings were partially revealed. No full building footprint was uncovered, but their dimensions can be deduced with reasonable confidence, assuming they were each built to the same plan. Each building footprint was 15.4 m (c. 50 ft) in length (that of 1034) x c 6.0 m (c. 20ft) wide (assuming the gable entrances were centrally sited). Each footprint was defined by a shuttered concrete plinth. The superstructure would have been a frame timber anchored to the concrete plinth by fixing to wedge- shaped wooden anchors previously set into the wet concrete. The rows of concrete blocks surviving within each building indicate that the internal floors were suspended plank over timber joists. Cast metal vents were incorporated into the concrete plinths to provide some ventilation under the floor (see Pl. 1)

Plate 1: Iron vent 1055 in the south-east wall of structure 1034

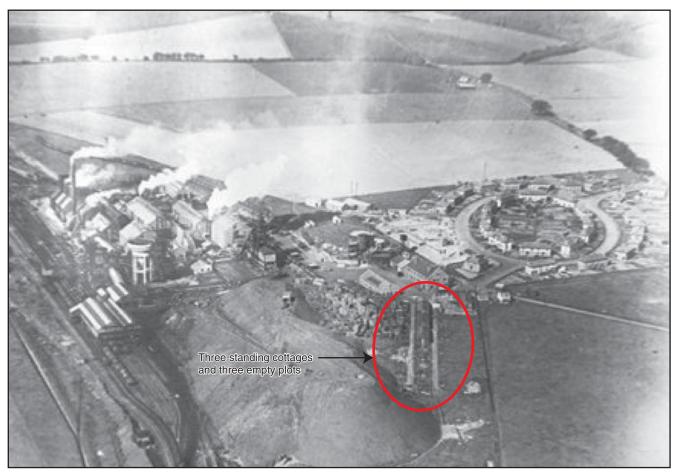
- 2.7.5 Three buildings - implying six dwellings - were exposed in the investigation. An aerial photograph taken in 1933 (Pl.2) and looking south-west shows three standing buildings in a row (the ones excavated), and three shrub-covered plots to the north-east. This suggests that there was originally accommodation for twelve families. It would appear that by 1933 the sinkers had moved on, and while three of the buildings were retained and reused, three were demolished. This contention is supported by the evidence of a concrete slab (1005) floor covering the south-west half of structure 1001 (Fig. 2). It is suggested that this relates to a second phase of use and may have been an attempt to strengthen the floor. Similar evidence can be seen in structure 1034 where floor supports were only seen in the south-west end of the structure. It is possible that those in the north-east end were destroyed during a later phase of use. The differential treatment within the structures also suggests that the buildings, although no longer serving as dwellings, were still sub-divided into two halves, with two different functions

Plate 2: Betteshanger Colliery 1933 looking southwest

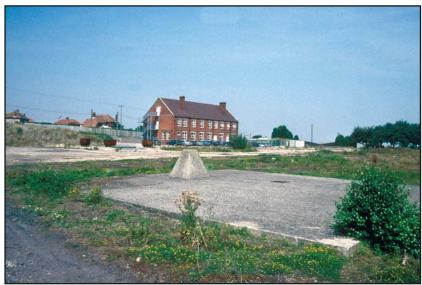
Plate 3: General view of the site from the south. Capped shaft in the foreground, main offices to the rear.

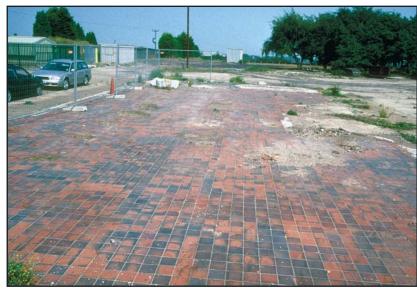
- 3.3.2 Immediately to the south-east of the offices was the lamp room (No. 3 on Figure 6) and although the building has been demolished the footings and ground floor slab survives (Pl. 5). The building was essentially a large single room with a quarry tile floor and brick walls.

Plate 5: Tiled floor of the lamp room

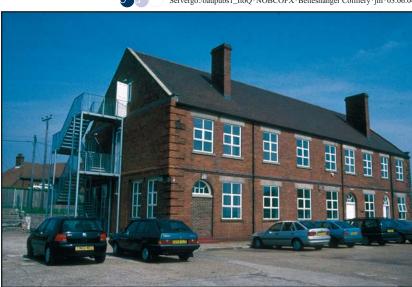
3.3.1 Almost all the above ground colliery structures have been demolished since the closure of the pit in 1989. The only surviving building directly associated with the colliery is the Main Office towards the north-west edge of the site (Pls 3 & 4). The Main Office is a two storey tall brick building with tile-covered gabled roof. It is nine bays long with 6-light, square-headed windows beneath stone lintels. The existing offices are the surviving half of a larger building shown on the c.1979 plan which extended further to the west (No. 1 on Figure 6).

Plate 4: Main offices from the south

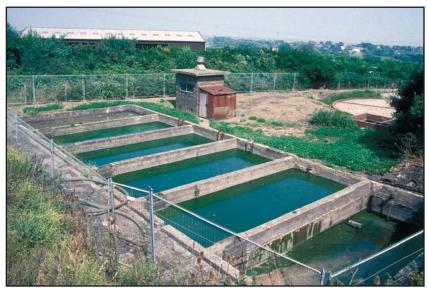
- 3.3.9 To the west of this, closer to the main colliery site are the surviving settling tanks, filter beds and other plant from a sewage plant established in c. 1934 (Pl. 5; J Davies pers. comm.).

Plate 6: Settling tanks in the sewerage works

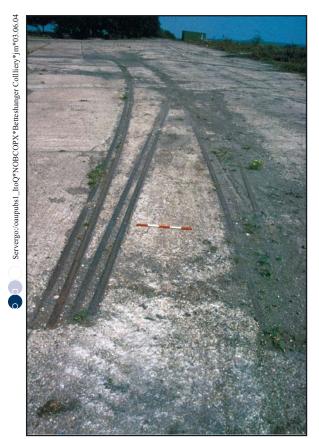
- 3.3.3 To the south and south-east of the lamp room was an open area in which several sections of rail track survive which curve around towards the south towards the location of former head stocks and the main processing areas (Pl. 7). Although a number of tracks survive in several areas across the site the layout shown on the c.1979 plan has been largely lost. The network of tracks comprised two main types: a narrower gauge (31'; 79 cm) for wagons and a wider gauge (60'; 153 cm) for a mobile crane (J Davis pers. comm.).

Plate 7: Two interlinking sets of rail tracks.

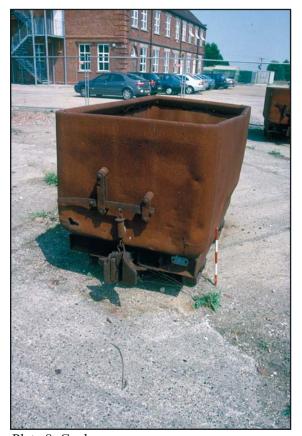
- 3.3.10 The most significant mining artefacts which remain on site are 3 coal wagons which are adjacent to the offices and former lamp room (Pl. 8). These are 1.36 m tall by 2 m long x 1.02 m wide and they are to be salvaged for a local mining museum (J Davis pers comm). Very few other mining artefacts of interest remain on the site although some bits of conveyor belt with stitching survive together with various small items such as bolts, pipes (Pl. 11), and sections of wheel. Also surviving, although not in-situ, are two large concrete conical structures which were added to the site in the 1960s as flower baskets (Pl. 12; J Davies pers. comm.). These are now in the area immediately south of No 2 winding house.

Plate 8: Coal wagon.

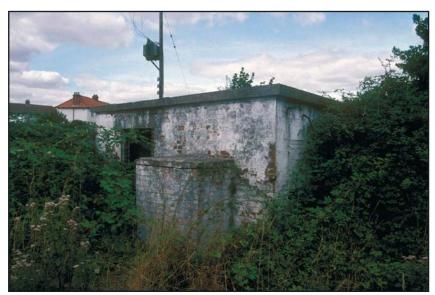
- 3.3.11 Betteshanger also acted as the main training pit for Kent and several small features survive from this at the northern end of the site. The training facilities comprised a c.100 m long training gallery with a series of semi-circular arches to simulate conditions underground. The arches have been removed but the truncated ends of the arches remain within the northern boundary wall to show where they once were. At the west end of the training gallery was a small brick engine house (still intact in current recording) which once housed an engine (not in-situ) to pull wagons along the training gallery track (Pl. 9). There was formerly a series of buildings adjacent to the engine house which housed a training centre, but these have now been lost.

Plate 9: Engine house at the end of training gallery.

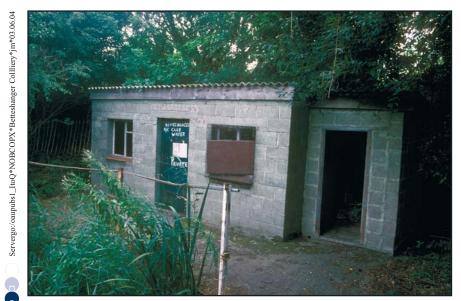
Plate 10: Hut for colliery angling club

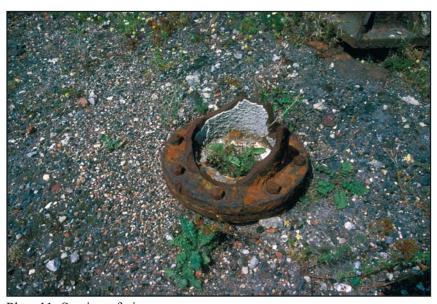
Plate 11: Section of pipe

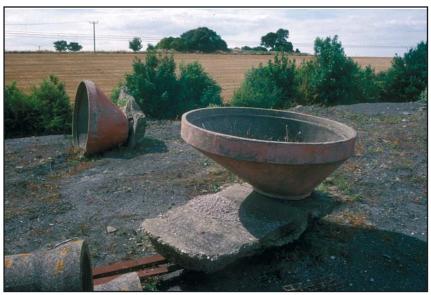
Plate 12: Concrete flower basket
