Apprentice Store De Montalt Mill Combe Down Bath

**Historic Building Investigation
and Recording**

May 2006

OA Job N^o: 2889

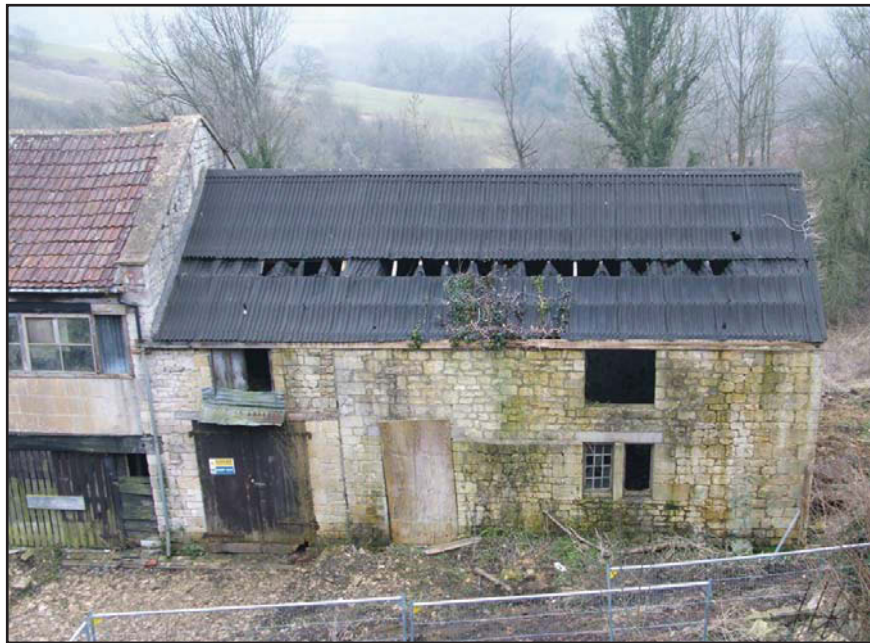
Plate 2: Phases 1 and 2 looking north, phase 1 on right.

3.1.1 **External Description** (plates 2 & 3). The oldest part of the structure is at the west end. This is a single cell two storey structure built of snecked rubble with better finished quoins and jambs. The pitched roof is a modern replacement with softwood frame clad in corrugated sheeting. There is a door opening in the east end of the north wall and a ground floor two-light mullion window in the west end of the north wall with an empty opening into the first floor directly above it. There is a similar mullioned window in the west end wall with a ventilation slit in the gable above. In the south wall there are two ventilation slits high up above the roof of the later lean-to.

- 3.2.1 **External Description** (see Plate 2). This is a small one bay two storey extension built onto the east end of phase 1 consisting of a waggon house with hayloft over (Plate 6). On the north wall there is a straight joint with no attempt at bonding the two phases but on the south the joint dog legs several times where phase 2 has been bonded in to some extent to the earlier structure.

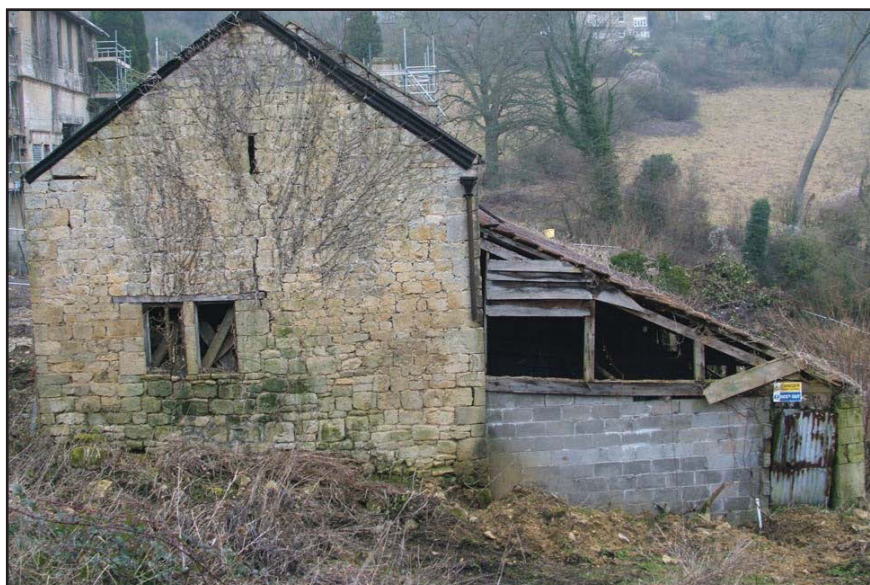
Plate 3: West end gable wall.

- 3.1.5 The top of the west gable wall has also been rebuilt suggesting that there may have been a half-hipped roof originally.
- 3.1.6 The former exterior east wall is now within the later coach house extension.

- 3.1.7 The previous owner, Heather Mann, in whose memory the rebuilding was carried out confirmed that the western gable previously had a half hip (Davenport 2001). The eastern half hip would have been replaced when the coach house extension was added at a much earlier date.

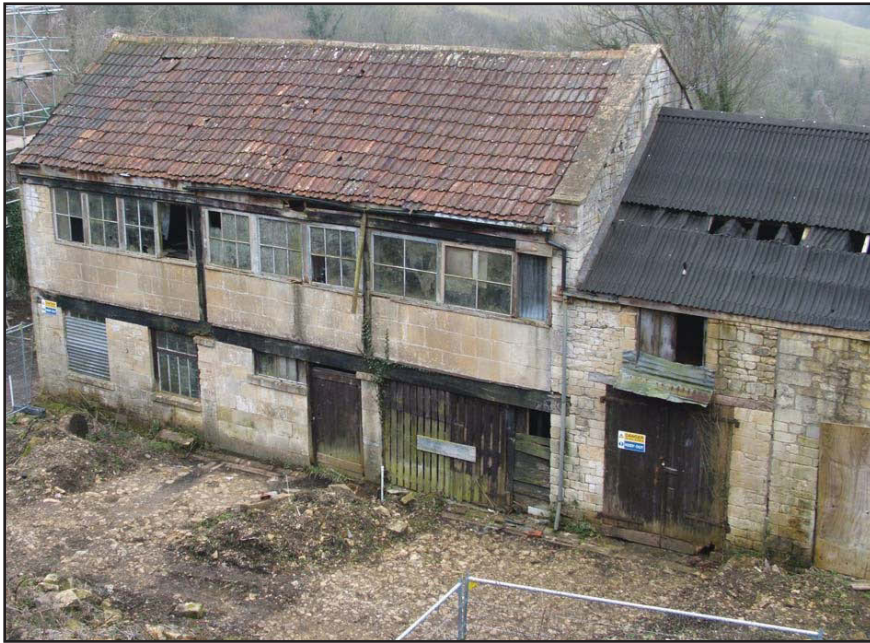
Plate 4: Phase 3 looking south east.

- 3.3 **Phase 3: Workshop/Timber store**
- 3.3.1 **External Description** (Plates 4-6) This is a further eastward two-storey extension to the existing range consisting of three bays. The extension is the same width as the previous phases but taller. The west wall is formed by the east gable of phase 2 which has been raised and capped with a flat coping course. The east gable is plain and the pitched roof is clad in ceramic tiles.

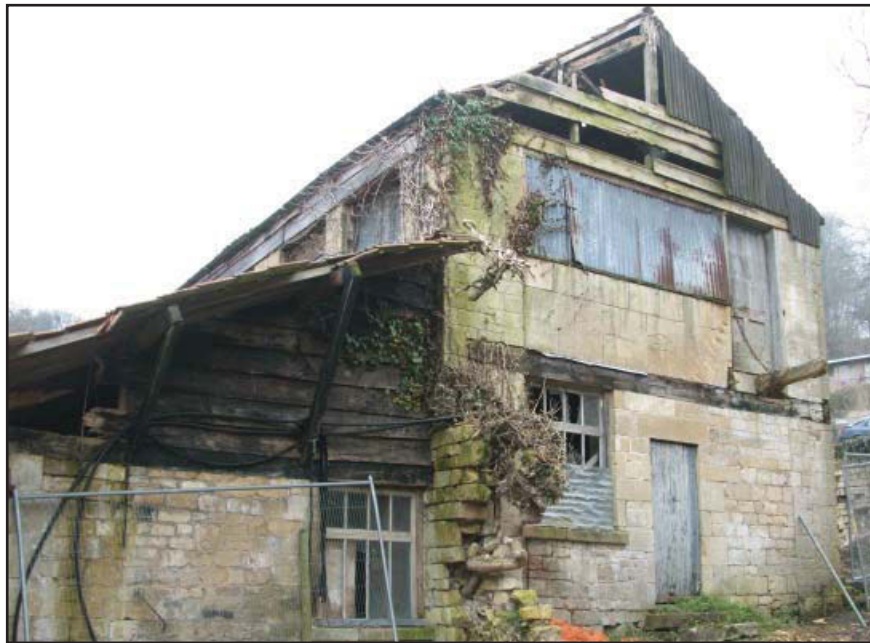
Plate 5: East end gable wall looking north-west.

- 3.1.10 The east wall wall exhibits two primary ventilation slits at head height and a blocked slit in the gable. There is a blocked doorway at the south end with a wooden lintel 'fossilised' in the stonework. The top of the gable above purlin height has also been rebuilt as at the west end which tends to confirm that this building had a half hipped roof in its primary phase (plate 5).
