Valentines Park Ilford

London Borough
of Redbridge

**Historic Building Recording and
Archaeological Watching Brief**

April 2009

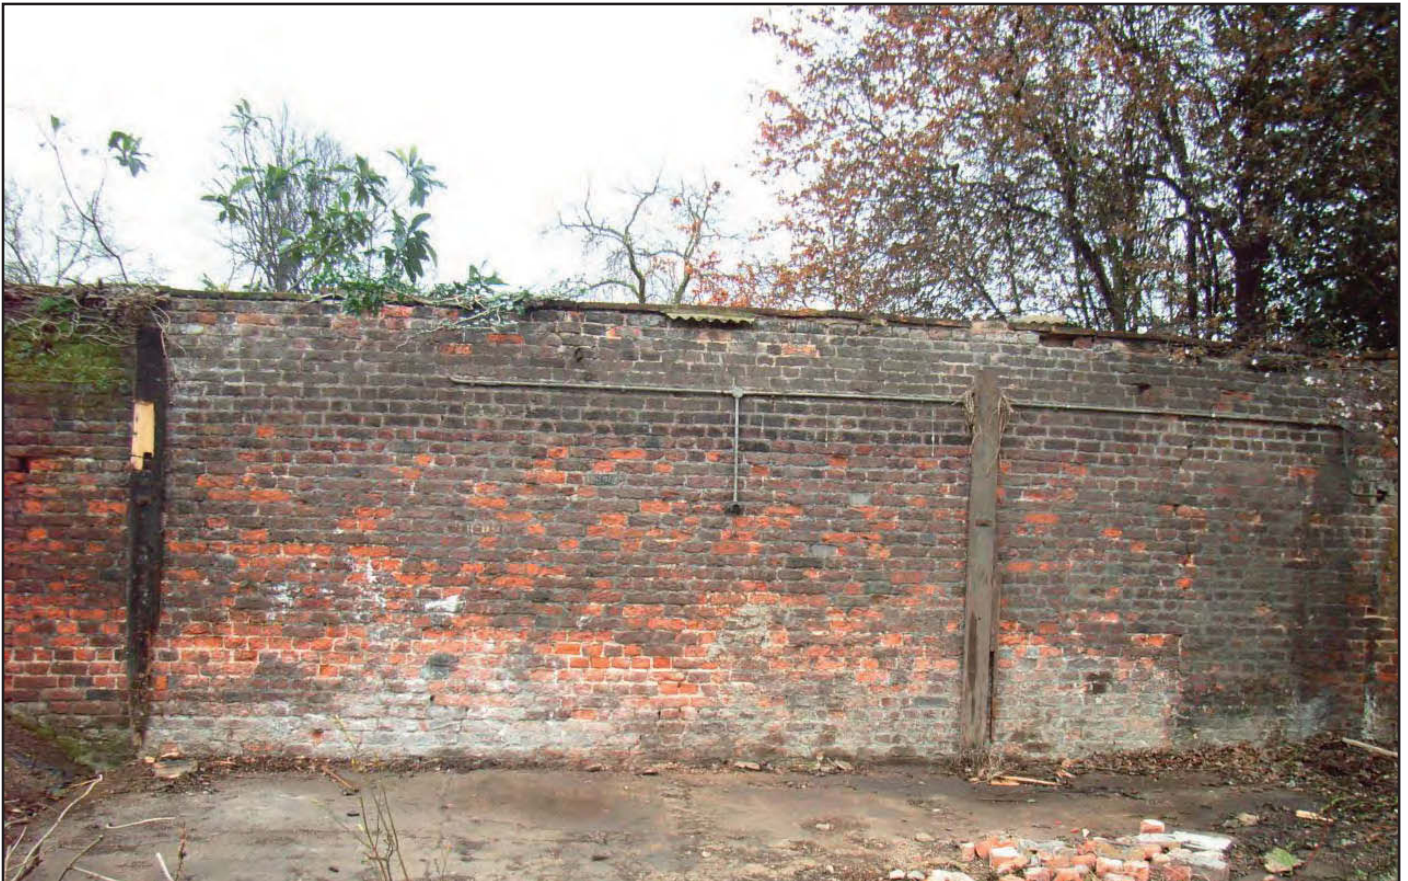
- 5.3.6 **Wall 2** forms the south-east side of the Kitchen Garden, adjoining the Parterre Garden, and both its form and condition are broadly similar to Wall 1 (Pl. 2-4). The north-eastern end of the wall was taken down in the early 20th century to allow the creation of a new path parallel to the Long Water which truncated the north-eastern end of the Kitchen Gardens. This path is shown on the 1939 OS map (Fig. 7). There are also other sections in poor condition but the main c.65 m remains intact. The primary fabric largely survives and it is formed from irregular, soft, handmade bricks without frogs. The bricks are a red/maroon colour on the outer face but an orange colour on the inside (where some have lost their face) and they measure 19.5-23 cm x 10-11 cm x 5.5-7 cm. There is no consistent brick coursing used; there are patches of English Garden Wall bond but in other areas there are whole header courses and many half bricks.

Plate 2: NW side of Wall 2a showing evidence of former lean-to's

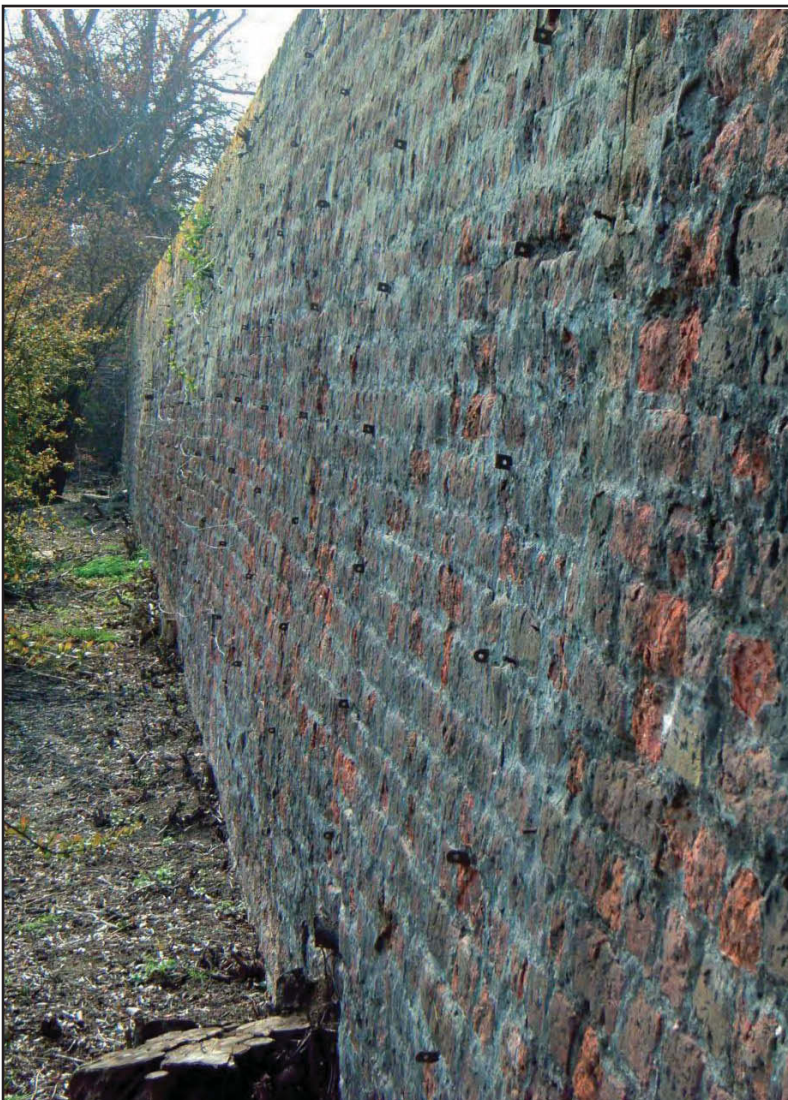
Plate 4: SE side of Wall 2 showing ash-rich repointing

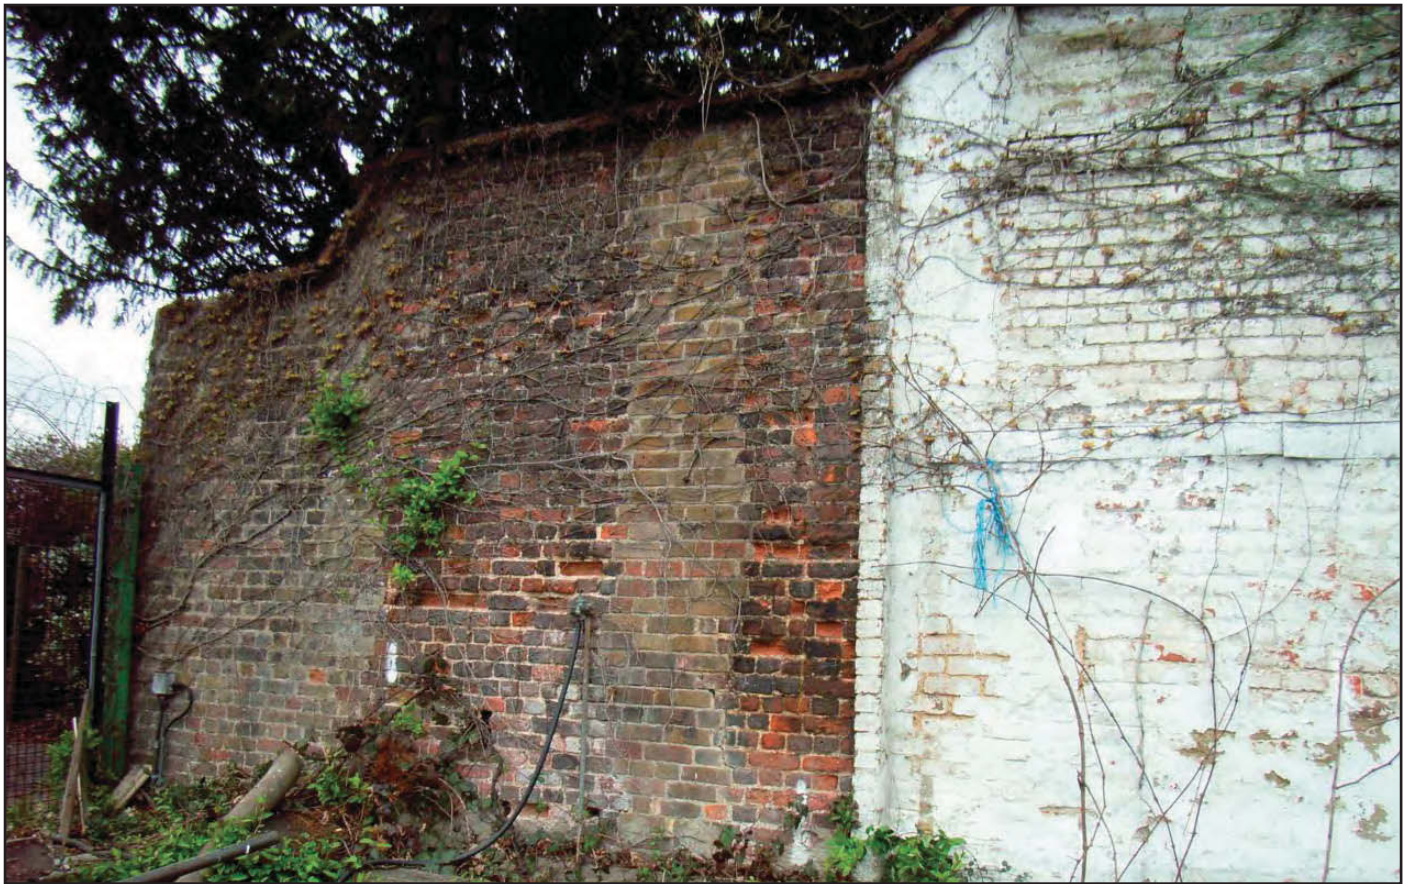
Plate 5: Pier of rebuilt brick towards centre of Wall 1 (Flue 1)

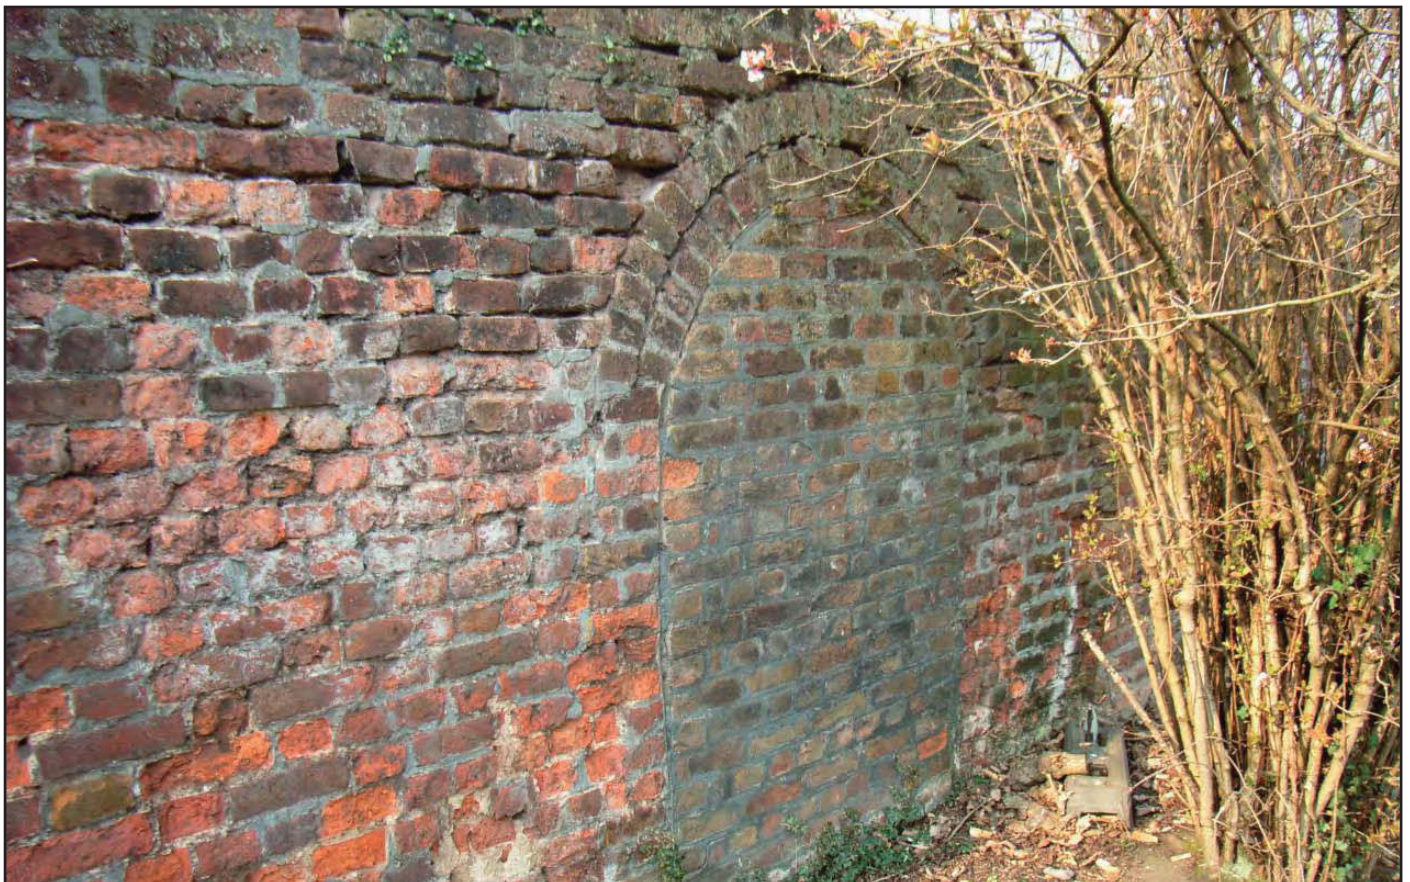
- 5.4.2 **Walls 4 and 5** are 35.5 cm thick, largely constructed of primary (1720s) soft red bricks and they form the south-west and south-east sides of the Parterre Garden (Pl 6 – 7, Fig. 9). The bricks measure 23 x 10-11 x 6-7 cm and the mortar is pale, creamy and relatively coarse with substantial grit inclusions. The bond is largely a Flemish variation bond and at the south end, where it appears to be full height, the wall is c.2.9 m tall. The upper courses of Wall 4 represent a secondary raising or repair of the structure and the brick is slightly yellower and slightly harder than the primary fabric. The join between the two phases of wall is clear at the north-east end but at the southern end it is hard to distinguish, possibly because some early bricks were also used in the later raising/repair. At the southern end (over the door) the later brickwork is only 4 courses high but at the mid wall it extends to seven courses and then reduces again to five courses towards the canal. This brickwork appears to be contemporary with four 19th-century buttresses on the south-east face of Wall 4 and both the buttress and the upper courses may all represent alterations undertaken in c.1870 when the Rose Garden was added by Sarah Ingleby.

Plate 6: Infilled doorway in Wall 4

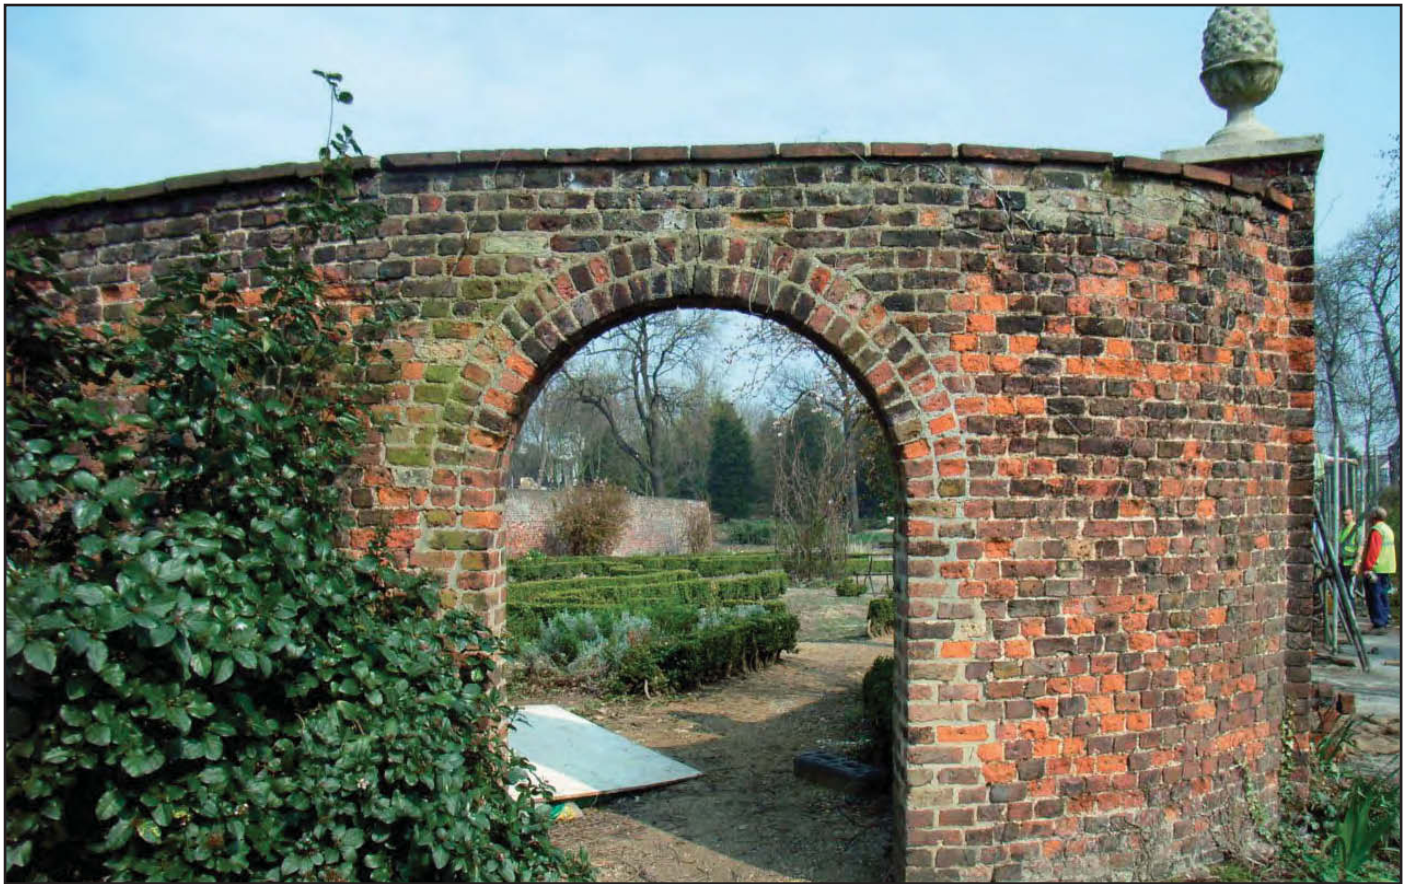
Plate 7: Secondary (early 20th century) doorway at corner between Walls 4 and 5

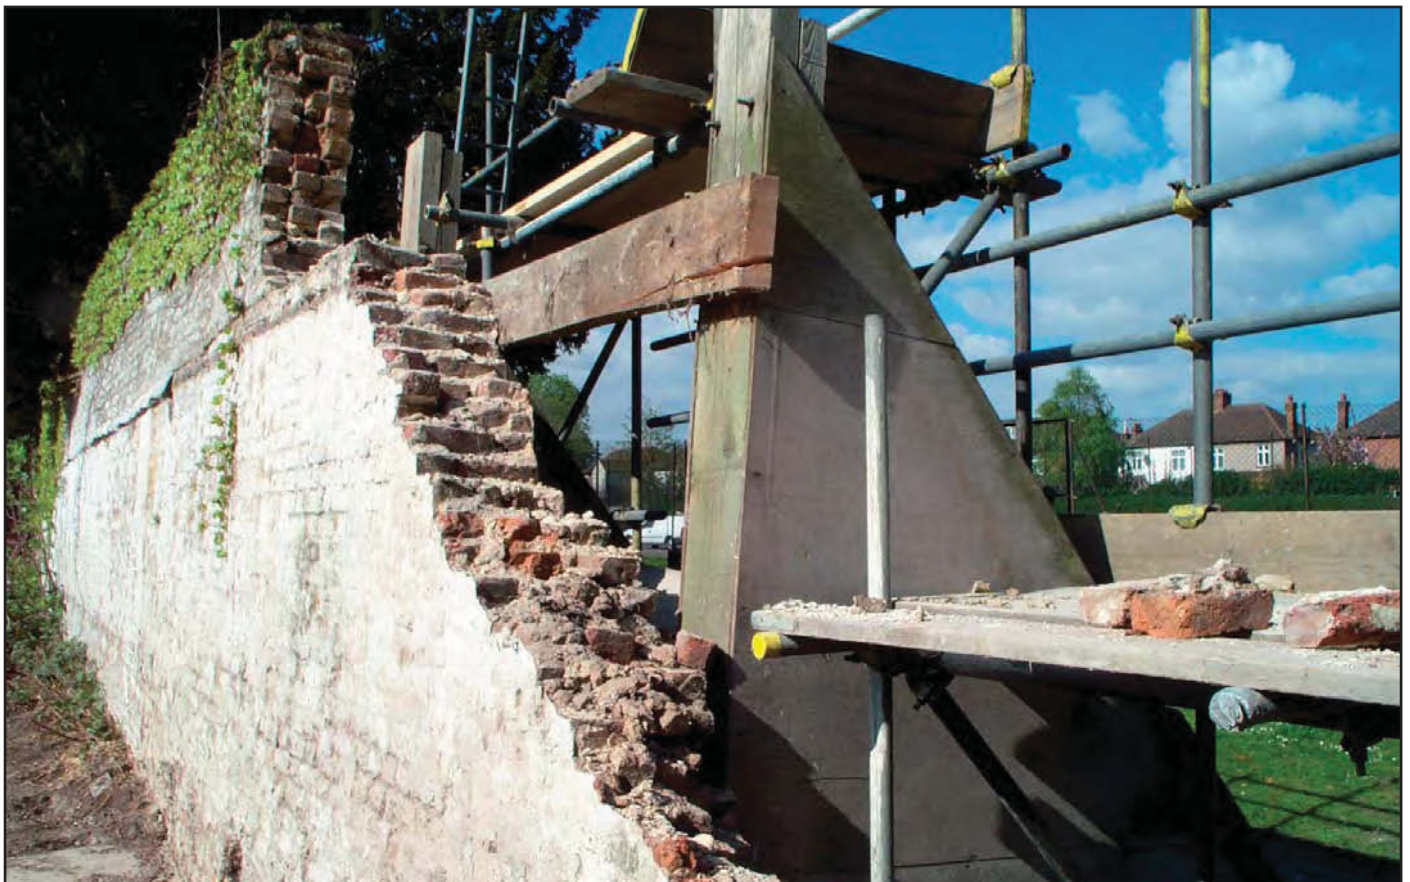
Plate 8: Wall 1 (NE end) during reconstruction

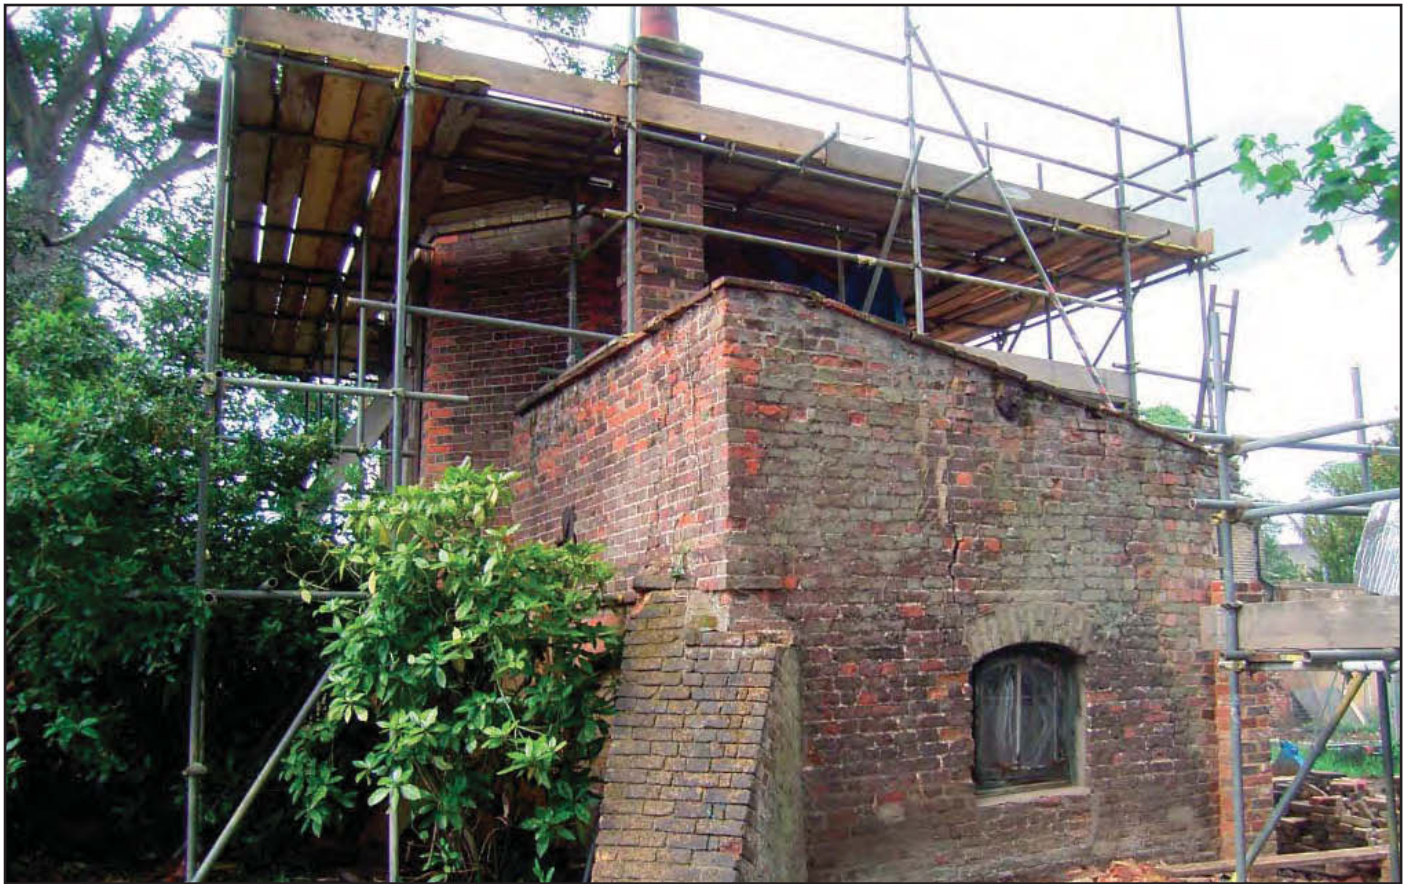
- 5.5.4 The south-east elevation is constructed from plain brickwork of a rough character, without any systematic bonding and with substantial cracks (Pl. 11). There is an iron tie-plate towards the roof ridge, many areas of patching to the wall and a low, thick buttress has been added to the western corner of the building (Pl. 12). This buttress uses hard yellow bricks and is probably of later 19th century date. The brickwork in the main south-east wall appears of 18th-century date and its poor quality is suggestive of a utilitarian garden building where appearance or longevity would not be principal concerns. The elevation incorporates a 2-light window beneath a segmental brick arch.

Plate 11: SE elevation of Dovecote with 18th-century brickwork at ground floor

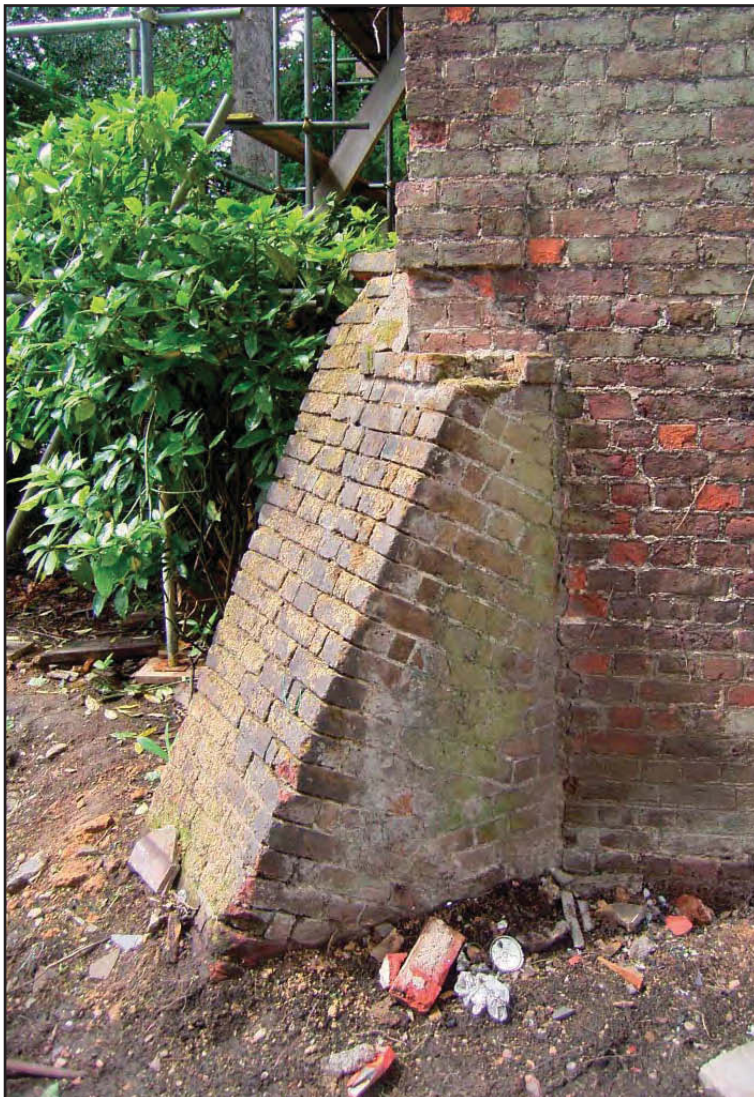
Plate 12: Later 19th-century buttress at south corner of Dovecote

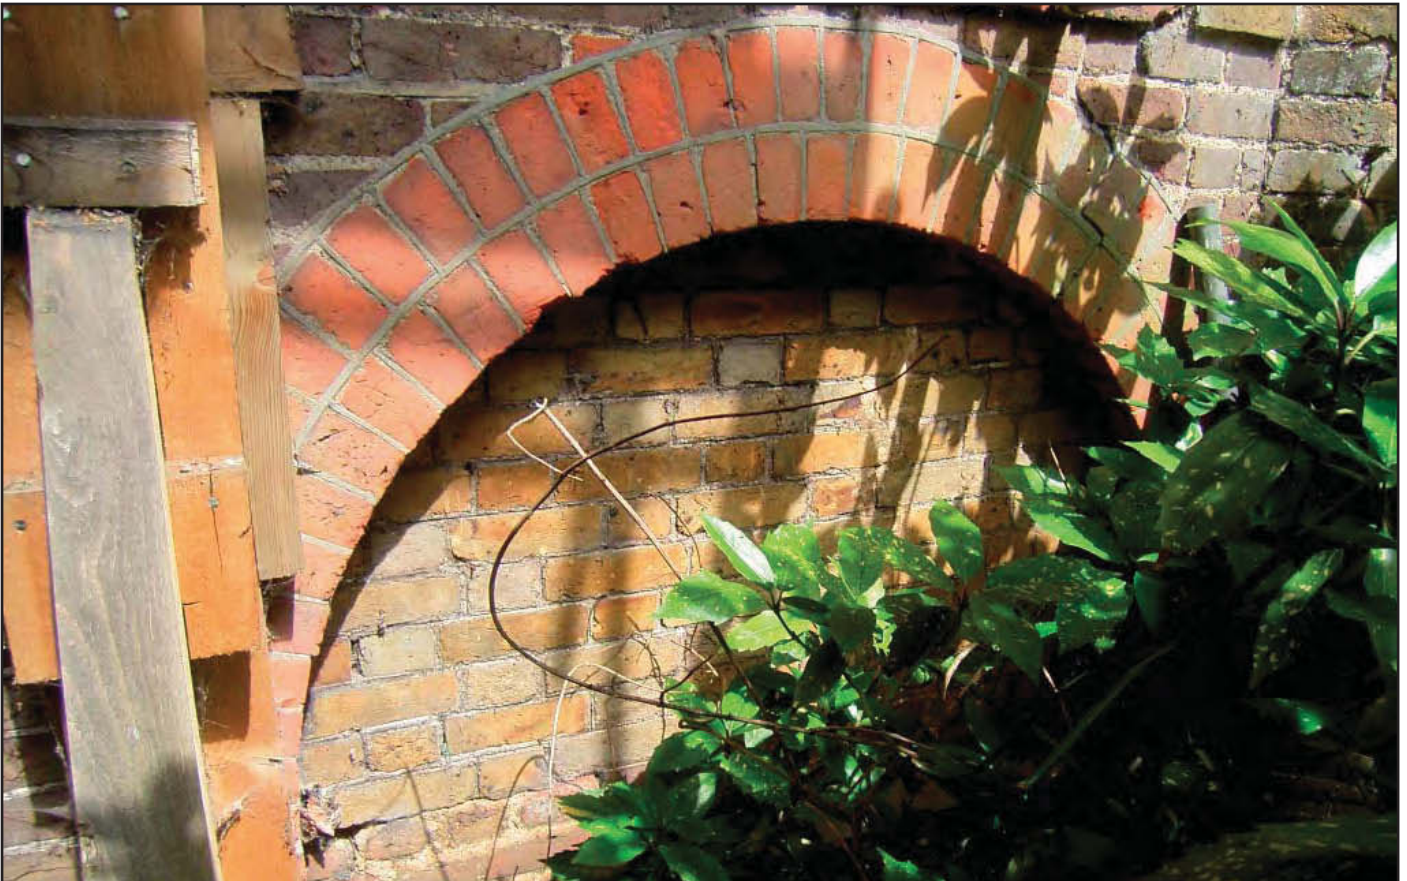
Plate 14: Blocked arch in SW elevation of Dovecote

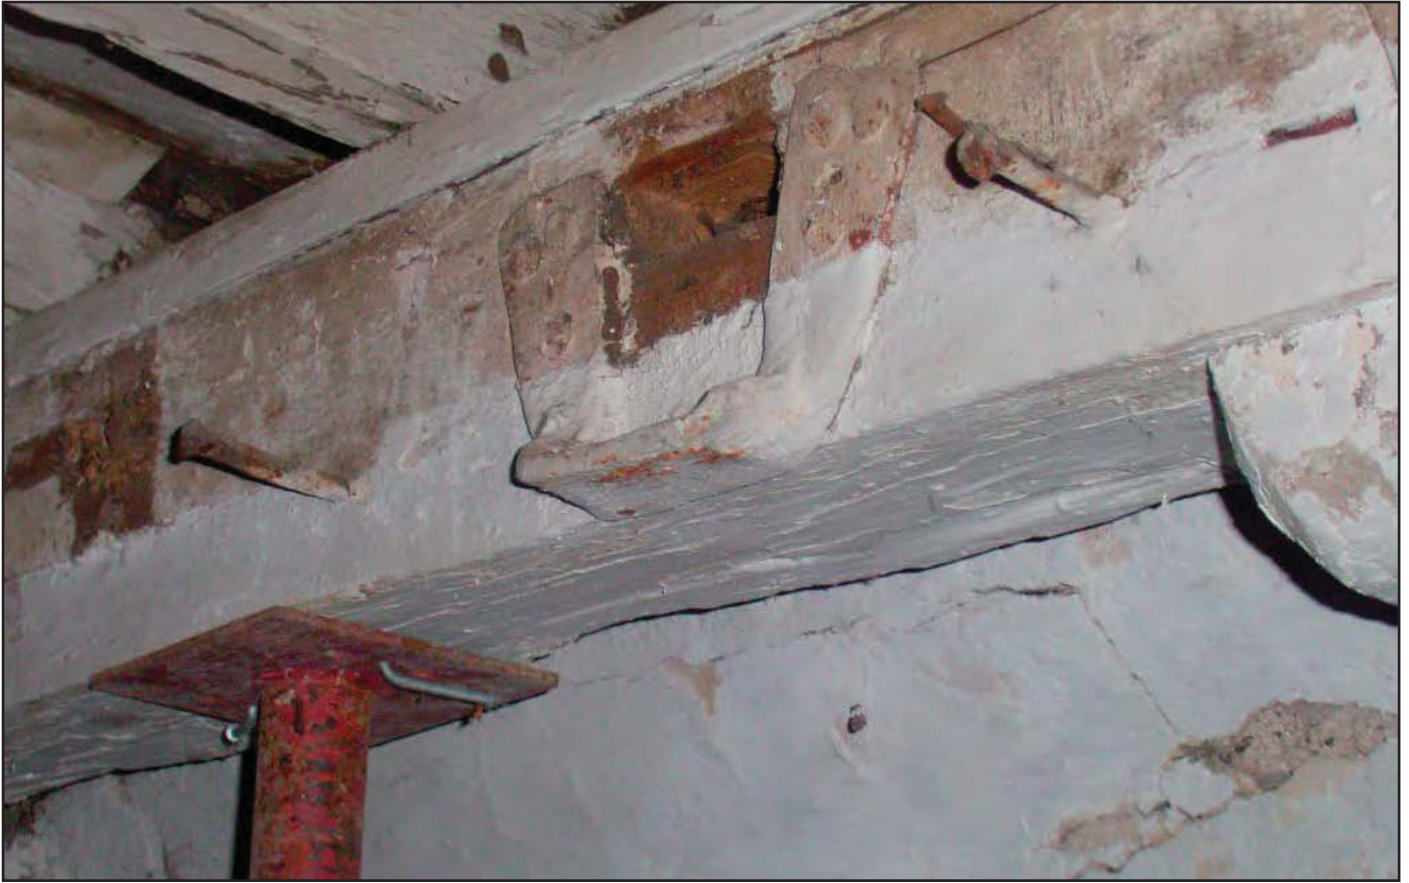
principal joist and an iron strap has been nailed beneath one of the holes to add additional support. The principal joist is now supported by two corbelled timbers set into the wall. This structural re-arrangement may have been a rather crude temporary solution to structural failures or it may relate to the creation of former openings between this area and the secondary lean-to. The north-west and south-east internal walls of the Dovecote's ground floor each comprise a wide semi-circular arch which support the octagonal first floor structure. The arches measure approximately 2.85m wide and 1.95m high although that to the SE has been partially infilled with a central doorway. The walls are plastered and painted white. The ground floor has a concrete, brick, and flagstone floor and a trench dug by contractors through the floor of this structure made visible foundations of soft red/orange brick with cream coloured lime mortar approximately 0.5m down from the existing floor level.

Plate 21: Sockets in principal joist of Dovecote central room

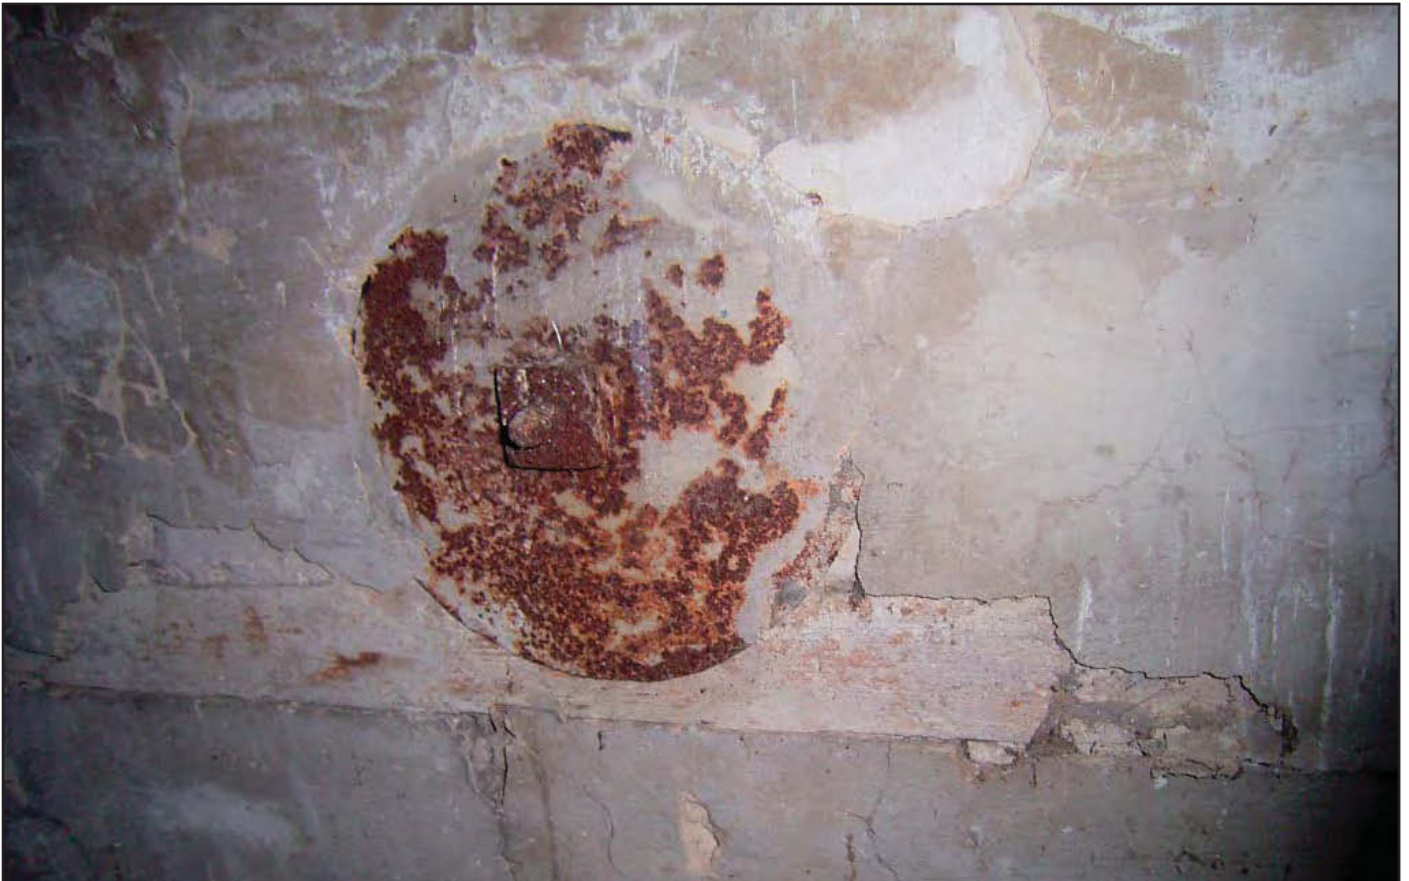
Plate 22: Tie bar plate in Dovecote

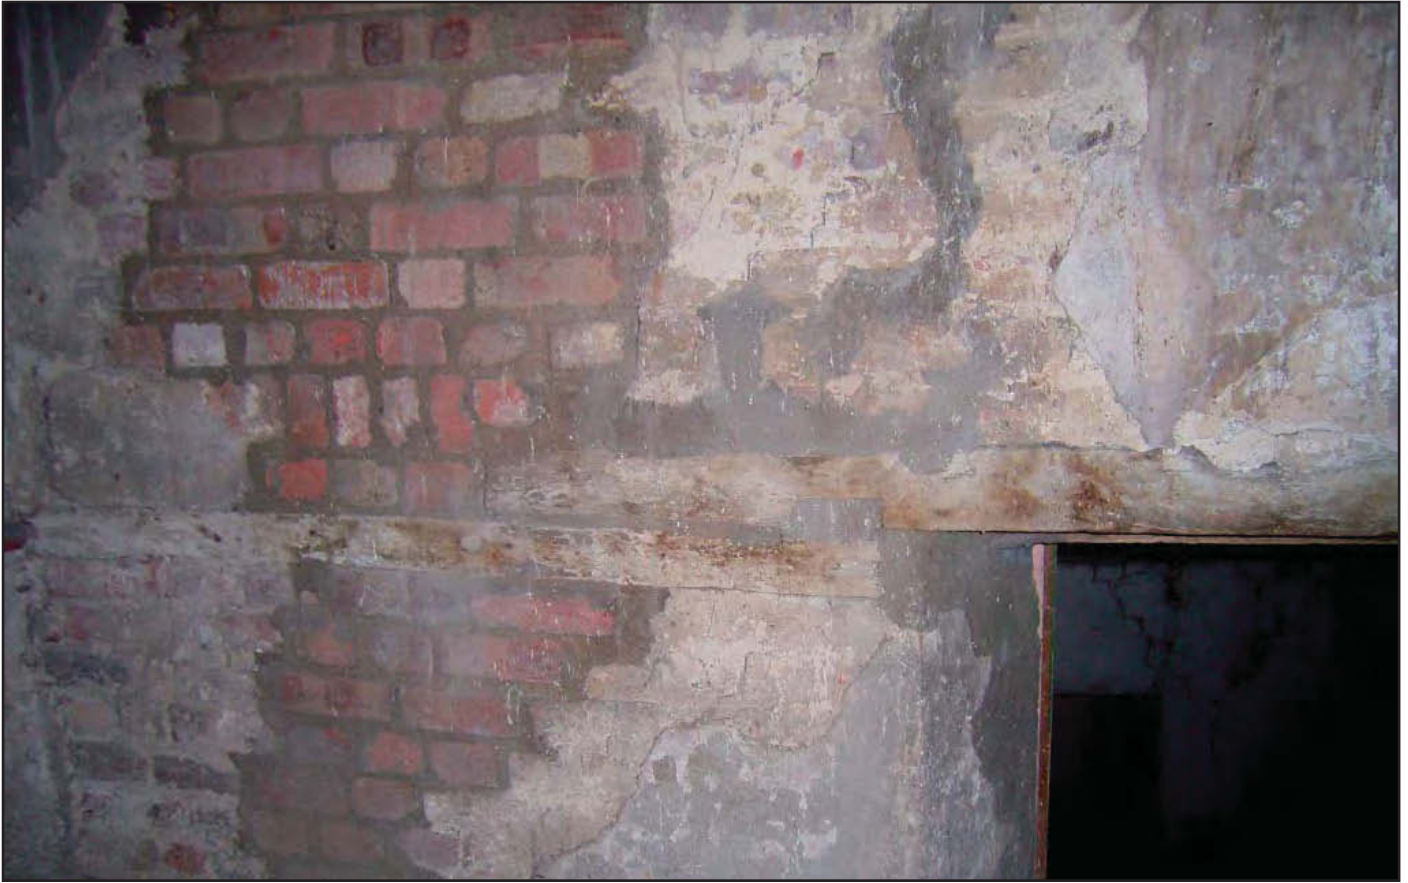
- 5.5.12 The walls are all plastered although this has come away in limited areas to show that a lower quality of brick was used on the internal faces than the external. There are some patches of repair including a large area of modern brickwork in the north-west wall, adjacent too the hatch, which rises in an irregular 'pier' towards the wall-plate (Pl. 29).

Plate 29: Repairs in internal walls of Dovecote

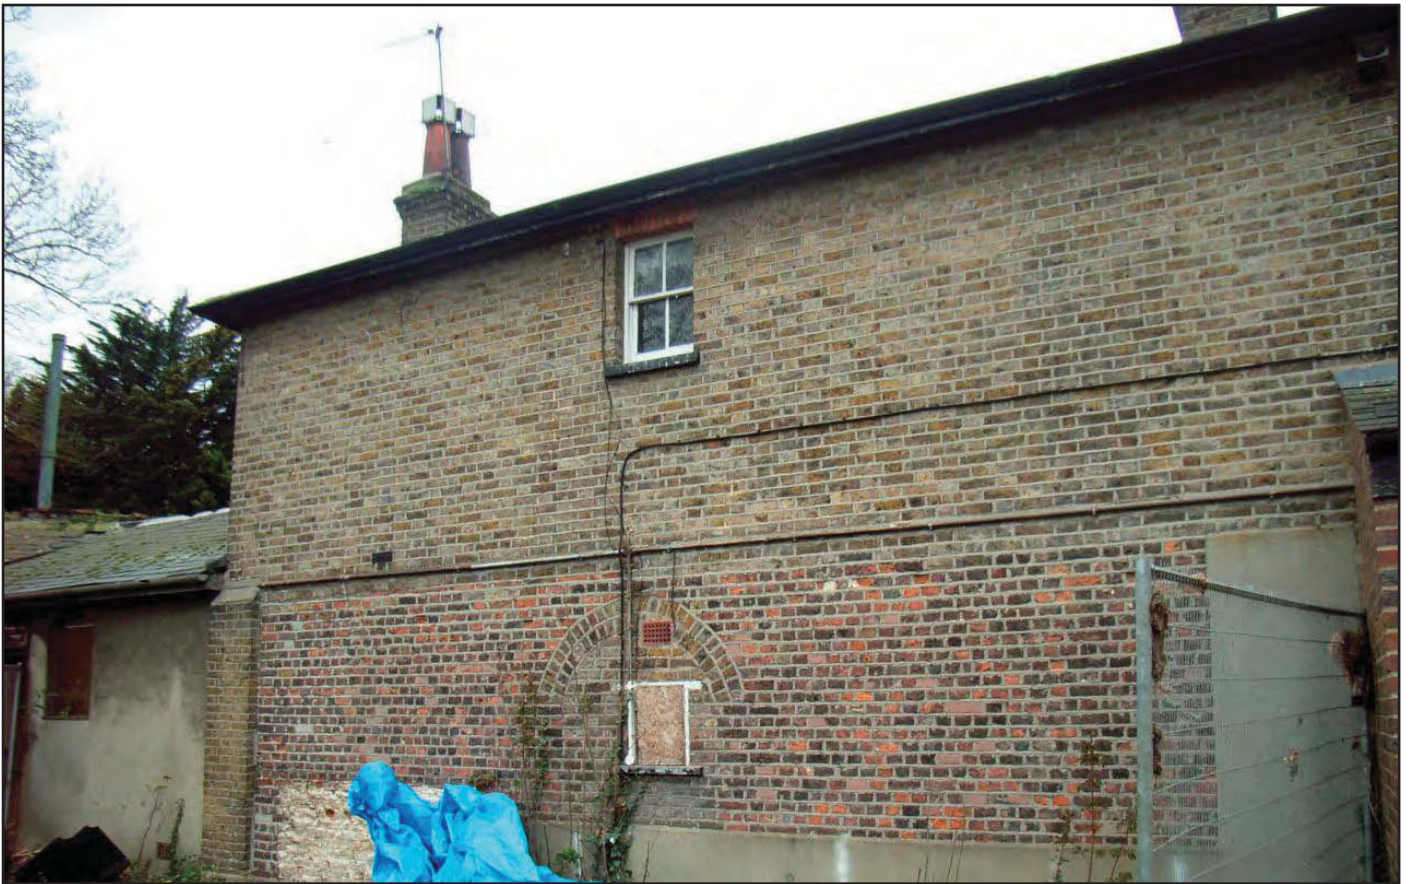
Plate 33: SE wall of Cottage showing 18th-century brick below 19th-century

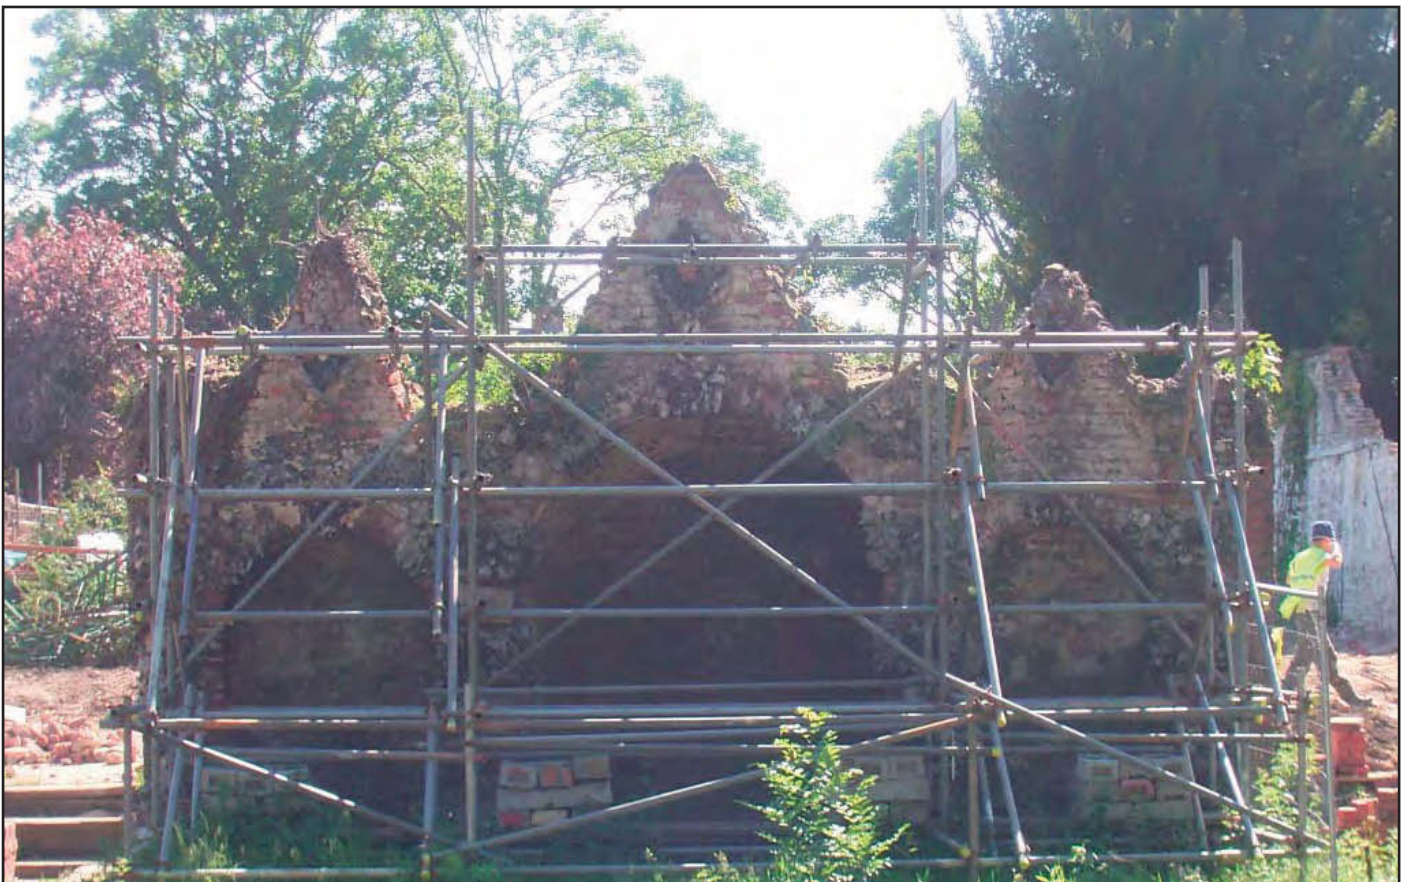
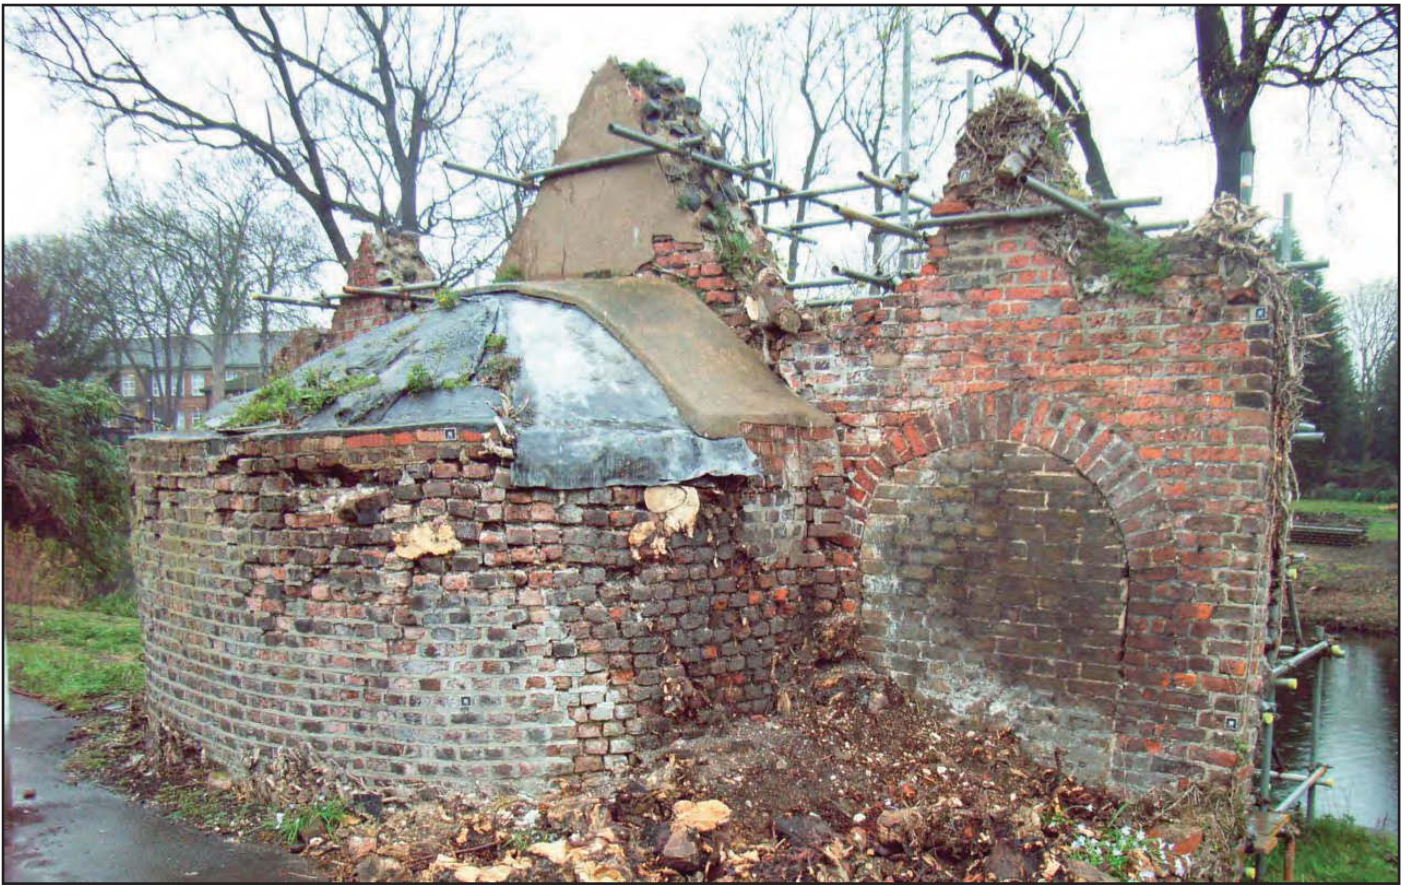
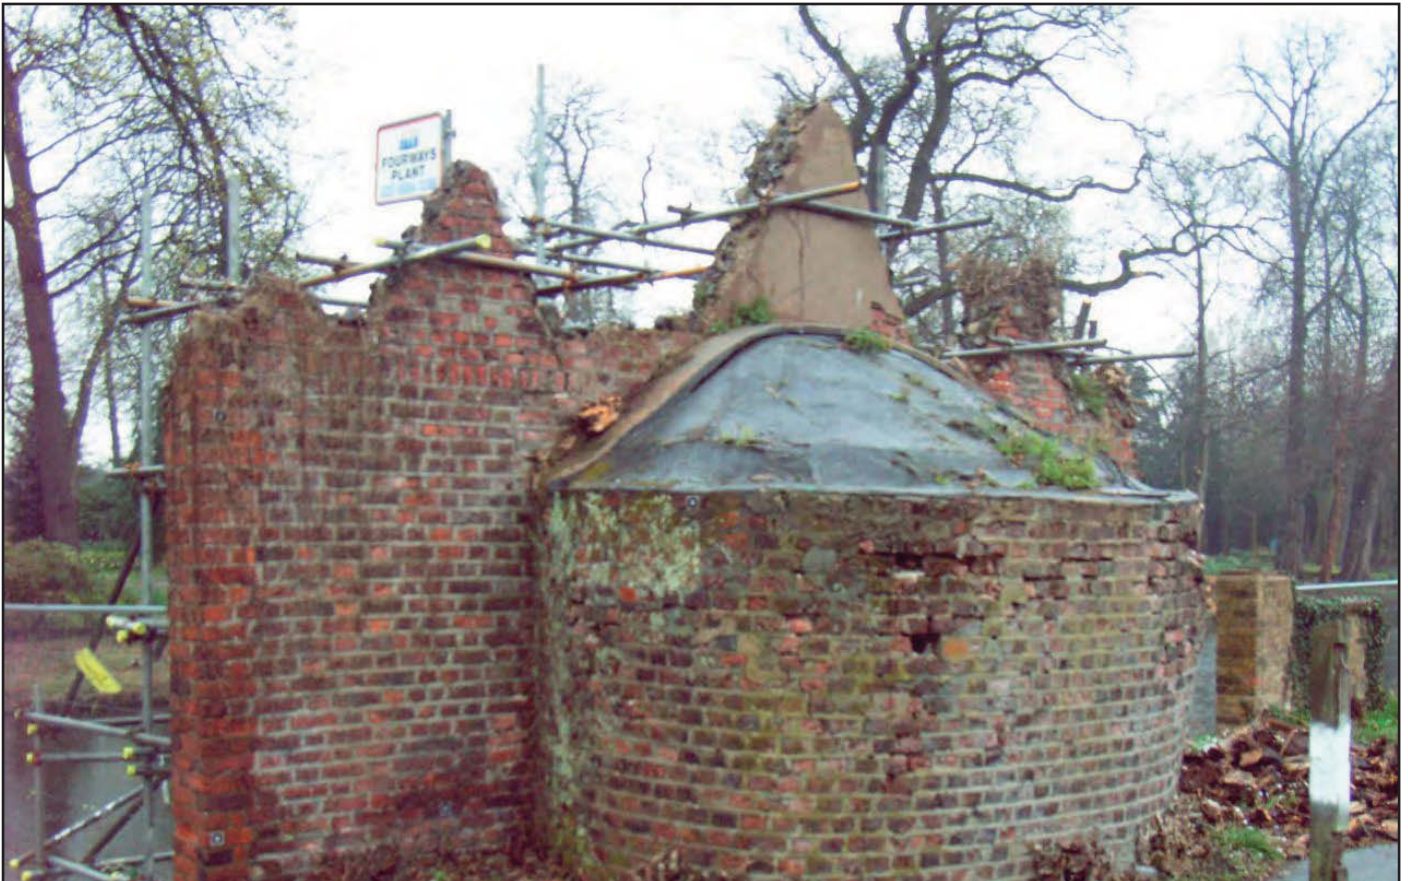
- 5.7.1 The Alcove Seat forms part of the early 18th century designed garden and is located at the north-east end of the Kitchen Garden within the largely collapsed Wall 6 (Pl. 40-42, Fig. 12-13). The structure would have formed a romantic eye-catching folly facing onto the Long Water and forming part of a group of similar, probably contemporary structures with the two grottoes and Jacob's Well.
- 5.7.2 Prior to the current restoration works the structure had become isolated due to the collapse of the surrounding walls and its condition had deteriorated severely by neglect and ill conceived 20th-century restoration works. The structure has a serious lean towards the north-east and scaffolding supports its north-east face.

- 5.7.5 The principal north-east front of the structure which faces onto Long Water is partially clad in decorative flint and shells, set in mortar, although many areas of this have come away to reveal brickwork behind. The face would have been given a classically inspired rustication with bands of flint and render to the piers between bays and the arches. The flintwork extends along the ridges and the whole elevation has an encrusted appearance.

- 5.7.6 The south-west rear side (facing the walled garden) is very plain in comparison with exposed brickwork and no romantic decoration. The brickwork appears to be largely primary although there have been repairs in patches and the rear of the main 'gable' is rendered. At the top of the main section of wall, but below the height of the gables, is a soldier course. The north-west end of the wall is capped with secondary brickwork presumably dating to when the main wall collapsed and the general condition of the wall is very poor, partially resulting from vegetation which covered the structure prior to the current works. There has clearly been a fire against the south-east side of the recess and there is much charring against both this wall and the adjacent section of the main wall.

Plate 40: Alcove Seat from NE before start of works

Plate 41: Rear SW face of Alcove Seat

- 1.3.6 **Alcove Seat:** A new buttress was constructed within the Kitchen Garden to stabilise the Alcove Seat. Stainless steel straps, rods and plates were also inserted in appropriate locations and the structure tied into the new wall. The roof to the central alcove was replaced with a new slate roof after the brick structure had been repaired and consolidated. An existing opening in the wall from the Kitchen Garden to the south of the Alcove Seat was not replicated in the new wall and the original accompanying steps were removed.
