Valentines Park Ilford

London Borough
of Redbridge

**Historic Building Recording and
Archaeological Watching Brief**

April 2009

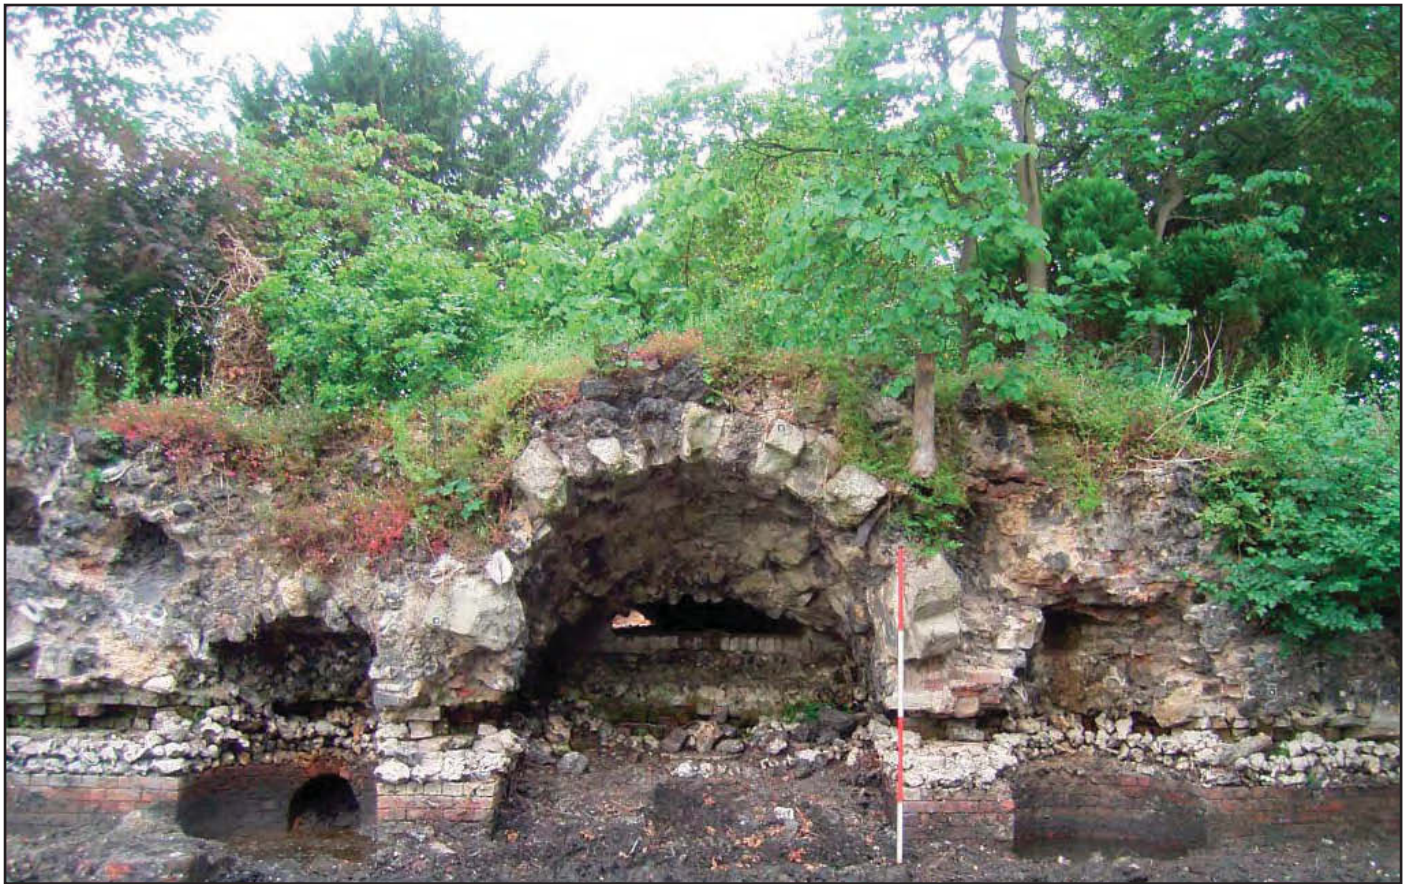
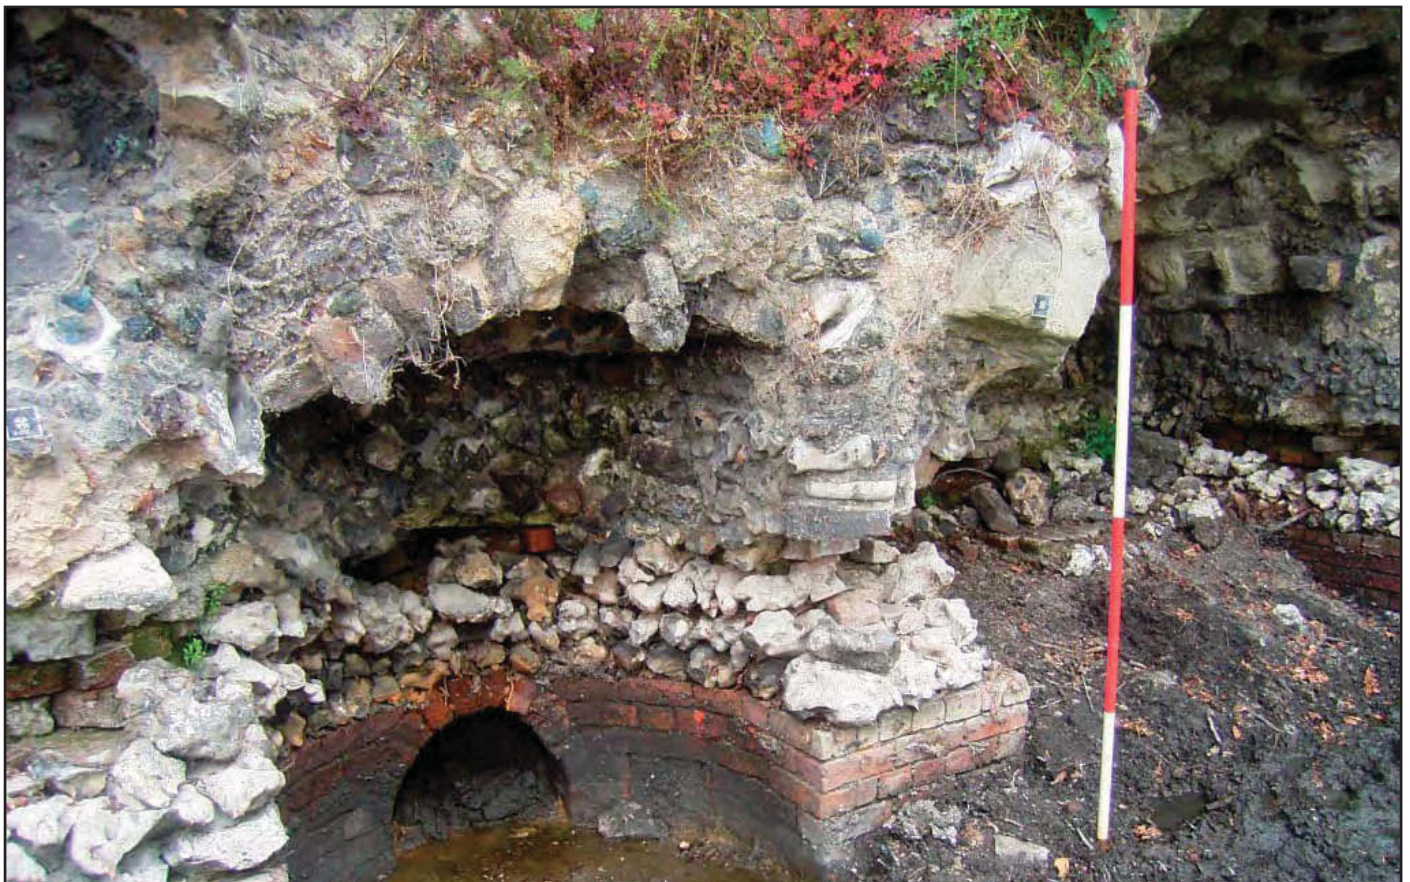
- 5.8.2 There are no clear indications of different phases other than re-pointing work. Re-pointing is patchy and sporadic and uses a number of different mortar types suggesting that it was repaired as and when necessary. It is difficult to attribute each mortar type to a specific phase however there are patches using a dark ashy grey mortar which suggest at least some of the repair work was carried during Phase III, mid to late 19th century.

Plate 43: North Grotto

Plate 44: Detail of North Grotto

- 1.3.7 **North Grotto:** There are grottoes at either end of the Long Water through which water flows. Limited repair and consolidation works were undertaken to the grotto at the north end including concrete underpinning, re-pointing, vegetation clearance and the re-laying of turf to the upper surface. The grotto at the south end of the Long Water is in need of major repair works but this was not included in the current restoration. It would be desirable for a programme of recording and restoration work to be carried out on this feature in the future if the opportunity and funding arose.

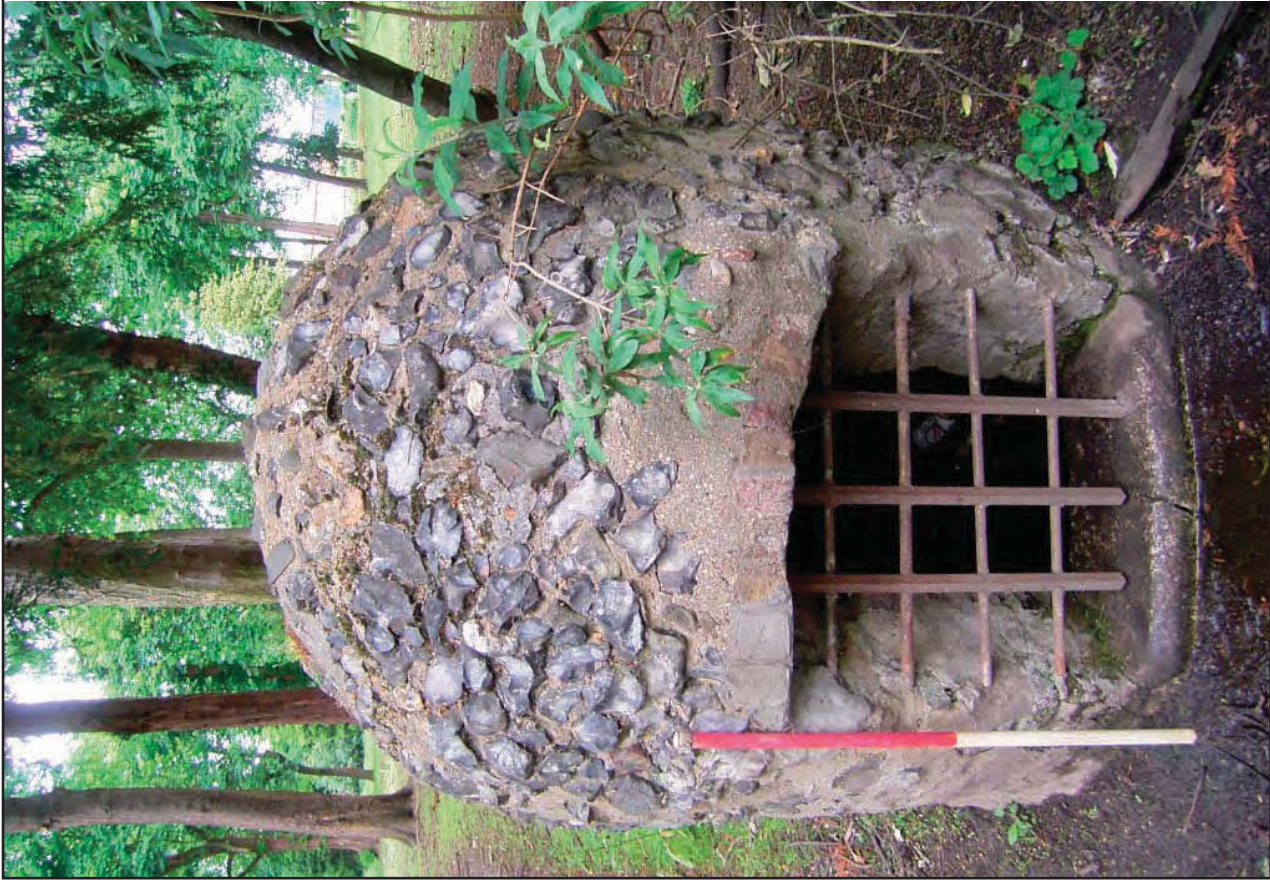
- 5.9.4 The date of its construction is not known for certain but its romantic design suggests that it is an 18th-century feature from the Rococo garden contemporary with the Alcove Seat and Grotto. The cement mortar used with large grit inclusions suggests that the structure has undergone considerable repairs since the park was purchased by the council in 1924. The condition of the feature is poor and it has suffered from the misguided use of cement mortar in the repairs. In areas this has cracked and come away from the main structure to reveal patches of the brickwork behind.

Plate 45: Jacob's Well

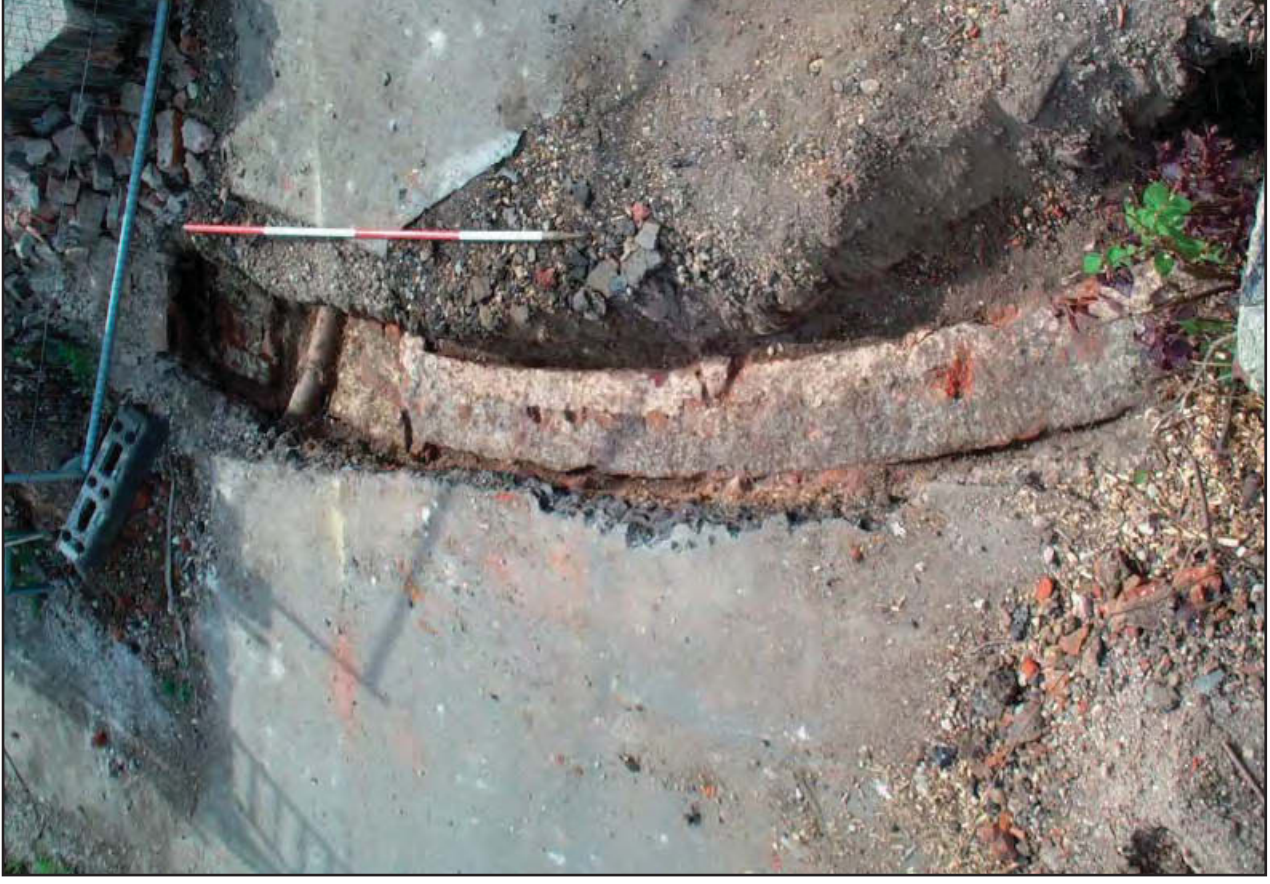
Plate 46: Footings from curved NE end of Wall 4 exposed during works

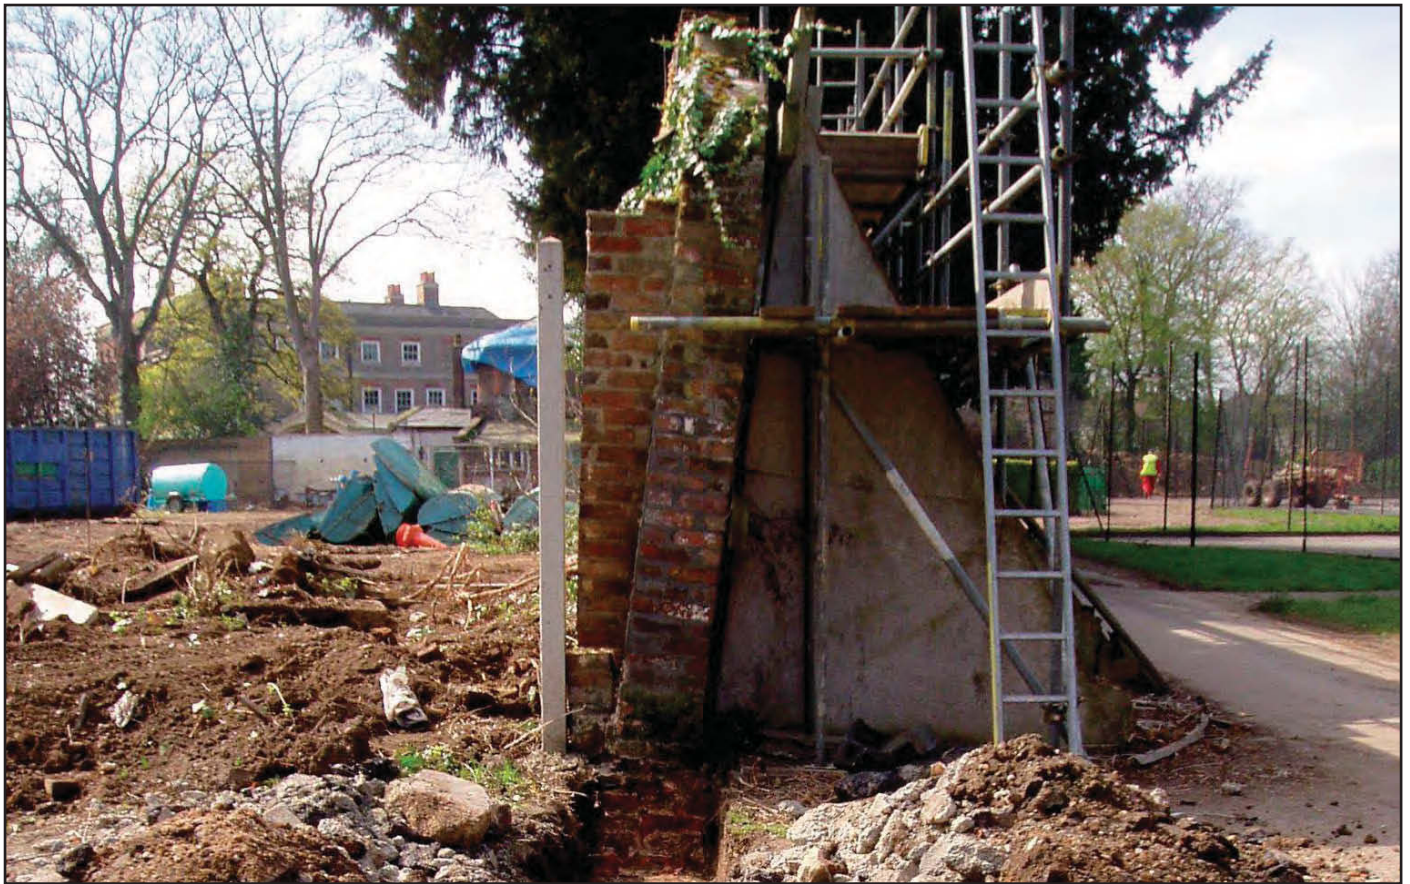
Plate 47: Footings from NE end wall of Wall 1 exposed during works

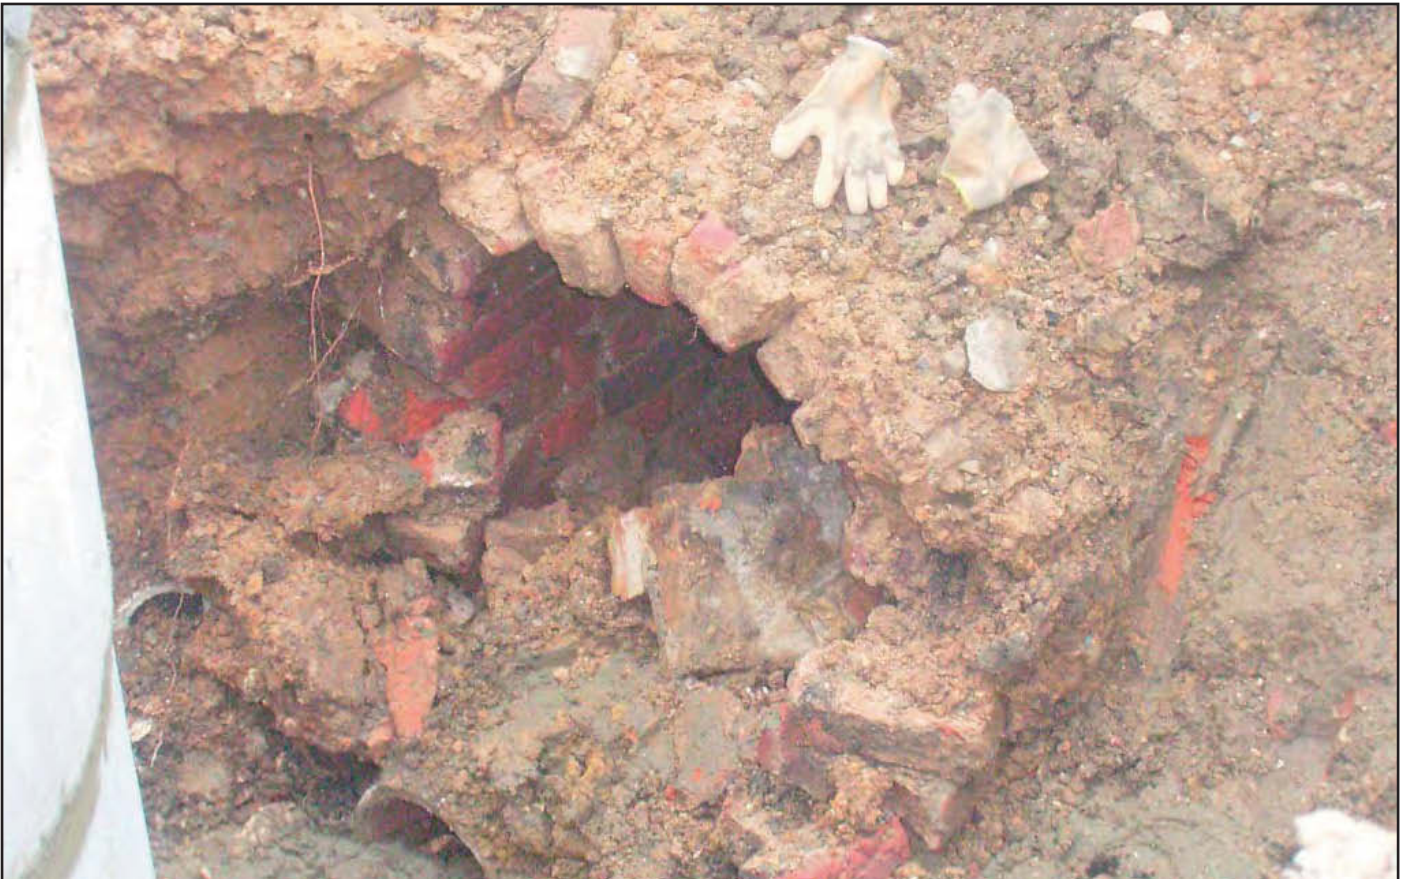
Plate 52: Culvert (5035) in Trench 33 adjacent to house

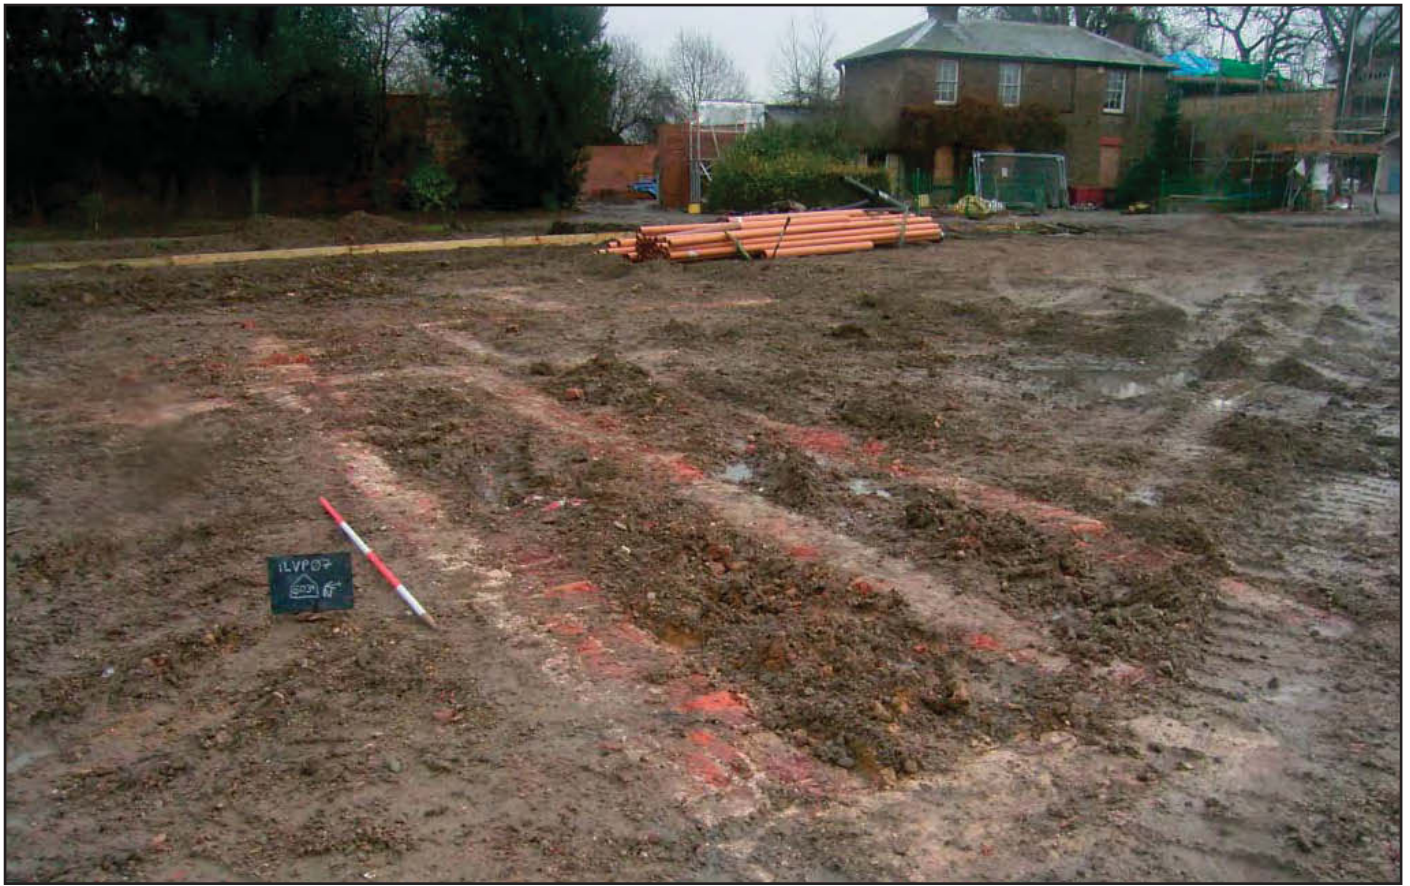
Plate 53: Footings (5034) exposed in Tennis Court Area viewed from north

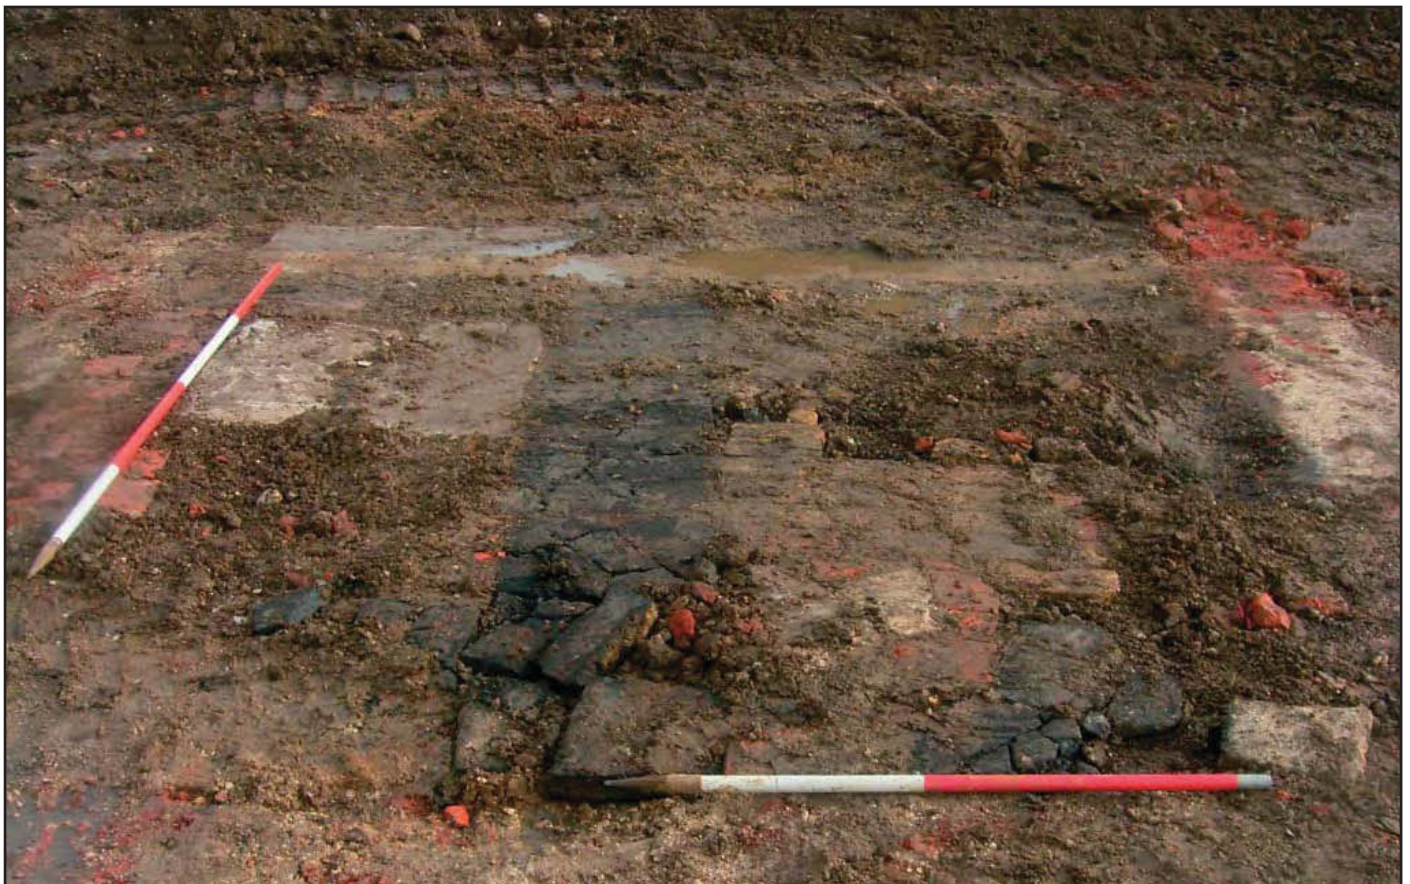
Plate 54: Footings (5035) of possible former blacksmiths in Tennis Court Area
